EAST AYRSHIRE COUNCIL

# **Local Development Plan 2**

## Dalmellington Conservation Area Appraisal

Non-statutory Planning Guidance

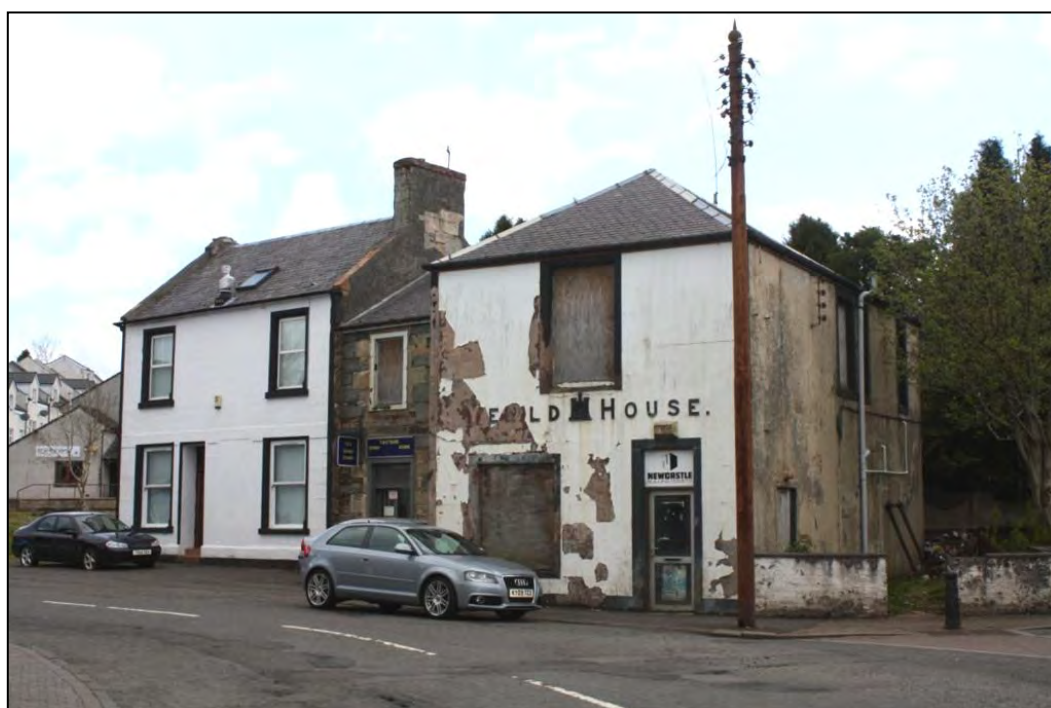
Vacant buildings can quickly deteriorate

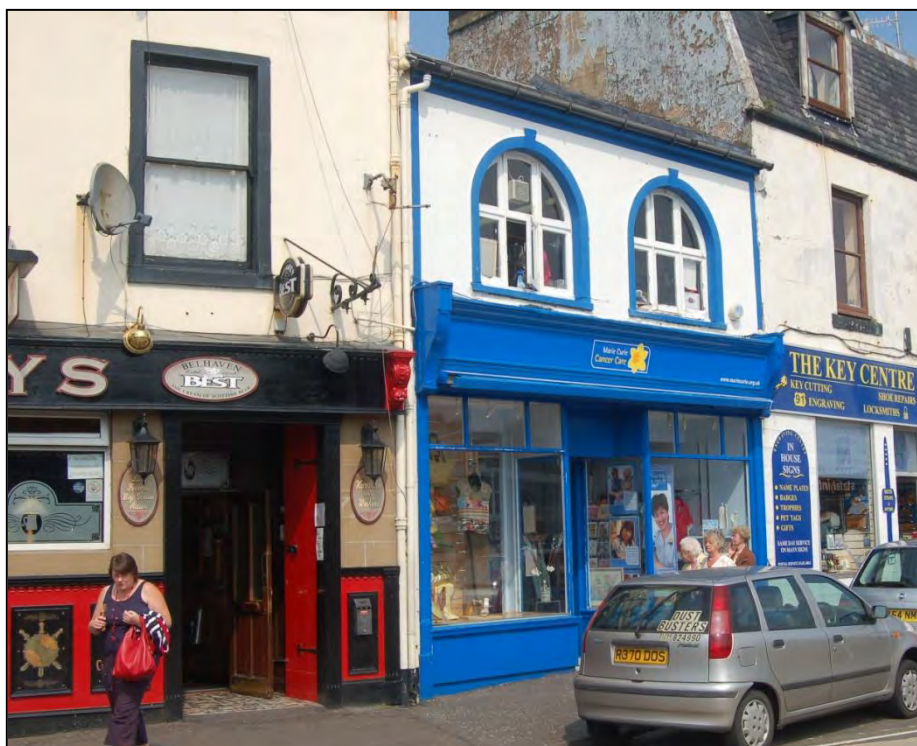
The signs, wires and satellite dish on the left hand building create street clutter and detract from historic buildings and settings

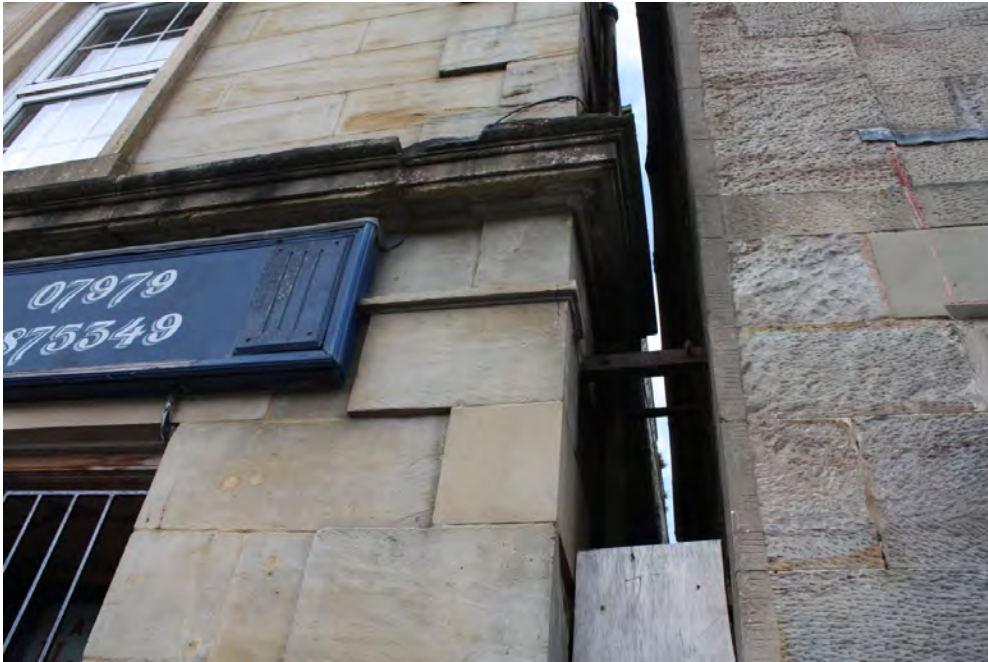
7 Main Street  
Damage evident to stone cornice

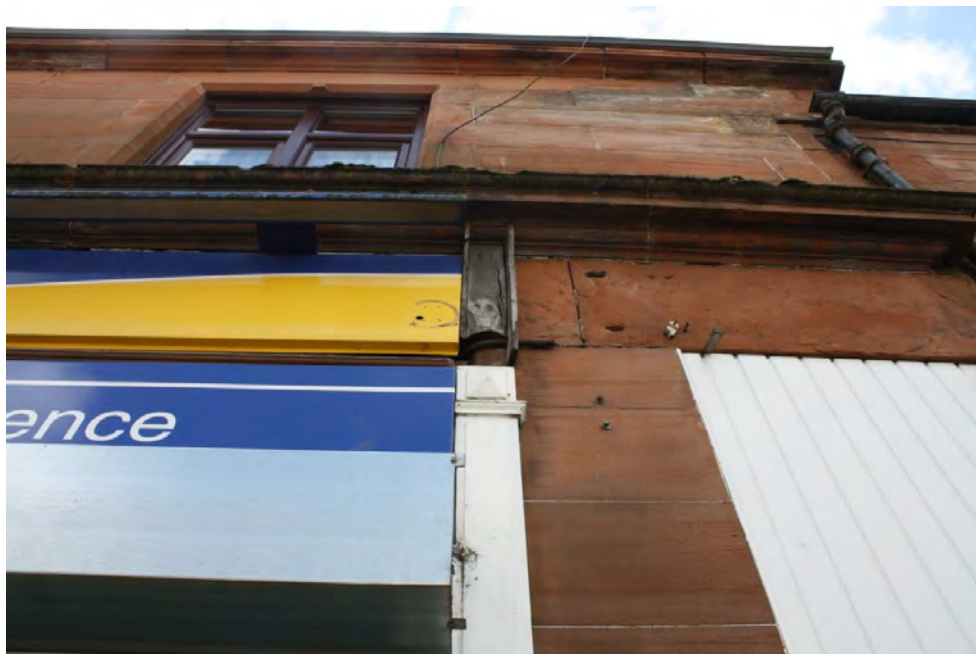
14 Main Street  
Pilaster detail with console bracket above missing

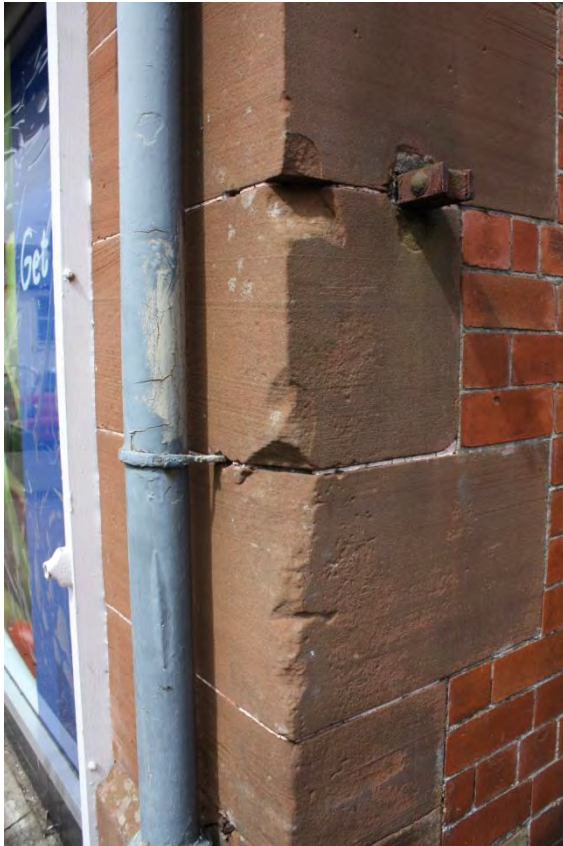
2 Church Hill  
Damage to stonework

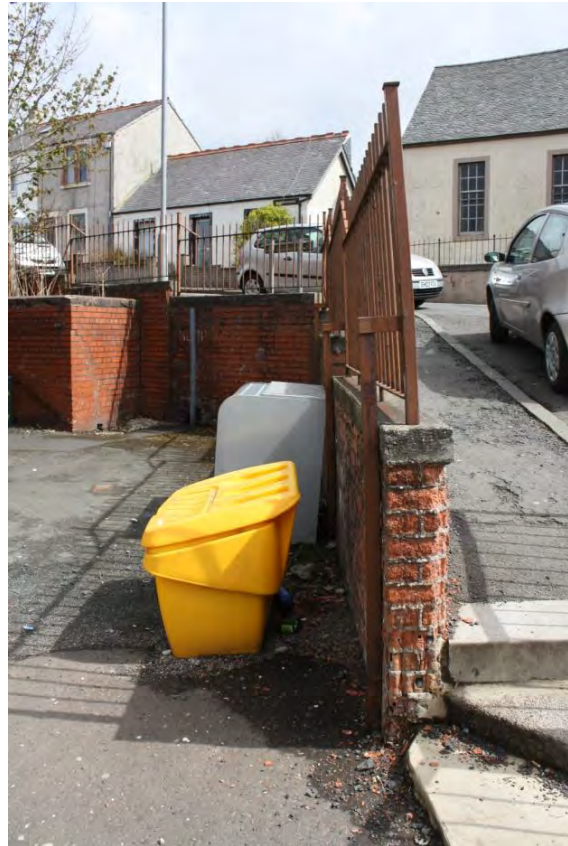
2 Church Hill  
Spalling brickwork on retaining wall

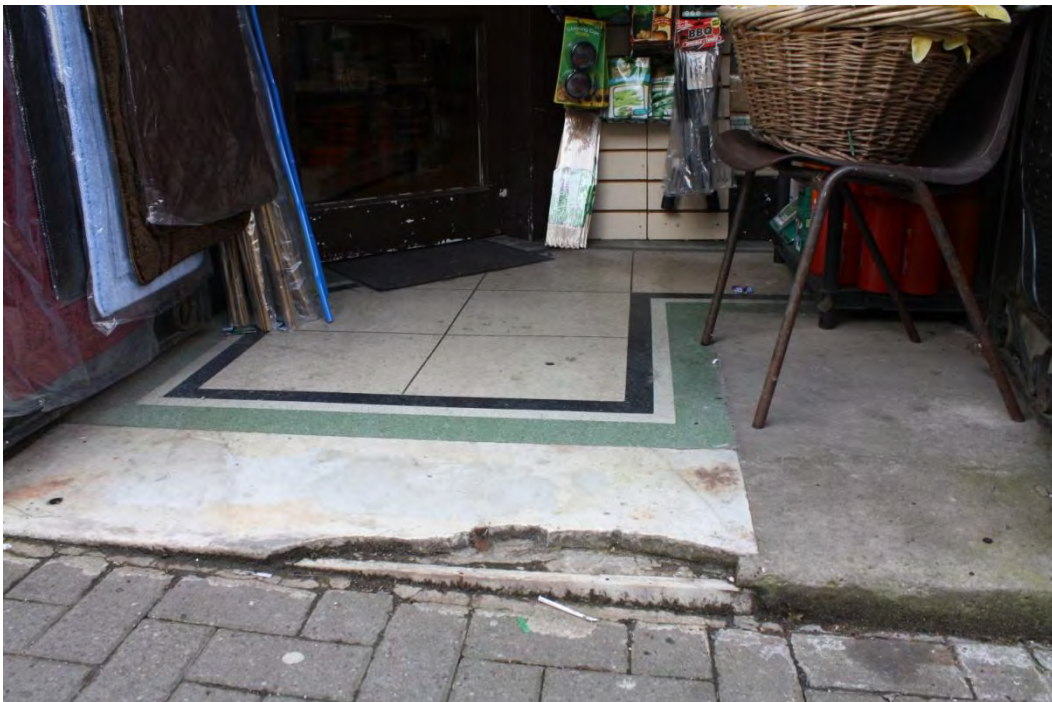
9 High Main Street  
The terrazzo has been damaged

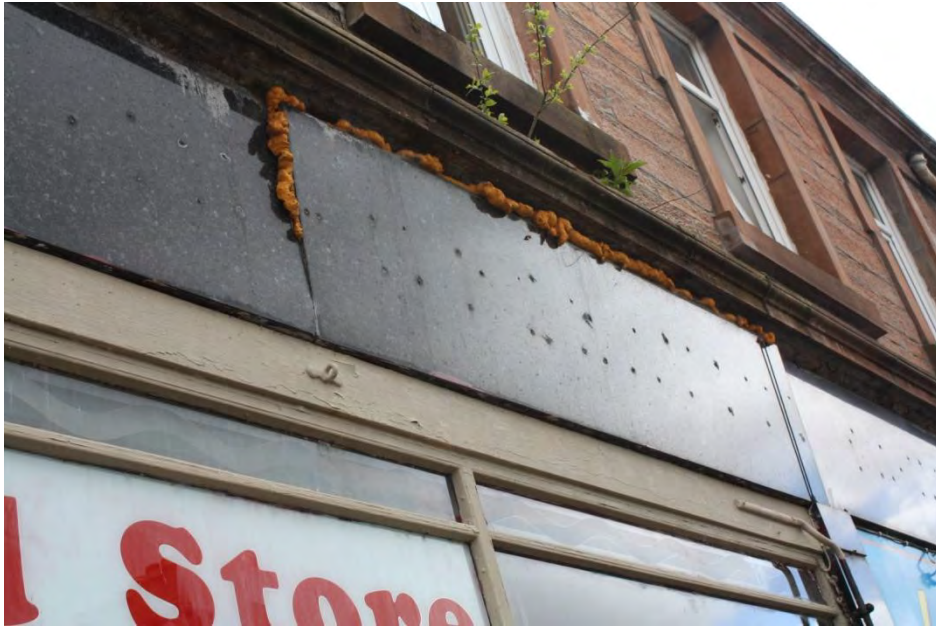
9 High Main Street  
Cladding panel is out of alignment

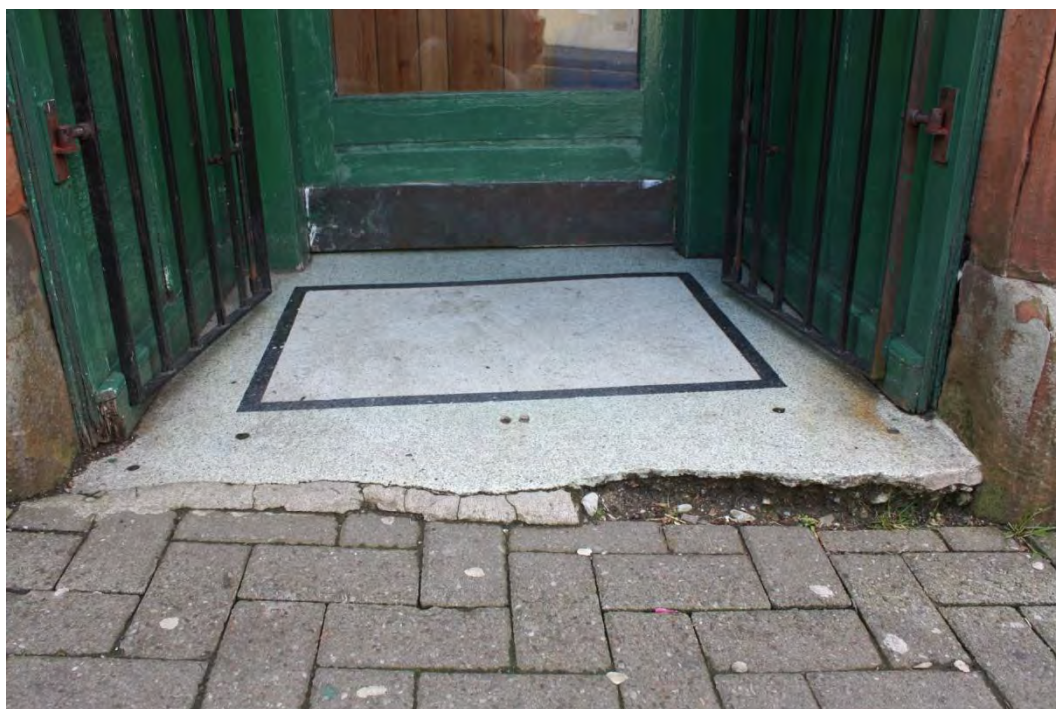
13 High Main Street  
Damaged terrazzo step in lobby

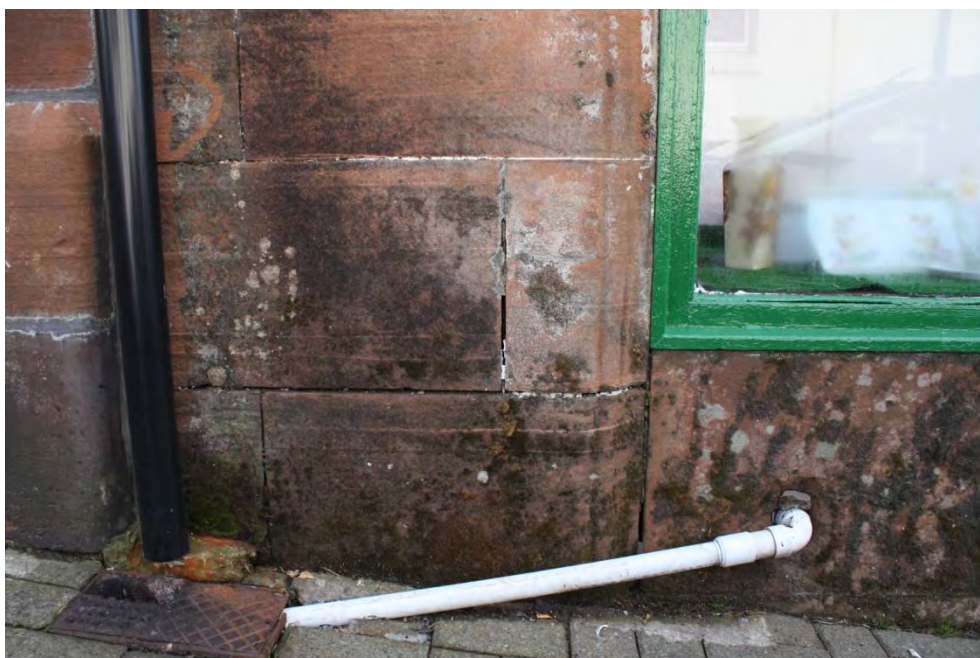
13 High Main Street  
Stonework requires repointing

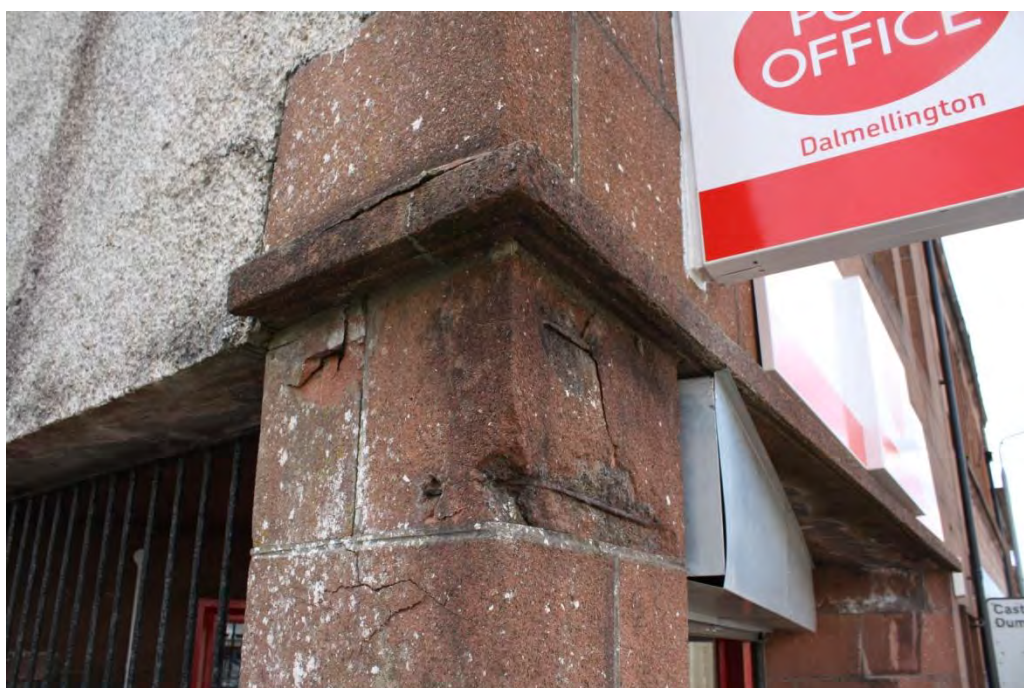
15 High Main Street  
Spalling evident to masonry pillar
