A BUILDING STONE AUDIT FOR KILMARNOCK

**Surveying, matching and sourcing
stone for the built heritage**

EWAN K. HYSLOP, LUIS J. ALBORNOZ-PARRA & EMILY A. TRACEY. 2009. A Building Stone Audit for Kilmarnock: Surveying, Matching and Sourcing Stone for the Built Heritage. *British Geological Survey Open Report*, OR/09/0002.

Surveys of the condition of the stone masonry in twenty-five buildings and structures in the John Finnie and Bank Street Conservation Area in Kilmarnock have provided information to guide forthcoming grant-aided repairs and inform future maintenance strategies. Stone samples from each surveyed structure have been characterised in order to identify the original stone types, and are matched to stone from currently active quarries to ensure that appropriate stone is used for the repairs.

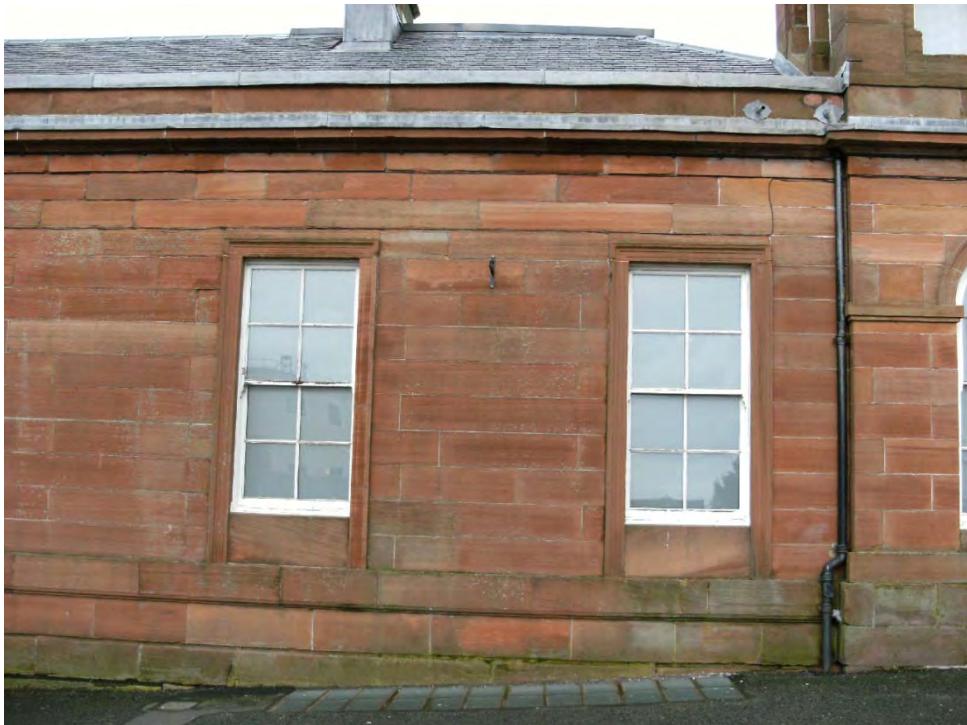
General view of part of main station building showing masonry in generally good condition, following relatively recent maintenance, including reinstatement of lead flashing on the cornice and copestones.

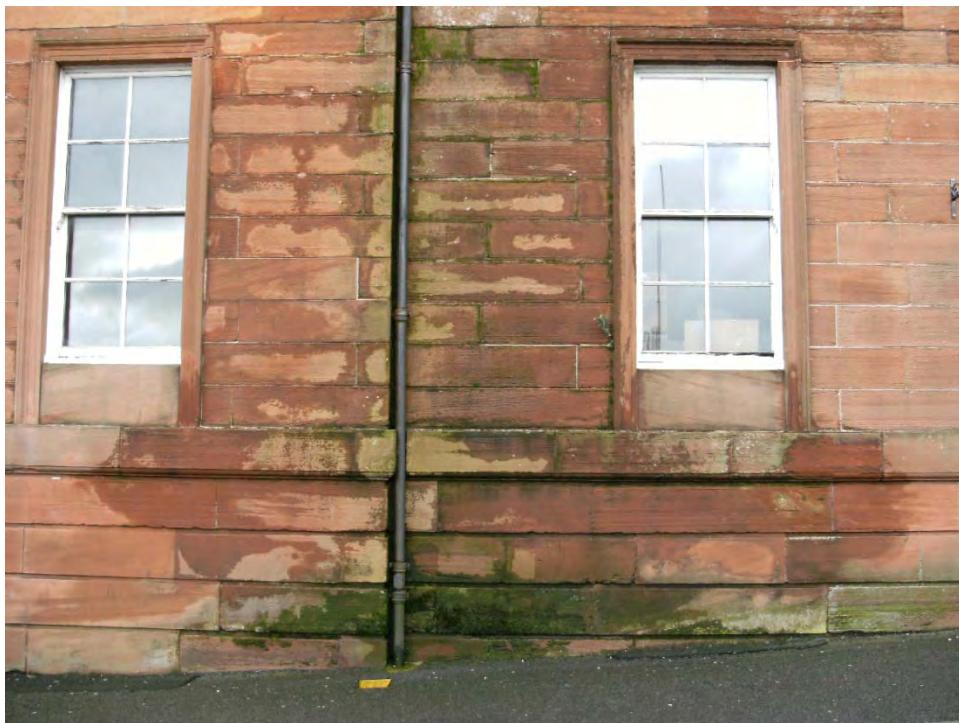
Part of main station wall showing area of water penetration due to failing downpipe. The sandstone masonry is saturated with much green organic growth and active scaling of the stone.

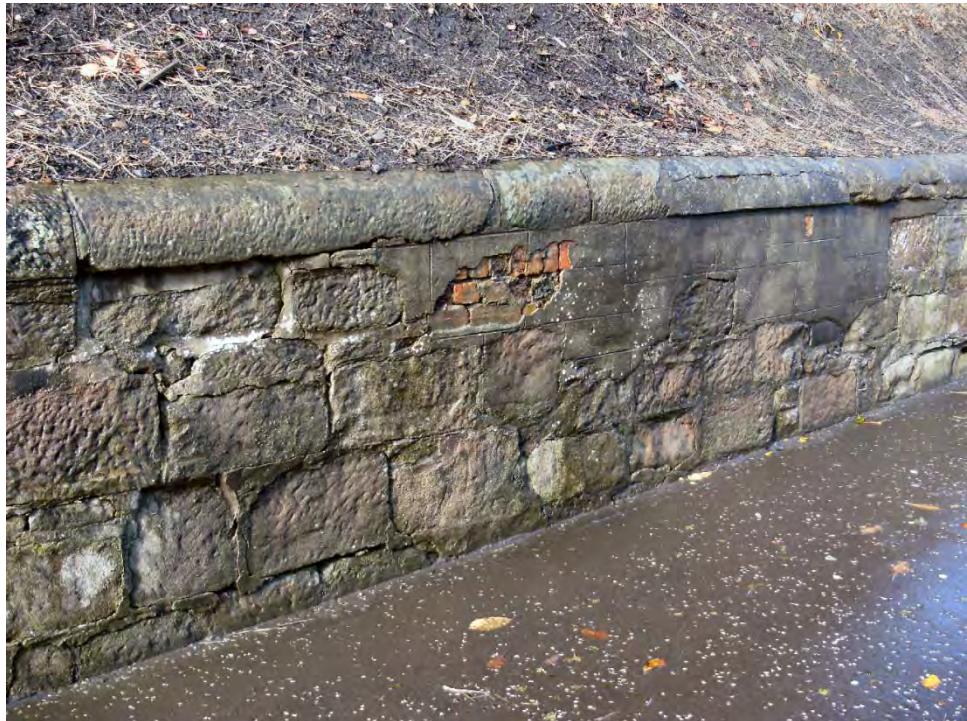
Area of wall in poor condition with structural movement resulting in displacement of blocks and loss of pointing, and areas of decayed stone repaired using brick and cement patches.

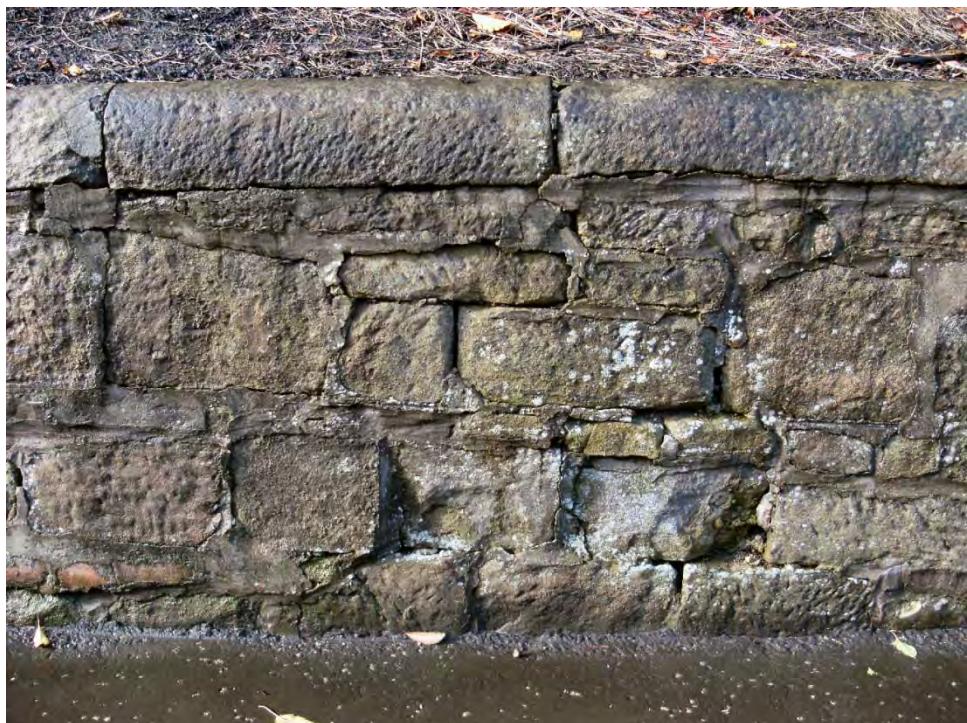
Typical area of wall showing loose cement pointing much of which is missing, and some decay of sandstone masonry.

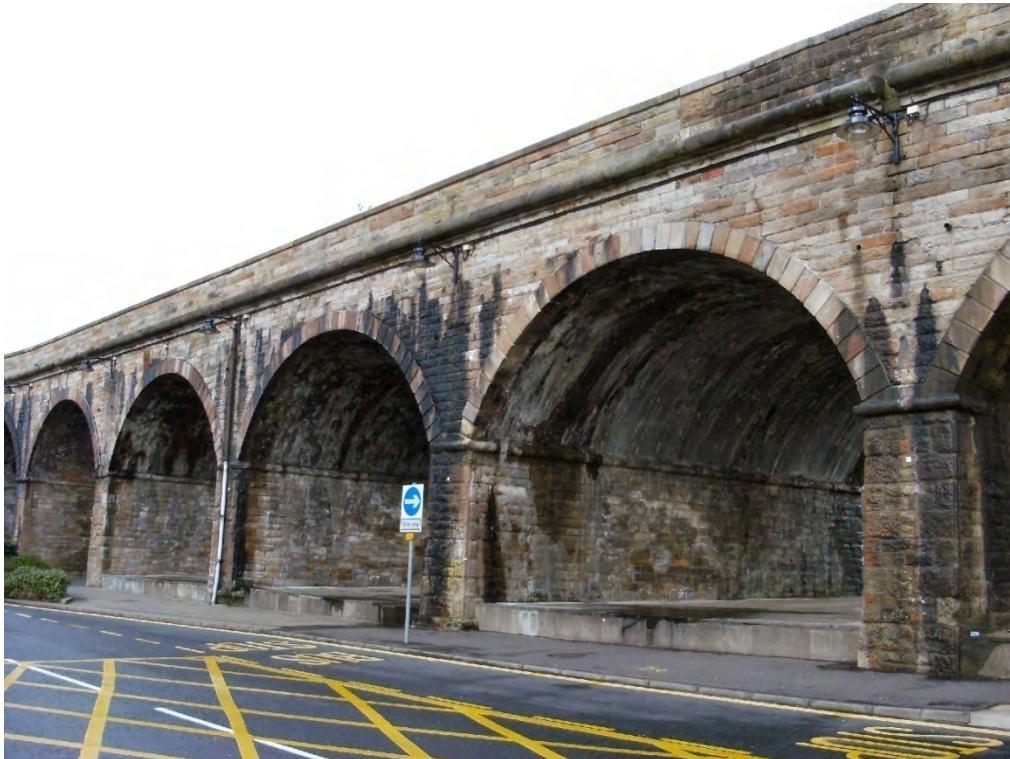
General view of the railway arches showing unsightly black staining caused by water drainage at high level.

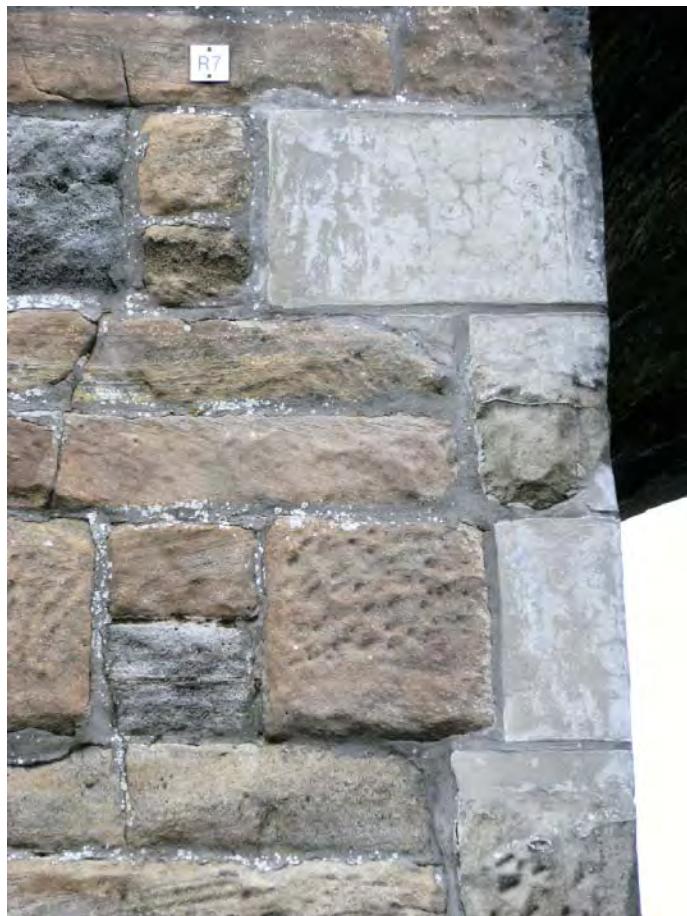
Detail of part of arch showing grey cement/concrete repairs where stone has decayed.
Not also crack to masonry on left-hand side.

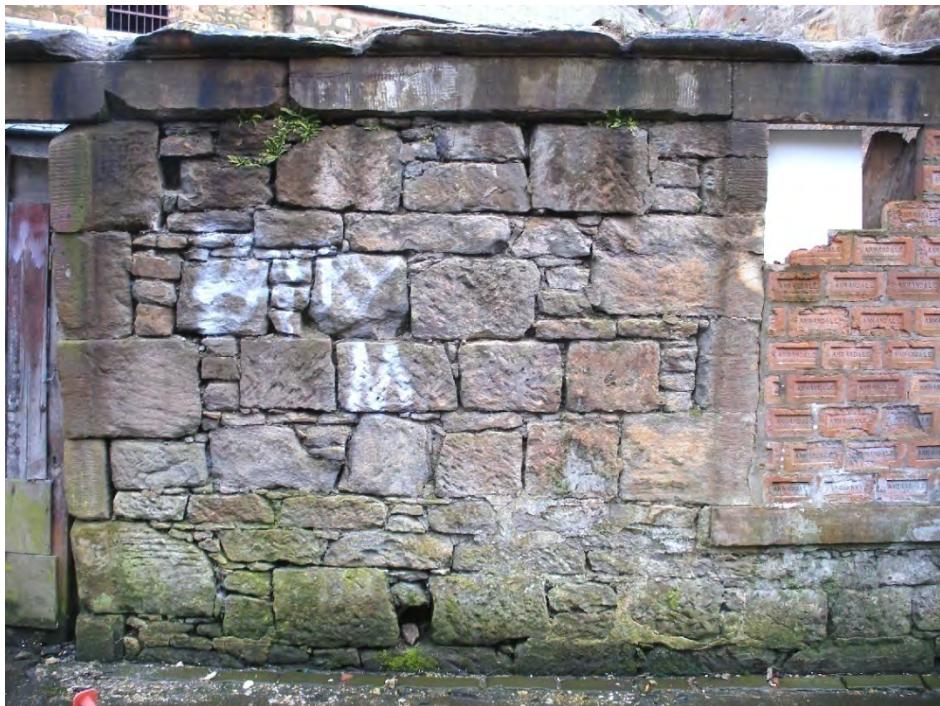
Part of wall showing lack of mortar with open joints resulting in water penetration and plant growth. Note the very poor condition of copestones.
