# Mauchline Conservation Area Management and Maintenance Plan

Prepared for East Ayrshire Council  
by  
Wylie Shanks Architects

Adopted 27.03.2023

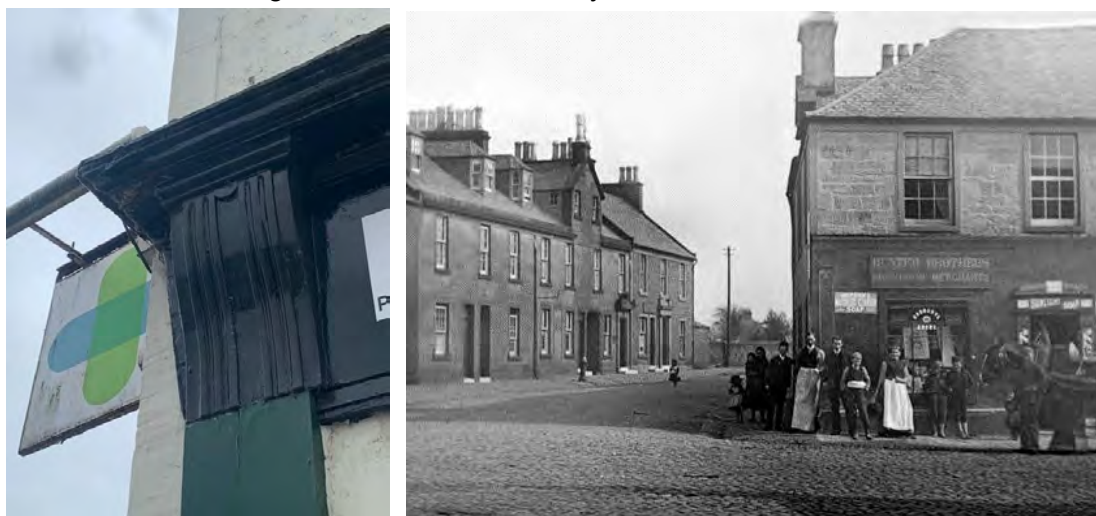
Figure 4 Console bracket at No 1 Loudoun Street. Historic photographs show however that this was a later addition to the building (refer to Gazetteer).

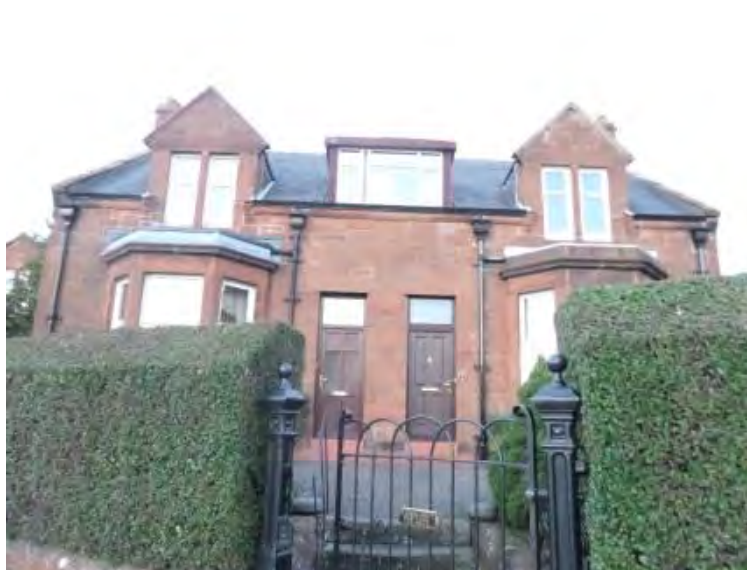
Restrictions	Restricted survey due to front garden.
Structural Issues	None apparent
Storey Height	1.5 – 2 x semi-detached.
Roof	Natural slate with zinc ridge and clips. Box dormer. Mortar skewers. Lead chimney flashings and on bay window roof.
Chimneys	1no. red sandstone gable stack with 4no. cans to l.h.s. 1no. red sandstone gable stack with 4no. cans to r.h.s.
Walls	Red squared sandstone with ashlar window and door surrounds. Single storey bay window. No

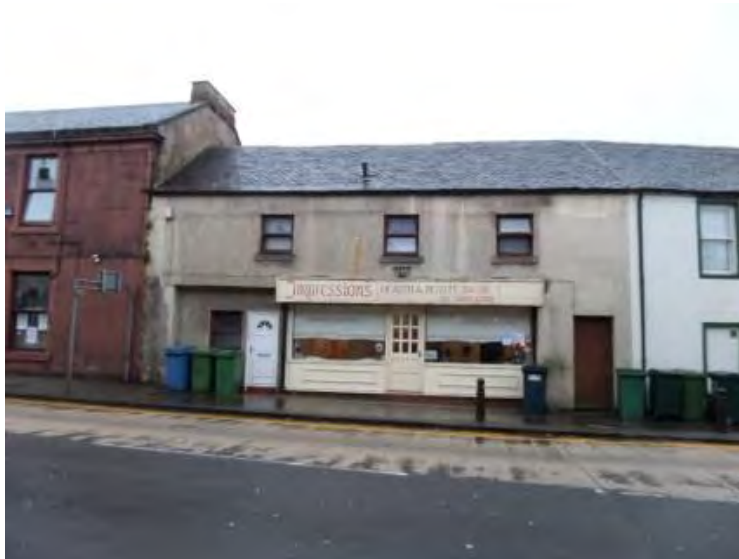
Ground – occupied
	First – occupied
Restrictions	Surveyed from Earl Grey Street only.
Structural Issues	None apparent
Storey Height	2 – mid terrace.
Roof	Pitched roof. Natural slate with zinc ridge and clips. Mortar / render skew.
Chimneys	n/a
Walls	Wet dash render.

### Recommendations:

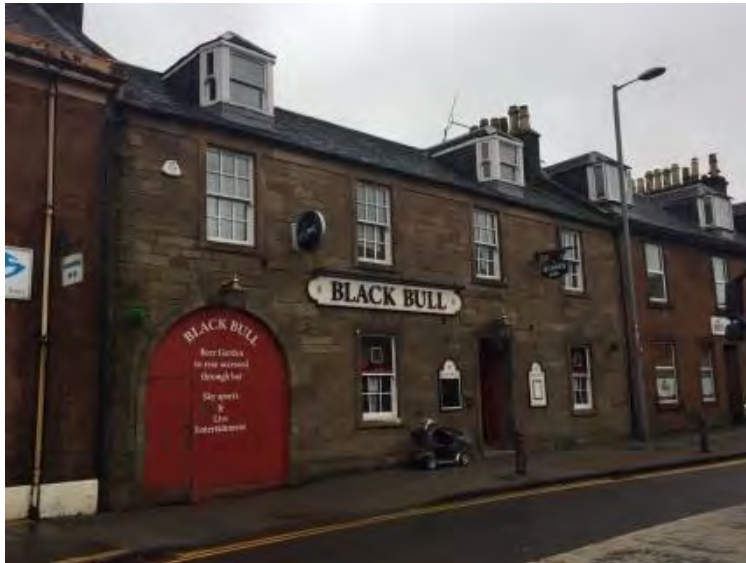
Ground – occupied First – occupied Second - occupied
Restrictions	Surveyed from Earl Grey Street only.
Structural Issues	None apparent
Storey Height	2 – mid terrace.
Roof	Pitched roof with straight skewes. 2no. hipped dormers. Natural slate with zinc ridge and clips. Mortar skewes. Lead dormer flashings.
Chimneys	Sandstone stack with 8no. pots on party wall to l.h.s

### Recommendations:

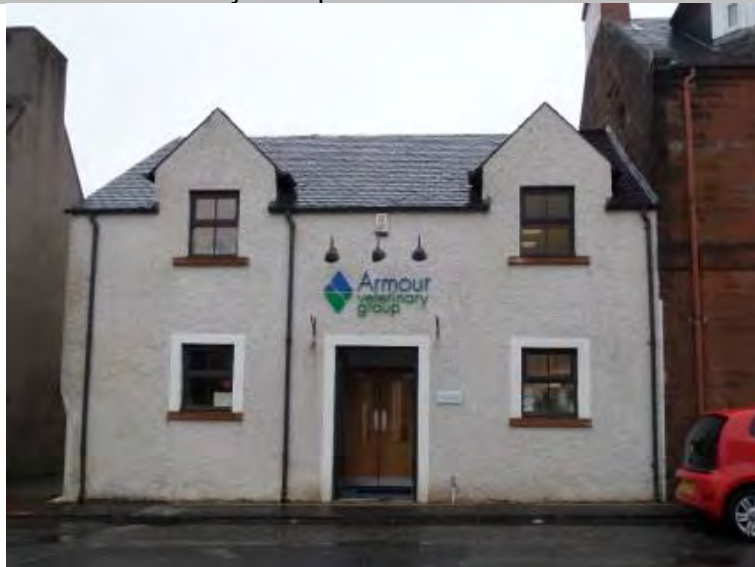
Armour Veterinary Group

Modern building. No recommendations.

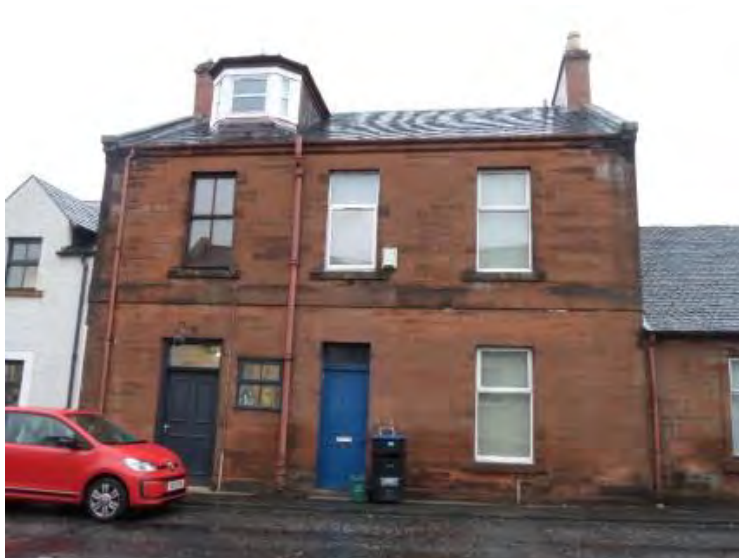
Ground – occupied First – occupied Second – uncertain
Restrictions	Surveyed from High Street only.
Structural Issues	None apparent
Storey Height	2 – mid terrace.
Roof	Modern slate with zinc ridge and clips. Lead skew and chimney flashings. Polygonal dormer.
Chimneys	Brick chimneys to each end. No pots to l.h.s. 8no original pots to r.h.s.
Walls	No structural

### Recommendations:

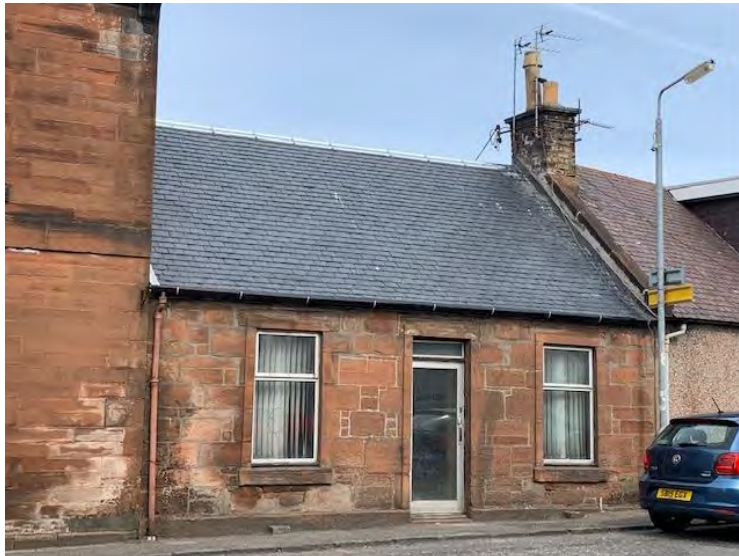
Restrictions	Surveyed from High Street only.
Structural Issues	None apparent.
Storey Height	1 – mid terrace.
Roof	Natural slate with zinc ridge and clips. Lead abutment flashing to l.h.s. Mortar skews to r.h.s.
Chimneys	n/a
Walls	Coursed red sandstone rubble with ashlar door and window

### Recommendations:

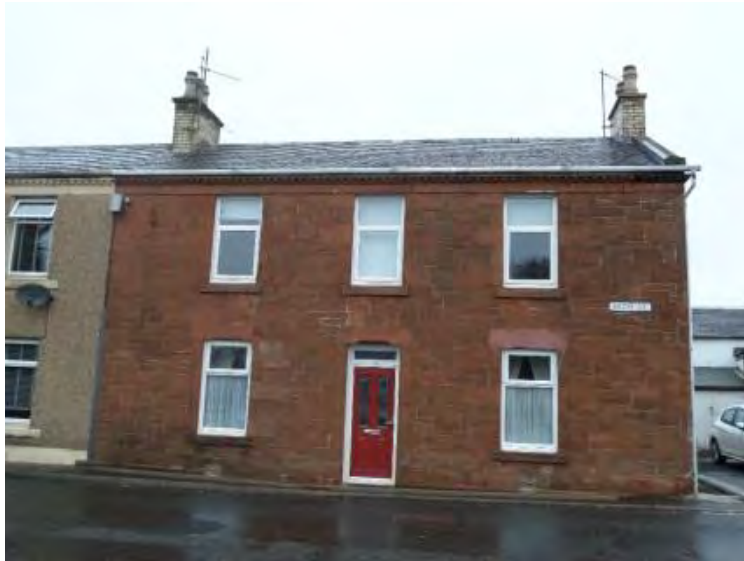
Restrictions	Surveyed from High Street only.
Structural Issues	Cracking between windows. 2no. cracked cills at ground level.
Storey Height	2 – end terrace.
Roof	Pitched roof with 1no. straight skew. Natural slate with zinc ridge and clips. Lead skew and partial capping. Lead chimney flashings.
Chimneys	Yellow brick chimney with dentil moulded stone cap and 3no. ornate pots on party wall to l.h.s. Yellow brick chimney with

concrete cap and 2no. ornate pots to r.h.s.
Walls	Red squared sandstone rubble. Dentil moulded wall head cornice. Plastic repairs to lintols and some stones. 2no. modern louvred air grilles.
Windows	uPVC
Doors	Modern composite door with fanlight.
External Pipework	uPVC

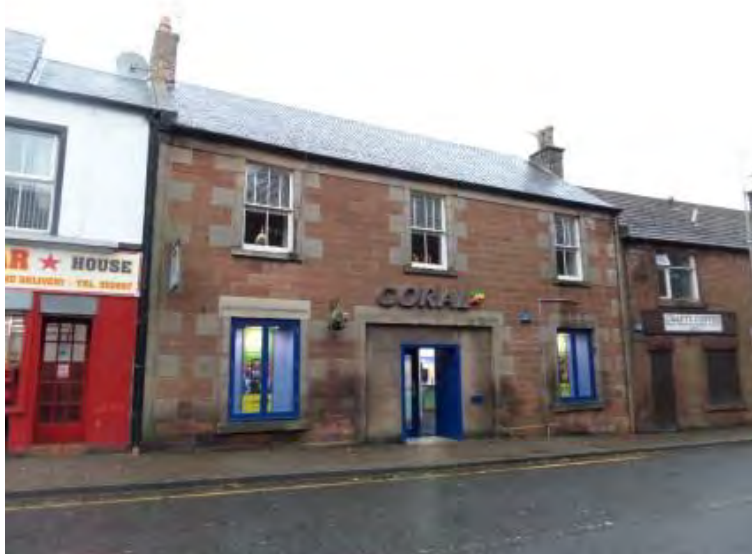
and erosion of render. 2no modern louvered air grilles.
Windows	uPVC
Doors	Modern timber glazed door
Shopfronts	Modern timber shopfronts. Doorway appears to have been reduced in size. Modern fascia's.
External Pipework	uPVC gutter. Cast iron downpipe requires refurbishment.

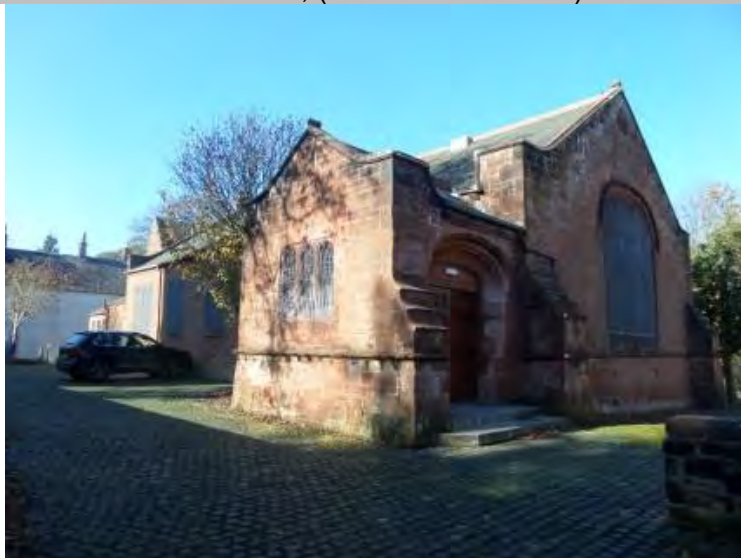
Restrictions	Full access
Structural Issues	None apparent
Storey Height	1 – standalone.
Roof	Natural slate roof with crested red terracotta ridge tiles with some missing. Mitred hip to rear. 2no. roof vents (Over sheeted?) Mortar skew to main hall. Lead valleys, copper flashings to rear vent.
Chimneys	Stone chimney to rear of main hall. 1no. pot
Walls	Squared red sandstone

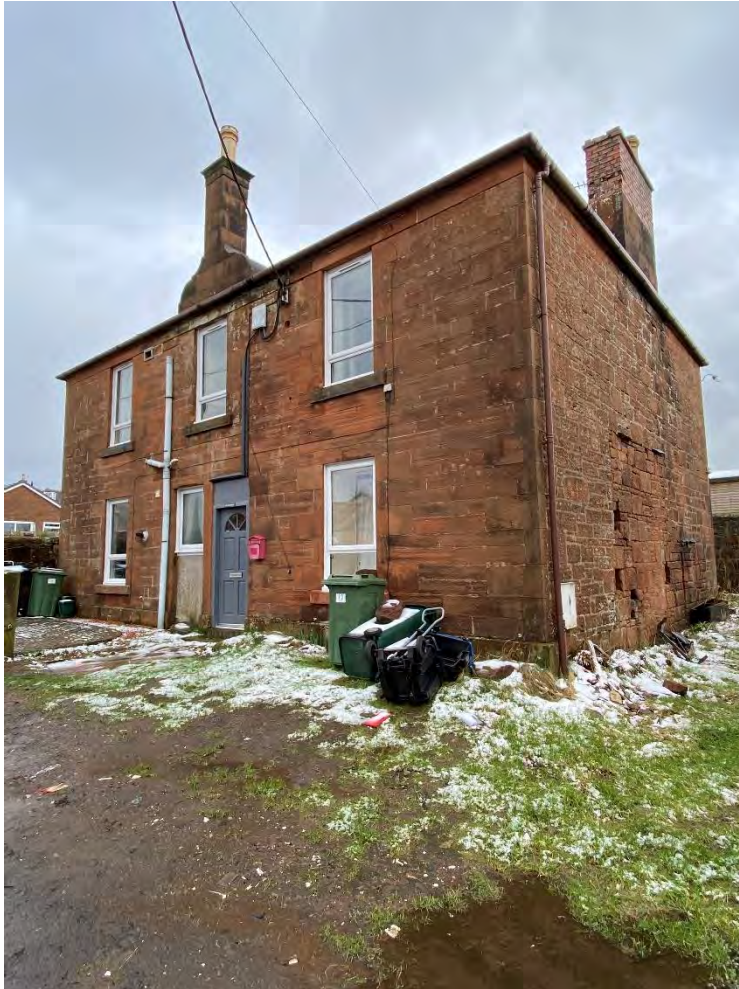
gable in poor condition. NE gable requires some indents. Air bricks missing.
Windows	uPVC.
Doors	Modern timber door with blank panel above.
External Pipework	uPVC gutters and downpipes.
<b>Priority Score</b>	<b>(0+2+1) 3</b>
