# **Mauchline Conservation Area Management and Maintenance Plan**

**Gazetteer**

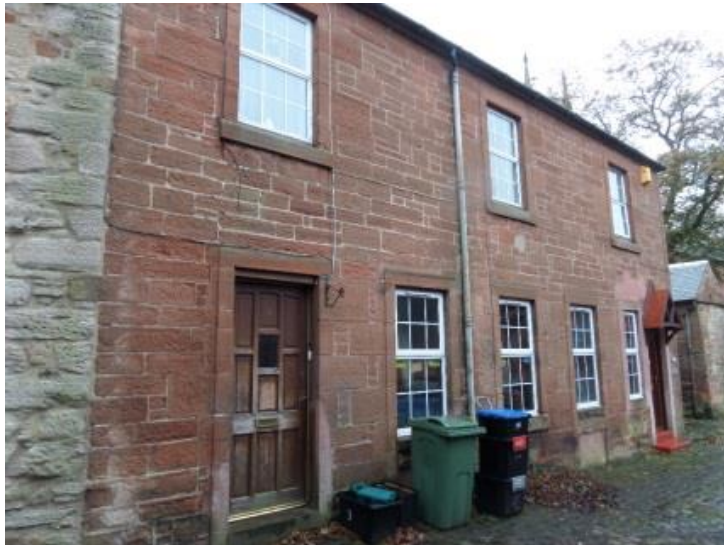
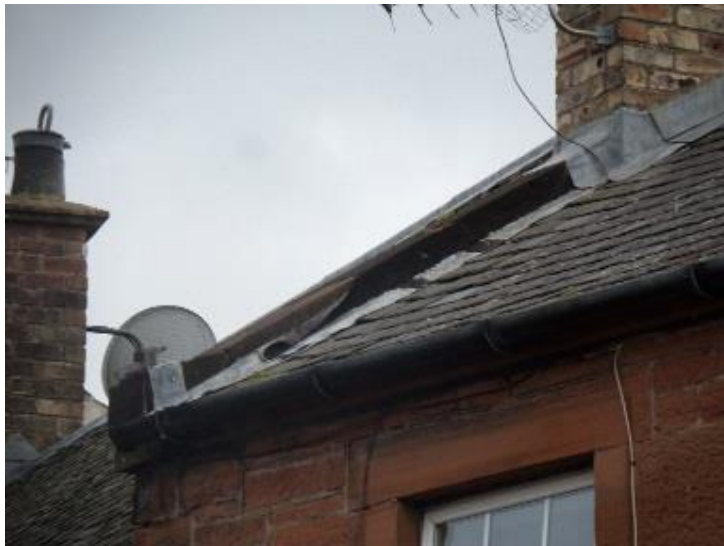
**Structural Issues** Movement crack between ground and first floor windows – No5.

**Storey Height** 2 – end terrace.  
**Roof** Natural slate with zinc ridge and clips.

Chimneys	Lead/felt flashing at straight skew. Felt loose. Brick chimney on party wall with No. 1 with 4no. cans. Brick chimney at wall head on gable return of No.5.
Walls	Squared red sandstone rubble with ashlar door and window dressings. Cementitious mortar with cementitious repairs around ground floor window to No.5 and up flue line on return.
Windows	7 no. uPVC windows.
Doors	2no. modern timber panelled doors. Modern timber porch to No. 5.
External Pipework	uPVC gutter. 1no. circular cast iron downpipe – requires refurbishment.

### Recommendations:

- Carry out minor slate repairs
- Replace felt flashing at skew with lead
- Replace uPVC gutter with CI
- Refurbish CI downpipe
- Replace windows
- Replace doors
- Remove mortar repairs around window and on gable, carry out stone repairs, and locally repoint

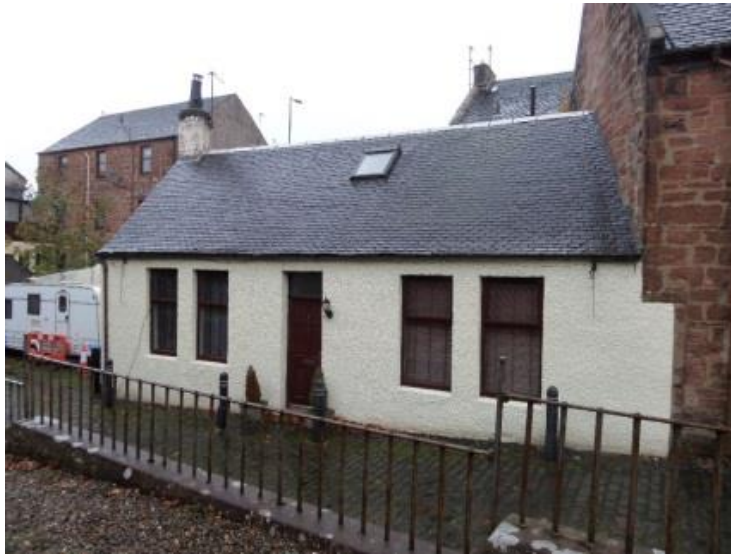
Structural Issues	None apparent
Storey Height	1 – end terrace.
Roof	Natural slate with zinc ridge and clips. Some loose along ridge. Lead chimney flashing. Mortar verge with no.4. Modern roof light.
Chimneys	Rendered chimney with modern metal can.
Walls	Modern cementitious wet dash. 2no. modern brick vents
Windows	4no. uPVC with leaded upper lights
Doors	Modern timber panelled door with fan light.
External Pipework	Cast iron half round gutter with 1no. cast iron down pipe. Requires refurbishment.
<b>Priority Score</b>	<b>(0+2+1) 3</b>

**Recommendations:**

- Carry out minor slate repairs
- Replace mortar skew
- Remove cementitious render, repoint stonework and apply lime based render system
- Replace modern vents
- Replace windows
- Replace door
- Refurbish cast iron rainwater goods

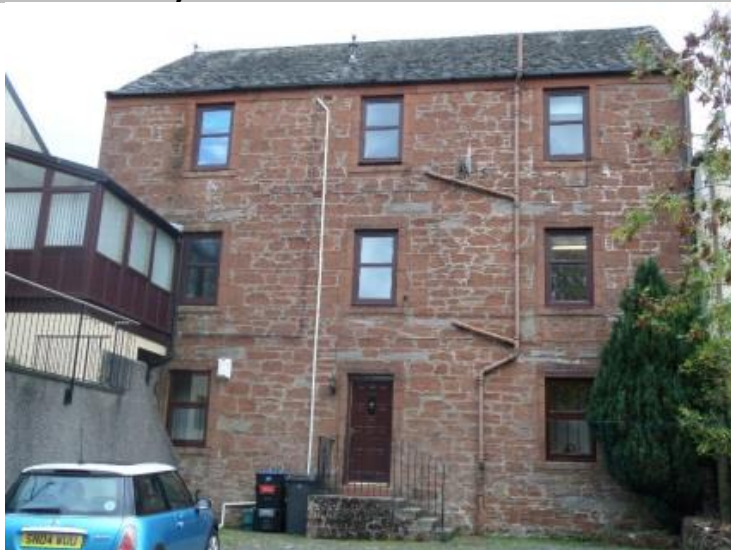
**10 Castle Street**  
Residential  
Read in conjunction with 7/9 Kilmarnock Road

Restrictions	Ground – occupied First – occupied Second - occupied
Structural Issues	None apparent.
Storey Height	3 – flatted.
Roof	Natural slate with zinc ridge and clips
Chimneys	n/a
Walls	Red sandstone. 2no. modern terracotta high level air bricks.
Windows	Modern timber casements at ground level. uPVC at 1 <sup>st</sup> and 2 <sup>nd</sup> floors.
Doors	1 modern timber

**Recommendations:**

- Carry out minor slate repairs
- Replace windows
- Replace door
- Replace uPVC rainwater goods with CI
- Refurbish CI stack

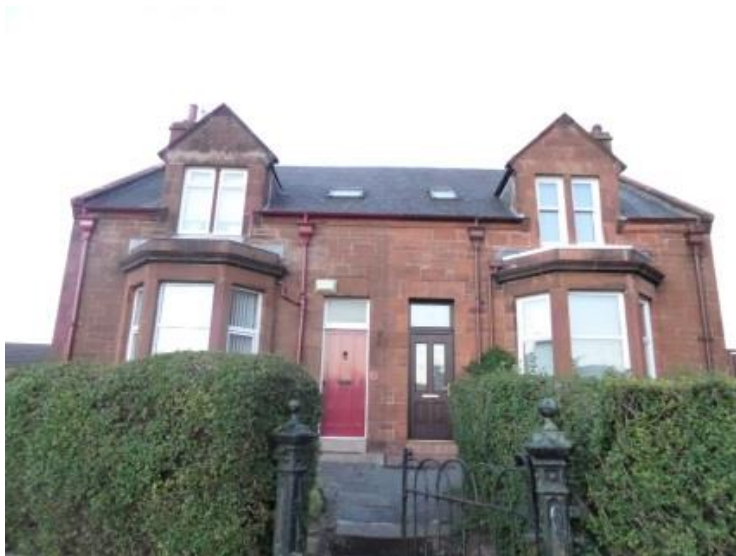
**1-3 Cumnock Road** Occupied  
Residential

Restrictions	Restricted survey due to front garden.
Structural Issues	None apparent.
Storey Height	1.5 – 2 x semi-detached.
Roof	Natural slate with zinc ridge and clips. Mortar skews. Lead chimney flashings and on bay window roof. Lead dormer valleys. 2no. modern roof lights.

Walls	Red squared sandstone with ashlar window and door surrounds. Single storey bay window. Masonry appears in good condition. No air bricks visible.
Windows	uPVC.
Doors	No.1 - Modern timber with fanlight No.3 – uPVC with fanlight
External Pipework	Cast iron wall head gutters. Rectangular cast iron downpipes with decorative hoppers and ear bands.
<b>Priority Score</b>	<b>(0+2+1) 3</b>

**Recommendations:**

- Carry out minor slate repairs
- Replace mortar skews
- Replace uPVC windows

- Refurbish timber sash and case windows
- Replace 2no. doors
- Refurbish CI rainwater goods

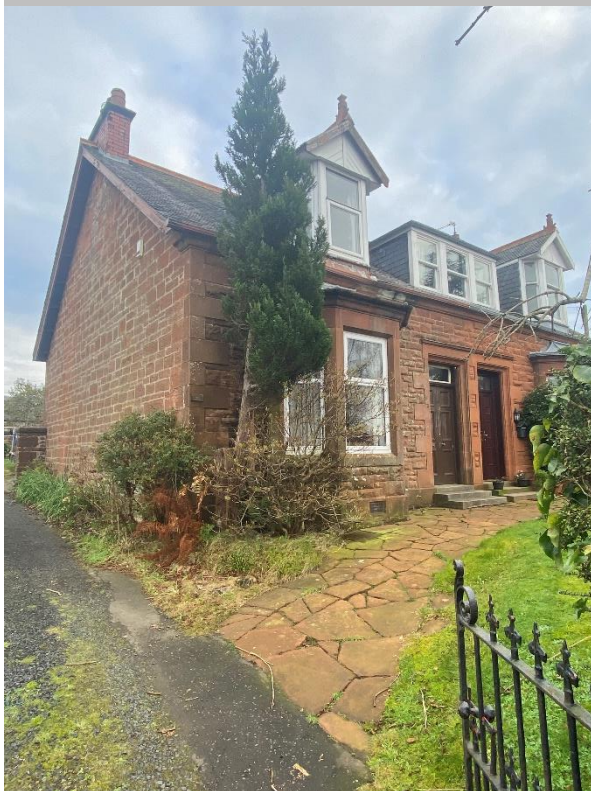
Restrictions	Access very restricted for survey
Structural Issues	None apparent
Storey Height	1.5 – semi-detached.
Roof	Dormer windows. Natural slate with crested terracotta ridge. Lead dormer and chimney flashings.
Chimneys	Red brick chimney with 3no. cans
Walls	Rock faced red sandstone with ashlar window dressings to bay window. Masonry appears in good condition. Ornate cast iron air grille below bay window.
Windows	uPVC
Doors	Timber panelled storm doors.
External Pipework	Not visible.

**Recommendations:**

- Carry out minor slate repairs
- Replace uPVC windows
- Refurbish storm door
- Replace 2no. doors
- Make allowance for new CI rainwater goods

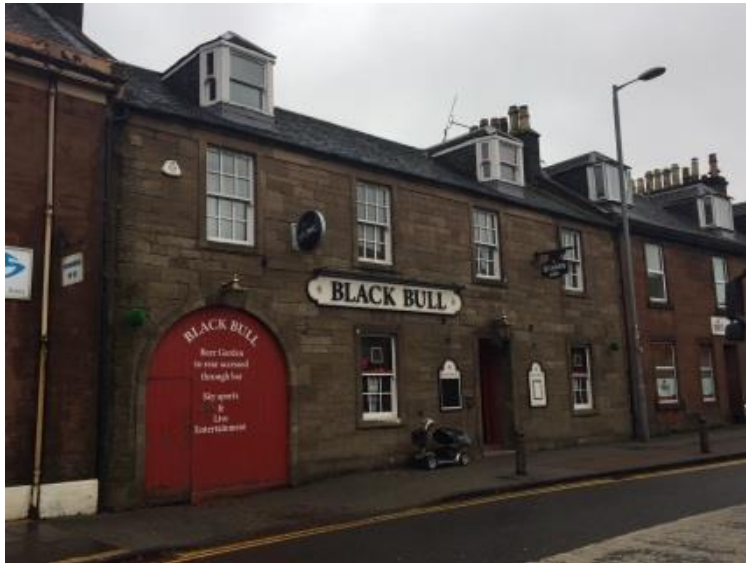
Ground – occupied First – occupied Second - occupied
Restrictions	Surveyed from Earl Grey Street only.
Structural Issues	None apparent
Storey Height	2 – mid terrace.
Roof	Pitched roof with straight skewes. 2no. hipped dormers. Natural slate with zinc ridge and clips. Mortar skewes. Lead dormer flashings.
Chimneys	Sandstone stack with 8no. pots on party wall to l.h.s

**Recommendations:**

- Carry out minor slate repairs
- Replace mortar skewes
- Replace first floor and dormer windows
- Refurbish timber sash and case windows
- Refurbish storm doors
- Refurbish CI rainwater goods
- New hanging sign

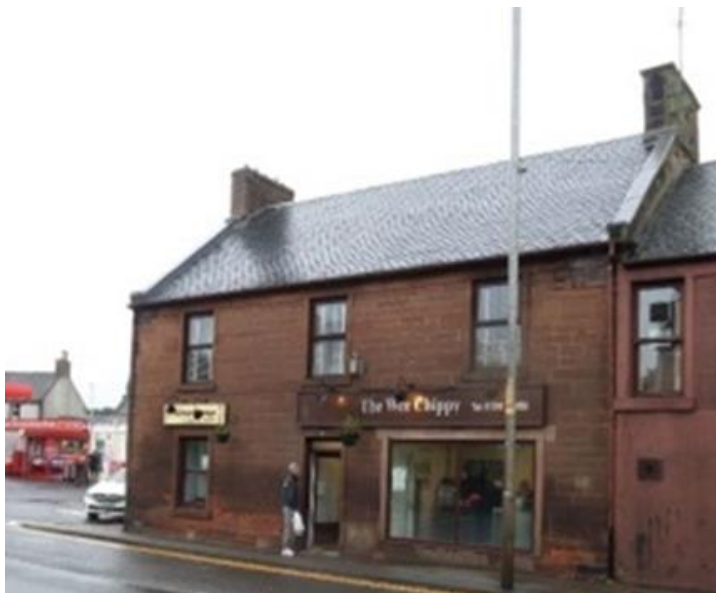
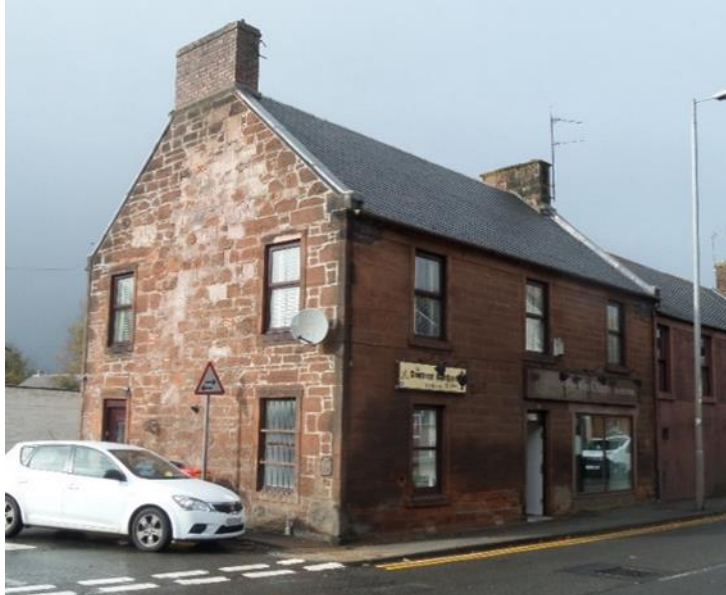
**18 Earl Grey Street**  
Corner Barber / Wee Chippy / Residential

Restrictions	Ground – occupied First – occupied Surveyed from Earl Grey Street / Cowgate only.
Structural Issues	None apparent
Storey Height	2 – end terrace.
Roof	Pitched roof with straight skewes. Natural slate (new) with zinc ridge and clips. Lead skew flashings and caps.
Chimneys	Red brick chimney to l.h.s. No pots. Red sandstone stack to r.h.s. on party wall. No pots.
Walls	Red squared rubble sandstone. Heavy erosion to masonry below windows and around window to l.h.s at ground level. Heavy pointing/plastic repairs to gable. Modern terracotta airbricks.
Windows	uPVC
Doors	uPVC
Shopfronts	uPVC shopfront/ timber fascia to r.h.s.
External Pipework	uPVC gutter (blocked). Cast iron downpipe (last section is uPVC) - Needs refurbishment.

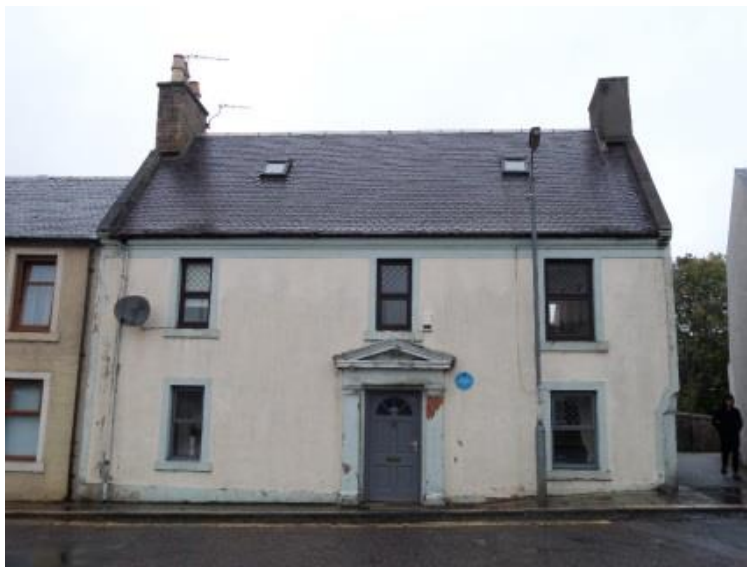
**Priority Score** (2+3+2) 7

**Recommendations:**

- Check chimney stability
- Carry out minor slate repairs
- Replace flashings and skews
- Remove cementitious render, repoint and re-render with a lime based product
- Remove paint from window and door surrounds
- Replace windows
- Replace door
- Replace uPVC rainwater goods with CI

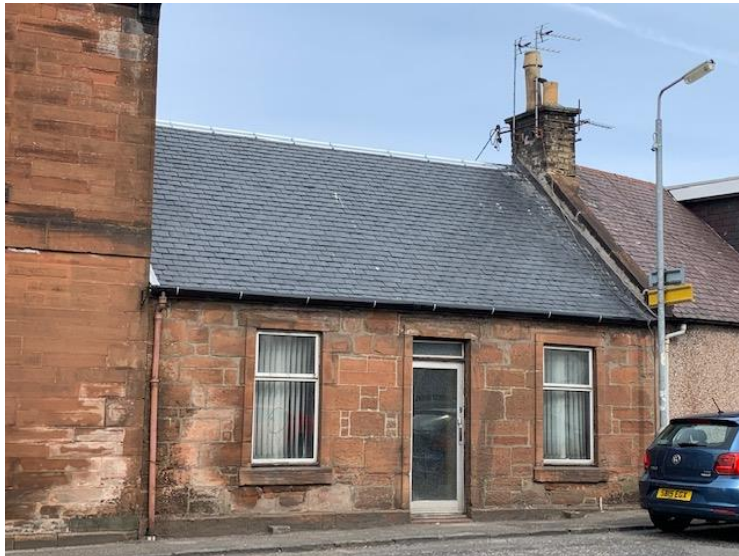
Restrictions	Surveyed from High Street only.
Structural Issues	None apparent.
Storey Height	1 – mid terrace.
Roof	Natural slate with zinc ridge and clips. Lead abutment flashing to l.h.s. Mortar skews to r.h.s.
Chimneys	n/a
Walls	Coursed red sandstone rubble with ashlar door and window

Windows	surrounds. Damp staining above left-hand window and door, and around base of dp. Heavy mortar pointing with stone erosion at low level.
Doors	Aluminium. Aluminium door with fanlight. No ironmongery of note.
External Pipework	Cast iron half round gutter and 1no. cast iron circular downpipe. Refurbish.

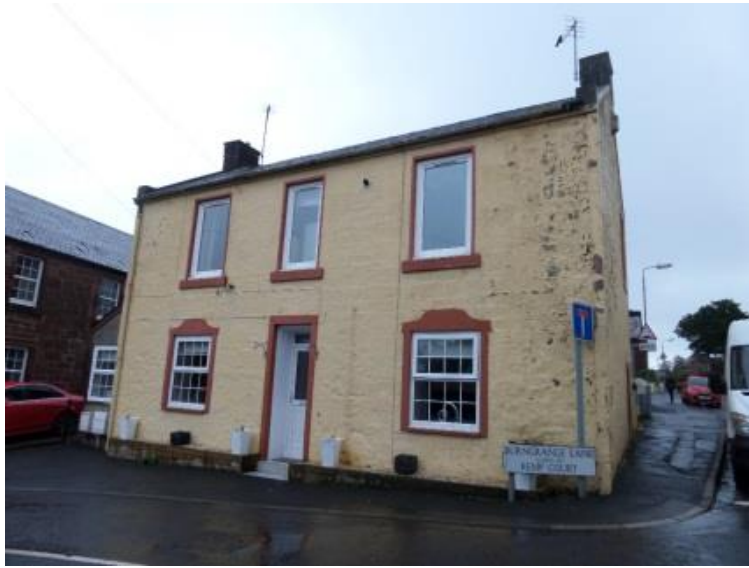
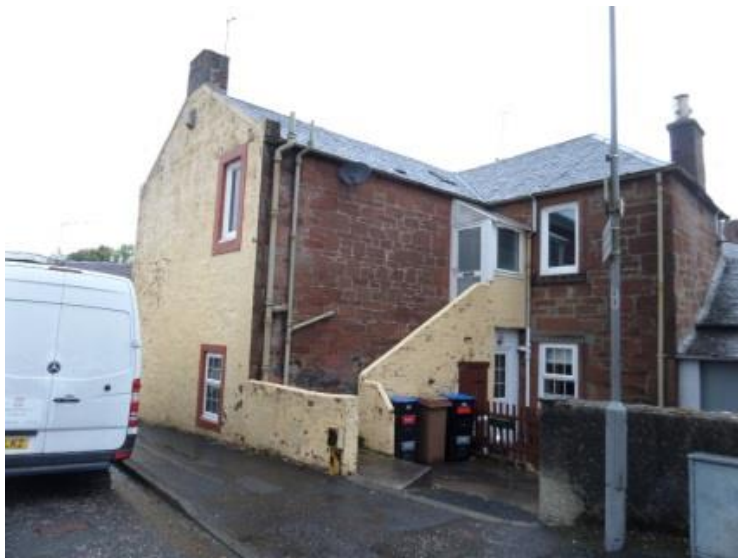
Restrictions	Surveyed from Burngrange Lane & High Street only.
--------------	---

- Carry out minor slate repairs
- Repaint masonry
- Repoint stonework
- Replace uPVC windows
- Replace doors and fanlight
- Refurbish CI rainwater goods
- Replace uPVC section with CI

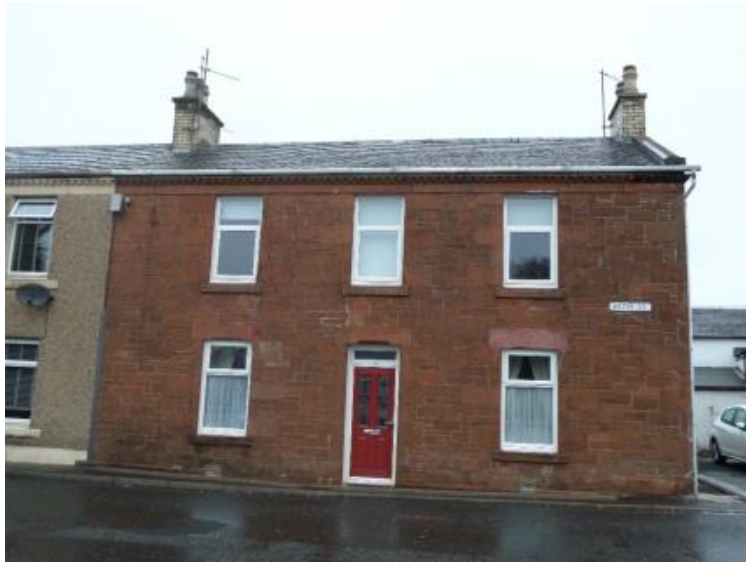
Occupied
Restrictions	Surveyed from High Street only.
Structural Issues	Cracking between windows. 2no. cracked cills at ground level.
Storey Height	2 – end terrace.
Roof	Pitched roof with 1no. straight skew. Natural slate with zinc ridge and clips. Lead skew and partial capping. Lead chimney flashings.
Chimneys	Yellow brick chimney with dentil moulded stone cap and 3no. ornate pots on party wall to l.h.s. Yellow brick chimney with

Walls	concrete cap and 2no. ornate pots to r.h.s. Red squared sandstone rubble. Dentil moulded wall head cornice. Plastic repairs to lintols and some stones. 2no. modern louvred air grilles.
Windows	uPVC
Doors	Modern composite door with fanlight.
External Pipework	uPVC

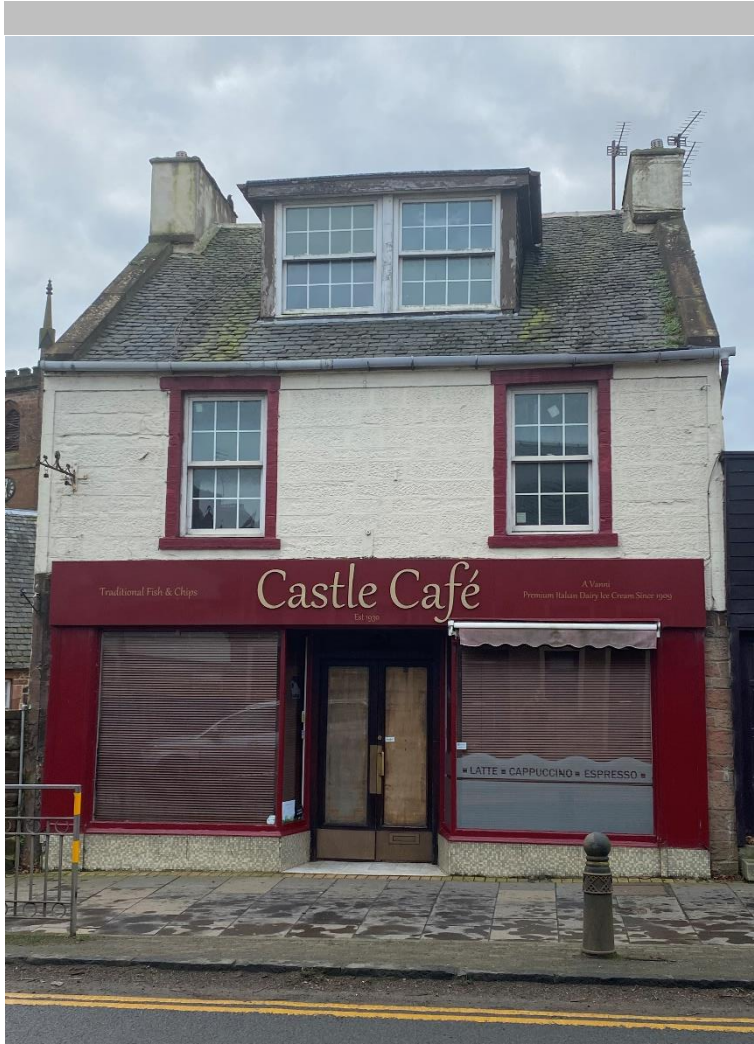
Restrictions	Second - uncertain Surveyed from Kilmarnock Road only
Structural issues	Crack on gable end.
Storey Height	2 - end terrace.
Roof	Natural slate with zinc ridge and clips – needs overhauled. Mortar skews – overgrown. Lead dormer flashings and chimney flashings.
Dormer	Box dormer – timber in poor condition. uPVC windows
Chimneys	Rendered brick chimney to r.h.s. No pots. Needs re-rendered.
Walls	Painted masonry.
Windows	uPVC
Doors	1920's/1930's timber entrance doors.
Shopfronts	Double fronted shopfront with recessed doorway. Modern fascia. Tiled stall riser.
External Pipework	uPVC gutter – overflowing at corner.

- Carry out structural inspection & any recommended remedial repairs
- Reslate roof and dormer
- Replace leadwork
- Replace ridge with wood core lead roll
- Replace mortar skews
- Replace dormer timbers
- Re-render chimney
- Replace windows, including dormer
- Refurbish door
- Repaint shopfront
- Install new timber fascia and signage
- New hanging sign
- Replace uPVC rainwater goods with CI

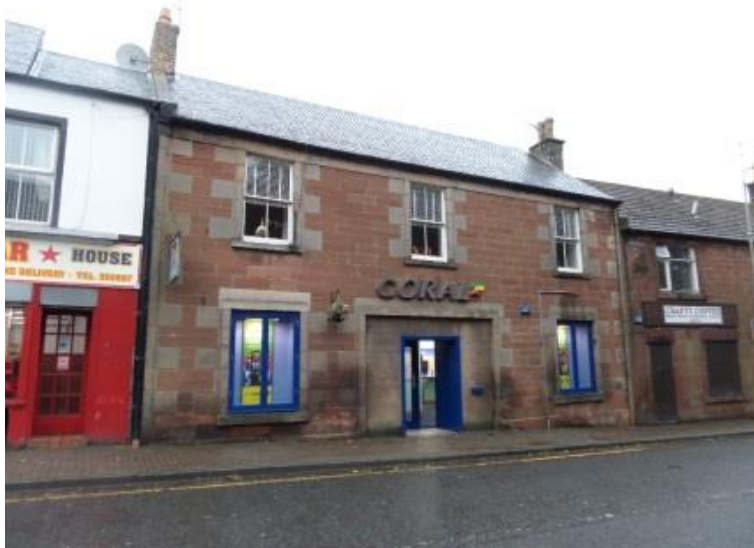
Ground – vacant First – occupied
Restrictions	Surveyed from Loudoun Street only
Structural Issues	None apparent
Storey Height	2 - mid terrace.
Roof	Natural slate with zinc ridge and clips. 1no. mortar skews. Lead chimney flashing. 1no. copper skew putt flashing. Section of mortar skew missing.
Chimneys	Brick chimney with 3no. pots to party wall on l.h.s. Stone chimney with 2no. damaged pots to r.h.s.
Walls	Red ashlar sandstone with blonde sandstone quoins. Partially rendered. 1no. dropped lintol to l.h.s. window at first floor level. Masonry in reasonable condition. Some heavy mortar repairs around downpipe connection. Some low-level staining

and erosion of render. 2no modern louvered air grilles.
Windows	uPVC
Doors	Modern timber glazed door
Shopfronts	Modern timber shopfronts. Doorway appears to have been reduced in size. Modern fascia's.
External Pipework	uPVC gutter. Cast iron downpipe requires refurbishment.

**Priority Score** (0+2+2) 4

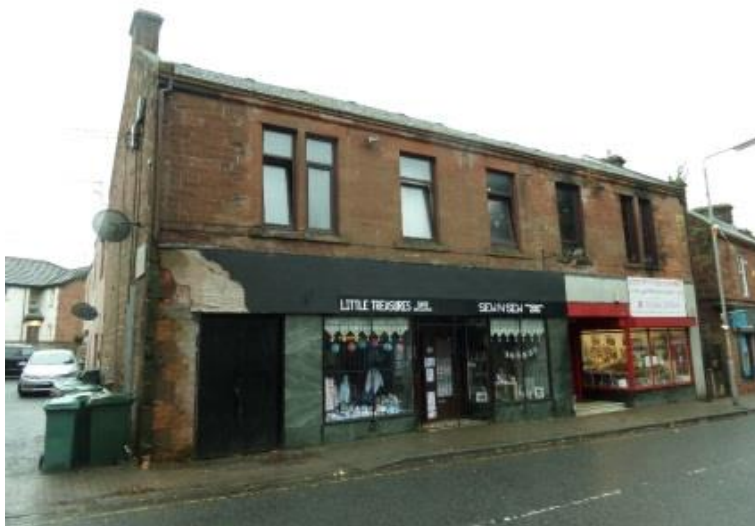
Restrictions	Surveyed from Loudoun Street only
Structural Issues	None apparent
Storey Height	2 - detached
Roof	Natural slate with zinc ridge and clips. uPVC ridge. Lead skews and chimney flashings. Ridge vents.
Chimneys	1no. red sandstone stack to l.h.s. No pots.
Walls	Red sandstone. Cracked lintol and cill to l.h.s. window at first floor level. Masonry is heavily water damaged and stained at first floor level, particularly to r.h.s.

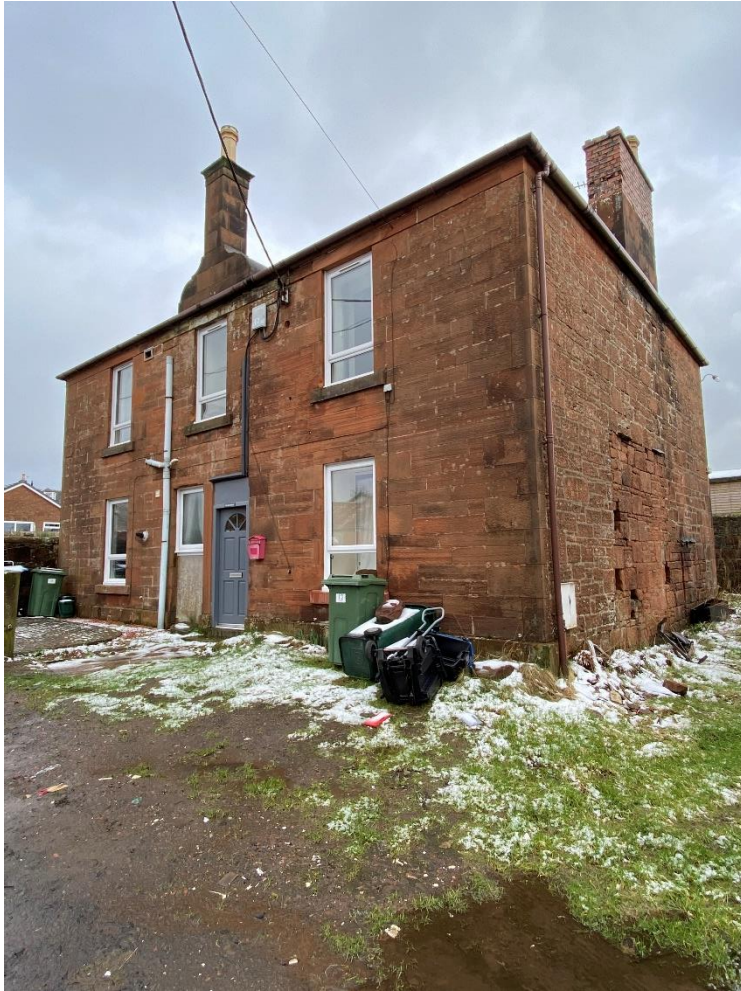
gable in poor condition. NE gable requires some indents. Air bricks missing.
Windows	uPVC.
Doors	Modern timber door with blank panel above.
External Pipework	uPVC gutters and downpipes.
