Mauchline Conservation Area Management and Maintenance Plan

Gazetteer

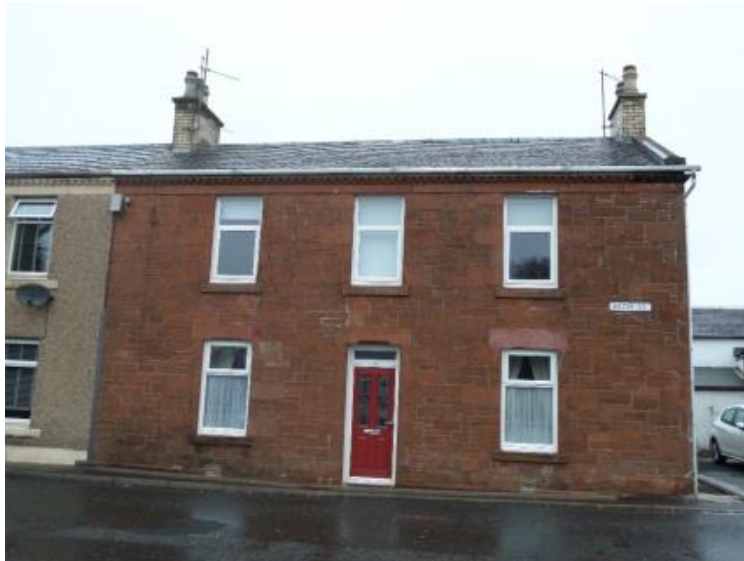
Restrictions	Surveyed from High Street only.
Structural Issues	Cracking between windows. 2no. cracked cills at ground level.
Storey Height	2 – end terrace.
Roof	Pitched roof with 1no. straight skew. Natural slate with zinc ridge and clips. Lead skew and partial capping. Lead chimney flashings.
Chimneys	Yellow brick chimney with dentil moulded stone cap and 3no. ornate pots on party wall to l.h.s. Yellow brick chimney with

concrete cap and 2no. ornate pots to r.h.s.
Walls	Red squared sandstone rubble. Dentil moulded wall head cornice. Plastic repairs to lintols and some stones. 2no. modern louvred air grilles.
Windows	uPVC
Doors	Modern composite door with fanlight.
External Pipework	uPVC

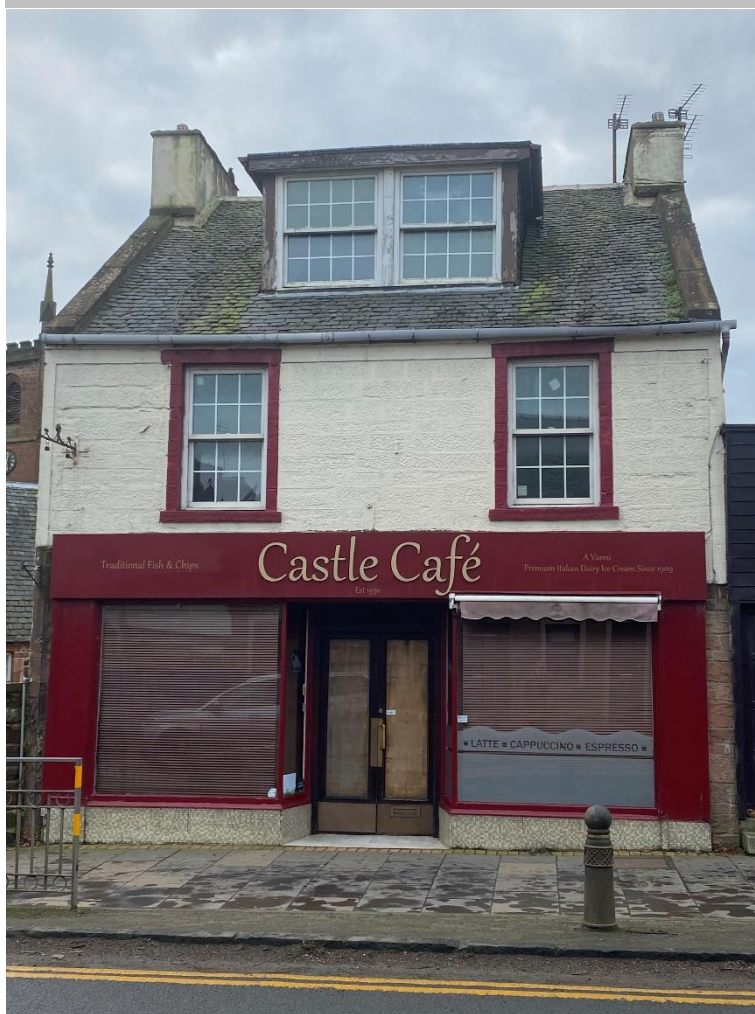
Restrictions	Second - uncertain Surveyed from Kilmarnock Road only
Structural issues	Crack on gable end.
Storey Height	2 - end terrace.
Roof	Natural slate with zinc ridge and clips – needs overhauled. Mortar skews – overgrown. Lead dormer flashings and chimney flashings.
Dormer	Box dormer – timber in poor condition. uPVC windows
Chimneys	Rendered brick chimney to r.h.s. No pots. Needs re-rendered.
Walls	Painted masonry.
Windows	uPVC
Doors	1920's/1930's timber entrance doors.
Shopfronts	Double fronted shopfront with recessed doorway. Modern fascia. Tiled stall riser.
External Pipework	uPVC gutter – overflowing at corner.

- Carry out structural inspection & any recommended remedial repairs
- Reslate roof and dormer
- Replace leadwork
- Replace ridge with wood core lead roll
- Replace mortar skews
- Replace dormer timbers
- Re-render chimney
- Replace windows, including dormer
- Refurbish door
- Repaint shopfront
- Install new timber fascia and signage
- New hanging sign
- Replace uPVC rainwater goods with CI

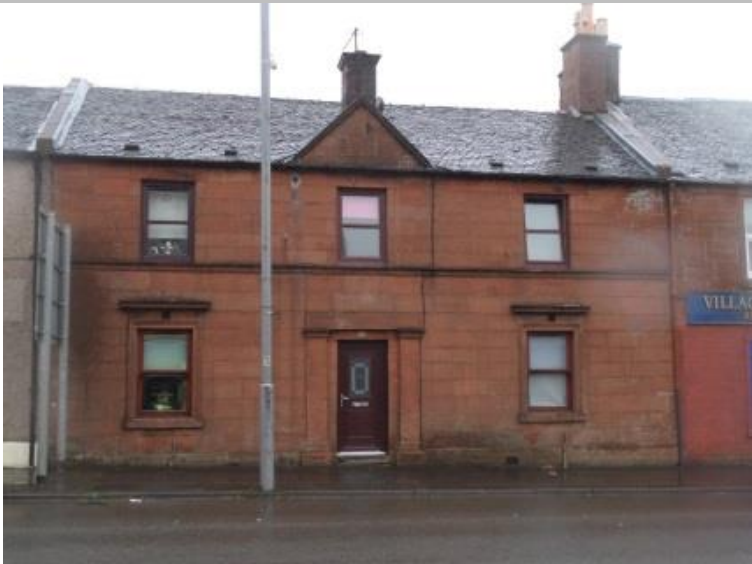
8a / 8b Kilmarnock Road		Priority Score	(0+2+2) 4
Residential			Ground – occupied First – occupied

Restrictions		Surveyed from Kilmarnock Road only.
	Structural Issues		None apparent.
	Storey height		2 – mid terrace.
	Roof		Natural slate with zinc ridge and clips. uPVC roof vents. Lead skewes and partial capping and lead valleys to gablet.
	Chimneys		Stone wall head chimney with no pots. Rendered chimney to r.h.s with 2no. pots.
	Walls		Red ashlar sandstone with pilasters either side of doorway. Some masonry erosion around doorway. 2no. modern air grilles.
	Windows		Modern timber casements at ground floor level. uPVC at first floor level.
Recommendations:		Doors	uPVC
<ul style="list-style-type: none"> • Carry out minor slate repairs • Carry out stone repairs around doorway • Replace modern vents • Replace windows • Replace door • Replace uPVC gutter with CI • Refurbish CI downpipe 		External Pipework	uPVC gutter (blocked) and cast-iron downpipe. Needs refurbishment.

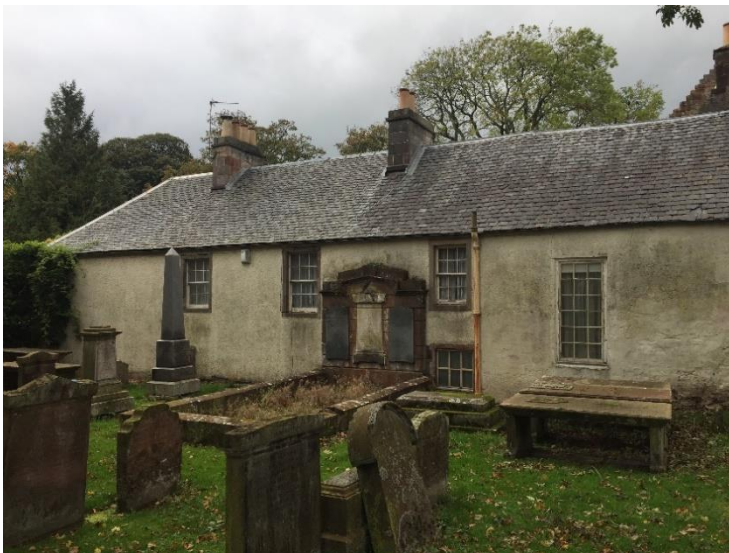
Structural Issues	Localised areas of bulging in external walls. Localised distortion on ridge line. Structural survey carried out 2018.
Storey Height Roof	2 – detached Slate, hipped gable to west
Chimneys	5no. stone chimney stacks and 1 brick chimney stack.
Walls	Painted masonry. Wet dash render to south and east elevations
Windows	Original timber sash and case
Doors	Timber panelled
External Pipework	Cast iron downpipes generally, uPVC downpipe on west elevation

House Priority Score (3+3+3) 9

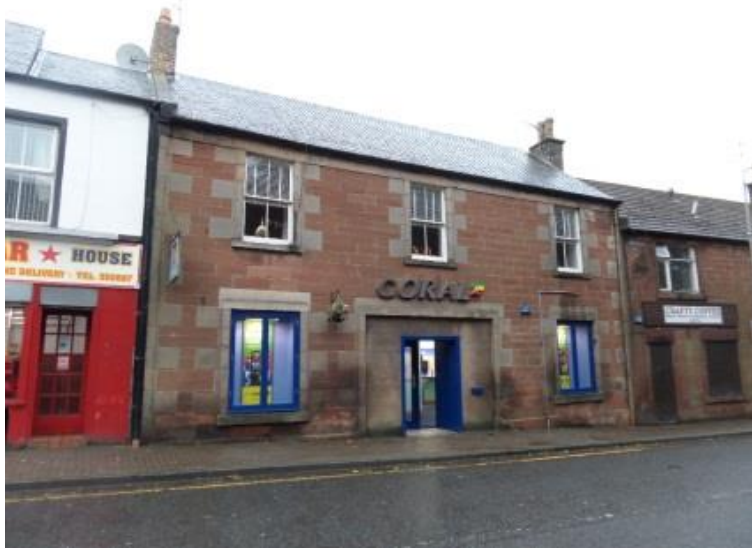
Ground – vacant First – occupied
Restrictions	Surveyed from Loudoun Street only
Structural Issues	None apparent
Storey Height	2 - mid terrace.
Roof	Natural slate with zinc ridge and clips. 1no. mortar skew. Lead chimney flashing. 1no. copper skew putt flashing. Section of mortar skew missing.
Chimneys	Brick chimney with 3no. pots to party wall on l.h.s. Stone chimney with 2no. damaged pots to r.h.s.
Walls	Red ashlar sandstone with blonde sandstone quoins. Partially rendered. 1no. dropped lintol to l.h.s. window at first floor level. Masonry in reasonable condition. Some heavy mortar repairs around downpipe connection. Some low-level staining

and erosion of render. 2no modern louvered air grilles.
Windows	uPVC
Doors	Modern timber glazed door
Shopfronts	Modern timber shopfronts. Doorway appears to have been reduced in size. Modern fascia's.
External Pipework	uPVC gutter. Cast iron downpipe requires refurbishment.

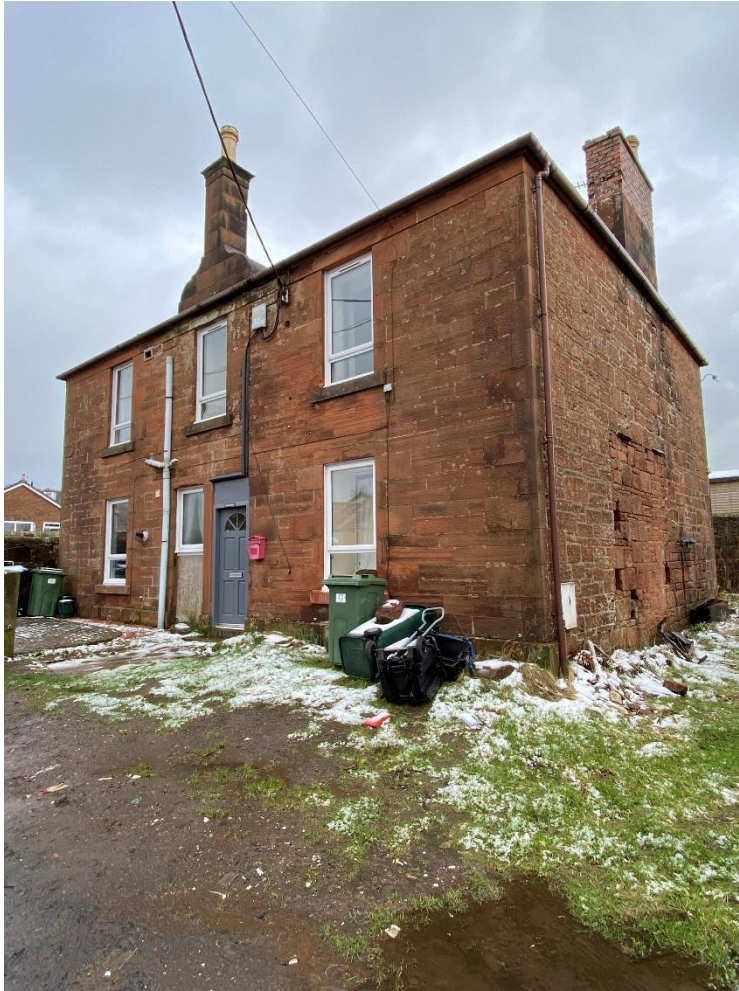
12-18 Tanfield Residential	'Building at Risk'	Partially occupied
	Restrictions	Fenced off. Surveyed from Tanfield only.
	Structural Issues	None apparent.
	Storey Height	2 – detached.
	Roof	Natural slate – nothing else visible.
	Chimneys	Half stone/half red brick stack to r.h.s. with 1no. decorative can. Stone wall head chimney with 1no. decorative can.
	Walls	Red sandstone. 1881 date stone. Stones have been removed from the southwest gable. Frontage in reasonable condition. Requires some pick pointing. SW

gable in poor condition. NE gable requires some indents. Air bricks missing.
Windows	uPVC.
Doors	Modern timber door with blank panel above.
External Pipework	uPVC gutters and downpipes.
Priority Score	(0+2+1) 3
