Mauchline Conservation Area Management and Maintenance Plan

Picture created by Miguel Silva Barral ©

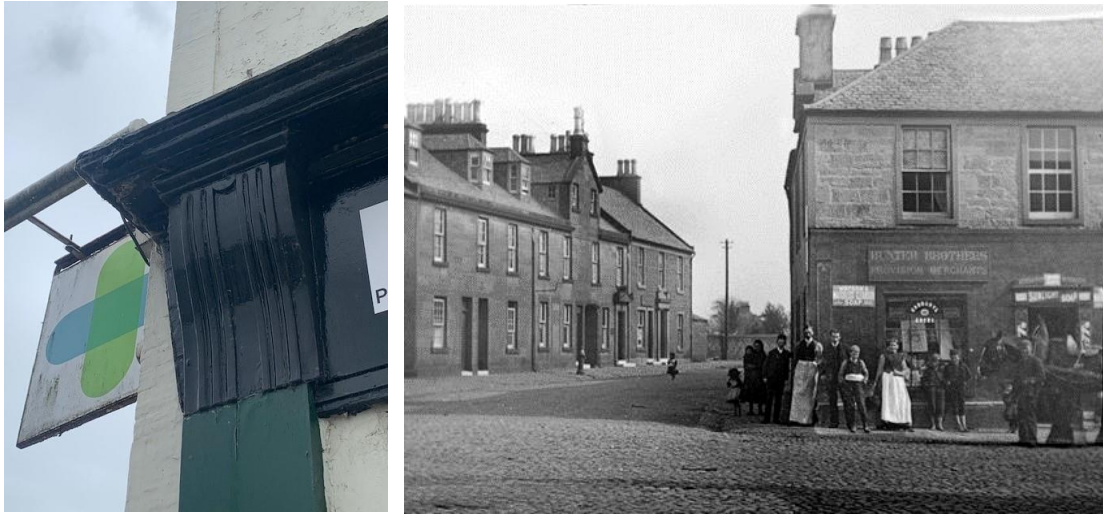
Figure 4 Console bracket at No 1 Loudoun Street. Historic photographs show however that this was a later addition to the building (refer to Gazetteer).

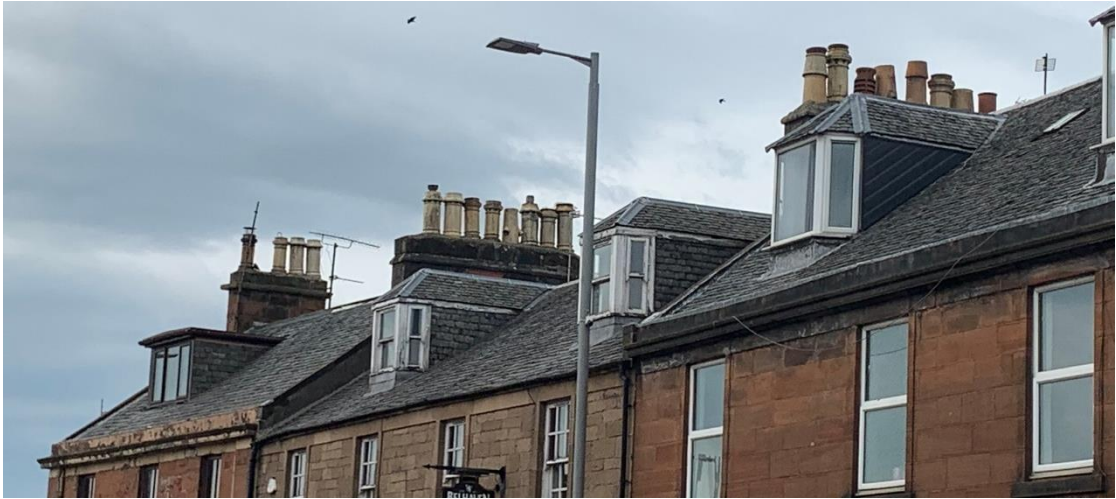
Eaves are typically flush with either cast iron gutters (unless replaced by uPVC) - either mounted on the wall head or bracketed - or lead lined wall head parapet gutters.

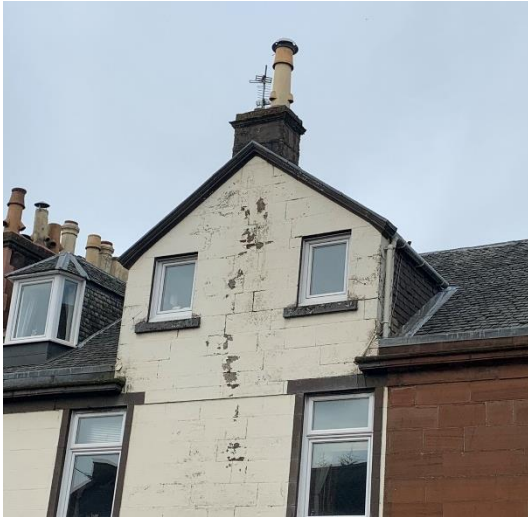
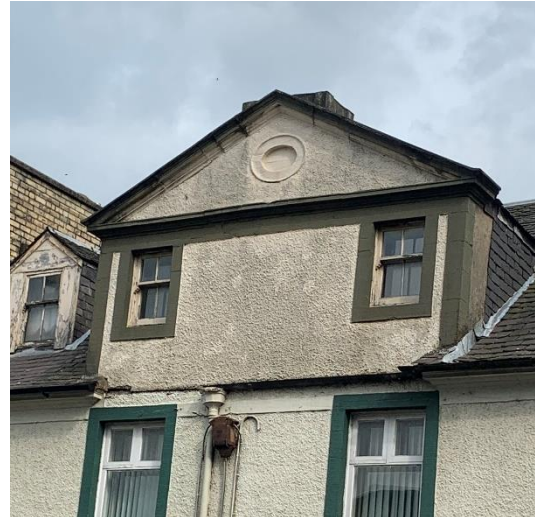
Figure 17 Tympany and Nepus gables.

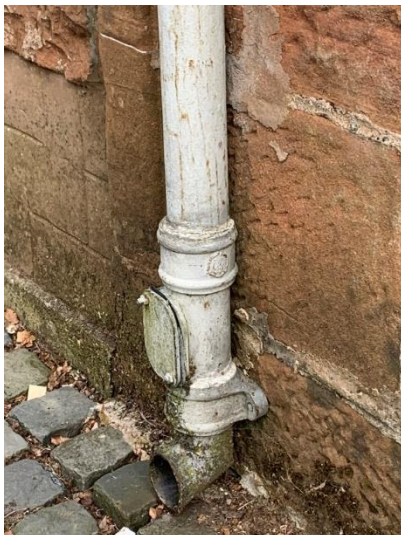
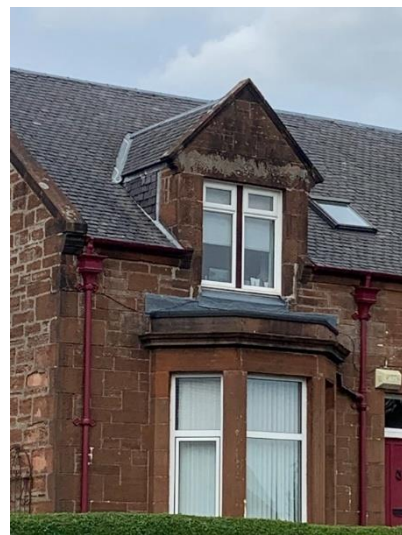
Figure 18 Cast iron rainwater goods. Decorative hoppers and wall head gutters can be found and, in some locations, decorative ear fixings can be found securing the down pipes.

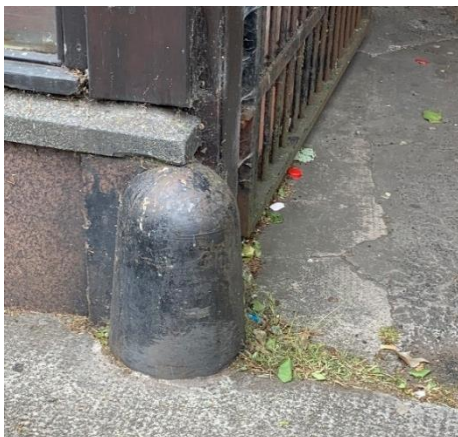
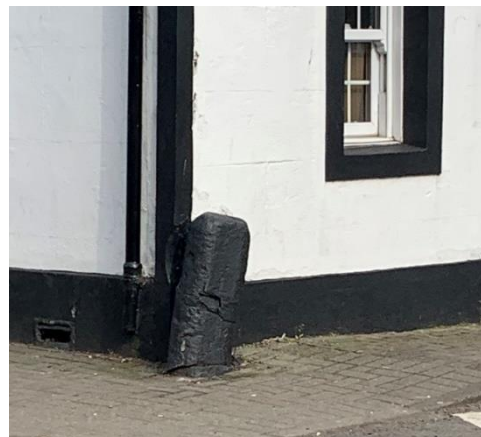
An interesting feature found in Mauchline are corner protection stones, used to safeguard the building from damage caused by cartwheels. Similarly chamfered corners were partly decorative, but also provided some protection by removing sharp stone edges which are more easily damaged. Refer to Appendix B for locations.

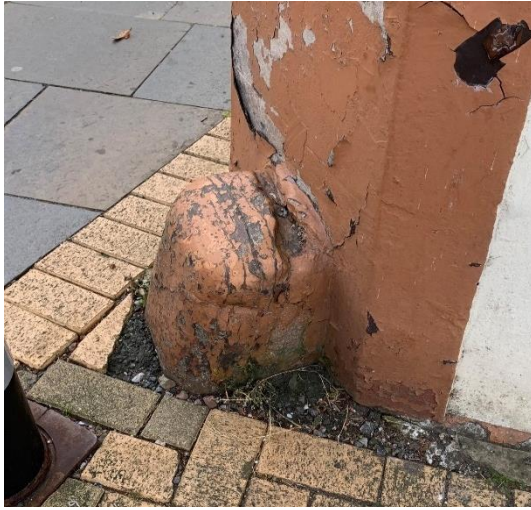
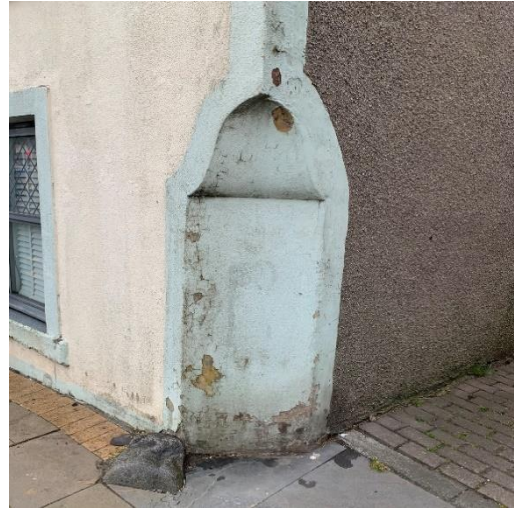
Figure 20 Corner stones and chamfered corners.

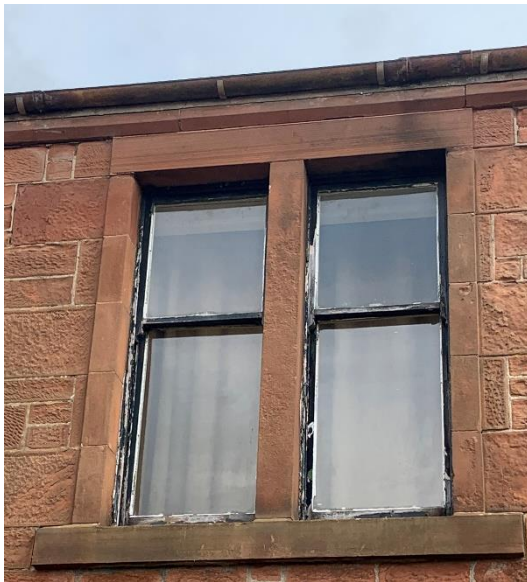
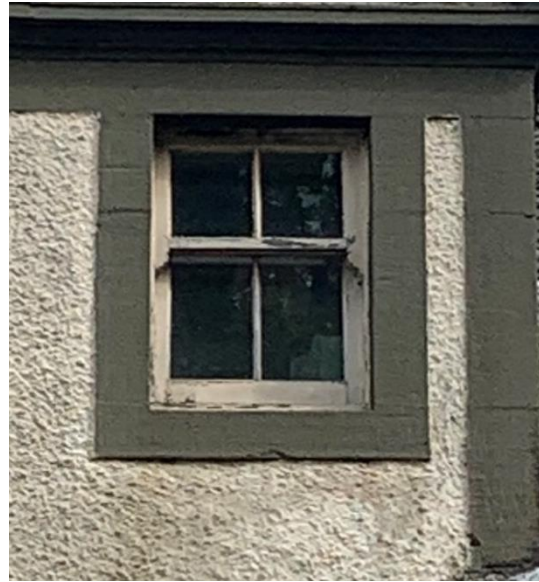
Figure 21 Timber sash and case windows

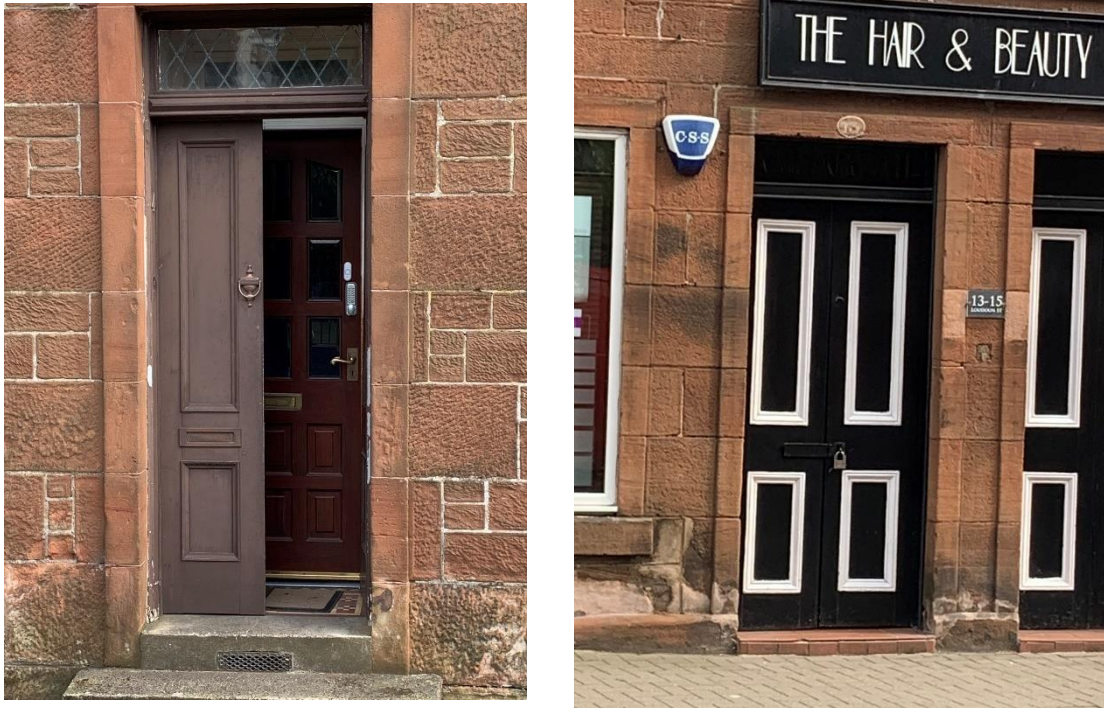
Figure 22 Storm Doors. Often with a fan light above. The double benefit of enhanced security and thermal comfort.

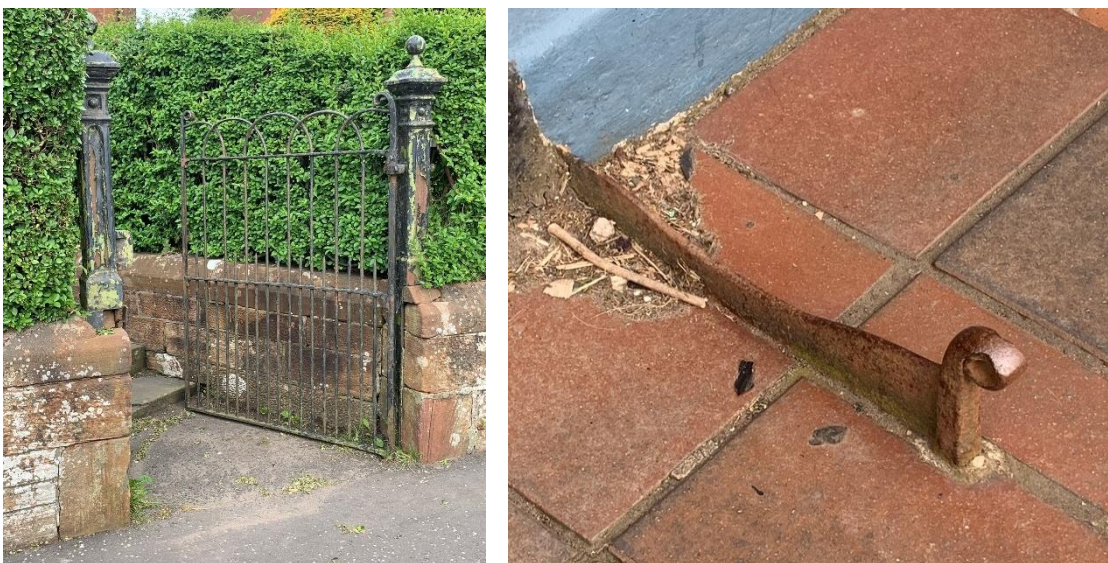
Figure 23 Decorative ironwork.

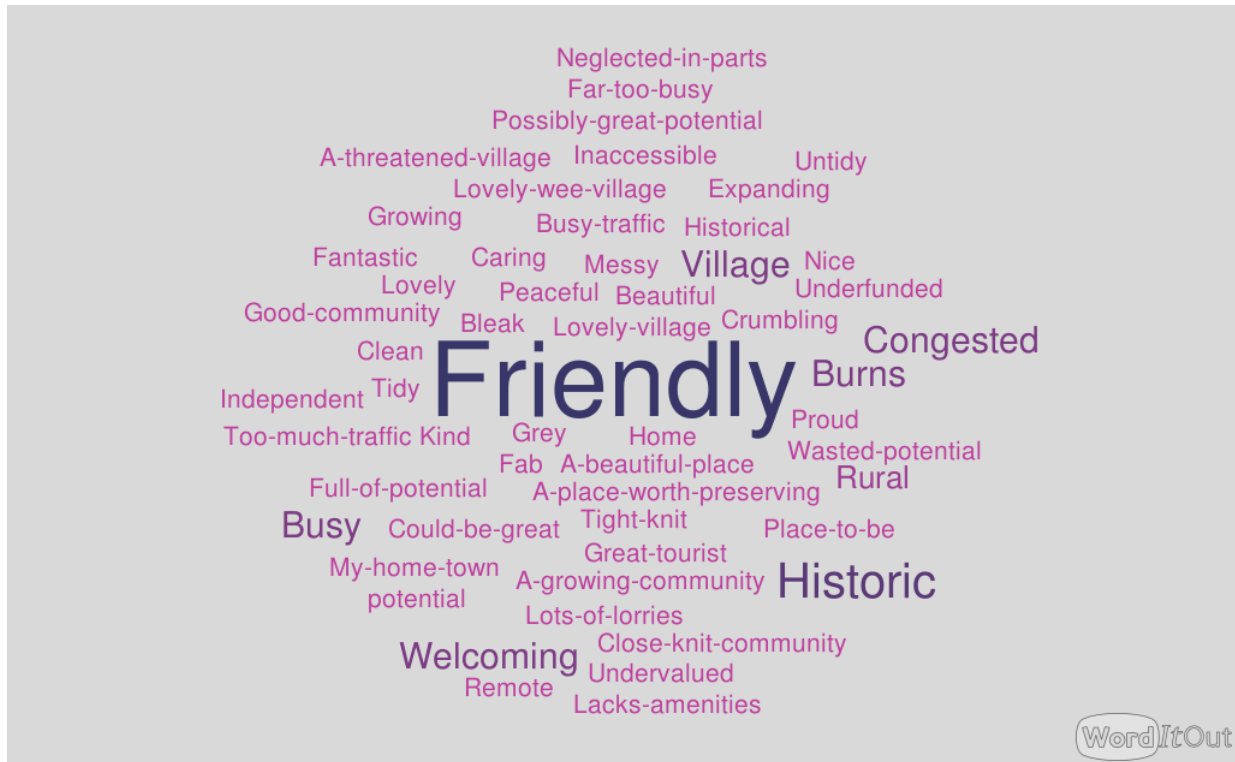
12. How would you describe Mauchline in three words?

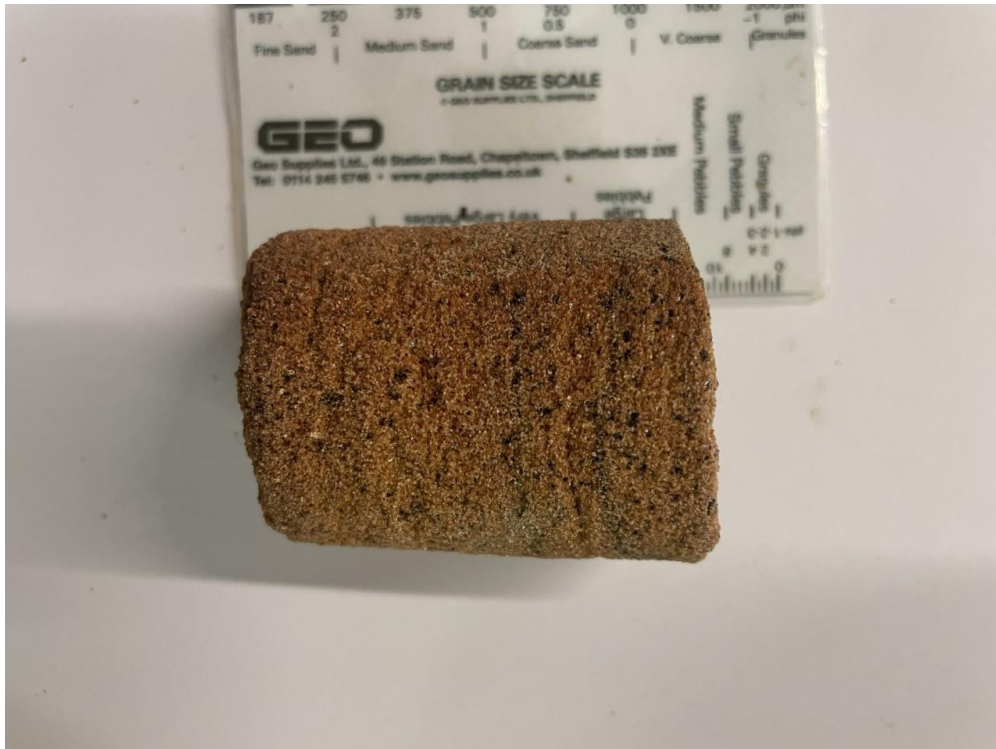
Plate 1. Image of the sample as received. Note the black speckling caused by Fe-oxides. Scale is in mm.

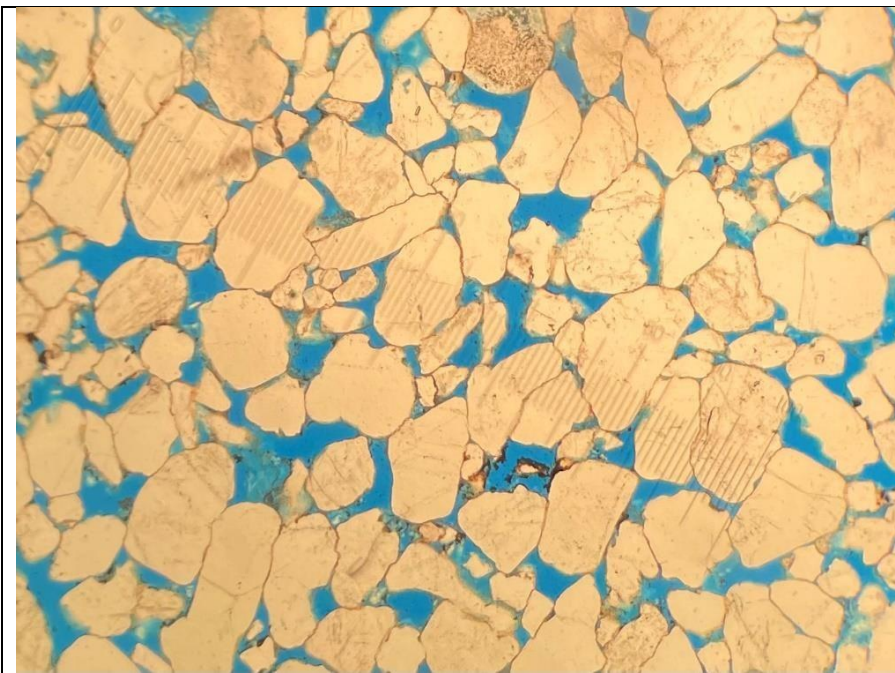
Plate 2. Thin section of the sample under plane polarised light. Pore spaces are highlighted in blue, while areas of light blue indicate pore filling clays that have absorbed some of the blue dye. Pores are moderately to well connected, with some of the larger pores filled with small, sub-angular to sub-rounded quartz, feldspar and lithic fragments.

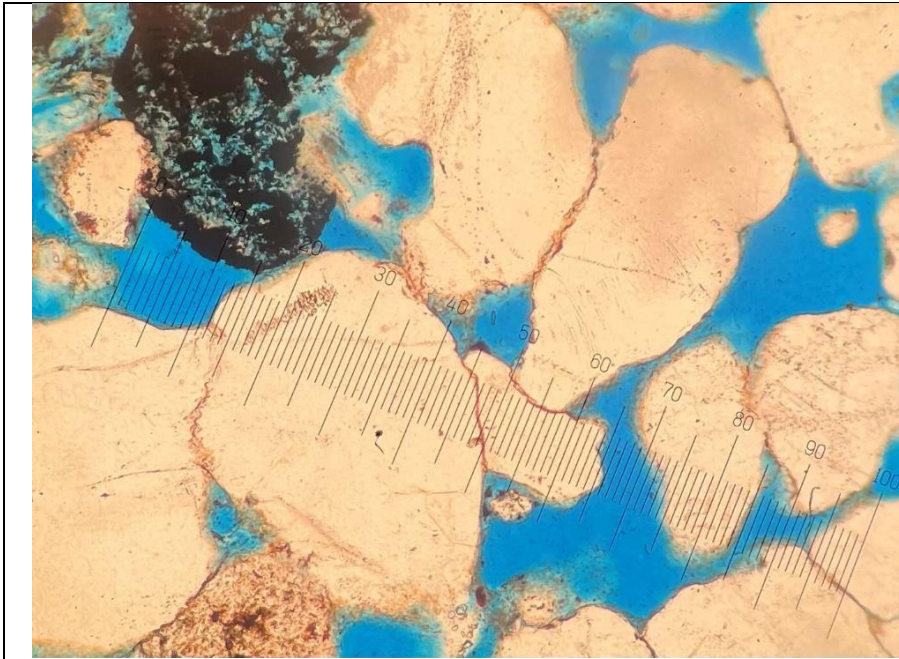
Plate 3. Thin section image of the sample under plane polarised light. Pore spaces are highlighted in dark blue, while areas of light blue indicate pore filling clays. There are some concentration of Fe oxides and organic carbonaceous matter within the thin section. Fe staining can be seen surrounding some of the quartz grains, which gives the sample its red colour.

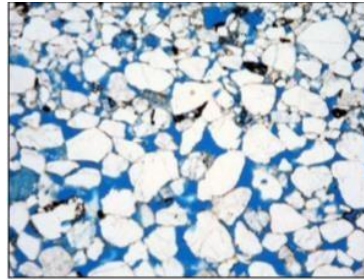
Sandstone is a natural material and by the nature of its origin, can be extremely variable within and between quarryfaces. Ideally, a considered match should be examined in the same manner as the stone to be replaced. Archive sandstone samples of possible quarries may not be equivalent to the currently extracted product.

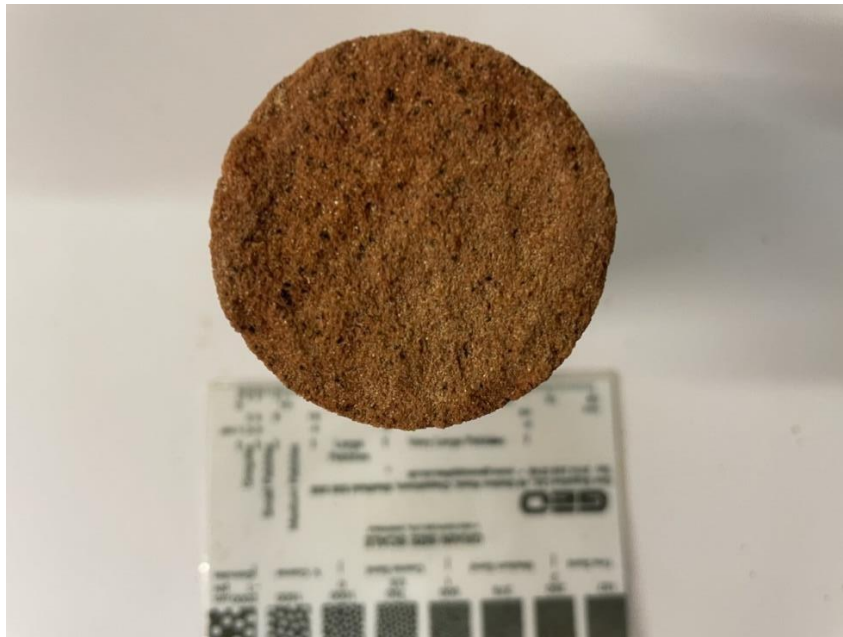
Plate 1. Image of the sample as received. Note the black speckling caused by Fe-oxides and carbonaceous matter. Scale is in mm.

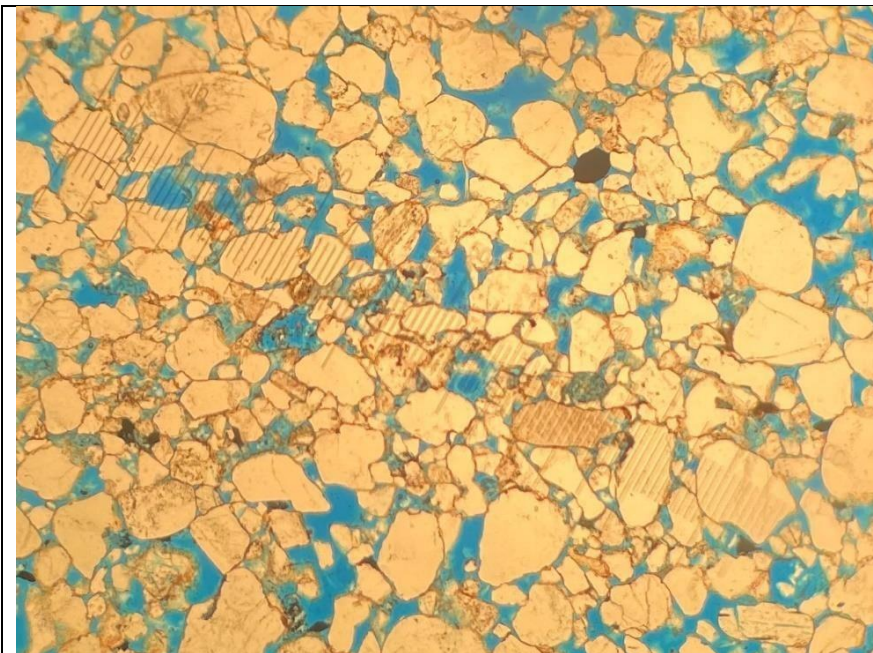
Plate 2. Thin section of the sample under plane polarised light. Pore spaces are highlighted in blue, while areas of light blue indicate pore filling clays that have absorbed some of the blue dye. Pores are moderately to well connected, with some of the larger pores filled with sub-angular to sub-rounded quartz, feldspar, and lithic fragments.

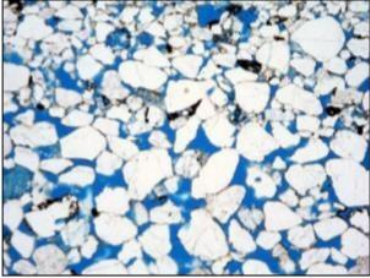
<p>Locharbriggs sandstone</p> <p>Colour: Reddish – pink - orange</p> <p>Fabric: Well bedded sandstone, with evidence of cross-beds in areas.</p> <p>Grain-size: Fine to medium grained sandstone.</p> <p>Permeability: High permeability parallel to bedding and low permeability perpendicular to bedding.</p> <p>Distinctive features: None.</p> <p>Comments: May not be suitable for buildings that are at risk of salt crystallisation damage: i.e., close to heavily salted roads in winter.</p>	<p>Hutton Stone Co Ltd.</p> <p>West Fishwick</p>

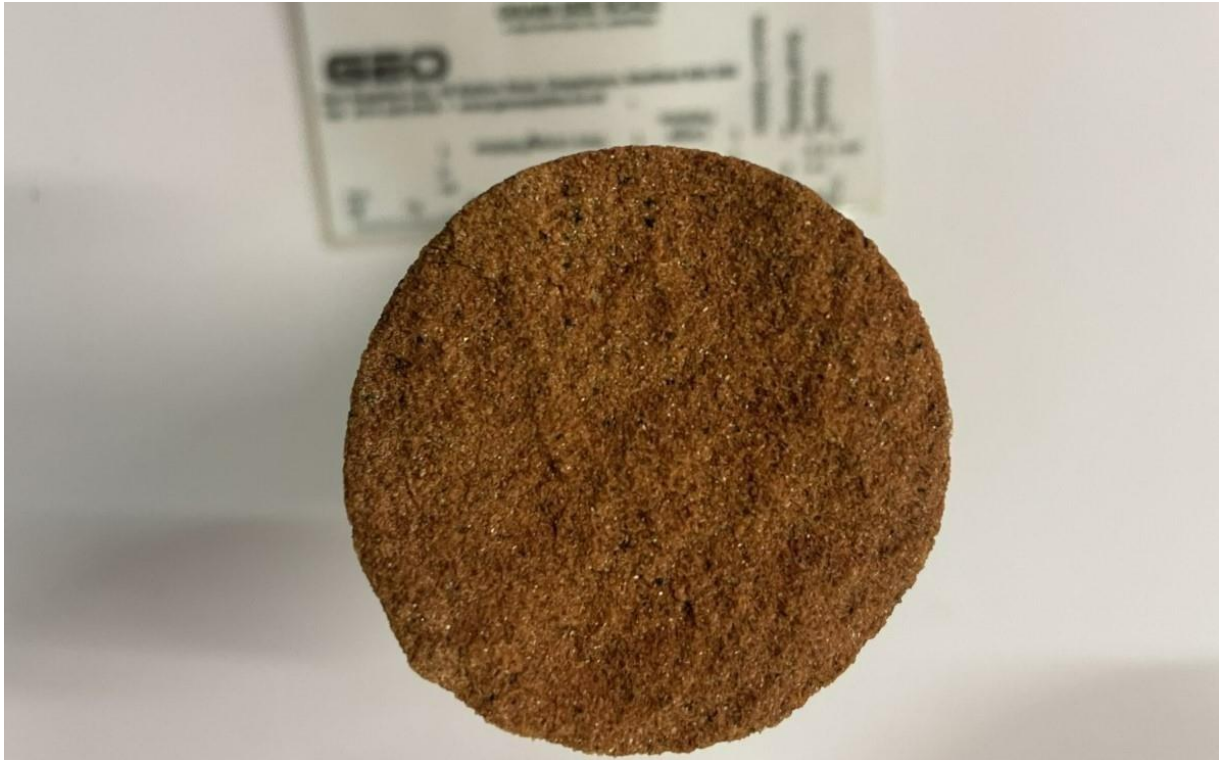
Plate 1. Image of the sample as received. Note the black speckling caused by Fe-oxides. Scale is in mm.

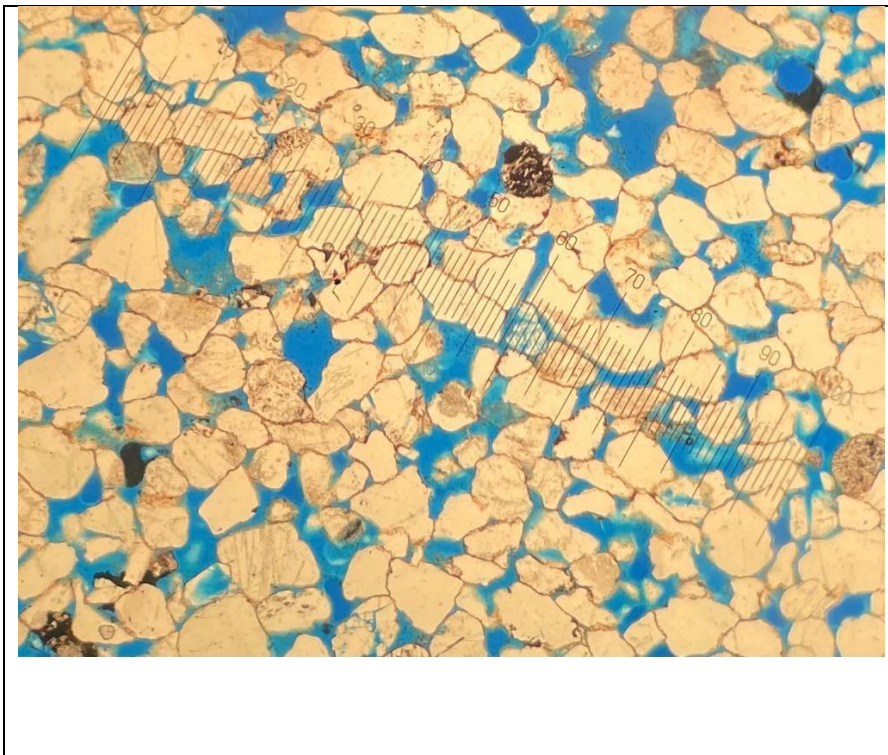
Plate 2. Thin section of the sample under plane polarised light. Pore spaces are highlighted in blue, while areas of light blue indicate pore filling clays that have absorbed some of the blue dye. Pores are moderately to well connected, with some of the larger pores filled with sub-angular to sub-rounded quartz, feldspar, and lithic fragments.

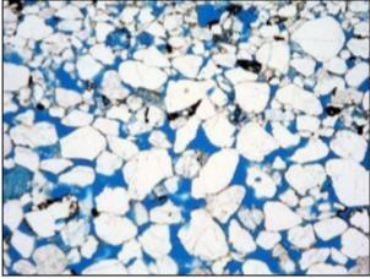
<p>Locharbriggs sandstone</p> <p>Colour: Reddish – pink - orange</p> <p>Fabric: Well bedded sandstone, with evidence of cross-beds in areas.</p> <p>Grain-size: Fine to medium grained sandstone.</p> <p>Permeability: High permeability parallel to bedding and low permeability perpendicular to bedding.</p> <p>Distinctive features: None.</p> <p>Comments: May not be suitable for buildings that are at risk of salt crystallisation damage: i.e., close to heavily salted roads in winter.</p>	<p>Hutton Stone Co Ltd.</p> <p>West Fishwick</p>

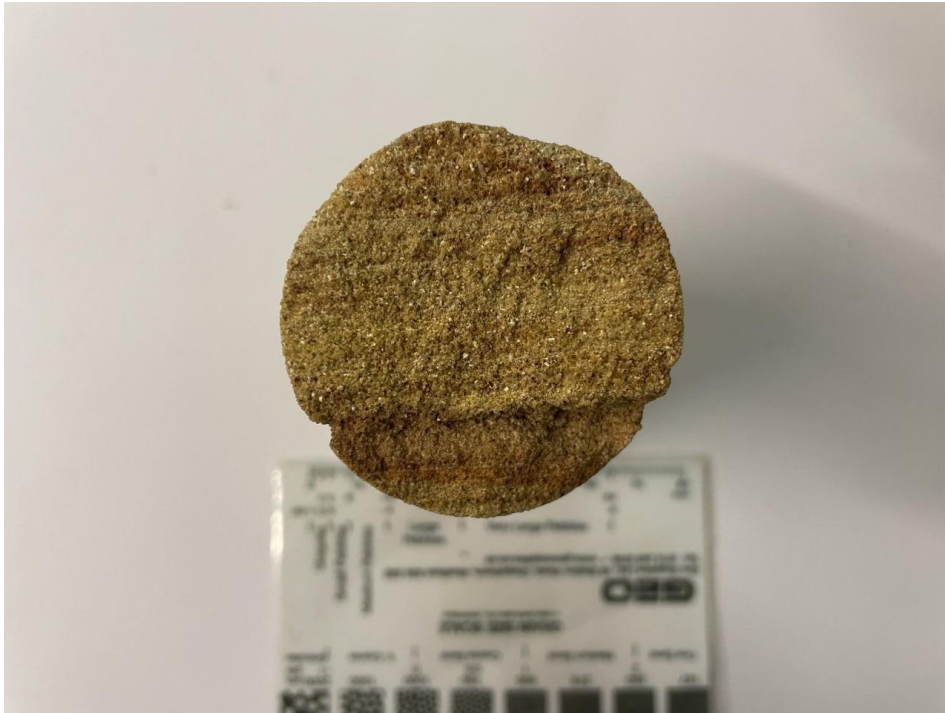
Plate 1. Image of the sample as received. Note the laminated texture and slight pink hue. Scale is in mm.

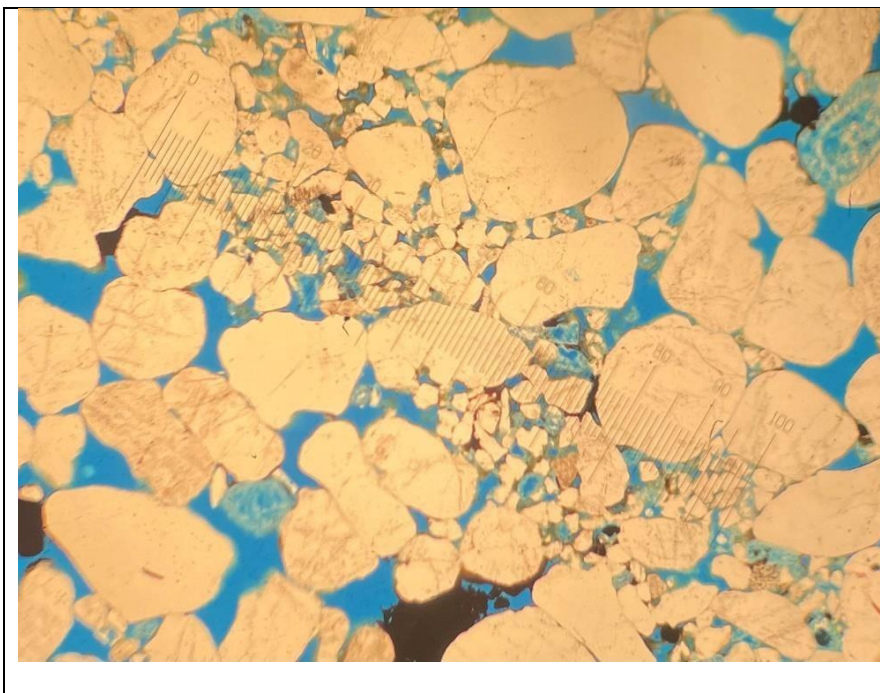
Plate 2. Thin section of the sample under plane polarised light. Pore spaces are highlighted in blue, while areas of light blue indicate pore filling clays that have absorbed some of the blue dye. The stone has distinct bedding which is characterised by layers of differing grain size.

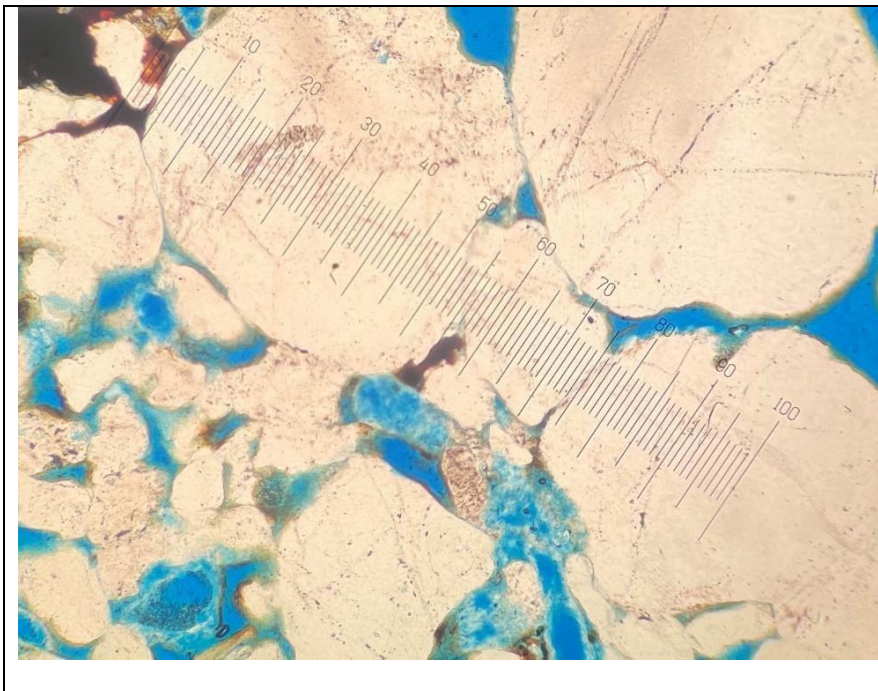
Plate 3. Thin section image of the sample under plane polarised light. Pore spaces are highlighted in dark blue, while areas of light blue indicate pore filling clays. Fe staining can be seen surrounding some of the quartz grains, which gives the sample its pinkish hue in some layers.

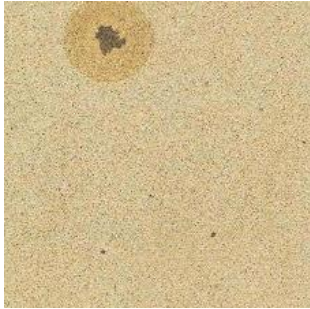
<p>High Nick Sandstone</p> <p>Colour: Buff coloured, with iron spots and iron-oxide banding.</p> <p>Fabric: Mainly uniform, with some aligned grains showing a slight orientation.</p> <p>Grain size: Medium grained.</p> <p>Permeability: Moderate to high.</p> <p>Distinctive features: occasional large ironstone nodules/concretions</p> <p>Comments: The stone contains distinctive iron- oxide nodules that vary in size from mm's to cm's in diameter. Iron-oxide banding is also common throughout.</p>	<p>Border Stone Quarries, Kirkholmedale Lanty's Lonnen Haltwhistle Northumberland NE49 0HQ Tel: 01434 322140</p>

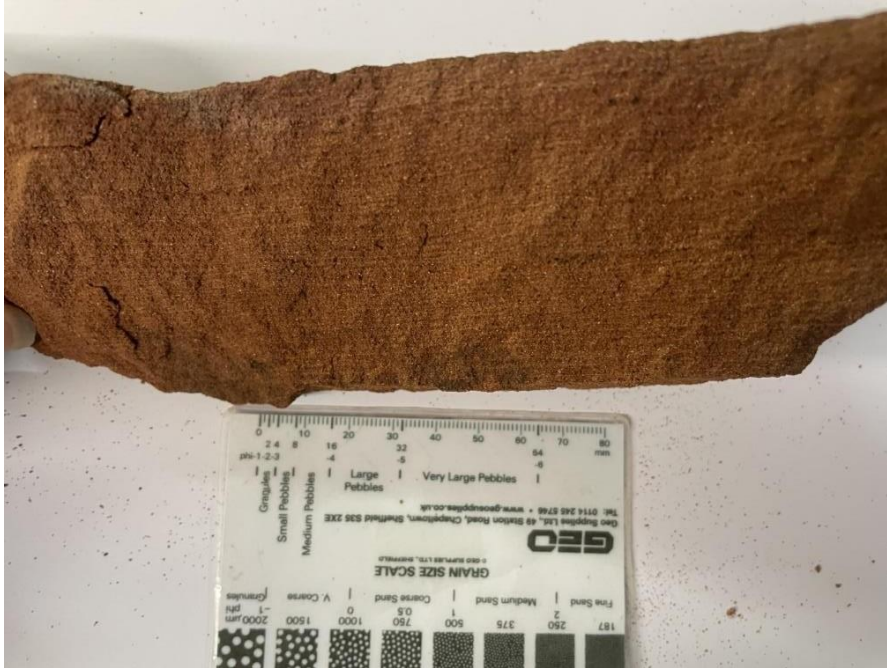
Plate 1. Image of the sample as received. Note the fine laminations in the stone. Scale is in mm.

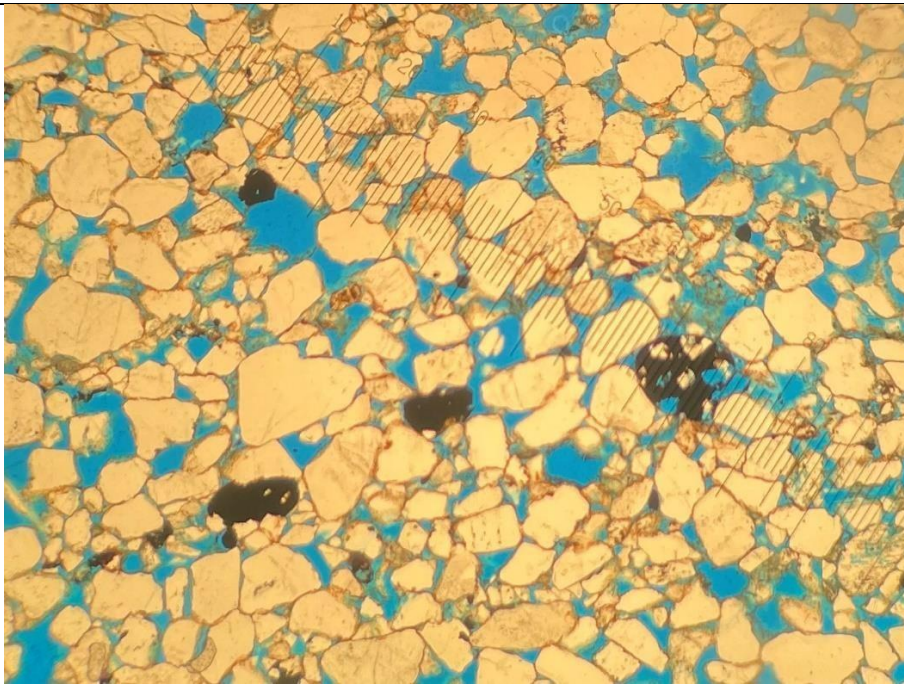
Plate 2. Thin section of the sample under plane polarised light. Pore spaces are highlighted in blue, while areas of light blue indicate pore filling clays that have absorbed some of the blue dye. Pores are moderately to well connected, however some regions are completely infilled with cement (both primary and secondary products).

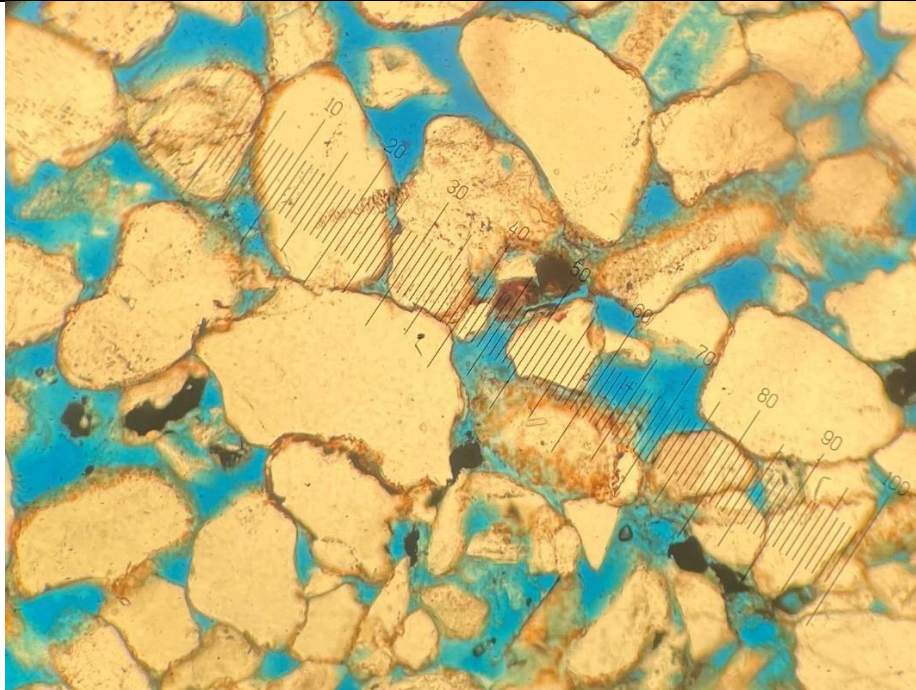
Plate 3. Thin section image of the sample under plane polarised light. Pore spaces are highlighted in dark blue, while areas of light blue indicate pore filling clays. There are some concentration of Fe oxides and organic carbonaceous matter within the thin section. Iron-oxide staining can be seen surrounding some of the quartz grains, which imparts the red colour to the stone.

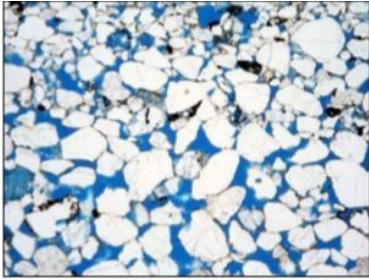
<p>Locharbriggs sandstone</p> <p>Colour: Reddish – pink - orange</p> <p>Fabric: Well bedded sandstone, with evidence of cross-beds in areas.</p> <p>Grain-size: Fine to medium grained sandstone.</p> <p>Permeability: High permeability parallel to bedding and low permeability perpendicular to bedding.</p> <p>Distinctive features: None.</p> <p>Comments: May not be suitable for buildings that are at risk of salt crystallisation damage: i.e., close to heavily salted roads in winter.</p>	<p>Hutton Stone Co Ltd.</p> <p>West Fishwick</p>

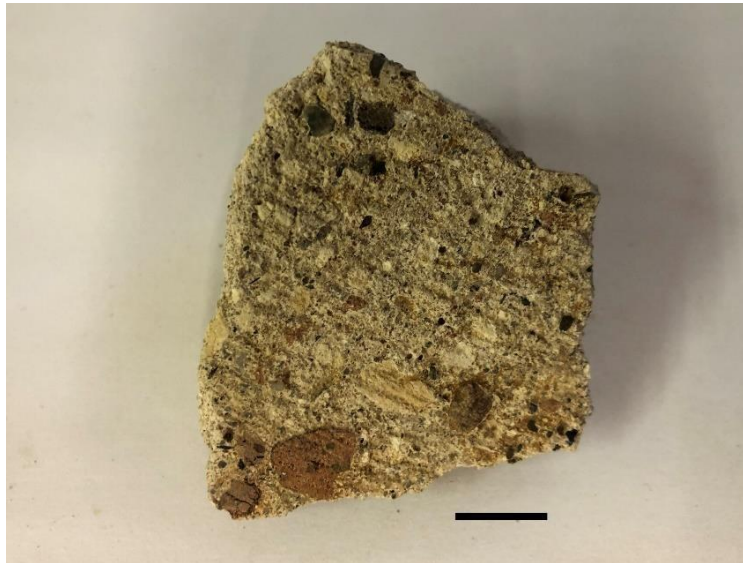
Figure 1. Image showing a freshly sawn face of the mortar. Scale bar = 10mm.

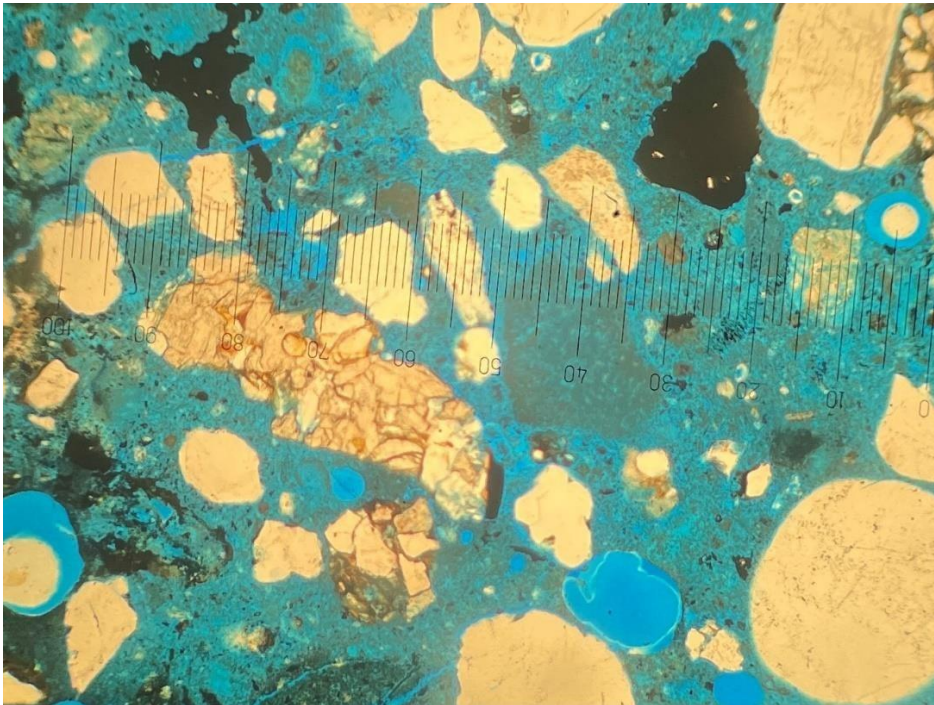
Figure 2. Thin section of the sample under plane polarised light. Pore spaces are highlighted in bright blue, while areas of dark/dull blue indicate the lime binder that has absorbed some of the blue dye. The binder is predominately heterogeneous throughout the sample. Image showing a typical view of large rounded aggregate grains and carbonated binder.

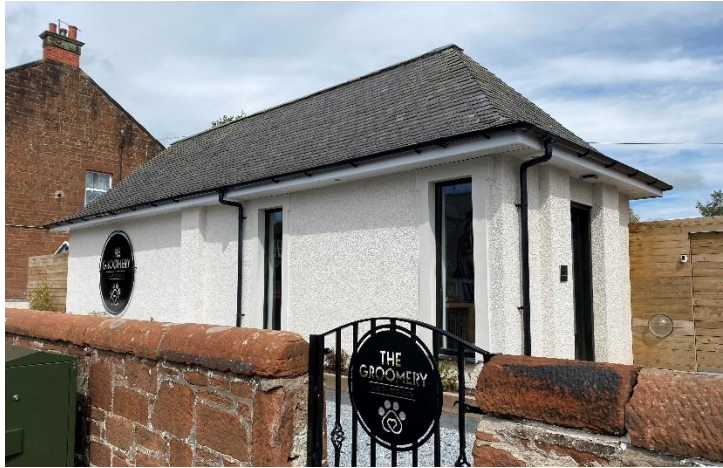
Windows	good condition uPVC.
Doors	Modern painted blank.
External Pipework	uPVC gutter and downpipes.

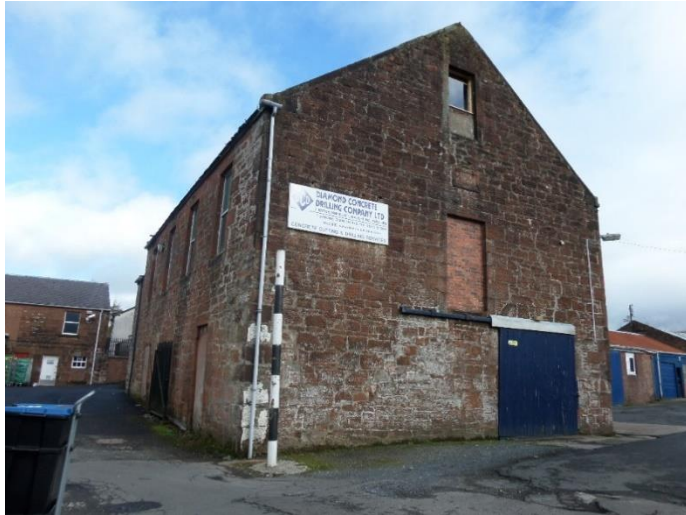
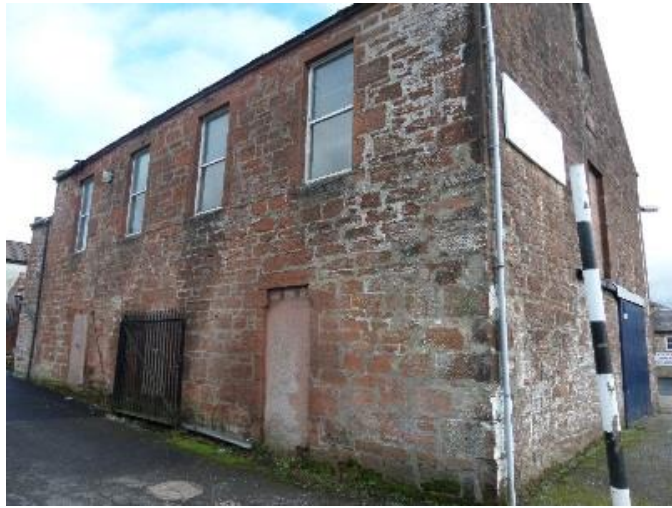
Restrictions	Surveyed from Barskimming Road only
Structural Issues	None apparent
Storey Height	2
Roof	Not visible. Presumed natural slate.
Chimneys	n/a
Walls	Red sandstone rubble. Cementitious pointing.
Windows	Modern timber casements – a number of windows are blocked up.
Doors	Vertically lined timber sliding door. Two blocked up door openings.
External Pipework	uPVC downpipes. uPVC gutters (partially missing)

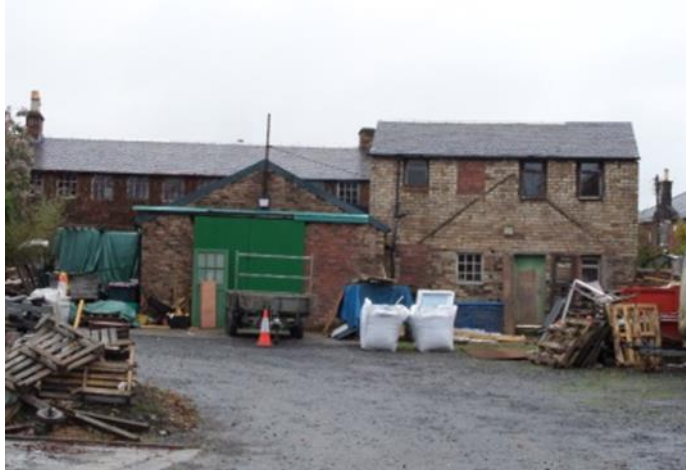
Restrictions	Surveyed from fence line on Barskimming Road only.
Structural Issues	Movement cracks to top right hand corner.
Storey Height	2
Roof	Natural slate with zinc ridge and clips.
Chimneys	None visible
Walls	Buff brick / red brick
Windows	Predominantly modern casement. 1no. 9 paned casement
Doors	Ply door blank
External Pipework	uPVC

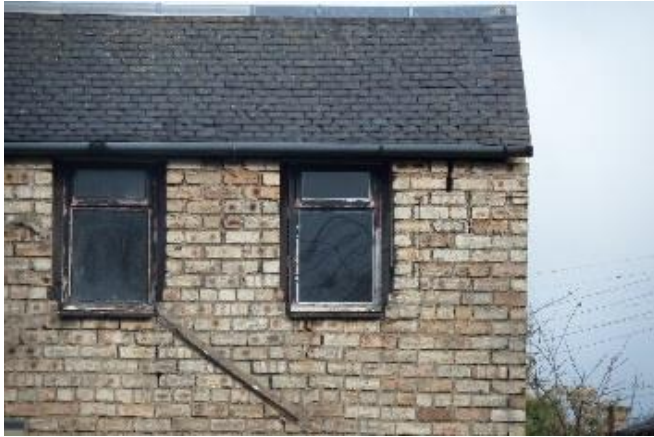
Priority Score (0+1+2) 3

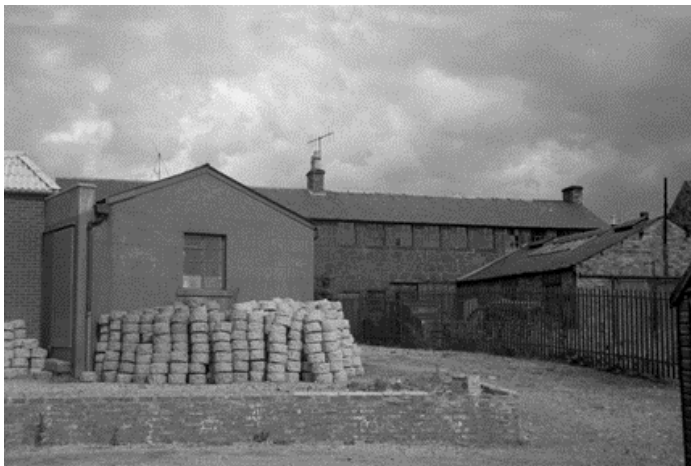
KAY'S CURLING STONE FACTORY ENHANCED FLOOR PROCESS

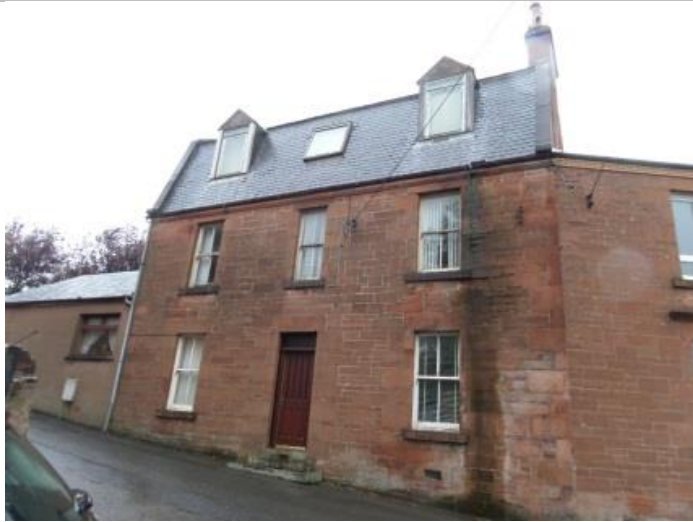
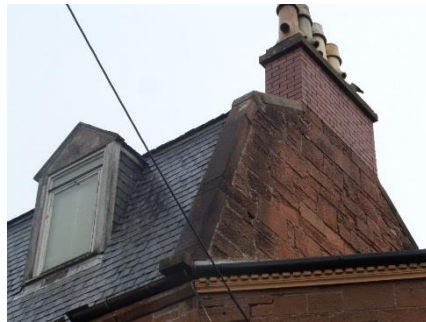
1-3 Burnside Road
Residential

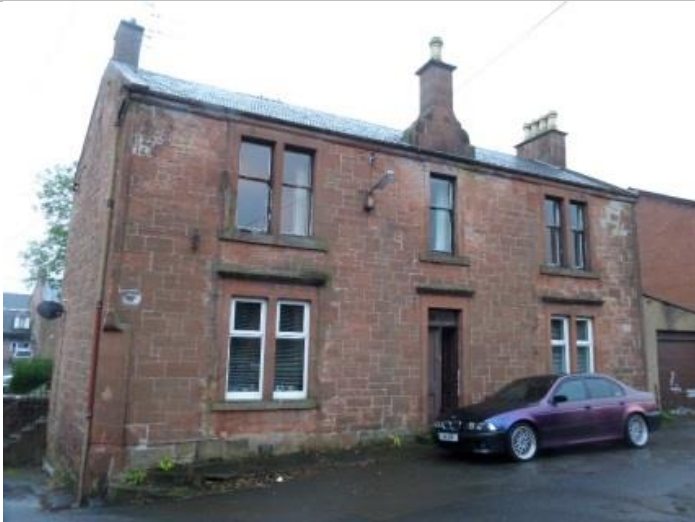
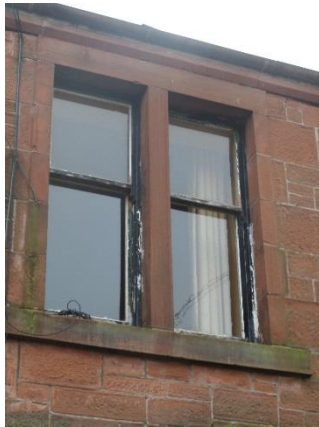
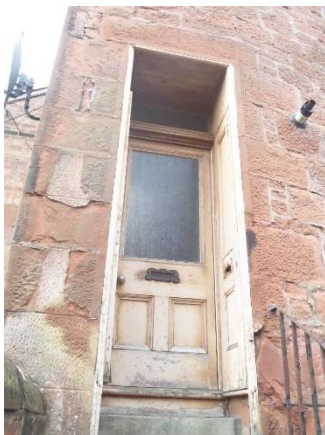
4-6 Burnside Road
Residential

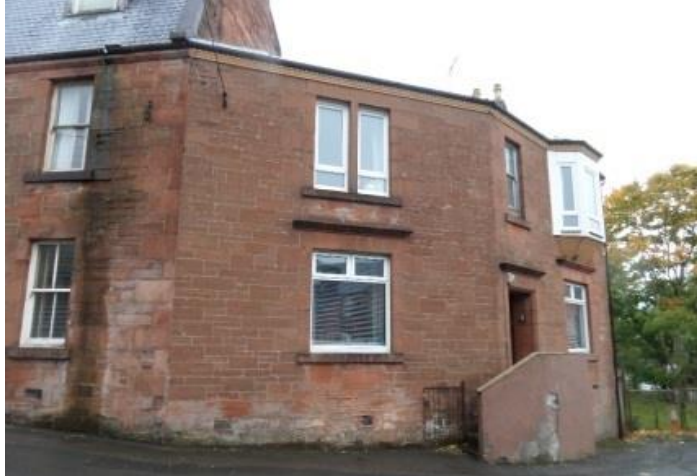
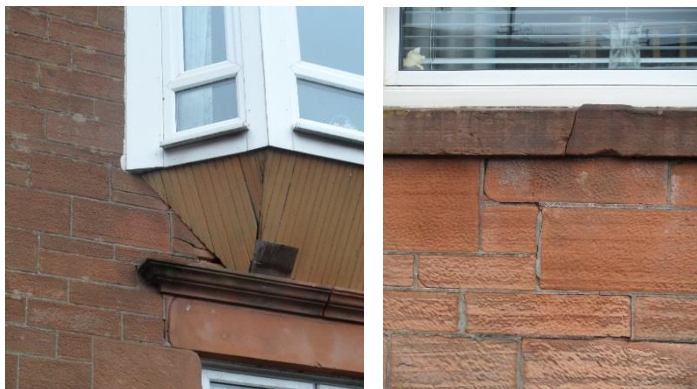
Ground – occupied
First – occupied

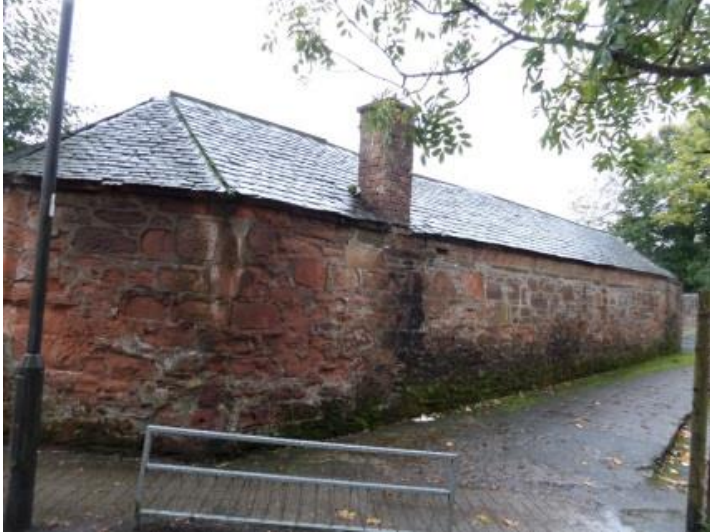
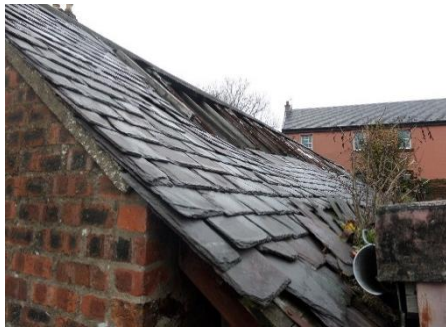
Restrictions	Surveyed from Burnside Road and courtyard.
Structural Issues	Crack at corner of brickwork.
Storey Height	1 – detached.
Roof	Natural slate. Ridge missing – partially collapsed to rear. Mortar skews to chimney.
Chimneys	Red brick wall head chimney. No pots. Open joints.
Walls	Red sandstone rubble with red brick wall head. Brick gable end. Heavily eroded with heavy cement over pointing. Very damp at ground floor level.
Windows	Remains of cast iron roof lights, now missing.
Doors	n/a
External Pipework	Missing.
