Mauchline Conservation Area Management and Maintenance Plan

Picture created by Miguel Silva Barral ©

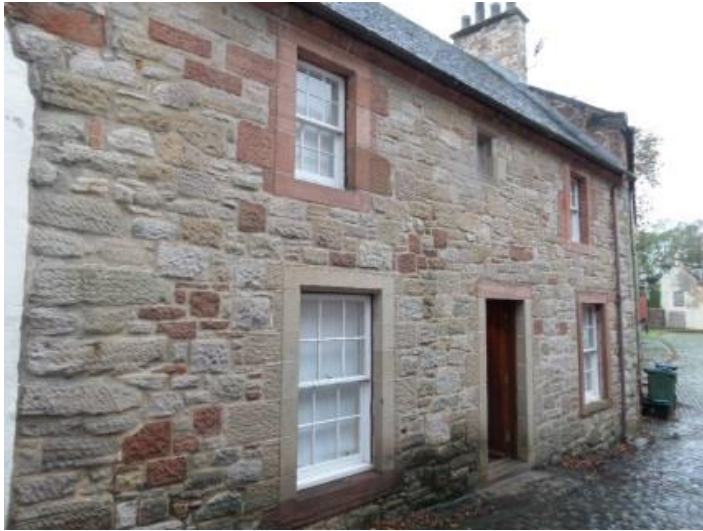
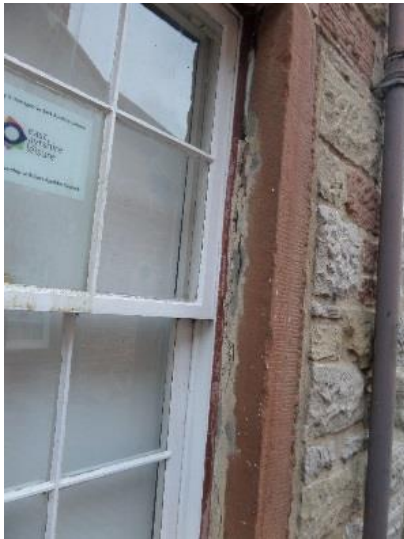
Restrictions	Surveyed from Castle Street only.
Structural Issues	None apparent.
Storey Height	2 – terraced.
Roof	Natural slate with lead ridge flashing and clips.
Chimneys	Brick chimneys at each party wall with black terracotta pots

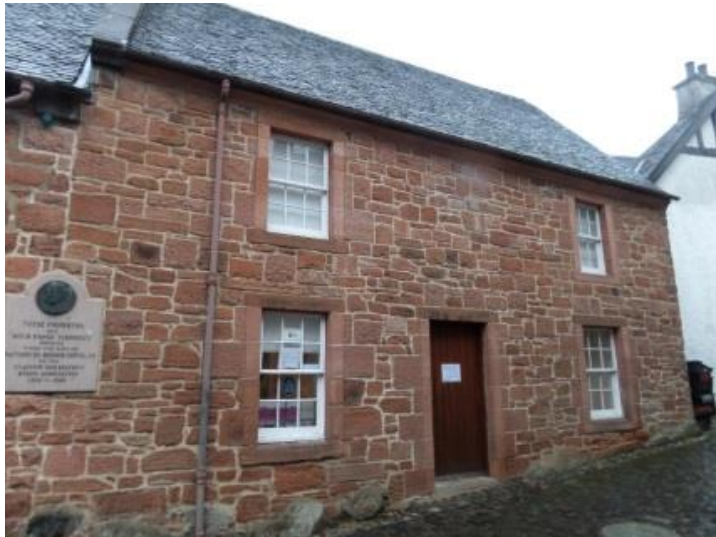
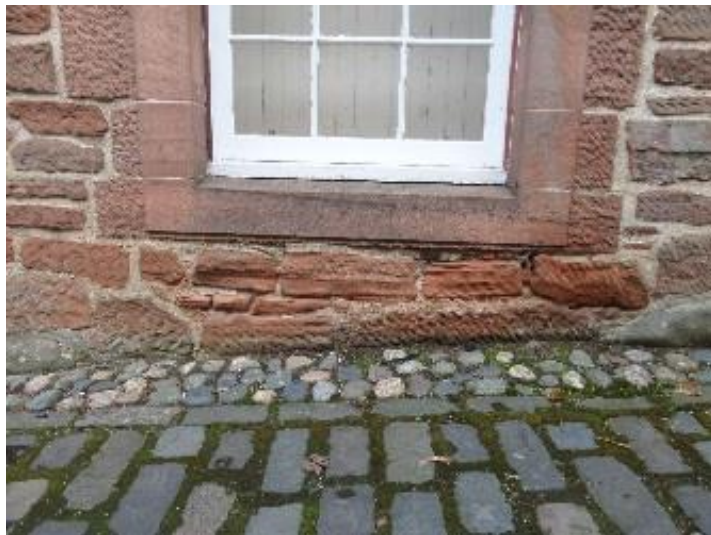
2 Castle Street Part of Burns Museum	Category B Listed	Occupied
	Restrictions	Surveyed from Castle Street only.
	Structural Issues	None apparent.
	Storey Height	2 - end terrace.
	Roof	Natural slate with lead ridge flashing and clips. Stepped lead soakers / mortar at chimney.
	Chimneys	At party wall. Red

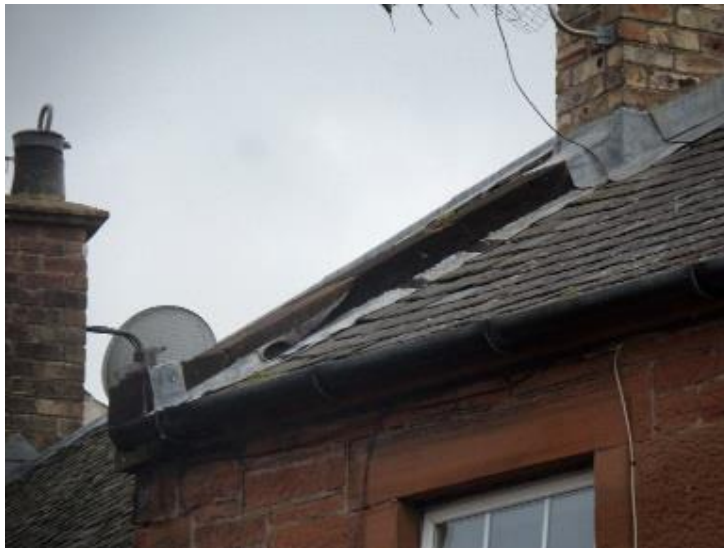
Lead/felt flashing at straight skew. Felt loose.
Chimneys	Brick chimney on party wall with No. 1 with 4no. cans. Brick chimney at wall head on gable return of No.5.
Walls	Squared red sandstone rubble with ashlar door and window dressings. Cementitious mortar with cementitious repairs around ground floor window to No.5 and up flue line on return.
Windows	7 no. uPVC windows.
Doors	2no. modern timber panelled doors. Modern timber porch to No. 5.
External Pipework	uPVC gutter. 1no. circular cast iron downpipe – requires refurbishment.

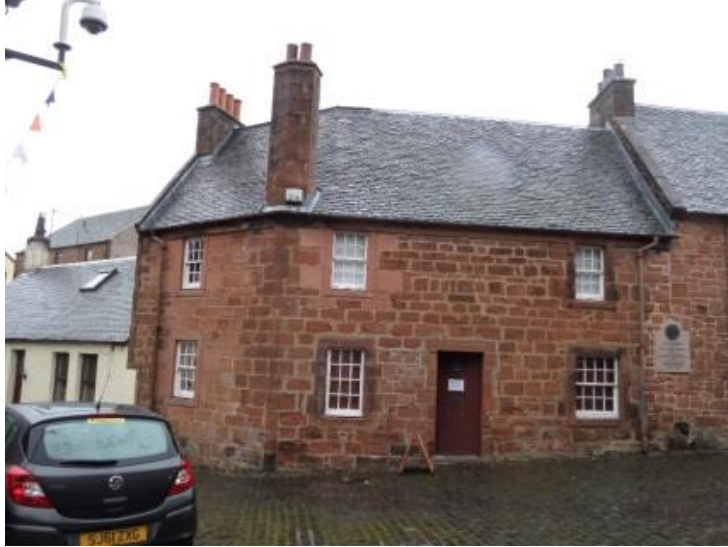
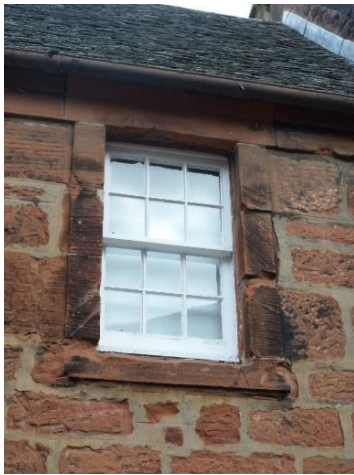
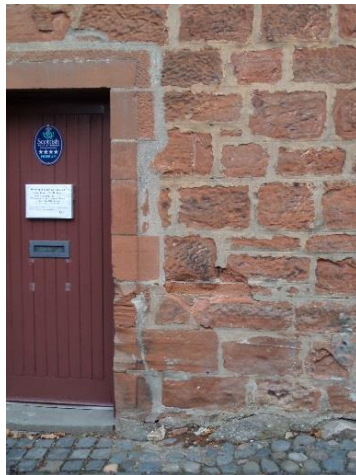
4 Castle Street
Part of Burns Museum

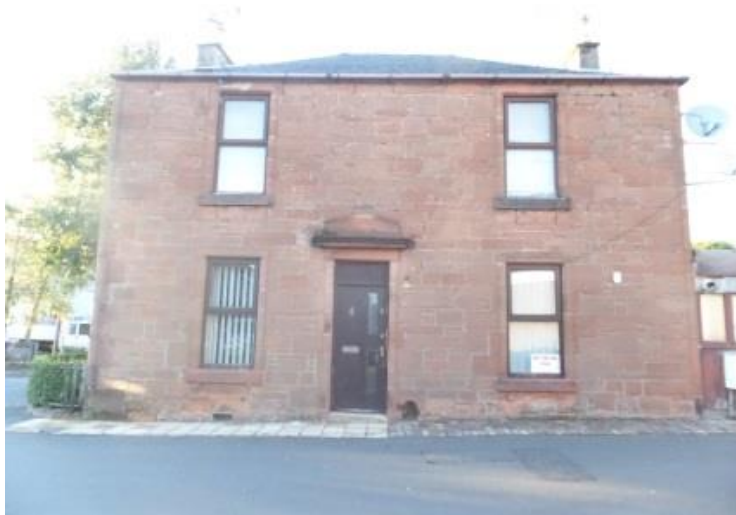
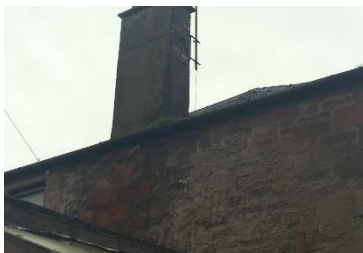
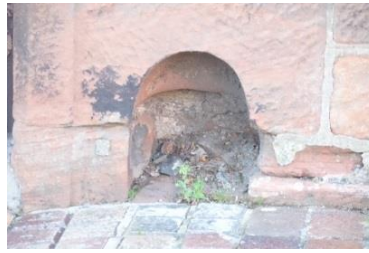
Occupied
Restrictions	Surveyed from Cowgate and also gable ends.
Structural Issues	None apparent.
Storey Height	2 - detached
Roof	Hipped roof. Natural slate with zinc ridges and clips. No skewes. Assume lead chimney flashing
Chimneys	Brick chimneys to l.h.s. and r.h.s. each with 2no. decorative cans.
Walls	Squared red sandstone rubble with ashlar window dressings and door surround. Street frontage requires repointing. Erosion below windows. Dry dash on l.h. gable. Heavy stone erosion along flue line on r.h. gable. 1no. modern grille. Recess for shoe scraper – ironwork missing.
Windows	Modern timber.
Doors	Modern door blank with vision panels.

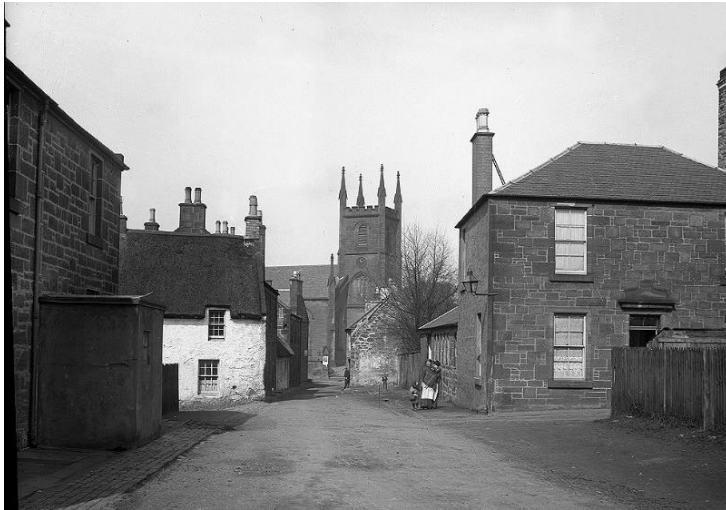
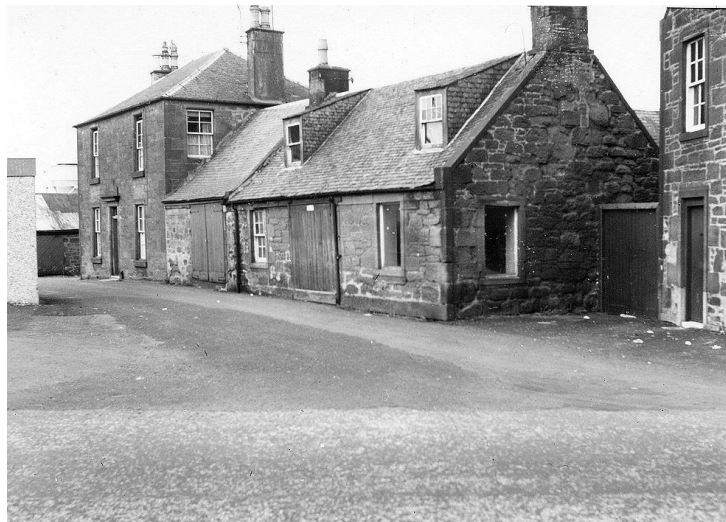
Priority Score (0+2+2) 4

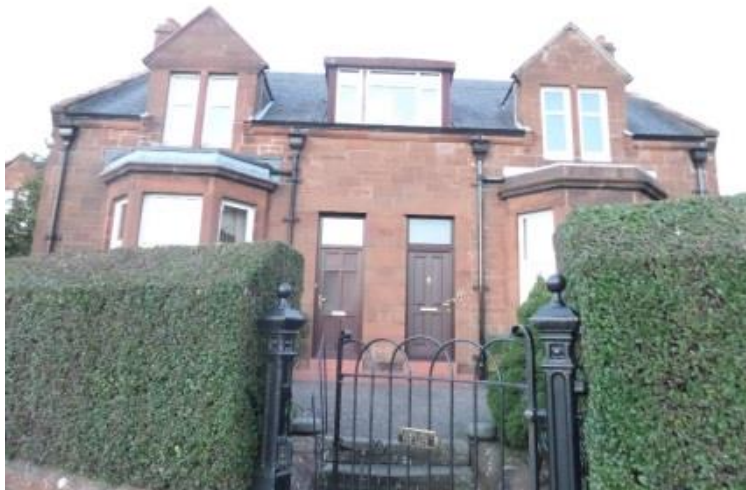
Restrictions	Restricted survey due to front garden.
Structural Issues	None apparent
Storey Height	1.5 – 2 x semi-detached.
Roof	Natural slate with zinc ridge and clips. Box dormer. Mortar skewes. Lead chimney flashings and on bay window roof.
Chimneys	1no. red sandstone gable stack with 4no. cans to l.h.s. 1no. red sandstone gable stack with 4no. cans to r.h.s.
Walls	Red squared sandstone with ashlar window and door surrounds. Single storey bay window. No

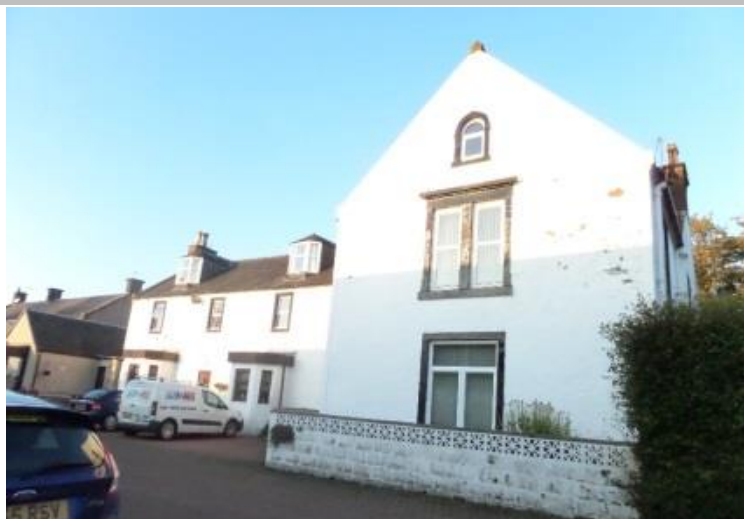
Ground – occupied First – occupied Second - occupied
Restrictions	Surveyed from Grove Park/Cumnock Road only.
Structural Issues	None apparent
Storey Height	2 – 2 x semi detached
Roof	Polygonal dormer windows. and roof lights. Natural slate with zinc ridge and clips. Mortar skews. Lead valleys and chimney flashings.
Chimneys	1no. stone stack with 3no. ornamental pots. 1no. stone ridge stack with no pots. 1no. stone stack with 2no. ornamental cans. 1no. stone stack with 3no. ornamental cans.
Walls	Painted masonry - requires repainting. Modern air bricks.
Windows	uPVC
Doors	uPVC

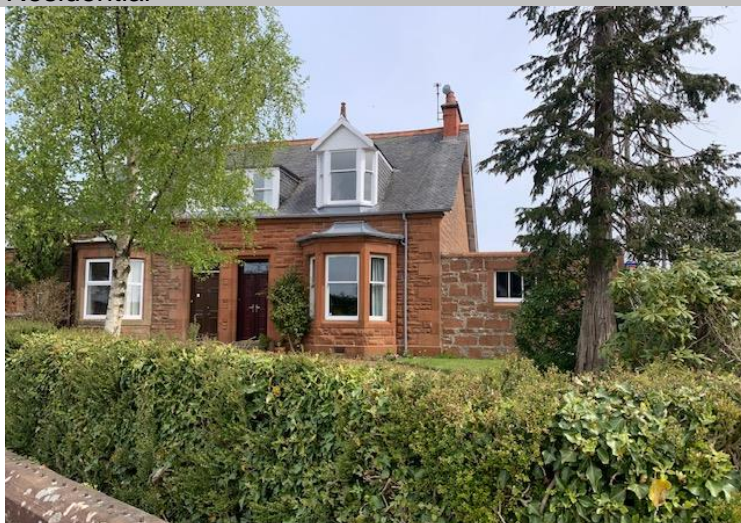
Restrictions	Access very restricted for survey.
Structural Issues	None apparent
Storey Height	1.5 – semi-detached.
Roof	Dormer windows. Natural slate with crested terracotta ridge. Lead dormer and chimney flashings.
Chimneys	Red brick chimney with 4no. cans.
Walls	Rock faced red sandstone with ashlar window dressings to bay window. No structural issues apparent. Masonry appears in good condition. Air bricks not visible.
Windows	1x1 timber sash and case.
Doors	uPVC
External Pipework	
Priority Score	(0+2+1) 3

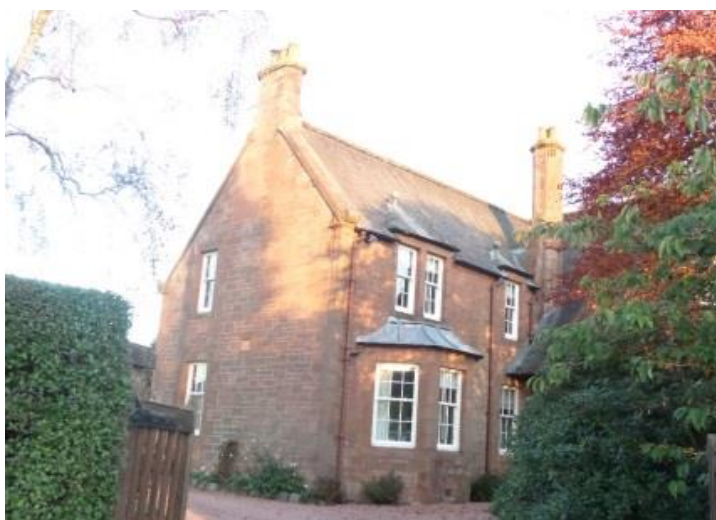
Restrictions	Survey access very restricted by driveway.
Structural Issues	None apparent
Storey Height	2 - detached
Roof	Natural slate, stone ridge tiles, mitred hips. Lead flashings and valleys. Skews not visible.
Chimneys	Visible. 1no. stone gable stack with 3no. cans. 1no. stone wall head stack with 3no. cans.

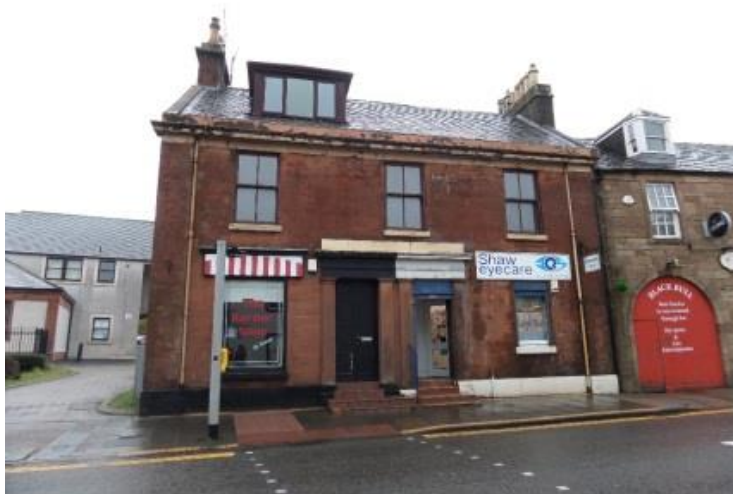
Restrictions	Ground – occupied First – occupied Second - occupied Surveyed from Earl Grey Street only.
Structural Issues	LH chimney leaning / heavily eroded stonework.
Storey Height	2 – end terrace.
Roof	Natural slate pitched roof with straight skews. Box roof dormer. Ridge needs replaced. Lead skews / chimney / dormer flashings. Parapet gutter.
Chimneys	Stone stack with 4no. ornate pots to l.h.s. Stone stack with 8no. pots on party

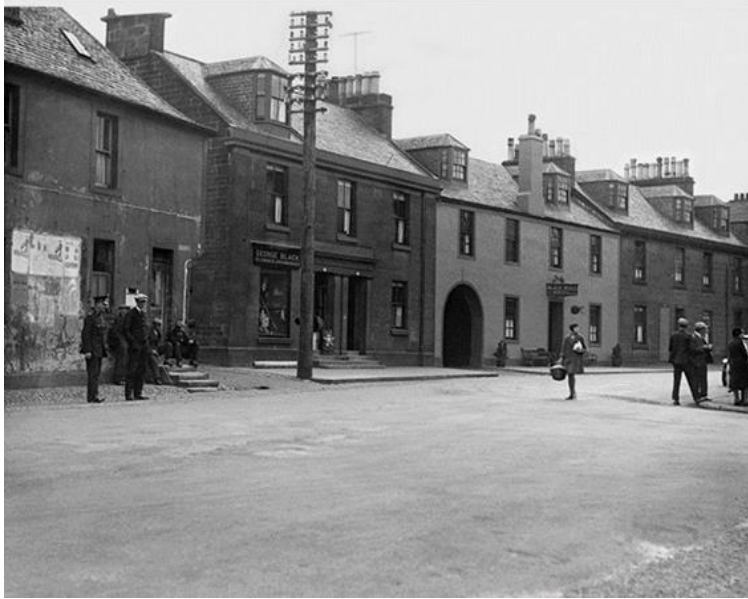
Priority Score (0+2+2) 4

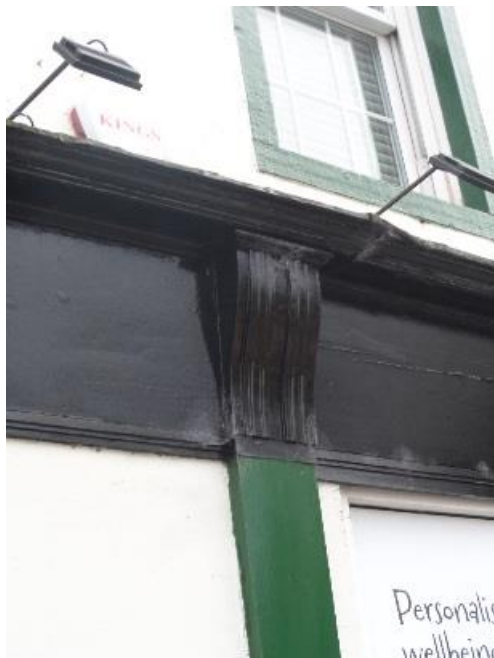
ground floor level. 4no. uPVC windows at first floor level.
Doors	Modern timber panelled door to Earl Grey Street.
External Pipework	uPVC gutter (blocked). Cast iron downpipes.
Shopfronts	Aluminium shopfront and door on to Loudoun Street. Timber fascia with console brackets and pilasters.
Priority Score	(2+2+1) 5

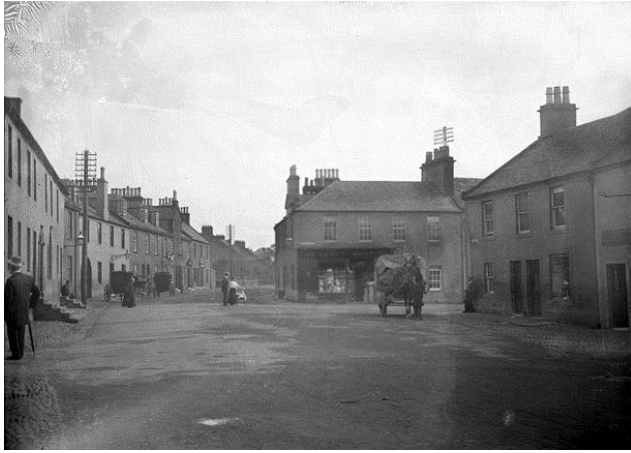
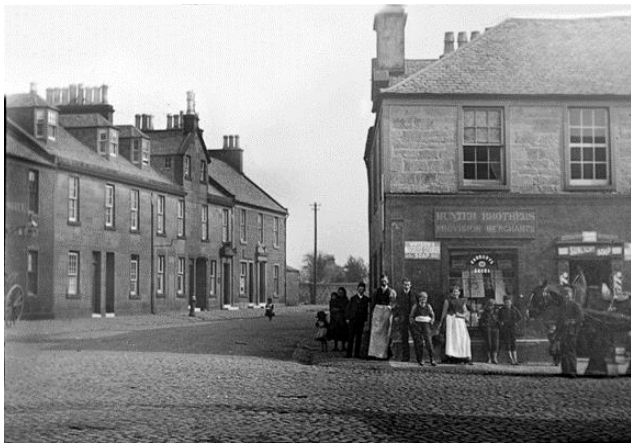
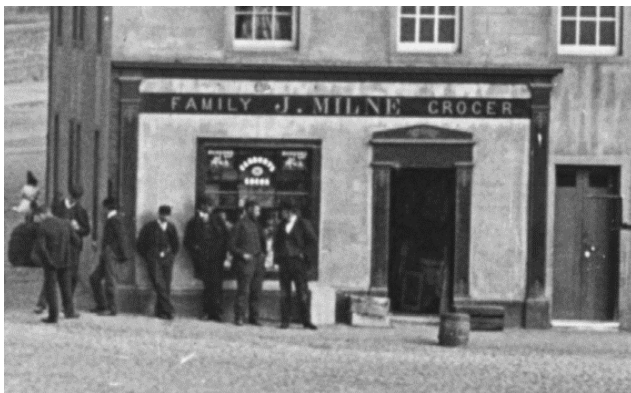
4-6 Earl Grey Street
 Impressions Beauty Salon / Residential

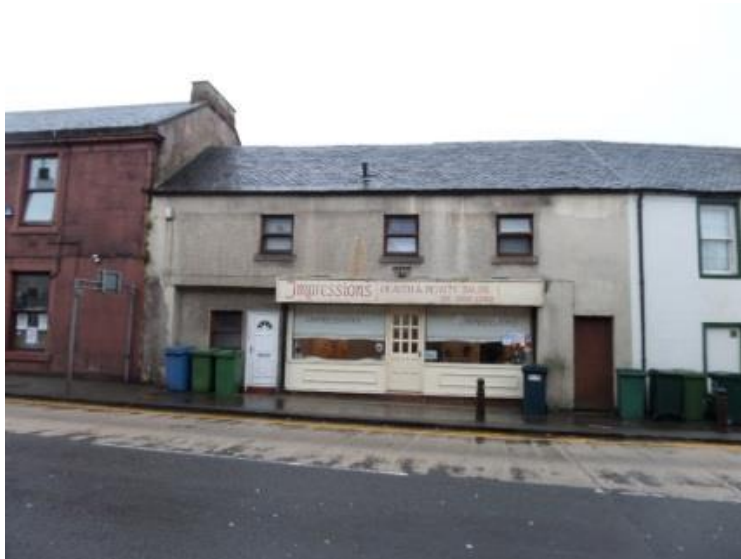
Ground – occupied First – occupied
Restrictions	Surveyed from Earl Grey Street only.
Structural Issues	None apparent
Storey Height	2 – mid terrace.
Roof	Pitched roof. Natural slate with zinc ridge and clips. Mortar / render skew.
Chimneys	n/a
Walls	Wet dash render.

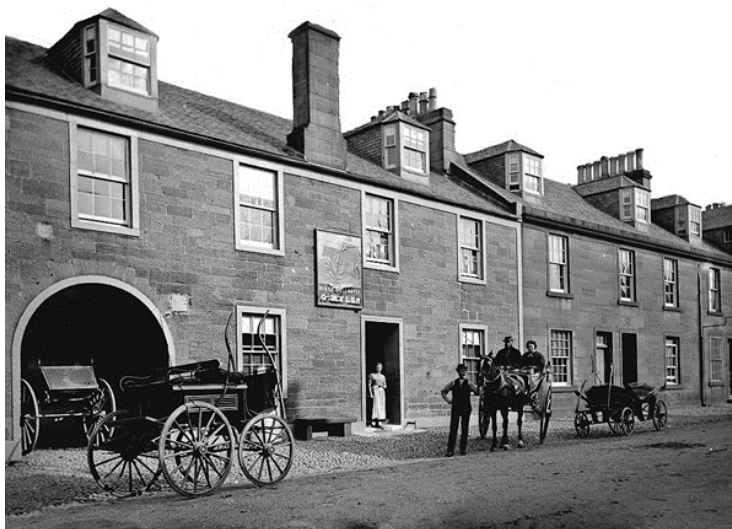
8-16 Earl Grey Street
Kilmarnock Supporters Club

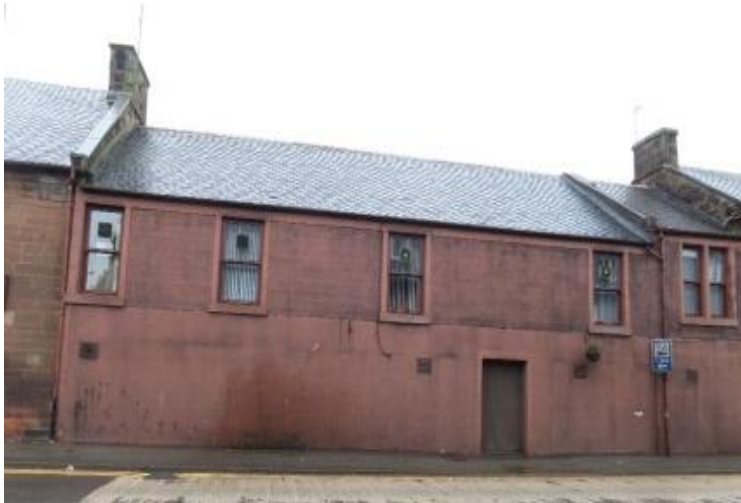
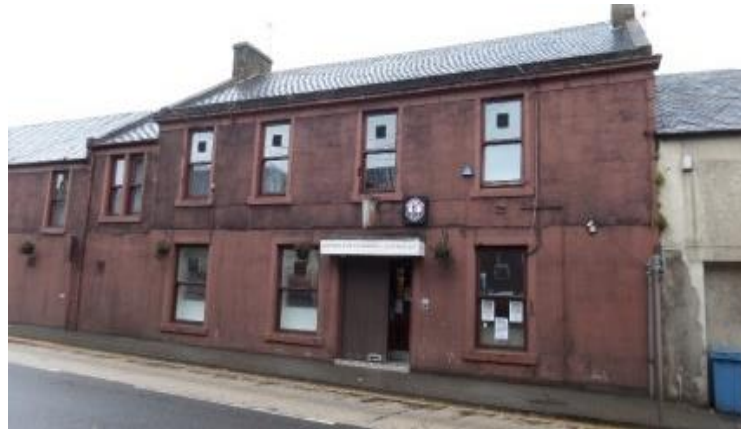
Structural Issues	None apparent
Storey Height	2 – mid terrace.
Roof	Slate roof with zinc ridge and straps to l.h.s. Lead ridge to r.h.s. Lead skew flashings to l.h.s. Mortar skews to
Chimneys	Masonry stack located centrally. No pots. Reduced height stack to r.h.s. No pots.
Walls	Painted render at low level & painted masonry at high level. Area of damp / boss render to l.h.s.
Windows	Modern timber casements with through glass vents.
Doors	Modern timber vertically lined doors.
External Pipework	uPVC gutter to l.h.s & uPVC downpipe. Parapet gutter to r.h.s. – no downpipes evident to r.h.s.

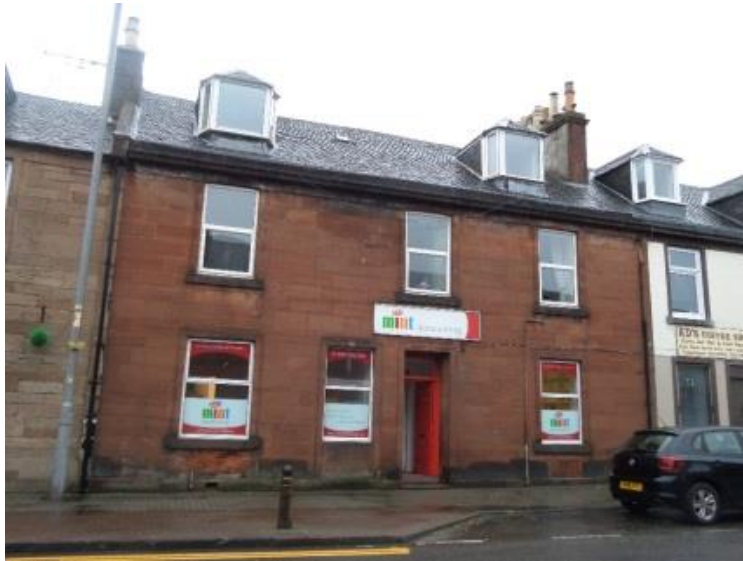
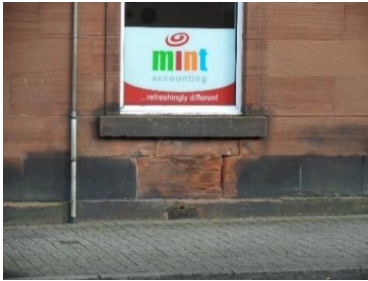
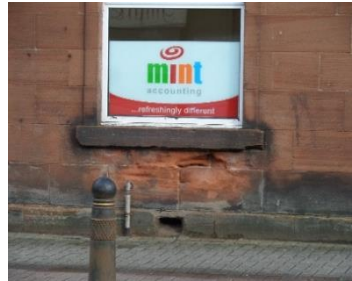
Structural Issues	None apparent.
Storey Height	2 – mid terrace.

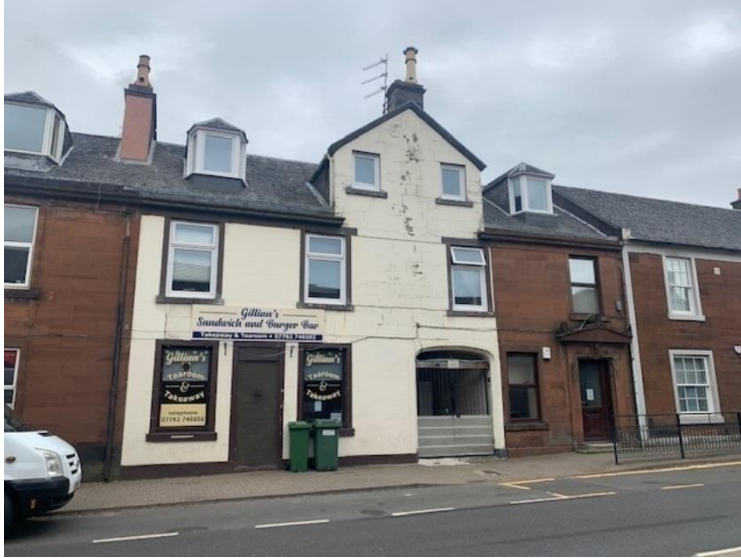
11 Earl Grey Street Gillian's Sandwich + Burger Bar / Residential	Ground – occupied First – occupied Second – occupied.
---	---

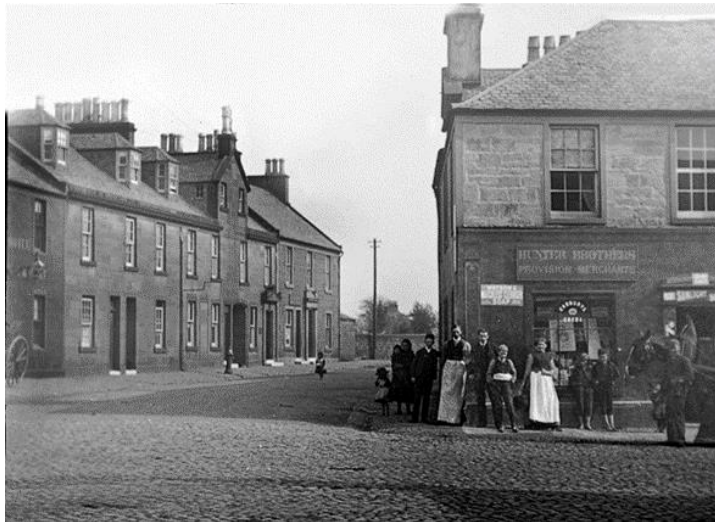
Restrictions	Surveyed from Earl Grey Street only.
Structural Issues	None apparent
Storey Height	2 – mid terrace.
Roof	Pitched roof. Gable dormer plus 1no. hipped dormer. Natural slate with lead ridge. Lead chimney / dormer / parapet flashings. Parapet gutters blocked. Plastic dormer apron flashings.
Chimneys	Red sandstone stack on party wall to l.h.s. 9no. ornate pots -1no. heavily damaged/taped up. 1no. stack on wall head dormer with 1no. pot.
Walls	Painted masonry – requires repainting. 2no. ornate air grilles – over painted. Pend access to rear.
Windows	uPVC.
Doors	Modern glazed timber door. No storm doors.
External Pipework	n/a
Priority Score	(0+2+1) 3

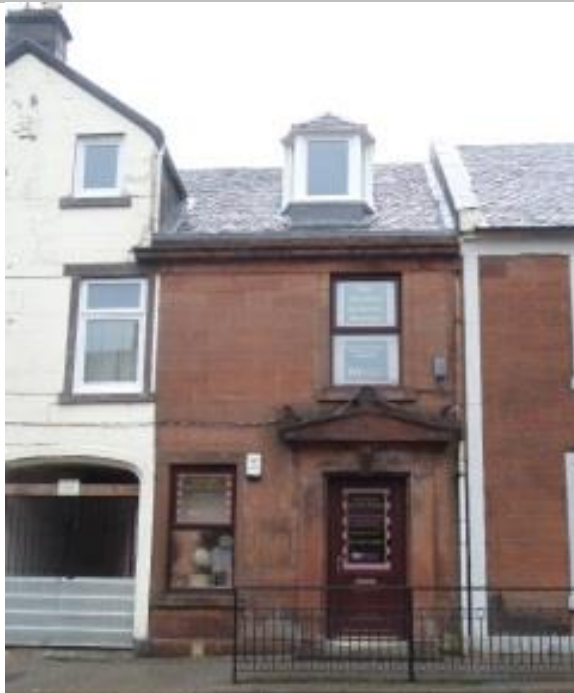
15 Earl Grey Street CARS Office / Residential

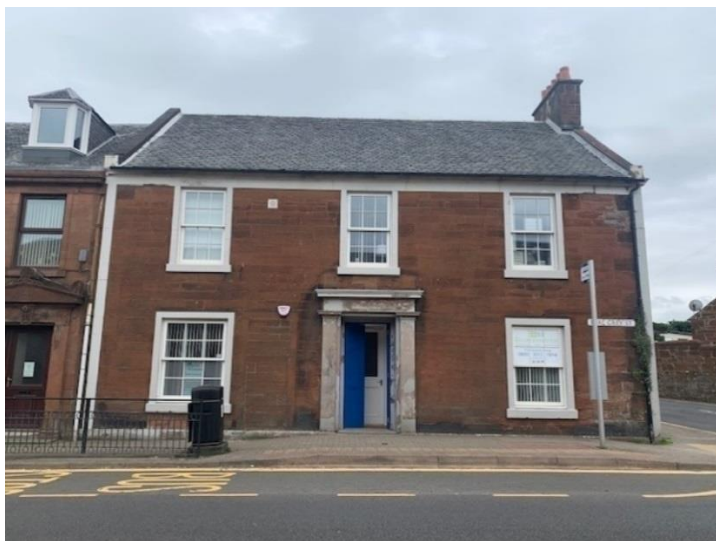
Ground – occupied
First – occupied

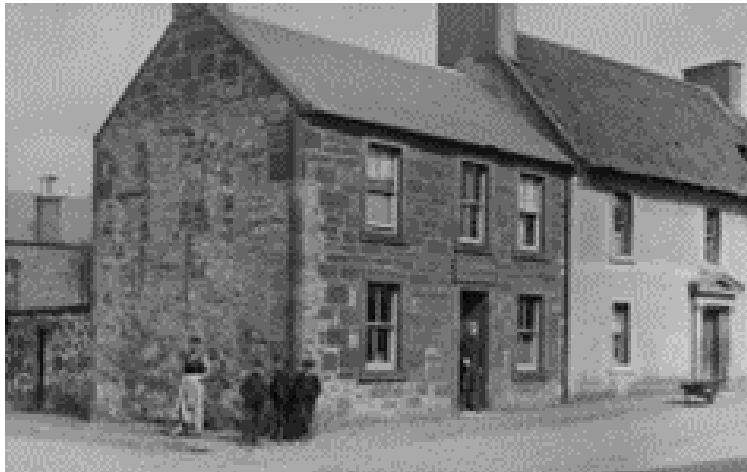
Restrictions	First – occupied Surveyed from High Street/Kilmarnock Road only.
Structural Issues	None apparent
Storey Height	2 – end terrace.
Roof	Natural slate with zinc ridge and clips. Some loose slates evident on High Street. Lead skew flashings No flashing visible at chimney. Timber fascia board (modern addition) requires painting.
Chimneys	Brick chimney on corner gable. No pots. Flue vent.
Walls	Rendered with painted ashlar dressings around windows and doors. Some cracking in wet dash render on Kilmarnock Road elevation. Modern painted terracotta brick vents onto Kilmarnock Road.
Windows	uPVC
Doors	uPVC door.
External Pipework	Kilmarnock Road – uPVC gutter and 2no. uPVC downpipes. High Street – Damp at skew putt. uPVC gutter and 1no. uPVC downpipe.
Priority Score	(0+2+1) 3

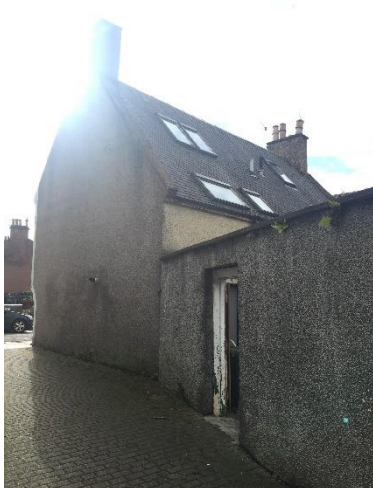
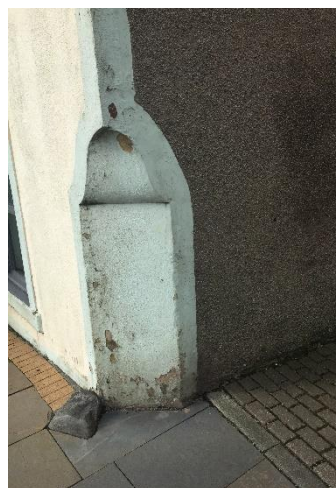
Priority Score (2+3+2) 7

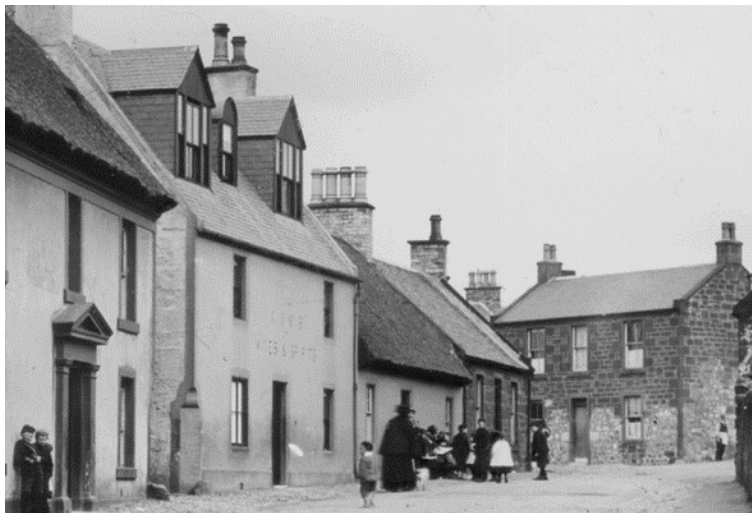
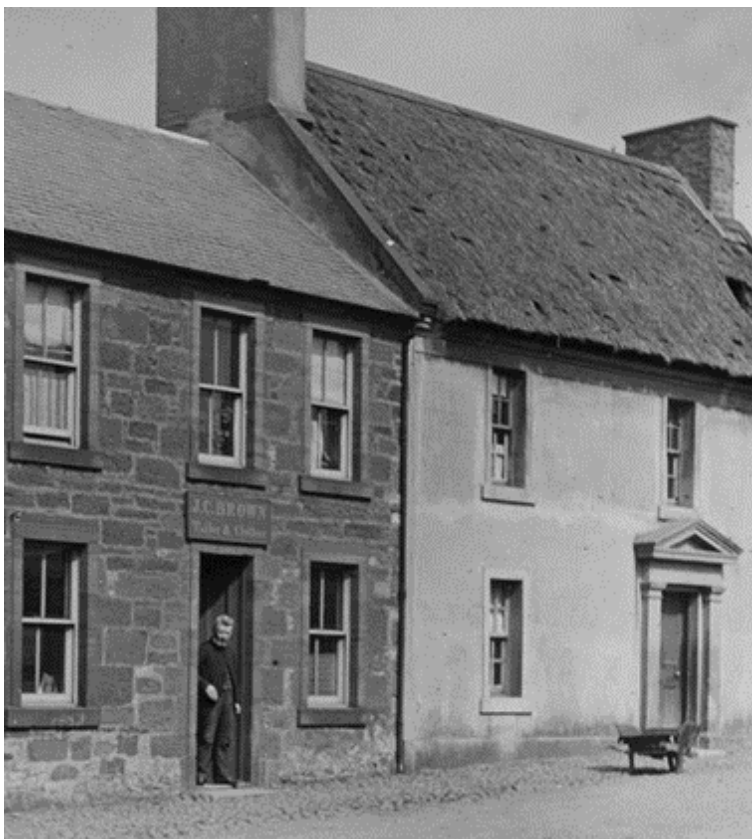
- Check chimney stability
- Carry out minor slate repairs
- Replace flashings and skews
- Remove cementitious render, repoint and re-render with a lime based product
- Remove paint from window and door surrounds
- Replace windows
- Replace door
- Replace uPVC rainwater goods with CI

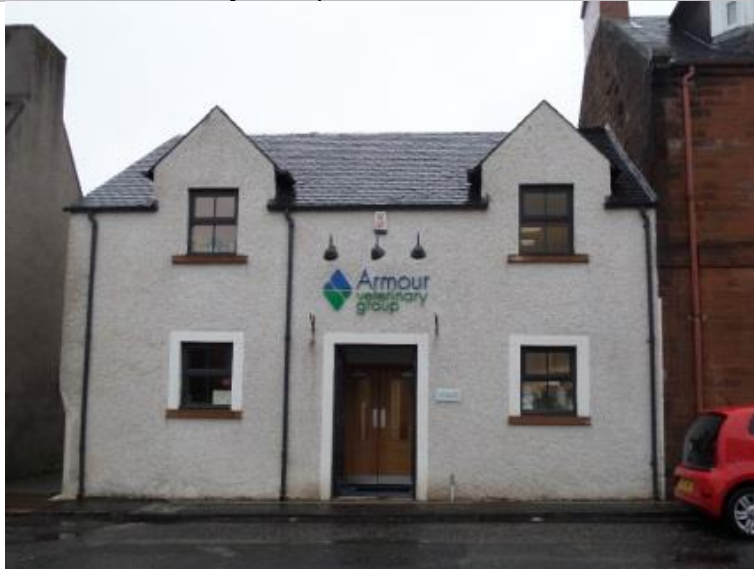
Modern building. No recommendations.

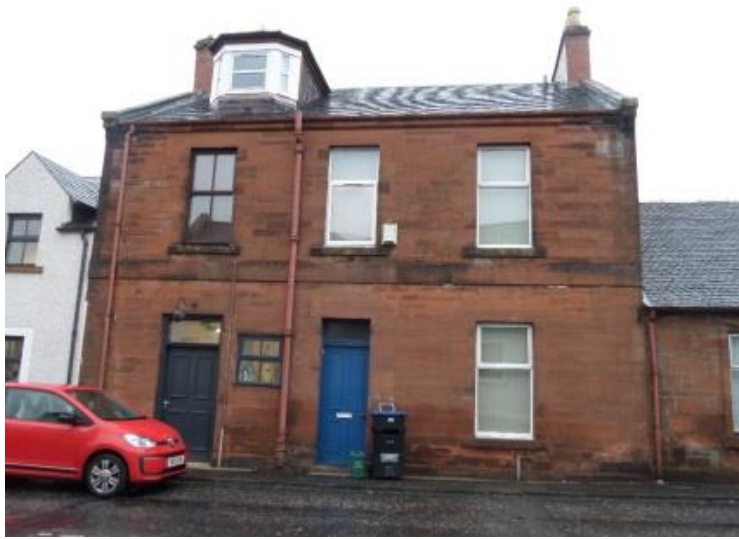
Ground – occupied First – occupied Second – uncertain
Restrictions	Surveyed from High Street only.
Structural Issues	None apparent
Storey Height	2 – mid terrace.
Roof	Modern slate with zinc ridge and clips. Lead skew and chimney flashings. Polygonal dormer.
Chimneys	Brick chimneys to each end. No pots to l.h.s. 8no original pots to r.h.s.
Walls	No structural

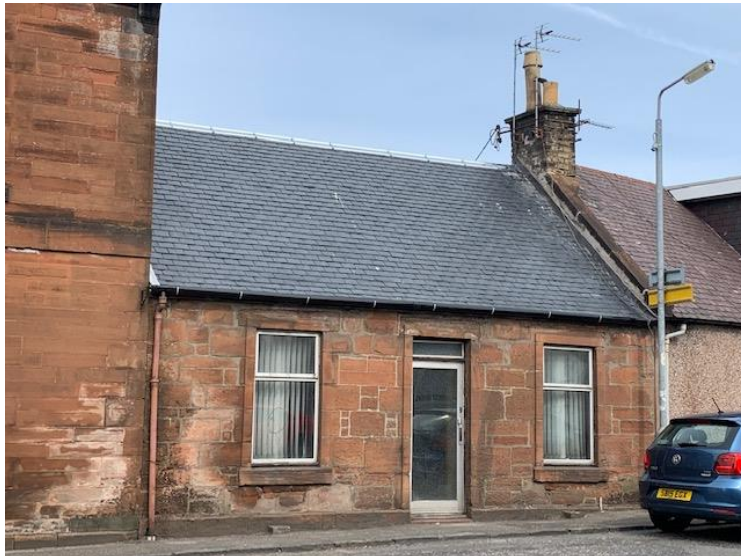
Windows	surrounds. Damp staining above left-hand window and door, and around base of dp. Heavy mortar pointing with stone erosion at low level.
Doors	Aluminium.
External Pipework	Aluminium door with fanlight. No ironmongery of note.
	Cast iron half round gutter and 1no. cast iron circular downpipe. Refurbish.

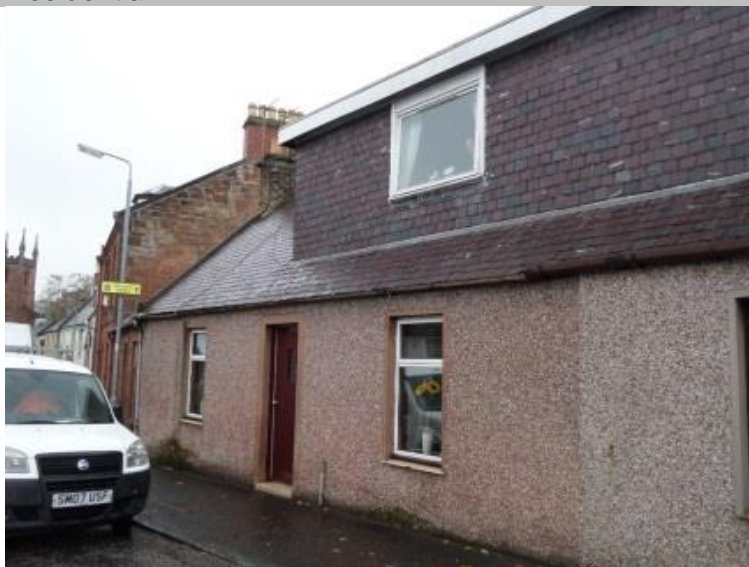
Restrictions	Surveyed from High Street only
Structural issues	None apparent
Storey Height	1- mid terrace.
Roof	Large flat roofed box dormer. Natural slate with zinc ridge and clips. Mortar skew. Lead flashing to dormer.
Chimneys	Brick chimney to l.h.s. 2no. pots. Some movement evident in brick.
Walls	Dry dash render. Area of damp at low level. 1no. modern steel grille.
Windows	2no. uPVC windows with slate cills. Modern

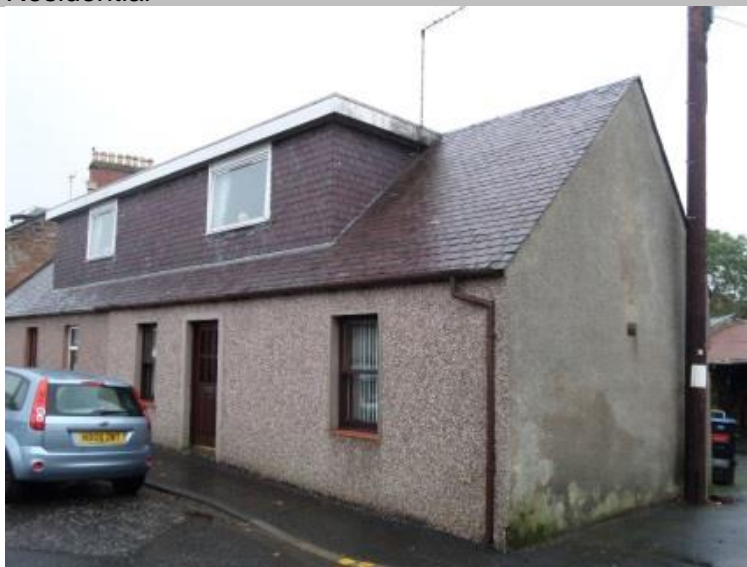
Restrictions	Surveyed from High Street / gable end only.
Structural Issues	None apparent
Storey Height	1 – end terraced.
Roof	Large flat roofed box dormer. Natural slate with zinc ridge and clips. Lead flashings around dormer.
Chimneys	n/a
Walls	Dry dash render.
Windows	Modern timber sash & case with horns at ground level, tiled cills. Modern timber casement in dormer.
Doors	Modern timber door with 6no. glass panels. Ironmongery not of note.
External Pipework	uPVC gutter and 1no. uPVC downpipe.
Priority Score	(0+1+1) 2

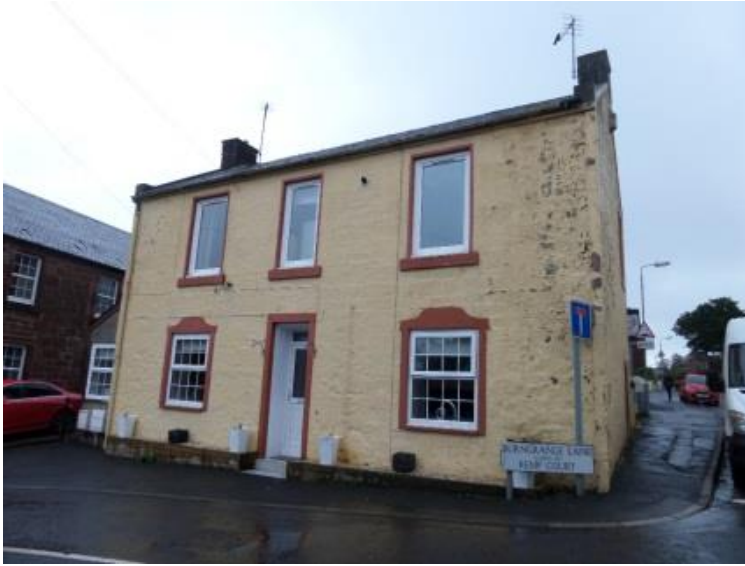
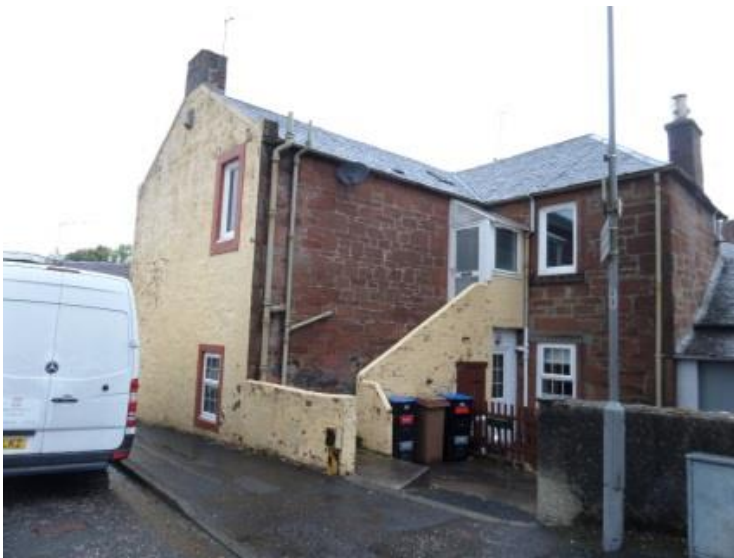
Upper floor reached by external stair

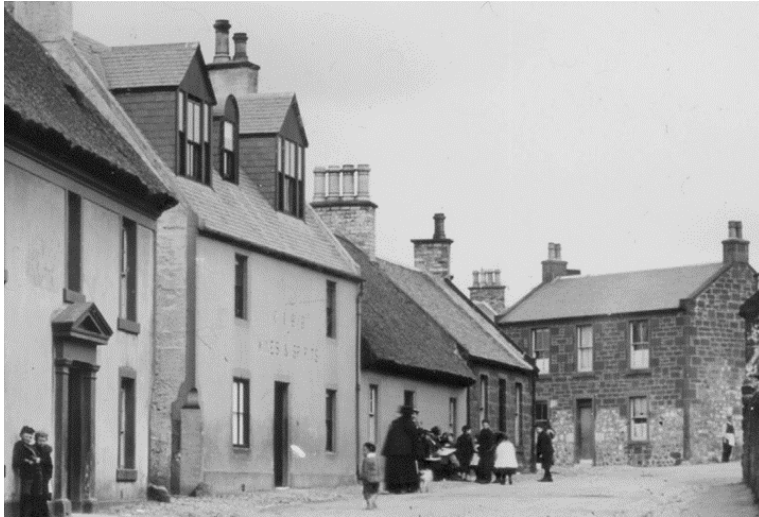
- Carry out minor slate repairs
- Repaint masonry
- Repoint stonework
- Replace uPVC windows
- Replace doors and fanlight
- Refurbish CI rainwater goods
- Replace uPVC section with CI

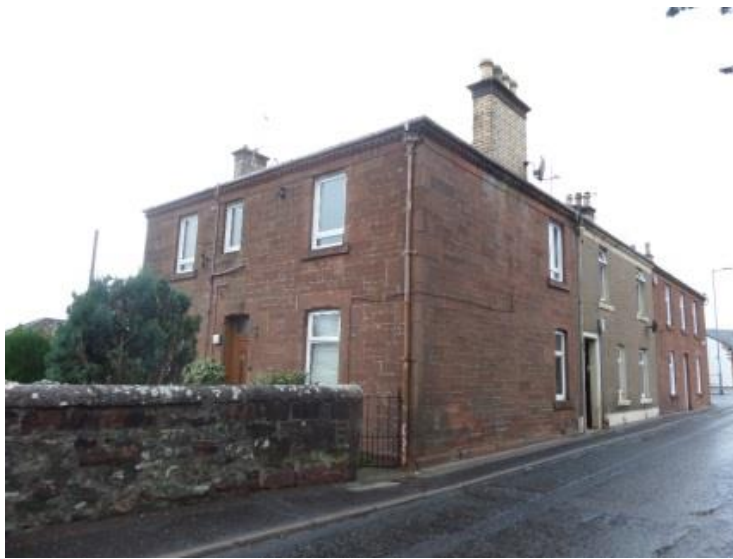
Restrictions	Surveyed from High Street only.
--------------	---------------------------------

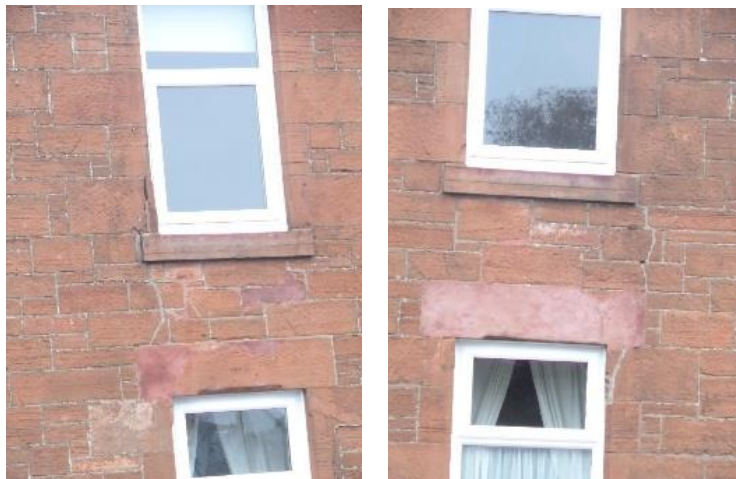
Priority Score	(0+2+1) 3
-----------------------	------------------

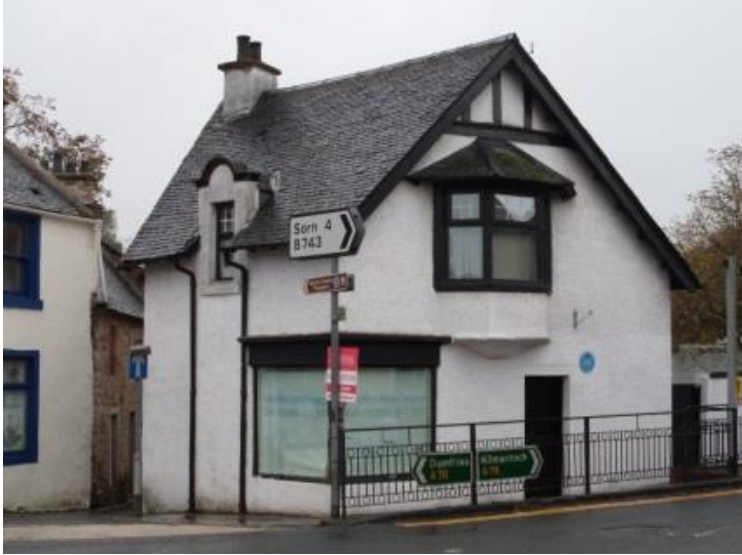
1 Kilmarnock Road
Mauchline Dental Surgery

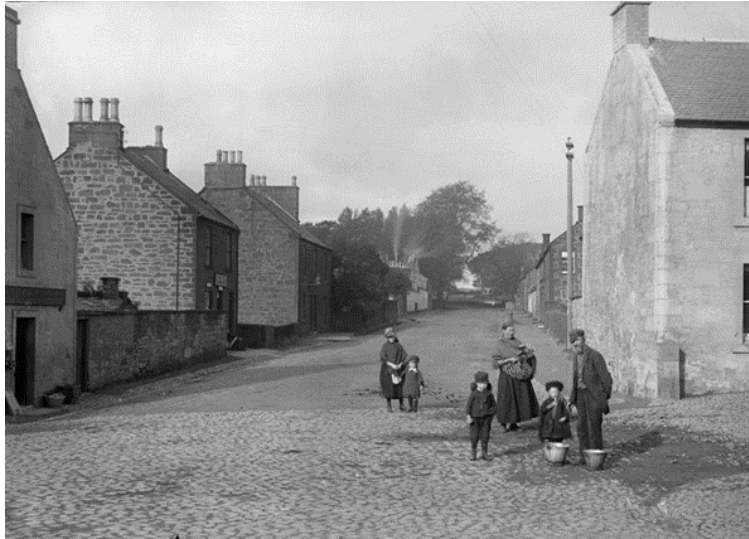
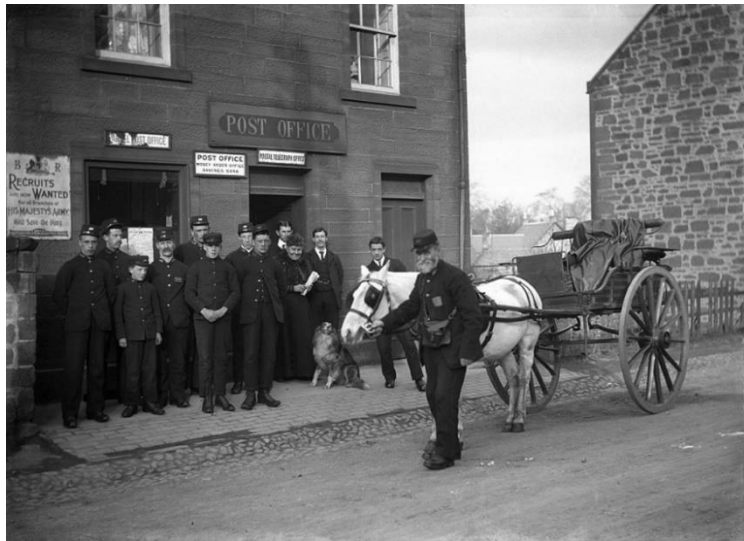
- Carry out structural inspection & any recommended remedial repairs
- Reslate roof and dormer
- Replace leadwork
- Replace ridge with wood core lead roll
- Replace mortar skews
- Replace dormer timbers
- Re-render chimney
- Replace windows, including dormer
- Refurbish door
- Repaint shopfront
- Install new timber fascia and signage
- New hanging sign
- Replace uPVC rainwater goods with CI

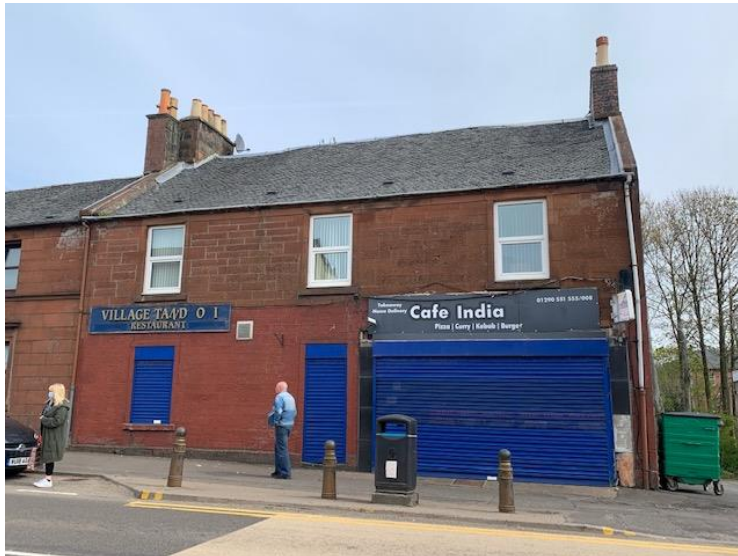
Chimneys
1no. stone chimney to l.h.s

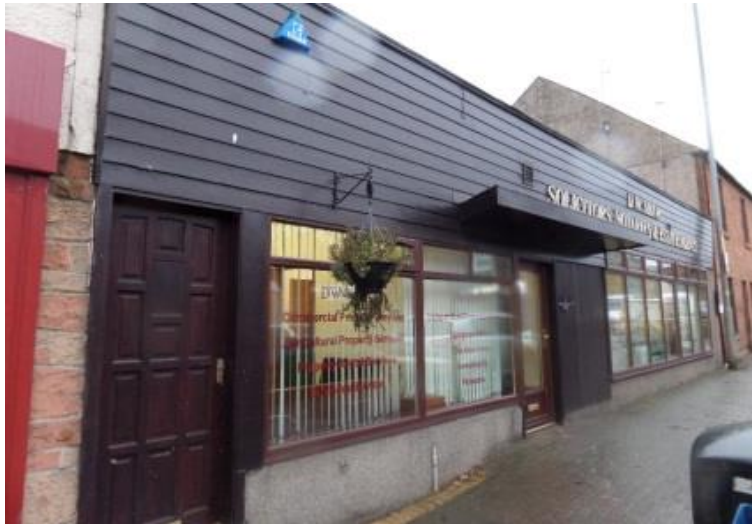
Windows	n/a
Doors	Modern timber panelled door to l.h.s. uPVC shop door.
External Pipework	None
Priority Score	(0+0+0) 0

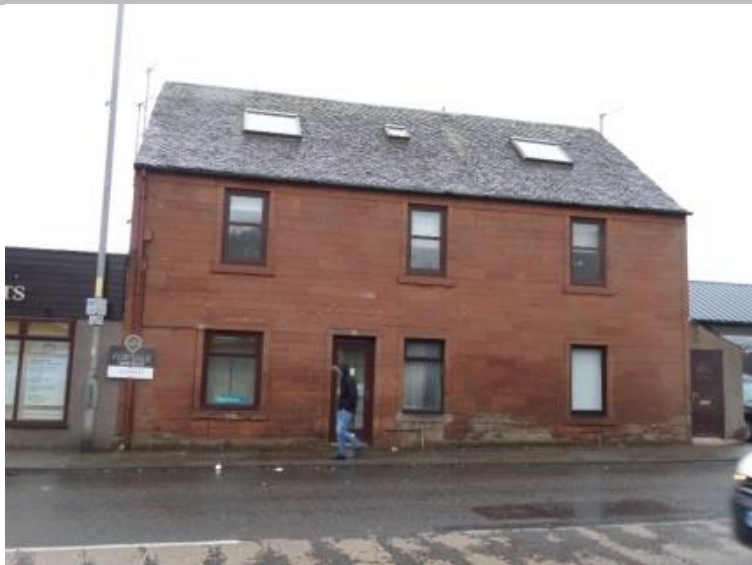
Ground – occupied First – occupied Second – uncertain
Restrictions	Surveyed from Kilmarnock Road and Castle Street.
Structural Issues	None apparent
Storey Height	2 – end terrace.
Roof	Natural slate with zinc ridge and clips. 3no. modern rooflights
Chimneys	n/a
Walls	Red sandstone. Concrete cill where door blocked up needs repointing. Damaged cill to l.h.s. Heavy erosion below window on r.h.s. damaged corner stones. 1no. partially hidden modern vent.
Windows	1no. uPVC and 2no. timber casements at ground floor level. uPVC at first floor level.
Doors	2no. uPVC doors
External Pipework	uPVC gutter with cast iron

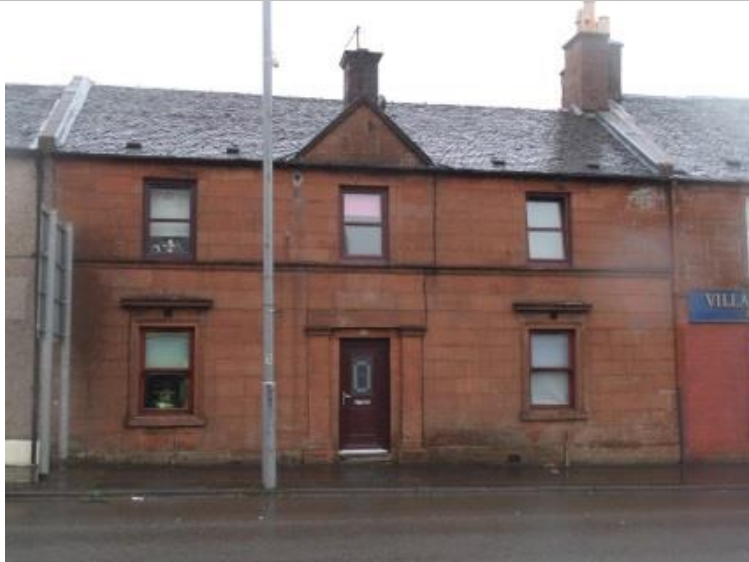
Restrictions	Surveyed from Kilmarnock Road only.
Structural Issues	None apparent.
Storey height	2 – mid terrace.
Roof	Natural slate with zinc ridge and clips. uPVC roof vents. Lead skewes and partial capping and lead valleys to gablet.
Chimneys	Stone wall head chimney with no pots. Rendered chimney to r.h.s with 2no. pots.
Walls	Red ashlar sandstone with pilasters either side of doorway. Some masonry erosion around doorway. 2no. modern air grilles.
Windows	Modern timber casements at ground floor level. uPVC at first floor level.
Doors	uPVC
External Pipework	uPVC gutter (blocked) and cast-iron downpipe. Needs refurbishment.
