Mauchline Conservation Area Management and Maintenance Plan

Picture created by Miguel Silva Barral ©

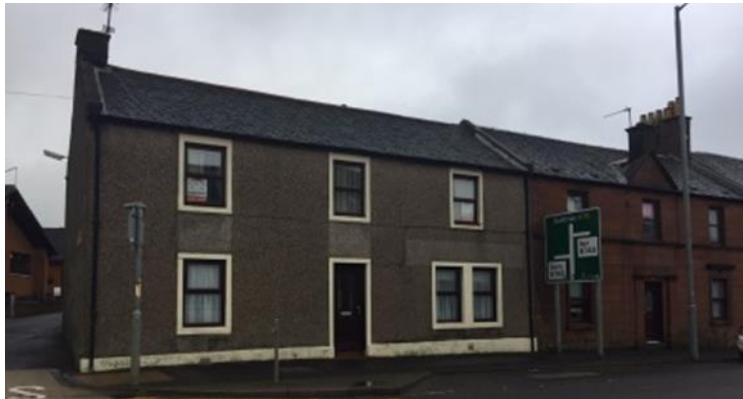
Restrictions	Surveyed from Kilmarnock Road only.
Structural Issues	None apparent.
Storey Height	2 – end terrace.
Roof	Natural slate with

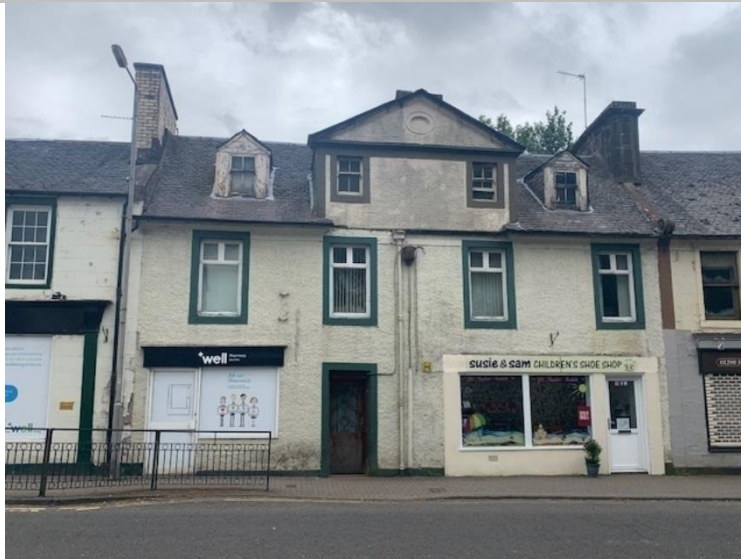
Well Pharmacy / Susie + Sam Children's Shoe Shop / Residential

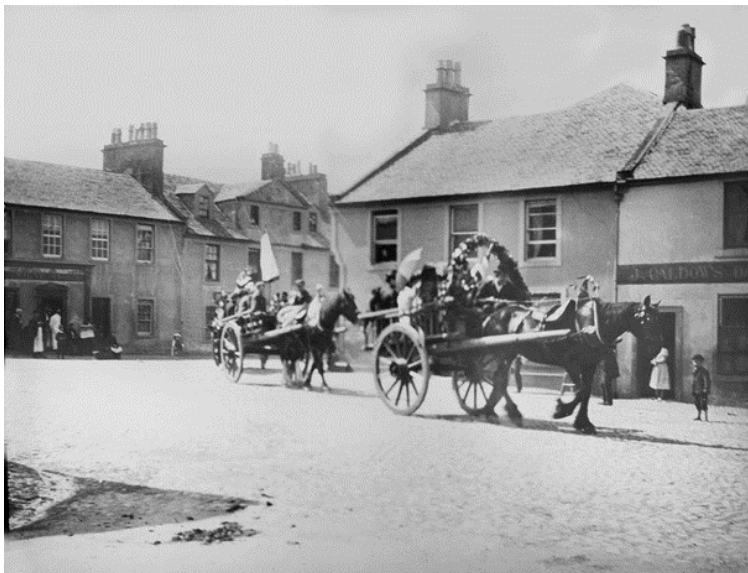
Priority Score (2+2+2) 6

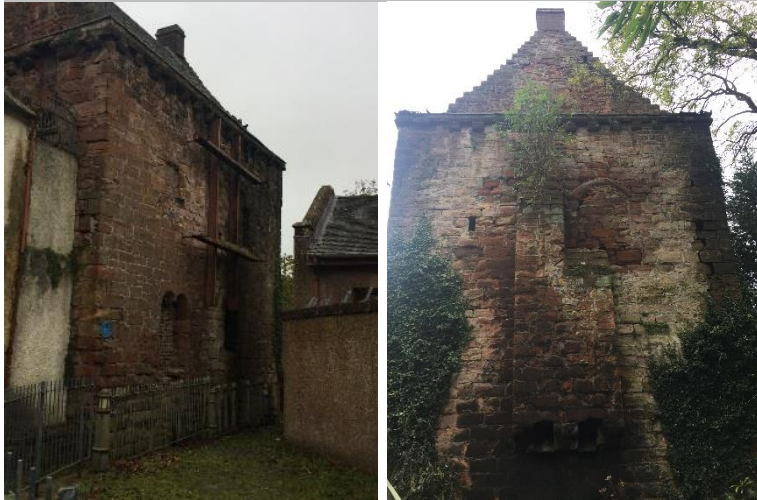
Abbot Hunter's Tower (Castle)

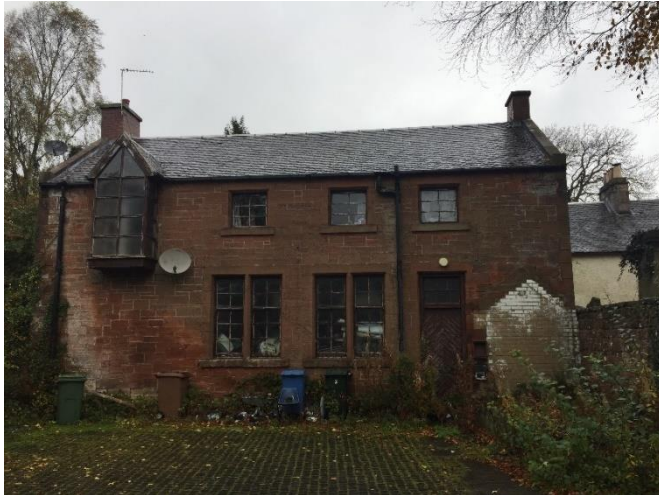
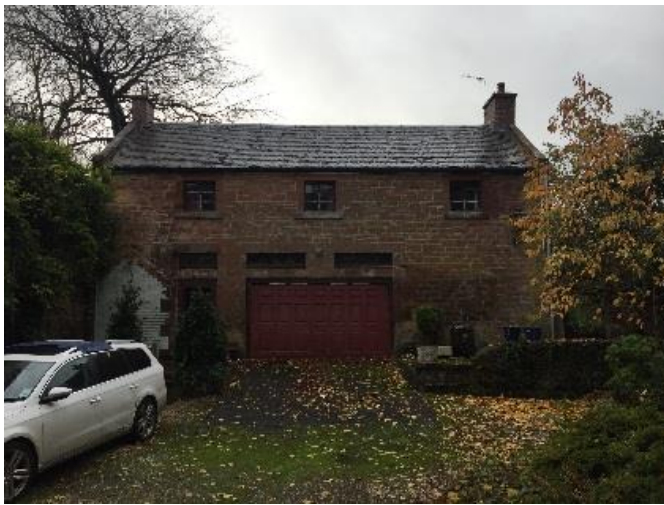
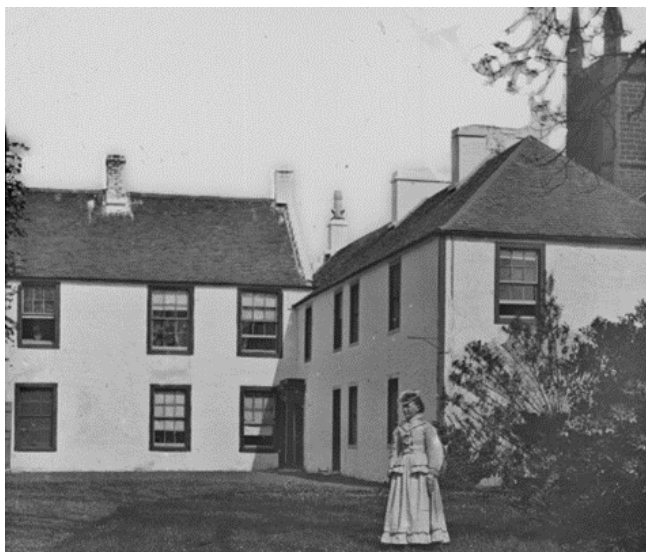
gable end. 1 pot on r.h.s, no pots on l.h.s.

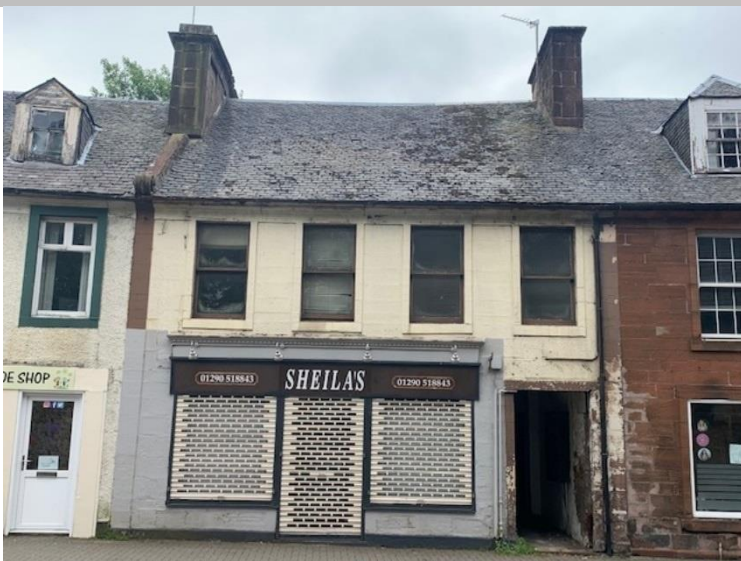
9-11 Loudoun Street
Sheila's / Residential

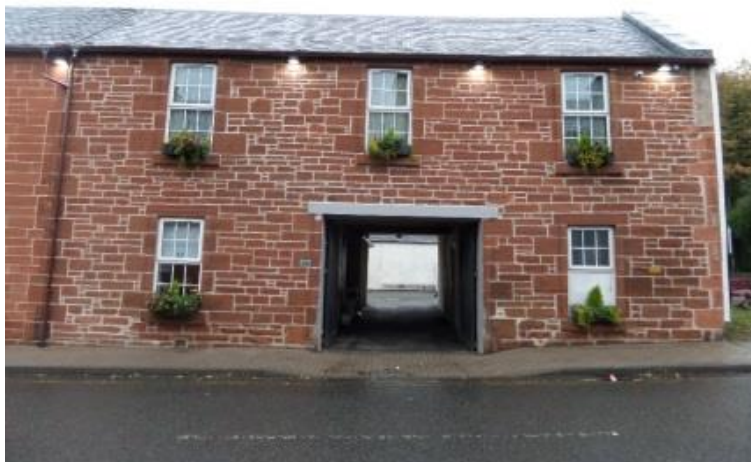
pointing appear generally in good condition. Dry dash over cladding to gable end. 1no. decorative iron grille. Central pend to rear court.
Windows	uPVC, 1no. with uPVC blind panel.
Doors	Timber vertically lined doors to pend.
External Pipework	uPVC profiled gutter and shared uPVC downpipe.

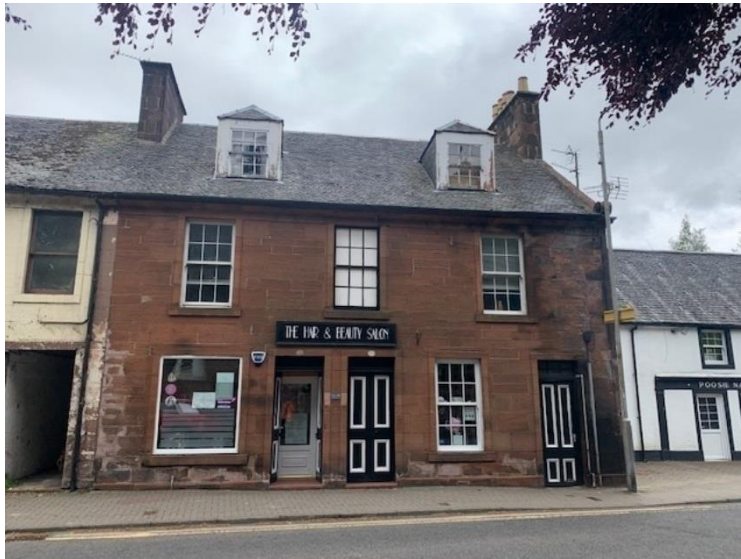
13-15 Loudoun Street The Hair and Beauty Salon / Residential	Category B Listed	Ground – occupied First – occupied Second - occupied
	Restrictions	Surveyed from Loudoun Street only.
	Structural Issues	None apparent.
	Storey Height	2- mid terraced with
	Roof	Natural slate with zinc ridge and clips. Mortar skews. Scrolled skew putt. Lead dormer flashing. 2no. hipped dormers.

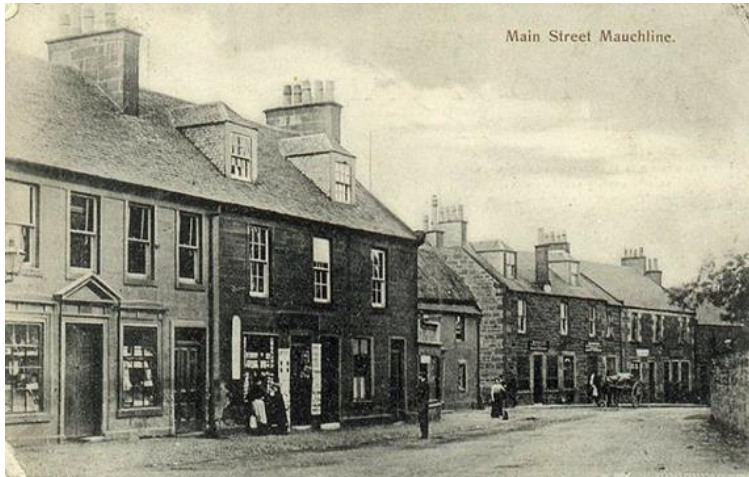
Chimneys	Red sandstone chimneys on party wall and gable wall. 1no. pot to l.h.s. 5no. pots to r.h.s.
Walls	Red ashlar sandstone. Masonry erosion at far gutter end and at ground level. Some plastic repairs. Pick pointing required. Damp staining around shopfront. 2no. modern terracotta air bricks. Pend access to flat above.
Dormers	2 gabled dormers with 6 over 6 timber sash & case windows. Windows and timber surrounds in poor condition. Slated cheeks.
Windows	1 blind opening at first floor level. uPVC at first floor. Timber sash & case (6x6) in dormers.
Doors	2no. sets panelled timber storm doors. Panelled timber door to pend – requires refurbishment.
Shopfronts	uPVC shopfront.
External Pipework	uPVC deep flow gutter. Shared uPVC downpipe.
Priority Score	(2+2+2) 6

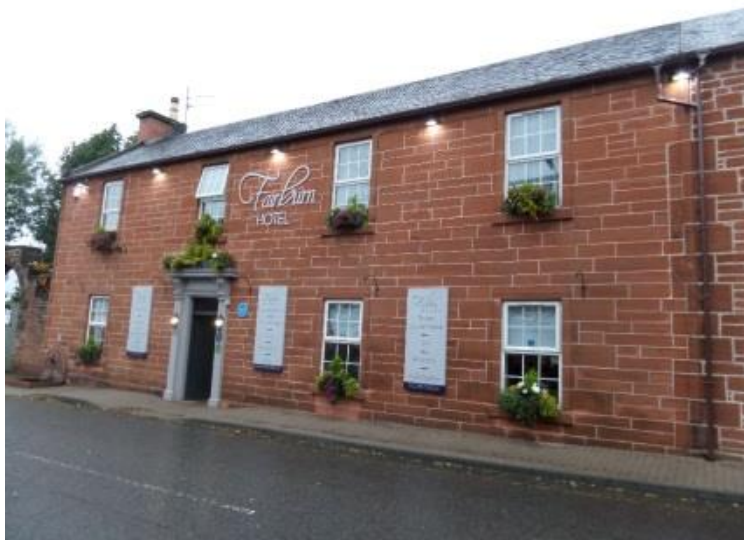
Restrictions	Surveyed from Loudoun Street only.
Structural Issues	None apparent
Storey Height	2 – semi detached
Roof	Natural slate with lead ridge and clips.
Chimneys	Red brick chimney to l.h.s. with 1no. can.
Walls	Red sandstone with ashlar window surrounds and classical doorway. Loudoun Spout to l.h.s.
Windows	uPVC
Doors	Modern timber storm doors – painted blanks. Ironmongery not of note.
External Pipework	uPVC profiled gutter and 1no. shared uPVC downpipe.

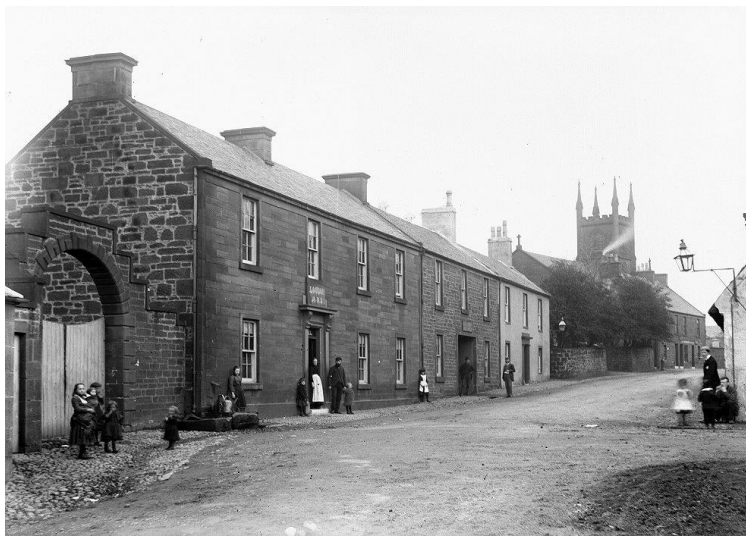
Priority Score (0+2+1) 3

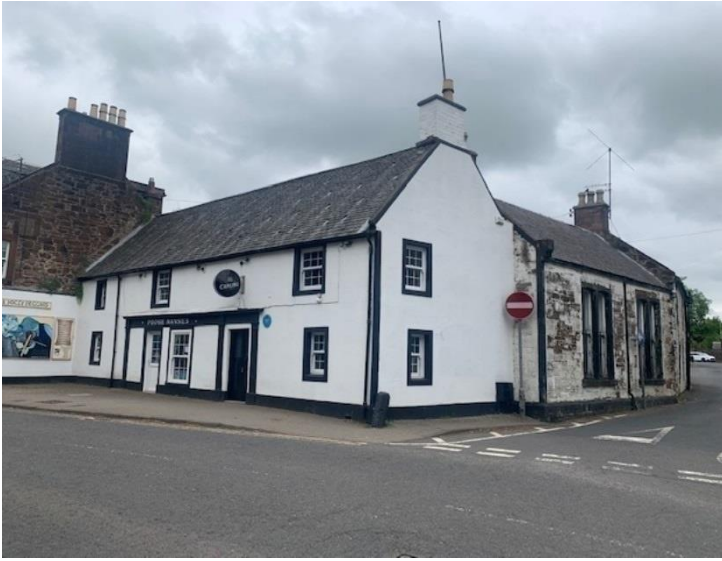
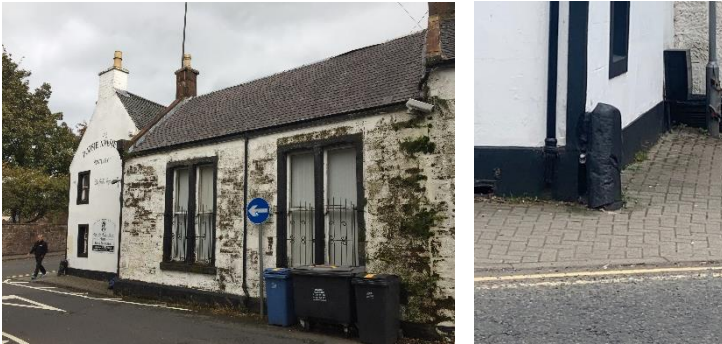
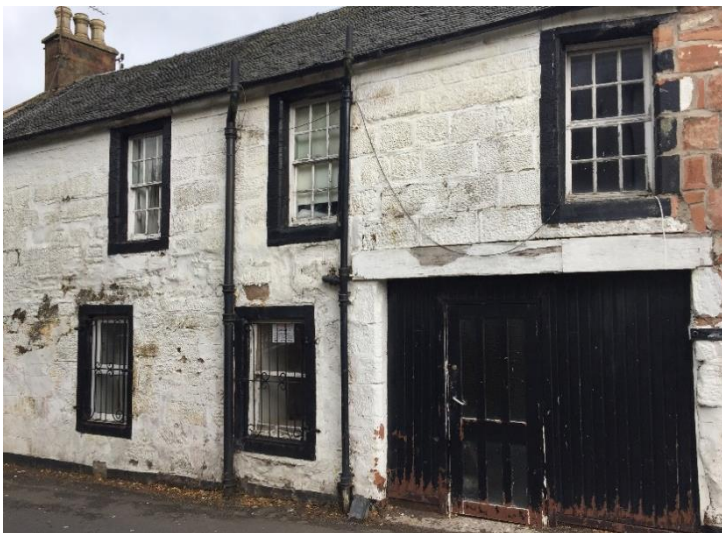
Ground – occupied
First – unoccupied

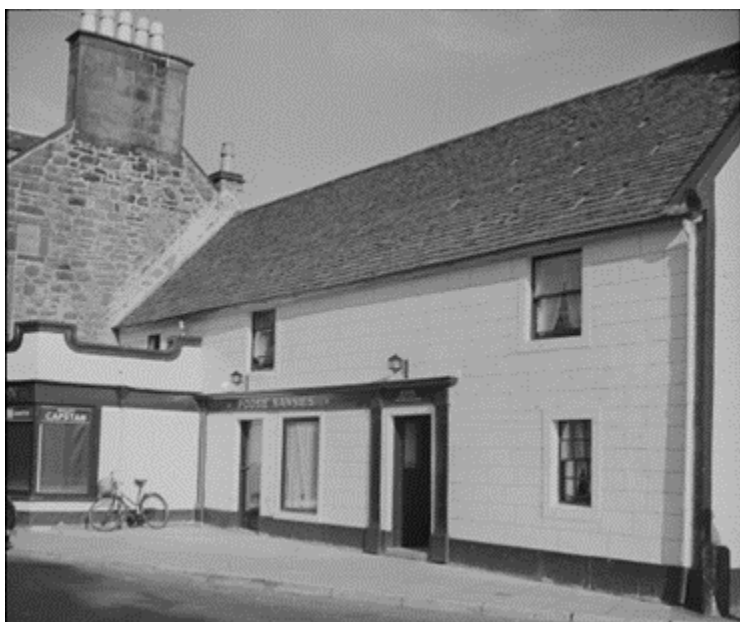
- Remove cement render, repoint, re-render with lime-based material, carrying out stone repairs where necessary.
- Remove paint from masonry.
- Replace windows
- Replace doors
- Refurbish CI rainwater goods, replacing uPVC.
- Add new downpipe to Cowgate elevation
- Replace signage.

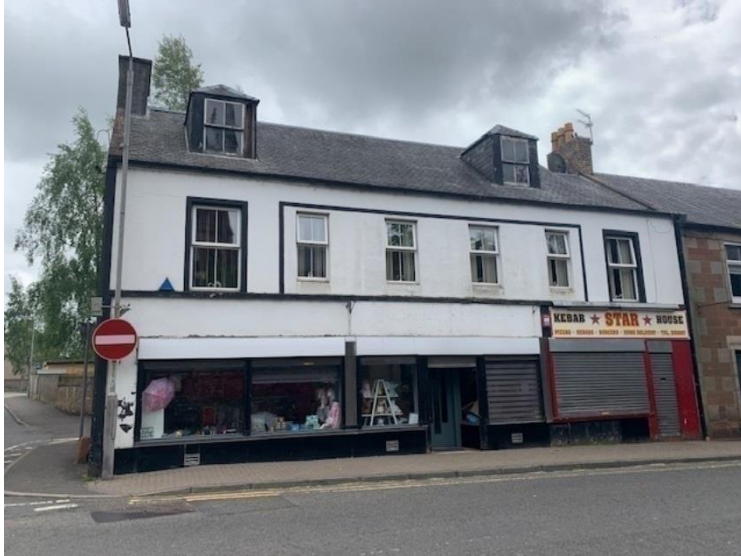
23/23a-25 Loudoun Street
 Blu Design / Residential

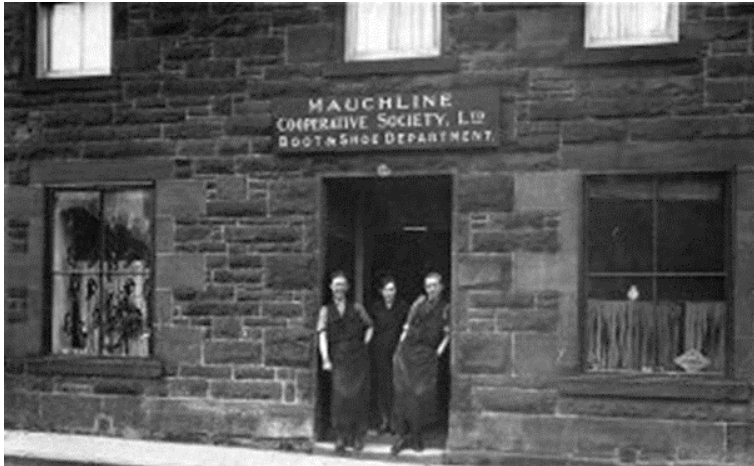
27-31 Loudoun Street
Commercial / Residential

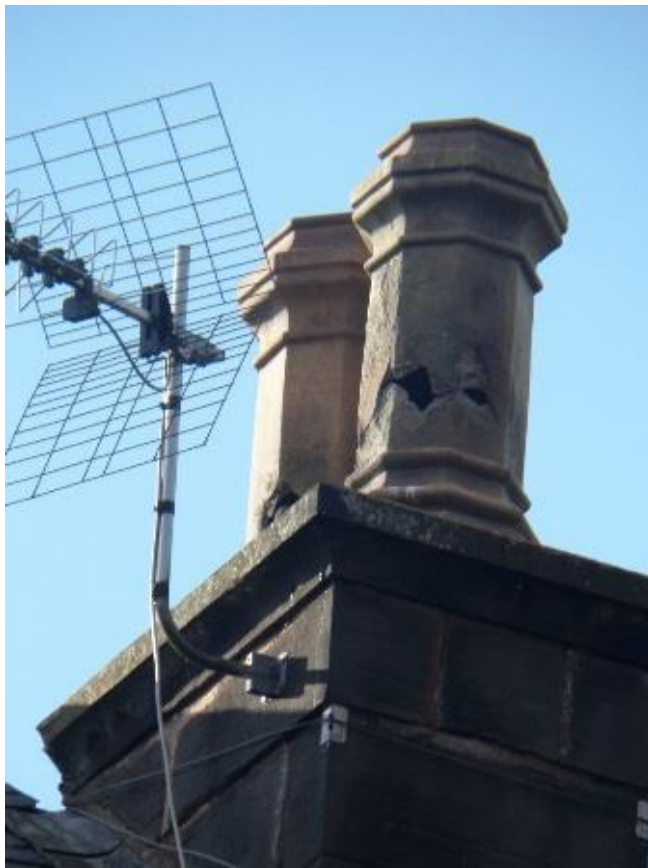
Priority Score (0+2+2) 4

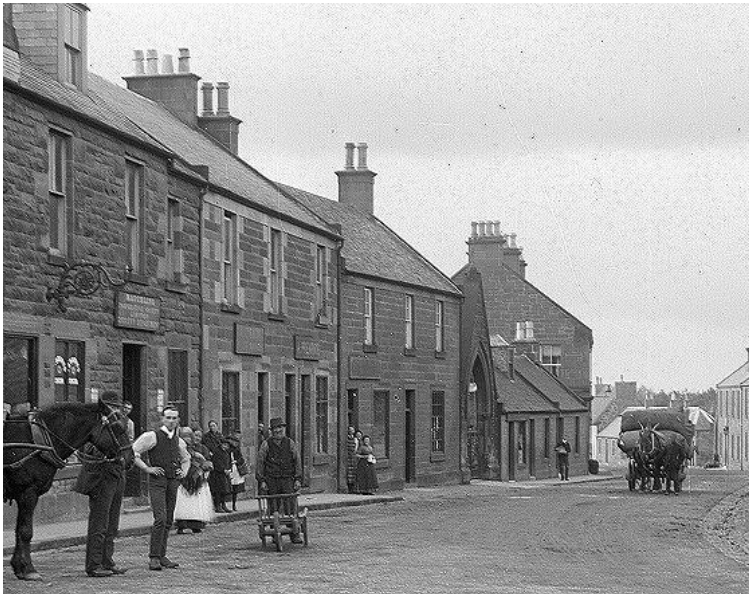
- New fascia signage

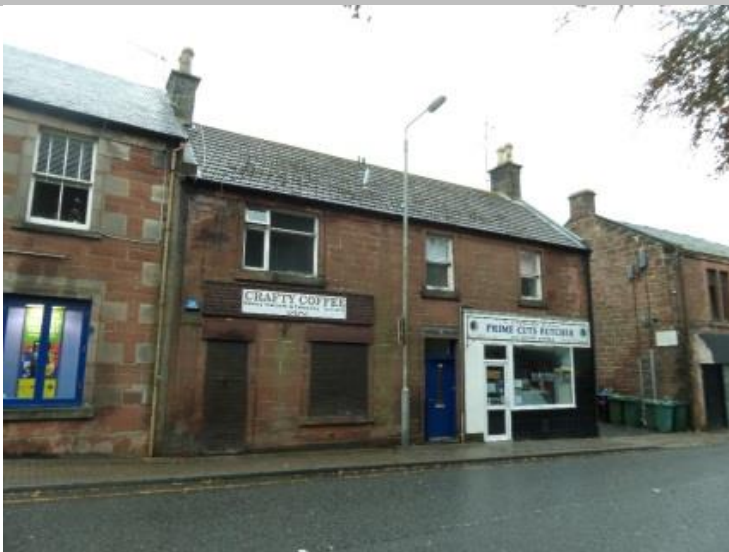
Restrictions	Surveyed from Loudoun Street only
Structural Issues	None apparent
Storey Height	2 – end terraced.
Roof	Concrete tiles and ridge. Lead skew and chimney flashings – Poor condition.
Chimneys	Stone chimney on party wall to l.h.s. with 2no. damaged pots. Same to gable on r.h.s.
Walls	Red ashlar sandstone. Central door to flats above. Movement in corner at r.h.s. crack in cill at first floor level. Some plastic repairs. Erosion at each end of gutter and at ground level.
Windows	uPVC
Doors	Modern timber partially glazed

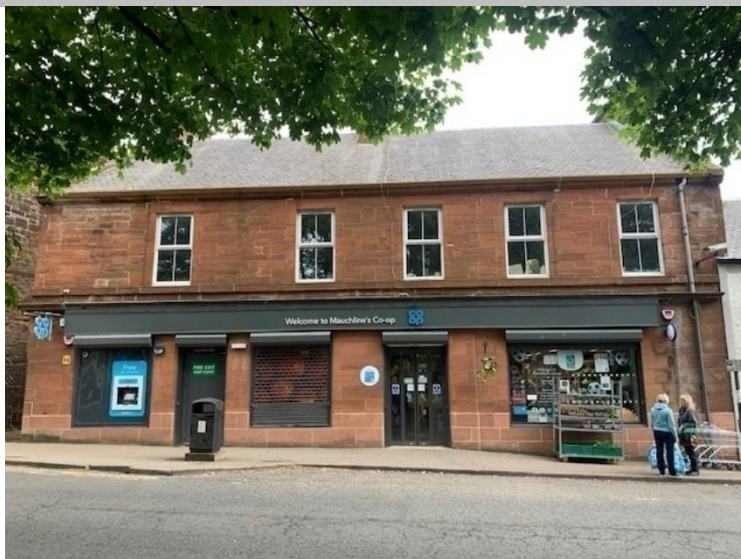
43-51 Loudoun Street The Co-op / Residential

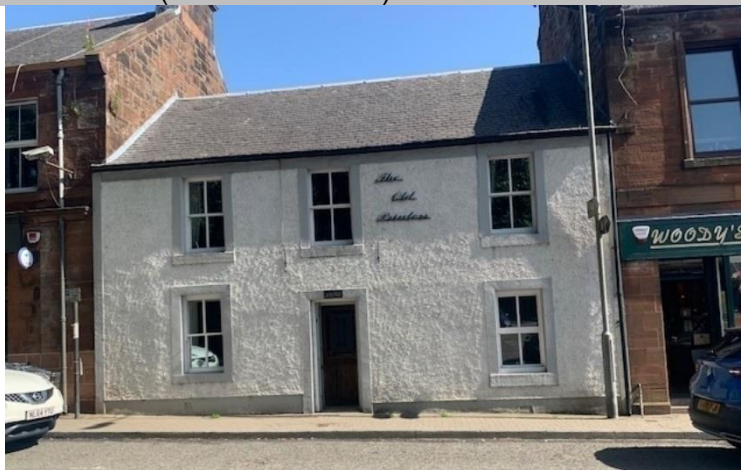
53-55 Loudoun Street
Residential (The Old Printers)

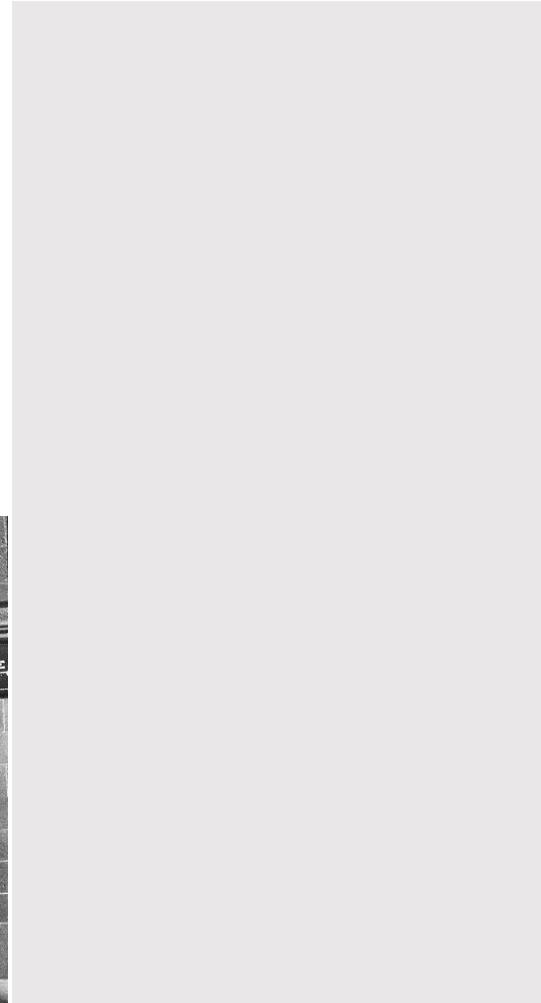
Occupied
Restrictions	Surveyed from Loudoun Street only
Structural Issues	None apparent
Storey Height	2 – mid terrace.
Roof	Natural slate with zinc ridge and clips. Lead skew flashings.
Chimneys	n/a
Walls	Painted wet dash. 1no. cast iron and 1no. modern louvered aluminium grille
Windows	Modern timber sash & case.
Doors	Vertically lined timber storm doors
External	uPVC gutter and

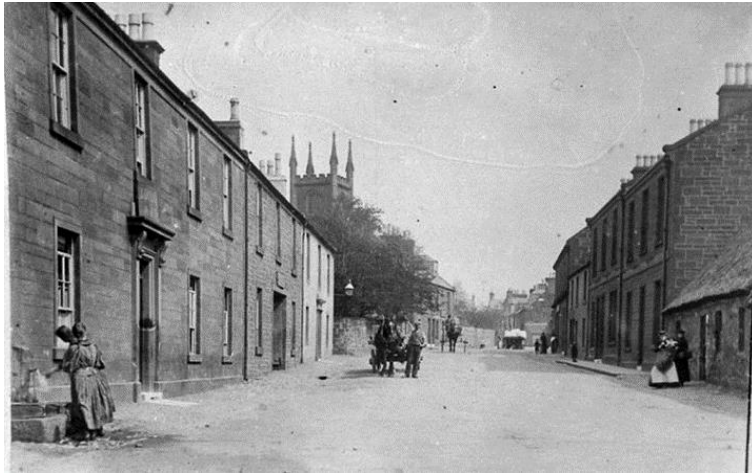
- Carry out minor slate repairs
- Replace mortar skews
- Replace missing stone to stack
- Carry out localised stone repairs and repointing
- Replace modern grille
- Replace uPVC windows
- Refurbish storm doors and fanlight
- Replace uPVC rainwater goods with CI

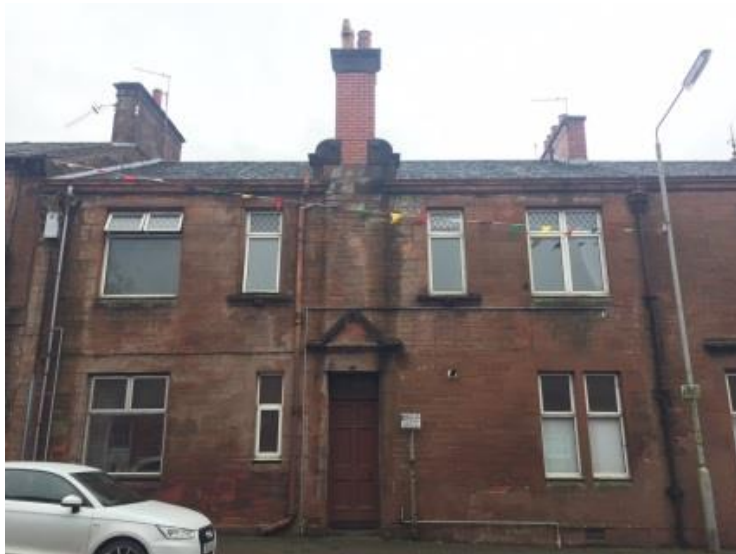
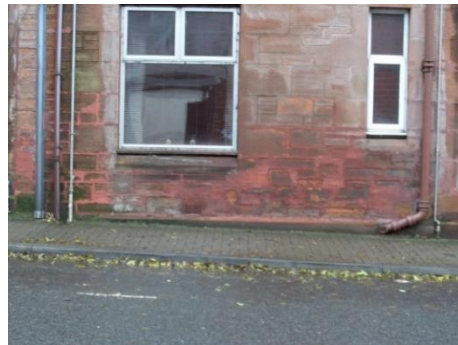
Ground – occupied(partially) First – occupied (partially)
Restrictions	Surveyed from Loudoun Street only.
Structural Issues	None apparent
Storey Height	2 – mid terrace.
Roof	Natural slate with lead ridge and clips. Lead skew and chimney flashings.
Chimneys	Red brick wall head chimney with scrolled stone shoulders and stone cap with 2no. pots. Red brick chimney shared with No. 65 to r.h.s.
Walls	Squared rugged red sandstone. Significant damage from defective rain water goods. Heavy over pointing at ground level particularly at gutter ends and shared downpipe. 1no. modern aluminium grille and 1no. ornate cast iron grille.
Windows	3no. stone mullions may have been removed. 7no. uPVC windows 1no. aluminium window
Doors	Panelled timber door with fanlight.
External	Cast iron wall head

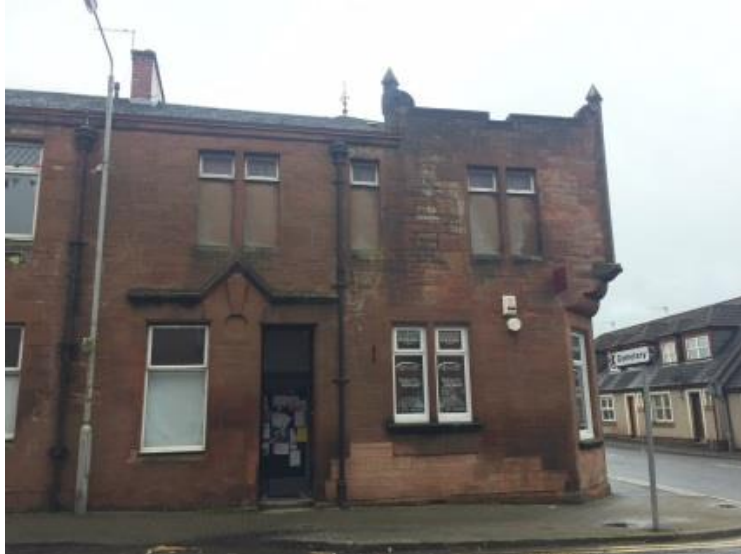
Restrictions Ground – occupied
First – occupied
Surveyed from Loudoun Street and Barskimming Road only.

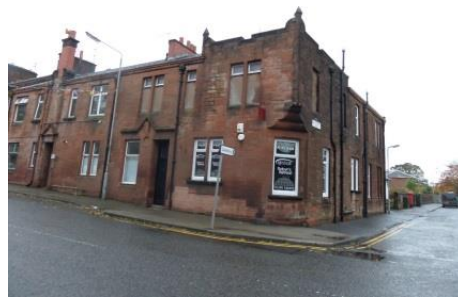
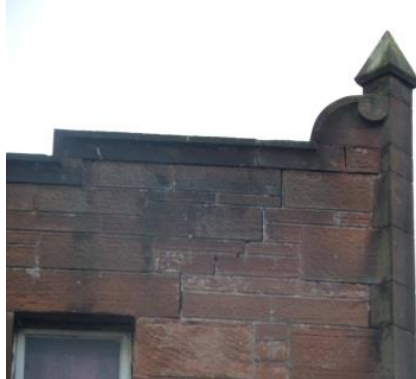
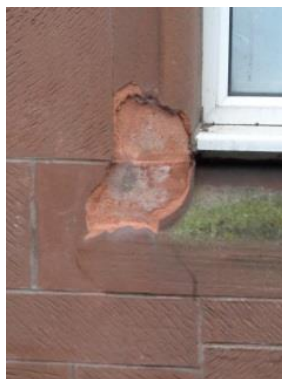
Walls Red sandstone. Squared ashlar chamfered corner with corbelled corner projection. Castellated parapet detail at corner with stone finials. Decorative iron roof finial. Some damp staining. Extensive indents at ground floor level. Additional indents and repointing required. 1no. partially covered

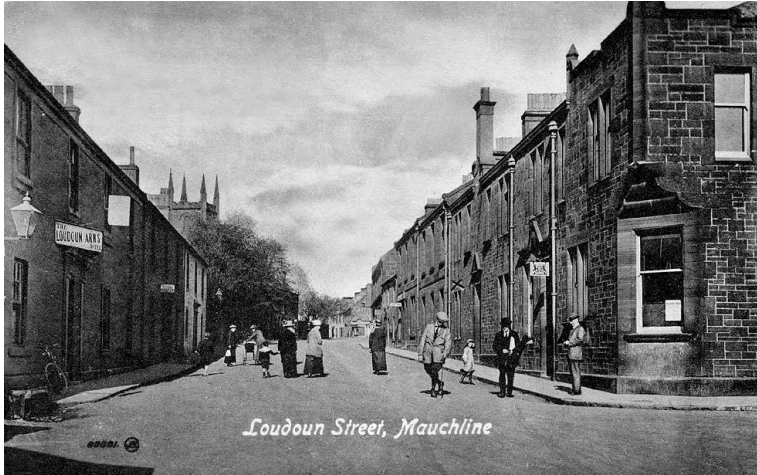
Loudoun Street, Mauchline

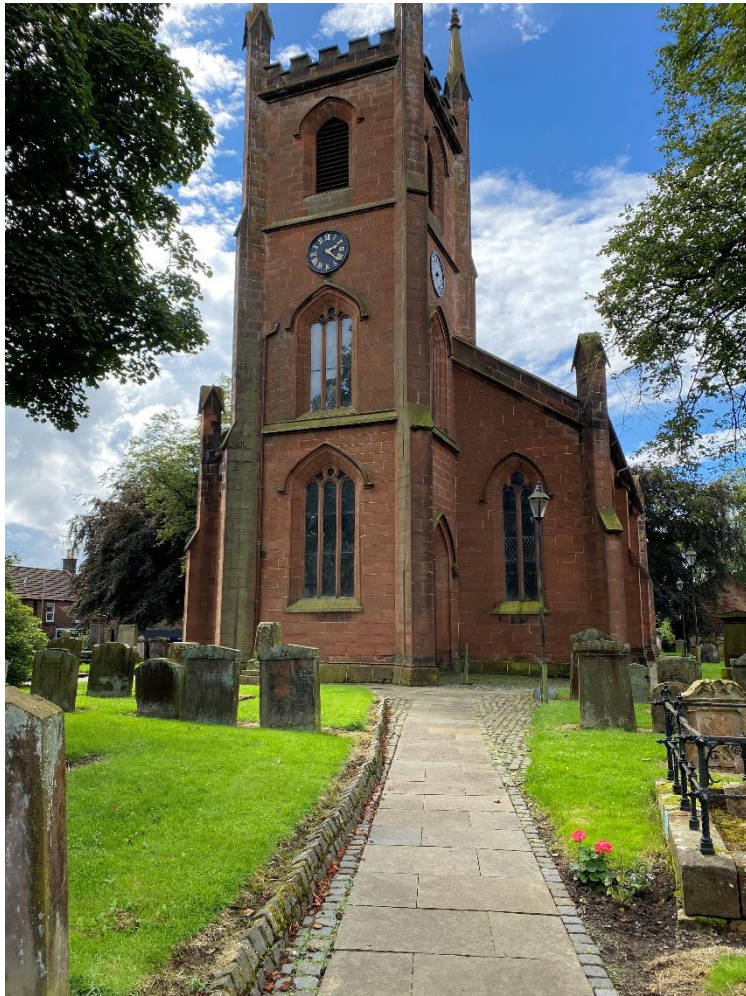
Doors	secondary glazing externally. Ornate timber storm doors to main entrance. (2no. sets)
External Pipework	Cast iron half round gutters and circular downpipes.

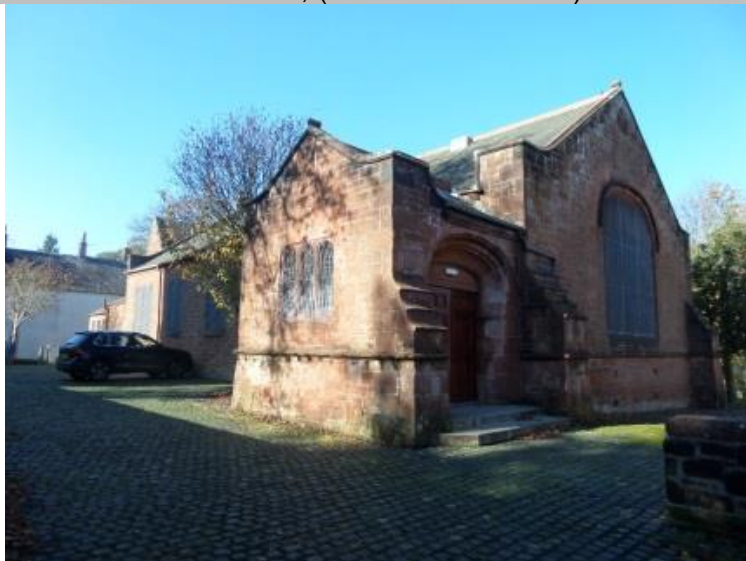
Restrictions	Full access
Structural Issues	None apparent
Storey Height	1 – standalone.
Roof	Natural slate roof with crested red terracotta ridge tiles with some missing. Mitred hip to rear. 2no. roof vents (Over sheeted?) Mortar skew to main hall. Lead valleys, copper flashings to rear vent.
Chimneys	Stone chimney to rear of main hall. 1no. pot
Walls	Squared red sandstone

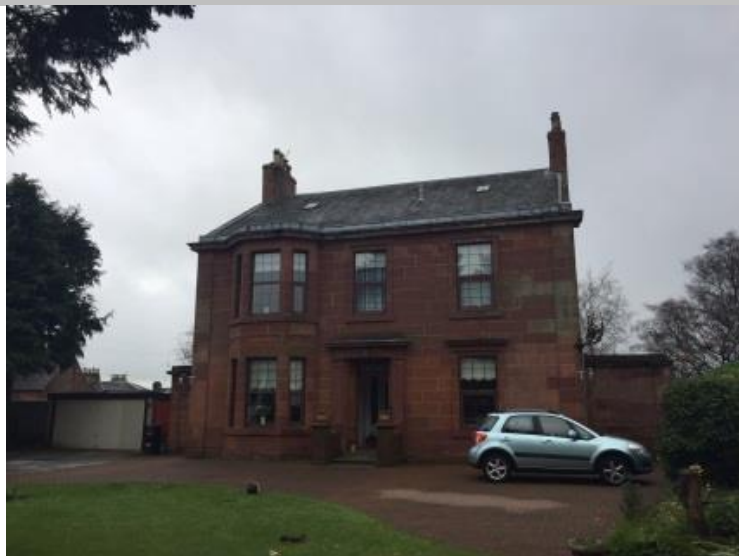
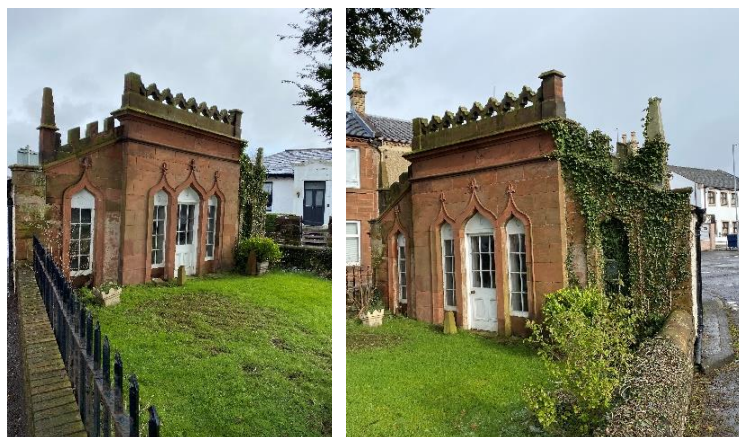
25 Mansefield Road
Residential (Springfield)

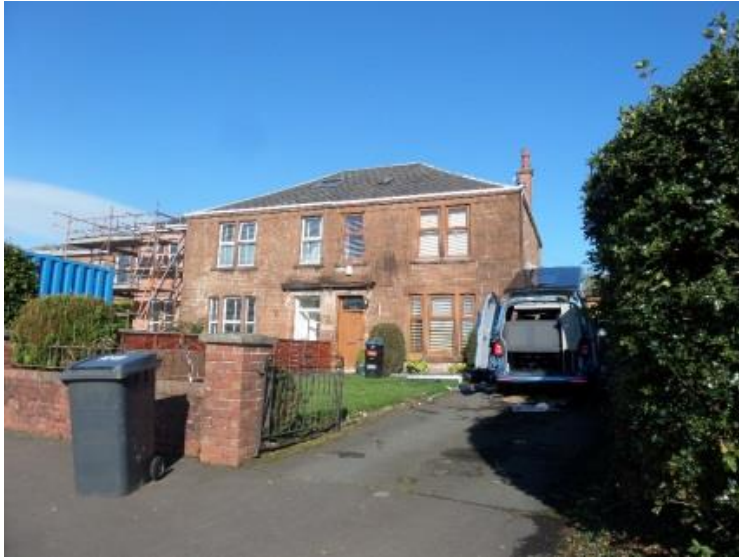
1 house has very recent side extension.

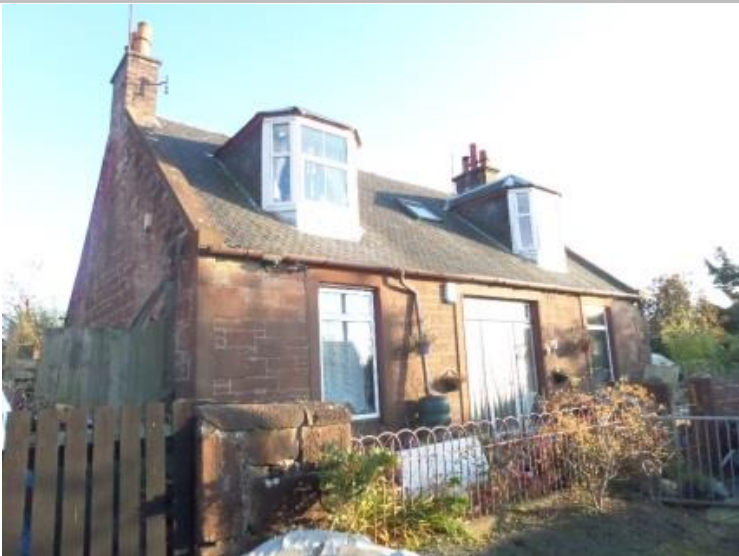
6-8-10 Tanfield Occupied
Residential

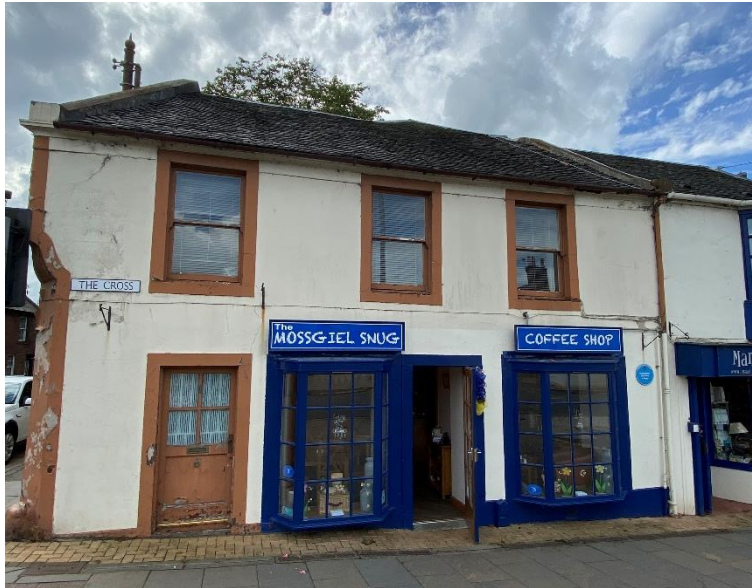
Ground – occupied First - occupies
Restrictions	Surveyed from The Cross only
Structural Issues	None apparent
Storey Height	2 – corner terrace.
Roof	Slate roof with zinc ridge and clips. Mortar skewers.
Chimneys	n/a

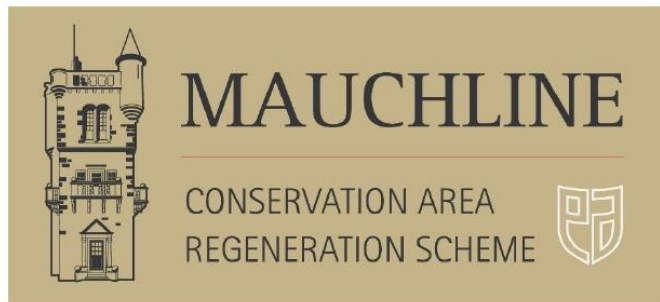
A digital version of this document can be found at;
<https://www.east-ayrshire.gov.uk/mauchlinecarsdownloads>

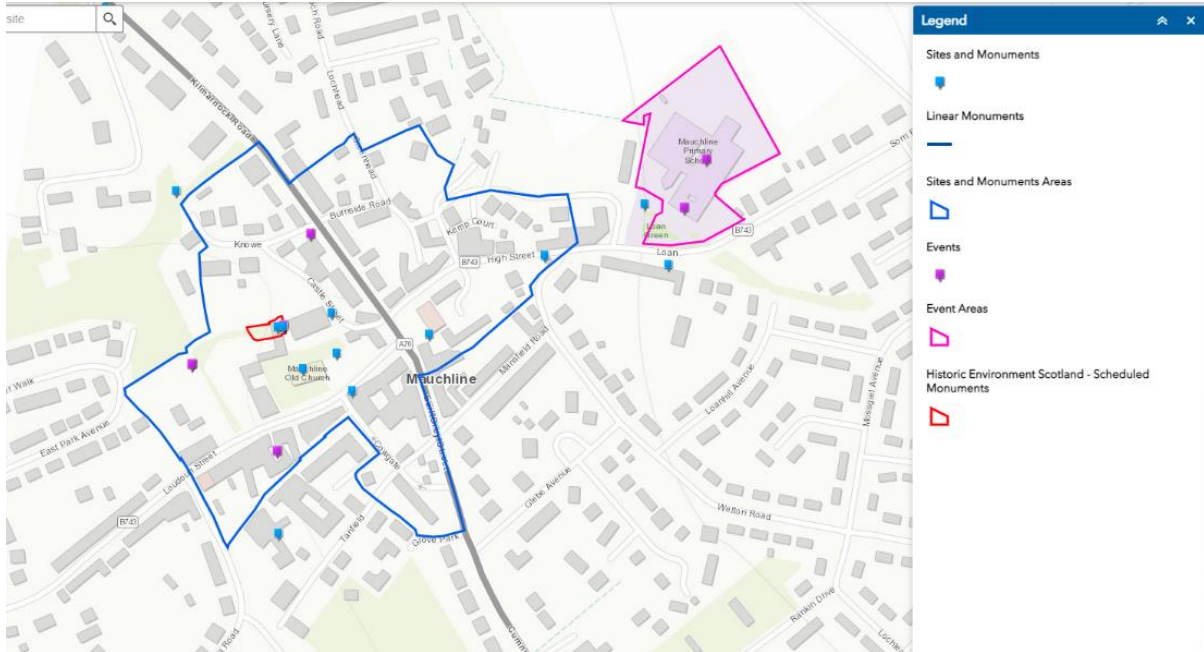
- Site Name: Archaeological Evaluation: Mauchline Primary School, Mauchline, East Ayrshire, 2006
Context: Evaluation took place prior to the redevelopment of Mauchline Primary School. An initial desk-based assessment had identified the possible site of the grave of a group of Covenanters on the southern edge of the site.
Results: The remains of the former dining hall (19th to 20th century) were found.
