Mauchline Conservation Area Management and Maintenance Plan

Prepared for East Ayrshire Council
by
Wylie Shanks Architects

Adopted 27.03.2023

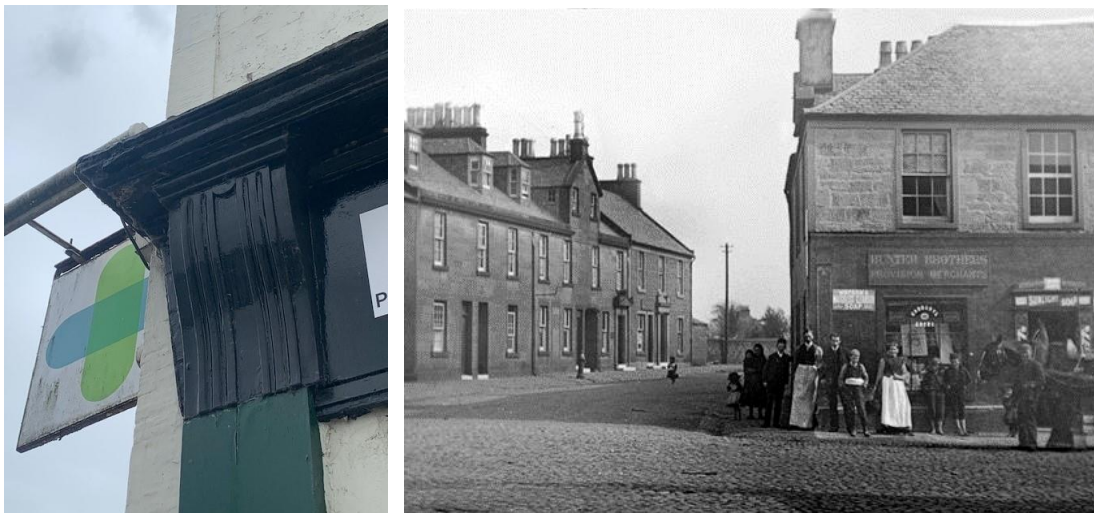
Figure 4 Console bracket at No 1 Loudoun Street. Historic photographs show however that this was a later addition to the building (refer to Gazetteer).

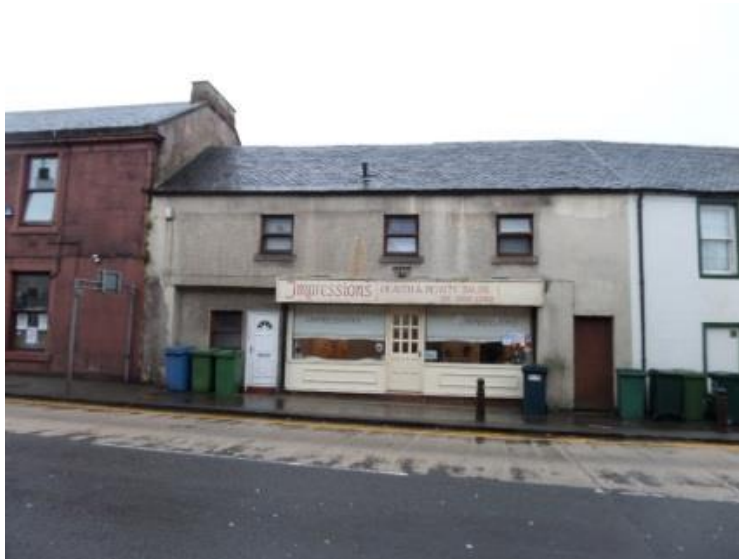
Ground – occupied
	First – occupied
Restrictions	Surveyed from Earl Grey Street only.
Structural Issues	None apparent
Storey Height	2 – mid terrace.
Roof	Pitched roof. Natural slate with zinc ridge and clips. Mortar / render skew.
Chimneys	n/a
Walls	Wet dash render.

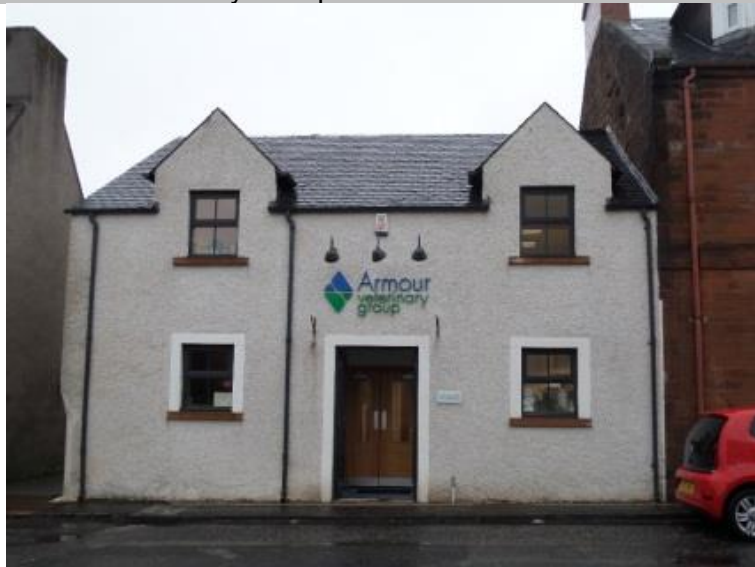
Armour Veterinary Group

Modern building. No recommendations.

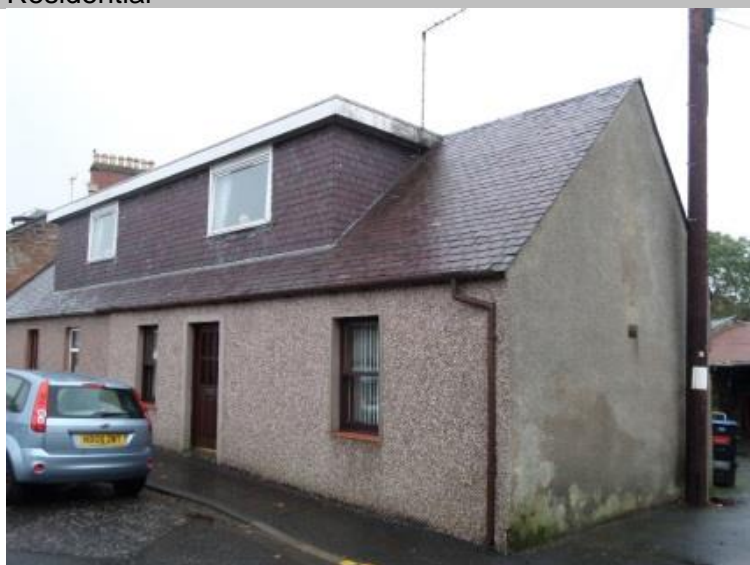
Restrictions	Surveyed from High Street / gable end only.
Structural Issues	None apparent
Storey Height	1 – end terraced.
Roof	Large flat roofed box dormer. Natural slate with zinc ridge and clips. Lead flashings around dormer.
Chimneys	n/a
Walls	Dry dash render.
Windows	Modern timber sash & case with horns at ground level, tiled cills. Modern timber casement in dormer.
Doors	Modern timber door with 6no. glass panels. Ironmongery not of note.
External Pipework	uPVC gutter and 1no. uPVC downpipe.
Priority Score	(0+1+1) 2

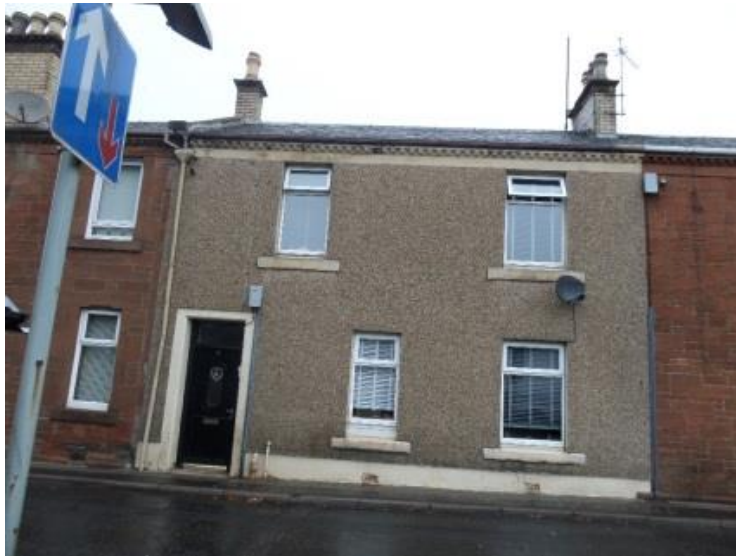
Restrictions	Surveyed from High Street only.
Structural Issues	None apparent
Storey Height	2 – mid terrace.
Roof	Pitched roof with 1no. straight skew to l.h.s. Natural slate with zinc ridge and clips. 1no. mortar skew. Lead chimney flashings.
Chimneys	Yellow brick chimney with dentil moulded stone cap

Walls	and 1no. ornate pot to l.h.s. yellow brick chimney with dentil moulded stone cap and 3no. ornate pots t r.h.s. Dry dash render. Dentil moulded wall head cornice 2no. modern louvred air grilles.
Windows	Composite
Doors	Modern timber door with fanlight
External Pipework	uPVC

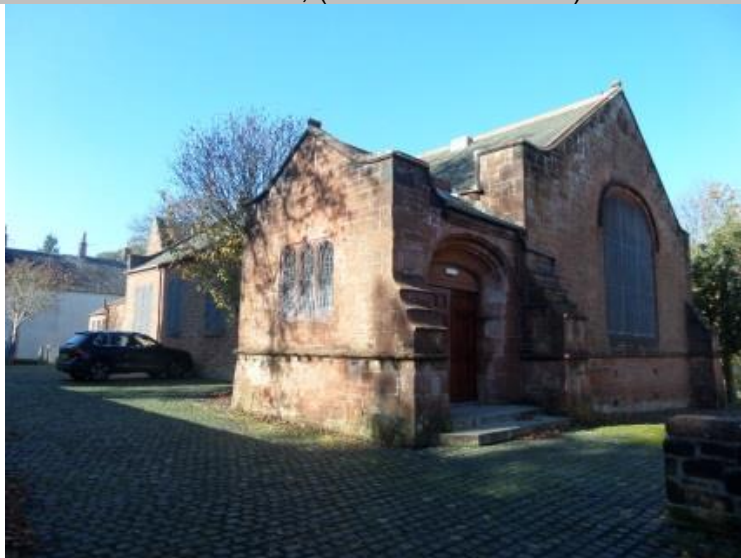
Restrictions	Full access
Structural Issues	None apparent
Storey Height	1 – standalone.
Roof	Natural slate roof with crested red terracotta ridge tiles with some missing. Mitred hip to rear. 2no. roof vents (Over sheeted?) Mortar skew to main hall. Lead valleys, copper flashings to rear vent.
Chimneys	Stone chimney to rear of main hall. 1no. pot
Walls	Squared red sandstone

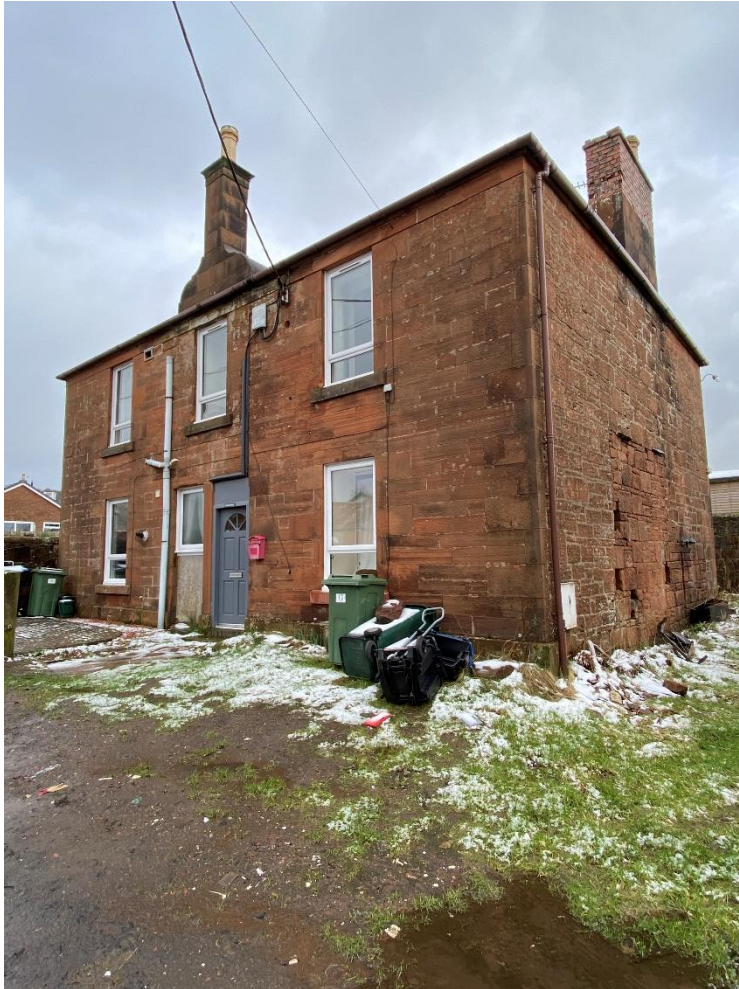
gable in poor condition. NE gable requires some indents. Air bricks missing.
Windows	uPVC.
Doors	Modern timber door with blank panel above.
External Pipework	uPVC gutters and downpipes.
Priority Score	(0+2+1) 3
