EAST AYRSHIRE COUNCIL

Local Development Plan 2

Galston Conservation Area Appraisal

Non-statutory Planning Guidance

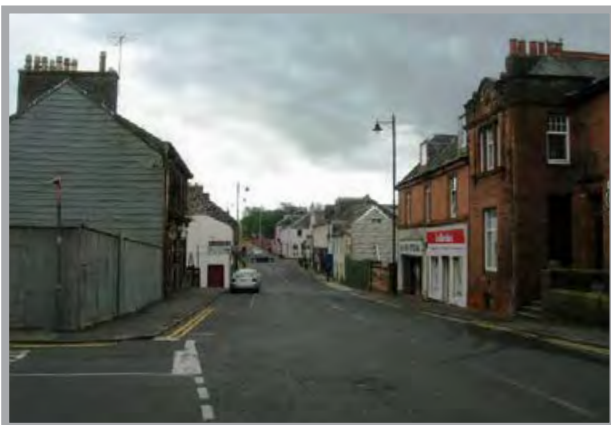
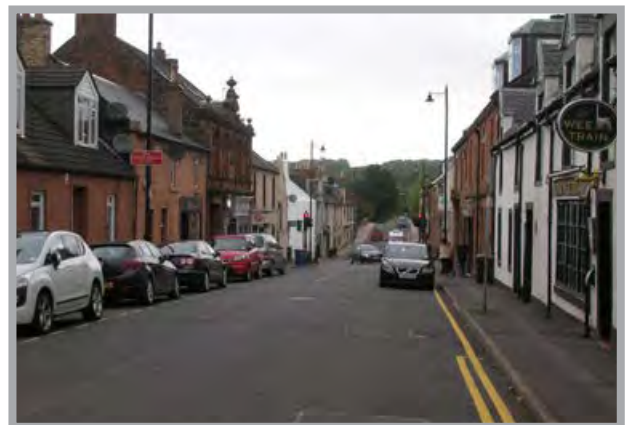
Views along Bridge Street and Wallace Street give an indication of the changing levels

5.6 Galston is located on the southern edge of the valley floor however the conservation area is not flat and there are distinct changes in level throughout. Burn Anne, flowing from south to north runs along the lowest point of the conservation area and several of the key routes within the conservation area have inclines and declines. It is most noticeable when travelling from the Four Corners south along Wallace Street.

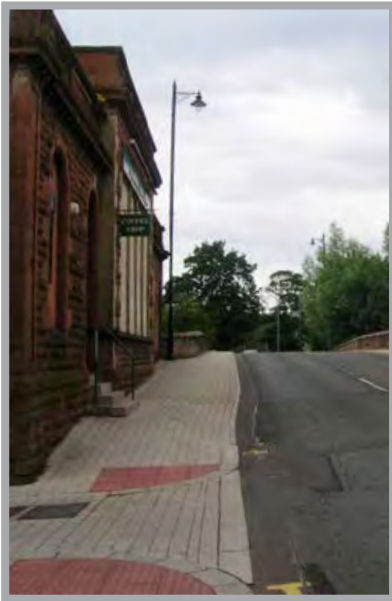
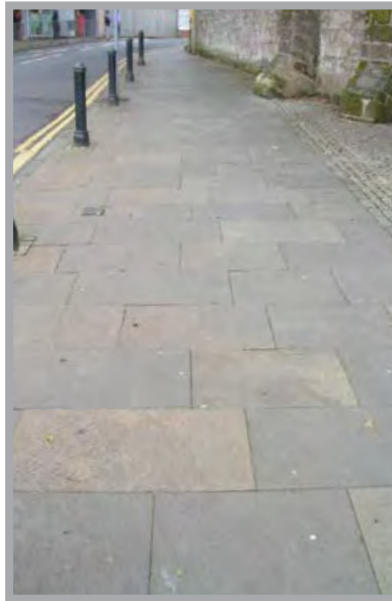
Examples of street surfaces of varying quality within the conservation area

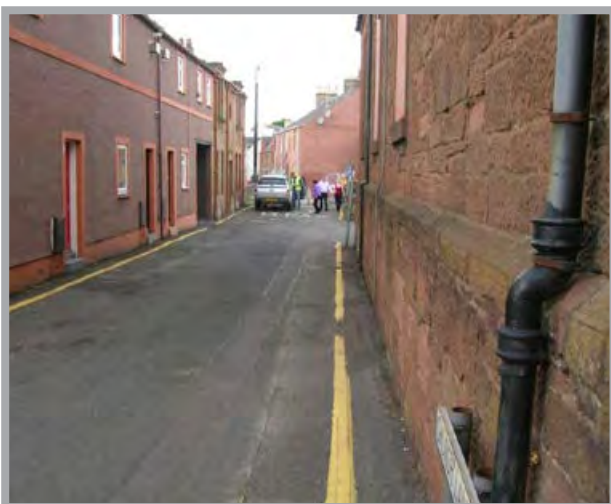
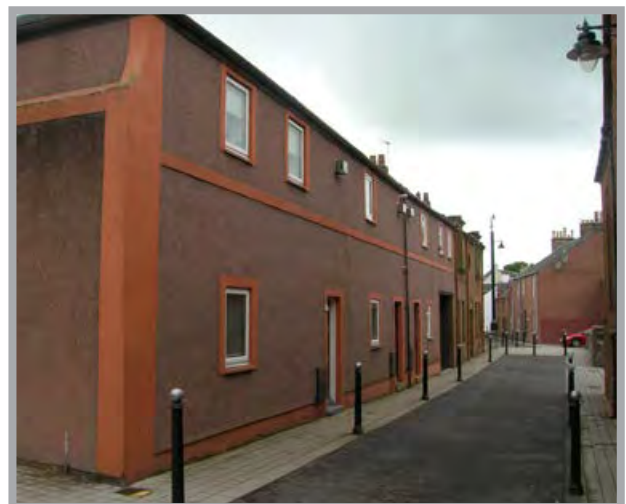
- 5.23 With funding from the Scottish Government's Town Centre Regeneration Fund, recent improvements have been made to the surface on Church Lane and footpaths on Polwarth Street. This involved using good quality materials and associated street furniture. There is a noticeable improvement that could be followed elsewhere in the conservation area.

Before and after the surface improvements to Church Lane

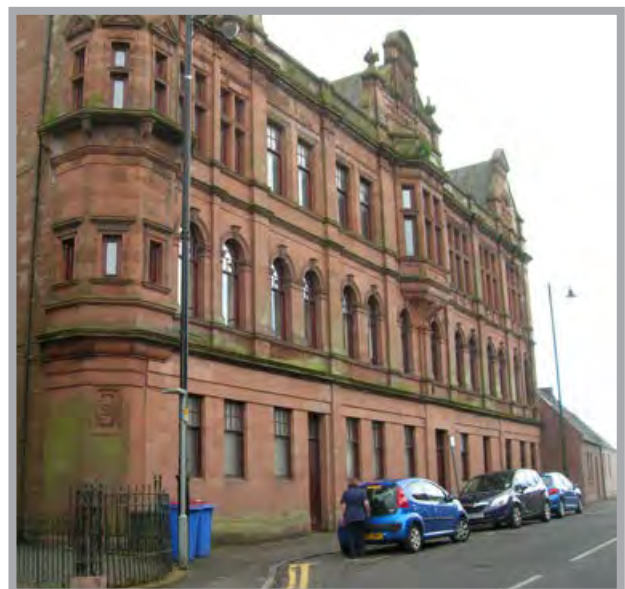
The 3½ storey former co-op building on Brewland Street

| Building | Description | Retention of original features and current condition |
|---|---|--|
| Former Co-op building, 4 – 12 Brewland Street | <p>Dated from 1901, the 3 storey plus attic red sandstone building forms a prominent former commercial building in the centre of Galston.</p> | <p>The building appears generally to be in good condition, although there is significant staining to the stonework. Secret gutters have been installed, within which there is significant visible vegetation.</p> |

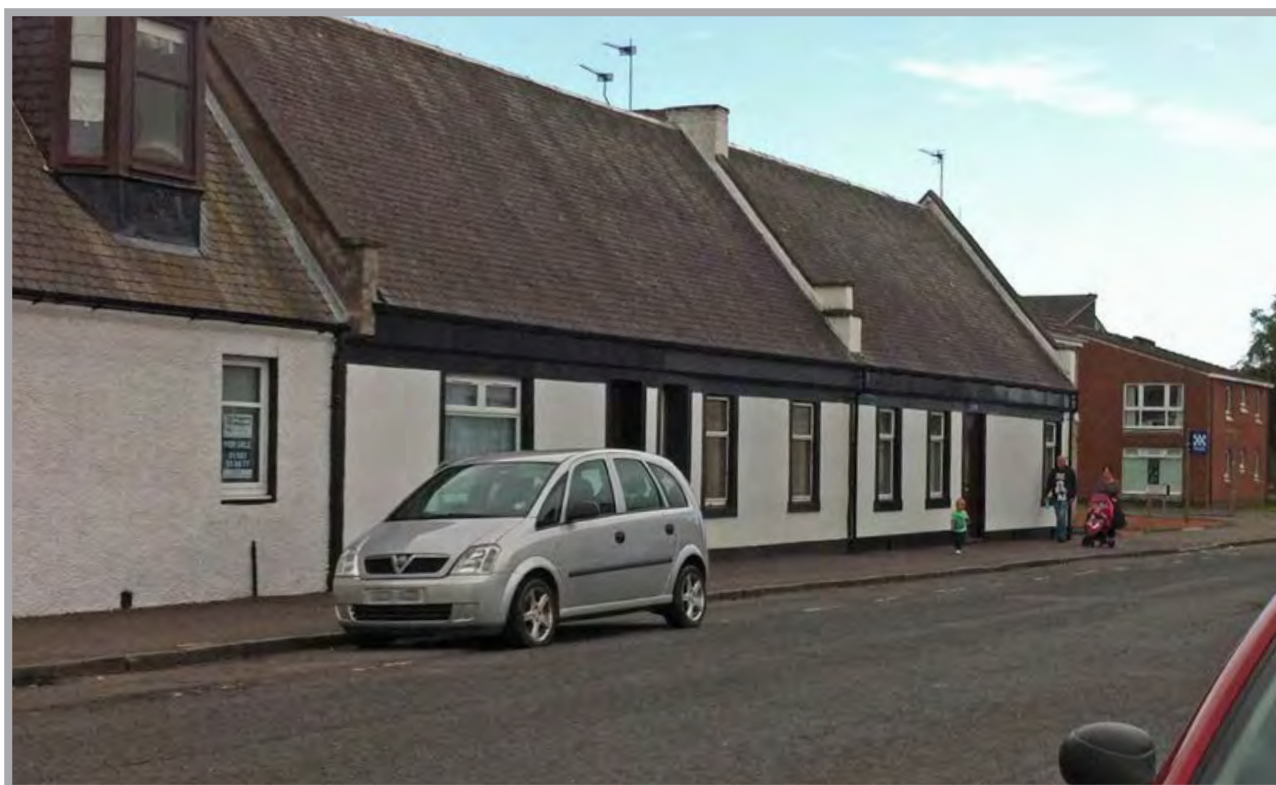
Prominent slate roofs on Titchfield Street.

- 5.34 The predominant roofing material found within the conservation area is West Highland slate, a dark grey slate generally laid in random graded courses diminishing towards the ridge. This was used extensively from the late eighteenth century onwards and contributes significantly to the character and appearance of the area. In some instances artificial slates and concrete tiles have replaced the original slate roofs. These detract from the character and appearance of the area, do not weather in the same way and have a shorter life span than the West Highland slate.

- 5.36 The chimneys and dormers within the Galston Conservation Area along with gables, parapets and skews and ridge details that exist on some of the buildings are important features in the long views into and through the Galston Conservation Area. Some of these tell the history of former thatching. There are also a number of places where chimney pots and whole chimneys have been lost or inappropriate replacement stacks and pots have been introduced. Some of these are noted in the key building appraisal.

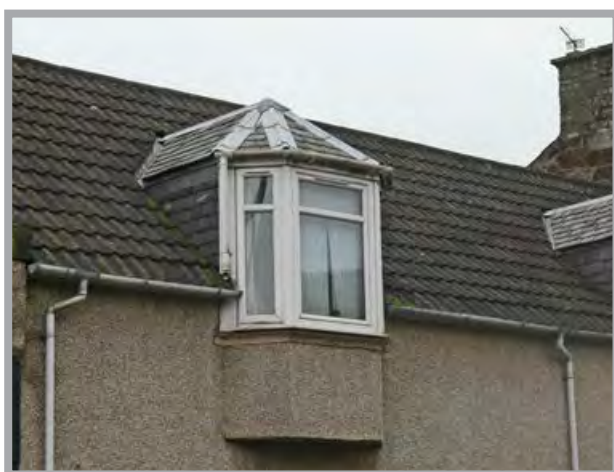
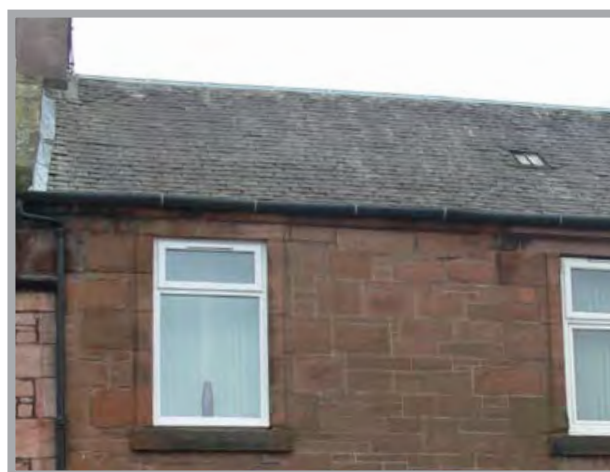
- 5.38 The use of traditional sash and case windows has diminished across Scotland since the Second World War. This can clearly be seen in the Galston Conservation Area. Those original windows that are still in place contribute significantly to the character of the conservation area. However, on many properties these have been replaced with modern windows, of a scale and detail that detract from both the quality of the individual buildings and the character of the area as a whole. The modern replacement windows have a number of different sections and patterns which reduces the cohesive style of the street and often jars with the materials of individual buildings.

Examples of non-traditional windows in the conservation area

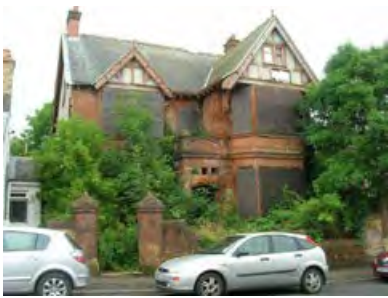
| Building | Description | Retention of original features and current condition |
|---|---|---|
| <p>34 Wallace Street</p> | <p>The B listed detached stone villa is located on the east side of Wallace Street towards the south of the conservation area.</p> <p>In 2010, planning permission and listed building consent were approved for the demolition of the building. No work has yet taken place to implement these consents.</p> | <p>The property is vacant and derelict and appears in a dilapidated condition, with overgrown front garden and boarded up windows.</p> <p><i>Medium / high</i></p> |

crossroads. Further towards the edge of the conservation area the very attractively detailed, stone faced B listed property at 34 Wallace Street has also been vacant for a number of years and its poor structural and very derelict condition, detracts from this part of the conservation area.

The derelict nature of 34 Wallace Street, has a negative impact on the southern end of the conservation area and its repair and refurbishment would therefore provide a significant enhancement. It is noted that the building has consent for demolition and the erection of replacement townhouses. It is, however, considered that in the interests of the built heritage of the conservation area, and bearing in mind that the building is B listed, it would be far preferable to seek the retention and repair of the building if at all possible.

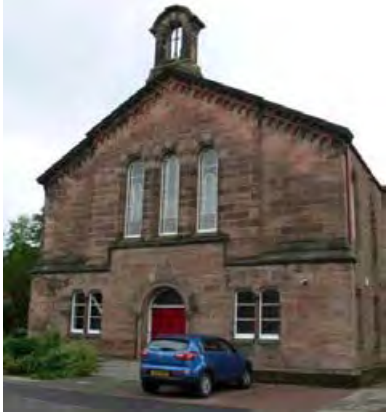
| Building | Description | Retention of original features and current condition |
|---|---|---|
| <p>Former UF church, Wallace Street</p> | <p>The B listed former church dates from 1859 and has several notable features including a bell-cote and 3 tall round headed windows to the front elevation.</p> <p>Following the granting of planning permission in 2006, the building has been successfully converted into residential accommodation comprising of 5 flats.</p> | <p>The conversion of the church building to provide residential flats has retained several features including the prominent windows and slate roof. Some modern additions have been added, including upvc downpipes.</p> <p>The building stonework and the roof appear to be in reasonable condition.</p> <p><i>Medium / high</i></p> |

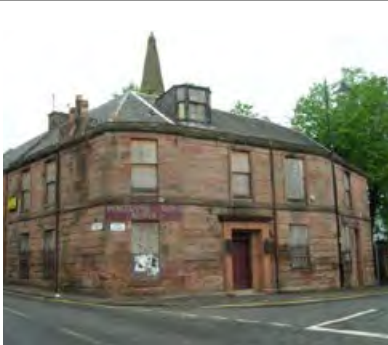
| Building | Description | Retention of original features and current condition |
|---|---|---|
| <p>The Former Portland Arms, 2-4 Cross Street</p> | <p>Dating from 1864, the B listed property is an attractive 2 storey red sandstone corner building, at the junction of Brewland Street and Cross Street.</p> <p>The former hotel has been vacant for a considerable number of years.</p> | <p>A number of inappropriate amendments have been made to the building including poor roof finishes, and an inappropriate and highly prominent dormer window.</p> <p>The building currently appears in a poor state of repair as a result of its falling out of use a number of years ago. Windows are boarded up and significant repairs are required to the stonework.</p> <p><i>Medium / low</i></p> |

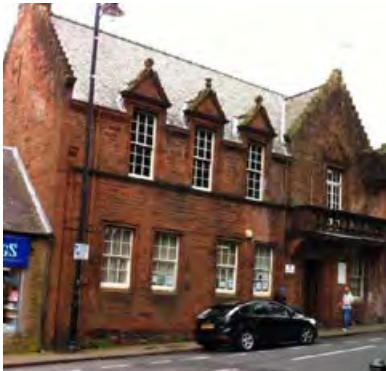
| Building | Description | Retention of original features and current condition |
|---|---|--|
| 11 Cross Street | <p>The prominent red sandstone building and former Burgh Chambers, dating from 1884, is of traditional Scottish construction comprising ashlar sandstone elevations supporting timber trusses with a slate roof covering.</p> | <p>The building retains some decorative features including the stone balcony above the main entrance and detailing above the first floor windows.</p> |
| | <p>The building is in use as the Council's Local Office and a programme of refurbishment is planned as part of the Council's regeneration strategy for the town.</p> | <p>The sash and case windows remain, but appear in poor condition and the upper floor panes have been blacked out.</p> <p>It is likely that a lack of long term maintenance has resulted in a requirement for significant works, particularly in terms of the roof and windows.</p> <p><i>Medium</i></p> |

As part of East Ayrshire Council's Regeneration Strategy for the town, it is intended that conservation repairs and refurbishment will be undertaken on the former Burgh Chambers on Cross Street, which will provide improved office accommodation and safeguard the physical fabric of the building for years to come. This work will noticeably enhance what is an important and prominent building within the conservation area.

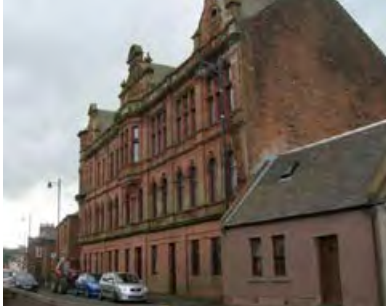
| Building | Description | Retention of original features and current condition |
|---|---|--|
| | <p>In the late 1990's the building was successfully converted into residential accommodation, forming 14 flats.</p> | <p>Windows have been replaced with non original timber windows. Attractive stonework detailing has been retained around the window arches and the along the roofline.</p> <p><i>Medium</i></p> |

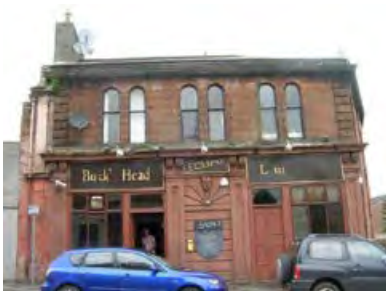
| Building | Description | Retention of original features and current condition |
|---|---|--|
| 8 – 12 Bridge Street | <p>2 storey red sandstone building is centrally located on Bridge Street. The exposed side gable has temporary structural protection since the demolition of the adjoining building.</p> | <p>Whilst the building remains in active use, it appears in a fairly poor state of repair.</p> |
| | <p>The building currently operates as a public house and sits on its own between Burn Anne and the corner Gap site at Bridge Street / Cross Street.</p> | <p>The shop front and fascia signs are modern additions, which do not reflect the architectural qualities of the buildings. New windows and upvc guttering and downpipes have been added, whilst some of the stonework appears in poor condition.</p> <p><i>Low</i></p> |

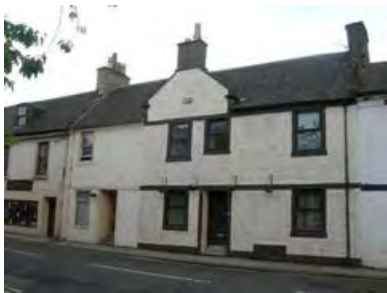
| Building | Description | Retention of original features and current condition |
|--|--|--|
| <p>20 - 22 Polwarth Street</p> | <p>2 storey building with painted stone façade and centre gabled chimney.</p> <p>The property is C(S) listed along with the rest of the terrace of properties that forms 4 – 24 Polwarth Street.</p> <p>The property is occupied for residential use on both the ground and upper floor.</p> | <p>The building has been affected by several modern additions, including a replacement brick built chimney and mixture of non-original timber and upvc windows.</p> <p>The building retains cast iron gutter and downpipe, however, the condition is questionable. Again, the condition of the stone underneath the paintwork is unknown.</p> <p><i>Medium</i></p> |

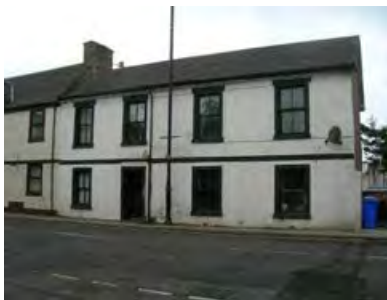
| Building | Description | Retention of original features and current condition |
|--|--|--|
| <p>24 Polwarth Street</p> | <p>2 storey building with painted stone façade.</p> <p>The property is C(S) listed along with the rest of the terrace of properties that forms 4 - 24 Polwarth Street.</p> <p>The building is in residential use and appears to be occupied.</p> | <p>The building is affected by modern additions including a prominent satellite dish on the front façade, upvc downpipes and guttering and non-original windows.</p> <p>The front façade shows some signs of deterioration, in terms of cracking and flaking paint.</p> <p><i>Medium</i></p> |

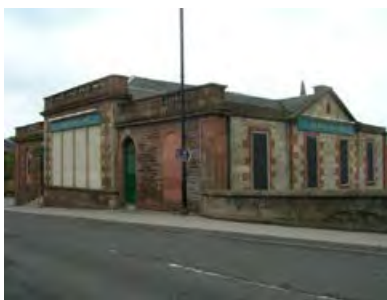
| Building | Description | Retention of original features and current condition |
|--|--|--|
| <p>28 – 30 Polwarth Street</p> | <p>The tall single storey former Brown's Institute building is an attractive sandstone building and is the first building that is passed when entering the town from the A71 via Polwarth Street.</p> <p>Brown's Institute was built in 1874 and was originally a recreational centre for local people. It is currently occupied by Balmoral Knitwear as a factory shop with associated coffee shop.</p> | <p>The current appearance of the building is affected by the blacked out windows, on the prominent northern and eastern elevation. Upvc gutters and downpipes have also been added.</p> <p>Whilst there is some staining to the stonework, it appears in relatively good condition.</p> <p><i>Medium</i></p> |

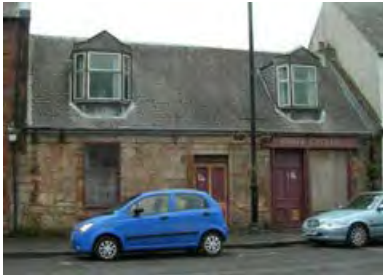
| Building | Description | Retention of original features and current condition |
|---|---|--|
| 14 – 16 Titchfield Street | One and a half storey cottage dating from 1797. The property is listed at C(S), along with numbers 18 – 28 Titchfield Street. | The appearance of the property is negatively affected by the insertion of dormer windows with modern windows frames. Modern upvc guttering has also been added. The property retains its original slate roof and stone walls. The condition of the property appears poor with significant staining and vegetation on the stonework. |
| | The property was originally constructed for residential use, however, number 16 was converted into a retail unit before falling out of use. Number 14 appears to be still in residential use | <i>Medium / low</i> |

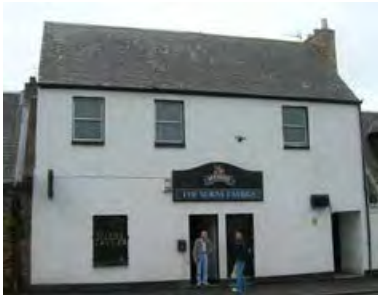
| Building | Description | Retention of original features and current condition |
|---|---|--|
| 18 – 20 Titchfield Street 80 | Two storey commercial building. The property is listed at C(S) along with 14 – 16 and 22 – 28 Titchfield Street. The property is currently in use as a public house, the Burns Tavern. | The original stone walls have been painted on smooth cementitious render. Upvc windows have been inserted as well as upvc gutters and downpipes. The front facade is also affected by a prominent extractor fan and non-traditional signage. The condition of the building appears reasonable. |
| | | <i>Medium / low</i> |

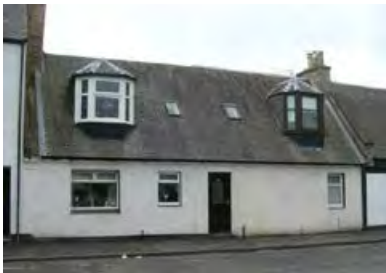
| Building | Description | Retention of original features and current condition |
|---|---|--|
| 22 Titchfield Street 81 | One and half storey residential property, listed as C(S) along with 14 – 20 and 24 – 28 Titchfield Street. The property remains in use as a residential dwelling | The original character of the building is affected by a number of modern additions. The insertion of 2 dormer windows with differing styles of windows and 2 skylights, together with the modern windows on the ground floor significantly impact on the building. Upvc guttering has also been added. Condition appears generally fair although inappropriate use of cementitious render may mask any problems with the stone. |
| | | <i>Medium / low</i> |

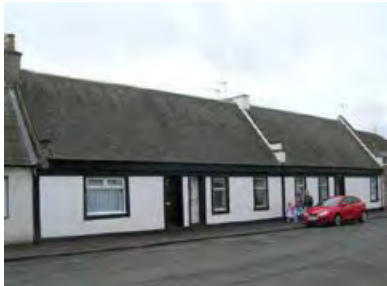
| Building | Description | Retention of original features and current condition |
|---|---|---|
| <p>24 –28 Titchfield Street</p> | <p>One storey residential cottages, listed as C(S) along with 14 – 22 Titchfield Street.</p> <p>The properties remain in use as residential dwellings</p> | <p>The prominent roofs remain of traditional slate build. The modern windows and doors and upvc gutters detract from the original character of the building.</p> <p>Condition appears generally fair although use of cementitious render may mask problems with the stone.</p> <p><i>Medium</i></p> |

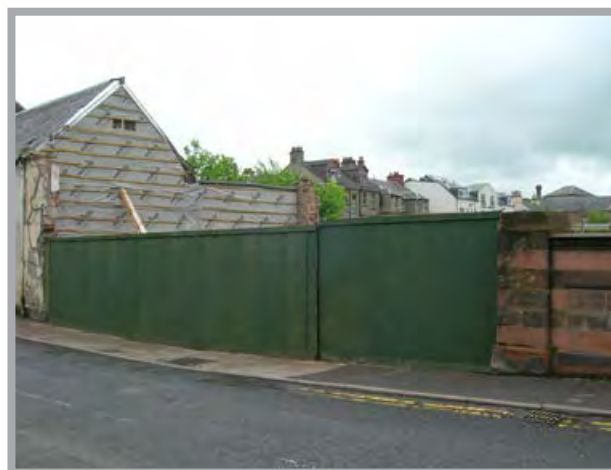
- 6.1 The character and appearance of the conservation area is affected by a number of vacant sites at key locations within the conservation area. A fire in 2010 led to the removal of 3 - 5 Cross Street and 2 - 4 Bridge Street, which has led to a prominent gap site at the corner of Cross Street and Bridge Street at the centre of the conservation area. Further along Bridge Street, the building at 13 – 17 has been removed, leaving another prominent gap site within the conservation area. Together, these two sites detract significantly from the environmental quality of Bridge Street which is the key route leading from east to west through the conservation area.

Prominent gap sites within the conservation area

The gap sites at the corner of Bridge Street and Cross Street and 13 – 17 Bridge Street are noted as being major negative factors on the character and appearance of the conservation area. As noted above, through its regeneration Strategy for Galston the Council is committed to redeveloping the site. Options for taking forward the redevelopment of 13 – 17 Bridge Street also need to be explored with the owner of the site.

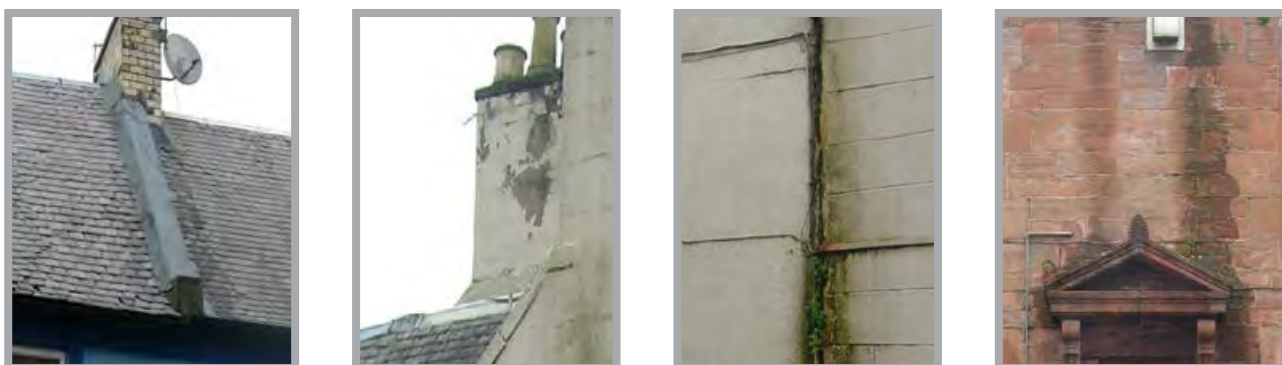
- 6.3 The conservation area is affected by many instances of poorly maintained buildings and signs of ongoing disrepair to the physical fabric of the area. Issues such as blocked drainage systems, vegetation growth, poorly maintained stonework and broken windows are all visible within the conservation area. This issue is not unique to Galston and is certainly not helped by the difficult economic times facing property owners and occupiers over the last few year.

Example of poor maintenance on Bridge Street and Polwarth Street

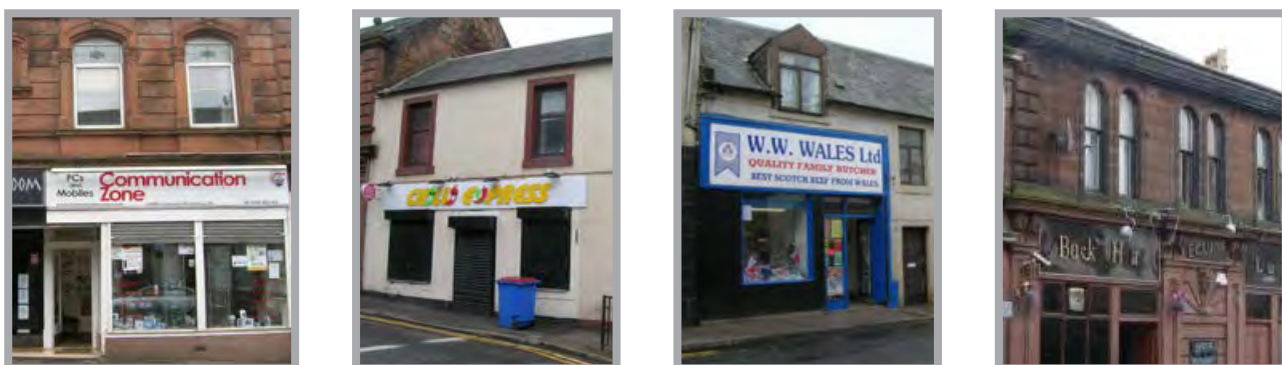
- 6.4 The Galston Conservation Area retains much of its historic fabric, but more recently the area has been affected by infill developments along with modernisation of, and additions to, buildings such as shop fronts and signage. The most notable building of more modern appearance is the Co-op store at 7 – 9 Cross Street, which is a flat roofed 1960's building, the form of which is not in keeping with any of the other buildings within the conservation area. In many instances the additions and alterations to historic and local vernacular buildings do not relate well to the traditional style of the individual buildings and do not preserve or enhance the character of the area. Such modern additions have a significant adverse affect on the appearance of the conservation area. A more sensitive and coordinated approach to signage and shop front design, for example, could have a marked impact on the area.

Examples of modern additions to the conservation area

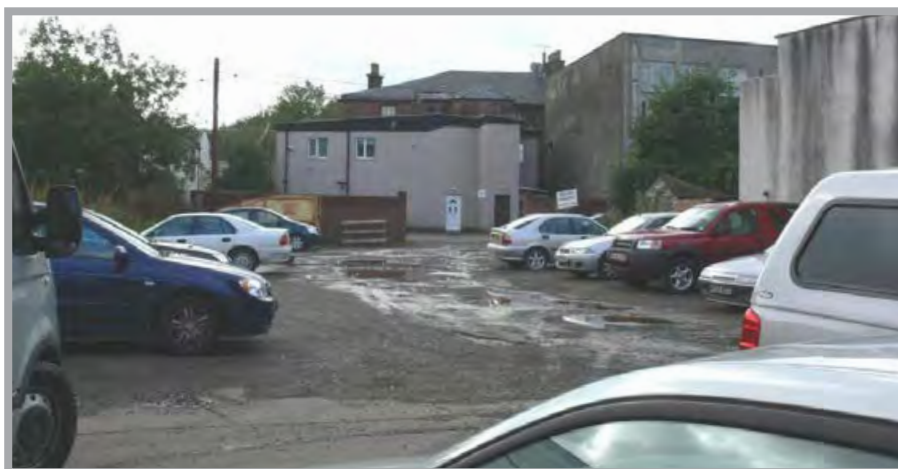
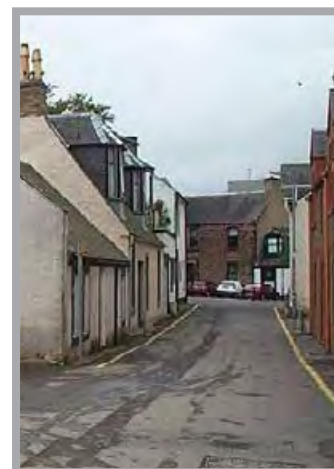
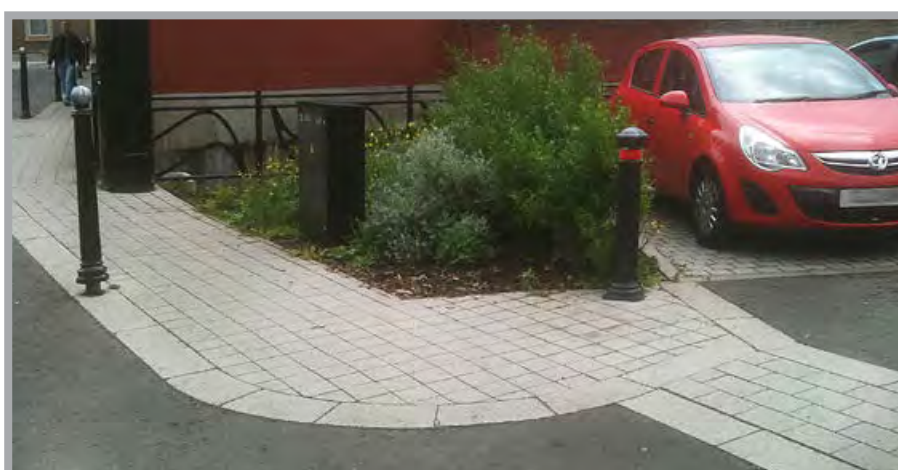
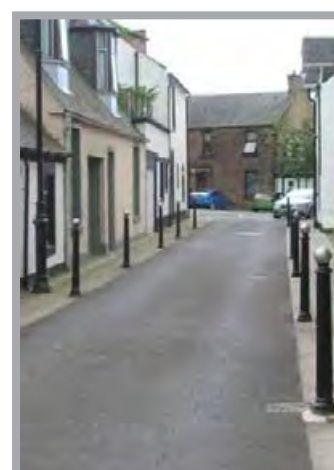
Before and after photos of Church Lane and associated car park

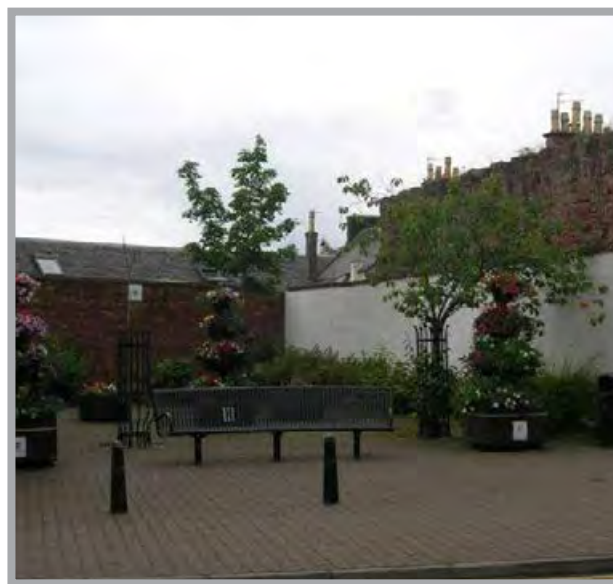
Area of open space on Bridge Street with potential for further improvements.

As noted in section 5 above there are relatively few areas of public space within the conservation area. Of the open space that does exist, the key opportunity for enhancement is considered to be the relatively small area at the Four Corners, on the north side of Bridge Street. Whilst the area currently benefits from some seating and planters, it could be improved with new landscaping and good quality materials. Given the importance of the Four Corners in the development of the town and that it is currently a busy junction, both for vehicles and pedestrians, the upgrading of this area would significantly enhance the amenity of the town centre.
