STONE ANALYSIS & MATCHING REPORT

AP 3760
15 Earl Grey Street,
Mauchline

Sample 1
Sandstone

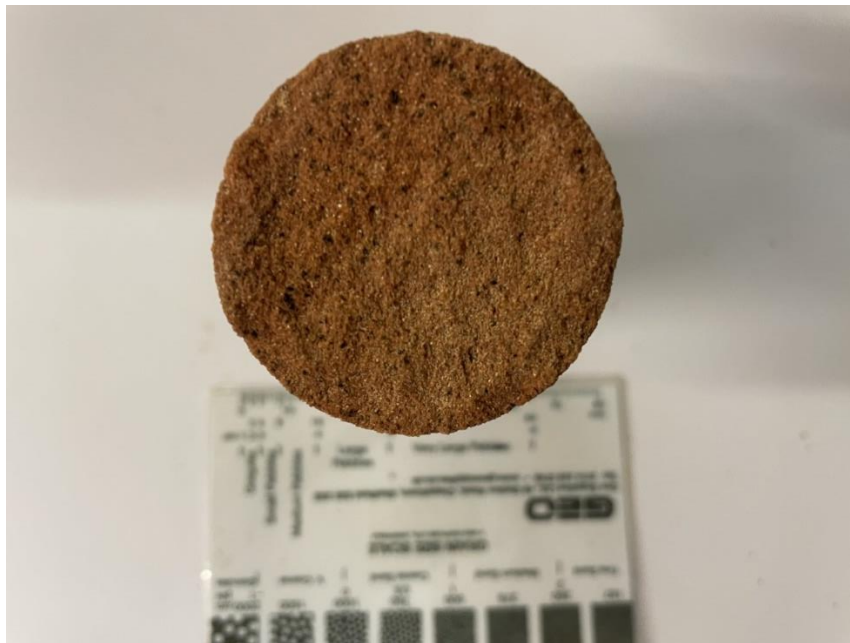
Plate 1. Image of the sample as received. Note the black speckling caused by Fe-oxides and carbonaceous matter. Scale is in mm.

In hand specimen the fresh faces measured 2.5YR 5/4 'reddish brown' to 2.5YR 4/8 'red' when assessed against the Munsell Soil Colour Charts. The sample exhibits a slight speckled appearance. The sandstone is predominantly medium grained, texturally sub-mature to mature and mineralogically sub-mature to mature. It is composed of sub-angular to sub-rounded to rounded haematite-stained quartz grains, occasional Fe-oxides and carbonaceous flakes (these both impart the slightly speckled appearance in hand specimen) and lighter coloured grains. Haematite staining of quartz grains provides the stone with its distinctive red colour in hand specimen. It experienced a weak to no reaction when subjected to 10% hydrochloric acid (HCL), indicating a low carbonate content within the stone. The sample displays a predominantly uniform texture with no obvious layers/laminations; however the stone may display bedding on a larger scale not visible in hand specimen. Grains are moderately well compacted, showing a range of point and line contacts throughout, leaving a clean and highly accessible pore network, clear of pore filling clays and defined by two main visually apparent pore size classes (ranging between small and medium sized, in relation to a typical sandstone). The stone experienced a low to moderate water absorption rate when subjected to the water droplet test, signifying a discontinuous internal pore network.

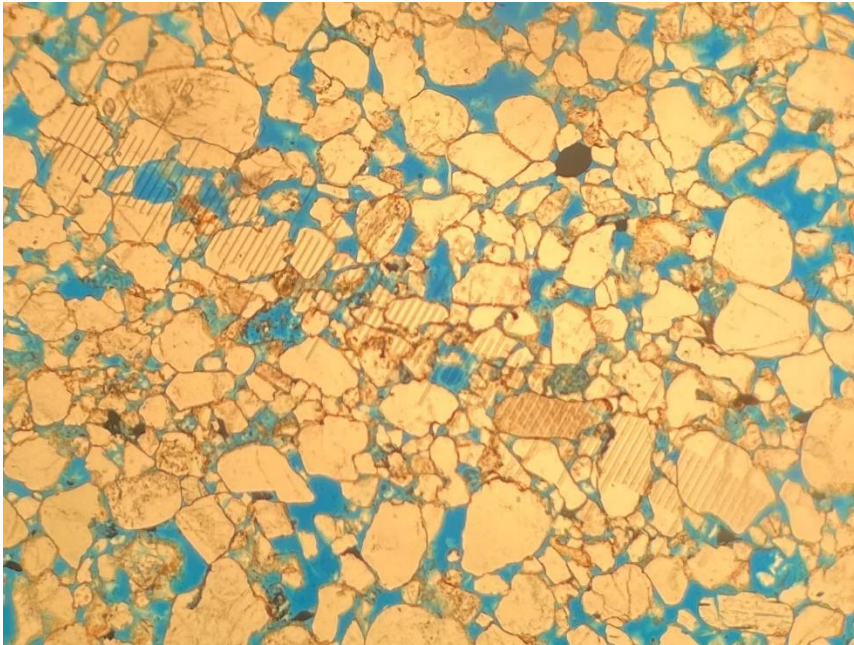
Plate 2. Thin section of the sample under plane polarised light. Pore spaces are highlighted in blue, while areas of light blue indicate pore filling clays that have absorbed some of the blue dye. Pores are moderately to well connected, with some of the larger pores filled with sub-angular to sub-rounded quartz, feldspar and lithic fragments.

Field of view is 4.2mm.

Porosity and permeability: The stone has a moderate visual porosity, estimated between 12-15%. Concentrations of Fe oxides and carbonaceous matter and finer grain size will act to significantly increase the tortuosity of the pore network, which will also impact on moisture movement through the stone. Small pores are evident between the smaller grains due to poor grain sorting, while larger pores are found between the larger grains in the main stone matrix, but are commonly filled with small, angular quartz grains and kaolinite clay.

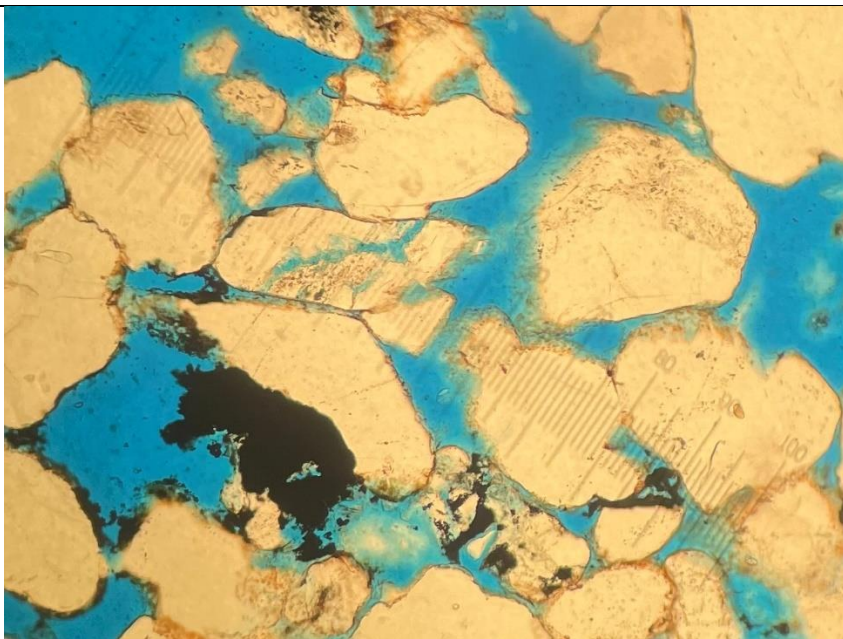
Plate 3. Thin section image of the sample under plane polarised light. Pore spaces are highlighted in dark blue, while areas of light blue indicate pore filling clays. Hematite rims can be seen surrounding the quartz grains, this is what gives the sample its distinct red colour.

Field of view is 1.2mm.
