# STONE ANALYSIS & MATCHING REPORT

AP 3761  
39a Loudoun Street,  
Mauchline

Sample 1  
Sandstone

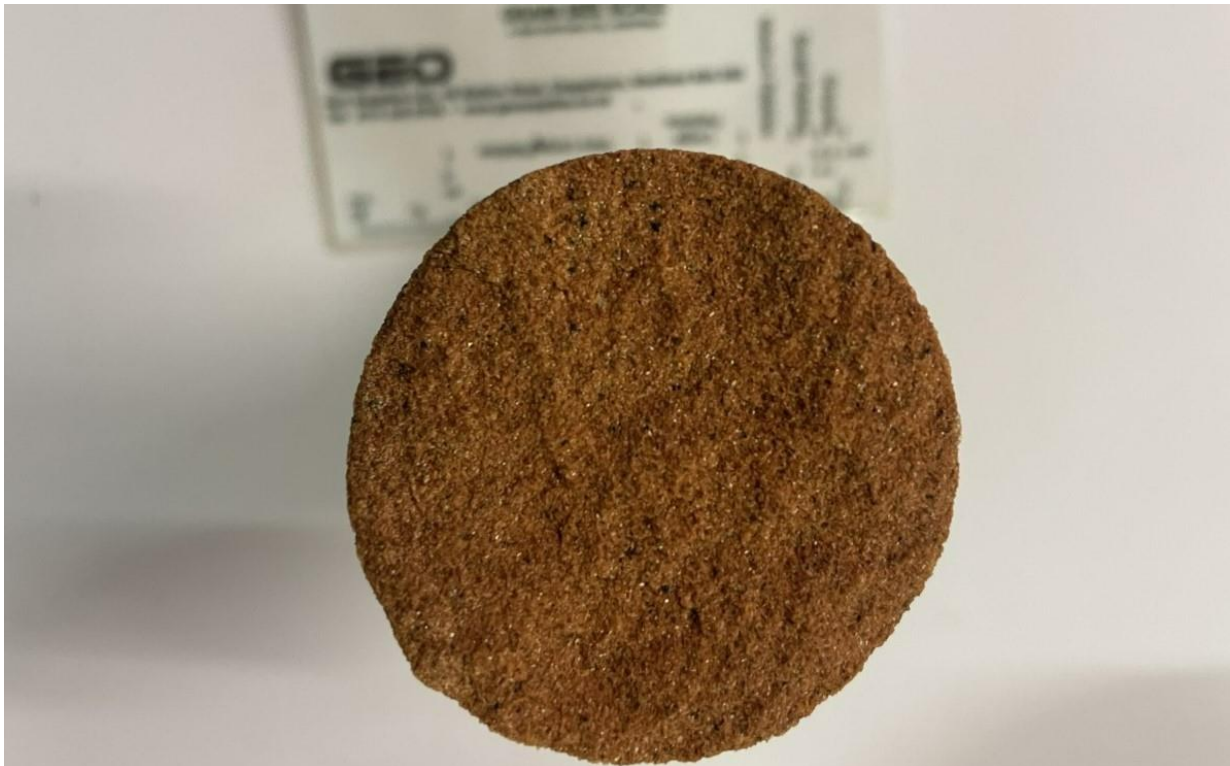
**Plate 1. Image of the sample as received. Note the black speckling caused by Fe-oxides. Scale is in mm.**

In hand specimen the fresh faces measured 2.5YR 6/4 'light reddish brown' to 2.5YR 6/6 'light red' when assessed against the Munsell Soil Colour Charts. The sample exhibits a slight speckled appearance. The sandstone is predominantly fine to medium grained, texturally sub-mature to mature and mineralogically sub-mature to mature. It appears to be composed of sub-angular, sub-rounded to rounded haematite-stained quartz grains, occasional Fe-oxides and carbonaceous flakes (these impart the the slightly speckled appearance) and lighter coloured grains. Haematite staining of quartz grains provides the stone with its distinctive red colour in hand specimen. It experienced a moderate reaction when subjected to 10% hydrochloric acid (HCL), likely from a carbonate cement and carbonate lithic fragments. The received sample displays a predominantly uniform texture with little evidence of layers/laminations, however it may display bedding on a larger scale not visible in hand specimen. Grains are moderately well compacted, showing a range of point and line contacts throughout, leaving a clean and highly accessible pore network, clear of pore filling clays and defined by two main visually apparent pore size classes (ranging between small and medium sized, in relation to a typical sandstone). The stone experienced a low to moderate water absorption rate when subjected to the water droplet test, signifying a discontinuous internal pore network.

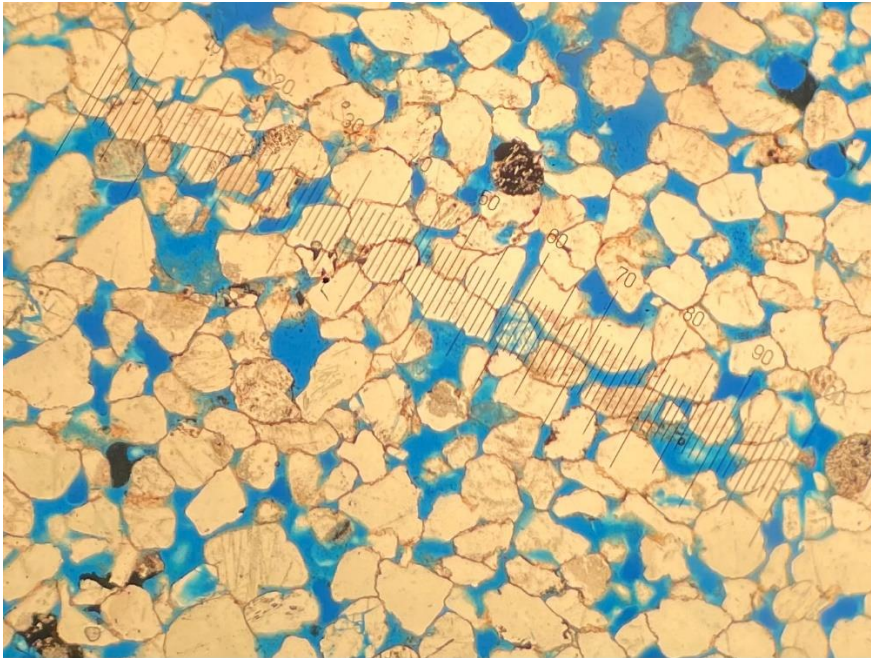
Field of view is 4.2mm.

**Plate 2.** Thin section of the sample under plane polarised light. Pore spaces are highlighted in blue, while areas of light blue indicate pore filling clays that have absorbed some of the blue dye. Pores are moderately to well connected, with some of the larger pores filled with sub-angular to sub-rounded quartz, feldspar and lithic fragments.

**Porosity and permeability:** The stone has a moderate visual porosity, estimated between 11-14%. Concentrations of Fe oxides and carbonaceous matter will act to significantly increase the tortuosity of the pore network, which will also impact on moisture movement through the stone. Small pores are evident between the smaller grains due to poor grain sorting, while larger pores are found between the larger grains in the main stone matrix, but are commonly filled with small, angular quartz grains and kaolinite clay.

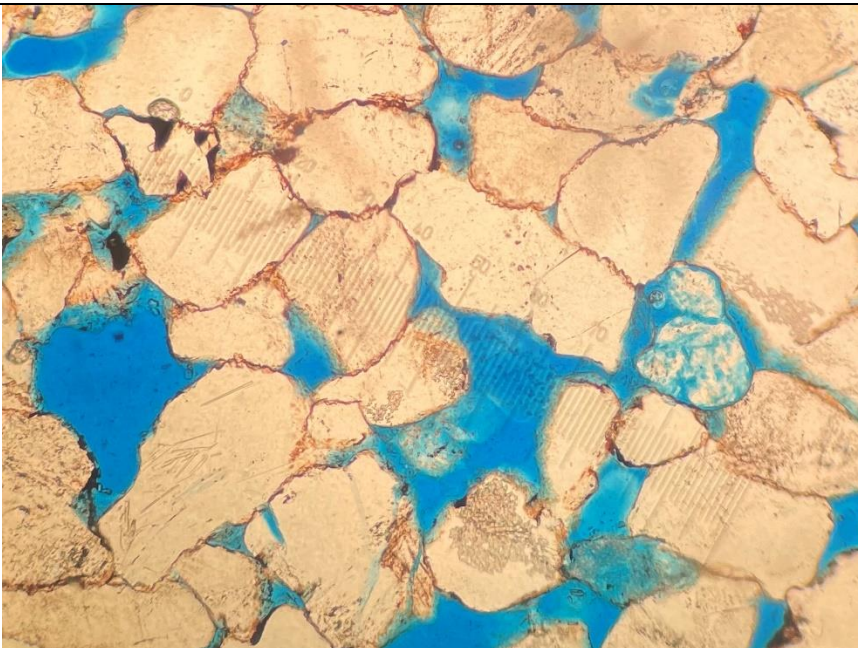
Field of view is 1.2mm.

**Plate 3.** Thin section image of the sample under plane polarised light. Pore spaces are highlighted in dark blue, while areas of light blue indicate pore filling clays. Hematite rims can be seen surrounding the quartz grains, this is what gives the sample its distinct red colour.
