REPORT ON MORTAR ANALYSIS BY PETROGRAPHY

AP 3779
Abbot Hunter's Tower/ Mauchline
Castle,
Mauchline

Sample 1
Mortar

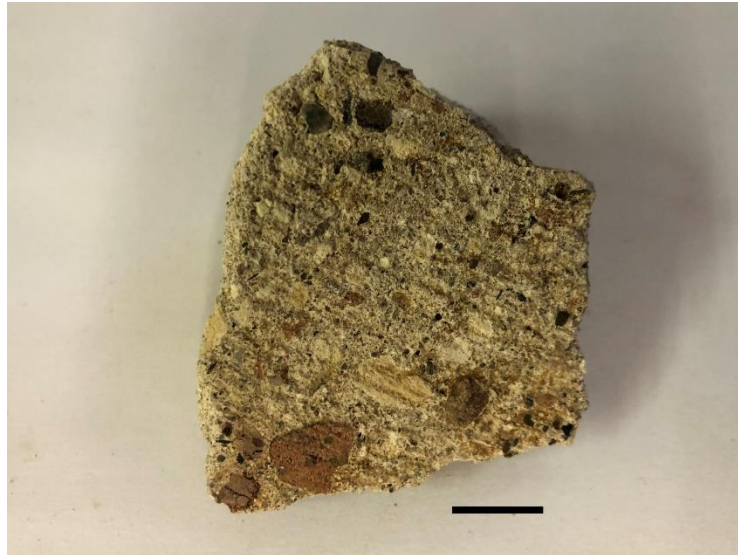
Figure 1. Image showing a freshly sawn face of the mortar. Scale bar = 10mm.

PROCEDURE	OBSERVATIONS
<p>PRELIMINARY VISUAL ANALYSIS OF SAMPLE BY BINOCULAR MICROSCOPE (X40 MAGNIFICATION)</p>	<p>The colour of the mortar, as assessed on a freshly fractured surface, against the Munsell Soil Colour Chart was found to be 10YR 7/2 “light grey” to 8/2 “very pale brown”. In response to a phenolphthalein indicator test the mortar was found to be fully carbonated throughout its depth. Water droplet tests indicated that the outer, weathered, surface was absorbent with droplets absorbed relatively quickly. Droplets placed onto freshly fractured surfaces, again showed fast absorption into the binder. The mortar was weak and friable, requiring little finger pressure to disrupt. The mortar doesn’t appear over air entrained, although there is a low abundance of small, entrapped air voids, up to 1.7mm in size, noted within the surfaces examined. Redeposited calcite, in the form of calcium carbonate, was observed to coat some surfaces/voids, suggested that water penetration through the sample had occurred, with localised leaching of binder components and their redeposition within the micro-crack pathways. The aggregate in the mortar consists mostly of sub-angular quartz grains, along with smaller proportions of crystalline lithic fragments, and a very small proportion of shell fragments. The particles range in size from 6mm down to <0.1mm.</p>

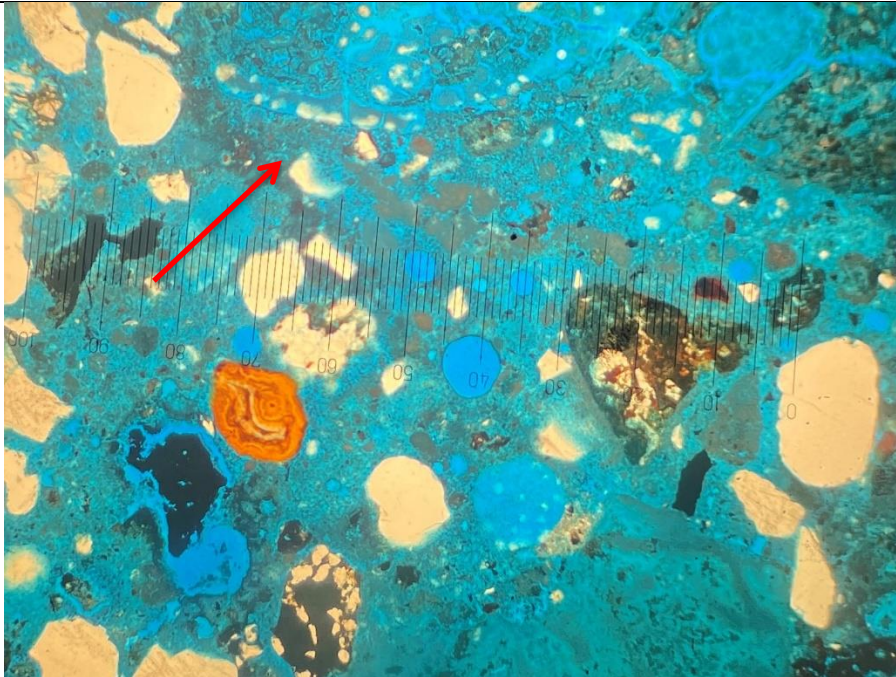
Field of view: 4.2mm.

The binder is lime rich and fully carbonated, containing relics of lime inclusions up to 3.2mm in diameter. Hydraulic components were readily observed, and the inclusions have the appearance of the lime having been used in the form of a quicklime, in a "hot lime" mortar. The inclusions commonly contain hydration/shrinkage cracks associated with hot lime mortars. The binder, particularly towards the internal margins of the sample, is disrupted by an abundance of microcracks and voids. Voids range from 0.1mm – 0.5mm wide and in some areas, they connect voids such that binder material forms a skeletal framework within the pore spaces. The outer surface is disrupted due to secondary calcite precipitation, and many voids are fringed with calcite.

Figure 4. Thin section of the sample under plane polarised light. Pore spaces are highlighted in bright blue, while areas of dark/dull blue indicate the lime binder that has absorbed some of the blue dye. Most lime inclusions show a diffuse contact with the surrounding paste (highlighted by red arrow).
