EAST AYRSHIRE COUNCIL

# **Local Development Plan 2**

## Dalmellington Conservation Area Appraisal

Non-statutory Planning Guidance

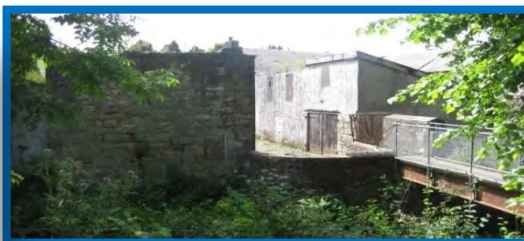
*Figure 50: old stables and byres*

- (i) **1 New Street (Figure 52)**
- (ii) **4-8 The Path (Figure 51)**
- (iii) **Ye Old Castle House, 5 High Street (Figure 21)**
- (iv) **building to rear of 18 High Street (The Black Bull/The Loch Doon) (Figure 49)**
- (v) **building to rear of 28 High Street (Figure 50)**

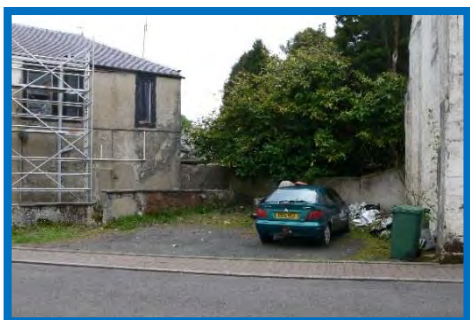
*Figure 53: New Street*

- 4.2 In addition to vacant buildings there are various vacant sites. Particularly prominent sites in the heart of the oldest area of the town are at 15 High Street (**Figure 54**), 15 New Street (**Figure 53**), and 2-4 Townhead. The sympathetic development of these sites would significantly enhance the Conservation Area and help to redefine the original street pattern, which remains intact but with a reduced sense of enclosure.

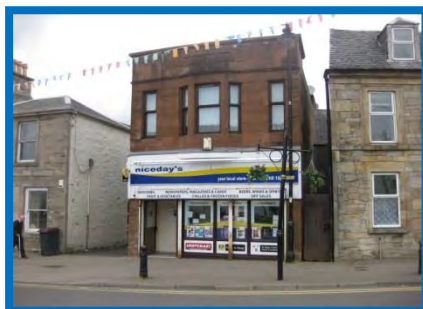
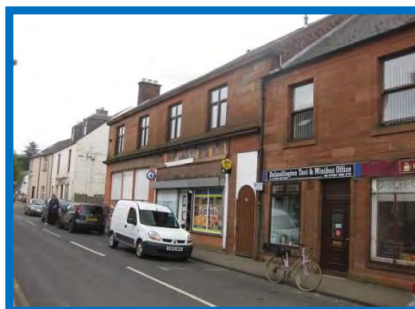
- 4.4 Much of the historic character of Dalmellington has been altered by new development and additions to buildings including shop frontages and signage. Such modern additions have an adverse effect on the appearance. A more sensitive and co-ordinated approach to signage and shop front design, for example, could have a marked positive impact on the area.

**Figure 55:** Shopfront on Main St

**Figure 56:** Shopfronts on Main St

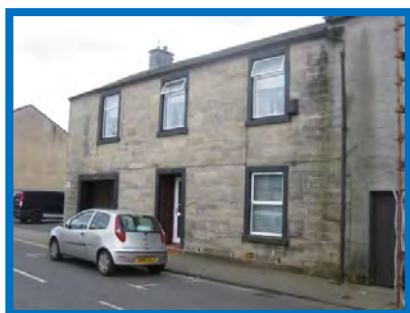
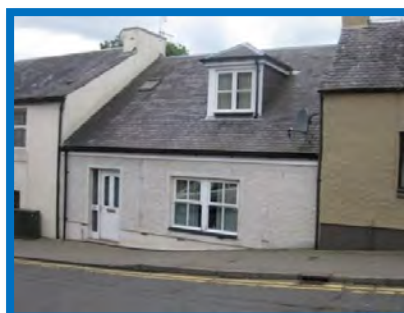
- 4.5 There is only one property within Dalmellington Conservation Area that retains its original sash and case windows.

**Figure 57:** Replacement windows

**Figure 58:** Replacement windows and render.

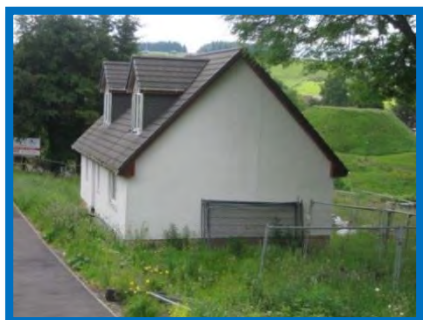
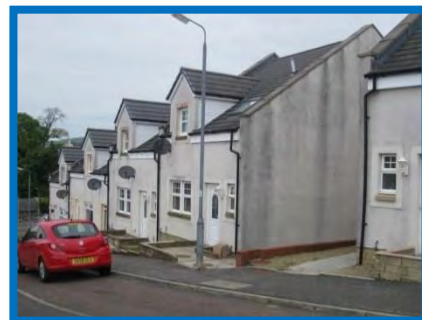
- 4.6 The most recent new-build developments at Melling Terrace (**Figure 59**) and Townhead (**Figure 60**) are constructed in unsympathetic materials that further contributes to the erosion of Dalmellington's character.

**Figure 59:** New build on Melling Terrace

**Figure 60:** New-builds on Townhead

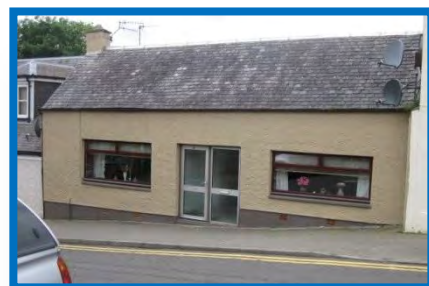
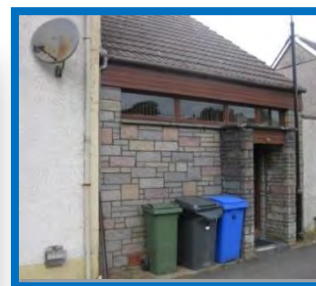
**Figure 61:** adaptations at High Main St

**Figure 62:** Unsympathetic adaption

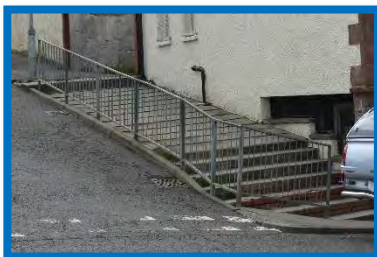
- 7.2 The Path itself requires improvement along with the steps and railings at the junction of Church Hill and High Main Street as well as the steps and railings from High Main Street to the Kirk of the Covenant.

**Figure 64:** hazardous steps

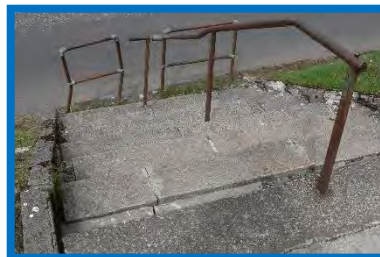
**Figure 65:** dilapidated railings

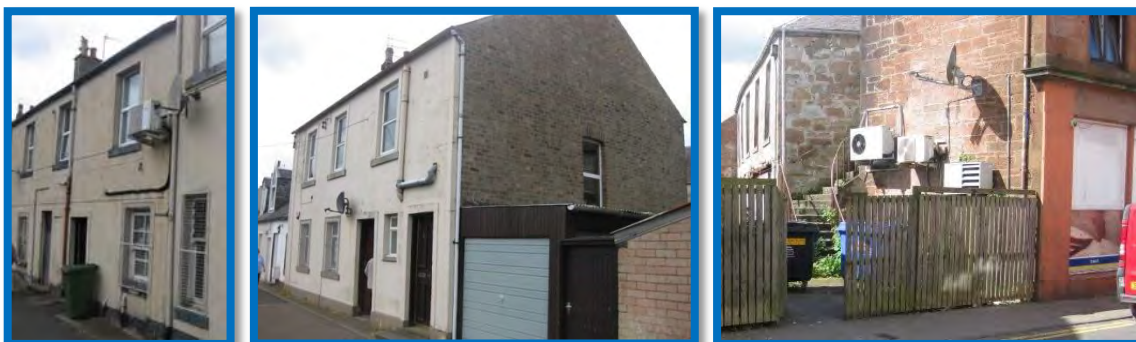
- 7.5 Street lighting and signage are standard with some modern ‘conservation style’ lamp standards, bollards and benches having been installed in and around the Square. Dominating the Square - the social heart of the town - is a huge security camera mast located in the roundabout, towering over the streets. There are no natural landscaping materials in situ in the town centre and no green landscaping to soften the harsh finishes. Street signage is standard and shop signage modern. There are various instances of prominently located satellite dishes, security alarm boxes, above-ground gas meters attached to walls, air-conditioning units, modern metal garage doors and wheelie bins all contributing to the impression of haphazard control and unfitting detail for a Conservation Area.

**Figure 72:** examples of unsympathetically located services detracting from the historic fabric

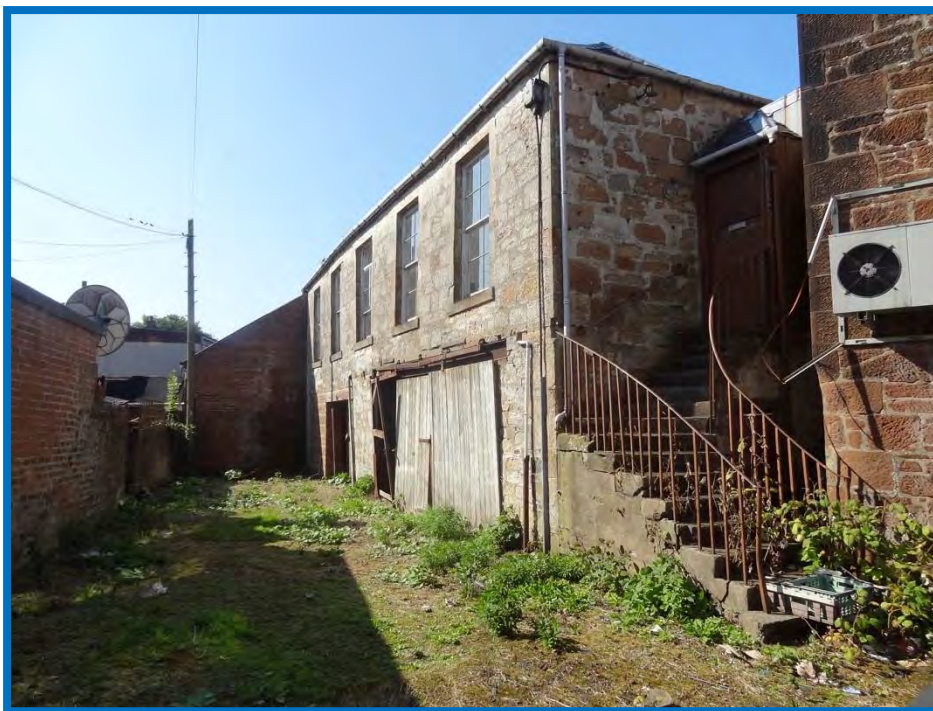
*Figure 79: The Eglinton Hall or The Old Band Hall*

- 14.3.1 Dalmellington Silver Band is world renowned and this property was their rehearsal venue from 1947 when, known as the Eglinton Hall, it was put up for sale and purchased by the Dalmellington Band for the sum of £300. The lower section of the property was formerly a brew house for the Eglinton Hotel with the upstairs part used as the hall. Accessed by a steep and winding stair the upper hall over-looks a charming cobbled courtyard. During the Second World War the hall was requisitioned for use by the army. The purchase proved to be an investment for the Band and gave them a long sought-after permanent home. The old band hall closed its doors for the last time in 2005 when the new purpose built hall on Ayr Road opened its doors. Today the hall is in a perilous condition exacerbated by its long-standing structural issues.

- 14.3.2 A formal application has been made to the **Buildings at Risk Register for Scotland** to have the property included on the register to highlight its plight and provide support for the case for funding required by this property.

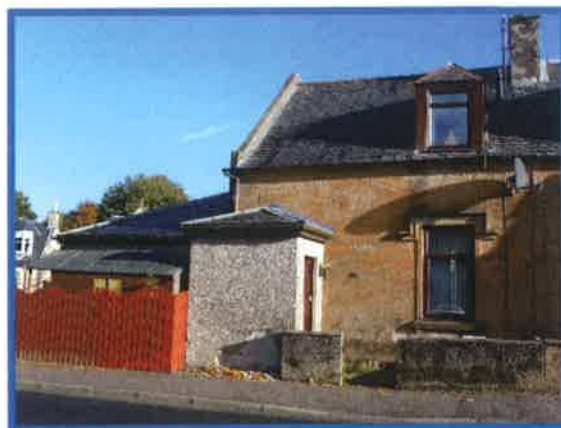
3 Bellsbank Road  
Dalmellington

**Fair condition. Roof slates to right of dormer look quite loose. Broken render on porch causing brick underneath to be exposed. Damaged sandstone underneath window sill.**

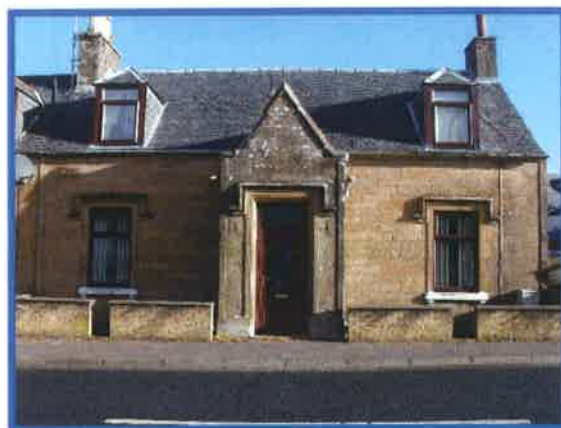
**3 bay single storey with 2 dormer windows. Pitched slate roof. Small skylight window in centre of building. Hood moulds surrounding windows and doors. Stone architraves. Projecting porch with tympanum. Missing cornice on right hand side of tympanum. White painted window cills. Modern windows and doors. UPVC downpipes and guttering.**

**Generally in good condition. Chimney stack in poor condition, damaged render, exposed brick.**

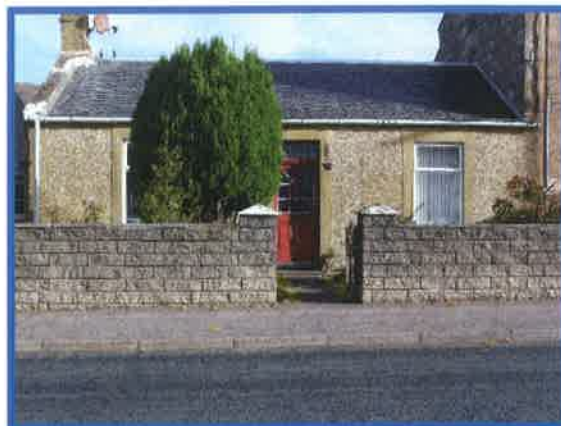
5 Bellsbank Road  
Dalmellington

**3 bay single storey semi-detached cottage. Pitched slate roof. Zinc ridge flashing on roof recently been restored. Smooth stone detail architrave around windows and doors. Contrasting repair at re-pointed gable. Pebble dash finish. Red painted timber door with small glazed panels to top half of door.**

**Good condition.**

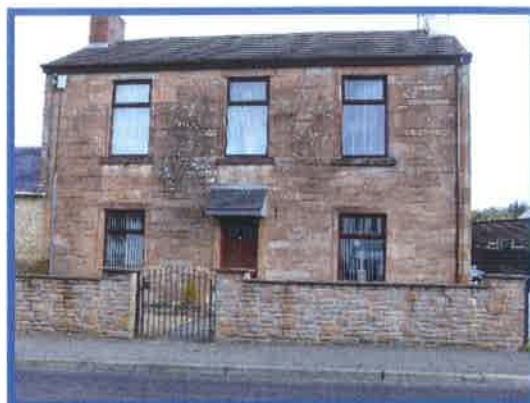
6 Bellsbank Road  
Dalmellington

**Fairly good condition. Discolouring of stone work around top centre and right of building.**

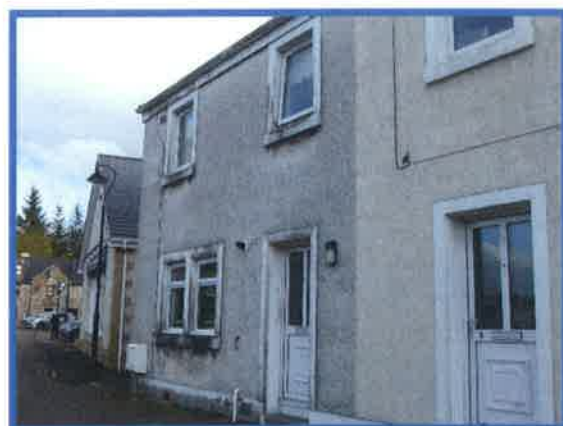
**Fair condition. Guttering in poor condition with vegetation growing from it. White paintwork at bottom, and surrounding window and doors in poor condition. Very dirty looking, detrimental to the visual amenity of the conservation area.**

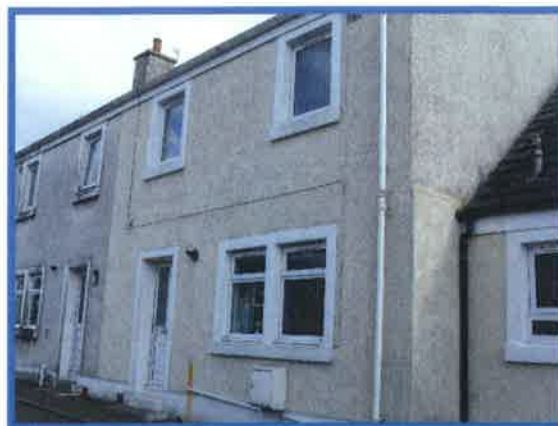
**Good condition. Slight damage to render at bottom left hand side of house. Water has been leaking from overflow pipe causing paintwork below to discolour.**

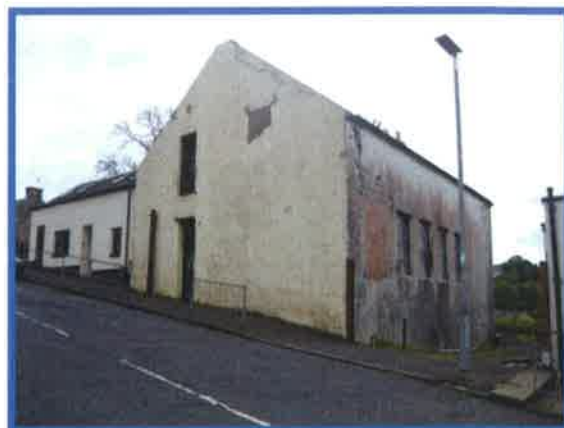
1 Church Hill  
Dalmellington

**2 storey, 4 bay detached villa. Former bakery. Windows boarded up on road facing side of property. 4 Victorian style 12 pane windows to rear elevation remain intact. Photo of rear elevation shows some damage to top of gable wall.**

**Fairly poor condition. Significant deterioration of paint finishing surrounding whole property. Patch of exposed render to top right of road facing elevation. Broken downpipe.**

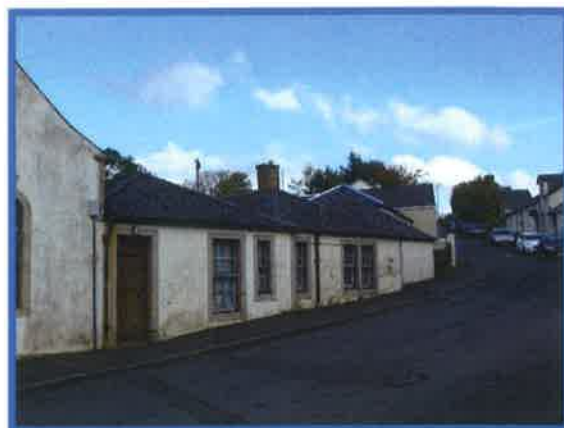
8 Church Hill  
 Dalmellington

**Fair condition. In need of external decoration. 2 small patches of render damaged exposing red brick substrate.**

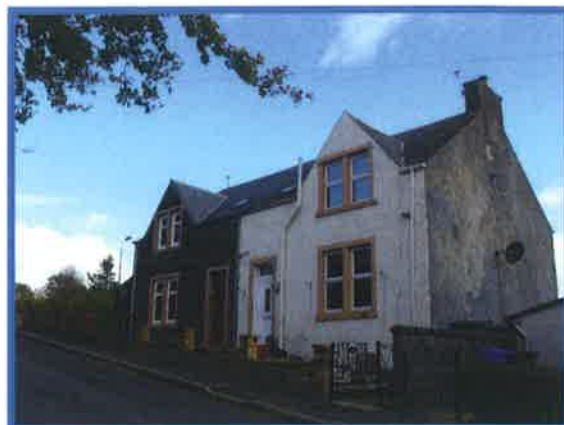
**Fairly good condition. Slightly damaged roughcast render on gable exposing brickwork below. Some paintwork peeling to right hand property.**

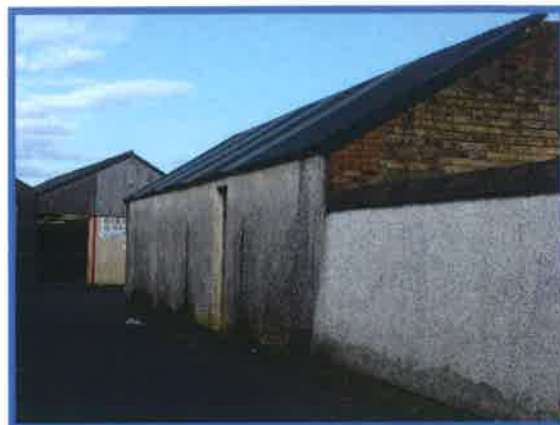
7-9 Croft Street  
Dalmellington

**Poor condition. Missing brick on gable wall. Damaged and missing brick at peak of gable wall.**

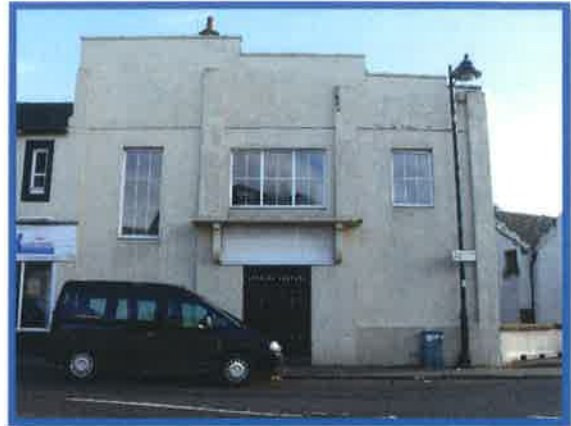
1 High Main Street  
Dalmellington

**The building appears to be in reasonably good condition although the elevation abutting the Muck Water is partly obscured by vegetation. There is cracking to the render on the SE elevation where the building abuts a bridge parapet.**

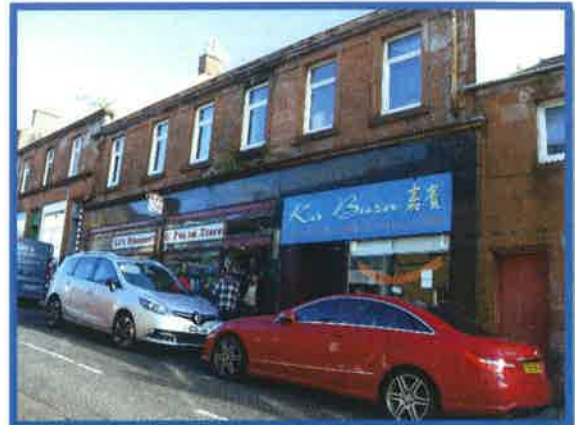
**Poor to fair condition. Damage to cornicing and gutter above 4<sup>th</sup> window causing water damage and discolour to window surround and sill. Moss and vegetation also growing from cornicing below this window. Gutter and downpipes badly rusted.**

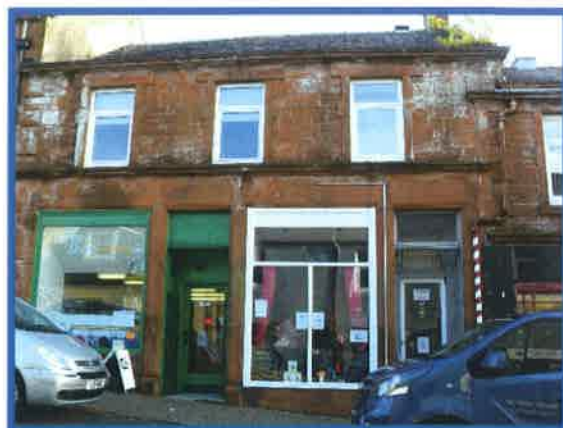
**Poor to fair condition. Staining of masonry above shopfront. Considerable weathering damage to sandstone on first floor. Plants growing from right hand side of roof.**

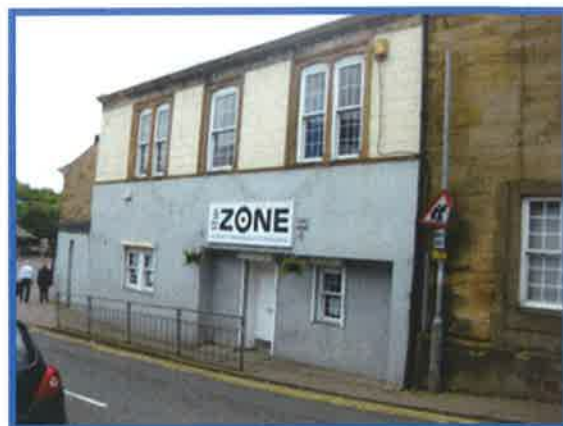
**Good condition, although the 2 contrasting styles of exteriors on ground and first floor have a detrimental effect on the visual amenity of the conservation area.**

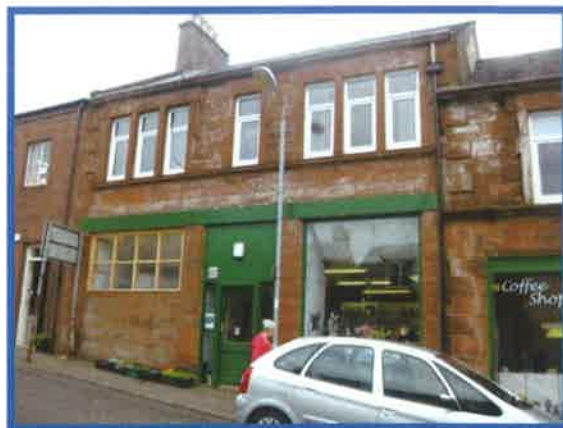
**Fair condition. Stonework has in places been re-pointed with a cementitious mortar. This is potentially damaging to historic masonry and its replacement with a lime-based mortar should be considered.**

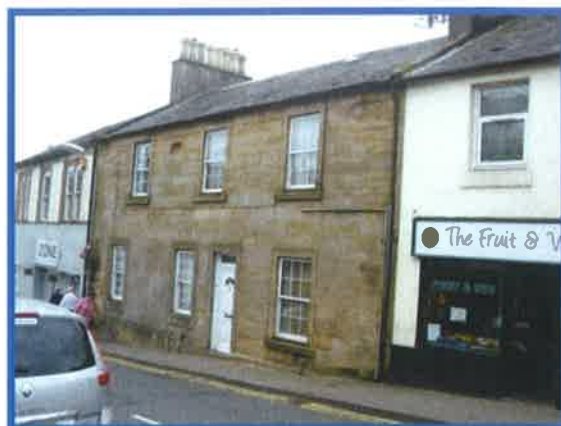
**Fair condition. Section of downpipe missing to left of property causing substantial damage to sandstone to bottom left front elevation. Damaged plinth. Stained and cracked.**

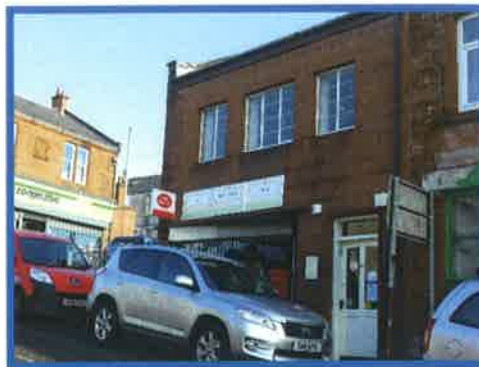
**Fair condition with some damage to the stonework so that the reinforcement is exposed beneath. Thus may require future replacement or repair. The first floor windows may benefit from attention but should be retained.**

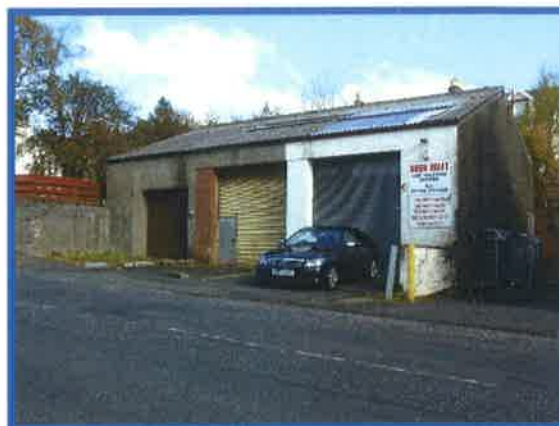
Dalmellington

**Fair condition. New part of corrugated steel roof on 3<sup>rd</sup> bay. The garage would aesthetically benefit from fresh paintwork all over.**

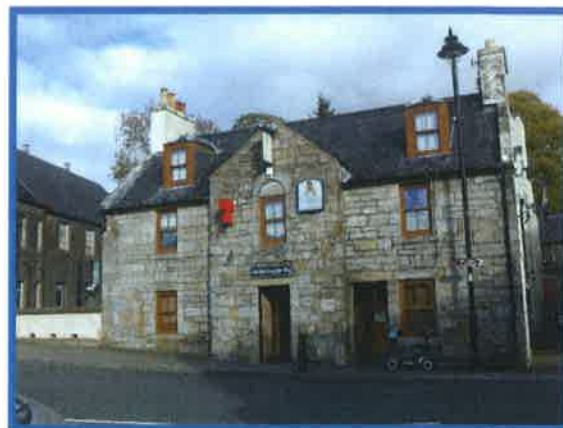
**Good condition. Effects of weathering can be seen on right hand side chimney stack - Would benefit from a fresh coat of paint, as would the top of the 2 gable ends.**

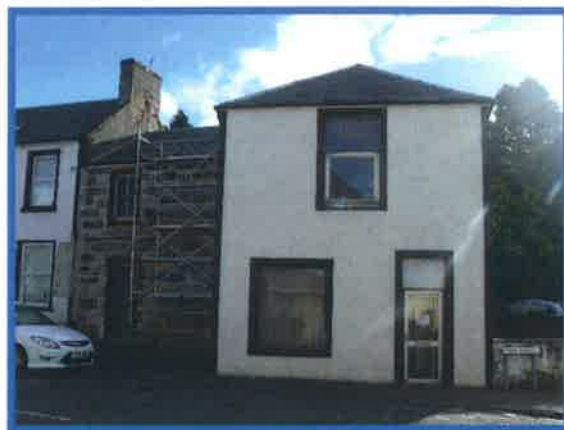
**Guttering appears to be faulty and is causing the render to become damp and fall away. Windows have been replaced and renovation work is being carried out to the building.**

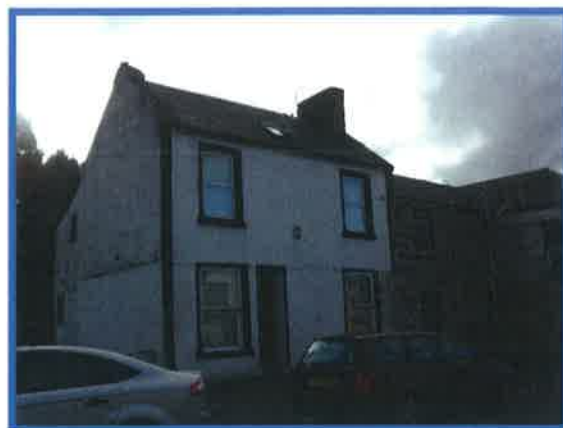
**Good condition. Discolouring of paint on gable end. Render has been patched to right hand side of ground floor window and not ben re-painted.**

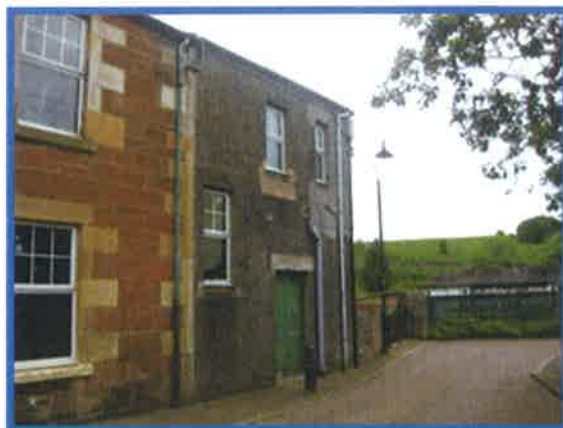
**Cracked, patched and missing render to front elevation.**

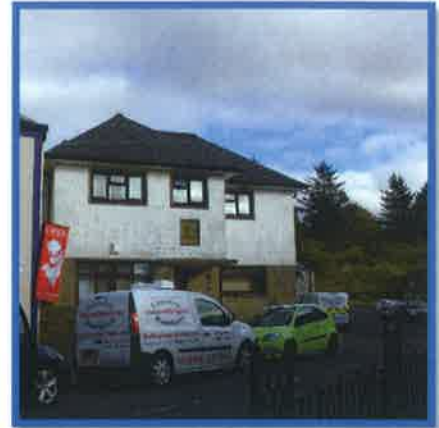
**Good condition, however stone window surround on left ground floor is missing on either side of the window. Paint work is flaking and a little discoloured. Damaged downpipe on right elevation causing water damage to stone facing.**

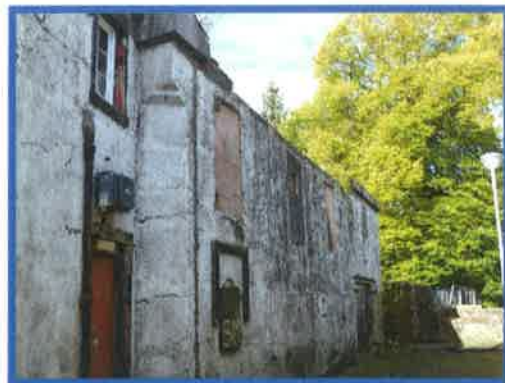
**Very poor. Eastern range of the building is roofless. The adjoining western range is intact, but in a neglected state with faulty rainwater goods, damp masonry and decaying window frames. Moderate risk category on Buildings at Risk Register.**

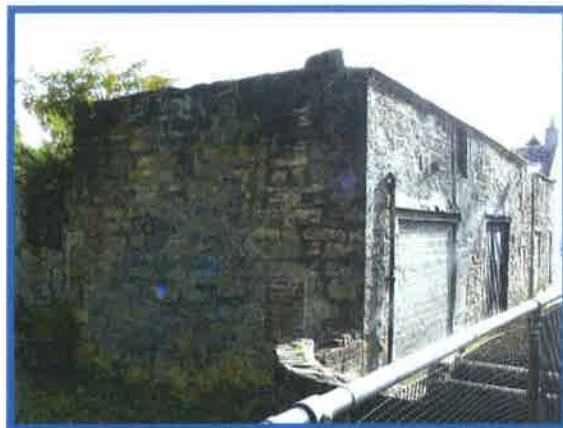
**Extremely poor condition. Building is a derelict shell. High risk category on Buildings at Risk Register.**

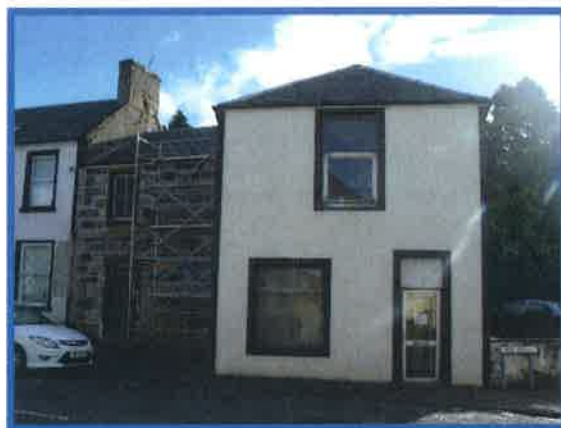
Ye Old House  
5 High Street  
Dalmellington

**Fairly poor condition. Side elevation has 2 smashed windows. External render quite badly damaged. Paintwork has been started and not completed. Renovation work is being carried out to the building.**

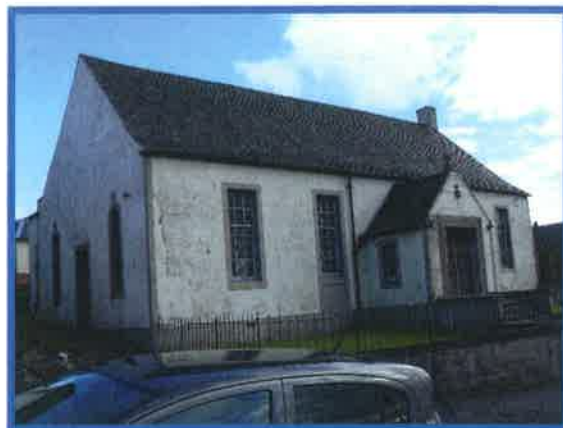
1 Knowehead  
Dalmellington

**Good condition. Some cracking of render and flaking of paintwork. Considerable amount of discolouring of paintwork to front of porch. Wooden doors on porch seem pretty weathered. Damaged eaves and slate on porch.**

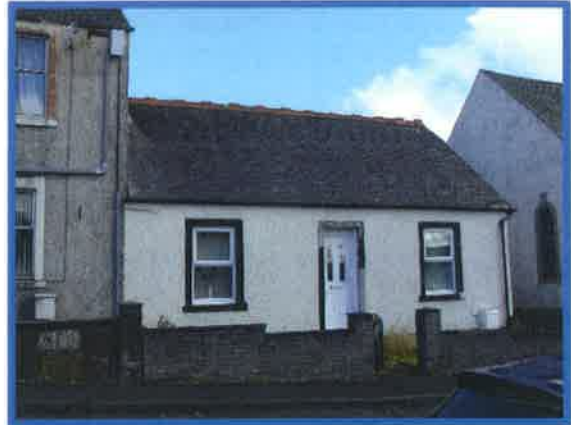
3 Knowehead  
Dalmellington

**Good condition. Damaged slate just above downpipe.**

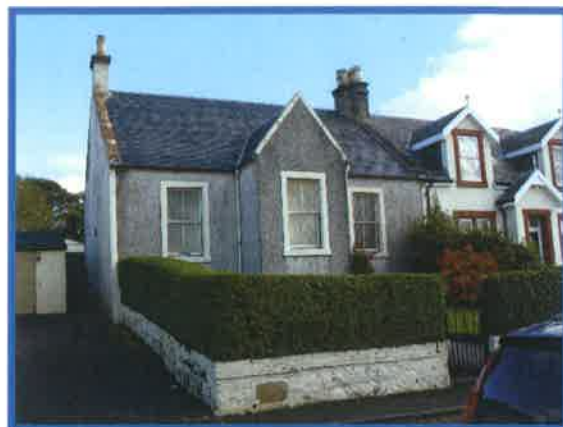
**Good condition. Effects of weathering can be seen to red stone on top of gable end. Paint slightly peeling on chimney stack.**

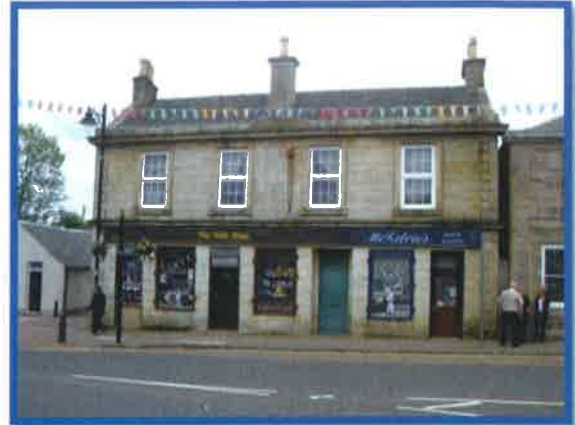
**Good condition. Minor damage to stonework, particularly on cornice.**

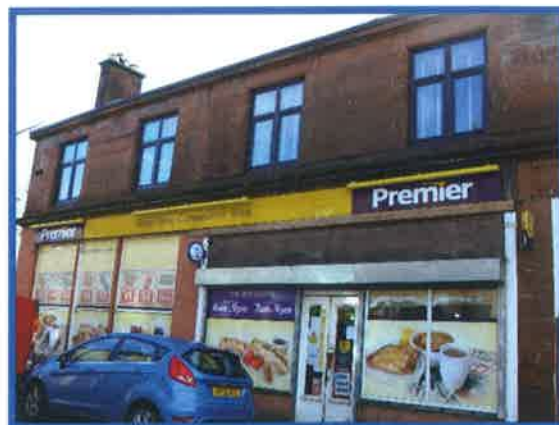
**Fair condition. Some damage to sandstone on first floor level. Discolouration of cornice with moss growing on it. Discoloured stallriser on shopfront.**

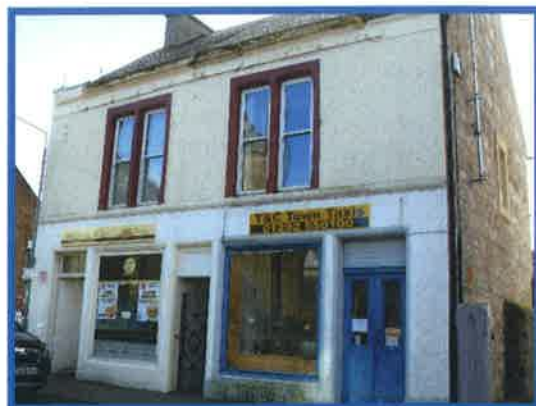
**Fair condition. Ground floor and First floor are painted in different colours which results in a un uniform appearance. Soffit board very discoloured with paint peeling. Parts of soffit also look damaged.**

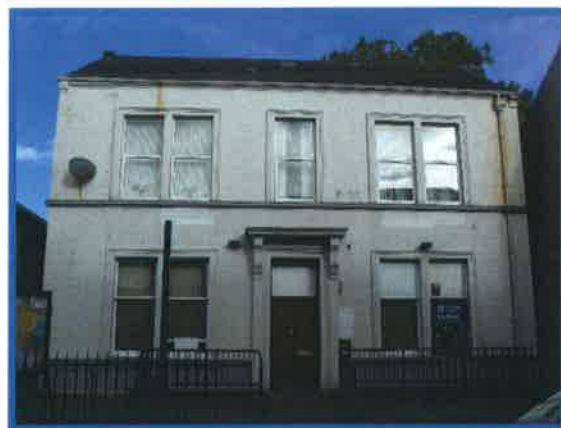
**Good condition. Downpipe slightly leaking causing discolouring to external paintwork.**

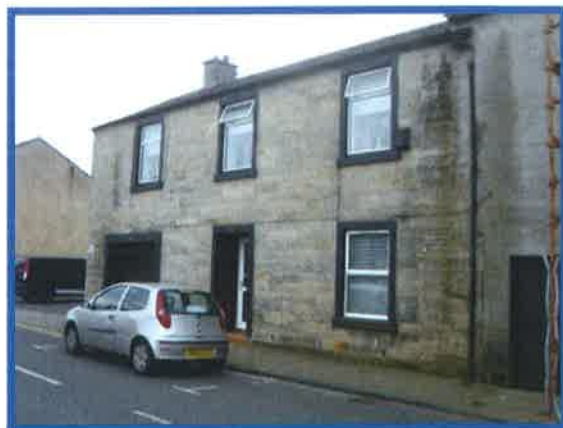
**Fair condition. Moss growing round bottom of property and a significant amount of water damage down right hand side of front elevation.**

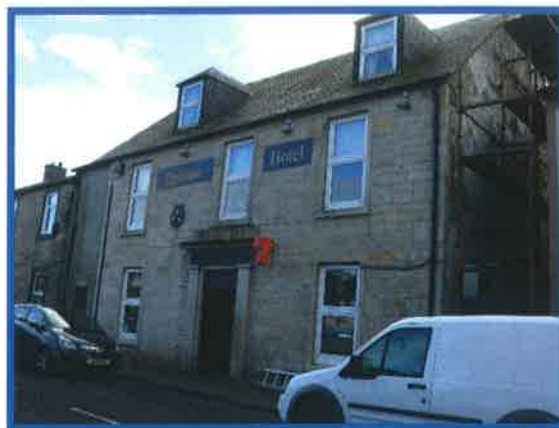
**Fair condition. Scaffolding up and work being carried out to gable end. Stone ledge above door quite badly discoloured.**

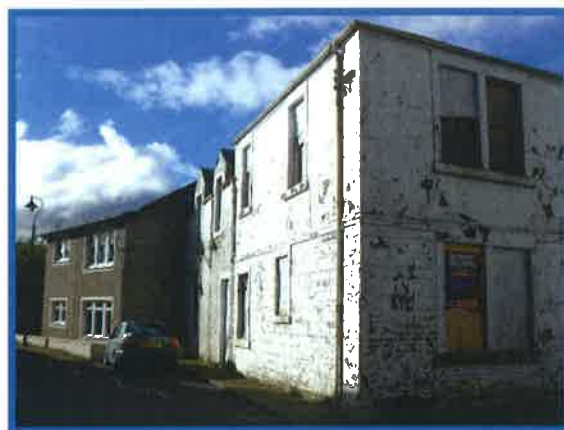
1 New Street  
Dalmellington

**Poor condition. General deterioration of the paint finishes and poor replacement window boarding, some of which is damaged, giving the building a poor cosmetic appearance. Some damage to external render, leaving brickwork exposed. Damaged downpipes. Low risk category on Buildings at Risk Register.**

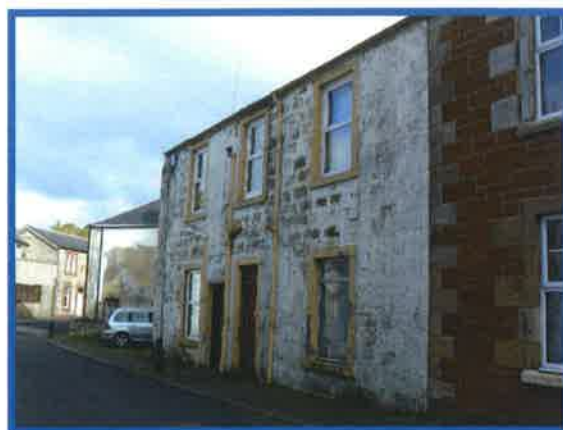
**Poor condition. External paintwork in extremely poor condition. Paintwork on window and door surrounds is flaking. Damaged downpipe to left of centre bay. Bottom of property extremely discoloured and dirty looking. The foregoing factors contribute to the building, in its present condition, having a detrimental visual effect on the conservation area.**

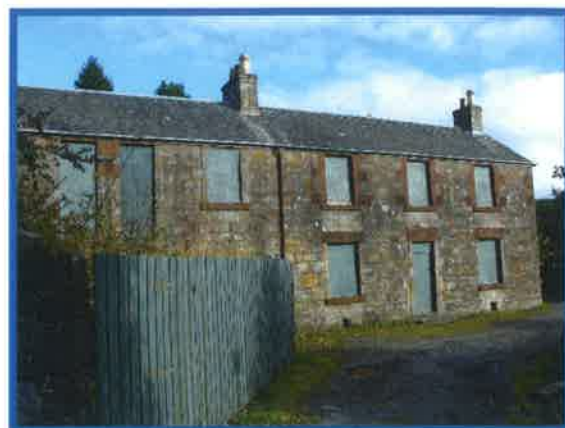
4-8 The Path  
Dalmellington

**Fair condition. The terrace is boarded-up and secure, although the rear of the buildings is not secure due to several broken windows. The roof appears sound, although some slates and gutters are loose or missing. The retaining wall for the garden and access stairs of No. 4 is severely cracked and possibly unstable. Moderate category of risk on Buildings at Risk Register.**

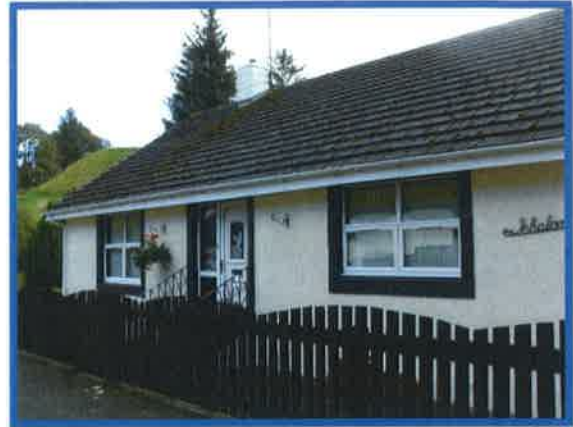
18 The Path  
Dalmellington

**Good condition. Some moss growing on roof.**

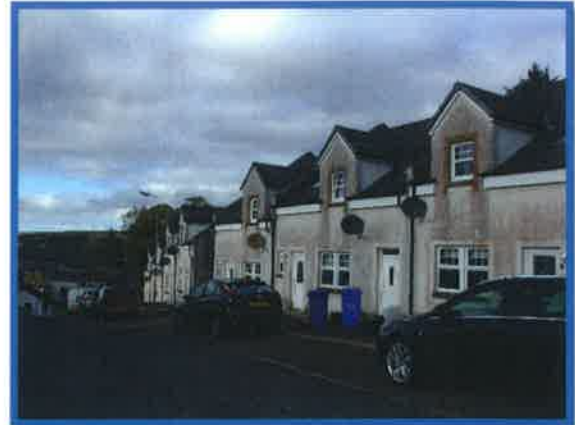
**Good condition. Weathering has decoloured the external render on the properties.**

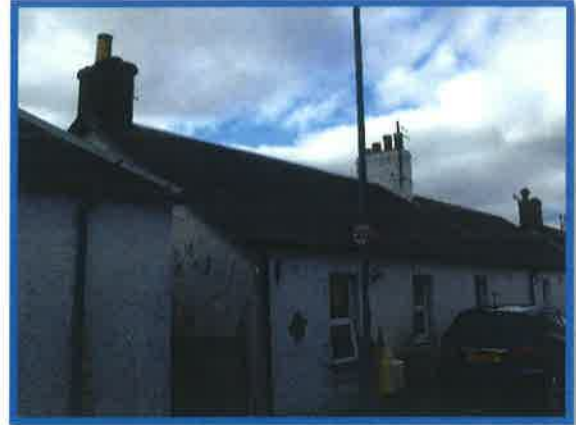
31 Townhead  
Dalmellington

**Fairly poor condition. Paintwork peeling quite bad on front elevation and gable end. Bad water and rust damage below overflow pipe on front elevation.**

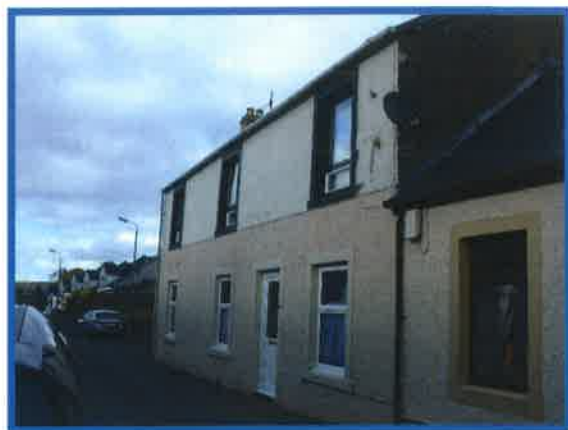
**Good condition. Slight cracking to render to right of first floor window.**

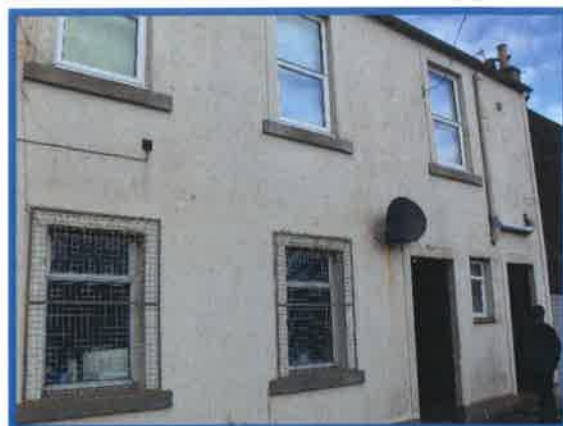
**Fair condition. Some cracking to external paint render on 1<sup>st</sup> bay. Discolouring to paintwork below satellite dish. Small part of downpipe missing at the top.**

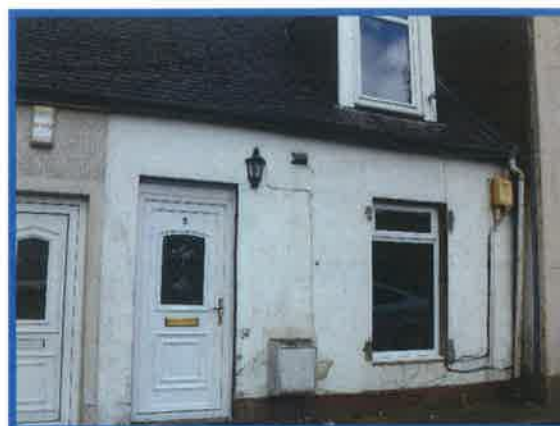
**Fairly poor condition. Bad cracking and peeling of paintwork render. Discoloured render barding, downpipe, external gas box and alarm box. Requires maintenance.**

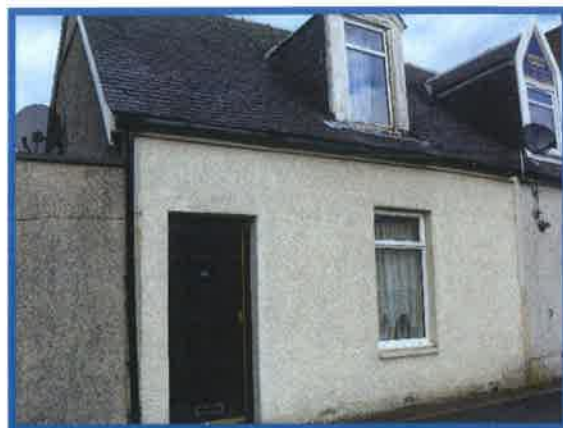
**Fair condition. Front of dormer in poor condition. Wood needs replaced, and may benefit from replacement window.**

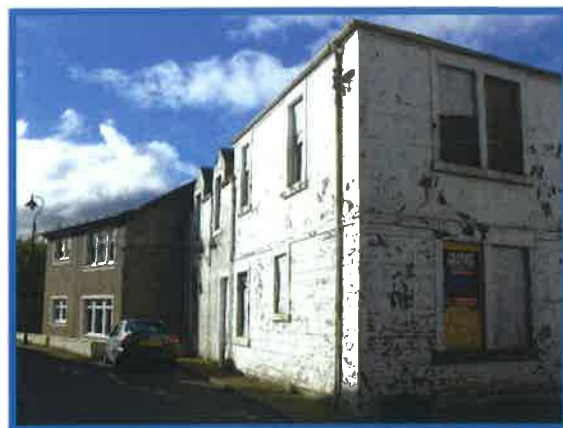
**Poor condition. General deterioration of the paint finishes and poor replacement window boarding, some of which is damaged, giving the building a poor cosmetic appearance. Some damage to external render, leaving brickwork exposed. Damaged downpipes. Low risk category on Buildings at Risk Register.**

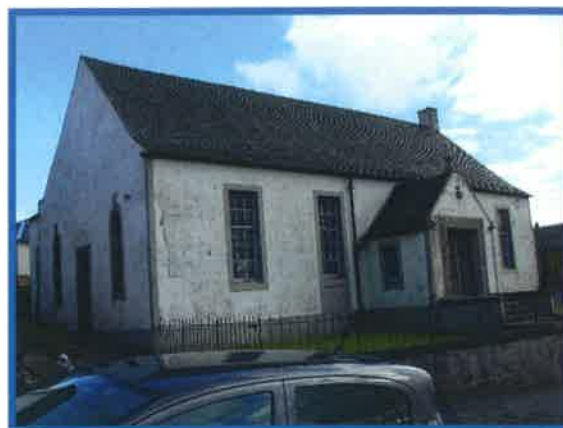
**Good condition. Some cracking of render and flaking of paintwork. Considerable amount of discolouring of paintwork to front of porch. Wooden doors on porch seem pretty weathered. Damaged eaves and slate on porch.**

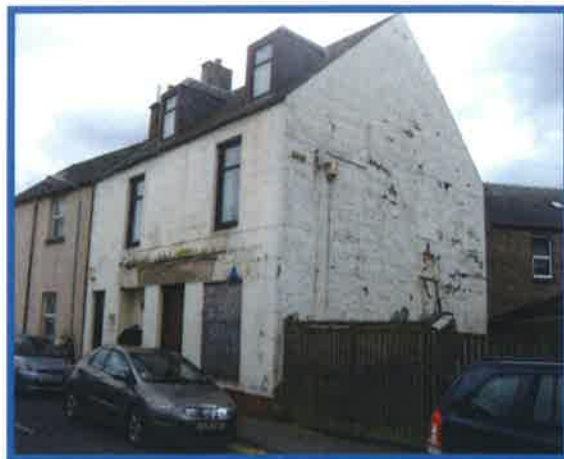
**Fairly poor condition. Ground floor window boarded up. External paintwork on gable flaking. Damage to paintwork where previous shop fascia signage has been.**

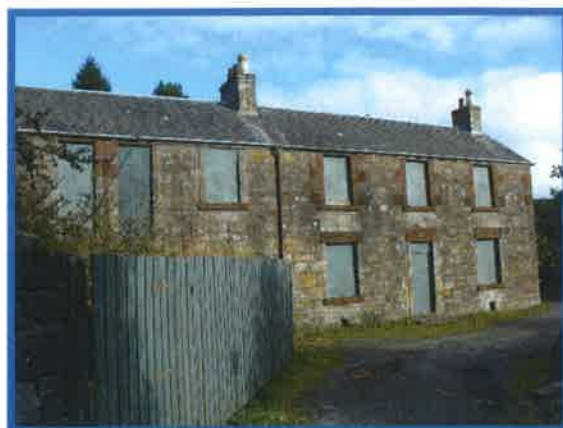
**Fair condition. The terrace is boarded-up and secure, although the rear of the buildings is not secure due to several broken windows. The roof appears sound, although some slates and gutters are loose or missing. The retaining wall for the garden and access stairs of No. 4 is severely cracked and possibly unstable. Moderate category of risk on Buildings at Risk Register.**

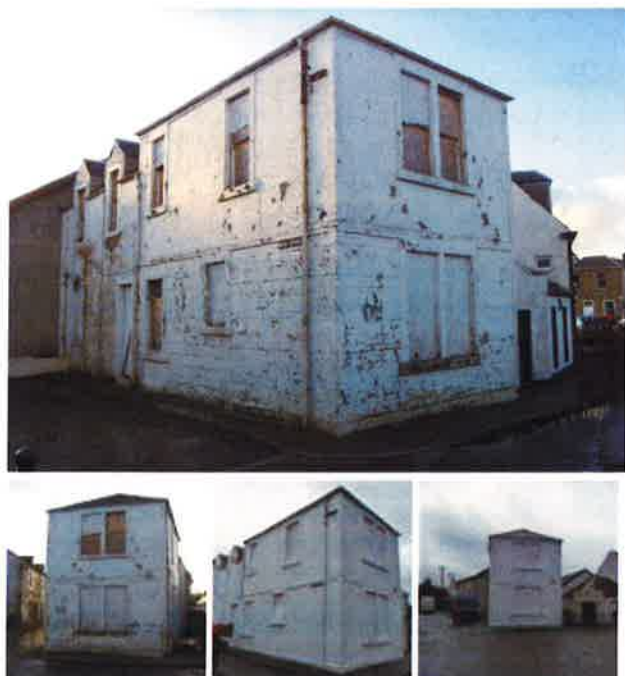
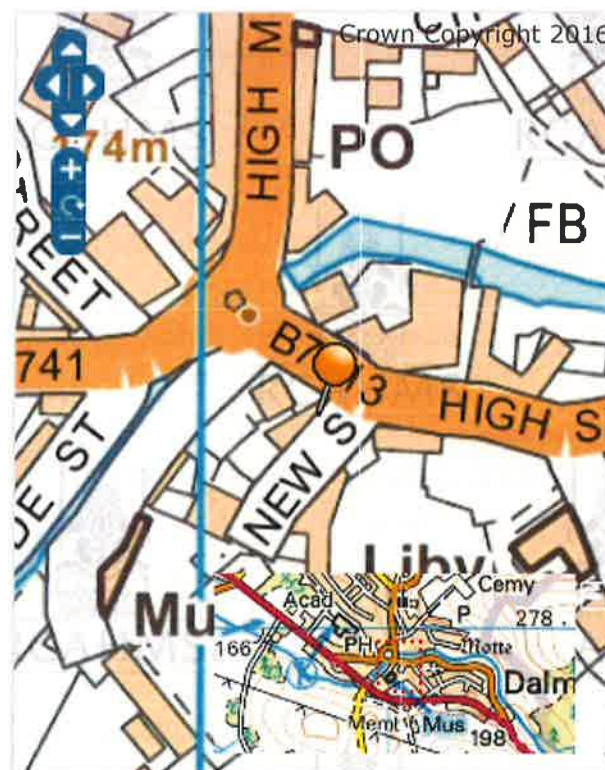
# 1, New Street, Dalmellington

February 2010: External inspection reveals that the building is vacant with windows boarded over. Overall the building appears to be in good condition.

19 March 2015: External inspection finds there has been general deterioration of the paint finishes and poor replacement window boarding giving the building a poor domestic appearance. However, the building appears to remain in fair condition underneath. The site remains disused. Full Planning Permission for change of use from office to residential was conditionally approved May 2012 ref: 12/0078/PP.

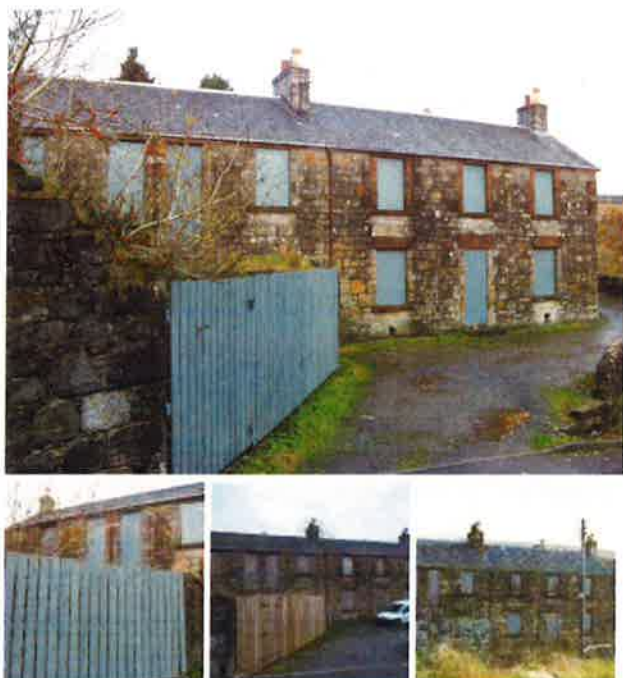
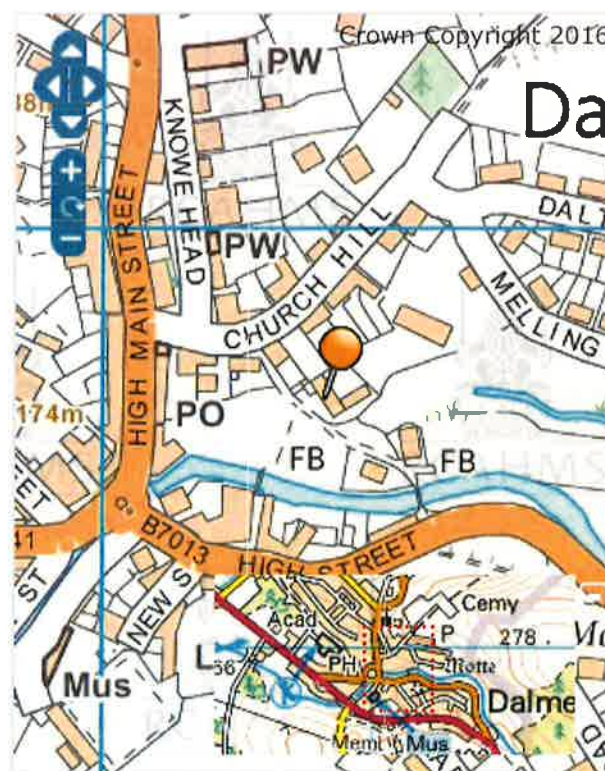
## 4-8, The Path, Dalmellington

September 1993: Cumnock and Doon Valley Council move the properties from their Vacant Buildings Register to their Buildings at Risk Register. The terrace is described as boarded-up and secure, although the rear of the buildings is not as secure due to several broken windows. The roof appears sound, although some slates and gutters are loose or missing. The retaining wall for the garden and access stairs of No. 4 is described as severely cracked and possibly unstable. The owner is reported to be considered converting the 3 properties into 1 or 2 dwellings, although he has not as yet responded to requests for a meeting with local planners. January 1995: Local planners report that the owner has been requested to regularly maintain the properties in order to halt their deterioration. July 1995: SCT understands that the owner has complied with this request and has undertaken repairs, as well as undertaking repairs under his own instigation. January 1996: Local planners report that minor repair works are continuing. 1997: An extensive study of opportunities for renovation has been compiled, although it concludes that renovation is not viable at this time through lack of grant aid. December 1998: SCT receives intimation that the properties have been identified as possible candidates for the Empty Homes Initiative. January 2000: Local planners are unaware of any change. November 2002: An on-site inspection is carried out by the owner and local planners.

February 2010: External inspection suggests that there is little change in the condition of the building since the last visit by SCT.

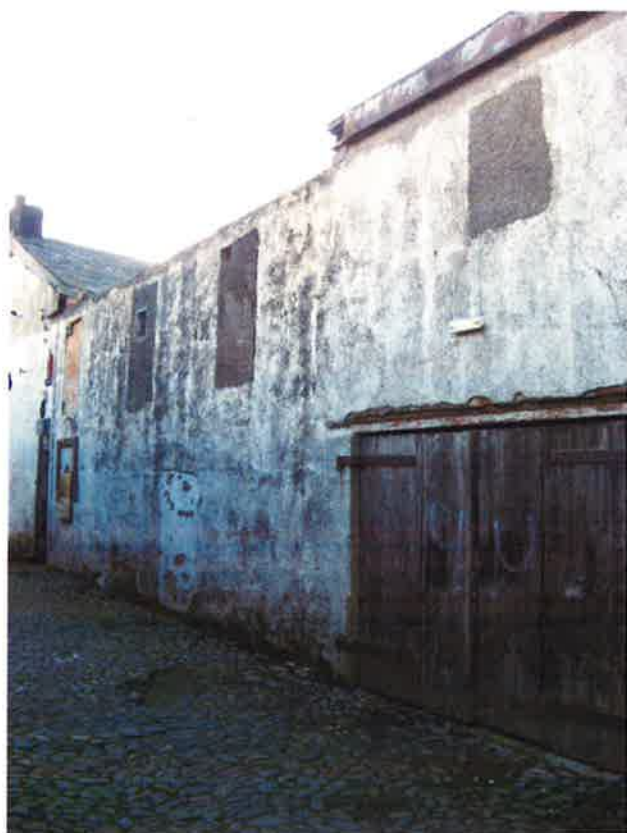
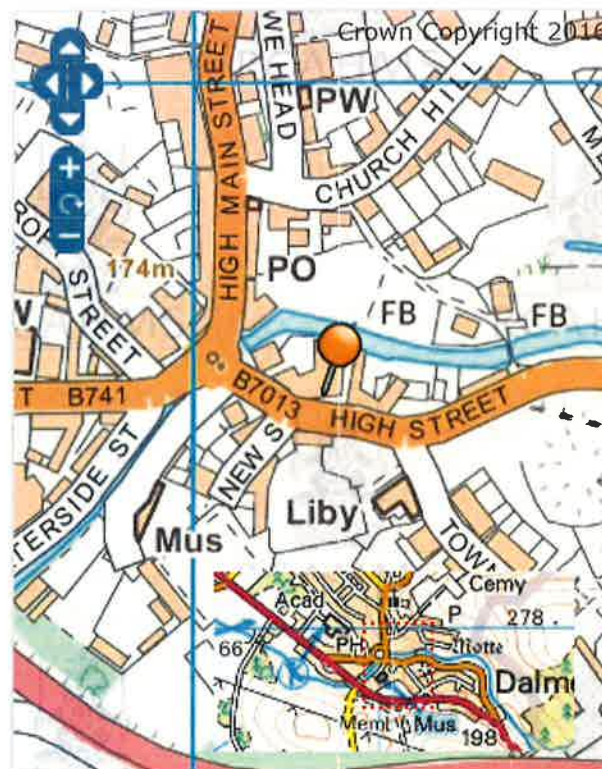
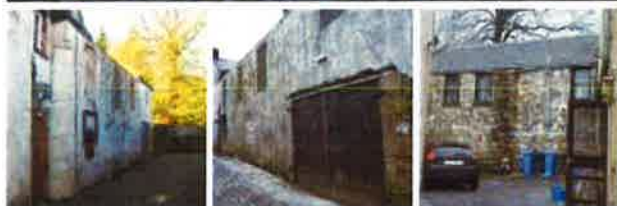
## Building to rear of The Loch Doon, 18, High Street, Dalmellington

February 2010: External inspection reveals the eastern range of the building is roofless. The adjoining western range is intact, but in a neglected state with faulty rainwater goods, damp masonry and decaying window frames.

28 October 2014: External inspection finds the building remains in much the same condition as seen previously.
