EAST AYRSHIRE COUNCIL

# **Local Development Plan 2**

## Dalmellington Conservation Area Appraisal

Non-statutory Planning Guidance

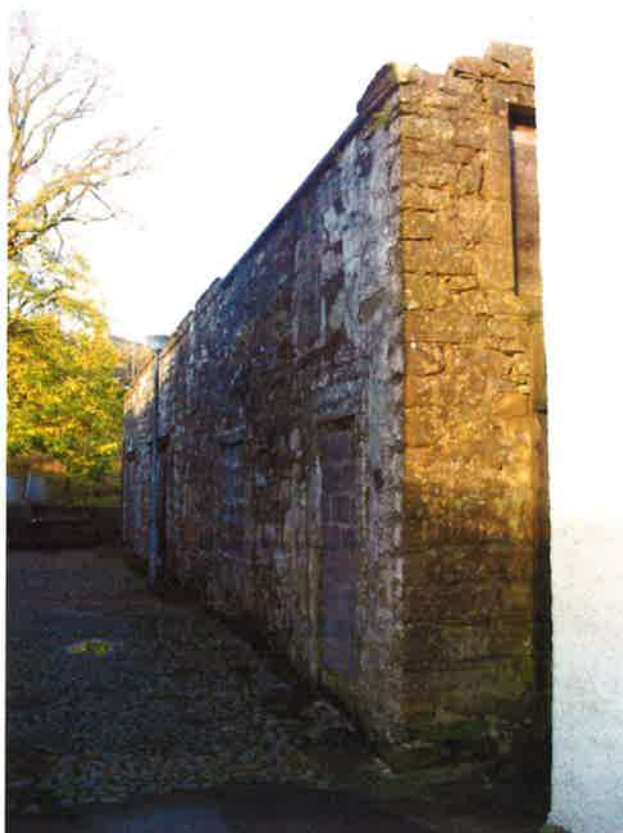
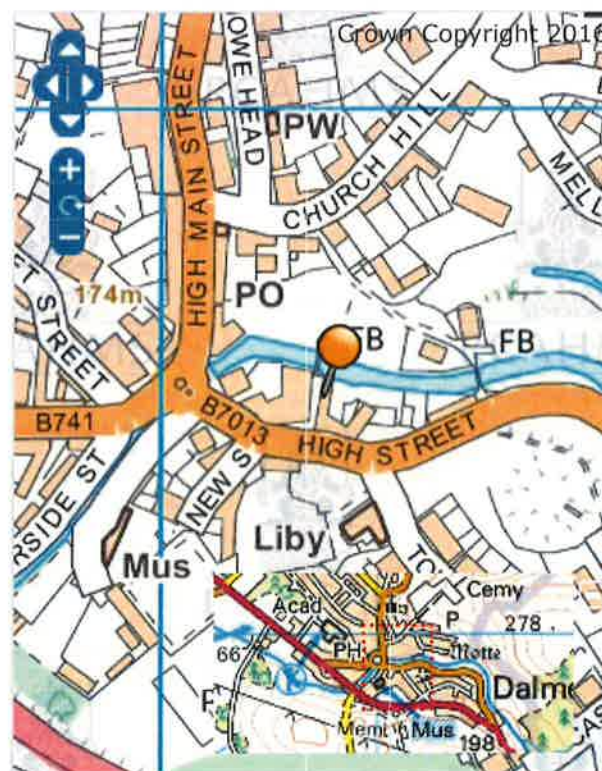
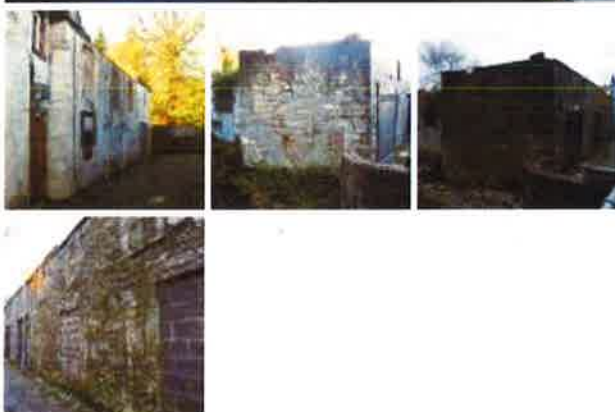
## Building to rear, 28, High Street, Dalmellington

28 October 2014: External inspection finds the northern doorways have been blocked up, otherwise the building remains in much the same condition as seen previously.

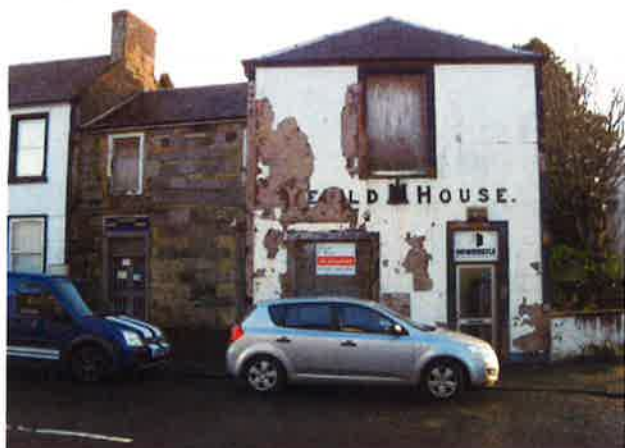
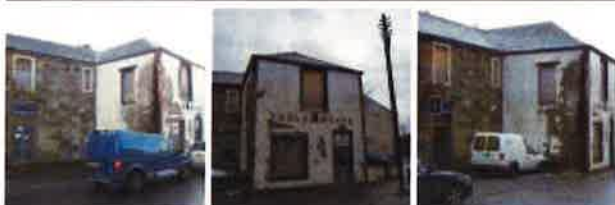
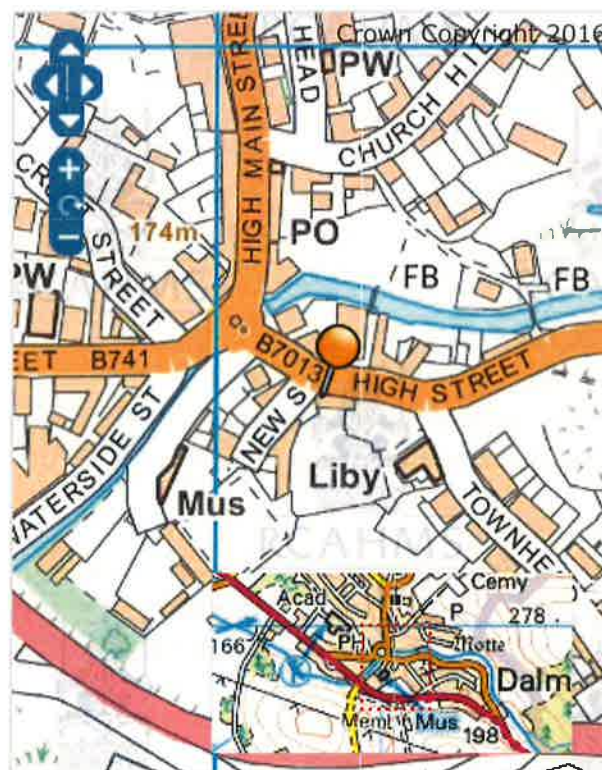
## Ye Olde House, 5, High Street, Dalmellington

28 October 2014: External inspection finds the building remains in much the same condition as seen previously. A marketing board is affixed advertising the site for sale through agent Kevin Oliver.

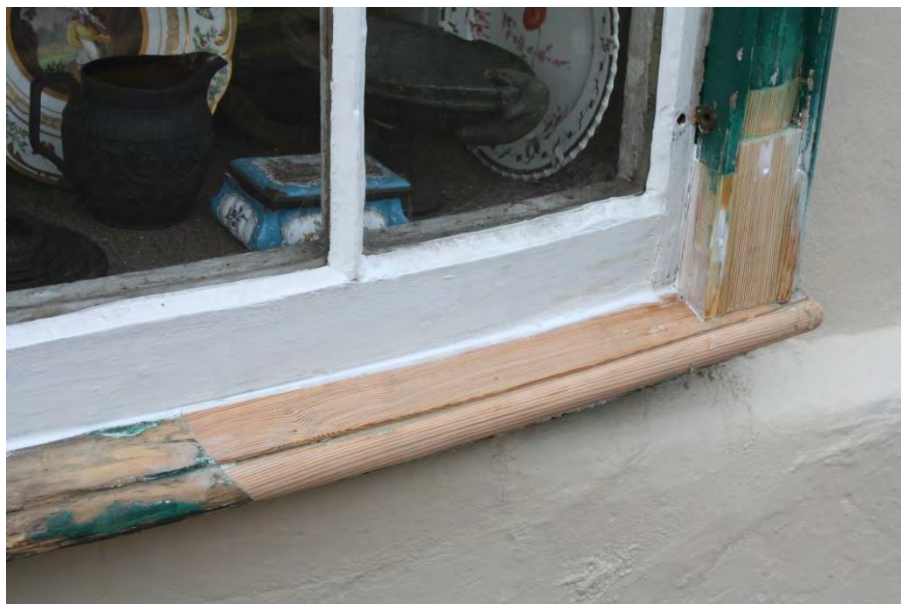
An example of minimal intervention and honest repairs to an eighteenth century shop window. The minimum amount of material has been replaced with timber of a suitable match. The new timber is not aged in any way but will blend in successfully once painted.

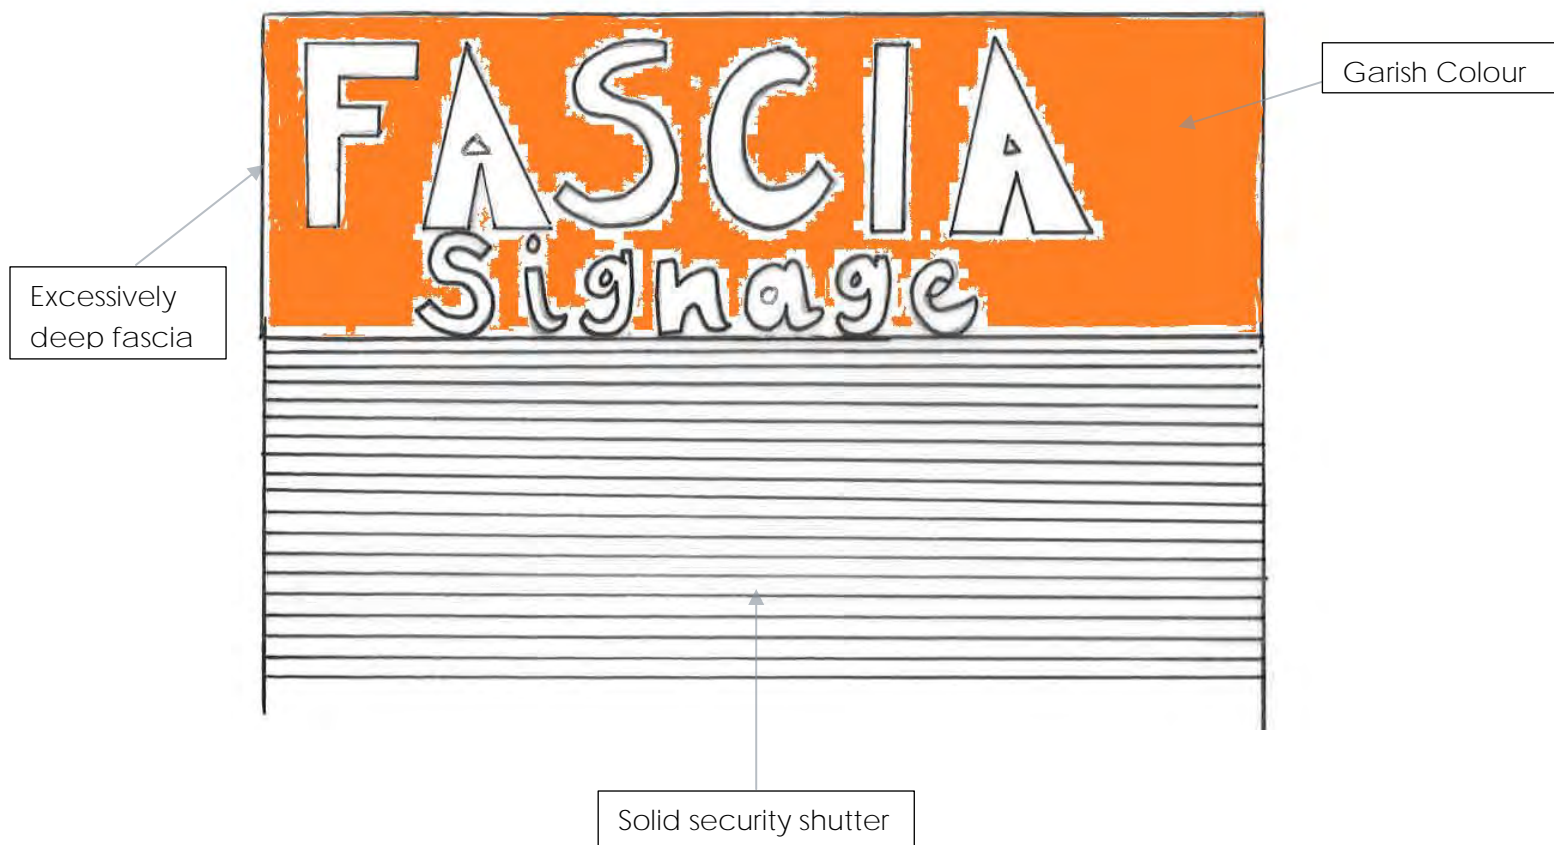
The picture below shows inappropriate use of colour for fascia signage, as well as the fascia being excessively deep. These two attributes coupled with steel security roller shutters make for a bad example of a shopfront.

Solid security roller shutters like the example above are discouraged. They have a detrimental effect upon the character and amenity of an area.

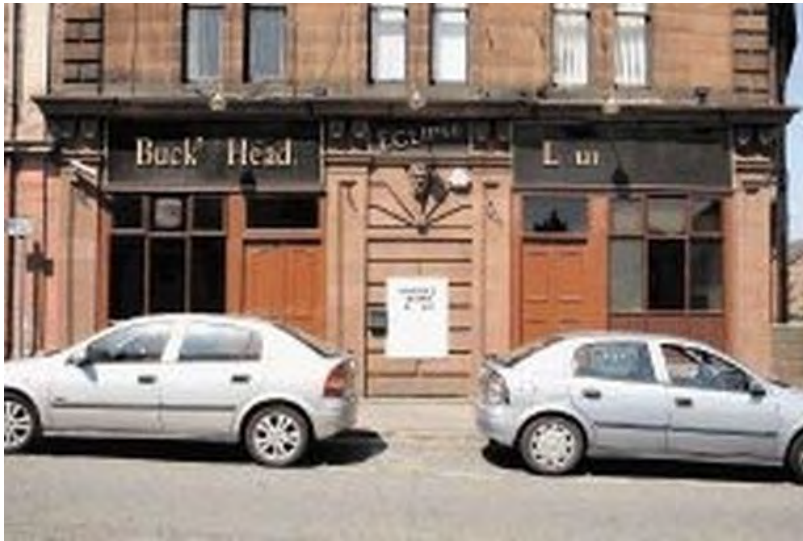
(Below)- Bucks Head pub in Galston before the new shopfront was designed and fitted. Note the deep fascia boards, letters on signage have fallen off over the years and that have not been replaced. The building itself had suffered from long-term neglect and was poorly maintained. Generally, it is not very inviting for customers, passers-by and potential new customers.

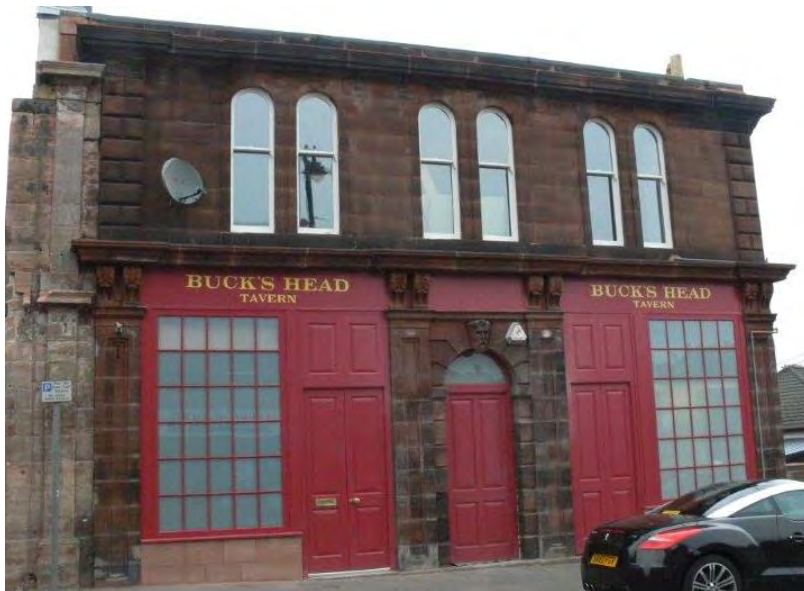
(Below) – Newly fitted shop frontage carried out under the Galston CARS (Conservation Area Regeneration Scheme) The developers have replicated the original design as seen in the above archived photo. The result is a sympathetic shopfront which compliments

the entire building. Good quality materials have been used, traditional sign-written lettering, subdivided windows have been fitted which are in keeping with the character of the building, and a new door has been fitted in the centre of the building which contributes to the visual amenity of the building and again in keeping with original design. The colour also compliments the building and this results in a visual improvement of the building in contrast to what the front of the building was like before renovation.

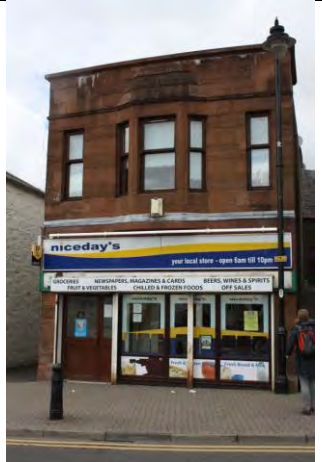
**Condition:**

Fair condition.

Address	Owner/ Occupier	Trading As	Use	Recommendations	Photo
1 Main Street	Aftab Malik	Nice Days supermarket	Supermarket	<ul style="list-style-type: none"> <li>Remove roller shutter doors and replace with more sympathetic style of security shutter;</li> <li>Replace plastic fascia sign with timber fascia board with hand-painted lettering;</li> <li>Improve visibility into shop and display opportunities;</li> <li>Repoint stonework with lime-based mortar as required;</li> <li>Consider whether illumination is necessary on signage;</li> <li>Long-term consider more sympathetic style of shopfront in timber with central entrance door.</li> </ul>

- Remove roller shutter doors and replace with more sympathetic style of security shutter;
- Replace plastic fascia sign with timber fascia board with hand-painted lettering;
- Improve visibility into shop and display opportunities;
- Repoint stonework with lime-based mortar as required;
- Consider whether illumination is necessary on signage;
- Long-term consider more sympathetic style of shopfront in timber with central entrance door.

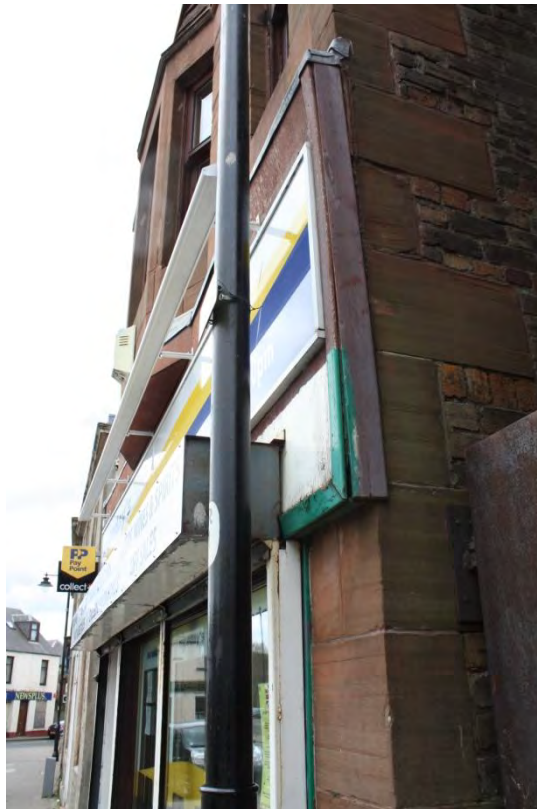
1 Main Street  
Roller shutter and signage

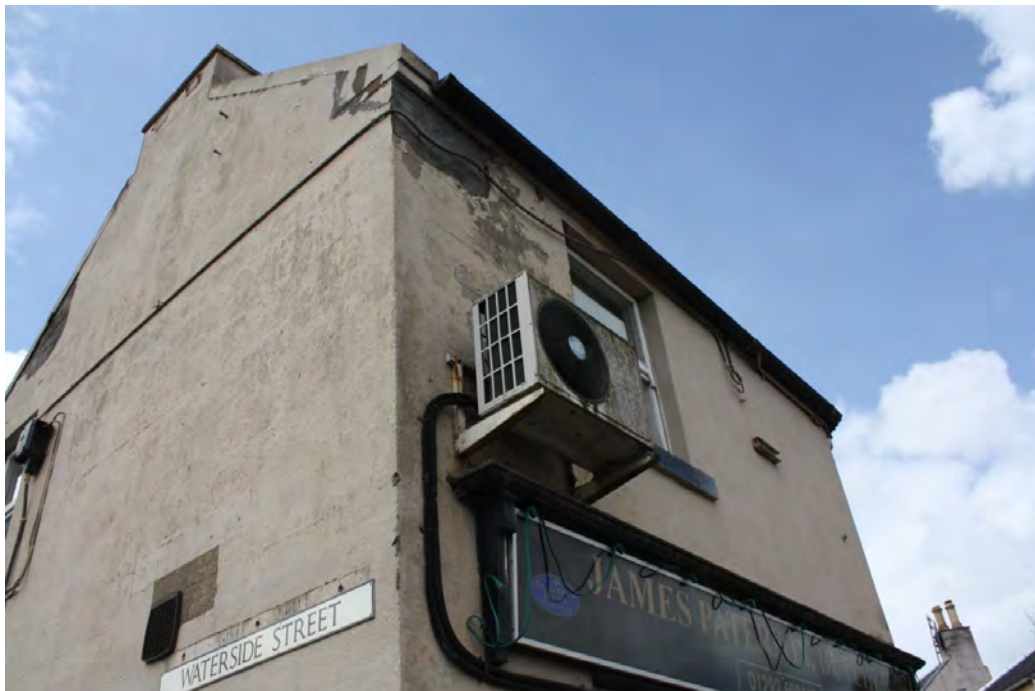
2 Main Street  
Externally mounted fans

- Small repairs as required to timberwork;
- Reposition extractor fans to less obtrusive location;
- Remove modern sign and use sign written lettering on the existing signboard;
- Consider whether a hanging sign would be beneficial;
- Paint timberwork and associated stonework of shopfront;
- Ensure glazed brick interior is retained.

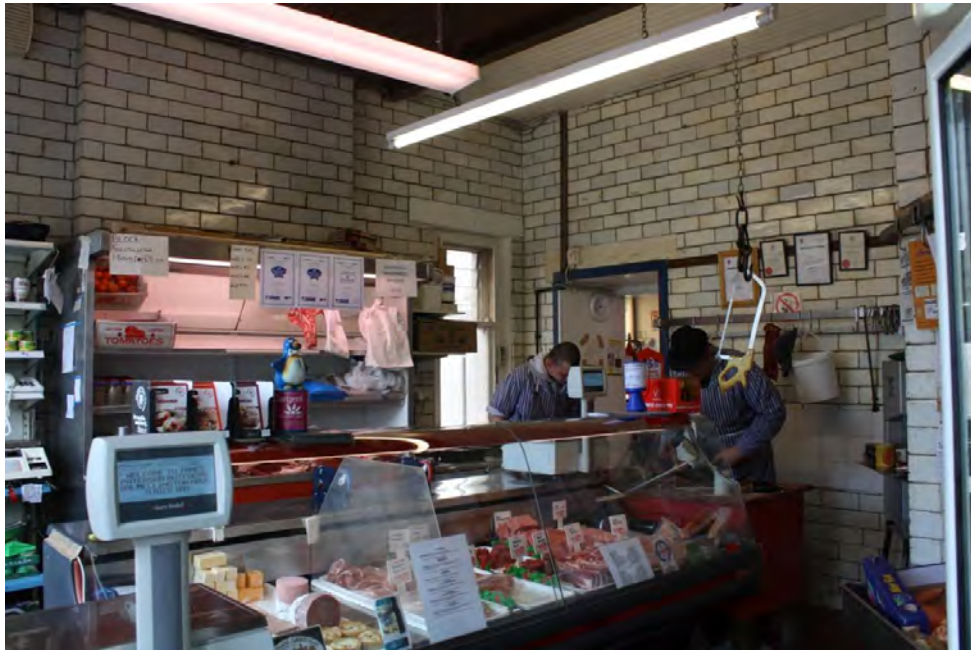
2 Main Street  
Interior showing glazed bricks

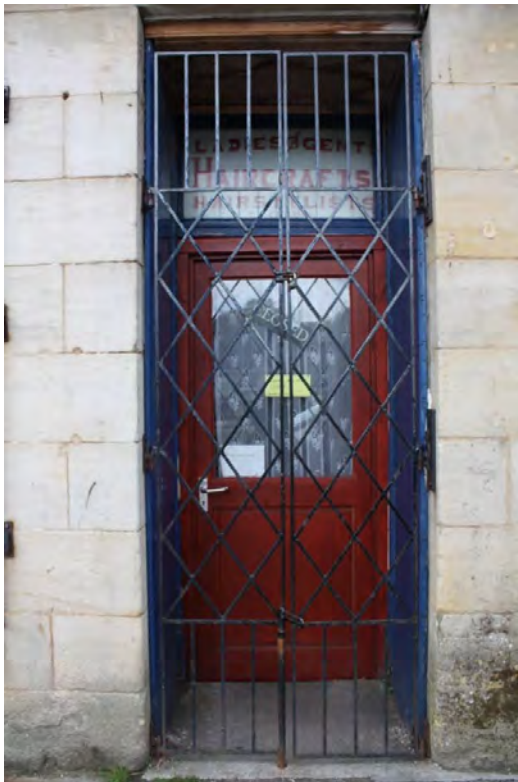
Entrance to Number 7 with iron grille

- Retain existing signage;
- Consider replacement of iron shutters with ones which are more easily removed;
- Consider a smaller shop gate which matches number 11;

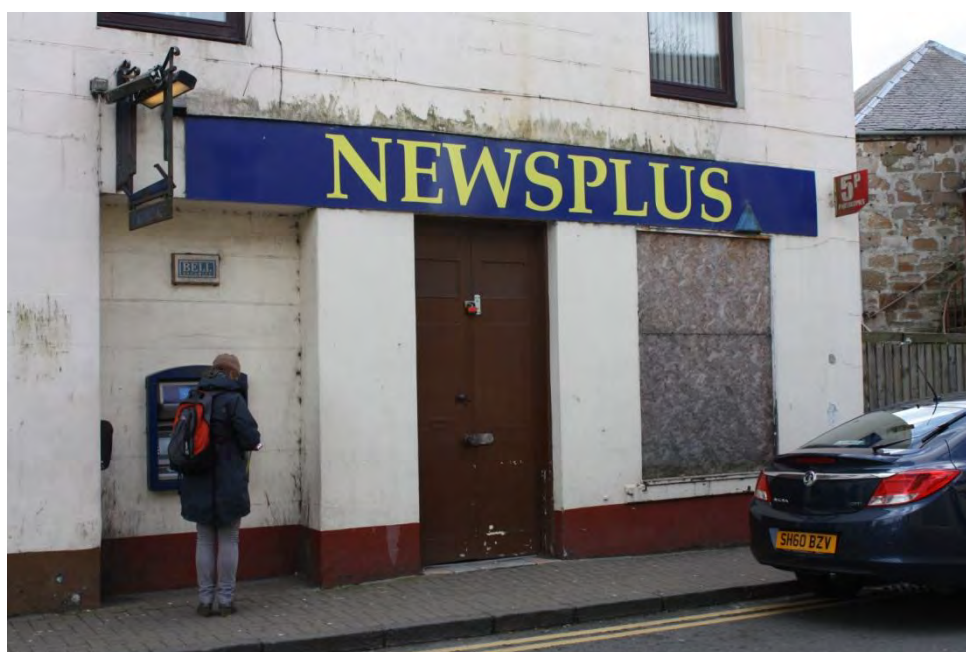
8 Main Street  
Shopfront

Fair to poor. Empty properties can quickly deteriorate.

- Improving the appearance by having an alternative to the boarded up window such as an image;
- Remove old signage and replace with a timber board ready for a new occupant;

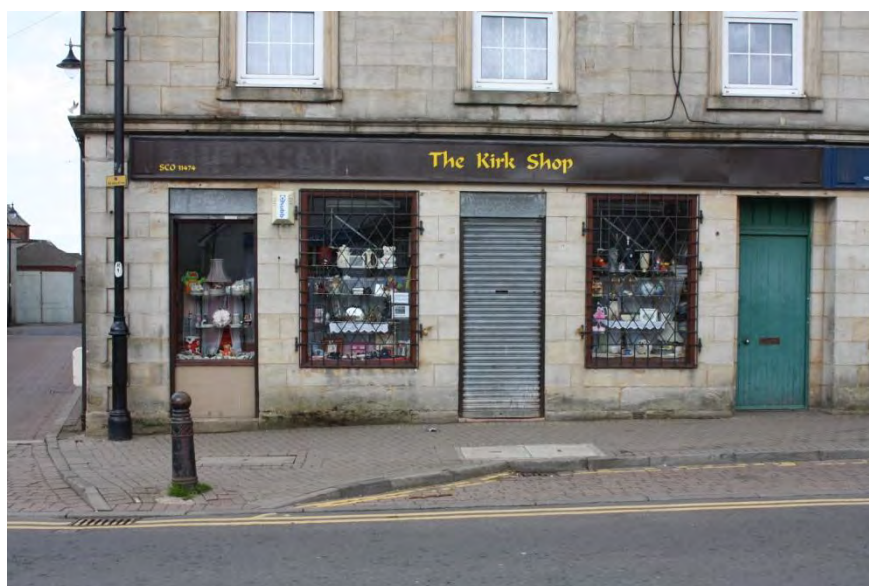
11 Main Street  
Shopfront

Originally two shops now combined and used as one. Door to original left-hand shop is now a window. Modern plastic fascia sign with illumination above. Timber double entrance doors. Windows are largely covered with advertising displays. Metal roller shutter. Timber pilasters but console brackets above are missing.

Fair condition

- Replace modern sign with timber fascia board and hand-painted lettering;
- Improve visibility into the shop;
- Reconsider necessity for illumination on fascia;
- Consider requirement for roller shutter and whether a more sympathetic alternative is available;
- Undertake repairs to pilasters and reinstate console brackets;
- Reinstall window height of right-hand shop so it matches left-hand shop;
- Consider better design for close gate to right side of shop.

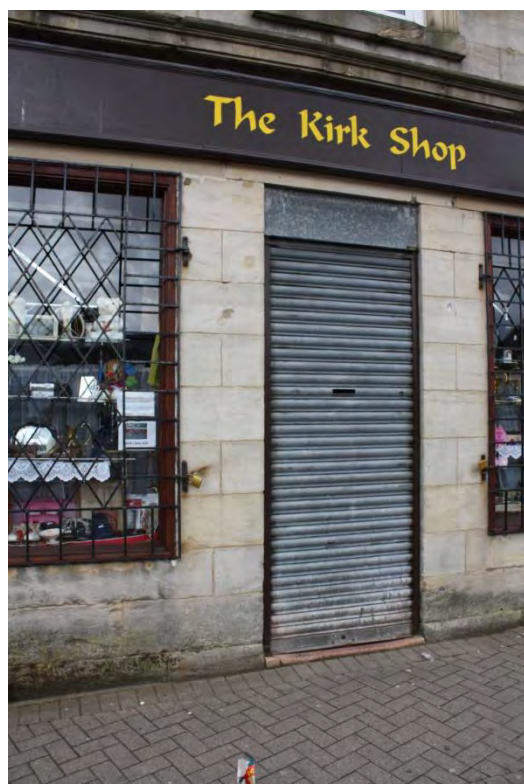
Roller shutter to entrance  
11 Main Street

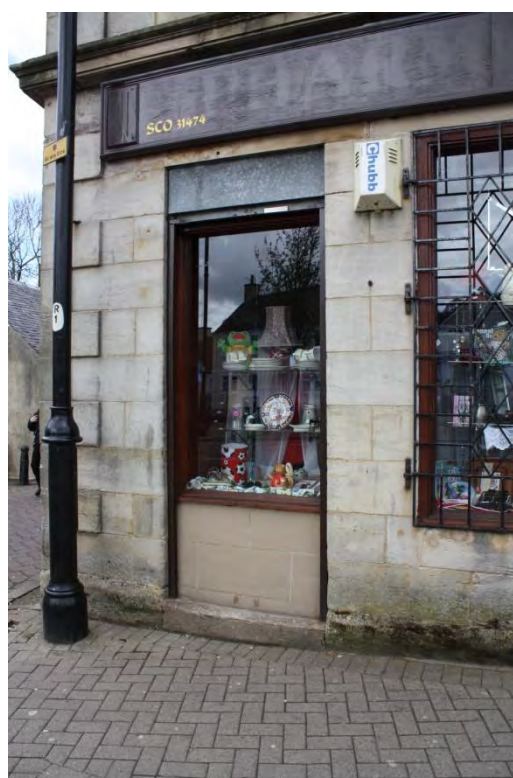
Former door now altered to form window  
11 Main Street

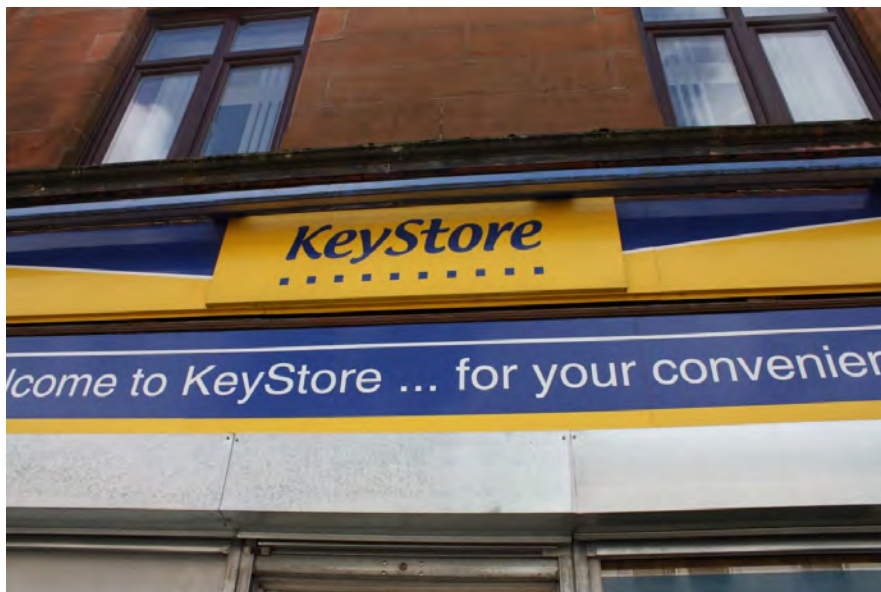
14 Main Street  
Modern fascia sign with illumination above

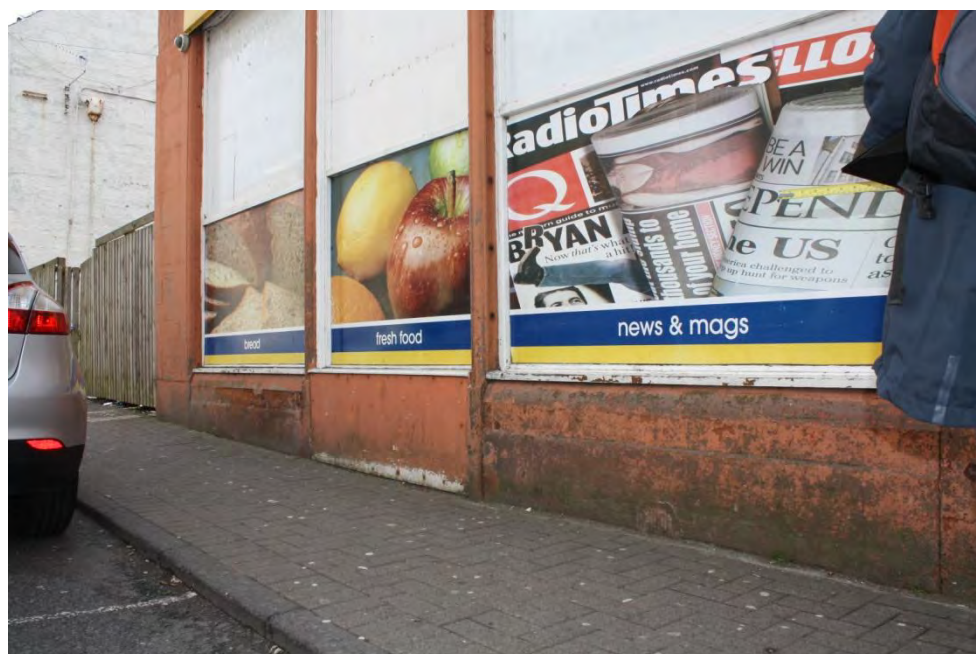
14 Main Street  
Window detail

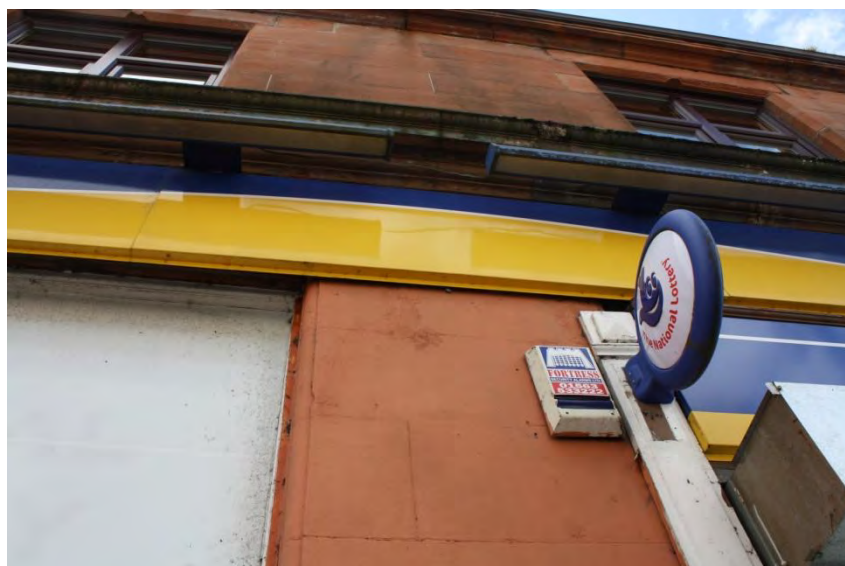
14 Main Street  
Projecting sign

- Remove existing sign and use string course for hand-painted signage;
- Long-term consider replacement of uPVC window and door with traditional timber alternatives in appropriate style for building.

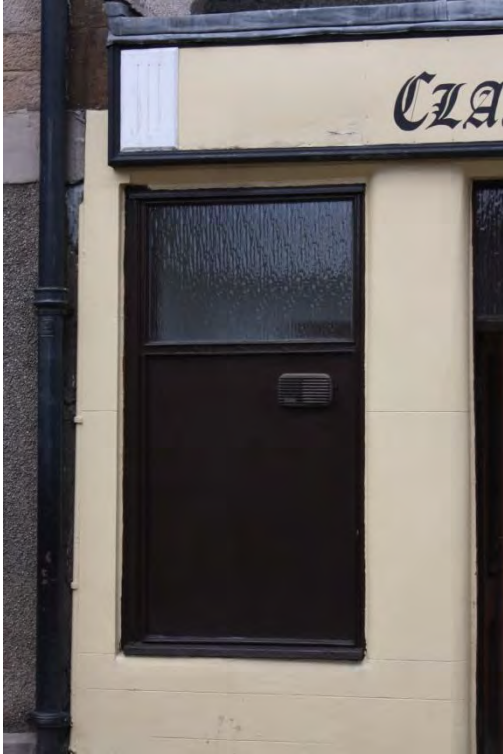
19 Main Street  
Window blanked out

- Shop may benefit from having an internal door which is partially glazed;
- Consider alternatives to blanked window;
- Current signage is sympathetic but if being replaced a hand-painted sign on the fascia board would be appropriate.

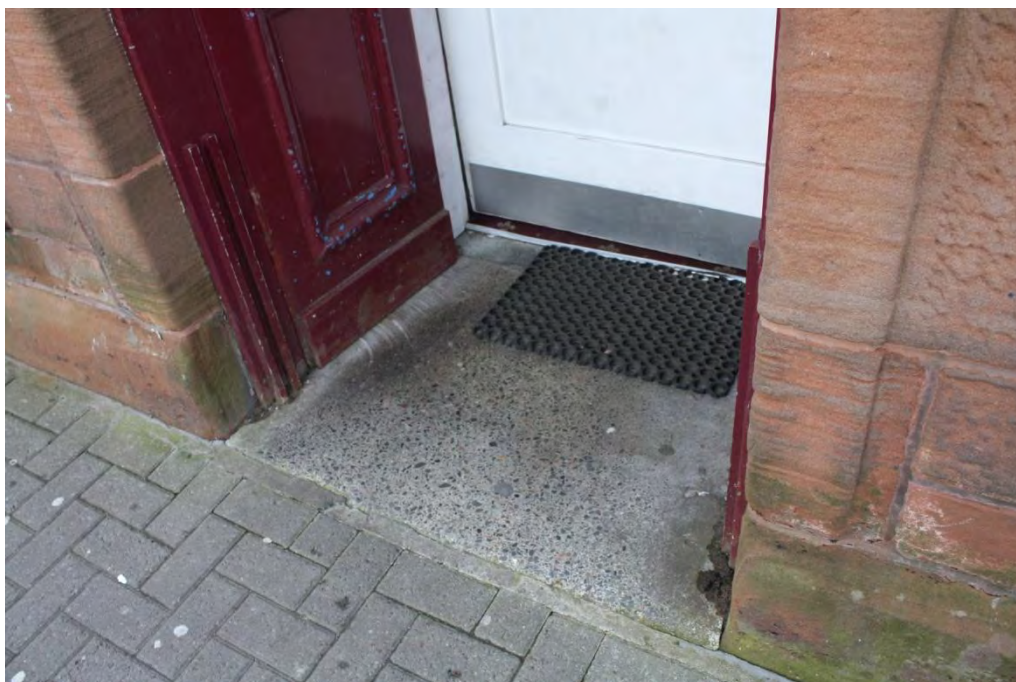
Concrete lobby floor  
20 Main Street

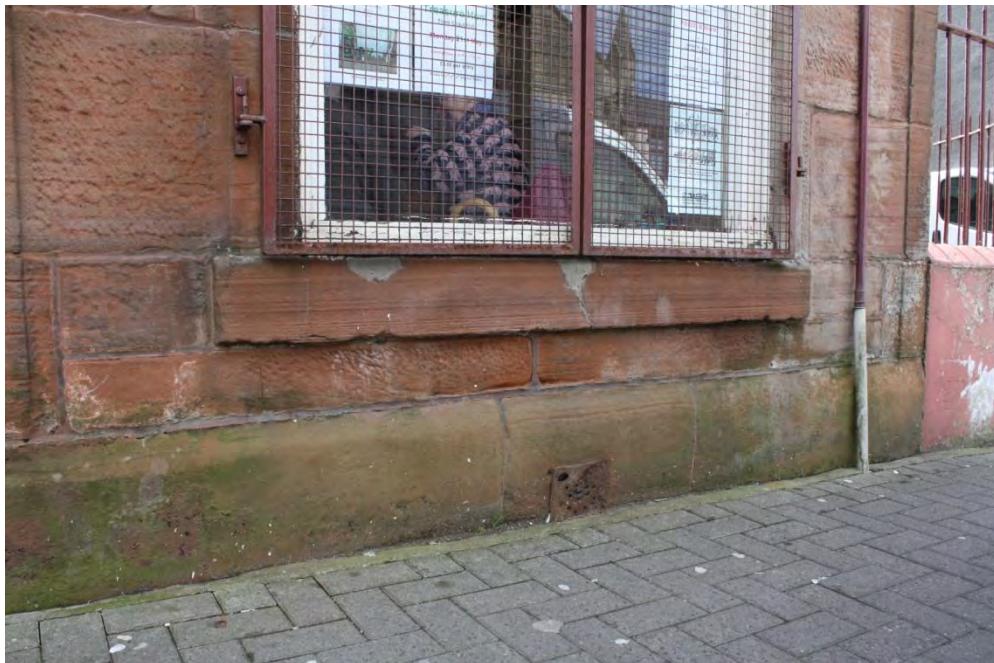
Window sill and security grilles  
20 Main Street

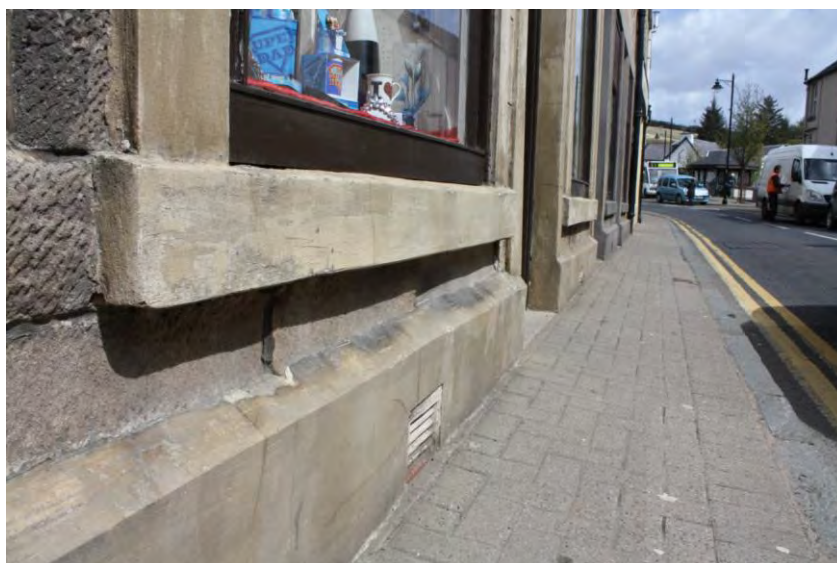
25 Main Street  
Window sill detail

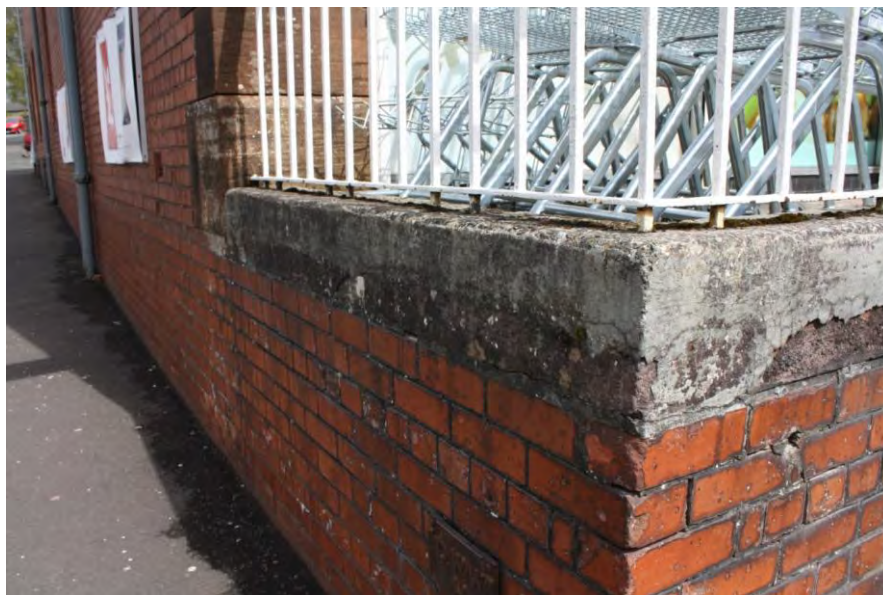
2 Church Hill  
Retaining wall and railings

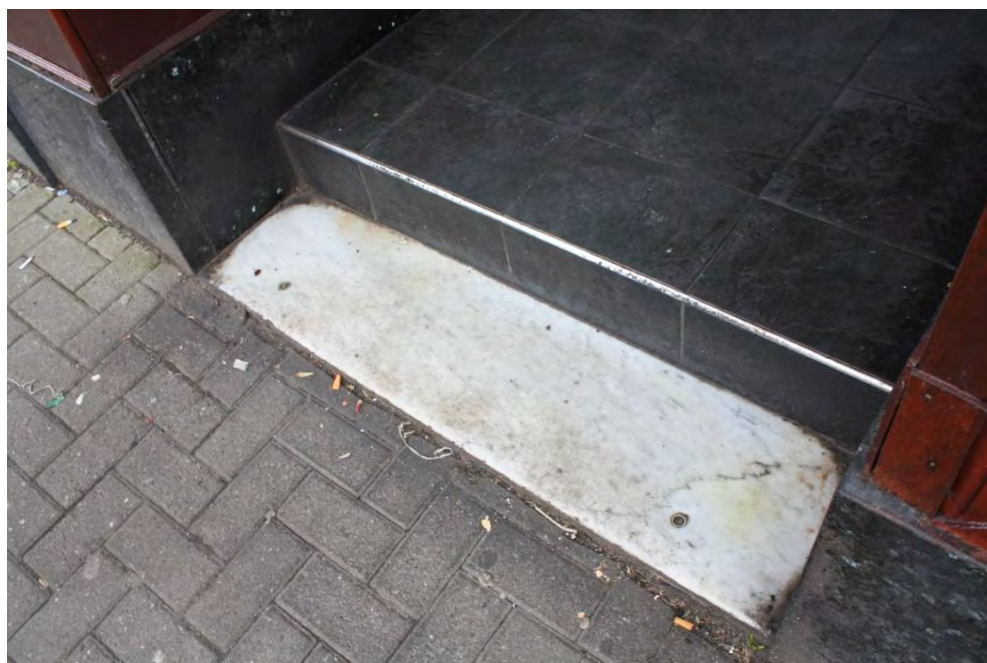
7 High Main Street  
Marble step with modern tiles to entrance steps

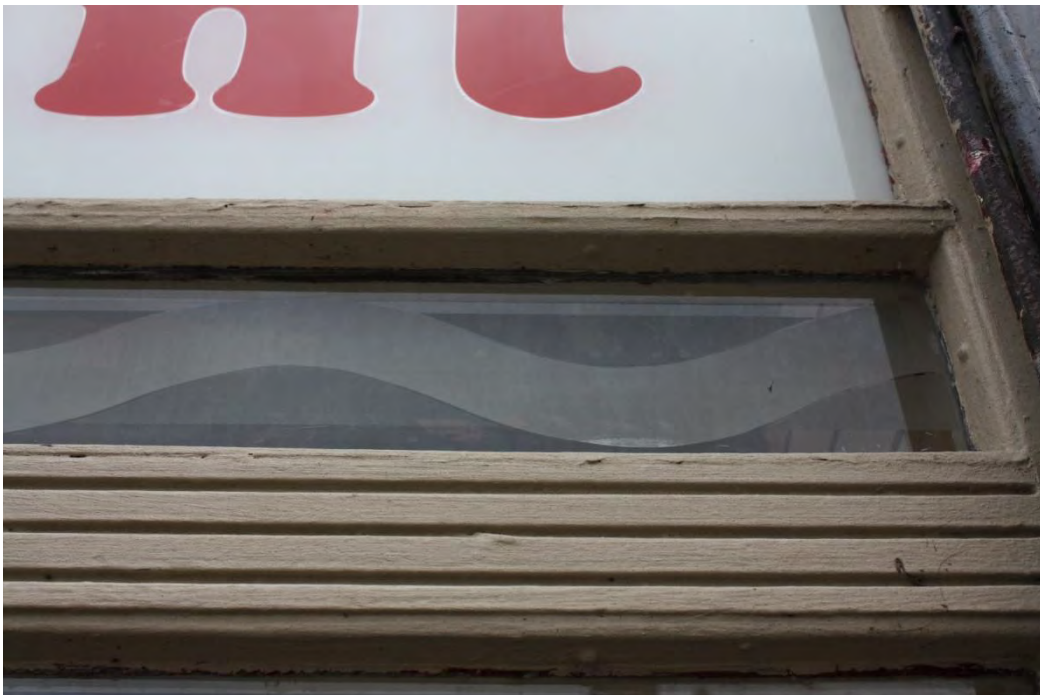
9 High Main Street  
Etched glass panels

- Remove window signage and use cut and applied lettering on fascia;
- Replace projecting sign with more traditional hanging sign;
- Investigate stability of stone cladding and repair as required;
- Check integrity of etched glazing and repair/ replace as required;
- Repair terrazzo in lobby entrance;
- Renovate existing blinds;
- Consider need for metal security grilles and possible alternatives;

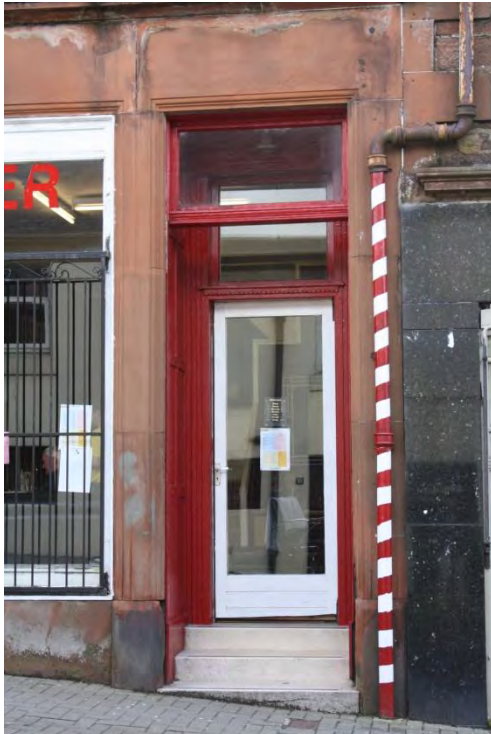
Fair but windows need repainting. Some cracking to terrazzo steps. Staining of masonry above shopfront.

11 High Main Street  
Entrance door with terrazzo steps

- Ensure fanlight in good working order;
- Remove iron grilles and if security is required replace with removable ones;
- Repair terrazzo step;
- Consider a shop gate;
- Use fascia for cut and applied lettering or incorporate lettering into a window sign.

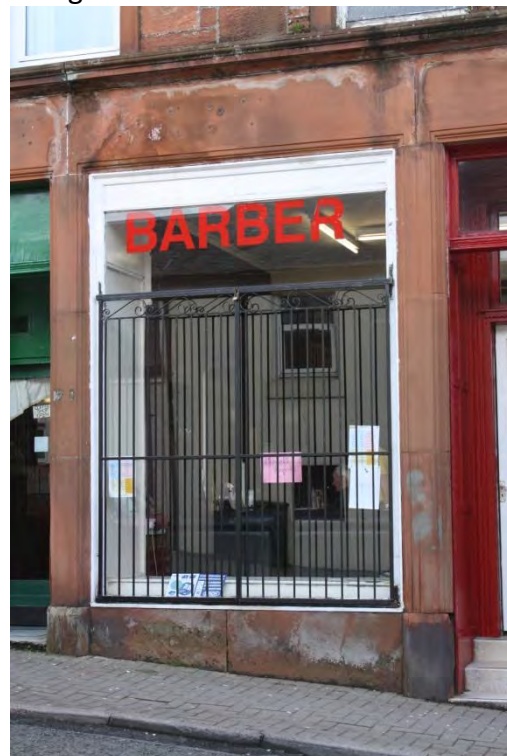
11 High Main Street  
Security grille on window

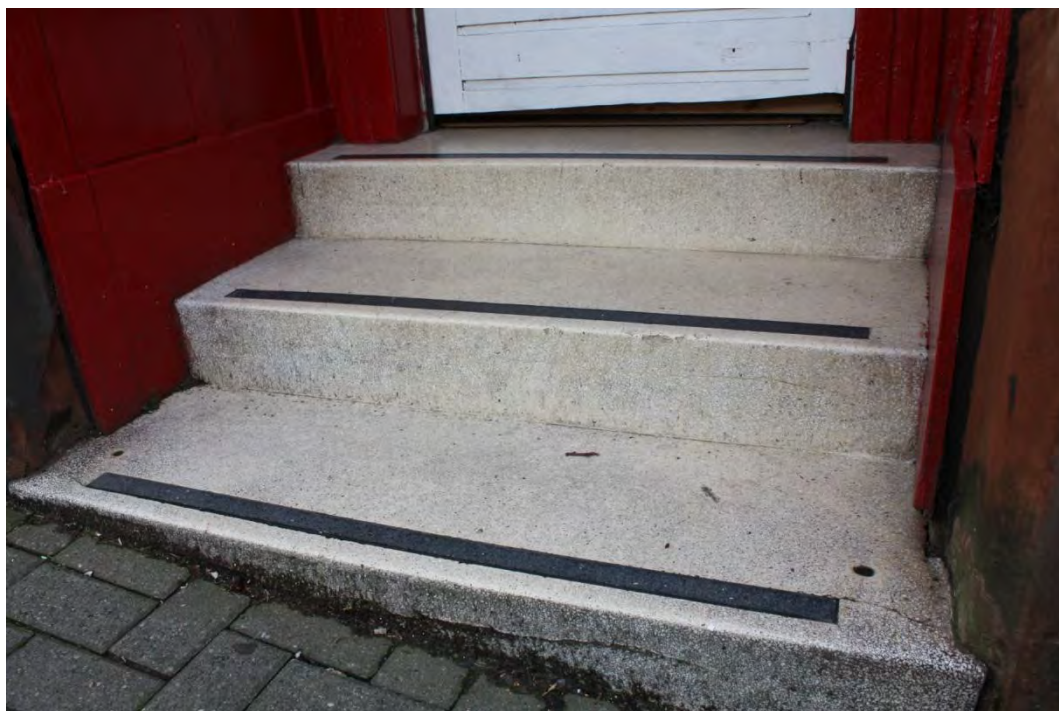
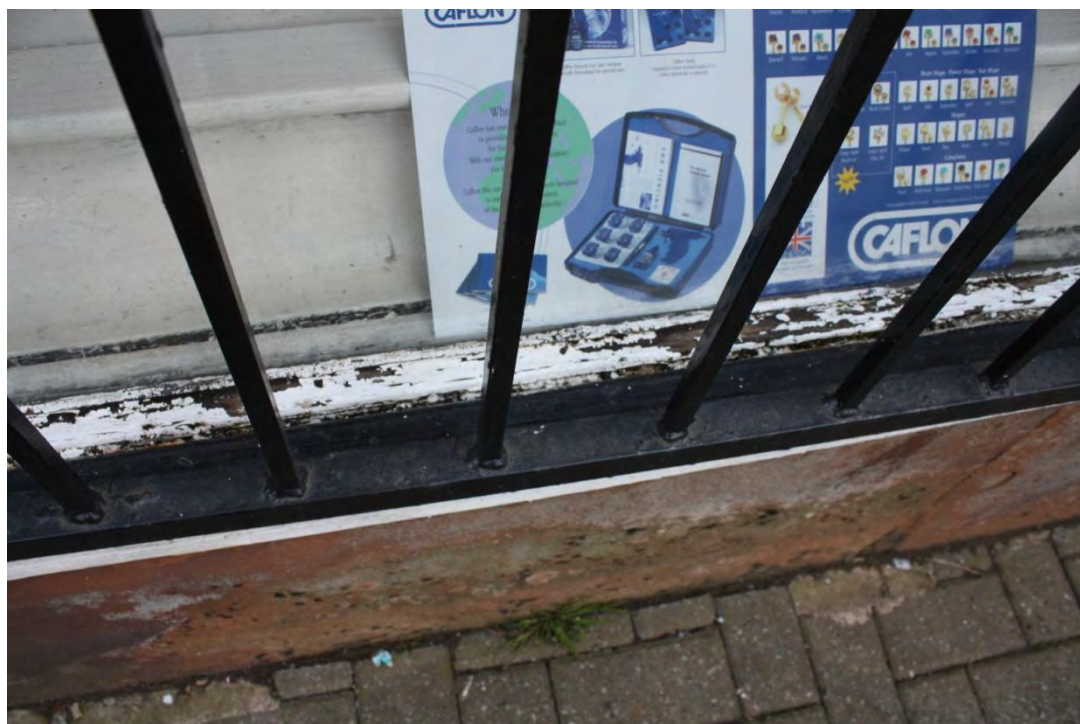
11 High Main Street  
Detail of window sill with security grille

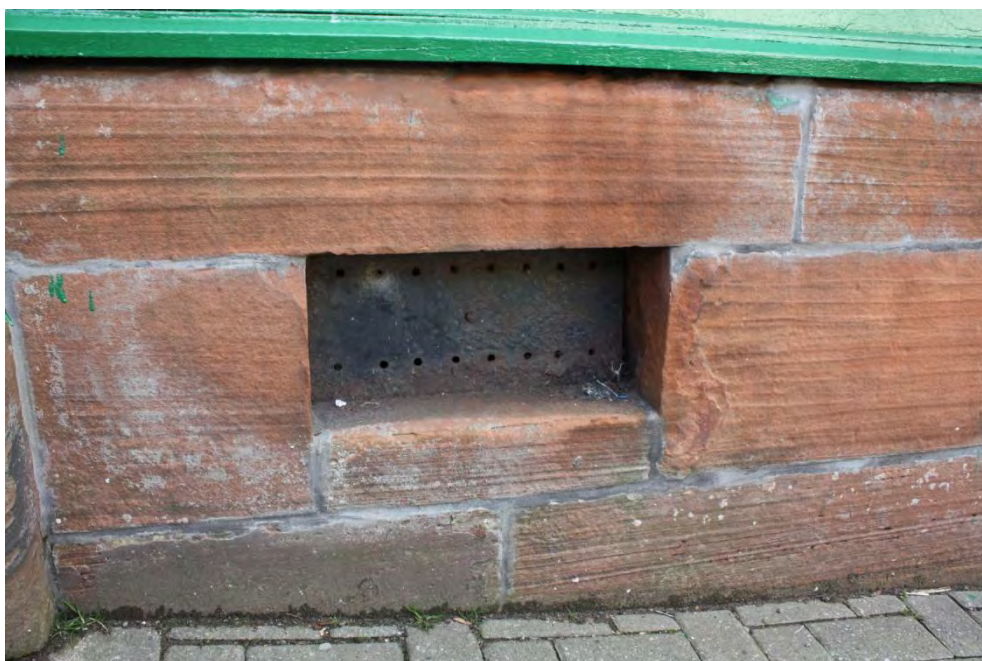
Fair but stonework has in places been repointed with a cementitious mortar. This is potentially damaging to historic masonry and its replacement with a lime-based mortar should be considered.

13 High Main Street  
Stallriser vent and repointing of stonework in cementitious mortar

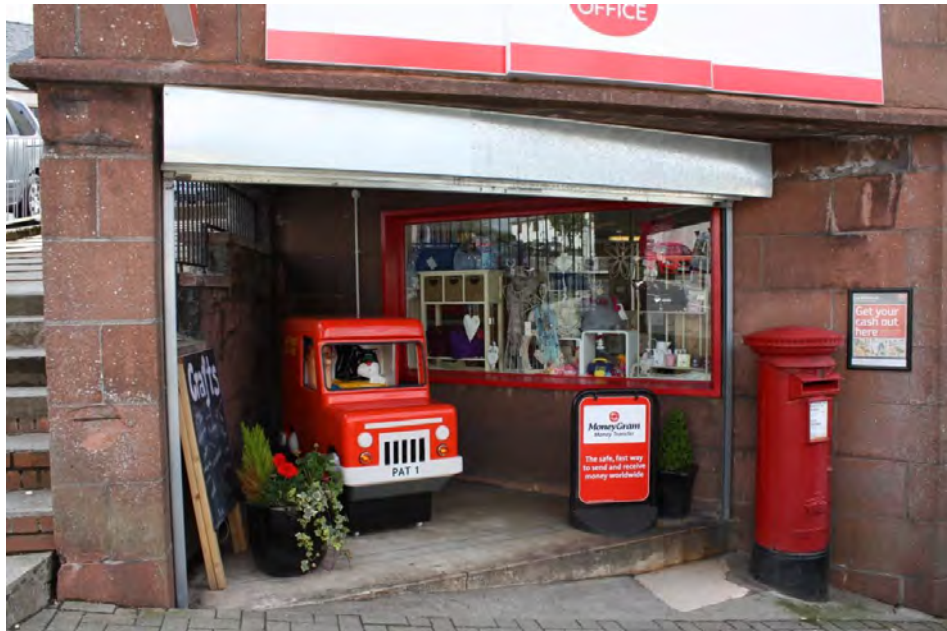
15 High Main Street  
Angled recessed window with modern roller shutter door

- Repair stonework as required;
- In longer term consider replacing metal roller shutter with gates
- When due for replacement, replace plastic fascia signs with timber signs with painted lettering or applied lettering.

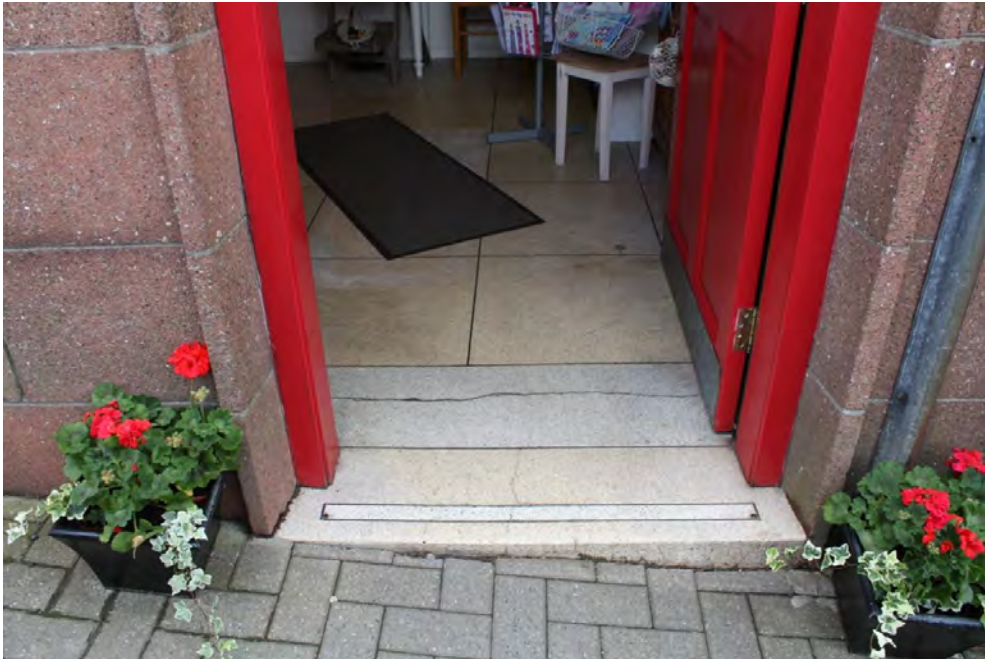
15 High Main Street

There is slight cracking evident to the terrazzo floor at the entrance to the shop.

Terrazzo floor showing slight cracking to step and immediately inside doorway

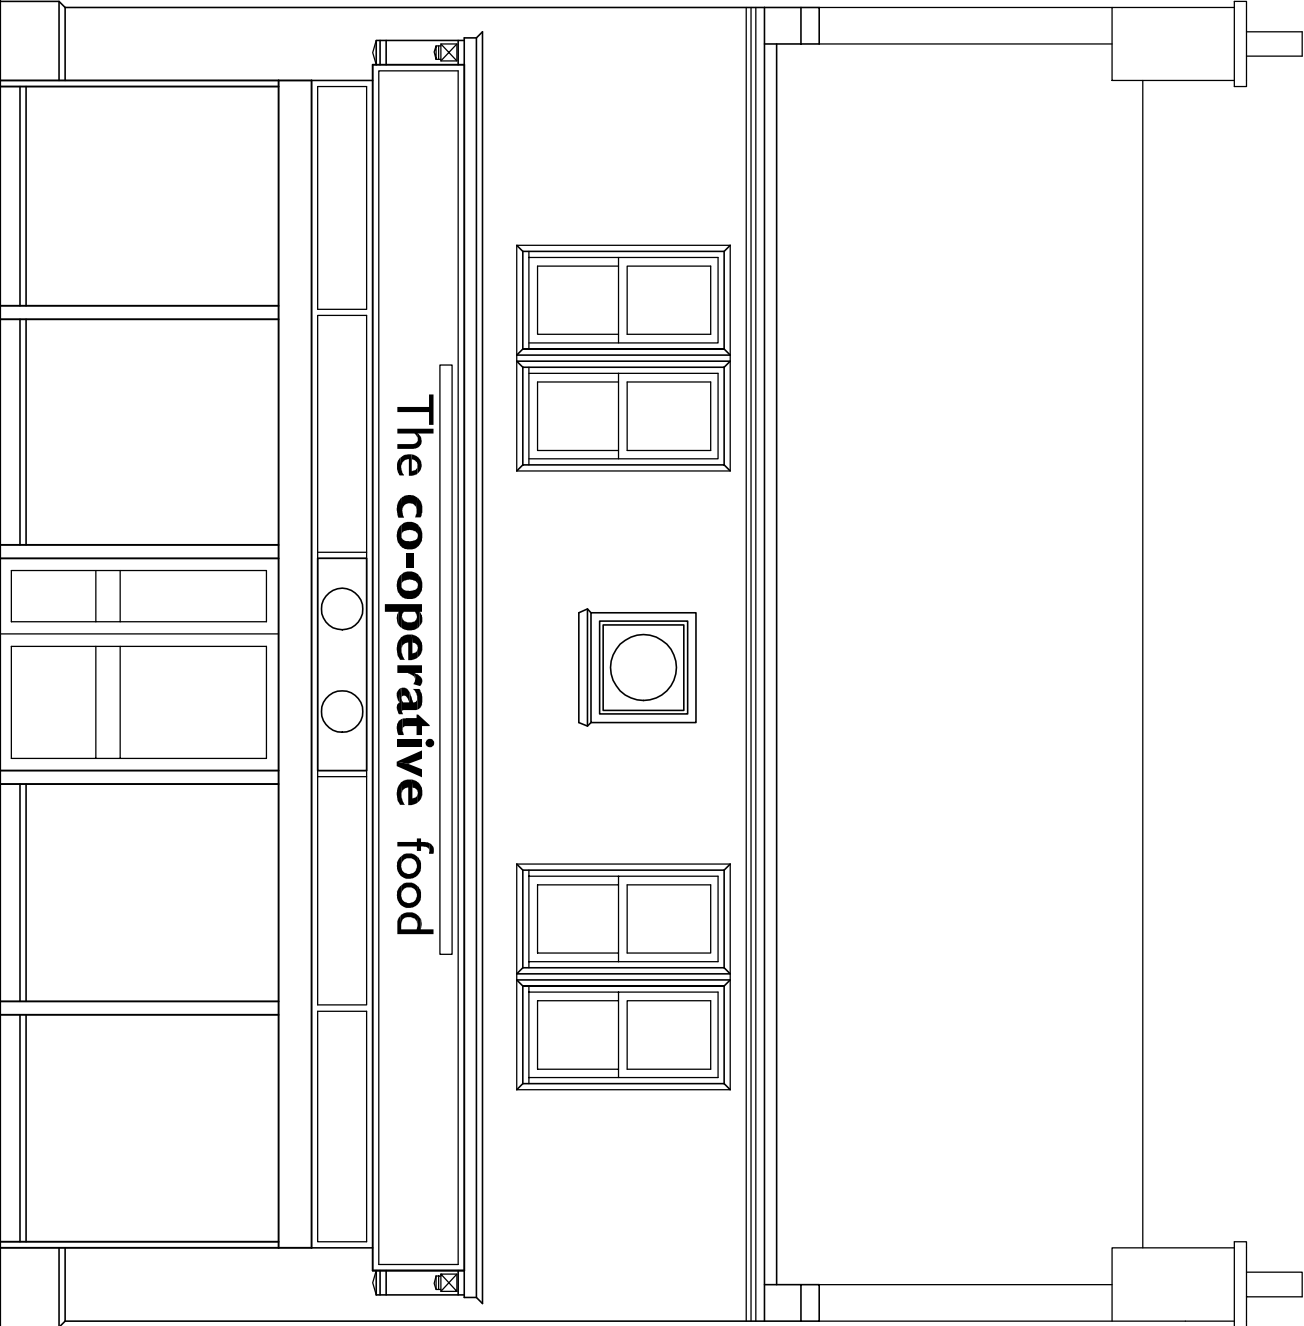
PROJECT REF		DRAWING REF
Sonya Linskaill RIAS RIBA slinskaill@blueyonder.co.uk: 07906 250234	DALMELLINGTON SHOP FRONTS for Dalmellington Partnership    June 2012    SCALE: NTS	2 CHURCH HILL: THE CO-OPERATIVE FOOD AS EXISTING

DESCRIPTION:  
Parent building:  
2-storey red sandstone building with slate roof and red brick gable and rear elevations. Built for the Dalmellington Industrial Cooperative Society, commemorated in the central date stone.

Repair: some damage to entrance.

Window display: visibility reduced by film applied to windows.

External fittings: extract vents located in prominent position above entrance doors.
