EAST AYRSHIRE COUNCIL

# **Local Development Plan 2**

## Dalmellington Conservation Area Appraisal

Non-statutory Planning Guidance

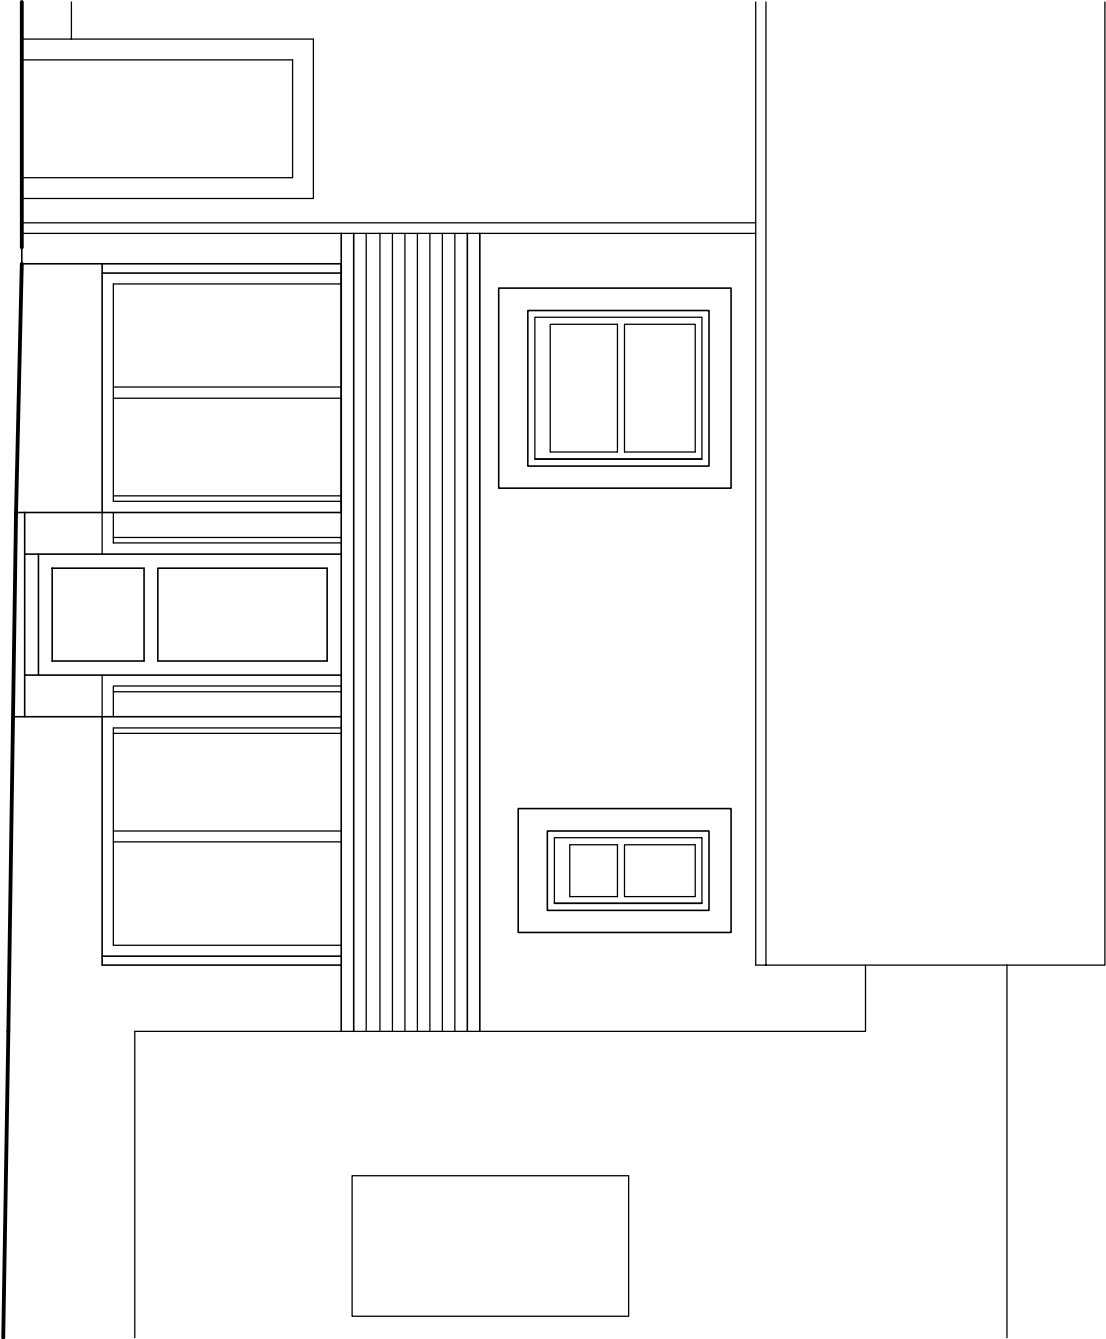
PROJECT REF		DRAWING REF
DALMELLINGTON SHOP FRONTS for Dalmeellington Partnership    June 2012    SCALE: NTS		3 HIGH MAIN STREET: Merrick Cafe AS EXISTING
Sonya Linskaill RIAS RIBA slinskaill@blueyonder.co.uk; 07906 250234

Shopfront:  
Double-fronted shop with central recessed entrance lobby. New replacement white upvc windows and glazed entrance door. Concrete floor to lobby.

Signage: deep horizontal upvc boarded fascia; no signage.

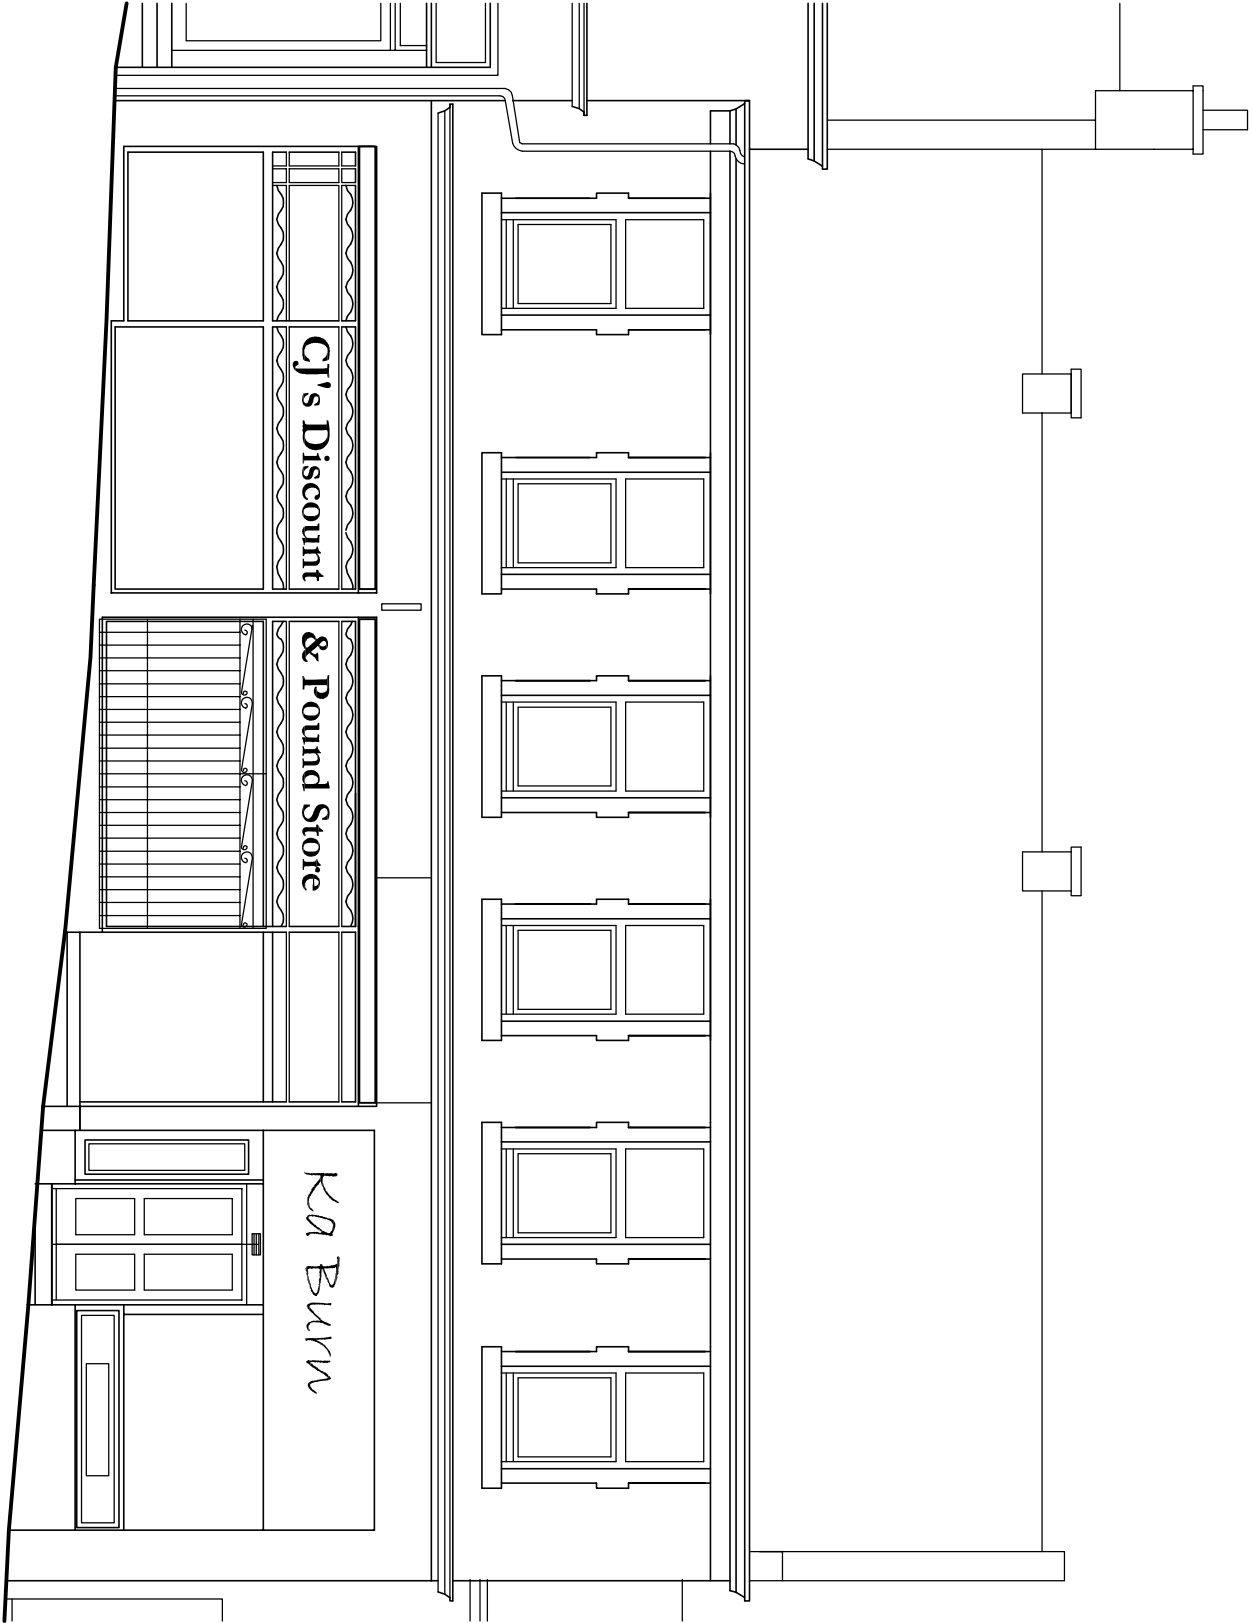
PROJECT REF	DRAWING REF
Sonya Linskaill RIAS RIBA slinskaill@blueyonder.co.uk: 07906 250234	7&9 HIGH MAIN STREET: CJ's DISCOUNT STORE & KA BURN AS EXISTING
DALMELLINGTON SHOP FRONTS for Dalmellington Partnership June 2012 SCALE: NTS

DESCRIPTION:  
Parent building:  
2—storey red sandstone building with slate roof.  
Repair: evidence of water damage/staining at eaves level and above cornice; cement pointing repair and open joints.

Sun blinds & awnings:  
No 9: 2 integral sun blinds above glazing.  
Repairs:  
No. 9: some damage evident to terrazzo entrance.  
A section of the stone fascia cladding has been temporarily repaired.

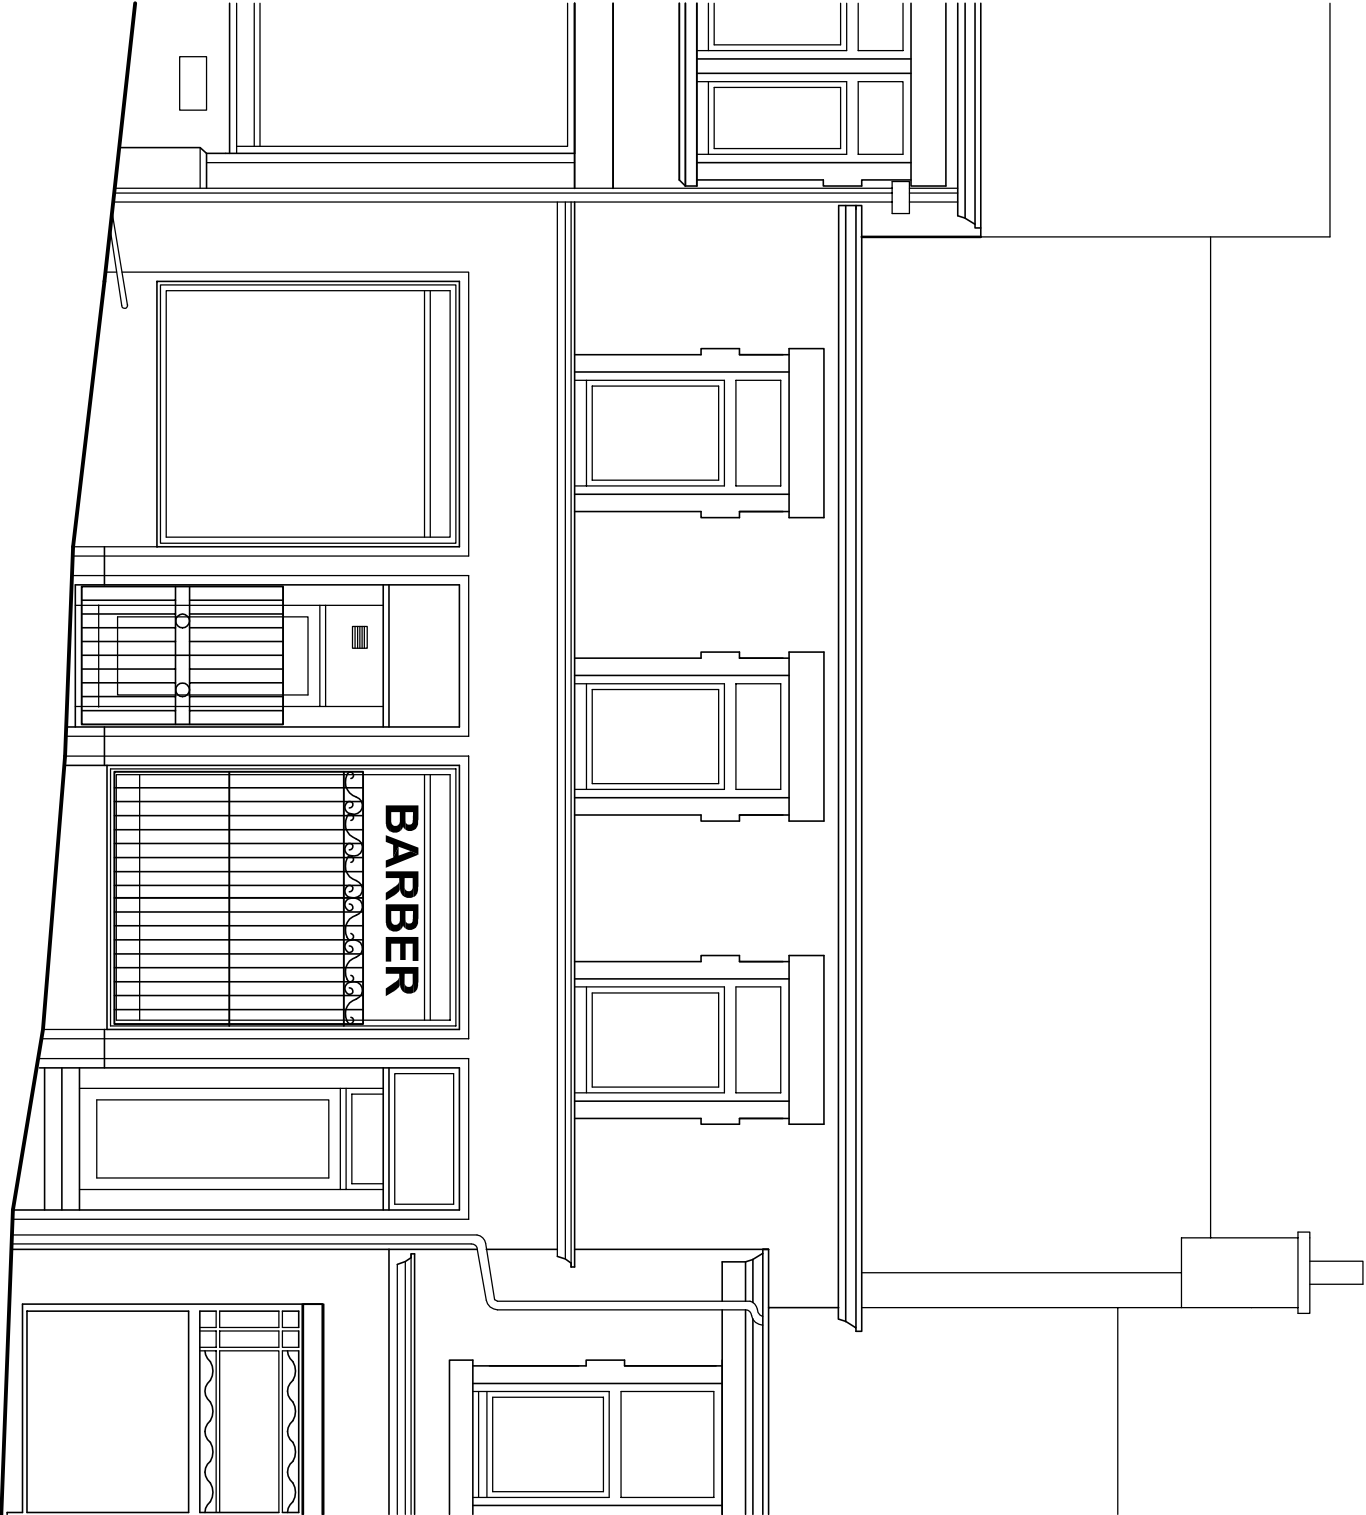
PROJECT REF		DRAWING REF	
Sonya Linskaill RIAS RIBA		11 & 13 HIGH MAIN STREET: BARBER & COFFEE SHOP AS EXISTING	
sinskaill@blueyonder.co.uk; 07906 250234		DALMELLINGTON SHOP FRONTS	
		for Dalmeington Partnership June 2012 SCALE: NTS

DESCRIPTION:  
Parent building:  
2–storey red sandstone building with  
slate roof. 2 replacement upvc windows  
at first floor; 1 original timber sash &  
case window. Pair of shopfronts below.

Repair: significant water  
damage/staining to stonework at first  
floor level.

Security:  
No. 11: window grilles.  
No 13: lobby has port height metal  
gates with original fanlight blocked  
above.

External fittings:  
No.13: poorly sited plastic pipe at  
plinth level.

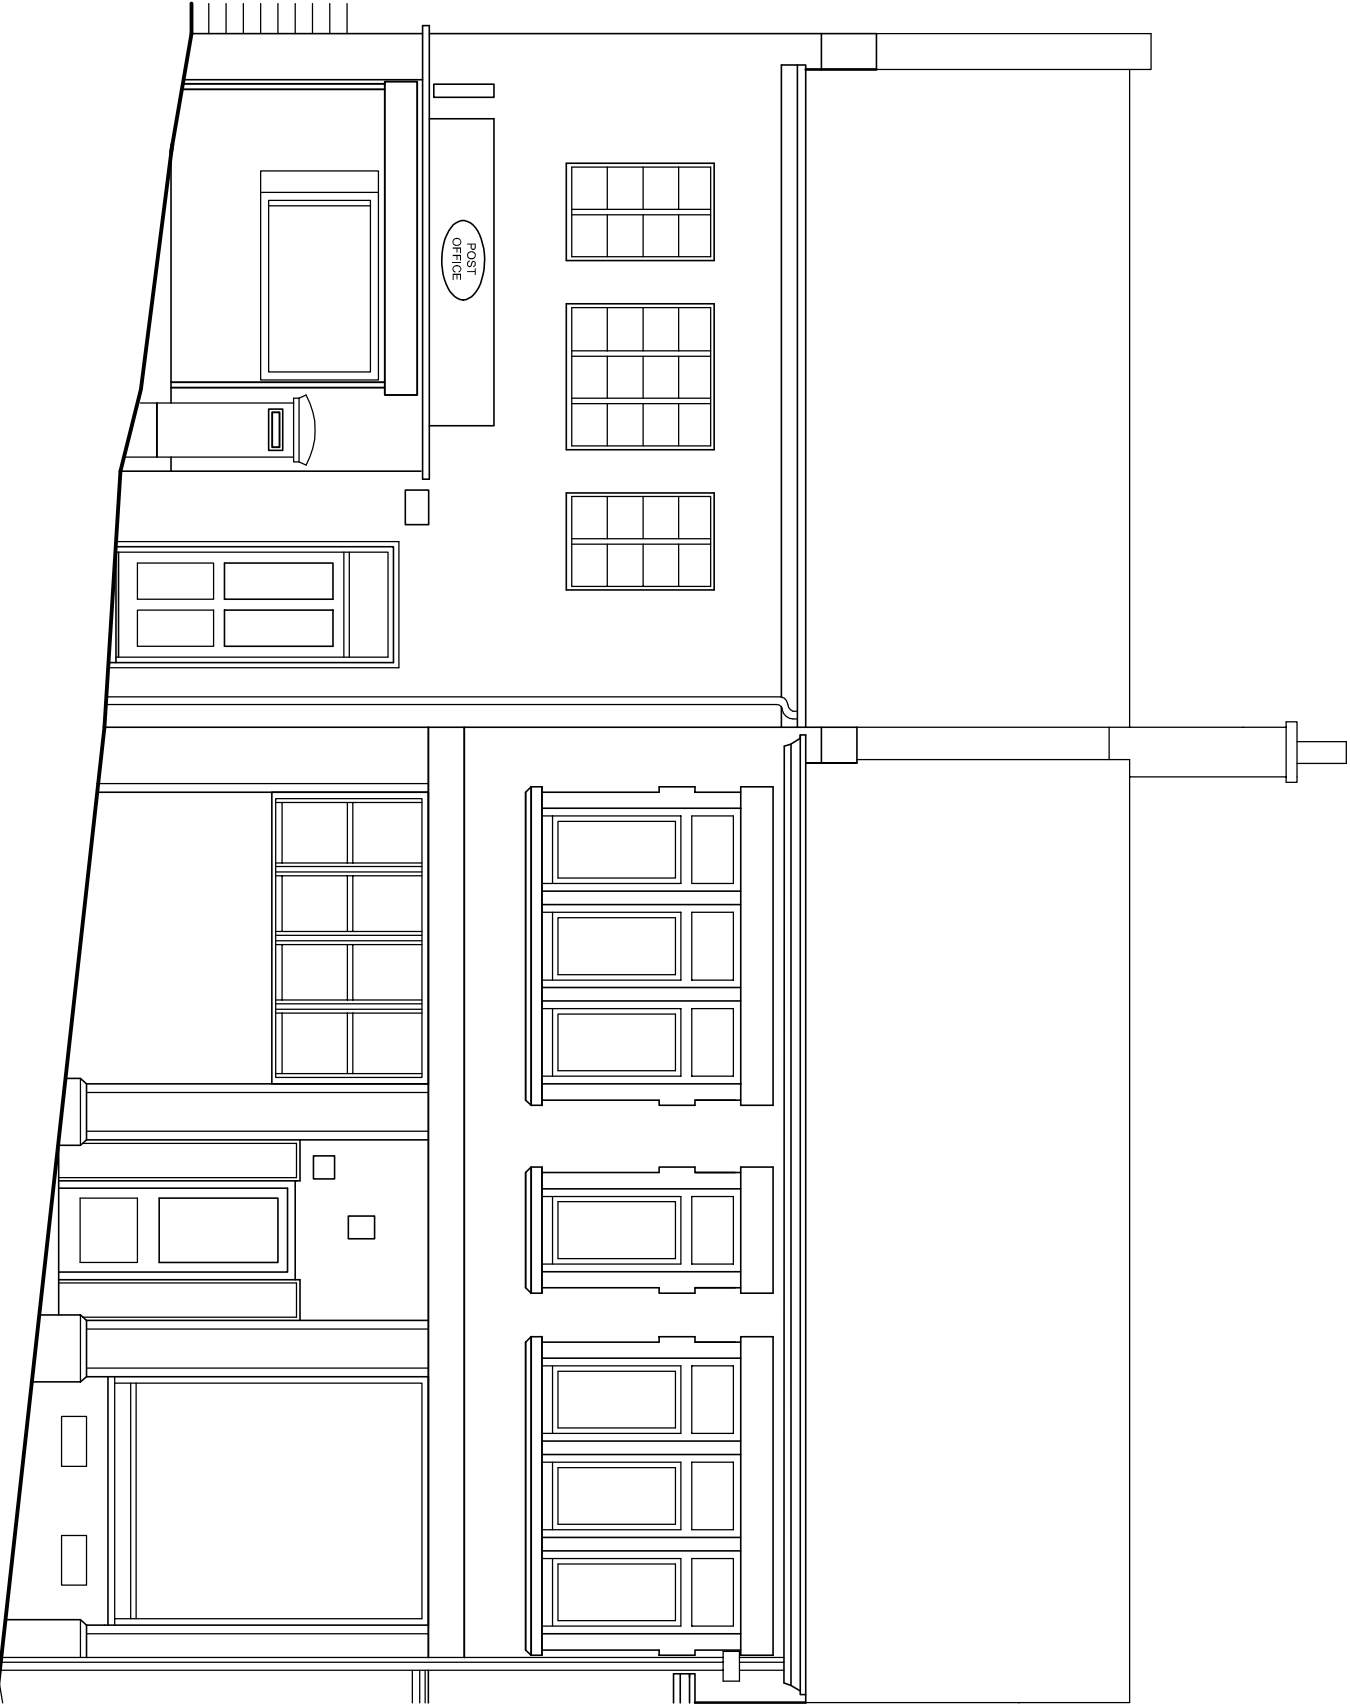
PROJECT REF		DRAWING REF	
Sonya Linskaill RIAS RIBA		13 & 15 HIGH MAIN STREET: FLOWER	
slinskaill@blueyonder.co.uk: 07906 250234		BOUTIQUE & POST OFFICE AS EXISTING	
DALMELLINGTON SHOP FRONTS			
for Dalmellington Partnership			
June 2012			
SCALE: NTS

DESCRIPTION: No. 13 (Flower shop)  
2-storey red sandstone building with  
slate roof. Replacement upvc windows  
at first floor. Shopfront below.  
Repair: evidence of previous repair  
(possibly as result of water damage)  
at first floor level with heavy cement  
pointing (this could cause further  
stone erosion).

DESCRIPTION: No.15  
2-storey 1950s end terrace built with  
red-coloured artificial stone and  
pitched slated roof. Original steel  
windows to first floor windows. Gable  
wall wet dash rendered.  
Repair: some damage to the  
stonework exposing metal  
reinforcement.

Security: steel roller shutter door at  
entrance.

Repair: slight cracking evident to the  
terrazzo floor at the shop entrance.

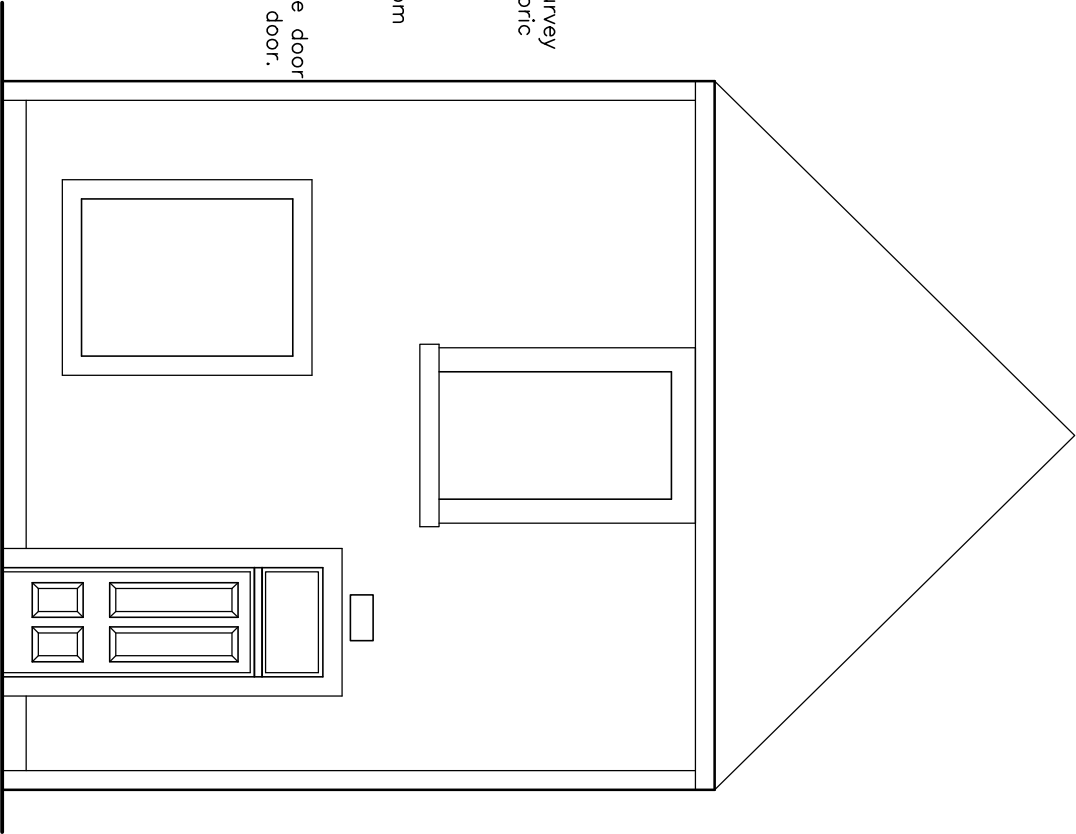
PROJECT REF		DRAWING REF	
Sonya Linskaill	RIAS RIBA	5 HIGH STREET: YE OLDE HOUSE (VACANT)	AS EXISTING / RECOMMENDATIONS
slinskaill@blueyonder.co.uk	07906 250234	DALMELLINGTON SHOP FRONTS for Dalmeilington Partnership June 2012 SCALE: NTS

In poor condition and appears to have been vacant for some time. Paint peeling and property is vacant which can lead to repairs not being undertaken and a general lack of maintenance.

DESCRIPTION:  
Parent building:  
2—storey building with ground floor shop. Walls cement rendered and painted with contrasting black margins; slated hipped roof. Single boarded window to first floor.

Repair: paint peeling off render; generally looks to be in poor condition.

RECOMMENDATIONS:  
Parent building:  
1. Undertake full survey to establish any fabric repair requirements.

Shopfront:  
Signage:  
1. Would benefit from window signage.

Repair:  
Longer term: replace door in traditional timber door.

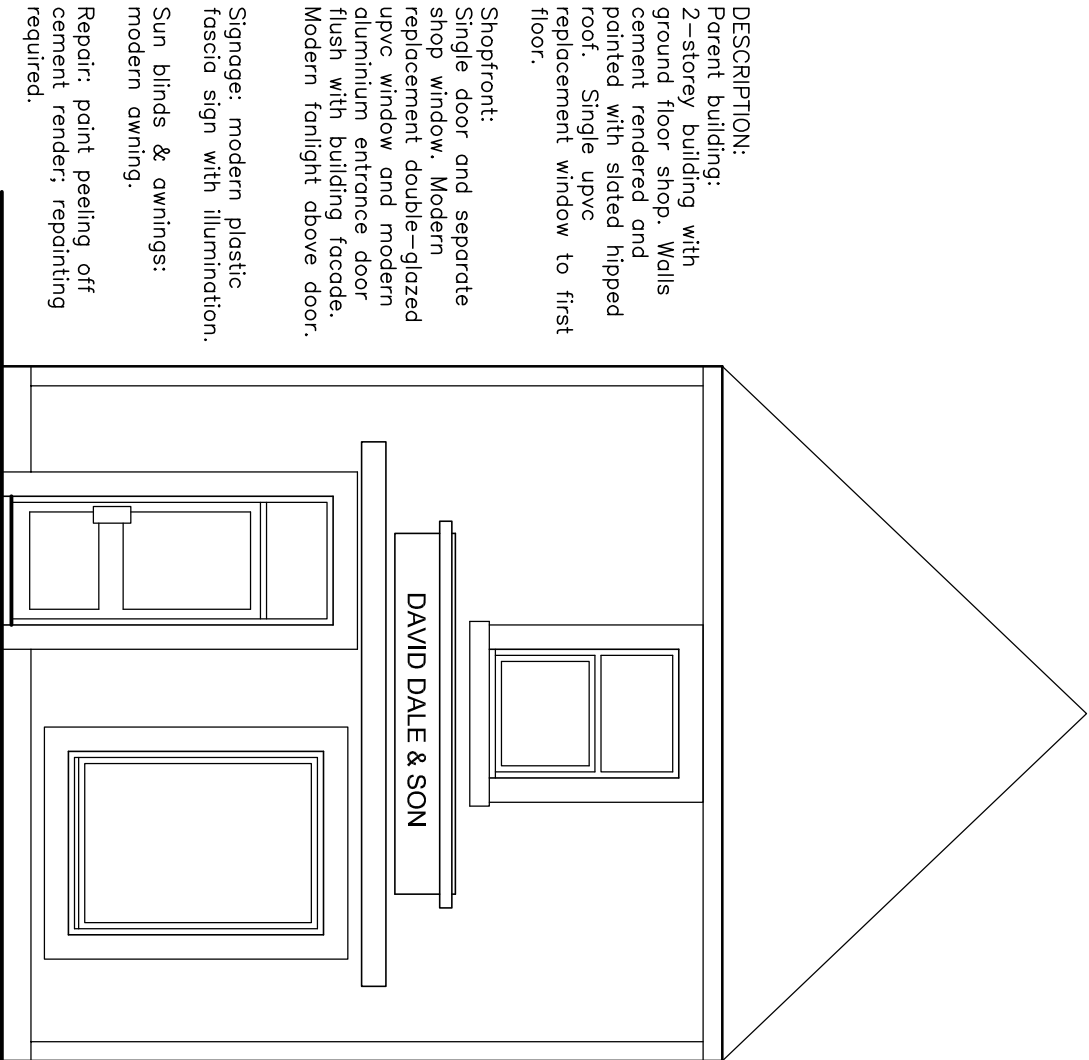
PROJECT REF		DRAWING REF	
Sonya Linskaill RIAS RIBA	DALMELLINGTON SHOP FRONTS	14 HIGH STREET: D. DALE & SON (VACANT)	
slinskaill@blueyonder.co.uk; 07906 250234	for Dalmeillington Partnership June 2012 SCALE: NTS	AS EXISTING / RECOMMENDATIONS

Fair but paint peeling and property is vacant which can lead to repairs not being undertaken and a general lack of maintenance.

Parent building:  
2-storey building with ground floor shop. Walls cement rendered and painted with slated hipped roof. Single upvc replacement window to first floor.

Shopfront:  
Single door and separate shop window. Modern replacement double-glazed upvc window and modern aluminium entrance door flush with building facade. Modern fanlight above door.

Repair: paint peeling off cement render; repainting required.

Sun blinds and awnings:  
1. Replace plastic awning with more traditional alternative.

Repair:  
Longer term: replace window and door in more sympathetic materials such as timber.

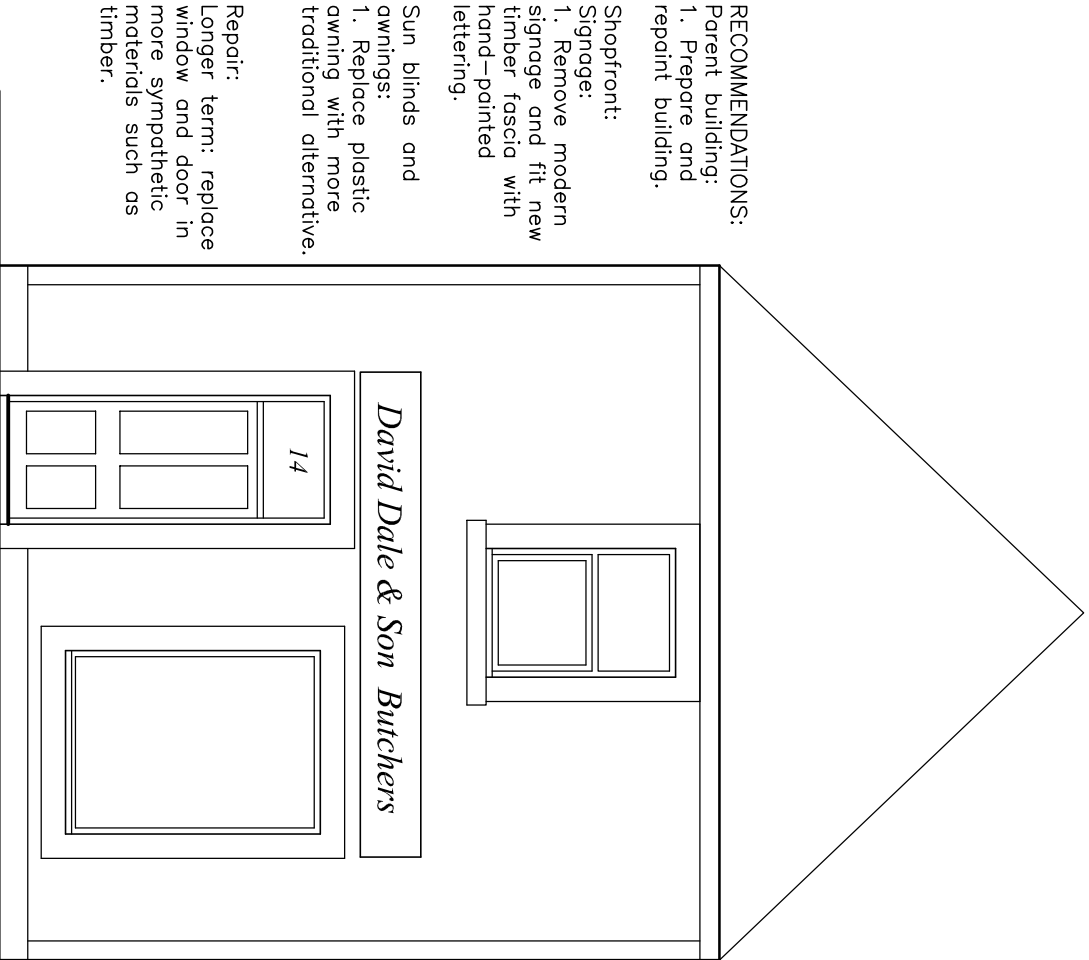
Sun blinds & awnings: modern awning.

RECOMMENDATIONS:

Parent building:  
1. Prepare and repaint building.

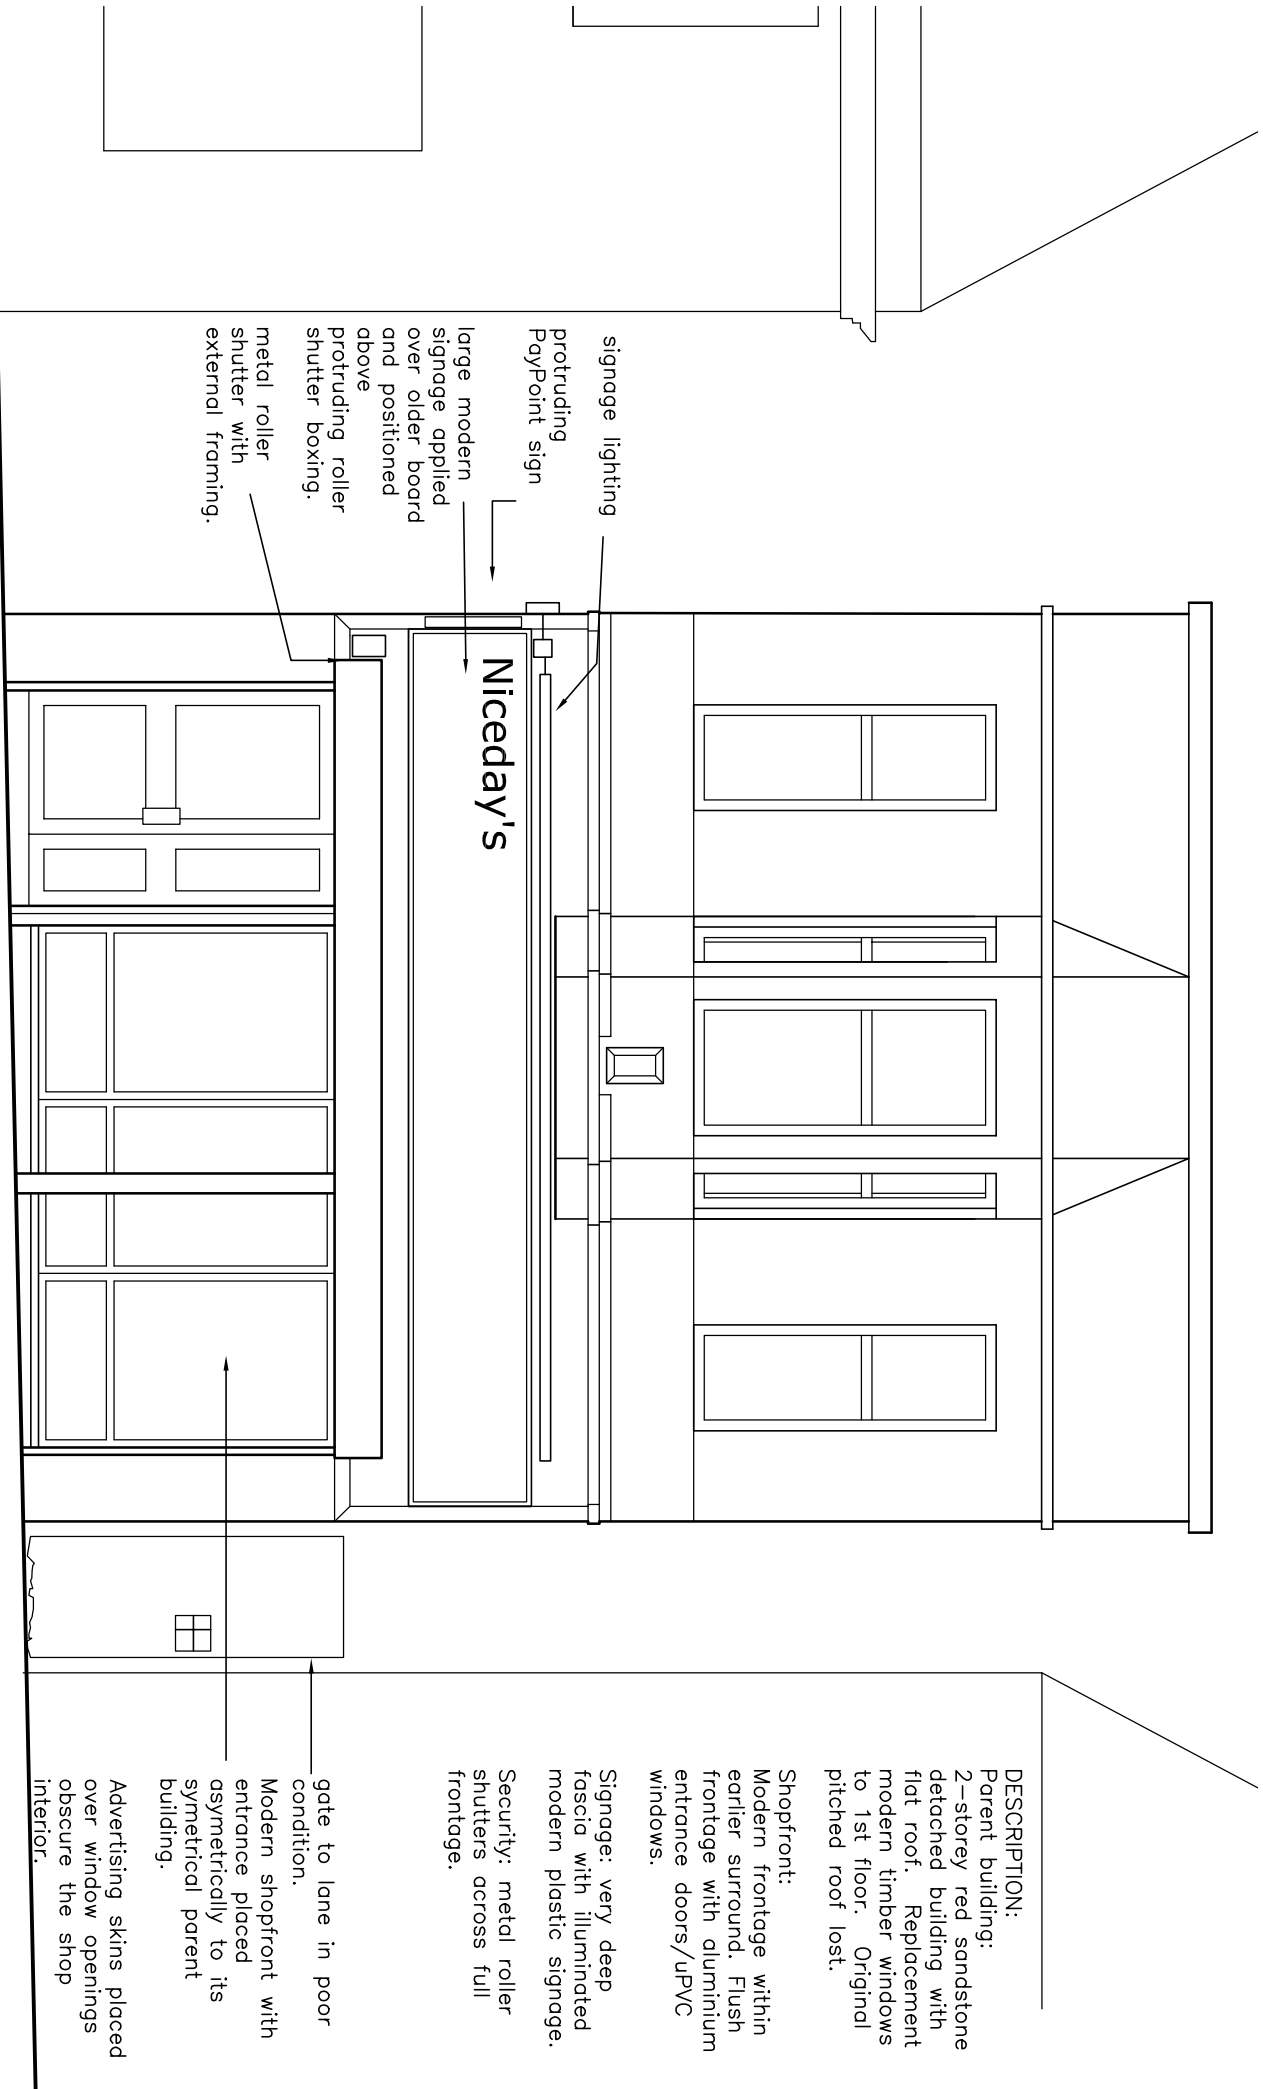
PROJECT REF	DRAWING REF
Sonya Linskaill RIAS RIBA slinskaill@blueyonder.co.uk. 07906 250234	DALMELLINGTON SHOP FRONTS for Dalmellington Partnership June 2012 SCALE: NTS	1 MAIN STREET: NICE DAYS MINIMARKET AS EXISTING

Parent building:  
2–storey red sandstone detached building with flat roof. Replacement modern timber windows to 1st floor. Original pitched roof lost.

gate to lane in poor condition.  
Modern shopfront with entrance placed asymmetrically to its symmetrical parent building.  
Advertising skins placed over window openings obscure the shop interior.

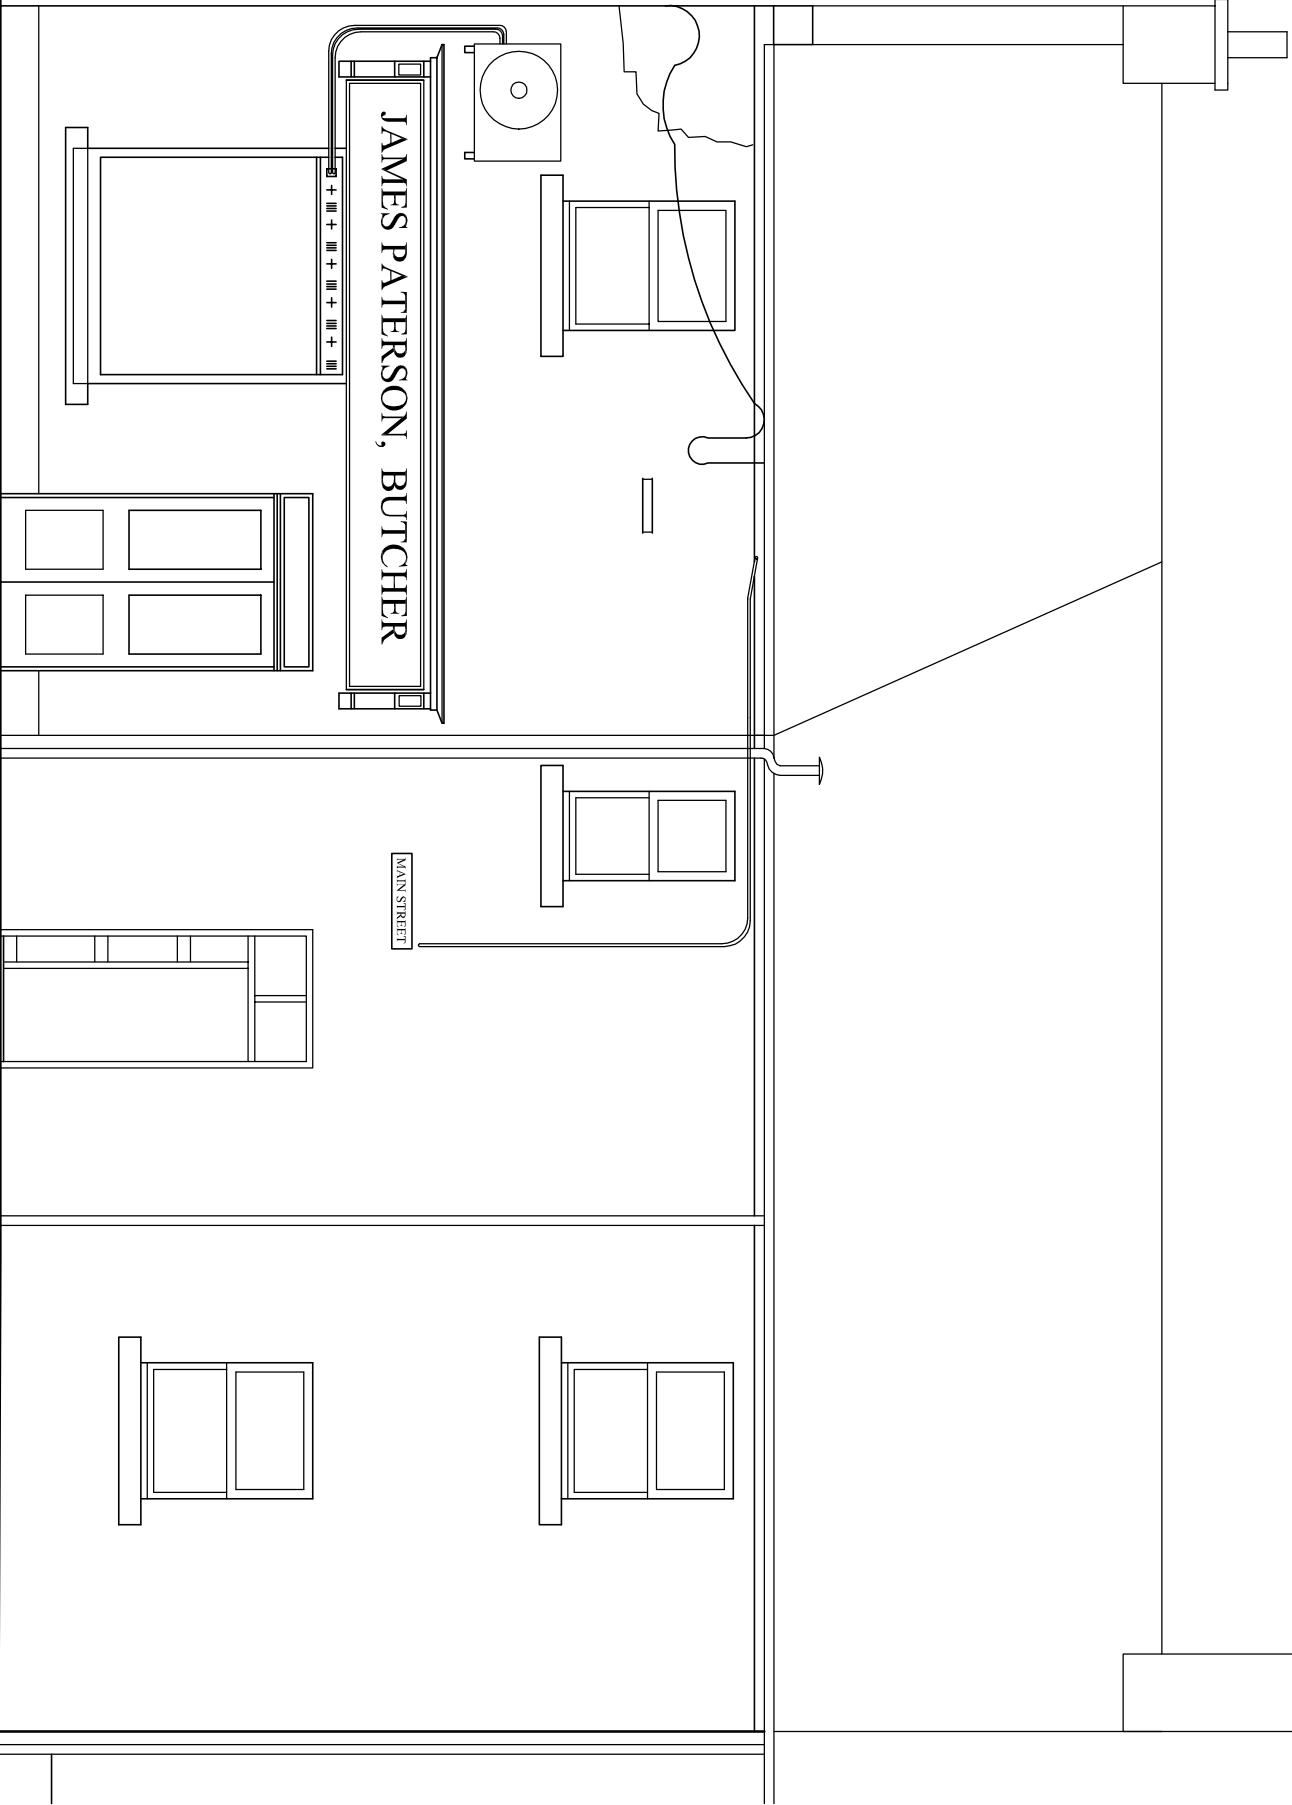
PROJECT REF		DRAWING REF	
DALMELLINGTON SHOP FRONTS		2 MAIN STREET: J. PATERSON BUTCHERS	
for Dalmellington Partnership		AS EXISTING	
June 2012		SCALE: NTS	
Sonya Linskaill RIAS RIBA			
slinskaill@blueyonder.co.uk; 07906 250234

DESCRIPTION:  
Parent building:  
2-storey corner building  
with rendered and  
painted facade, and  
slate roof.  
Patch cement repair  
below skew.

External fittings: cabling  
and pipework across  
facade; redundant  
bracket.  
Large wall mounted  
extract unit with cabling  
into butchers.

Signage: modern sign  
applied to the original  
timber signboard with  
traditional timber cornice  
and console brackets.  
traditional butcher's shop  
window with original  
decorative cast iron  
ventilator at its head.  
painted joinery and  
stonework to shopfront.

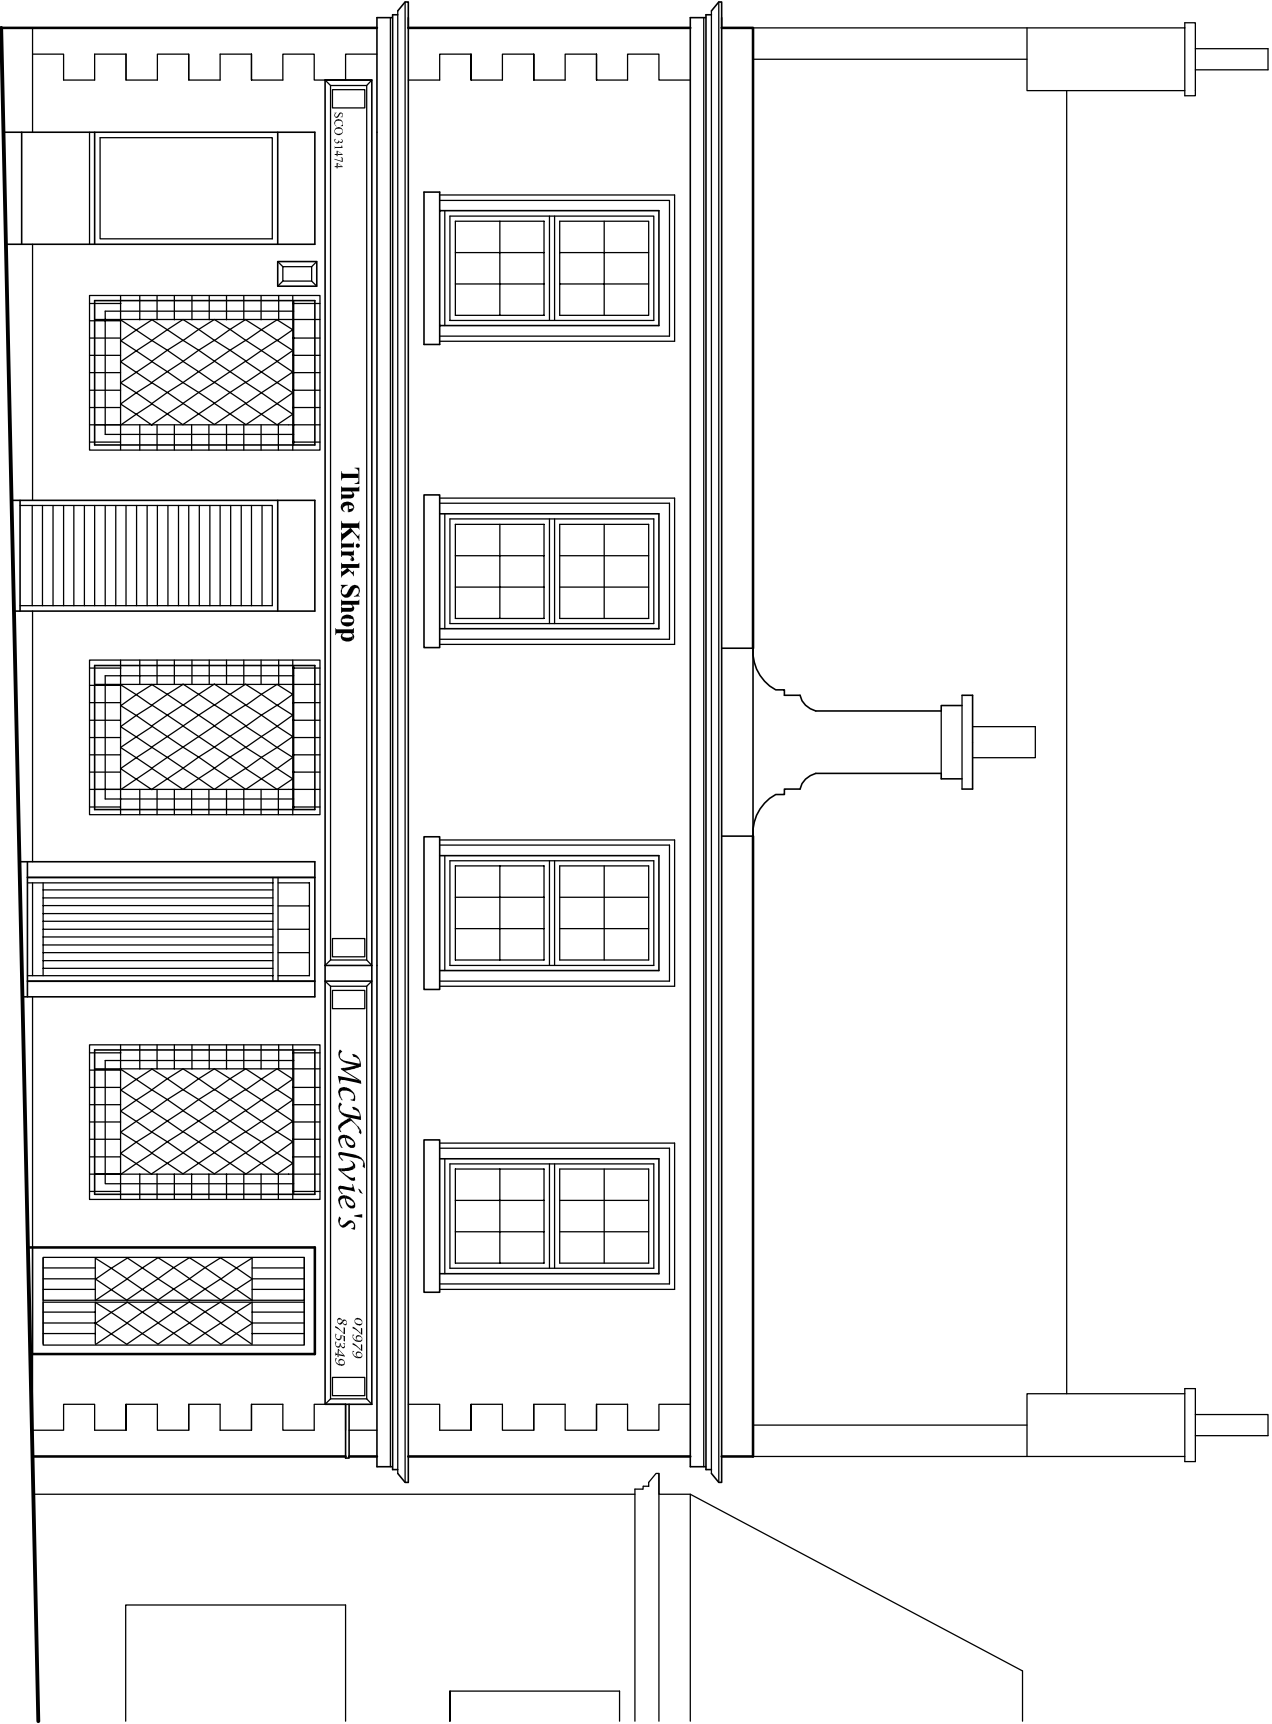
PROJECT REF		DRAWING REF	
DALMELLINGTON SHOP FRONTS		7&11 MAIN STREET: The Kirk Shop & McKelvie's	
for Dalmellington Partnership		AS EXISTING	
June 2012		SCALE: NTS	
SONYA LINSKAILL RIAS RIBA			
slinskail@blueyonder.co.uk: 07906 250234

DESCRIPTION:  
Parent building:  
2—storey building with refined ashlar stone facade and slate roof. Symmetrically designed shopfront now comprising 2 shops (originally 3 single fronted shops) with close entrance (retaining traditional timber boarded door and laylight above). 4 windows at first floor level (replacement uPVC).

No. 7 has a single window and separate door.  
Security: full height metal entrance gates enclosing entrance recess, with a half glazed timber (replacement) door with glazed fanlight above.

No. 9 now encompasses 2 shops and has an off—centre door with 3 windows (one an altered doorway).  
Security: modern metal roller shutter to door.  
Both shops have iron window geometric patterned iron grilles.

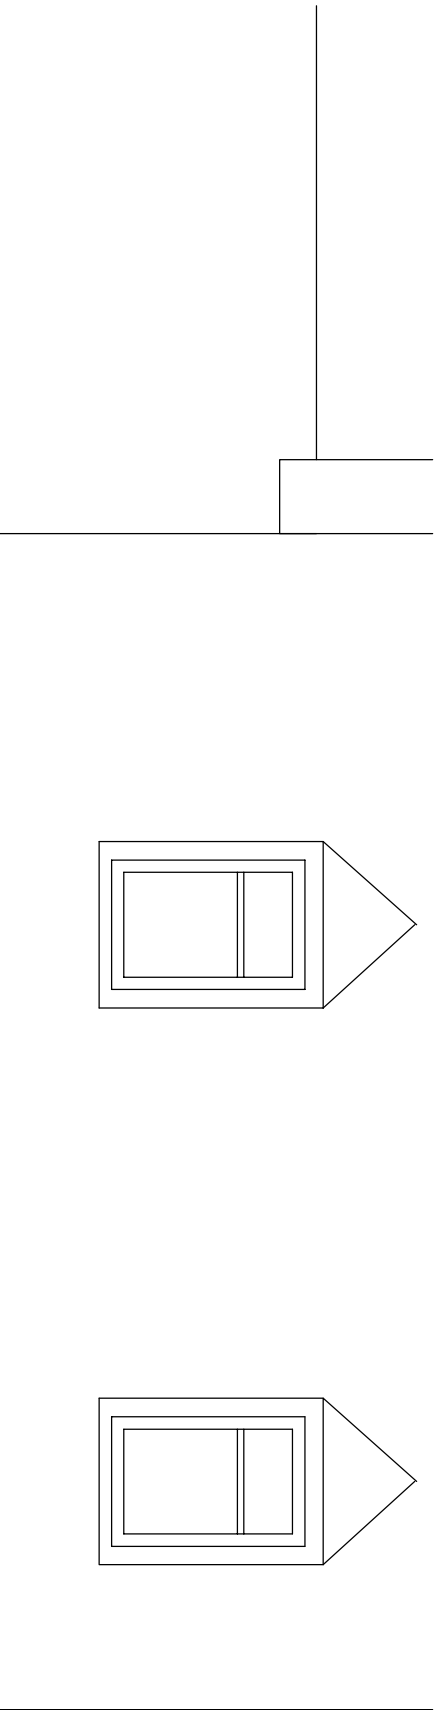
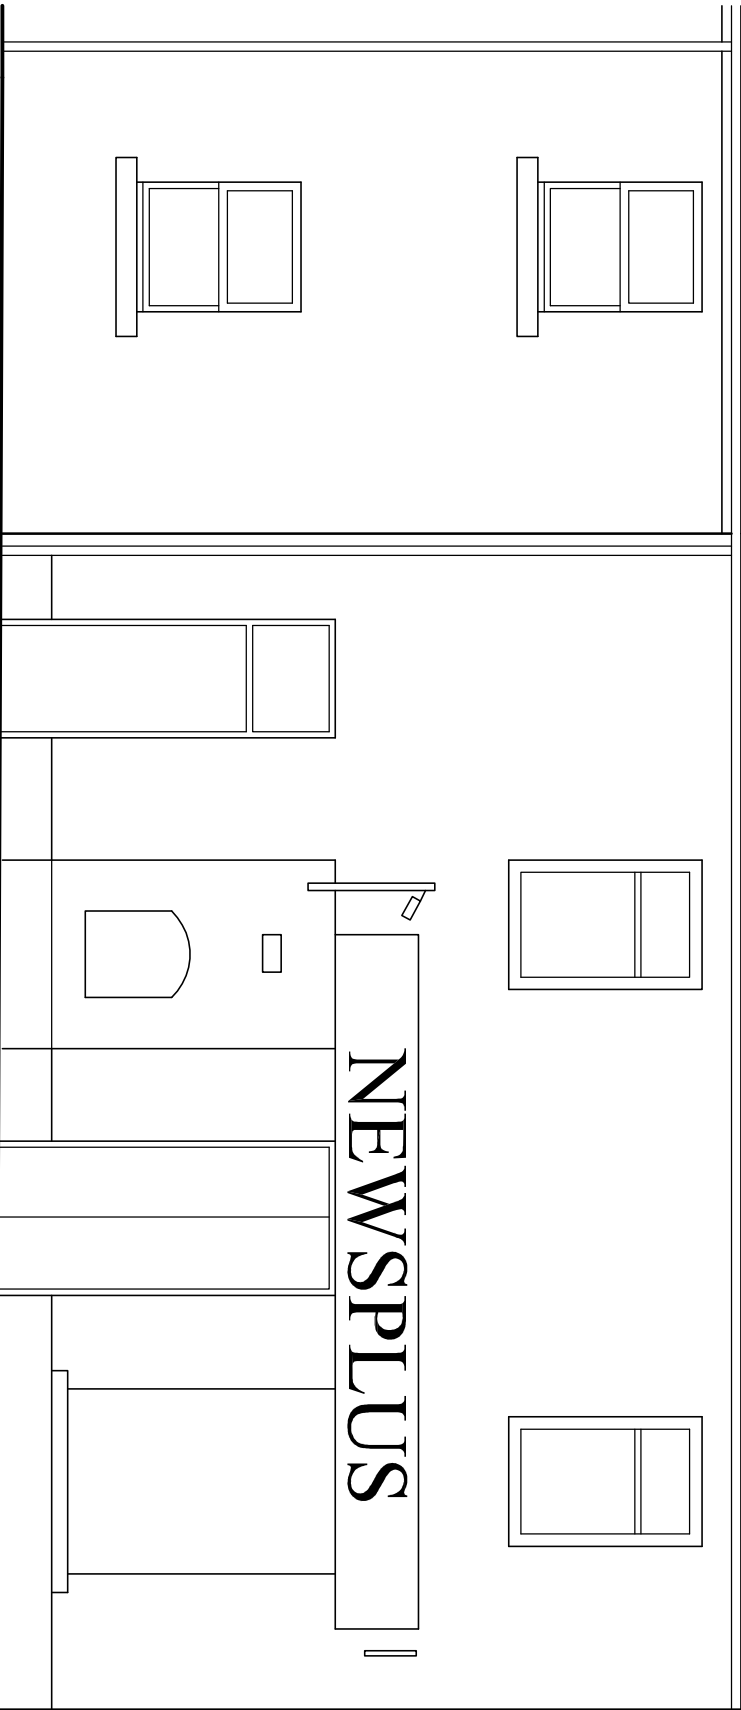
PROJECT REF		DRAWING REF	
DALMELLINGTON SHOP FRONTS		8 MAIN STREET: NEWSPLUS (VACANT)	
for Dalmellington Partnership			
June 2012			
SCALE: NTS			
Sonya Linskaill RIAS RIBA			
slinskaill@blueyonder.co.uk: 07906 250234

**DESCRIPTION:**  
Parent building:  
2-storey and attic end terrace. Rendered and painted masonry walls and slate roof.  
Windows all modern replacements. Entrance door to flat above to left side of shop with modern domestic door. Cash point machine in recessed bay between flat entrance and shop.

**Shopfront:**  
Single fronted shop with traditional tall timber flush panelled storm doors and seperate plain shop window (with temp. boarding as vacant).

**Signage:** redundant oversized modern plastic signage and hanging signs, one with light fitting.

**Recommendations:**  
short-term:  
1. Replace boarded window with alternative display/image.  
2. Remove any redundant items, signage, alarm etc.  
3. Fit timber fascia board ready for new occupant.
