EAST AYRSHIRE COUNCIL

# **Local Development Plan 2**

## Dalmellington Conservation Area Appraisal

Non-statutory Planning Guidance

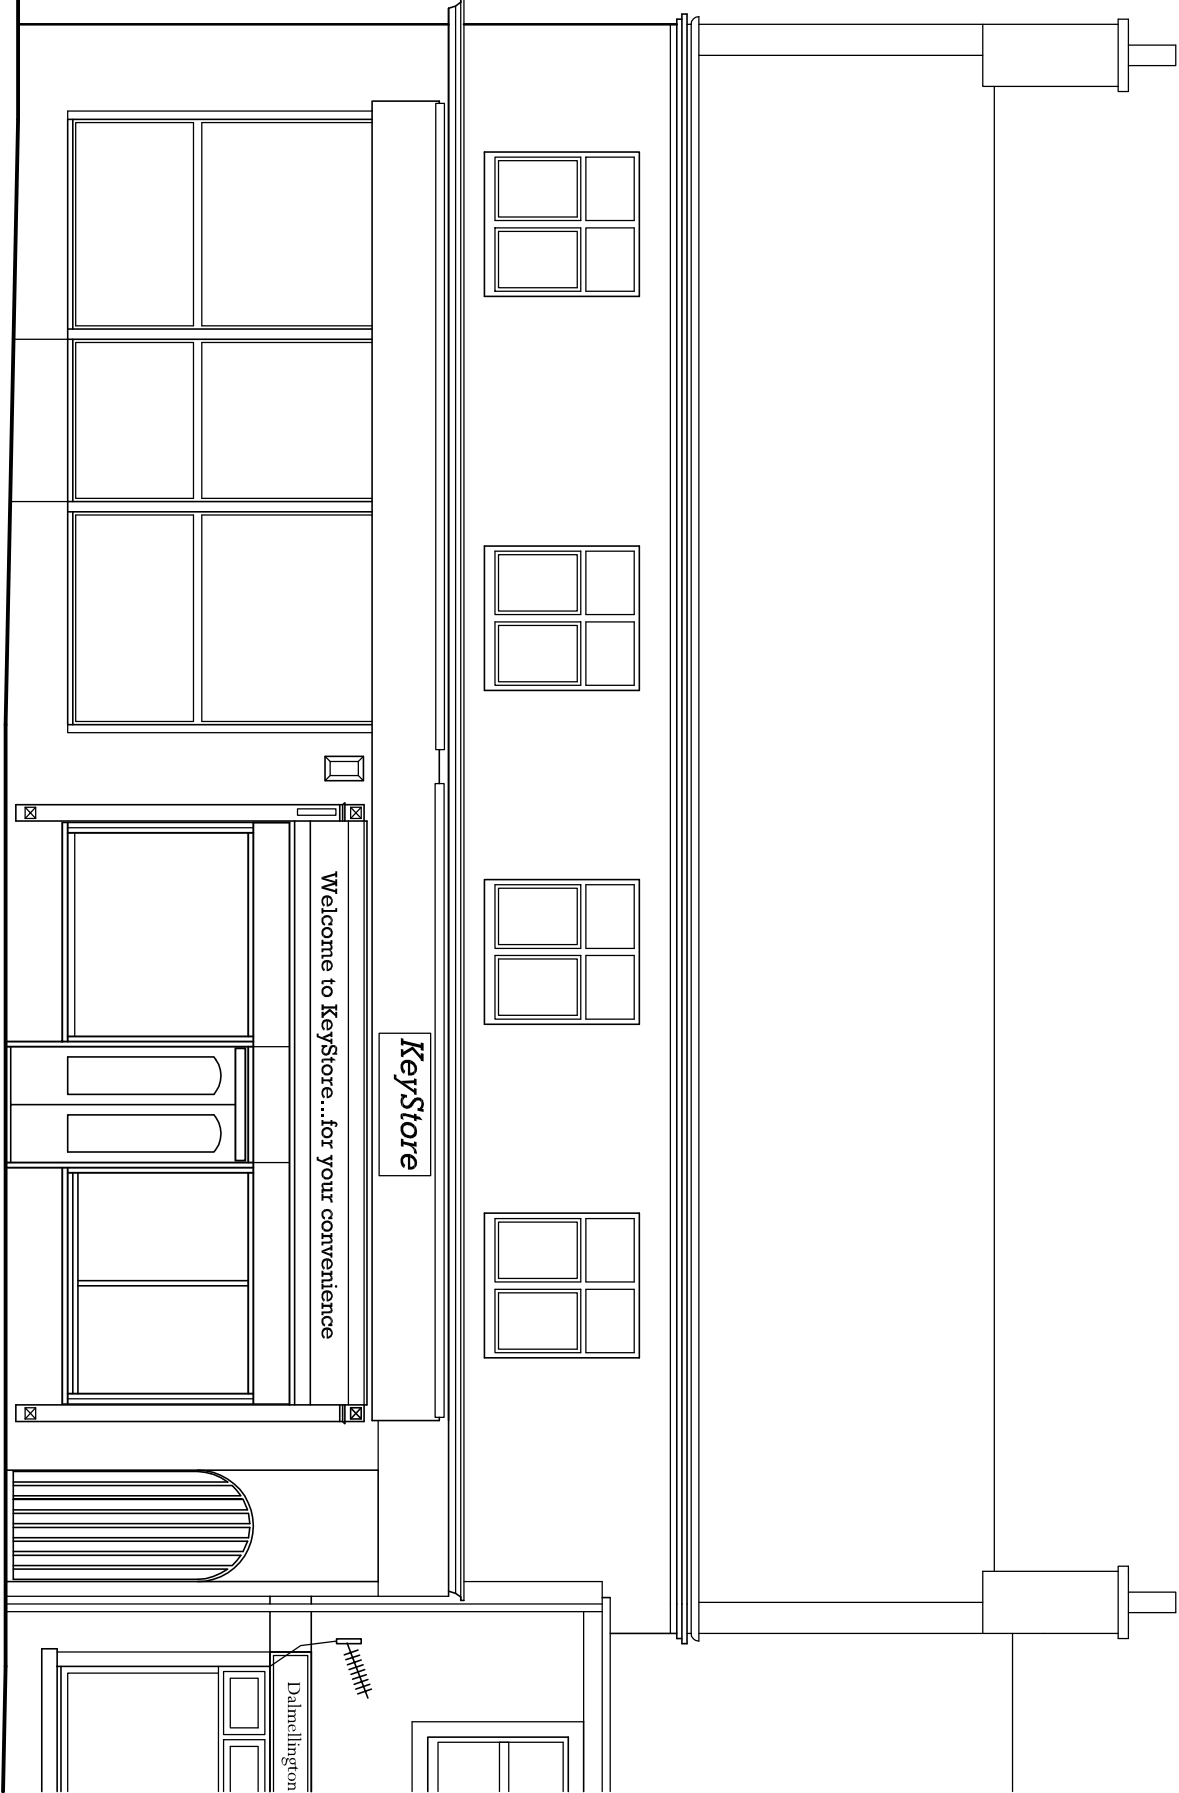
PROJECT REF		DRAWING REF	
Sonya Linskaill RIAS RIBA slinskaill@blueyonder.co.uk, 07906 250234		14 MAIN STREET: KeyStore AS EXISTING	
DALMELLINGTON SHOP FRONTS for Dalmellington Partnership		June 2012 SCALE: NTS

DESCRIPTION:  
Parent building:  
2-storey red sandstone building with slate roof. Close gate to right-hand side.  
Repair: water damage and staining to stonework and open joints at eaves level.

Security: roller shutters over windows and entrance door to right-hand side.

Window display: largely covered with advertising displays with no visibility into shop.

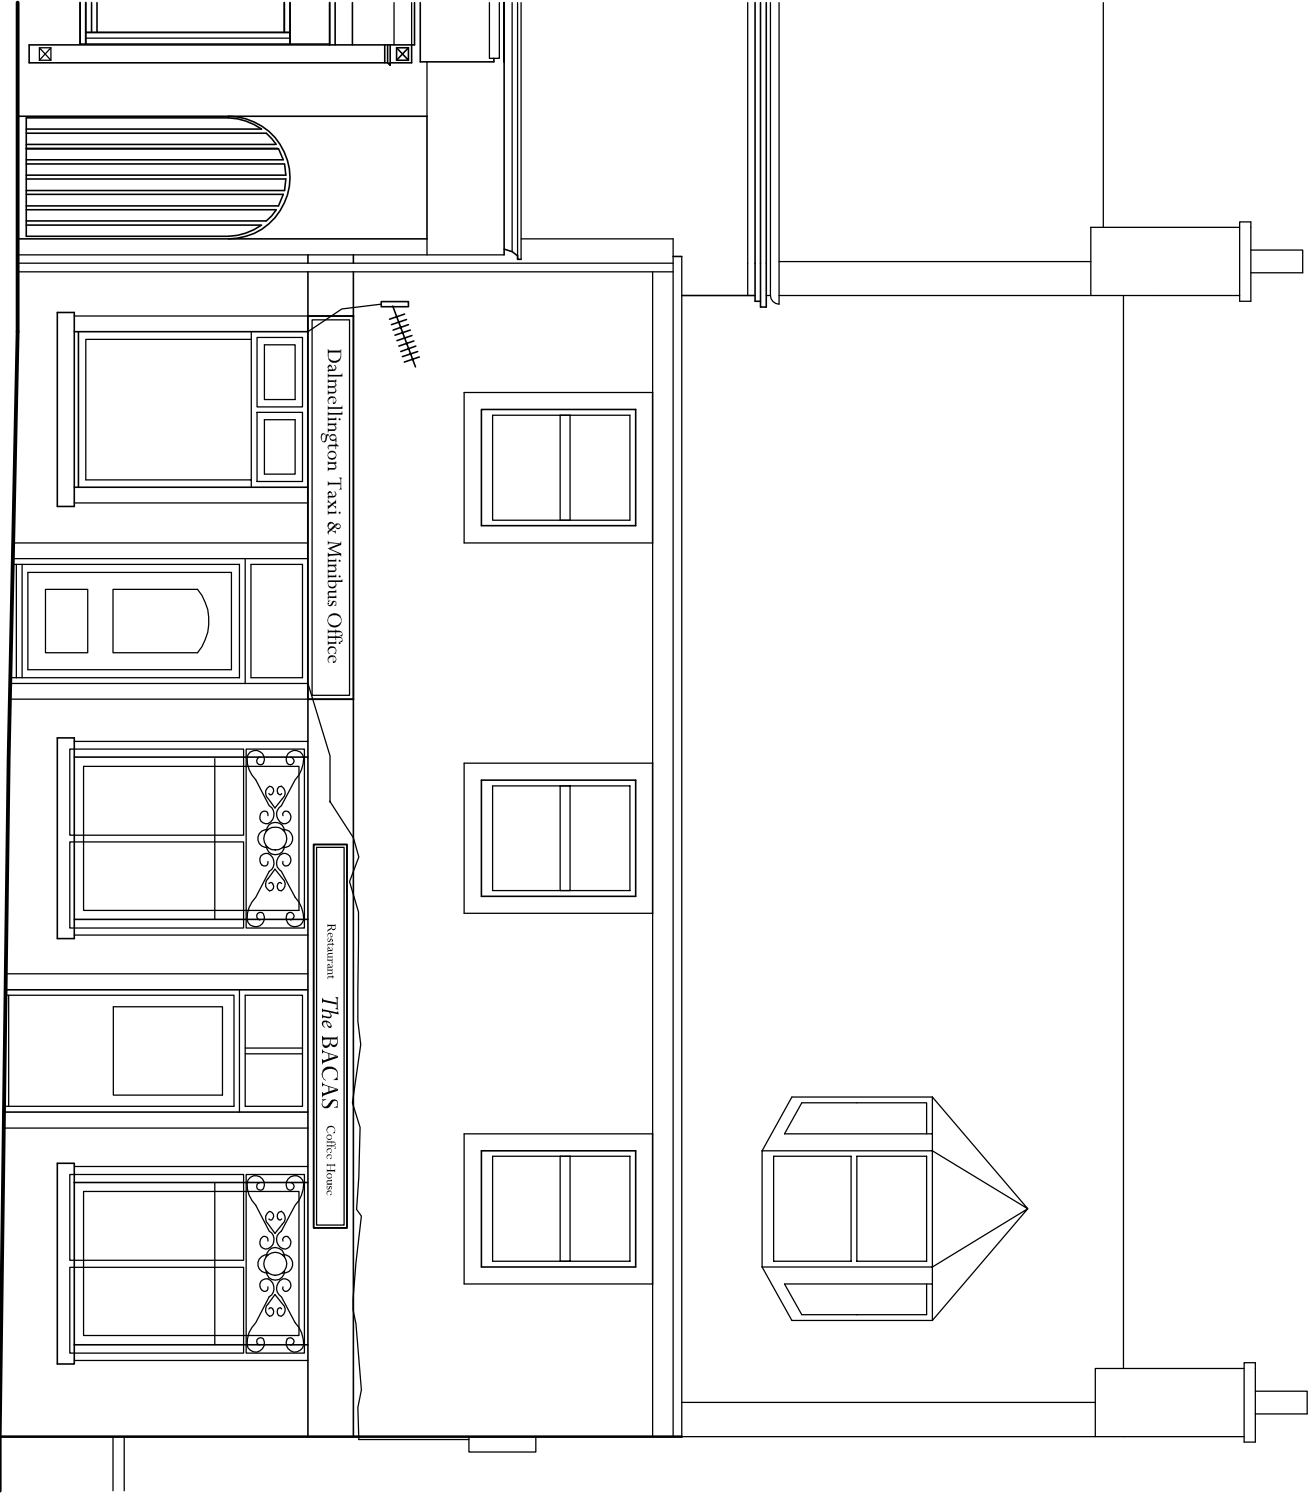
PROJECT REF	DRAWING REF
DALMELLINGTON SHOP FRONTS for Dalmellington Partnership    June 2012    SCALE NTS	18&20 MAIN ST:Taxi & Minibus Office & The Bacas Coffee House/Restaurant    AS EXISTING

DESCRIPTION:  
Parent building:  
2-storey and attic red  
sandstone building and slate  
roof.

Shopfronts:  
No 18: single-fronted shop with  
small window and single door.  
Replacement window with hopper  
vents and door are both brown  
upvc of domestic style. Door  
repositioned flush with frontage.

Security: original timber panelled  
storm doors with upper panels  
with pierced fretwork.  
Iron mesh security grilles with  
wrought iron work.

Window display: internal blinds.

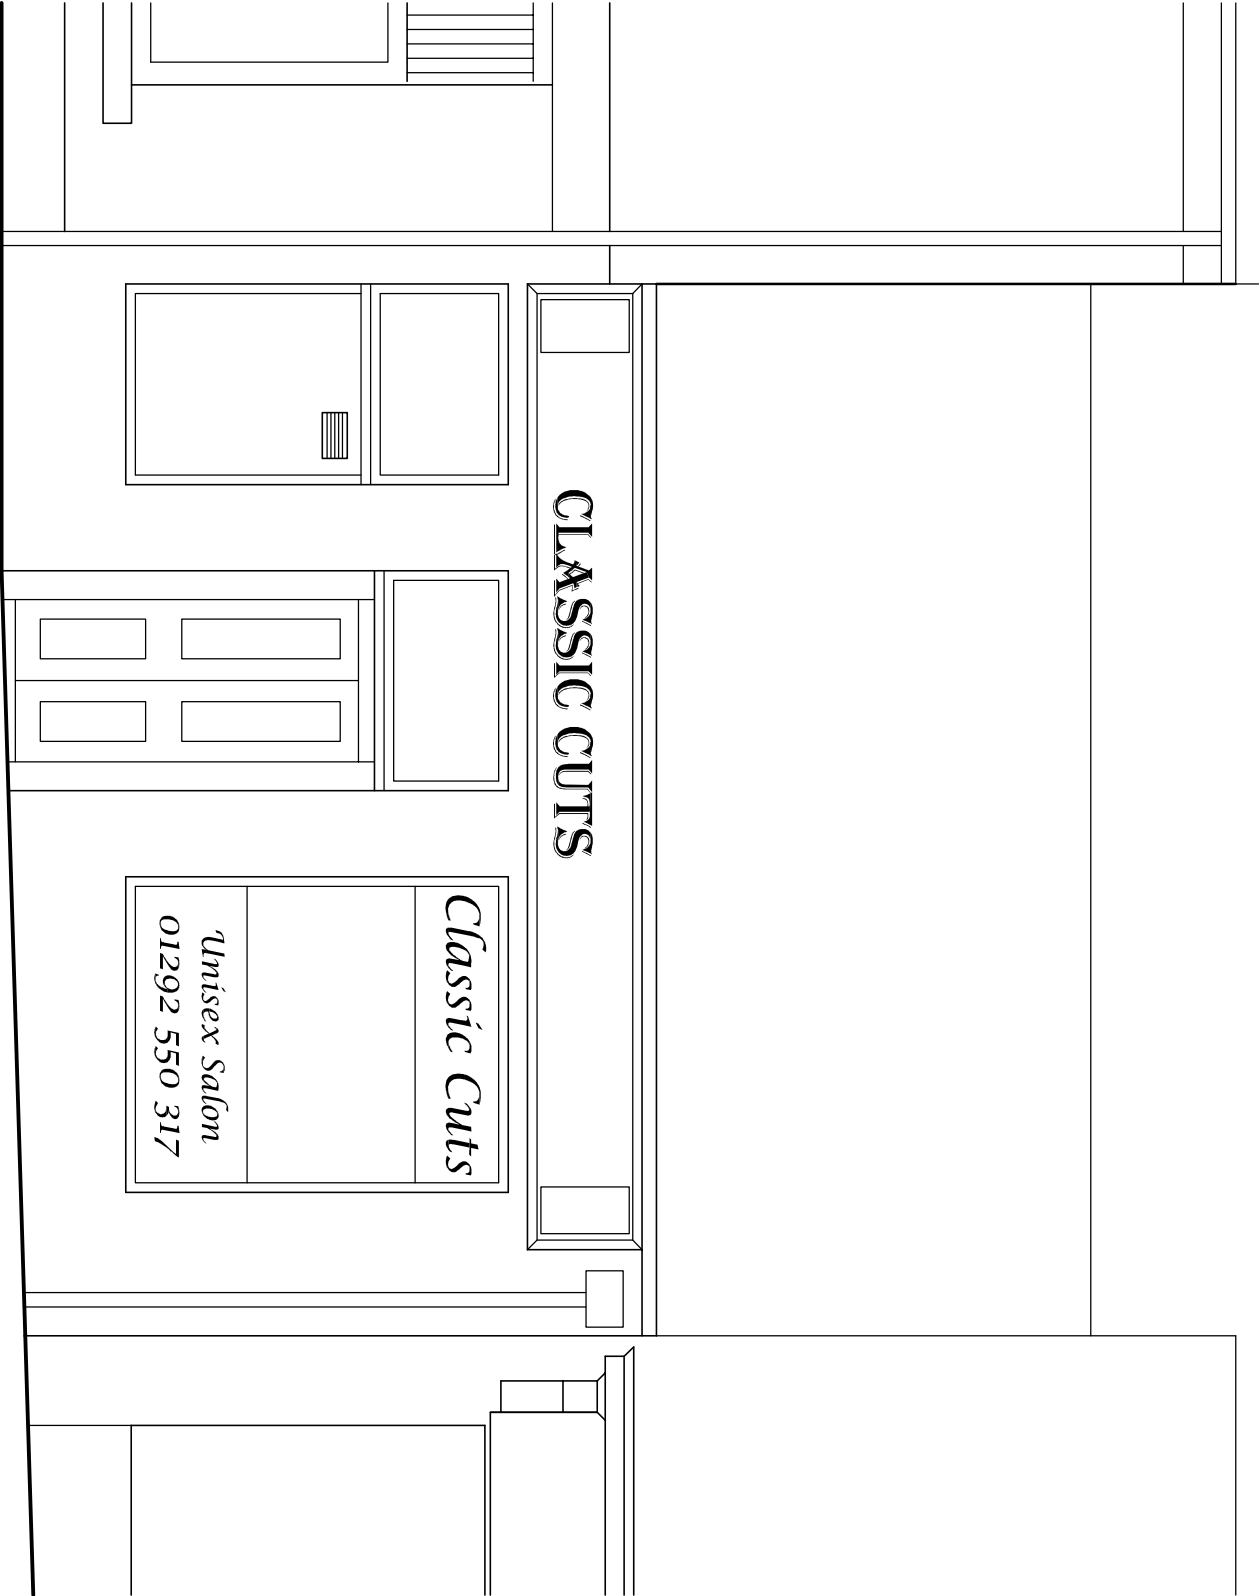
PROJECT REF		DRAWING REF	
Sonya Linskaill RIAS RIBA slinskaill@blueyonder.co.uk 07906 250234	DALMELLINGTON SHOP FRONTS for Dalmellington Partnership June 2012 SCALE: NTS	19 MAIN STREET: CLASSIC CUTS & GIBSON (VACANT) AS EXISTING

DESCRIPTION:  
Parent building:  
Single storey infill, bungalow shop. Pitched roof with mineral felt tiles. Stone walls, smooth rendered and painted.

Security: modern storm doors.

Window display: window to left-hand side has been blanked out and incorporates an extractor fan vent. Window to right-hand side has additional signage.

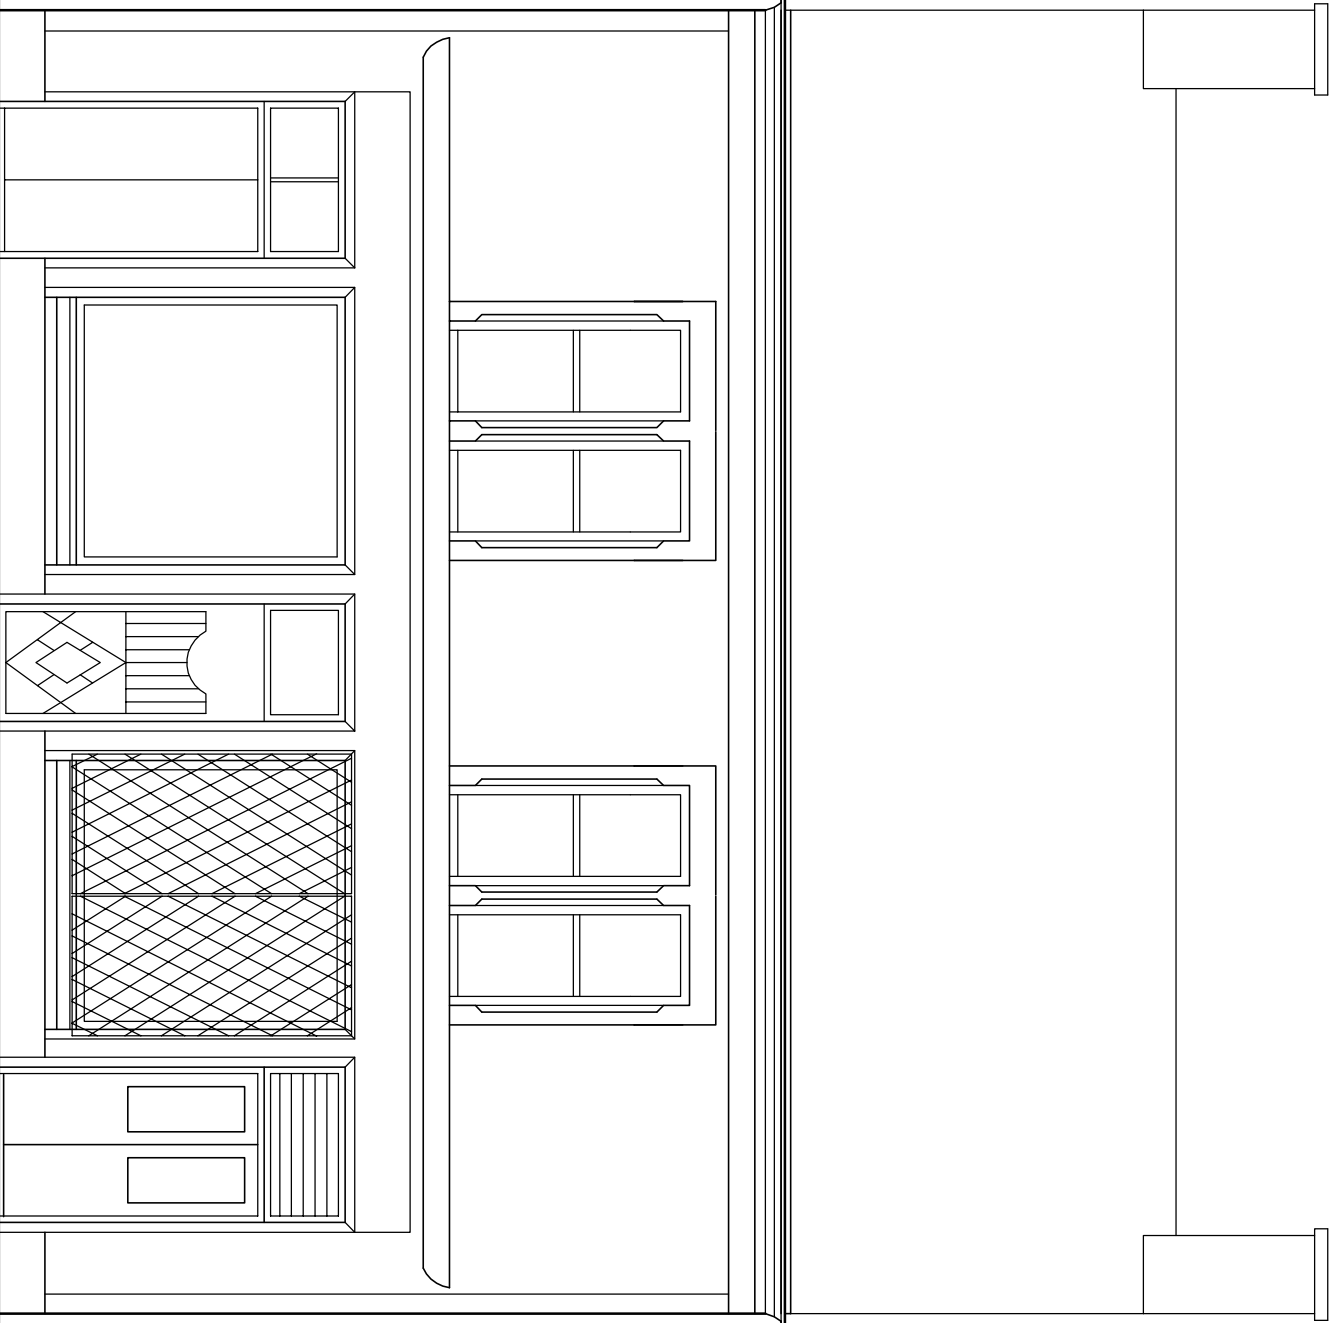
PROJECT REF		DRAWING REF	
Sonya Linskaill RIAS RIBA slinskaill@blueyonder.co.uk; 07906 250234		26 & 30 MAIN STREET N BELL & SONS & TAXI OFFICE AS EXISTING	
DALMELLINGTON SHOP FRONTS for Dalmellington Partnership June 2012 SCALE: NTS

DESCRIPTION:  
Parent building:  
2-storey detached building with slate roof. Pair of ground floor shops with central close. Painted wet dash render applied to facade with contrasting painted margins (brown and black). Historic damage and repairs evident at parapet level.

Security:  
No. 26: flush timber storm doors with original fanlight above.

No.30: replacement timber half-glazed doors; fanlight has been boarded up. Metal grilles applied over the windows.
