A BUILDING STONE AUDIT FOR KILMARNOCK

**Surveying, matching and sourcing
stone for the built heritage**

EWAN K. HYSLOP, LUIS J. ALBORNOZ-PARRA & EMILY A. TRACEY. 2009. A Building Stone Audit for Kilmarnock: Surveying, Matching and Sourcing Stone for the Built Heritage. *British Geological Survey Open Report*, OR/09/0002.

Surveys of the condition of the stone masonry in twenty-five buildings and structures in the John Finnie and Bank Street Conservation Area in Kilmarnock have provided information to guide forthcoming grant-aided repairs and inform future maintenance strategies. Stone samples from each surveyed structure have been characterised in order to identify the original stone types, and are matched to stone from currently active quarries to ensure that appropriate stone is used for the repairs.

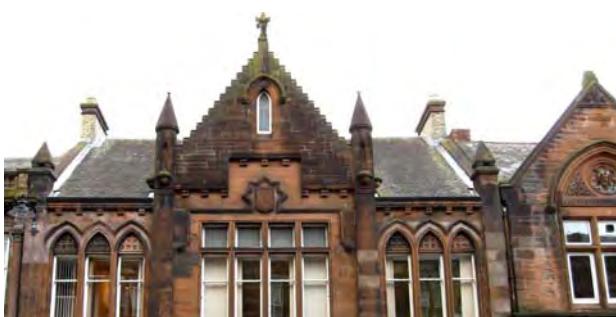
Fig. 11: General discolouration of a facade due to water penetration and dark organic soiling, with salts in parts of the masonry, and occasional blocks patched with cement (K15; Atrium Homes, John Finnie Street).

Almost every building and structure examined in the study shows some degree of damage to stone resulting from rainwater penetration. This ranges from staining and minor localised damage (e.g. K17 Victoria Wine; K15 Atrium Homes; Fig. 11) to more extensive stone decay (e.g. K19 Tannahills; K20 Paper Roses; K25 Goodfellows; Fig. 12). Damage due to water is most common on protruding masonry features such as cornices, string courses, sills, hoods etc., and particularly on the upper parts of buildings where features such as parapets and copesstones present horizontal and low-angle surfaces to rainwater.

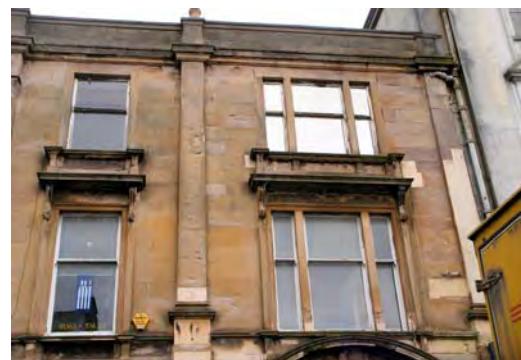
Fig. 12: General decay of masonry over large parts of façade due to long term water penetration. Some lighter patches represent cement repairs (K25; Goodfellows, West George Street).

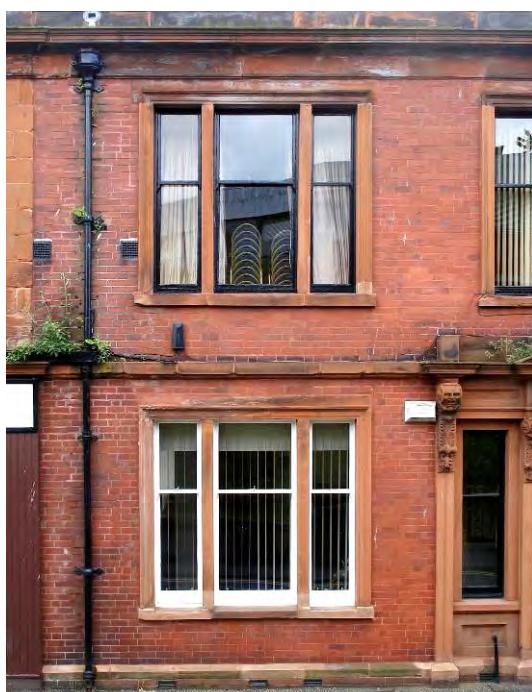
Fig. 13: Water penetration to exposed and prominent masonry (parapet, cornice, decorative stonework above entrance), showing organic soiling, salt staining and plant growth (K3; Kilmarnock Club, Dunlop Street).

It is also particularly apparent on protruding decorative elements and carved work, such as above entranceways (e.g. K14 Laigh Kirk; K3 Kilmarnock Club; Fig. 13). Such water penetration is commonly associated with dark organic soiling of the stone surface, which develops due to persistent moisture within the stone.

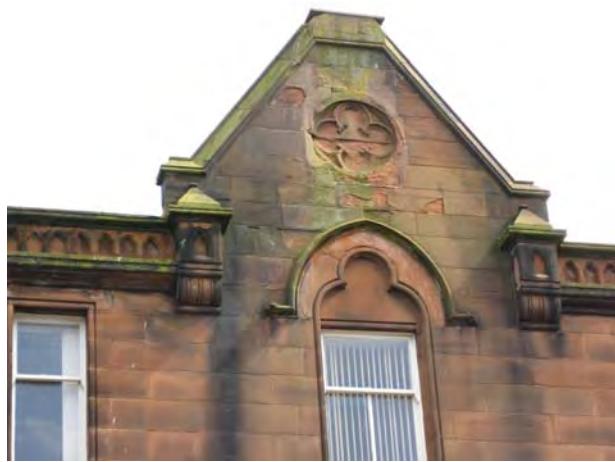
Fig. 14: Soiling and scaling of masonry due to water penetration. Note cement patch repairs above and around quatrefoil detail which may have increased the rate of decay in adjacent stone (K17; Victoria Wine, John Finnie Street).

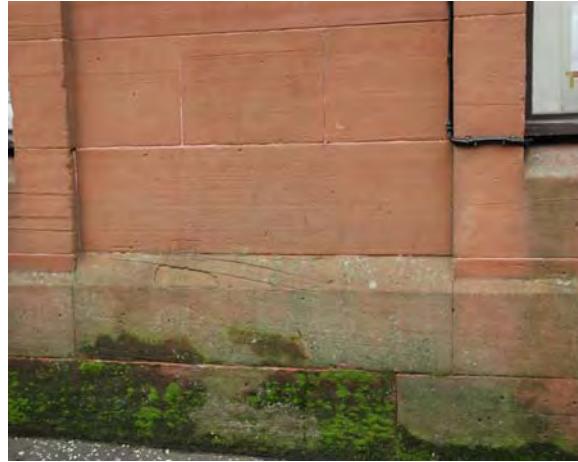
Fig. 15: Water penetration and soiling of basal masonry courses adjacent to the pavement. The increased amount of water evaporation is causing stone decay by scaling of the masonry surface (K1; Whites, 60 Bank Street).

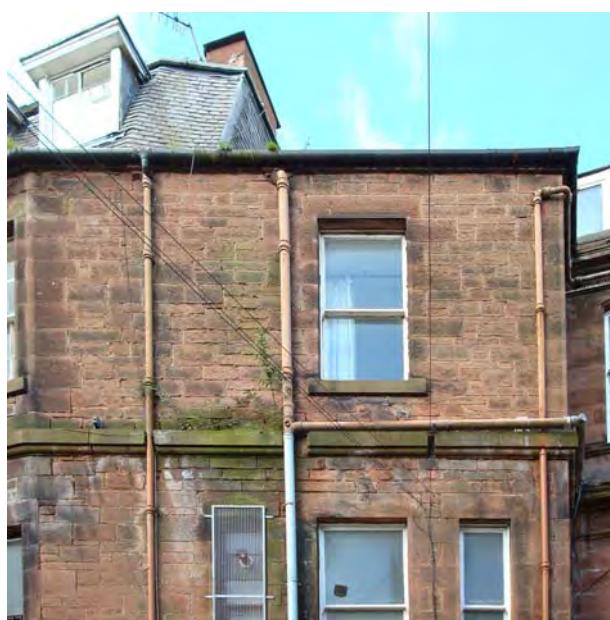
A consequence of continual saturation of the masonry is the opening up of mortar joints due to dissolution of mortar, commonly allowing mobilisation of salts into the stones (Fig. 16). Where open joints allow plants to become established the root systems can exploit saturated mortar, resulting in further opening of the joints and increasing water penetration as they grow (e.g. K11 Opera House) (Fig. 17: K21 Balti House).

Fig. 16: Damage to stone masonry resulting from lack of maintenance. The gutter is blocked with vegetation growth, resulting in water running down face of the building causing erosion of pointing, water saturation and green soiling of the prominent central band course. The open joints are being exploited by higher plants, and the washing-out of the mortar is introducing white salts into the underlying masonry (K10; Allen & Harris, Strand Street Lane).

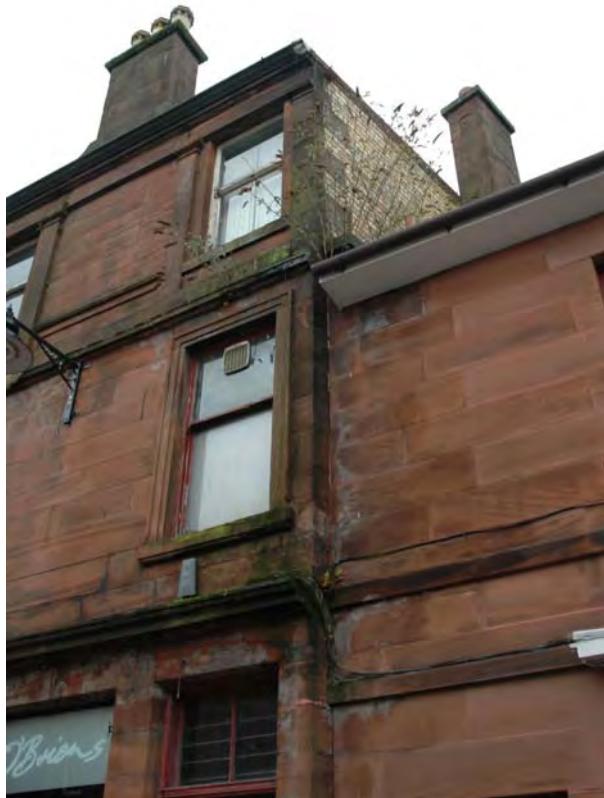
Fig. 17: Failed rainwater goods resulting in the growth of higher plants and saturation of the underlying masonry with white salts. (K21; Balti House, 108 John Finnie Street).

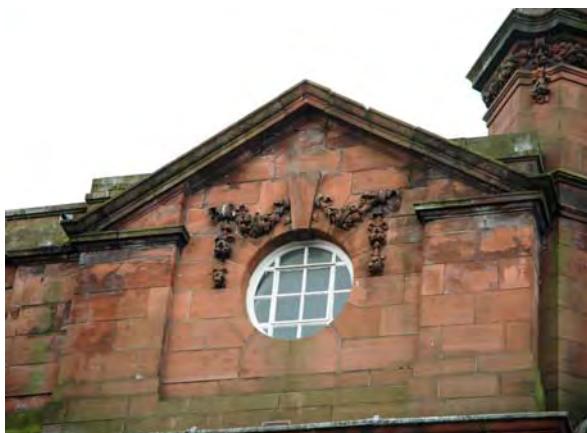
cases, in particular where maintenance has been poor, water can have penetrated beyond (through) these protective elements and into the underlying ashlar stonework which is now in need of repair (e.g. K10 Allen & Harris) (Figs. 18 & 19). In a number of buildings water penetration to cornices has resulted in deterioration of the underlying dentils which are in very poor condition (e.g. K24 Johnnie Walker building).

Fig. 18: Organic (green) soiling of exposed masonry adjacent to prominent and horizontal masonry surfaces. Downwards penetration of water into the stonework underlying the cornice and copestones has led to accumulations of white salts and scaling of the stone surface. The copestones show damage to the drip detailing and also require repointing (K18; 73 John Finnie Street).

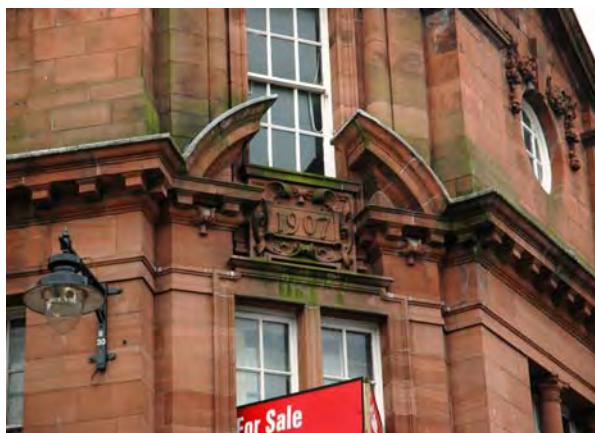
Fig. 19: Organic soiling of masonry adjacent to prominent and horizontal masonry surfaces where water has accumulated. Note that the upper surface of the cornice has lead flashing which prevents water penetration and protects the underlying stone (K18; 73 John Finnie Street).

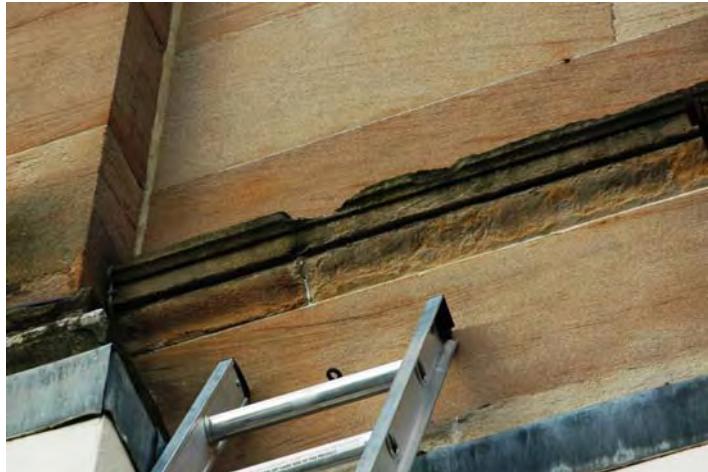
The vulnerability of permeable sandstone which has been used for prominent and water shedding elements underlines the importance of good maintenance. Physical damage to specific elements such as the drip detailing on moulded string courses can also lead to damage to the underlying ashlar masonry (Fig. 20). In many of the surveyed buildings parts of these water shedding features are no longer functioning correctly to protect the adjacent masonry and are in need of replacement. Relatively recent repairs to the railway station (upper building) have involved the application of lead flashing to horizontal surfaces (parapet and cornice), enabling these water shedding elements to function correctly and allow the underlying stone to remain dry.

Fig. 20: Damaged string course on façade with broken drip detailing allowing water to run onto the underlying masonry, causing stone decay (Building K22; Mason Murphy, Portland Street).

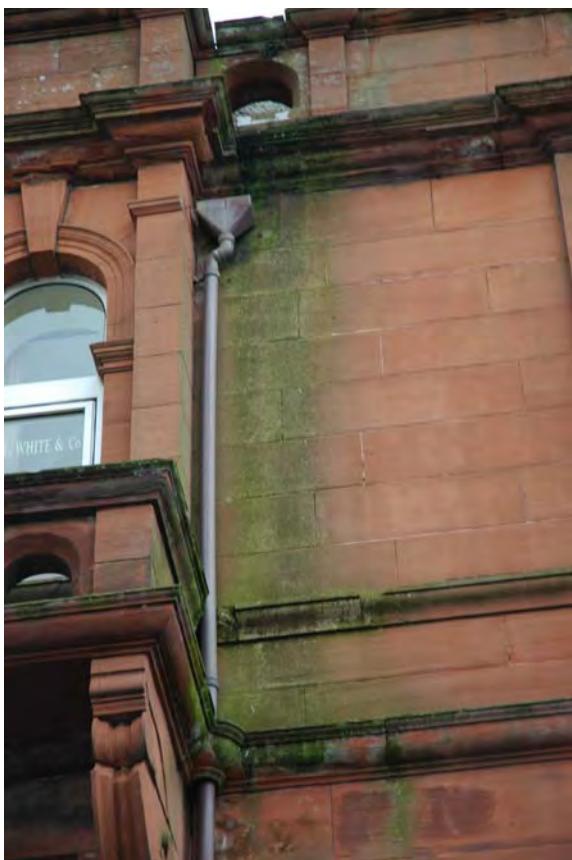
Fig. 21: Defective rainwater drainage from a parapet gutter leading to saturation and soiling of the underlying masonry. The stonework on the upper cornice is badly decayed as a result of the water saturation with splitting of the stone and loss of prominent elements. Note the damaged drip detailing on the string course (Building K1; 60 Bank Street).

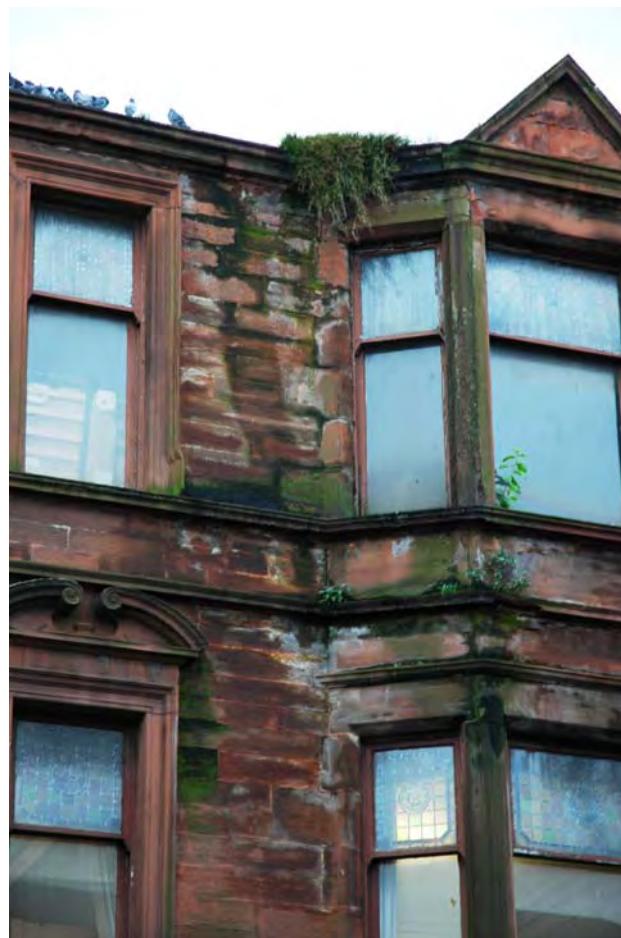
Fig. 22: Severe water penetration caused by blocked rainwater goods. Saturation of the underlying masonry has led to intense organic soiling and growth of higher plants, and development of white salts within the stone. This level of damage indicates that the water penetration has probably been occurring over a long period of time, likely to result in internal dampness to the building (Building K19; Tannahills, 75 John Finnie Street).

A significant problem observed in many buildings is excessive water penetration due to failing rainwater goods, normally resulting from lack of maintenance (e.g. blocked or broken gutters and downpipes, or problems with parapet gutters and internal drainage). Such problems typically concentrate large volumes of water into localised parts of the masonry, which is unable to cope. Damage to stone resulting from failed rainwater goods is observed in a number of buildings (e.g. Fig. 21: K1 Whites; Fig. 22: K19 Tannahills; Fig. 17: K21 Balti House; K12 Handling Hair), and in the most severe cases it is clear that these problems have been occurring for a long period of time. Where saturated, the masonry is likely to show biological growth and soiling, with white salts typically precipitated in areas where continual wetting and drying of the masonry is occurring. Scaling of the stone takes place where the level of water evaporation is enhanced, and granular disintegration occurs where accelerated wetting and drying results in the formation of salts. It is important to note that damage to masonry from defective rainwater goods can be relatively easily and cheaply avoided by regular maintenance.

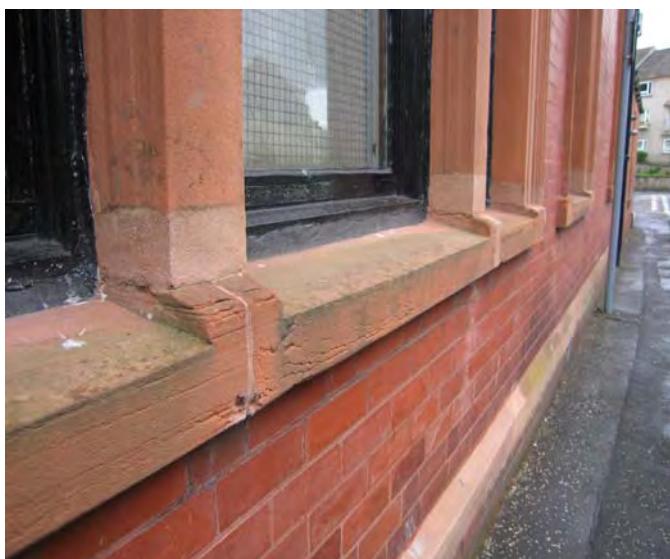
Fig. 23 Decay to red sandstone sills due to splitting along bedding planes. Note coloured cement repairs to the base of mullions (K3 Kilmarnock Club, John Dickie Street).

Some prominent horizontal masonry elements such as sills, cornices and string courses show splitting along natural bedding planes (e.g. Fig. 23). This occurs where such features have been water saturated over a long period of time. The Mauchline sandstone in particular is generally strongly bedded, and internal contrasts in grain size and porosity/permeability between the beds can result in planes of weakness which, where relatively poorly supported in prominent masonry elements, can be prone to failure. The presence of excess moisture in the stone greatly increases the likelihood of the stone splitting along the bedding.

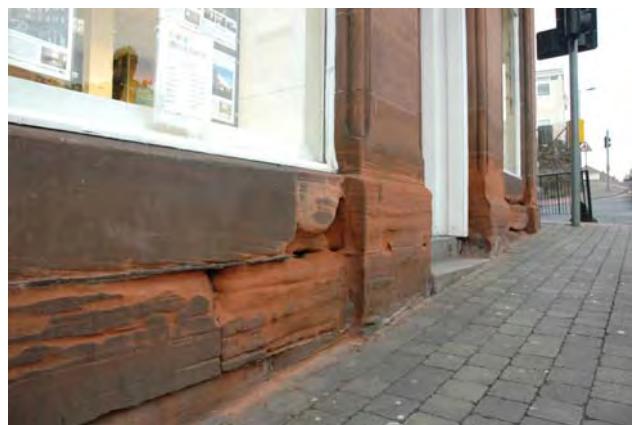
Fig. 24: Severe damage to lower masonry courses caused by contamination from de-icing salts used on the pavement. The most intense damage is adjacent to the block margins where water is transported along the mortar joints and penetrates into the adjacent stone. Evaporation of water then causes the salts to crystallise out within the pore spaces of the stone, resulting in granular decay (Building K10; Allen & Harris, West George Street).

- ii. Salt splash due to contamination of stone from de-icing salts on roads and pavements, typically seen in basal masonry courses and around entranceways. Salts are dissolved in rainwater and drawn into the porous sandstone where they precipitate within the pore spaces of the sandstone causing granular disintegration. This can be a very destructive process, resulting in severe damage to masonry (e.g. Fig. 24; K10 Allen & Harris).

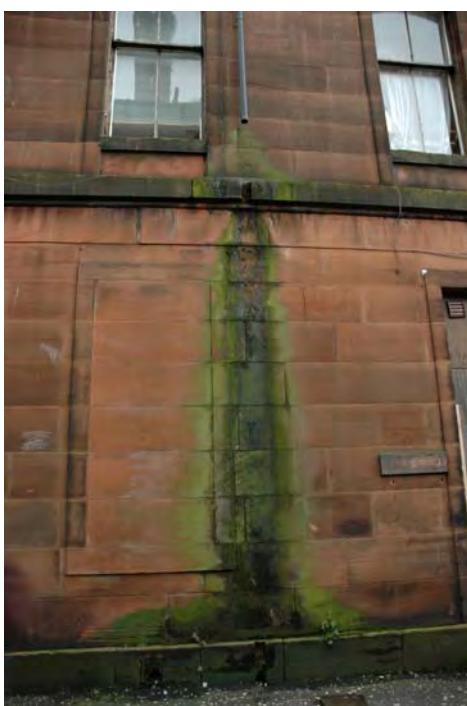
Fig. 25: Broken downpipe producing intense water saturation of the masonry with severe organic soiling. The sandstone is unable to cope with this level of moisture and will undergo relatively rapid stone decay, unless the issue is addressed (K20; 100 John Finnie Street).

Soiling is best treated by eliminating the source of the problem, in most cases prevention of water penetration, by reinstating or maintaining rainwater goods and ensuring run-off at the base of the building. It can then be allowed to dry and eventually removed by brushing. The application of biocides and other more aggressive treatments may not be necessary.

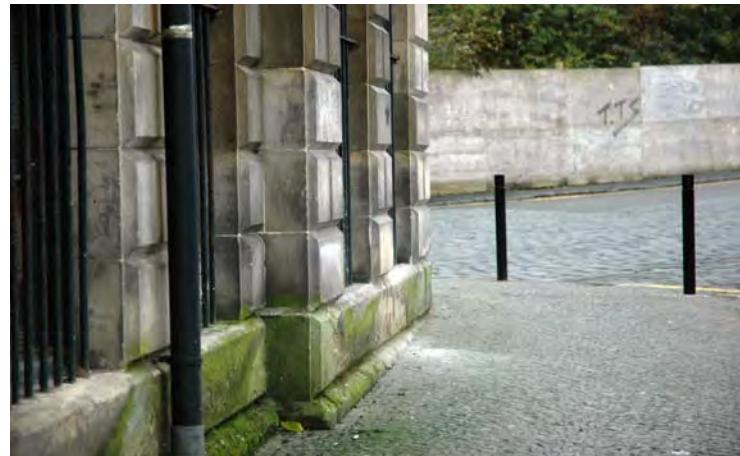
Soiling is also commonly present on lower masonry courses where water splash and/or rising damp has introduced moisture into the stone, particularly where drainage is limited by impermeable paving surfaces (e.g. Fig. 26). Over time, the presence of soiling can impede evaporation of moisture in the stone, leading to stone decay. In several buildings soiling is present resulting from bird colonisation, in particular pigeon droppings (guano) which can cause chemical damage to the stone.

Fig. 26: Organic soiling to damp basal courses of masonry caused by water ingress from the pavement (K24; Johnnie Walker building, Croft Street).

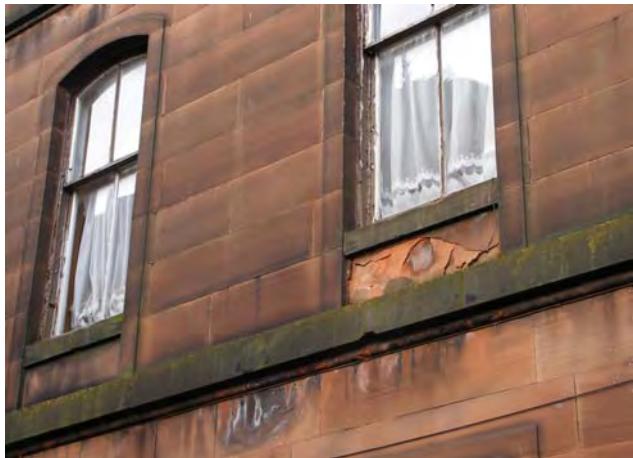
Fig. 27: Face bedded stone beneath window sill showing spalling of bedding layers (K20; Paper Roses, John Finnie Street).

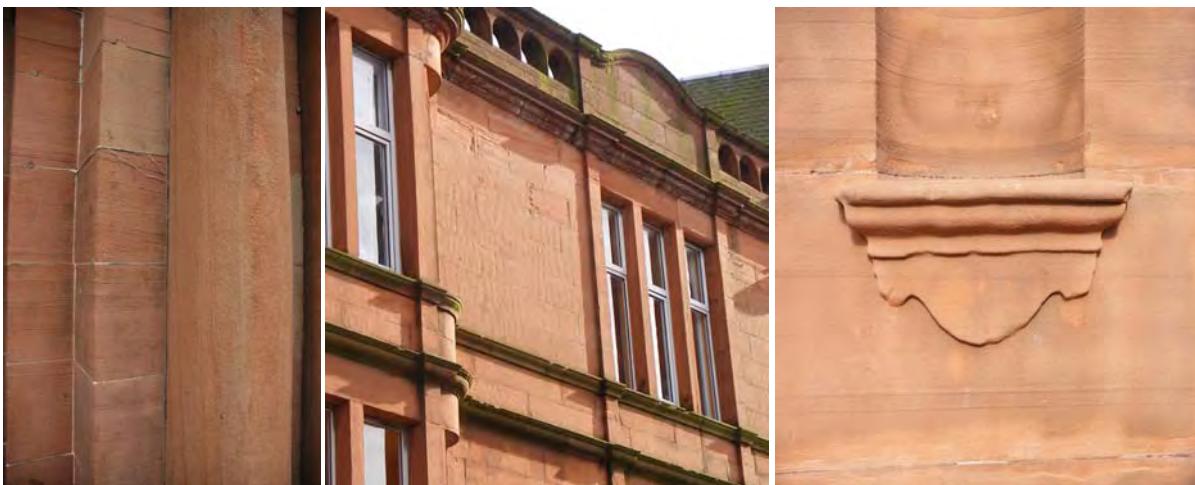
A number of surveyed buildings (7) show evidence of previous stone cleaning. No records have been found regarding the cleaning methods used (e.g. chemical or abrasive), although the roughened and etched surfaces of (previously smooth) masonry indicates mostly abrasive cleaning by grit blasting (Figs. 28 & 29). Several buildings show evidence of over-aggressive cleaning which has resulted in loss of carved details and the rounding of previously sharp edges, reducing the quality of the masonry and degrading the appearance of the buildings (Fig. 30).

Fig. 28 (LEFT): Masonry that has been cleaned by abrasive methods (probably grit-blasting) showing etching of the once smooth masonry surfaces and loss of sharpness to the edges and moulded details (K11; Opera House, 6 John Finnie Street).

Fig. 29 (CENTRE): Damage to masonry caused by abrasive stone cleaning, leading to loss of the smooth ashlar surface and an overall reduction in the architectural quality and appearance of the building (K1; 60 Bank Street).

Fig. 30 (RIGHT): One of the effects of former stonecleaning; a loss of sharpness to carved ornamental details, leading to a reduction in the quality of the architecture (K1; 60 Bank Street).

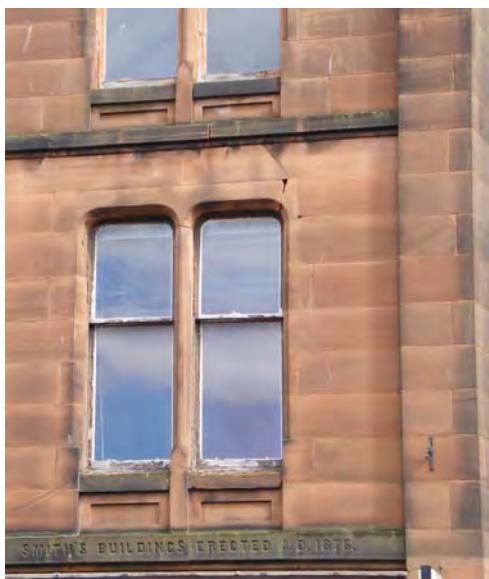
Fig. 31: Cracks to stone lintel and overlying ashlar block (K20; Paper Roses, John Finnie Street).

A number of the surveyed buildings have masonry which is considered to be in urgent need of attention. These represent a variety of problems, for example cracks due to structural movements where broken stone could become detached (e.g. Fig. 31), or where defective rainwater goods have led to long-term saturation of stone resulting in masonry which is unsound (e.g. decay of dentils beneath saturated a cornice). In a number of buildings loose cement pointing or cement ‘plastic repairs’ has been observed, resulting from water trapped behind the impermeable cement causing the stone to decay. All areas designated as unsafe masonry are highlighted on the digital survey sheets, and EAC has been notified of these problems in advance of this report.

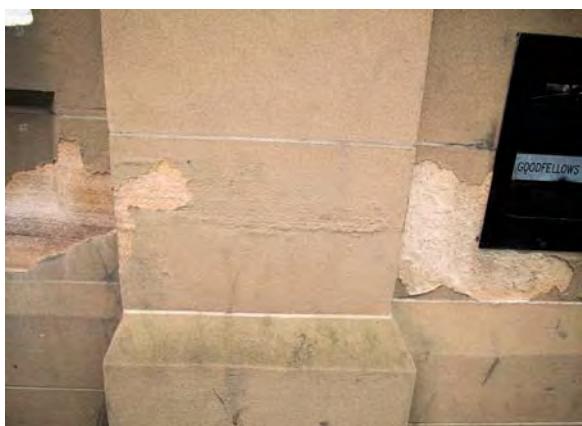
A number of buildings have plastic cement repairs and painted masonry, including epoxy-based coatings (commonly known as ‘linostone’). Where these impermeable materials have been used the adjacent stone commonly shows damage due to increased water runoff, and the underlying stone appears weak and decayed due to trapping of water behind the coating (e.g. Fig. 14). An epoxy-based coating has been used on parts of the ground floor masonry of the Goodfellows building (K25), which is now showing blistering and detachment (Fig. 32). Overpainting of the lower cornice on the southern part of the Johnnie Walker building (K24) is now flaking, revealing highly friable stone underneath where water has been trapped (Fig. 33). Although it is likely in many cases that the plastic repairs were applied as a ‘cosmetic’ solution to already damaged masonry, it is apparent that these products have a relatively short life and are likely to result in increased stone decay.

Fig. 32: Detachment of epoxy-based coating, revealing damaged stone underneath (K25; Goodfellows, West George Street).

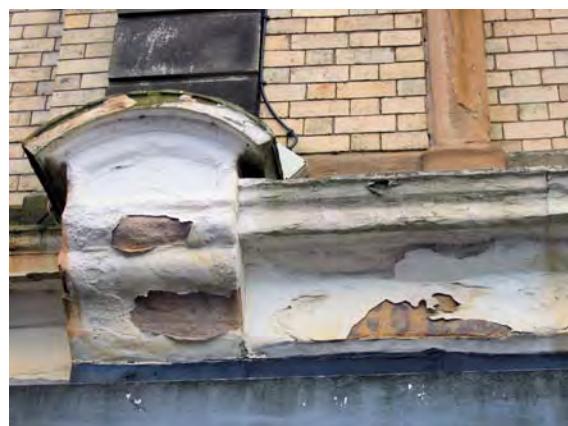
Fig. 33: Flaking of paint showing badly decayed stone underneath (K24; Johnnie Walker, Strand Street/John Dickie Street).

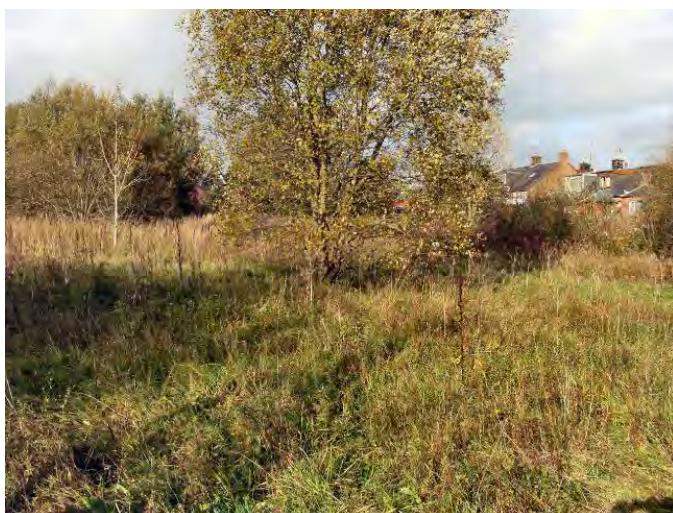
Fig. 46. Image from 2008 showing the infilled quarry at Ballochmyle (west of Haugh Road) in Fig. 45 (note the buildings are the same as those in the previous figure).

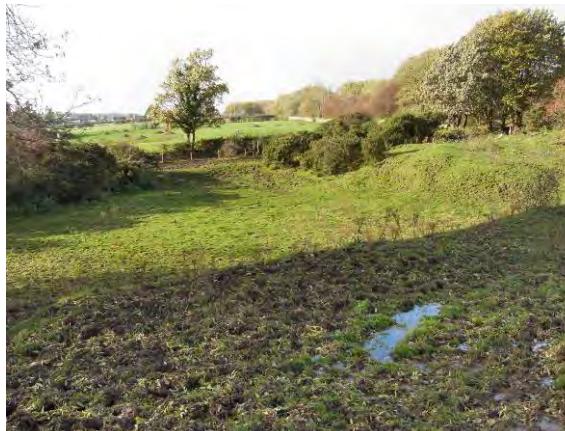
Today the Ballochmyle Quarries are closed and infilled. The site of Haughyett Quarry is a hollow with scrub vegetation and arable fields (Fig. 48). Much of the area is now quarry spoil up to 8 m thickness in places (Fig. 49). The Ballochmyle Quarries north of the railway lines are completely infilled, forming scrub land and fields for livestock. No exposures of stone remain at any of the sites.

Fig. 48. Haughett quarry (east) in 2008. The quarry is almost completely infilled and no stone is exposed.

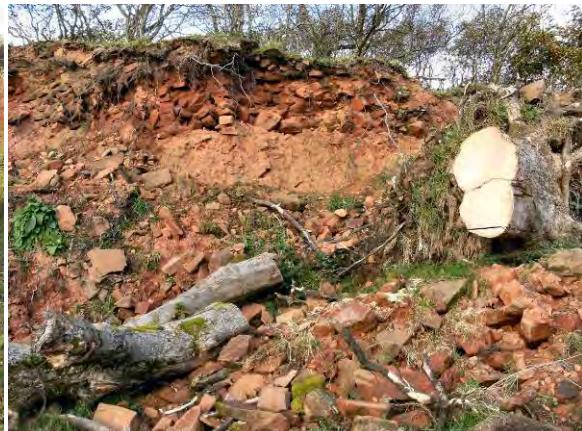
Fig. 49. Part of Haughett quarry (east) in 2008, showing recent trial excavation revealing extensive infill of red sandstone quarry spoil. Most of the stone is too small to be of use for building purposes, and no bedrock is exposed.

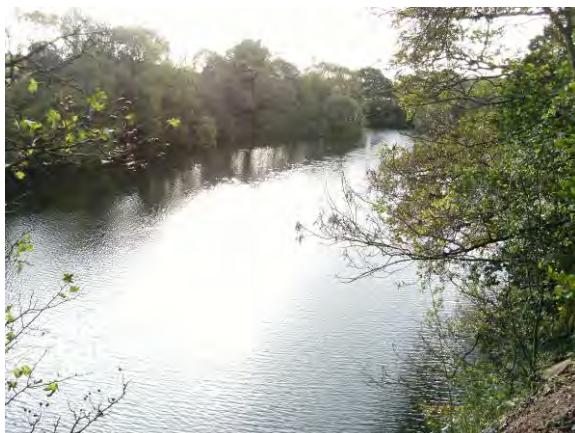
Fig. 50. Barskimming quarry near Mauchline in 2008. The quarry is completely flooded and the former faces are inaccessible.

The Barskimming quarry, about 1km southwest of Mauchline, is shown on the 1860 Ordnance Survey map as an ‘old freestone quarry’, and is not marked on the 1897 edition. However, by 1911 the quarry appears reopened and much expanded. It is likely that the earliest quarrying at Barskimming predated the railways (it may have supplied building stone for Mauchline village), and the quarry was reopened in the late 19th century as the market for Mauchline sandstone increased. Today the quarry is abandoned and exists as a large water-filled hole (Fig. 50).

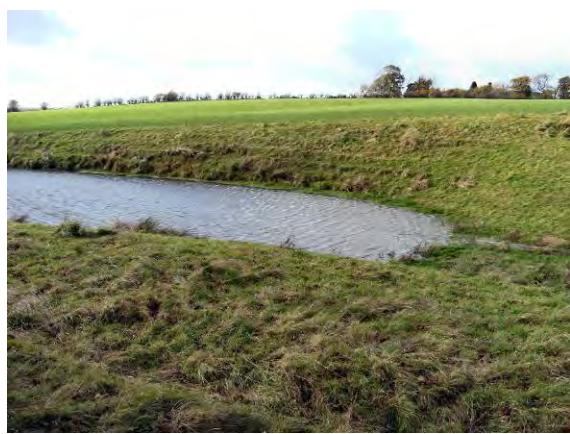
Fig. 51. Grassmailees quarry in 2008, now partially infilled and flooded, with no stone exposed. The quarry site is now agricultural land.

These two quarries are recorded on the early Geological Survey map from the late 19th century (Fig. 52). Grassmailees (alternatively spelt Grassmillees) Quarry is a small quarry situated approximately 2.5 km to the southeast of Mauchline [NS508263]. Unlike the others it is located away from the railway (which it probably predates) and it is unlikely ever to have developed as a major quarry. It is shown as a freestone quarry on the 1860 Ordnance Survey map, but is not present on the maps after 1897. Today no stone is exposed and the site forms a flooded depression in an area of open fields (Fig. 51).

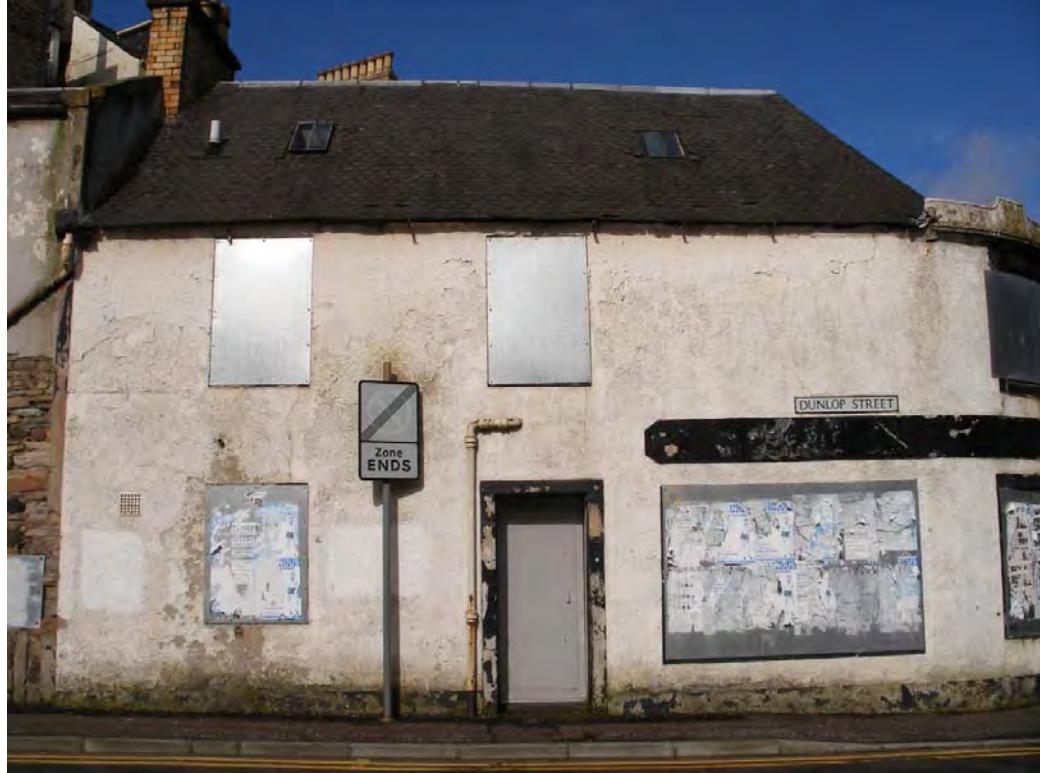
K2 Harled cottage 1 Dunlop Street

Comments: (Description for adjacent building) Previously harled. Rainwater goods all defective resulting in water penetration to entire façade. Sandstone shows some surface scaling and granular decay (due to water penetration) but much can be dressed back to sound stone. Occasional sandstone blocks are face bedded. Blonde freestone dressings are relatively soft and have weathered back (granular disintegration). If building is to be re-harled them much of the existing masonry can probably be retained as most of rubble is in relatively good condition, although some replacement of weathered sandstone will be required. Pale sandstone dressings (in particular window surrounds) are badly decayed in places. Areas of brick repairs are present where stone dressings have failed (e.g. to window surrounds).
--

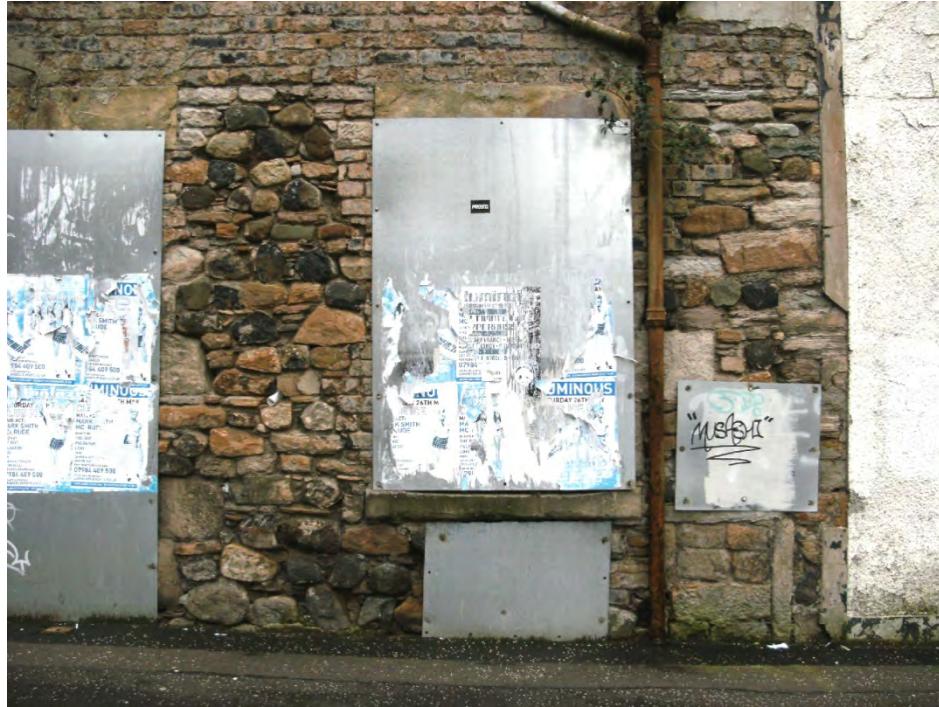
Rubble wall to building immediately adjacent to 1 Dunlop Street (harled building to right-hand side), showing mixture of stone types built as random rubble.

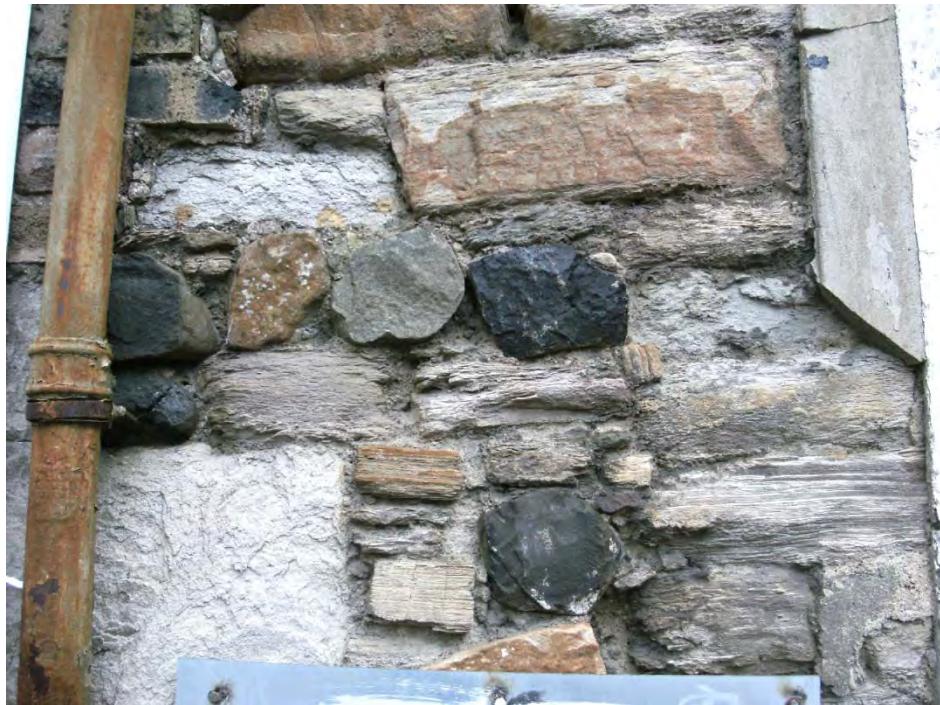
Detail of rubble wall adjacent to 1 Dunlop Street, showing elongate blocks of bedded sandstone (pale colours weathering to orange) and rounded boulders of split basaltic rock (whinstone) of black to grey colour). The sandstone is of relatively poor quality and shows extensive scaling and granular disintegration.

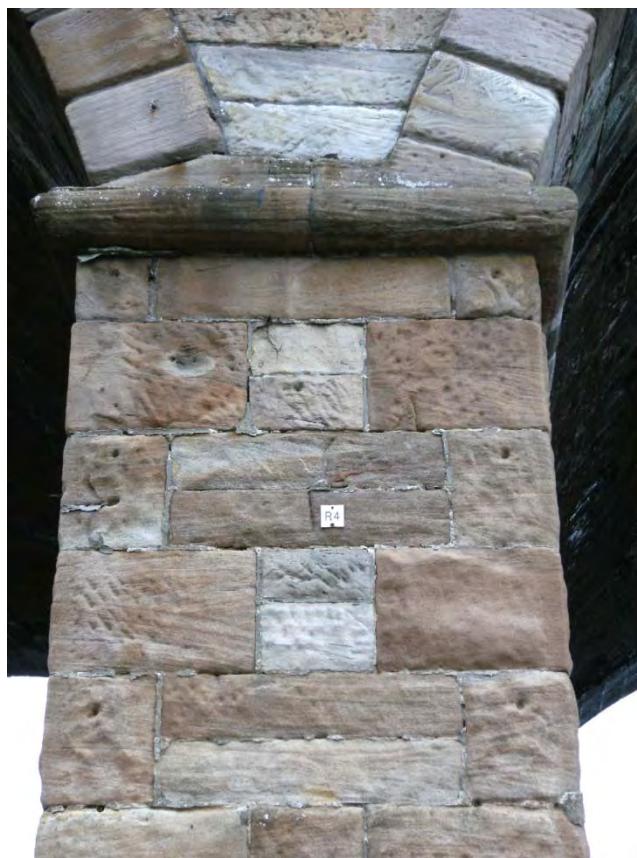
Detail of arch showing the variation of sandstone colours present. Note the condition of the cement pointing, much of which is loose and some is missing.

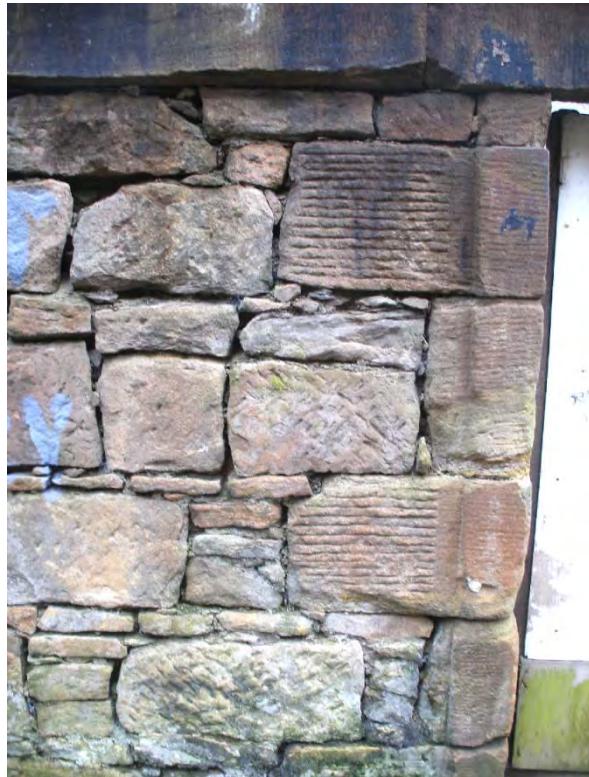
Detail of the masonry showing prominent margins with fine horizontal tooling (right-hand edge) and coarse broached tooling in recessed area indicating the wall is likely to have been harled.

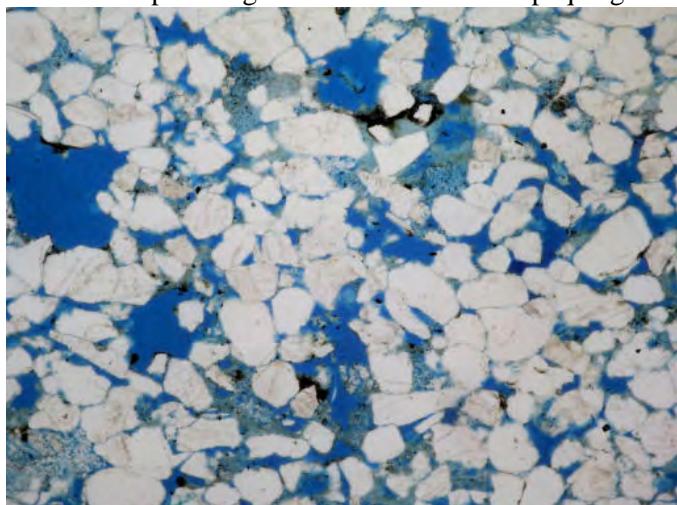
Building No.	<i>Building</i>	Sample No.
K6A (blonde sandstone sample)	(East Ayrshire Council Offices) - Citizen's Advice Bureau	ED10362A
<i>Macroscopic Description</i>		
General Description:	Pale, yellowish buff, near white ('blonde') sandstone.	
Colour: (<i>Munsell</i>)	2.5Y 8/2, light grey.	
Grainsize	'Fine' to 'medium', occasional 'coarse'.	
Texture	Uniform.	
Composition	Quartz, feldspar, lithic grains, clays, minor iron oxides.	
Grain Hardness	Friable.	
Grain Texture	Open.	
Water Absorption	Rapid.	
10% HCl Test	None.

<i>Microscopic Description</i>
Fine to medium with occasional coarse grains, poorly sorted sandstone. Framework grains are mostly angular to subrounded, dominated by quartz, commonly strained. Feldspar grains often have parallel twinning and commonly weathered to skeletal remains. Lithic grains are both of fine and medium grainsize, and metamorphic origin. Minor amounts of opaque grains (organic matter and iron oxides/hydroxides). Muscovite present, often crushed and altered into clays. Clays are abundant, infilling partially or totally some of the pore spaces, mostly of secondary origin due to alteration of minerals, occasionally greenish in colour. Tourmaline appears as accessory. Silica cement is relatively abundant. Open and well communicated porosity (relatively highly permeable) with a range of pore sizes from fine to large.

Comments/Possible Original Source: High quality blonde freestone, uniform texture suitable for polished ashlar and carving. Likely to be from good quality West Central Scotland quarry.
Currently available matching stone: Darney, Dunhouse Buff, Black Pasture

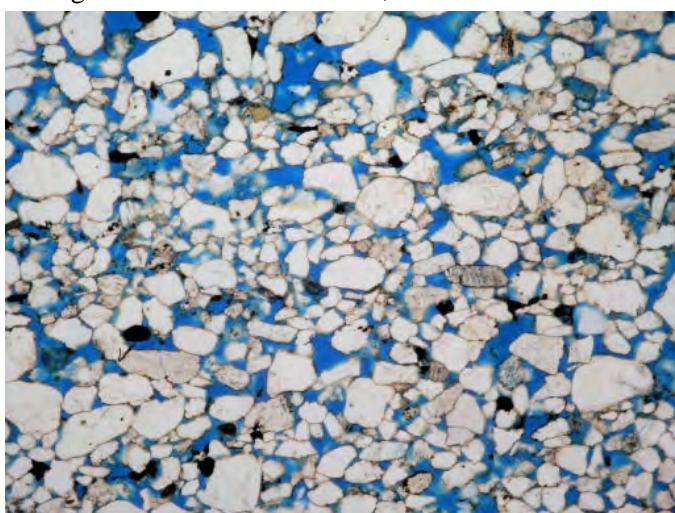
<i>Macroscopic Description</i>	
General Description:	Red sandstone, faintly laminated with small white feldspars and some manganese spots.
Colour: (Munsell)	c.2.5YR 5/6, bright reddish brown.
Grainsize	Poorly sorted ‘fine’, ‘fine to medium’ and ‘medium’ with occasional ‘coarse’ grains.
Texture	Uniform, with a hint of fabric.
Composition	Quartz, coated in a patina of iron oxides/hydroxides. Minor lithics, feldspars and iron oxides. Feldspars appear weathered. Minor dark ?manganese spots.
Grain Hardness	Intermediate.
Grain Texture	Intermediate.
Water Absorption	Moderate.
10% HCl Test	None.

<i>Microscopic Description</i>
Poorly sorted fine to coarse, planar bedded sandstone. Grainsize varies in different beds, but these are not clearly differentiated. Fine grainsize is c.0.1-0.15mm, medium is c.0.3-0.4mm and the occasional coarse grains can reach 0.9mm. Dominated by quartz (>80%) with several percent of feldspar and lithics. Abundant small size round iron oxide/hydroxide grains. Minor clays partially infilling the porosity. Tourmaline appears as accessory mineral. Moderate compaction with mostly punctual and sporadic pressure-solution contacts. Moderate porosity and permeability. Irregularly developed, scarce silica cement. The patina of iron oxides/hydroxides act also as cement.

‘Mauchline sandstone type’ (e.g. Mauchline/Ballochmyl/Barskimming quarries)

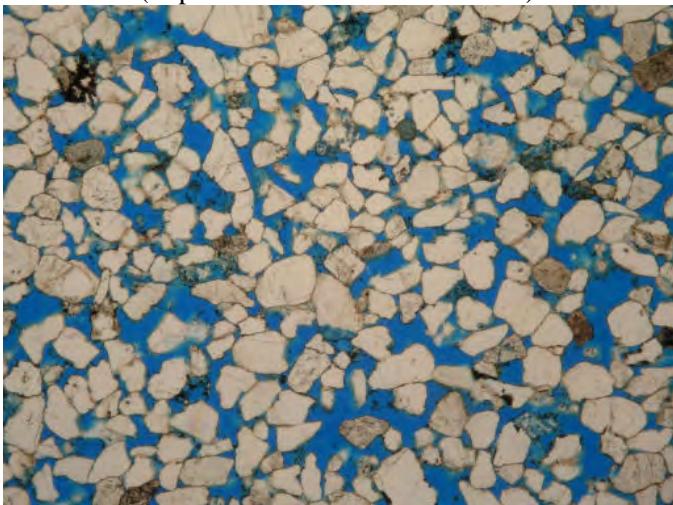
Uniform, moderately sorted ‘fine to medium’ sandstone with minor fractions of ‘fine’ and coarse grains. Grains are subangular to rounded (in particular the coarser fraction). Dominated by quartz (>85%) with relatively abundant twinned feldspar, mostly fresh, and lithic grains. Scarce iron oxide grains, both altered and mobilized as well as discrete and round. Moderate to low compaction, contacts are mostly punctual and long, occasionally pressure-solution. Porosity is abundant and moderately open, giving moderate to high permeability. Scarce, irregular silica cement, the patina of iron oxides that covers the grains acts as cement.

‘Mauchline sandstone type’ (e.g. Mauchline/Ballochmyle/Barskimming quarries).

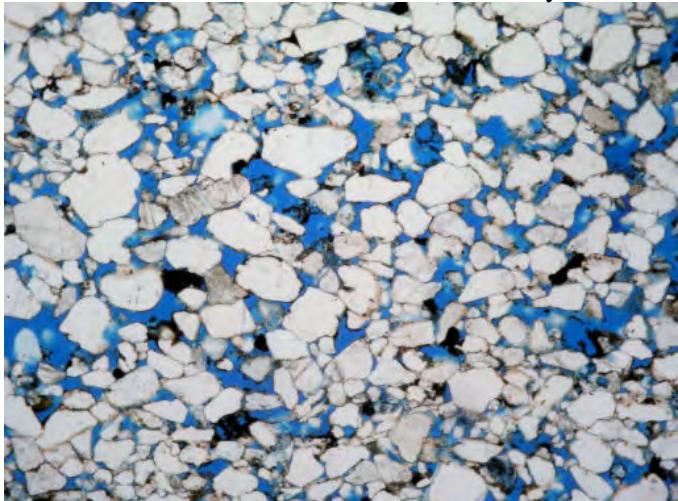
<i>Macroscopic Description</i>	
General Description:	Faintly laminated dark red sandstone, relatively ‘dense’.
Colour: (Munsell)	Between 2.5YR 5/6 and 4/6, bright reddish brown to reddish brown.
Grainsize	‘Fine’ to ‘medium’.
Texture	Uniform.
Composition	Quartz coated in patina of iron oxides/hydroxides. Relatively abundant white feldspar, round discrete iron oxides/hydroxides.
Grain Hardness	Strong.
Grain Texture	Intermediate to tight.
Water Absorption	Slow.
10% HCl Test	None.

<i>Microscopic Description</i>
Uniform, poorly sorted ‘fine’ to ‘medium’, almost bimodal. Grainsize ranges from c.0.1mm for the finer sizes (subangular) to 0.4-0.5mm for the medium sizes. These medium size grains are well rounded. Quartz comprises more than 80% of the stone, with relatively abundant feldspar (both fresh and weathered) and there are abundant small size iron oxide grains, some discrete and others altered and mobilized. Occasional white mica (muscovite). Irregular layer of silica cement partially coats some of the framework grains. The patina of iron oxides/hydroxides act also as cement. Contact between the grains are mostly punctual with some long and pressure. Moderately compact, with moderate porosity and permeability.

‘Mauchline sandstone type’ (e.g. Mauchline/Ballochmyle/Barskimming quarries)

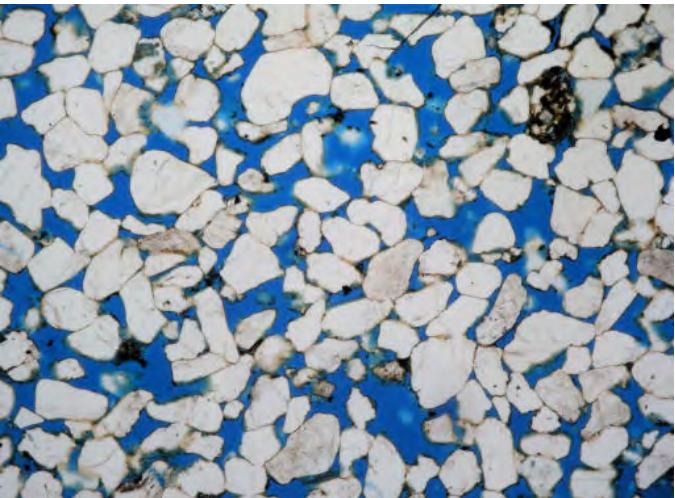
<i>Macroscopic Description</i>	
General Description:	Orange-red, uniform sandstone.
Colour: (Munsell)	c.2.5YR 5/6, bright reddish brown.
Grainsize	Mostly 'medium'.
W	Uniform.
Composition	Quartz coated in patina of iron oxides/hydroxides. A few white feldspar grains, lithics and minor iron oxides/hydroxides.
Grain Hardness	Intermediate.
Grain Texture	Open.
Water Absorption	Moderate to rapid.
10% HCl Test	None.

<i>Microscopic Description</i>
Uniform sandstone, moderately sorted, mostly medium (typical 0.35-0.5mm) with some minor randomly scattered finer and coarser grainsizes. Grains are mostly subangular to subrounded, occasionally rounded. Quartz comprises >90%, often polycrystalline. Feldspar grains show twinning and they appear occasionally weathered. Lithics are of undetermined sedimentary origin. The uncommon iron oxides/hydroxide grains appear moderately altered. The patina of iron oxides/hydroxides act also as cement. Open texture with abundant porosity and high permeability.

Comments/Possible Original Sources: Probable coarser grained, uniform variety of 'Mauchline sandstone type' (e.g. Mauchline/Ballochmyle/Barskimming quarries)
Currently available matching stone: Corncockle, Knowehead, (red Locharbriggs).

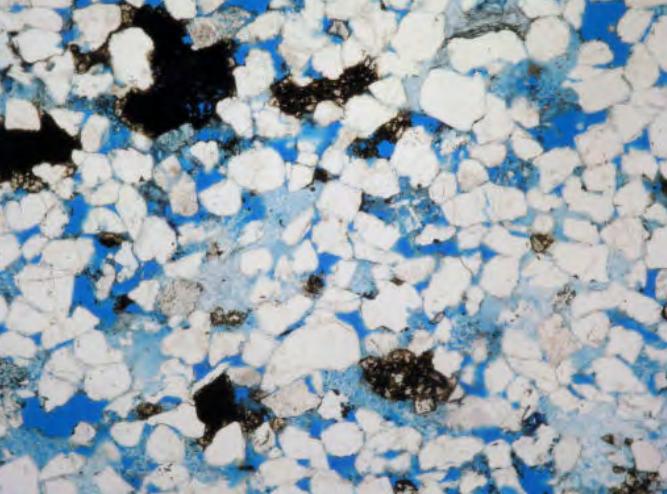
<i>Macroscopic Description</i>	
General Description:	Whitish grey, micaceous, 'impure' clay-bearing sandstone with relatively abundant orange iron oxide/hydroxide grains, giving a slightly speckled appearance, sometimes in accumulations giving a slight lamination.
Colour: (<i>Munsell</i>)	2.5Y 8/1, light grey.
Grainsize	'Fine to medium' to 'medium'.
Texture	Bedded.
Composition	Quartz, F?, clays, muscovite, iron oxides, carbonates (possibly calcite).
Grain Hardness	Intermediate to strong.
Grain Texture	Intermediate to open.
Water Absorption	Rapid.
10% HCl Test	Strong.

<i>Microscopic Description</i>	
Mostly 'fine to medium' with smaller 'fine' and 'coarse' fractions, moderately sorted. Mostly angular to subrounded grains, grainsize varying from 0.05 to 0.8mm, mostly between 0.3 to 0.4mm. Dominated by quartz, mono and polycrystalline, abundant feldspars mostly altered (sericitized) into clays, leaving only skeletal remains. Relatively abundant lithic grains of metamorphic (microquartzite) origin. Muscovite appears crushed and broken. Relatively abundant primary and secondary clays. Porosity is mostly infilled by clay although there are also abundant large clean pore spaces. Carbonate is clear, often in rhombic shapes, though often associated with mobilised iron oxides. Well developed silica cement, which appears to have suffered some dissolution making it a poor cementing agent.

Standard quality local sandstone, suitable for rubble building and walling. Bedded texture. Likely to be from local Kilmarnock quarries (e.g. Dean quarry; other local quarries such as Braehead)

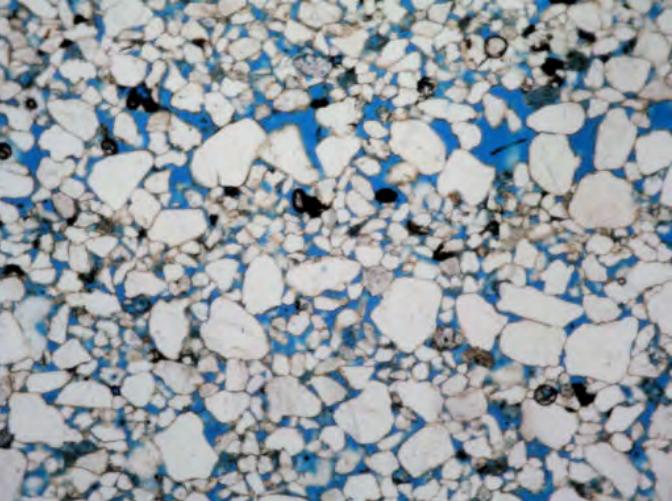
<i>Macroscopic Description</i>	
General Description:	Red sandstone with small, white feldspars.
Colour: (Munsell)	2.5YR 5/4 and 5/6, dull to bright reddish brown.
Grainsize	Extremely variable, from uniform 'fine to medium' with some 'medium' to bedded and bimodal 'fine' and 'medium'.
Texture	Uniform to bedded.
Composition	Quartz covered in a red patina of iron oxides/hydroxides. Abundant feldspars, angular and broken. Minor black iron oxide/hydroxides.
Grain Hardness	Friable to intermediate.
Grain Texture	Tight to intermediate.
Water Absorption	Moderate.
10% HCl Test	None.

<i>Microscopic Description</i>	
Variable from uniform to mostly bedded, bimodal 'fine' and 'medium'. The 'fine' fraction is typically c.0.1-0.15mm and the 'medium' fraction is typically c.0.4-0.5mm, distributed sometimes homogeneously and some other times separated into different bedding laminae (c.1mm thickness). Coarser grainsizes tend to be rounder than the finer grainsizes. Dominated by quartz (>90%) with feldspars (some altered) generally of untwinned varieties but occasionally twinned. Minor lithics are of unknown sedimentary and metamorphic origin. Minor small, fairly competent iron oxides are present. The patina of iron oxides/hydroxides act also as cement. The stone is moderately 'dense', with long, punctual and pressure solution contacts between the grains. Porosity and permeability tend to be variable, depending on the distribution of the grainsizes, but overall they both can be considered moderate.

'Mauchline sandstone type' (e.g. Mauchline/Ballochmyle/Barskimming quarries)

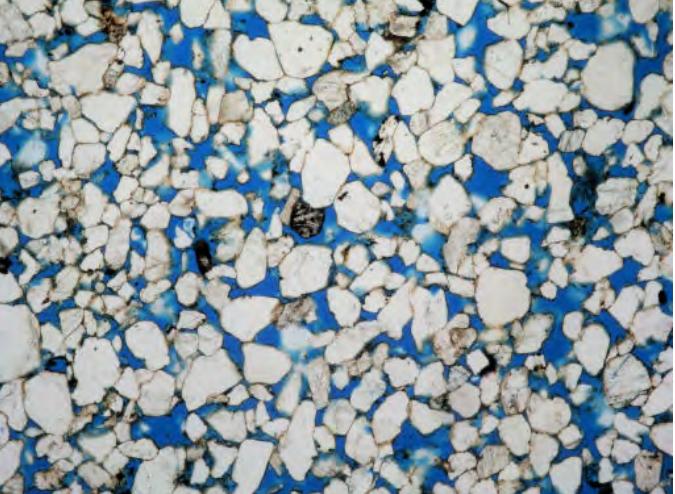
<i>Macroscopic Description</i>	
General Description:	Uniform red, slightly orange-red sandstone.
Colour: (Munsell)	Between 2.5YR 5/6 and 4/6, bright reddish brown –reddish brown.
Grainsize	Moderately to poorly sorted ‘fine’ to ‘medium’.
Texture	Uniform.
Composition	Mostly quartz, covered in red iron oxide patina. Minor feldspars/lithics and iron oxide grains.
Grain Hardness	Intermediate.
Grain Texture	Tight to intermediate.
Water Absorption	Moderate.
10% HCl Test	None.

<i>Microscopic Description</i>	
<p>‘Fine’ to ‘medium’, mostly ‘fine to medium’ and ‘medium’ sandstone, typical average grainsize c.0.3-0.4mm, the coarser ‘medium’ fraction reaching 0.5mm. Uniform and poorly sorted, with grains varying from subangular to subrounded within the smaller fractions and subrounded to rounded within the coarser fraction. Dominated by quartz (>90%), with minor lithic and feldspars grains, mostly fresh. Scarce, generally corroded small iron oxide/hydroxide grains. A small amount of clays partially infills some of the pore spaces. Moderately compacted, with fairly open porosity, contacts are punctual, long and pressure-solution. Poorly developed silica cement. The patina of iron oxides/hydroxides acts also as cement.</p>

Probable variety of ‘Mauchline sandstone type’ (e.g. Mauchline/Ballochmyle/Barskimming quarries)
