A BUILDING STONE AUDIT FOR KILMARNOCK

**Surveying, matching and sourcing
stone for the built heritage**

EWAN K. HYSLOP, LUIS J. ALBORNOZ-PARRA & EMILY A. TRACEY. 2009. A Building Stone Audit for Kilmarnock: Surveying, Matching and Sourcing Stone for the Built Heritage. *British Geological Survey Open Report*, OR/09/0002.

Surveys of the condition of the stone masonry in twenty-five buildings and structures in the John Finnie and Bank Street Conservation Area in Kilmarnock have provided information to guide forthcoming grant-aided repairs and inform future maintenance strategies. Stone samples from each surveyed structure have been characterised in order to identify the original stone types, and are matched to stone from currently active quarries to ensure that appropriate stone is used for the repairs.

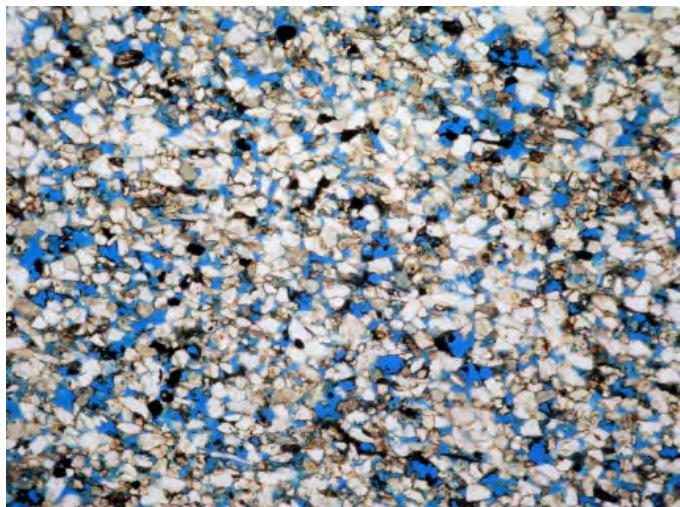
Uniform ‘fine’ grained sandstone with occasional ‘fine to medium’ grains. Typical grainsizes are 0.1-0.2mm, subangular to subrounded. Contains abundant small feldspars (twinned and untwinned varieties, slightly weathered) and lithic grains as well as abundant small size, discrete iron oxide grains, well preserved. Occasionally quartz grains may contain rutile needles. Small, well oriented broken muscovite flakes. Moderately compacted, but rather porous and permeable through a range of small pores and micropores and conduits. Cemented by well developed silica cement overgrowth.

Unusual finer grained sandstone similar to Corsehill, or possible fine grained variety of Mauchline sandstone.

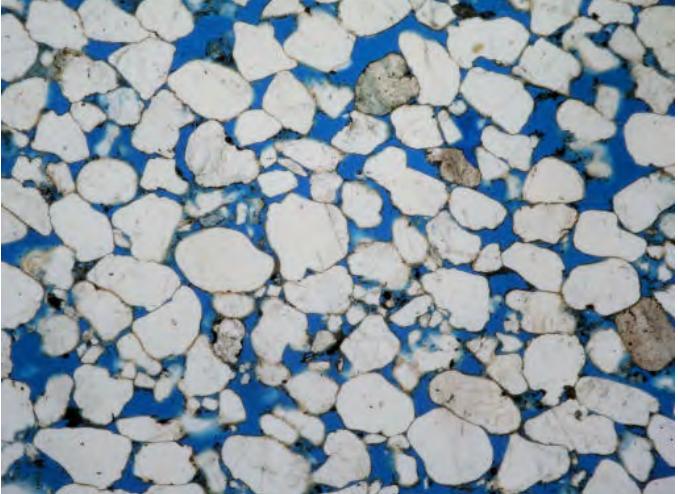
<i>Macroscopic Description</i>	
General Description:	Red sandstone, faintly bedded.
Colour: (<i>Munsell</i>)	c.2.5YR 5/6-5/5?, reddish brown.
Grainsize	Mostly ‘medium’, some ‘fine’.
Texture	Faintly bedded.
Composition	Quartz, coated in a patina of iron oxides/hydroxides. Relatively abundant, white, round feldspars and black round iron oxide grains.
Grain Hardness	Intermediate towards hard.
Grain Texture	Intermediate.
Water Absorption	Rapid.
10% HCl Test	None.

<i>Microscopic Description</i>	
<p>Mostly ‘medium’ grained sandstone, well sorted, with a small ‘fine’ fraction randomly scattered throughout the stone. Typical grainsize is c.0.4 to 0.5mm. Quartz dominated (>85%) with fresh and weathered feldspar grains and fairly uniform microscopic texture although with a faint hint of fabric (orientation of some grains). Some lithic grains of various different origins are present. Feldspar and lithic grains comprise up to 10% of the stone. Minor small iron oxide/hydroxide grains, generally altered and mobilized. The patina of iron oxides/hydroxides that covers the quartz grains acts as cement. Some clays, product of the alteration of feldspar grains, partially infill some of the porosity, but the stone has a very open texture, with abundant and well communicated porosity giving it relatively high permeability.</p>

‘Mauchline sandstone type’ (e.g. Mauchline/Ballochmyle/Barskimming quarries)

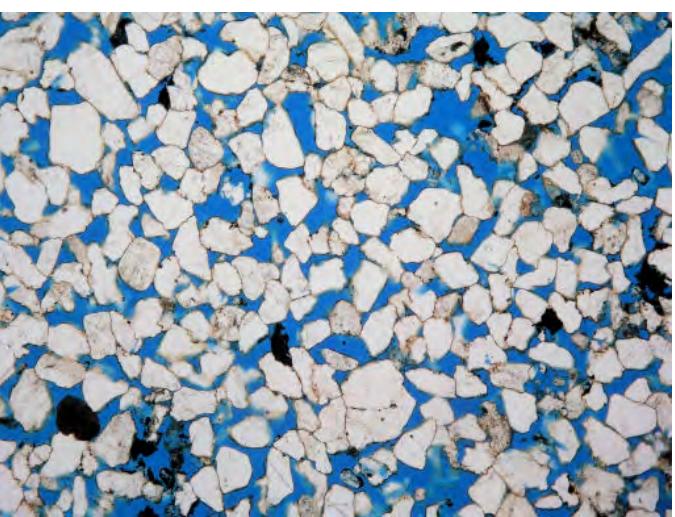
<i>Macroscopic Description</i>	
General Description:	Uniform orangeish red sandstone.
Colour: (Munsell)	2.5YR 5/4 to 5/6, dull to bright reddish brown.
Grainsize	Poorly sorted 'very fine' to 'coarse'.
Texture	Uniform.
Composition	Quartz, coated in a red patina of iron oxides/hydroxides. Feldspars. Some small round iron oxides.
Grain Hardness	Intermediate towards friable.
Grain Texture	Intermediate.
Water Absorption	Moderate.
10% HCl Test	None.

<i>Microscopic Description</i>	
Uniform, poorly sorted sandstone, mostly 'fine to medium' and 'medium' grainsize, typically 0.25-0.35mm with a range from 'very fine' to occasional 'coarse' grains. Grains are subangular to subrounded, occasionally rounded. Quartz, coated with iron oxide, comprises over 90% of the stone, with many being polycrystalline and the medium sizes more rounded. Relatively abundant feldspars appear both as twinned and untwinned varieties, generally fresh. There is also a small percentage of small size lithic grains of fine sedimentary origin. Iron oxides are rounded, often slightly corroded. The patina of iron oxides/hydroxides that covers the quartz grains acts as cement. Minor clays partially infilling some of the porosity. Zircon and tourmaline as accessories. Only a small amount of silica cement holding the grains, but the contacts between grains are long and pressure-solution. The stone has an intermediate texture, with a range of small to medium pore sizes, moderately communicated.

'Mauchline sandstone type' (e.g. Mauchline/Ballochmyle/Barskimming quarries)

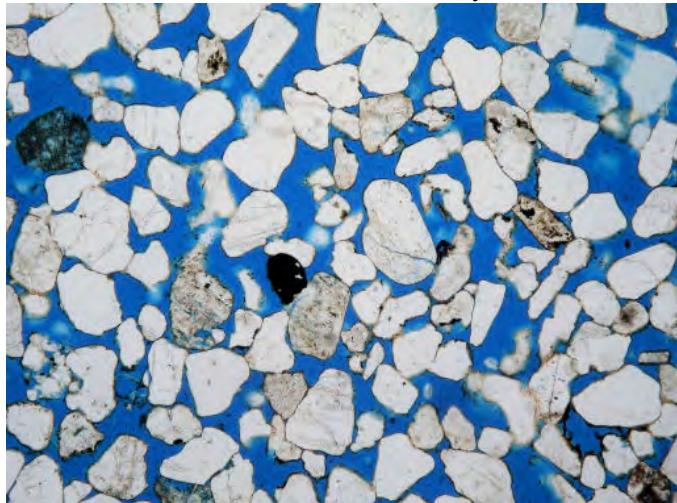
<i>Macroscopic Description</i>	
General Description:	Uniform red sandstone, rather coarse grained, with some white feldspars and black iron oxides.
Colour: (Munsell)	2.5YR 5/4 to 5/6, dull to bright reddish brown.
Grainsize	Fine to coarse.
Texture	Uniform.
Composition	Quartz, coated in a red patina of iron oxides/hydroxides. Relatively abundant altered feldspars. Some grains of iron oxide/hydroxide.
Grain Hardness	Friable.
Grain Texture	Moderate.
Water Absorption	Moderate.
10% HCl Test	None.

<i>Microscopic Description</i>
Uniform, rather poorly sorted, with a bimodal tendency, 'fine' to 'coarse', mostly within the range of 'medium' grainsizes, typically 0.3-0.5mm with finer and coarser grains. Grains are subangular to rounded. Mono and polycrystalline quartz, coated with iron oxide, comprises c.85% of the stone. Relatively abundant feldspar and lithic grains. Feldspars appear both as twinned and untwinned varieties, both fresh and weathered to clays. Lithic grains are of fine sedimentary and metamorphic origins. Iron oxides are rounded, occasionally corroded. The patina of iron oxides/hydroxides that covers the quartz grains acts as cement. There is also a small amount of irregular silica cement holding the grains. Contacts between grains are long and pressure-solution, sometimes interlocked. Minor clays partially infilling some of the porosity. The stone has an moderate texture, with a range of small to large pore sizes, moderately communicated due to the packing of the different grainsizes, making this stone moderately permeable.

'Mauchline sandstone type' (e.g. Mauchline/Ballochmyle/Barskimming quarries)

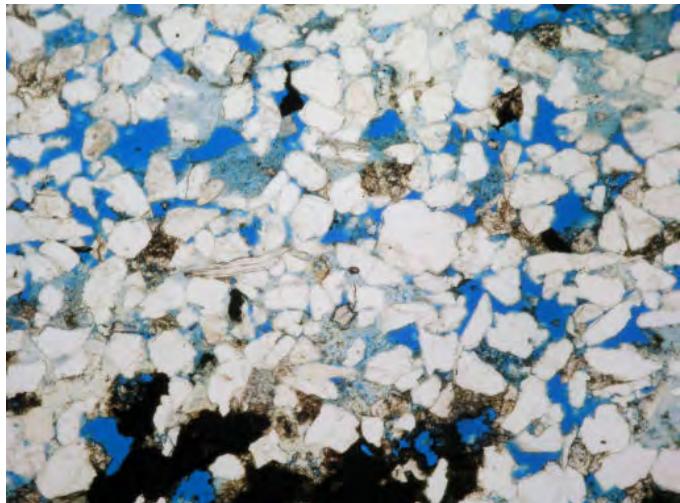
<i>Macroscopic Description</i>	
General Description:	Blonde, coarse grained and impure greyish buff sandstone, with some thin dark grey laminae.
Colour: (Munsell)	Between 2.5Y 8/1 and 8/2, light grey.
Grainsize	Poorly sorted fine to coarse, mostly medium.
Texture	Bedded.
Composition	Quartz, feldspar, lithic grains, iron oxides/hydroxides, organic matter, clays and carbonates, muscovite.
Grain Hardness	Intermediate to strong.
Grain Texture	Intermediate to open.
Water Absorption	Rapid to moderate. Directional.
10% HCl Test	Strong.

<i>Microscopic Description</i>
Mostly 'medium' grained sandstone, with 'fine' and 'coarse' fractions, poorly sorted with angular to subrounded framework grains. Composition is over 80% quartz, mostly mono-, occasionally polycrystalline, with relatively abundant, commonly fresh, small twinned feldspar grains (some altered) and minor lithic grains of unknown (metamorphic?) origin. Several percent of mobilized and altered iron oxide/hydroxide grains, sometimes accumulated into laminae, often associated with abundant carbonate which appears as microsparite, both euhedral (with crystalline shape) and anhedral. Muscovite flakes appear crushed. Abundant primary and secondary clays (from weathering of feldspars and muscovite). Contacts are mostly long and punctual, with abundant, well developed silica cement. Porosity is relatively abundant (with large size pores) with moderate permeability due to the rather high content of matrix minerals.

Comments/Possible Original Source:
Standard quality sandstone, variable composition and texture, probably from local Kilmarnock quarries e.g. Dean quarry. Possibly obtained from immediate vicinity (former Braehead quarry in Kay Park).
Currently available matching stone: No identical stone types are available. Banded or coarse sandstones: Drumhead (Dorghillock), Northumberland Buff, Bearl, Catcastle Buff. Uniform sandstones: Millknock, High Nick, Birchover

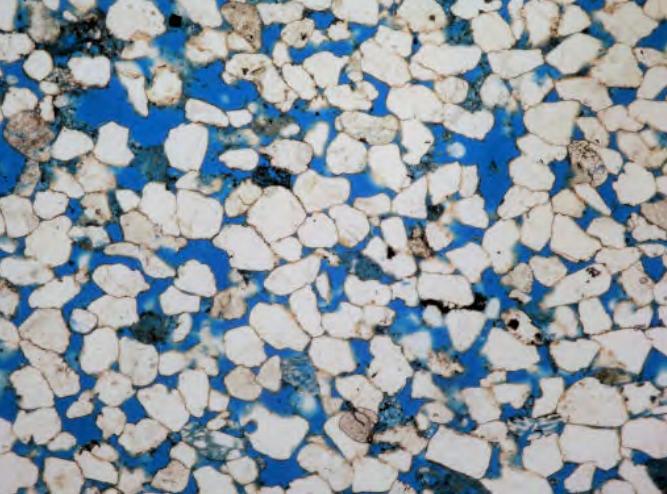
<i>Macroscopic Description</i>	
General Description:	Fairly uniform red sandstone, with occasional black spots of ?manganese.
Colour: (Munsell)	2.5YR 5/4 to 5/6, dull to bright reddish brown.
Grainsize	Mostly ‘medium’, some ‘fine to medium’.
Texture	Uniform.
Composition	Quartz, coated in a red patina of iron oxides/hydroxides. Relatively abundant feldspars of small size. Some grains of iron oxide/hydroxide.
Grain Hardness	Intermediate.
Grain Texture	Intermediate.
Water Absorption	Rapid.
10% HCl Test	None.

<i>Microscopic Description</i>	
Uniform, moderately to well sorted sandstone, mostly ‘medium’ grainsize, typically 0.4-0.5mm with occasionally slightly finer or coarser grains. Grains are subangular to subrounded, occasionally rounded. Quartz, coated with iron oxide, comprises over 90% of the stone. Feldspars appear both as twinned and untwinned varieties, both fresh and weathered to clays. There is also a small percentage of lithic grains of unknown origin. Iron oxides are rounded, occasionally slightly corroded. The patina of iron oxides/hydroxides that covers the quartz grains acts as cement. There is also a small amount of irregular silica cement holding the grains. Minor clays partially infilling some of the porosity. The stone has an open texture, with a range of small to large pore sizes, well communicated making this stone relatively permeable.

‘Mauchline sandstone type’ (e.g. Mauchline/Ballochmyle/Barskimming quarries)

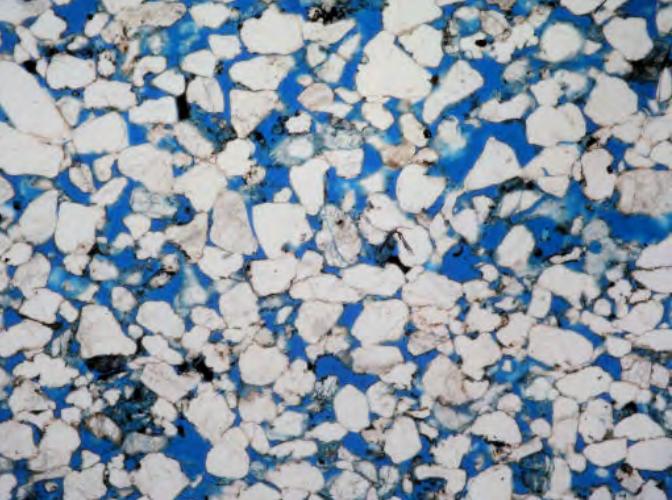
<i>Macroscopic Description</i>	
General Description:	Red sandstone with very abundant white feldspars and a pinkish shade. Well cemented.
Colour: (Munsell)	2.5YR 6/4, ‘dull orange’.
Grainsize	‘Fine to medium’ and ‘medium’, some small ‘fine’ fraction.
Texture	Bedded, thinly laminated.
Composition	Quartz, covered in an iron oxide patina. Abundant round, medium size white feldspars. Some possible clays. Dark round iron oxides, scattered throughout.
Grain Hardness	Strong.
Grain Texture	Intermediate to tight.
Water Absorption	Very slow.
10% HCl Test	None.

<i>Microscopic Description</i>	
<p>Mostly ‘fine to medium’ and ‘medium’ grained with some thin laminae (<1mm) constituted by ‘fine’ grains (c.0.1mm). Typical average grainsize ranges from 0.35-0.5mm. Grains are mostly angular to subrounded. The stone is dominated by quartz (>90%) with a small percentage of feldspar, often weathered and with uncommon lithic grains of mostly metamorphic origin with some of fine sedimentary origin. Iron oxides are abundant, very small sizes scattered throughout. Grains are well compacted, often with pressure-solution and long contacts as well as having a well-developed silica cement coating strongly cementing all the grains. Although moderately porous, the pores are badly communicated, due to the abundant silica cement, making this a stone with a relatively low permeability.</p>

Possible Locharbriggs.

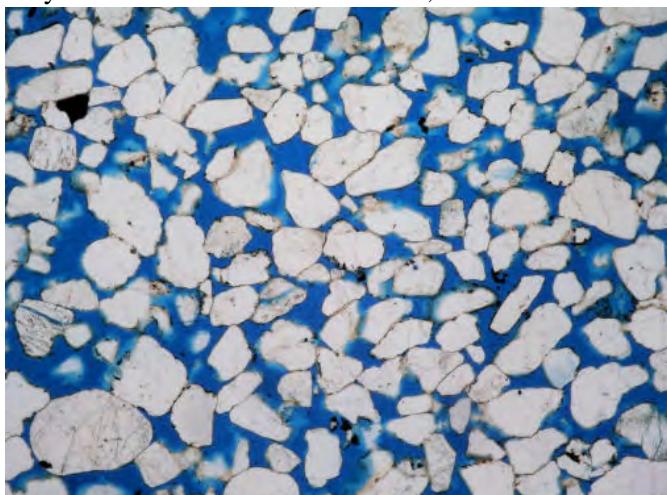
<i>Macroscopic Description</i>	
General Description:	Red slightly orange sandstone, with white feldspar grains and occasional medium size black mottles of ?manganese.
Colour: (<i>Munsell</i>)	Between 2.5YR 6/6 and 6/5, bright reddish brown to orange.
Grainsize	Mostly 'medium' to 'coarse', well rounded with a 'fine' fraction within laminae.
Texture	Uniform.
Composition	Mostly quartz, grains coated in a patina of iron oxides/hydroxide. Some white feldspars, medium size. Occasional round black iron oxide grains.
Grain Hardness	Intermediate.
Grain Texture	Intermediate.
Water Absorption	Rapid to slow, directional.
10% HCl Test	None.

<i>Microscopic Description</i>	
<p>Slightly laminated (although mostly uniform) sandstone, generally 'medium' grainsize (0.3-0.5mm), except for a fine laminae of more abundant 'fine' grainsizes (0.1-0.15mm) and occasional 'coarse' grains, no larger than 0.7mm. Quartz is over 90%, rather rounded. Some feldspar grains, many weathered into clays. Minor fine and medium size, discrete iron oxide grains. Relatively abundant lithic grains of both fine sedimentary and metamorphic origin. Contacts are mostly punctual and long, with some irregularly distributed silica cement. Minor, irregularly distributed silica cement. The patina of iron oxides/hydroxides that coats the quartz grains acts as cement. Open and abundant porosity, highly permeable where the grainsizes are medium, and relatively impervious through the fine grained laminae (as they are densely packed).</p>

'Mauchline sandstone type' (e.g. Mauchline/Ballochmyle/Barskimming quarries)

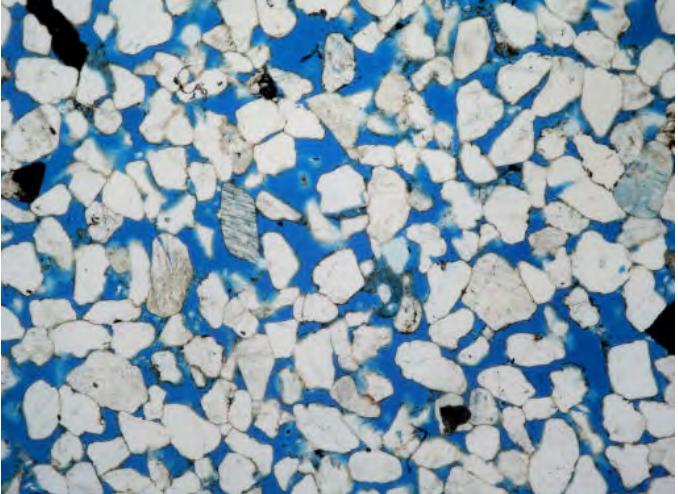
<i>Macroscopic Description</i>	
General Description:	Red sandstone with some dark spotting due to ?manganese on the bedding planes. Fairly uniform.
Colour: (Munsell)	c.2.5YR 5/6, bright reddish brown.
Grainsize	'Medium', some 'fine to medium', rounded and well sorted.
Texture	Uniform with a hint of fabric.
Composition	Quartz, coated in an iron oxide/hydroxide patina. Minor white, medium size, angular and broken feldspars.
Grain Hardness	Intermediate.
Grain Texture	Intermediate.
Water Absorption	Rapid.
10% HCl Test	None.

<i>Microscopic Description</i>	
Uniform, well sorted, mostly medium grained sandstone. Grainsize is mostly 0.35-0.45mm. Grains vary from subangular to subrounded. Quartz is c.90% with relatively abundant feldspar and lithic grains. Feldspar appears both twinned and untwinned, generally fresh. Minor well preserved iron oxides/ hydroxide grains. Open texture with abundant porosity, highly permeable. Contacts are punctual and long, with an irregular and poorly developed layer of silica cement. The patina of iron oxide/hydroxide that covers the quartz grains acts as cement.

'Mauchline sandstone type' (e.g. Mauchline/Ballochmyle/Barskimming quarries)

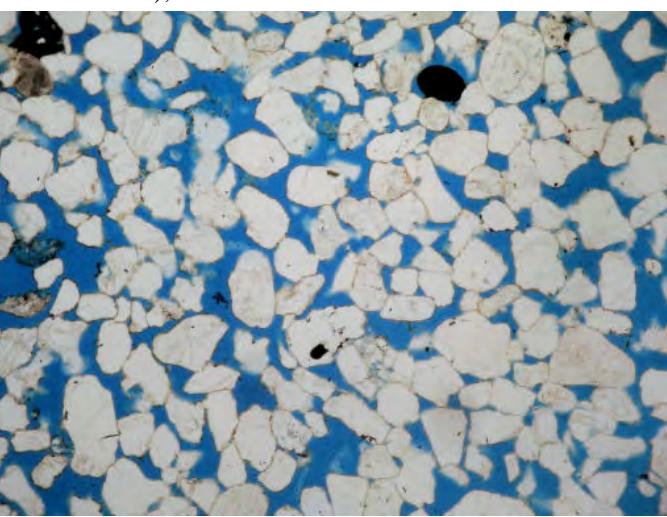
<i>Macroscopic Description</i>	
General Description:	Red sandstone with some small white feldspar and black spots of ?manganese. Slightly laminated, with parallel lamination.
Colour: (Munsell)	Between 2.5YR 6/4-5/6, dull orange to bright reddish brown.
Grainsize	'Medium'.
Texture	Faintly bedded, almost uniform.
Composition	Quartz, coated in a red patina of iron oxides/hydroxides. Small amount of feldspars.
Grain Hardness	Intermediate to strong.
Grain Texture	Tight.
Water Absorption	Moderate to rapid.
10% HCl Test	None.

<i>Microscopic Description</i>
Moderately to well sorted, mostly medium grainsize, typically 'fine to medium' c.0.25 and 'medium' c. 0.4-0.45mm. Uniform at microscopic scale. Quartz appears over 90%, with feldspars (both twinned and untwinned varieties), rather fresh. There is a number of lithic grains (rock fragments) of both sedimentary and metamorphic origin. Framework grains vary between subangular to rounded (in the larger sizes). Relatively common opaque detrital iron grains, kidney-shaped, both as very fine grains and medium sizes. Contacts between grains are mostly punctual and long, with occasional pressure-solution. Open texture with abundant and well communicated porosity. Minor silica cement. The patina of iron oxides/hydroxides that covers the quartz grains acts as cement.

Comments/Possible Original Sources: 'Mauchline sandstone type' (e.g. Mauchline/Ballochmyle/Barskimming quarries)
Currently available matching stone: Knowehead, Gatedlawbridge/Newton.

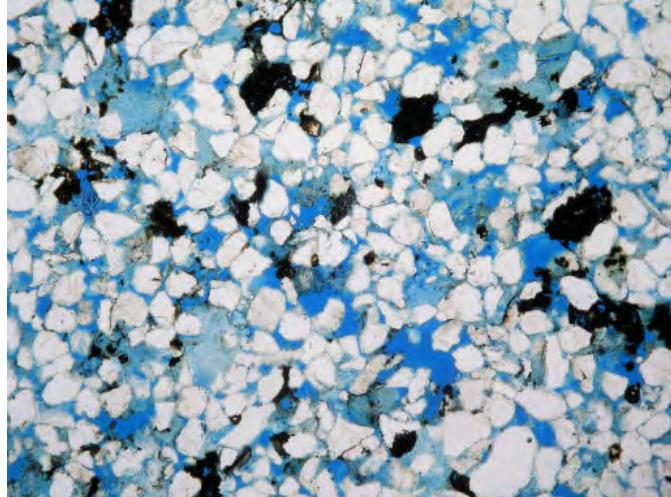
<i>Macroscopic Description</i>	
General Description:	Blonde, fine to coarse grained, rather impure greyish buff sandstone, with some grey laminae.
Colour: (Munsell)	2.5Y 8/2, light grey.
Grainsize	Poorly sorted fine to coarse, mostly medium.
Texture	Bedded.
Composition	Quartz, feldspar, lithic grains, iron oxides/hydroxides, organic matter, clays and carbonates, muscovite.
Grain Hardness	Intermediate to friable.
Grain Texture	Intermediate.
Water Absorption	Rapid to moderate.
10% HCl Test	Weak.

<i>Microscopic Description</i>
Slightly laminated, poorly sorted 'fine' to 'coarse' grained sandstone, grainsize mostly within the 'fine to medium' except in some bands where tends to be more 'medium' and occasionally 'coarse' with angular to subrounded framework grains. Composition is over 80% quartz, both mono and polycrystalline, with relatively abundant, fresh and altered twinned feldspar grains and lithic grains of unknown (metamorphic?) origin. Several percent of mobilized and altered iron oxide/hydroxide grains, sometimes accumulated into laminae, mostly associated with carbonates (ankerite?), both euhedral (with crystalline shape) and anhedral. Muscovite flakes appear crushed. Abundant primary and secondary clays (from weathering of feldspars and muscovite). Contacts are mostly long and punctual, occasional pressure-solution, with abundant, well developed silica cement. Porosity is relatively abundant (with large size pores) with moderate permeability due to the rather high content of matrix minerals.

Comments/Possible Original Source:
Stone reputed to come from Dean Quarry. Highest quality local blonde sandstone (uniform texture and grainsize).
Currently available matching stone: No identical stone types are available.
Banded coarse sandstones: Drumhead (Dorghillock), Northumberland Buff, Bearl, Catcastle Buff
Uniform sandstones: Millknock, High Nick, Birchover.

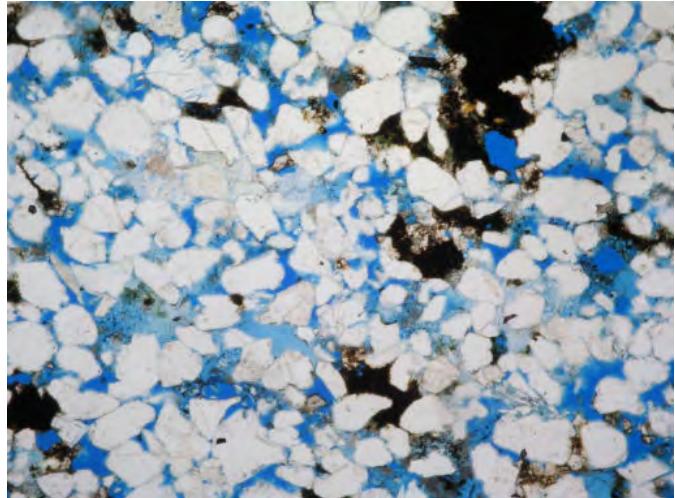
<i>Macroscopic Description</i>	
General Description:	Pale greyish buff sandstone, laminated and with 'speckled' appearance due to iron oxides/organic matter.
Colour: (<i>Munsell</i>)	2.5Y 8/1, light grey.
Grainsize	Poorly sorted 'fine' to 'medium'.
Texture	Bedded.
Composition	Quartz, feldspar, lithic grains, opaque grains (organic matter/iron oxides), muscovite, clays, carbonates.
Grain Hardness	Intermediate to strong.
Grain Texture	Open.
Water Absorption	Rapid.
10% HCl Test	Strong.

<i>Microscopic Description</i>
Poorly sorted 'fine' to 'medium' grained sandstone. Grainsize ranges from 0.1 to 0.45mm, mostly c.0.3mm, angular to subrounded. Although dominated by quartz, there are several percent of feldspars, both twinned and untwinned varieties. These appear often altered into clays, leaving skeletal remains. Lithic grains are scarce, of undetermined metamorphic origin. Muscovite flakes, moderately aligned, appear often crushed. Mobilized iron oxides are relatively abundant, sometimes appearing as elongated aggregates (with muscovite) forming the laminae. Carbonates are scattered throughout as small sparry crystals, yellowish brown, sometimes euhedral, occasionally associated with iron oxides. Primary (platy) and secondary clays are relatively abundant, partially infilling much of the pore spaces. Porosity (c.20-25%) is well communicated (high permeability). Moderately cemented by silica cement, mostly long contacts between grains.

Local blonde sandstone of standard quality. Banded texture. Probably obtained from the local Kilmarnock quarries (e.g. Dean quarry, or others such as Braehead).

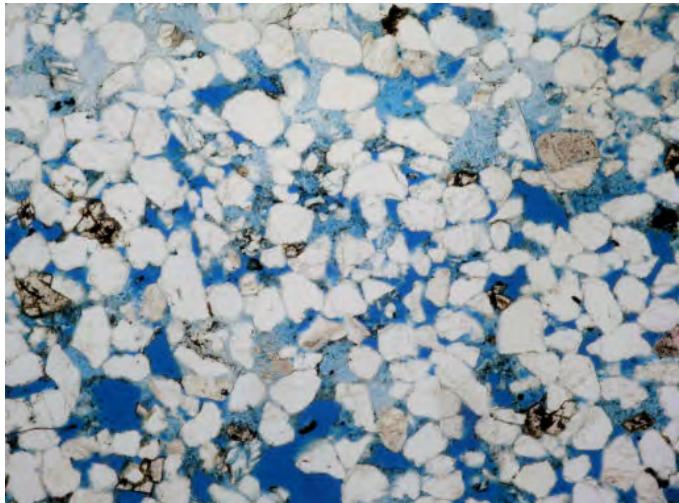
<i>Macroscopic Description</i>	
General Description:	Pale greyish buff, impure sandstone with faint irregular laminae of organic matter/iron oxides.
Colour: (Munsell)	2.5Y 8/1, light grey.
Grainsize	Poorly sorted, ‘fine’ to ‘medium’.
Texture	Bedded.
Composition	Quartz, feldspar, lithic grains, iron oxides, organic matter, clays, carbonates. Minor muscovite.
Grain Hardness	Intermediate.
Grain Texture	Intermediate.
Water Absorption	Rapid to moderate.
10% HCl Test	None.

<i>Microscopic Description</i>
Moderately sorted, ‘fine’ to ‘medium’ grained sandstone. Grainsize ranges form 0.1 to 0.35mm, mostly c.0.25-0.3mm, angular to subrounded. Dominated by quartz, with feldspars (both twinned and untwinned varieties) often altered into clays. Lithic grains are scarce, of undetermined metamorphic origin. Muscovite flakes, moderately aligned, appear often crushed. Very fine grainsize opaque grains (iron oxides/organic matter) present in small amounts, scattered throughout, occasionally faintly aligned. Carbonates appear as small sparry crystals, yellowish brown, sometimes euhedral, occasionally associated to iron oxides. Primary (platy) and secondary clays are relatively abundant, partially infilling most porosity. Porosity (c.25%) is well communicated (high permeability). Moderately cemented by silica cement, mostly long contacts between grains.

Variable local blonde sandstone of standard quality, suitable for rubble building. Banded texture. Probably obtained from the local Kilmarnock quarries (e.g. Dean quarry, or others such as Braehead). Because of the variable quality the wall is likely to have been lime harled for protection.

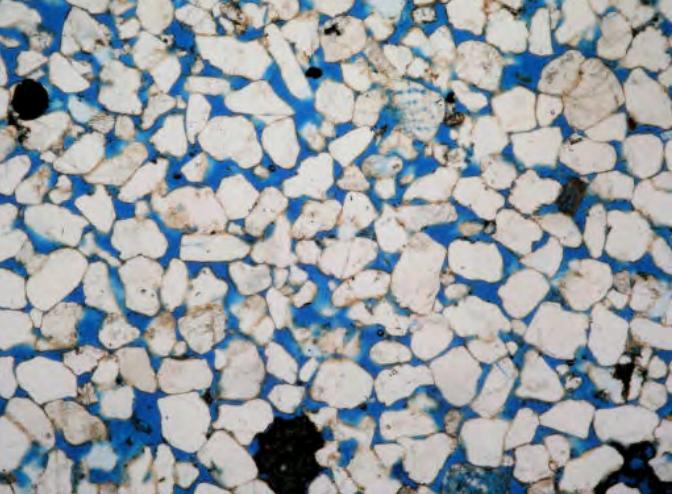
<i>Macroscopic Description</i>	
General Description:	Orange-red sandstone, fairly uniform. Occasional black spots of ?manganese.
Colour: (<i>Munsell</i>)	Between 2.5YR 5/4 and 5/6, dull to bright reddish brown.
Grainsize	Mostly ‘medium’, some ‘fine to medium’.
Texture	Uniform.
Composition	Mostly quartz, coated by a thin red iron oxide/hydroxide patina. Scarce white feldspars, lithic grains and black iron oxide/hydroxide grains.
Grain Hardness	Intermediate.
Grain Texture	Intermediate.
Water Absorption	Rapid.
10% HCl Test	None.

<i>Microscopic Description</i>	
<p>Uniform mostly ‘fine to medium’ and ‘medium’ grained sandstone, with a small ‘fine’ fraction. Grainsize average is 0.3-0.4mm. Dominated by quartz (>85%) with medium size feldspars and some lithic grains. Grains are generally subrounded to fairly rounded. There is a small amount of discrete round iron oxide/hydroxide grains together with larger size mobilized iron or manganese oxide/hydroxides which enclose quartz grains, giving the distinct mottled aspect. The patina of iron oxides/hydroxide that coats the quartz grains acts also as cement. Moderately compact, the stone has moderate porosity with generally medium to small pore sizes, but well communicated by relatively wide and clean conduits. Contacts between grains are mostly punctual, with some being pressure-solution. Some thin, irregular, amount of silica cement partially coats some of the grains.</p>

‘Mauchline sandstone type’ (e.g. Mauchline/Ballochmyle/Barskimming quarries)

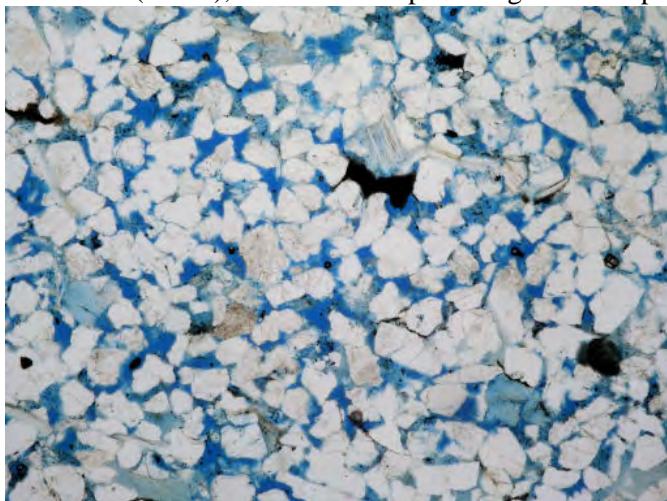
<i>Macroscopic Description</i>	
General Description:	White, ‘pure’ and quartz-rich sandstone, with muscovite flakes and minor organic matter/iron oxide speckles.
Colour: (<i>Munsell</i>)	10YR 8/1, white.
Grainsize	Well sorted, mostly ‘medium’, some ‘fine to medium’.
Texture	Uniform.
Composition	Quartz, muscovite, minor opaque grains (organic matter/iron oxides).
Grain Hardness	Strong.
Grain Texture	Intermediate.
Water Absorption	Moderate.
10% HCl Test	None.

<i>Microscopic Description</i>
Quartz rich sandstone, moderately to well sorted, mostly ‘fine to medium’ and ‘medium’, average grain sizes 0.2-0.25mm, occasionally coarse (c.0.5mm) or fine (c.0.1mm). Grains are subangular to subrounded. Quartz dominated (>80%), with a small percentage of feldspars (twinned and untwinned varieties) and minor lithic grains. Feldspars are fresh, occasionally weathered. Abundant well oriented muscovite flakes. Scarce small mobilized iron oxides/organic matter. Abundant oval-shaped, fairly large zircon grains. Moderate amount of mainly secondary clays (from weathering of muscovite and feldspars). Abundant well communicated porosity (through small pore sizes with fairly large conduits) with abundant silica cement and long and punctual contacts.

High quality fine grained uniform sandstone freestone suitable for polished ashlar and carved work. Likely to have been imported into Kilmarnock, either from high quality Ayrshire sandstone quarry (source not identified) or further afield (e.g. major quarries in West Central Scotland or Glasgow area). Also similar to certain Northumberland sandstones (quarries in northeast England connected to Scottish Central belt by rail from mid-19th century).

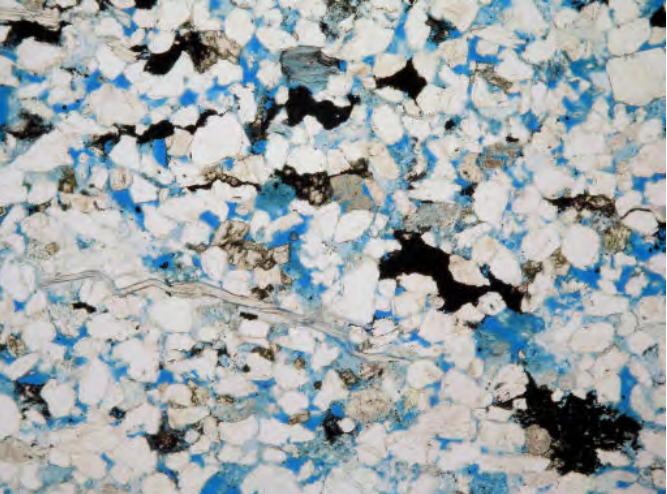
<i>Macroscopic Description</i>	
General Description:	Pale, whitish sandstone, with a strongly speckled appearance caused by brown iron oxides.
Colour: (<i>Munsell</i>)	c. 10YR 8/1, white.
Grainsize	'Fine' to 'medium', poorly sorted.
Texture	Uniform, with some minor fabric.
Composition	Quartz, feldspars, iron oxides/organic matter, muscovite, carbonate.
Grain Hardness	Strong.
Grain Texture	Intermediate.
Water Absorption	Moderate to rapid.
10% HCl Test	Moderate.

<i>Microscopic Description</i>	
<p>'Fine to medium' grained sandstone, poorly sorted with relatively abundant iron oxides/organic matter and clays and a certain amount of carbonates. Slight fabric parallel to the bedding. Framework grains are generally subangular to subrounded. Dominated by quartz (c.80%) ranging from 0.04 to 0.8mm, mostly 0.20-0.35mm in size, generally monocrystalline. Lithic grains are very scarce. Various types of feldspar appear well preserved, both K-feldspar and plagioclase, in twinned and untwinned varieties. Occasionally feldspars are altered. Muscovites appear abundantly, well oriented, often crushed. Opaque grains (iron oxides/hydroxides and organic matter) appear scattered throughout, mobilized into pore spaces, of variable sizes, stretched parallel to the bedding. Matrix minerals constitute >15%. Abundant primary (well preserved minute platy crystals) and secondary clays appear partially infilling porosity. Small amount of carbonate, appears as sparry crystals, occasionally euhedral. Round zircon and tourmaline as accessory minerals. Moderate porosity; permeability reduced due to the infilling of the matrix minerals. Cemented by well developed and abundant silica overgrowth as well as matrix minerals. Contacts long and punctual.</p>

Moderate quality freestone sandstone similar to sandstones from West Central Scotland area.

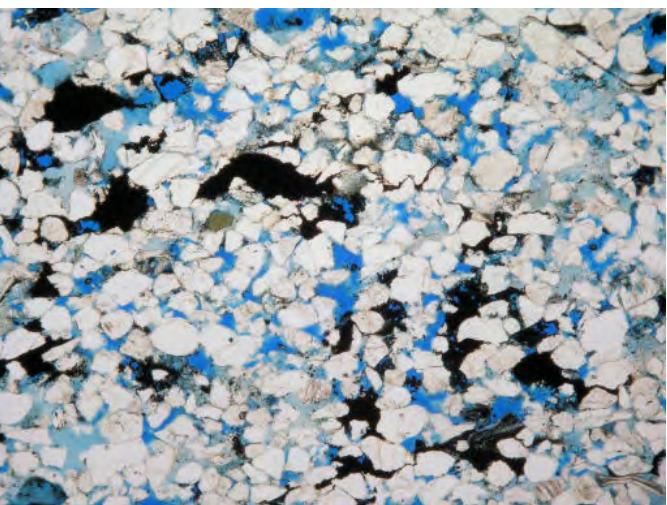
<i>Macroscopic Description</i>	
General Description:	Fine grained, dense in appearance, brownish grey sandstone, with a strong, finely speckled appearance caused by orange iron oxides.
Colour: (<i>Munsell</i>)	c. 5Y 7/1, greyish yellow.
Grainsize	Mostly 'fine to medium'.
Texture	Uniform freestone.
Composition	Quartz, feldspars, iron oxides/organic matter, muscovite.
Grain Hardness	Strong.
Grain Texture	Tight.
Water Absorption	Moderate.
10% HCl Test	No reaction.

<i>Microscopic Description</i>
<p>'Fine' to 'medium', mostly 'fine to medium' grained sandstone, moderately to well sorted with relatively abundant iron oxides, organic matter and clays. Bedding marked only by alignment of mica flakes. Framework grains are subangular to rounded. Dominated by quartz (>80%) ranging from 0.06 to 0.4mm, mostly 0.25-0.3mm in size, generally monocrystalline. Both feldspar and lithic grains are relatively scarce. Feldspar appears well preserved, occasionally altered leaving skeletal remains. Muscovites appear in small sizes, well oriented, often crushed and altered into clays. Often large opaque grains (iron oxides/hydroxides and organic matter) appear scattered throughout, mobilized and stretched parallel to the bedding. Matrix minerals constitute slightly less than 15%. Mostly secondary clays with some well preserved primary clays appear partially infilling porosity. Round and faceted zircon appear as accessory minerals. Porosity and permeability are moderate. Cemented by some thin and irregularly distributed silica overgrowth as well as the matrix minerals. Contacts are a mixture of long, punctual and pressure-solution.</p>

Comments/Possible Original Source: Moderate quality freestone sandstone similar to some sandstones from Glasgow area and West Central Scotland.

Currently available matching stone: No identical stone types are available. Uniform pale buff/orange sandstones: Darney, Dunhouse Buff, Stanton Moor (High Nick, Birchover, Blaxter).

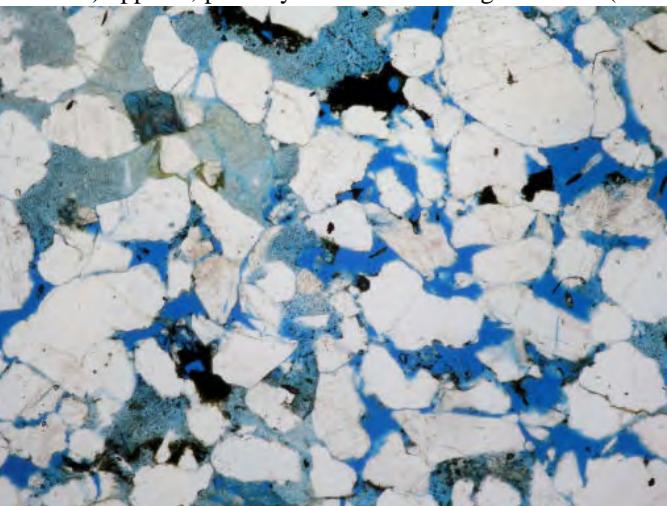
<i>Macroscopic Description</i>	
General Description:	Quartz-rich, coarse grained ('gritty'), buff coloured sandstone, with orange iron oxides and clays.
Colour: (Munsell)	2.5Y 8/3-7/3, greyish yellow.
Grainsize	Fine to very coarse.
Texture	Uniform (though small sample).
Composition	Quartz, yellowish feldspar, lithic grains, iron oxides, white clays/carbonates.
Grain Hardness	Friable.
Grain Texture	Open.
Water Absorption	Rapid.
10% HCl Test	Strong, due to lime mortar/cement contamination.

<i>Microscopic Description</i>
Poorly sorted (fine to very coarse grained) quartz sandstone with relatively abundant feldspar (both fresh and weathered) and clay minerals. Framework grains are subangular to subrounded. Dominated by quartz c.75%, ranging from 0.1 to 1.5mm, average grains 0.4-0.6mm (medium to coarse) generally monocrystalline, occasional polycrystalline, often strained. Small percentage of lithic grains of metamorphic origin. Abundant feldspar grains, often altered, appear as relicts now replaced by clays. A small percentage of irregularly shaped iron oxides are present, corroded, others have idiomorphic shape. Abundant primary and secondary clays are present, patchily distributed partially or totally infilling the porosity. Minor chlorite (green mica) appears, possibly due to weathering of biotite (black mica), releasing iron oxides. Scarce randomly oriented muscovite (white mica) is present, crushed and altered. Greyish tourmaline appears as accessory mineral. Matrix minerals constitute less than 15%. Porosity is high (20-25%) and well communicated. Porosity is both primary and secondary (due to weathering of feldspars) although partially infilled by clays. There is cracking along grain boundaries, explaining the friable nature of the sample. Poorly cemented, although contains some silica cement, now partially dissolved.

Unusual very coarse grained sandstone possibly used for base course only (i.e. not representative of rest of masonry on this building). Source unknown.

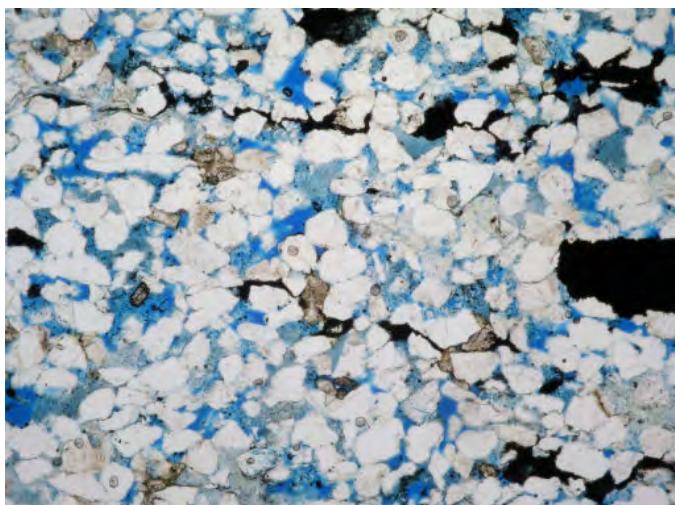
<i>Macroscopic Description</i>	
General Description:	Quartz rich pale (whitish) sandstone, with a strongly speckled appearance caused by orange iron oxides.
Colour: (<i>Munsell</i>)	c. 10YR 8/1, white.
Grainsize	'Fine to medium'.
Texture	Uniform, with some fabric.
Composition	Quartz, feldspars, iron oxides/organic matter, muscovite, carbonate.
Grain Hardness	Strong.
Grain Texture	Intermediate.
Water Absorption	Moderate.
10% HCl Test	Moderate.

<i>Microscopic Description</i>
<p>'Fine to medium' grained sandstone, well sorted with relatively abundant iron oxides, organic matter and clays. Slight fabric parallel to the bedding. Framework grains are generally subangular to subrounded. Dominated by quartz (c.75-80%) ranging from 0.05 to 0.5mm, mostly 0.25-0.3mm in size, generally monocrystalline. Lithic grains are very scarce. Various types of feldspar appear rather well preserved, both K-feldspar and plagioclase, in twinned and untwinned varieties. Occasionally feldspars are altered. Muscovites appear abundantly, well oriented, often crushed. Opaque grains (iron oxides/hydroxides and organic matter) appear scattered throughout, often mobilized into other pore spaces, in variable sizes, stretched parallel to the bedding. Matrix minerals constitute >15%. Primary (with well preserved minute platy crystals) and secondary clays appear partially infilling porosity. Minor carbonate, possibly dolomite appears as sparry crystals, occasionally euhedral. Round zircon and tourmaline appear as accessory minerals. Porosity is moderate and permeability is reduced due to the infilling of the matrix minerals. Cemented by some silica overgrowth as well as the matrix minerals. Contacts are long and punctual.</p>

Comments/Possible Original Source: Moderate quality freestone sandstone similar to many types of sandstone in the Glasgow area, but possibly also from an Ayrshire quarry.
Currently available matching stone: No identical stone types are available.
Pale sandstone: High Nick, Birchover, Blaxter. Buff sandstones (to replicate weathered surface): Peak Moor, Stanton Moor, Swinton, Dunhouse Buff.

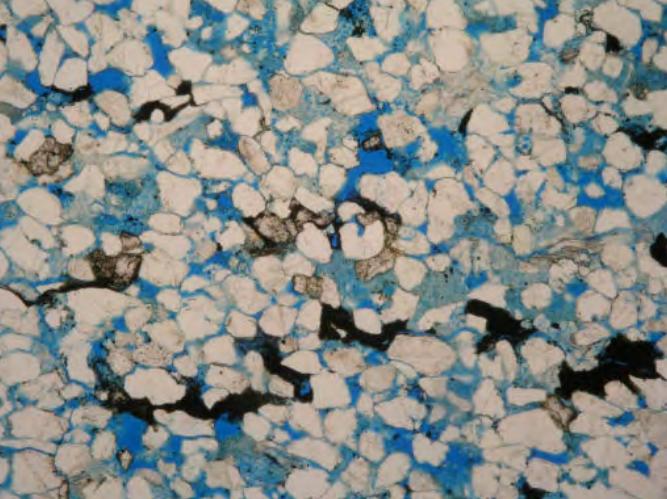
<i>Microscopic Description</i>	
<p>'Fine to medium' and 'medium' grained sandstone, moderately sorted with abundant iron oxides, organic matter, muscovite and clays. Framework grains are generally angular to subrounded. Quartz (c.70%) ranges from 0.1 to 0.5mm, mostly 0.25-0.35mm in size, generally monocrystalline (some undulating extinction) and occasionally containing rutile needles, although there are polycrystalline grains. Rare lithic grains of sedimentary origin, well rounded. Feldspars appear well preserved, mostly untwinned varieties, occasionally altered. Well oriented muscovite, accessory biotite often crushed can be long (over 1mm). Abundant iron oxides and organic matter appear scattered throughout, often mobilized into pore spaces, in variable sizes and stretched parallel to the bedding. Matrix minerals constitute >15%. Primary clays (with well preserved minute platy crystals) and secondary clays virtually infill the porosity.</p> <p>Relatively abundant carbonate, possibly dolomite, appears as yellowish sparry crystals, occasionally euhedral, sometimes associated with iron oxides. Round zircon and tourmaline appear as accessory minerals. Porosity is moderate and permeability is reduced due to the infilling of the matrix minerals. Contacts are long and punctual. The sandstone is cemented with silica overgrowth, but it has been partially dissolved and there is dislocation of grain boundaries, making the stone friable and prone to breakage. The stone is currently cemented mostly by the matrix minerals.</p>

Moderate to high quality sandstone freestone. Similar to 'blonde' sandstone from quarries in Glasgow area and West Central Scotland (including high quality Ayrshire quarry).

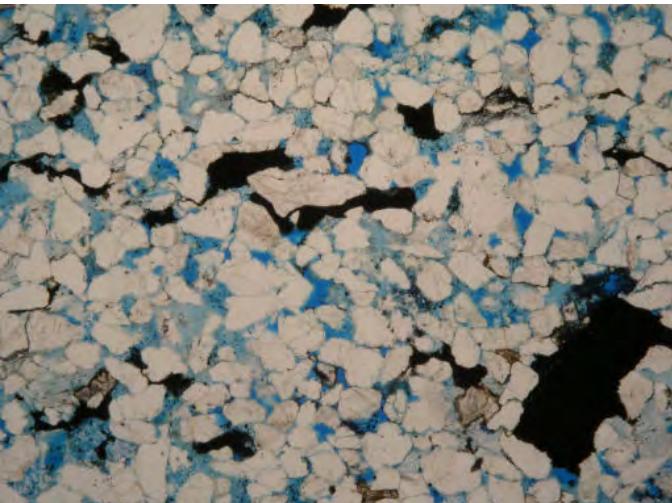
<i>Microscopic Description</i>
<p>'Fine to medium' and 'medium' grained sandstone, moderately sorted with abundant opaques, muscovite and clays. Framework grains are generally angular to subrounded. Dominated by quartz (c.70%) ranging from 0.1 to 0.7mm, mostly 0.25-0.35mm in size, generally monocrystalline although there are polycrystalline grains. Lithic grains are rare. Relatively abundant feldspars appear well preserved, mostly untwinned varieties. Abundant long muscovite well oriented, often crushed. Abundant opaque grains, sometimes in large sizes over 2mm, appear scattered throughout often mobilized into pore spaces and stretched parallel to the bedding. Muscovite flakes are long, often over 1mm, mostly crushed. Matrix minerals constitute >15%. Primary clays (with well preserved minute platy crystals) and secondary clays appear infilling the porosity. Relatively abundant carbonate, possibly dolomite appears as yellowish sparry crystals, occasionally euhedral. Zircon and tourmaline appear as accessory minerals. Porosity is moderate and permeability is reduced due to the infilling by matrix minerals. Contacts are long and punctual. Moderately cemented with some silica overgrowth, with minor dislocation of the grain boundaries, making the stone rather friable. The stone is currently cemented mostly by the matrix minerals.</p>

Moderate to high quality sandstone freestone, suitable for ashlar and carved work. Similar to 'blonde' sandstone from quarries in Glasgow area and West Central Scotland (including high quality Ayrshire quarry).
