# Mauchline Conservation Area Management and Maintenance Plan

Prepared for East Ayrshire Council  
by  
Wylie Shanks Architects

Adopted 27.03.2023

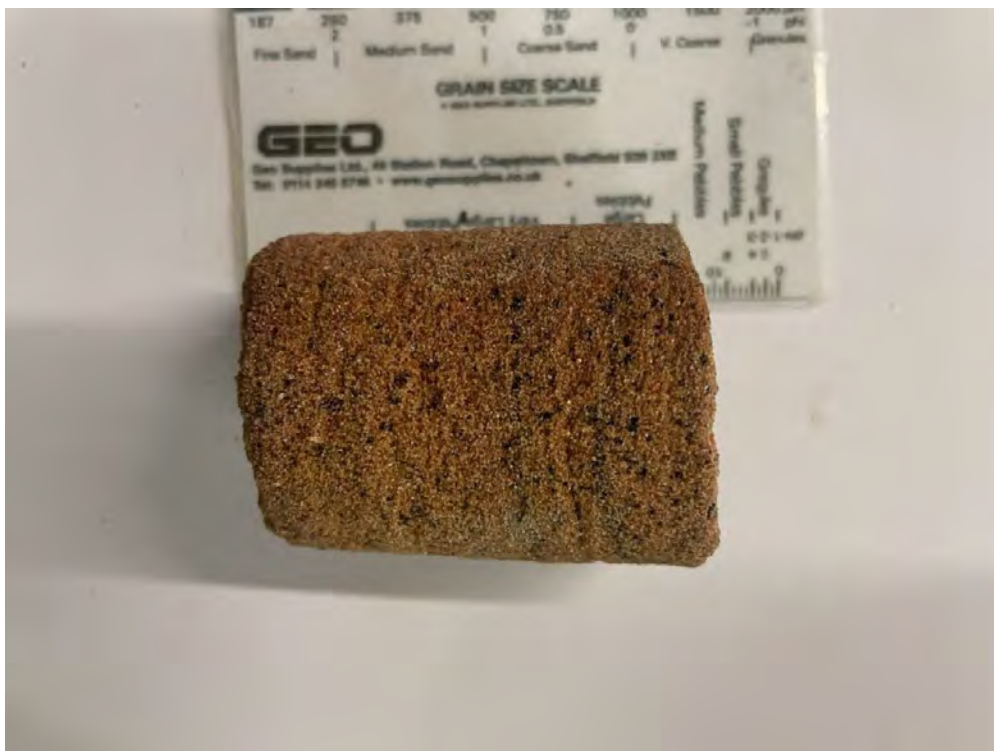
Plate 1. Image of the sample as received. Note the black speckling caused by Fe-oxides. Scale is in mm.

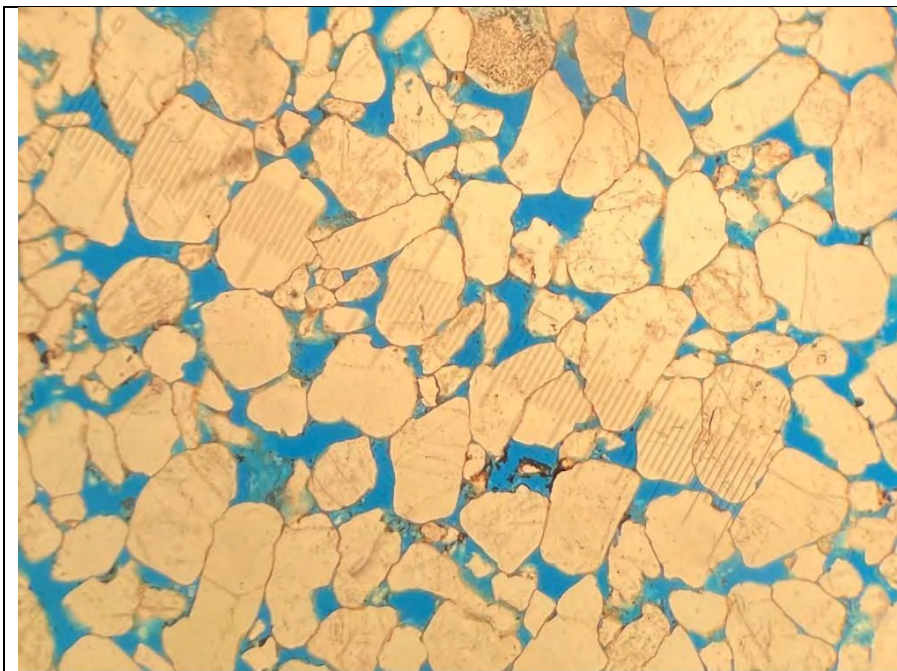
Plate 2. Thin section of the sample under plane polarised light. Pore spaces are highlighted in blue, while areas of light blue indicate pore filling clays that have absorbed some of the blue dye. Pores are moderately to well connected, with some of the larger pores filled with small, sub-angular to sub-rounded quartz, feldspar and lithic fragments.

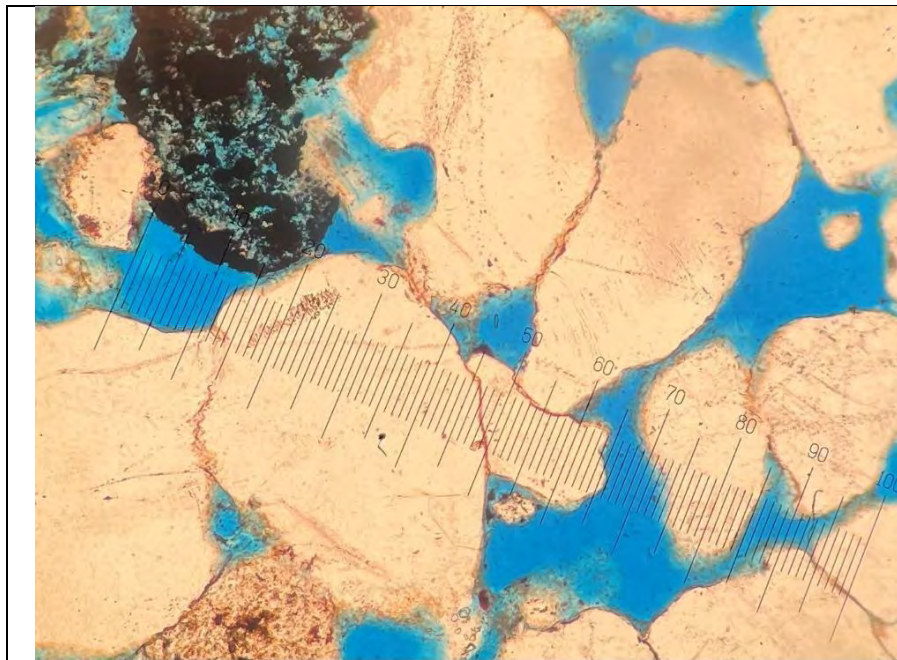
Plate 3. Thin section image of the sample under plane polarised light. Pore spaces are highlighted in dark blue, while areas of light blue indicate pore filling clays. There are some concentration of Fe oxides and organic carbonaceous matter within the thin section. Fe staining can be seen surrounding some of the quartz grains, which gives the sample its red colour.

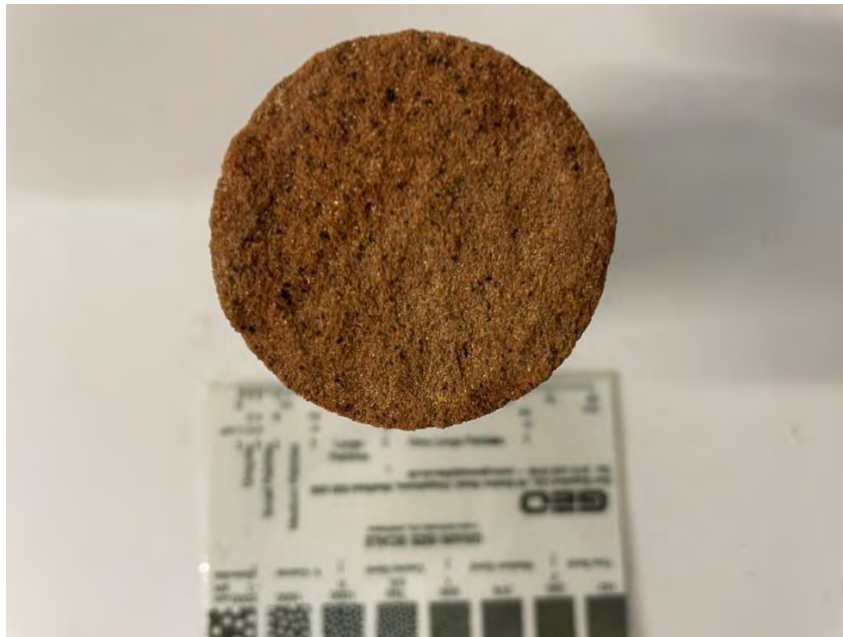
Plate 1. Image of the sample as received. Note the black speckling caused by Fe-oxides and carbonaceous matter. Scale is in mm.

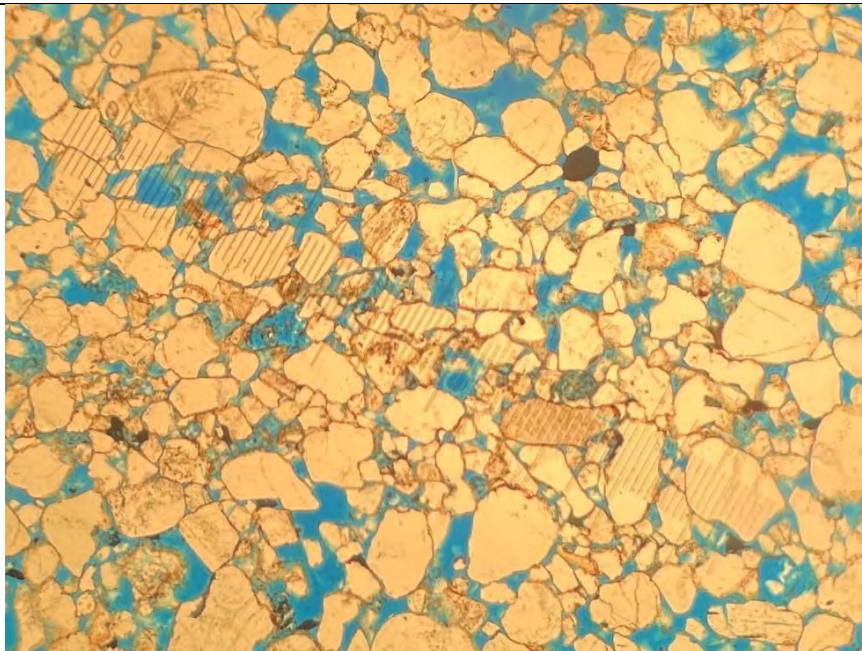
**Plate 2.** Thin section of the sample under plane polarised light. Pore spaces are highlighted in blue, while areas of light blue indicate pore filling clays that have absorbed some of the blue dye. Pores are moderately to well connected, with some of the larger pores filled with sub-angular to sub-rounded quartz, feldspar, and lithic fragments.

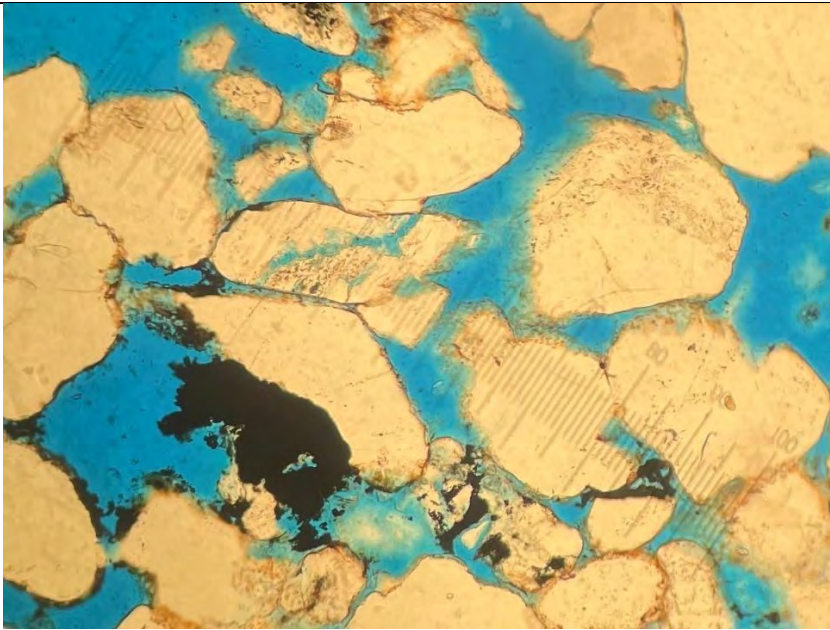
Plate 3. Thin section image of the sample under plane polarised light. Pore spaces are highlighted in dark blue, while areas of light blue indicate pore filling clays. Hematite rims can be seen surrounding the quartz grains, this is what gives the sample its distinct red colour.

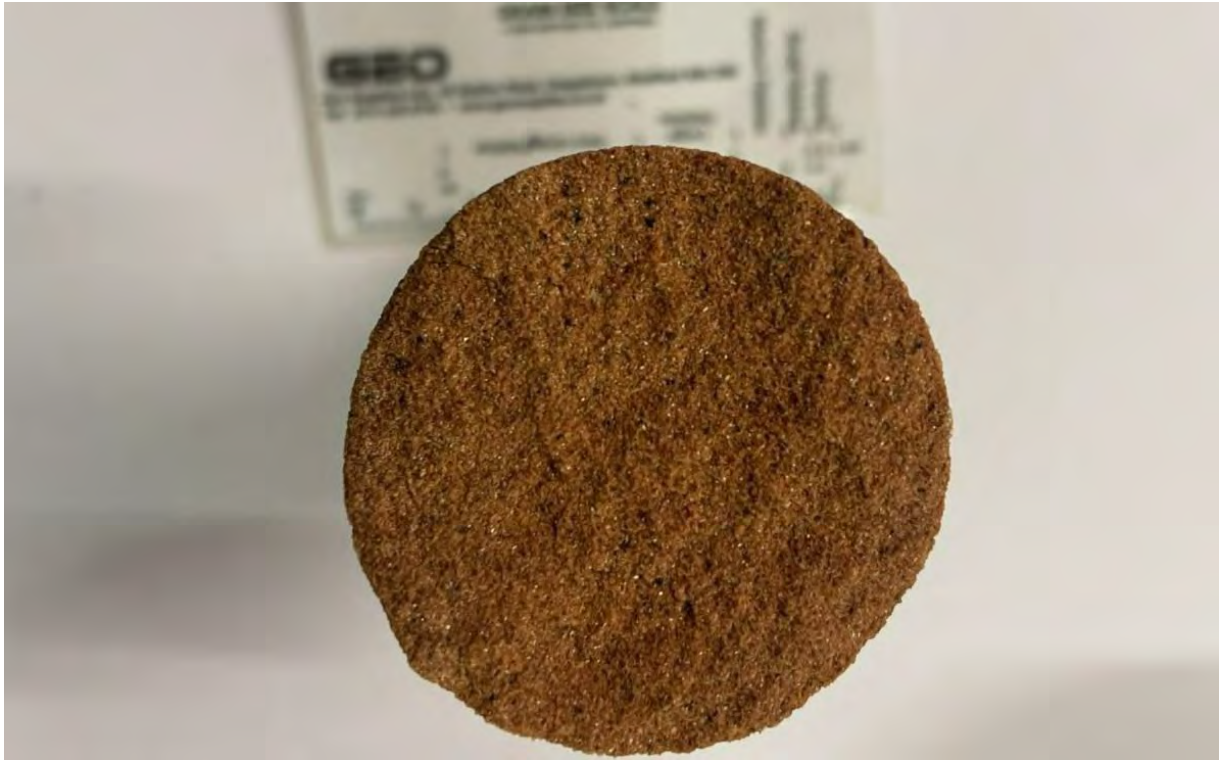
Plate 1. Image of the sample as received. Note the black speckling caused by Fe-oxides. Scale is in mm.

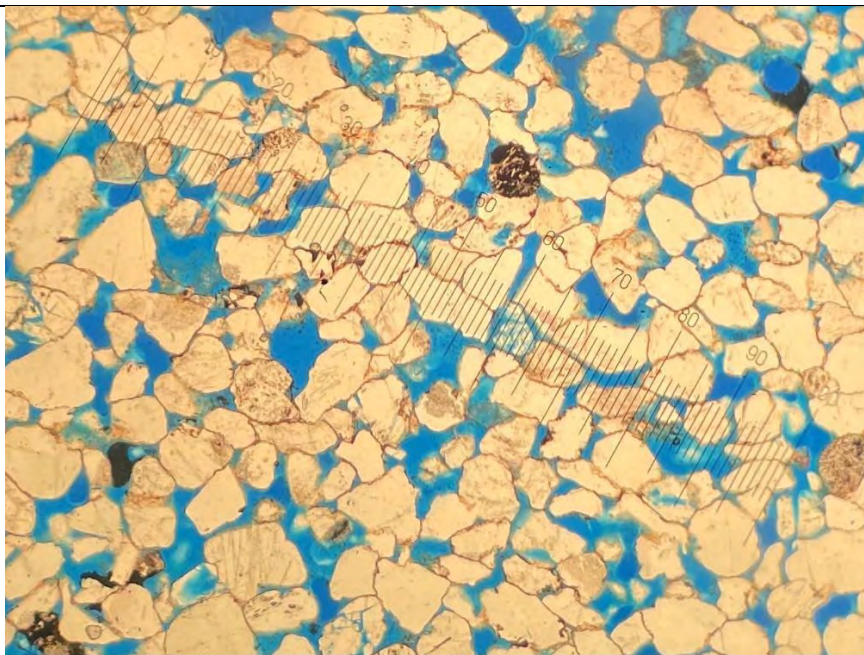
Plate 2. Thin section of the sample under plane polarised light. Pore spaces are highlighted in blue, while areas of light blue indicate pore filling clays that have absorbed some of the blue dye. Pores are moderately to well connected, with some of the larger pores filled with sub-angular to sub-rounded quartz, feldspar, and lithic fragments.

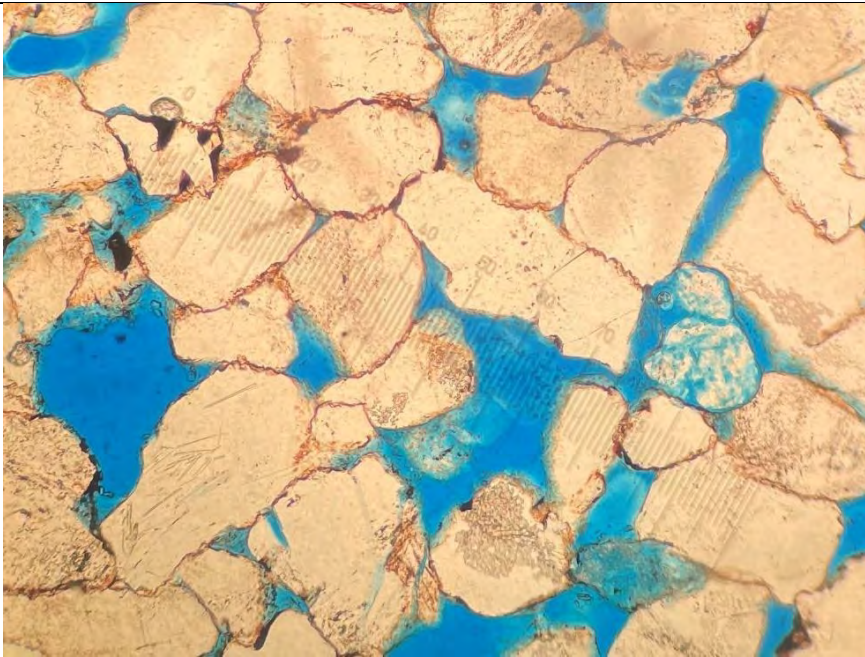
Plate 3. Thin section image of the sample under plane polarised light. Pore spaces are highlighted in dark blue, while areas of light blue indicate pore filling clays. Hematite rims can be seen surrounding the quartz grains, this is what gives the sample its distinct red colour.

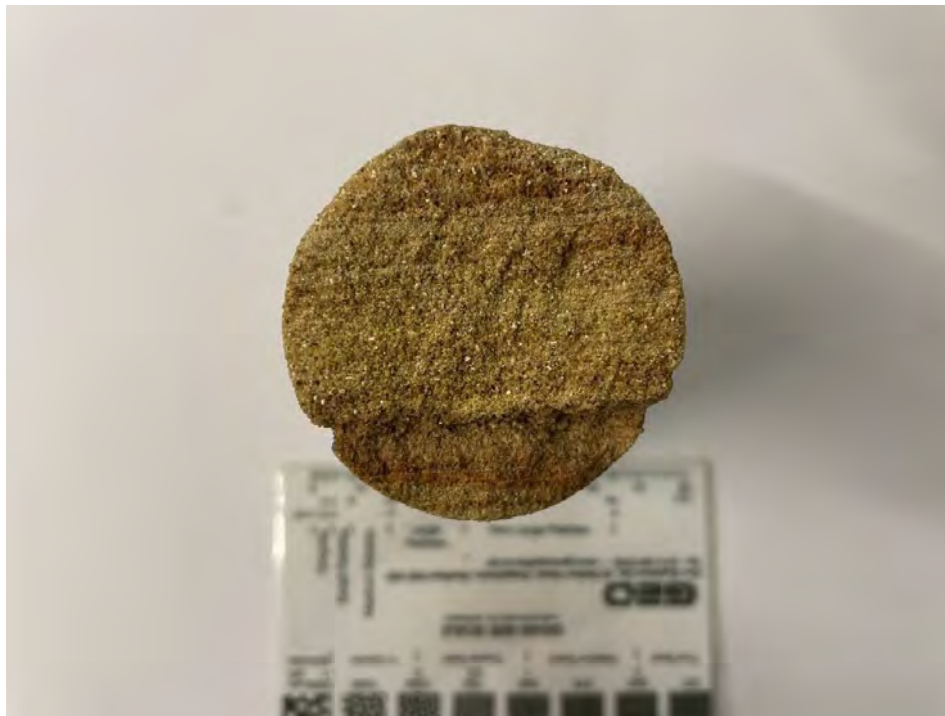
Plate 1. Image of the sample as received. Note the laminated texture and slight pink hue. Scale is in mm.

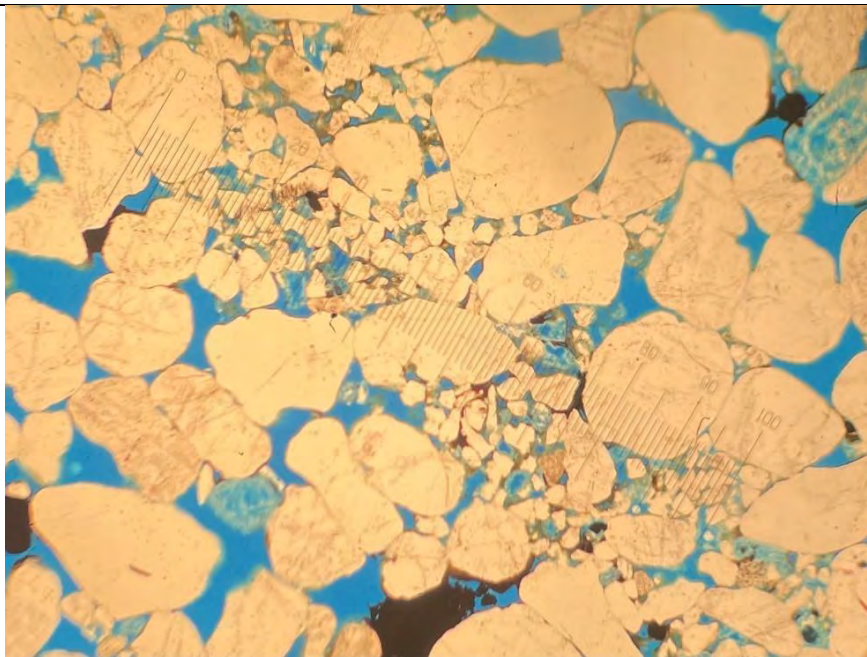
Plate 2. Thin section of the sample under plane polarised light. Pore spaces are highlighted in blue, while areas of light blue indicate pore filling clays that have absorbed some of the blue dye. The stone has distinct bedding which is characterised by layers of differing grainsize.

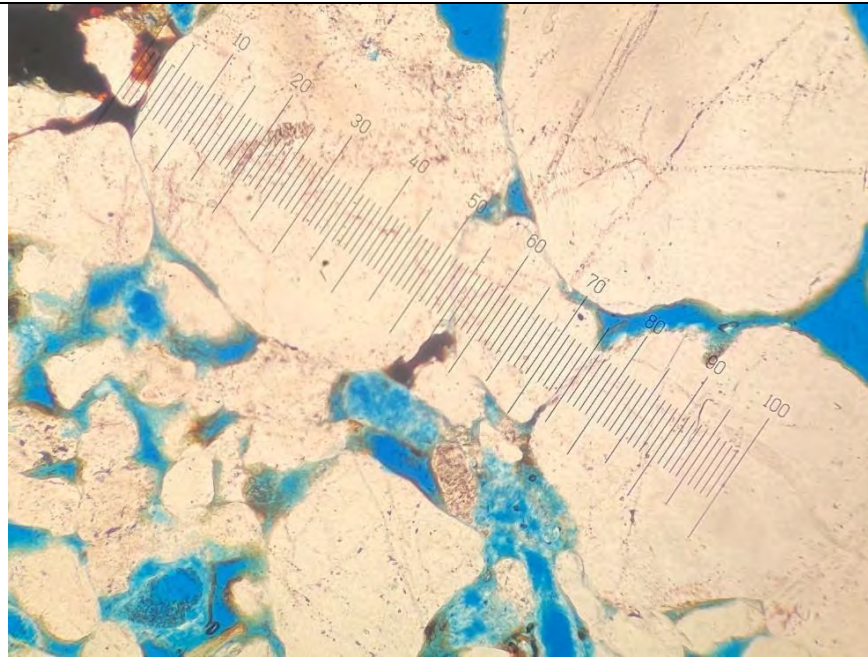
Plate 3. Thin section image of the sample under plane polarised light. Pore spaces are highlighted in dark blue, while areas of light blue indicate pore filling clays. Fe staining can be seen surrounding some of the quartz grains, which gives the sample its pinkish hue in some layers.

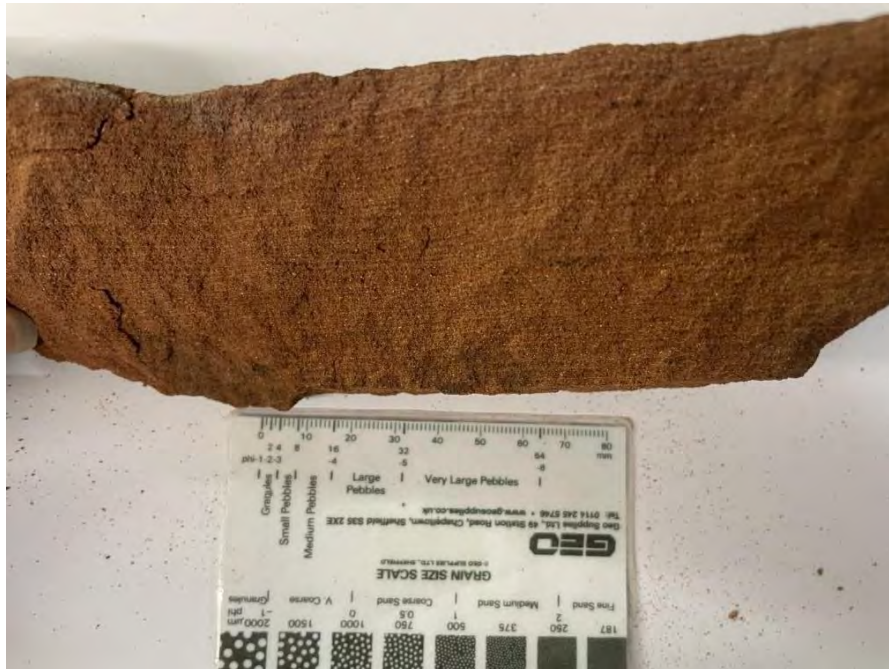
**Plate 1.** Image of the sample as received. Note the fine laminations in the stone. Scale is in mm.

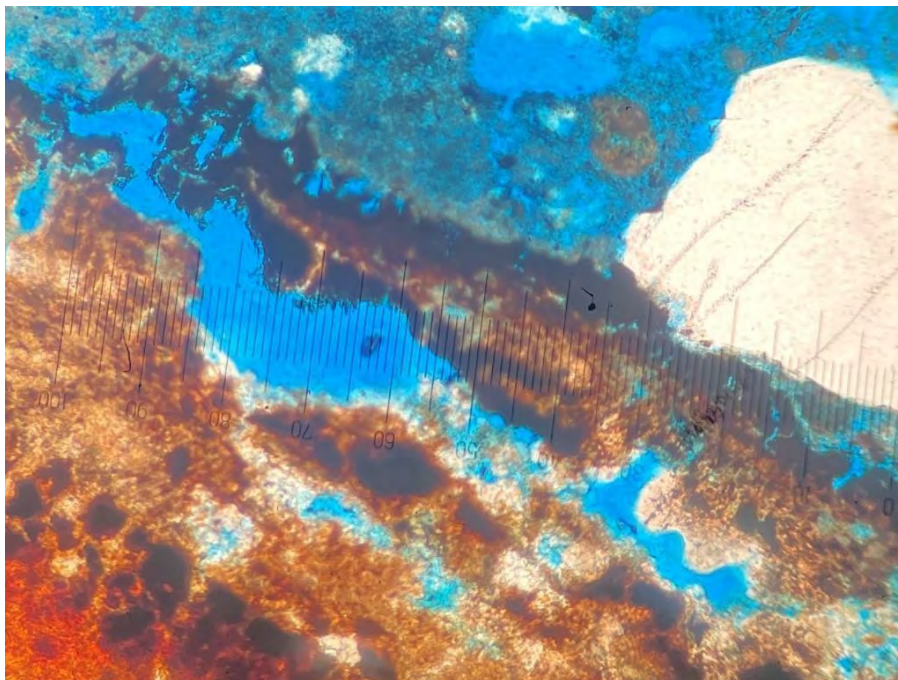
**Figure 5.** Thin section of the sample under plane polarised light. Pore spaces are highlighted in bright blue, while areas of dark/dull blue indicate the lime binder that has absorbed some of the blue dye). Microcracks in some areas are lined by secondary binder products - evidence of abundant binder leaching and dissolution, highlighted by red arrows.

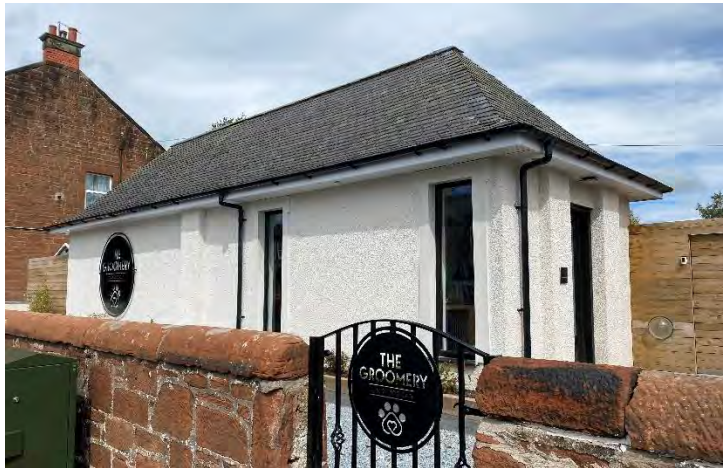
Restrictions	Surveyed on all elevations.
Structural Issues	None apparent.
Storey Height	1 – detached
Roof	Natural slate with close mitred hips. Concrete ridge tiles. Timber fascia's and soffits.
Chimneys	n/a
Walls	Wet dash render in

- Minor slate repairs
- Refurbish windows
- Replace door
- Replace uPVC gutters and downpipes with CI

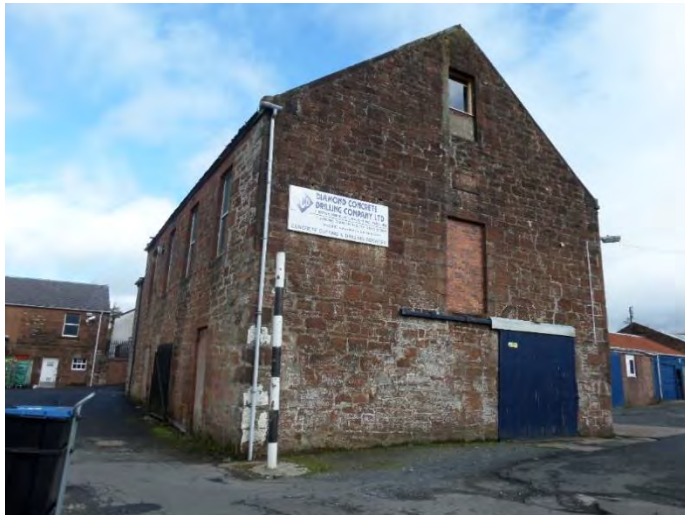
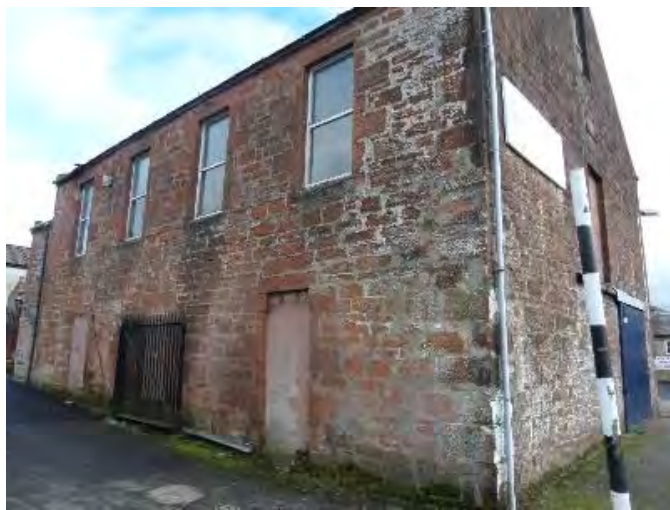
Restrictions	Surveyed from Barskimming Road only
Structural Issues	None apparent
Storey Height	2
Roof	Not visible. Presumed natural slate.
Chimneys	n/a
Walls	Red sandstone rubble. Cementitious pointing.
Windows	Modern timber casements – a number of windows are blocked up.
Doors	Vertically lined timber sliding door. Two blocked up door openings.
External Pipework	uPVC downpipes. uPVC gutters (partially missing)

- Carry out significant slate repairs (assumed)
- Repoint stonework
- Paint existing windows
- Replace uPVC gutters and downpipes with CI

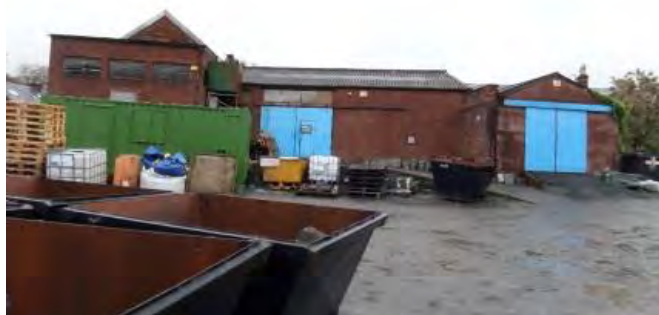
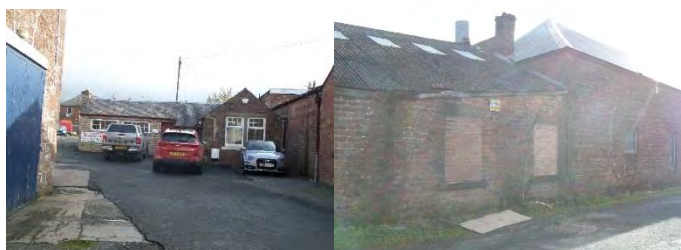
Restrictions	Surveyed from fence line on Barskimming Road only
Structural Issues	None apparent
Storey Height	1
Roof	Predominantly profiled metal sheets. Natural slate with zinc ridge and clips to the rear. Possible asbestos roof?

- Make minor slate repairs to rear extension
- Replace windows
- Refurbish existing CI rainwater goods
- Install new CI rainwater goods
-

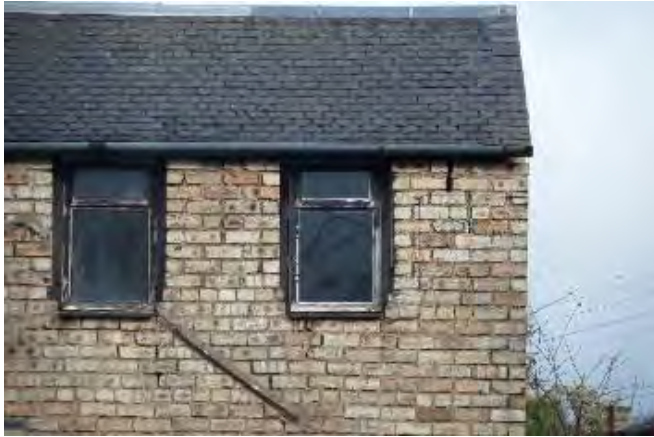
Restrictions	Surveyed from fence line on Barskimming Road only.
Structural Issues	Movement cracks to top right hand corner.
Storey Height	2
Roof	Natural slate with zinc ridge and clips.
Chimneys	None visible
Walls	Buff brick / red brick
Windows	Predominantly modern casement. 1no. 9 paned casement
Doors	Ply door blank
External Pipework	uPVC

- Carry out structural inspection & any recommended remedial repairs
- Carry out minor slate repairs
- Repoint brickwork
- Replace windows
- Replace door
- Replace uPVC rainwater goods with CI

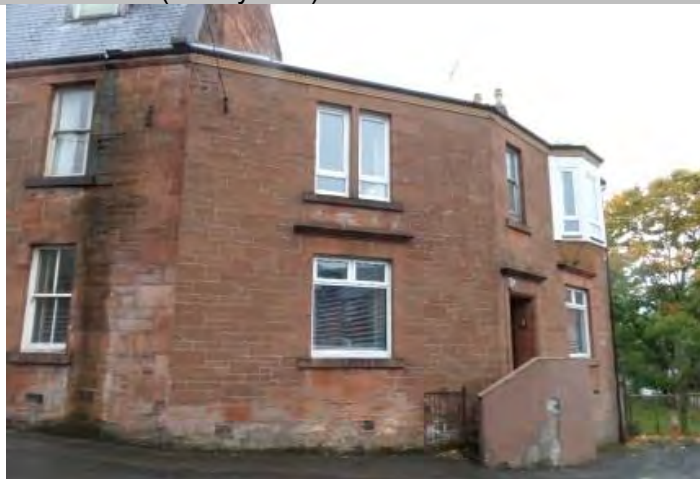
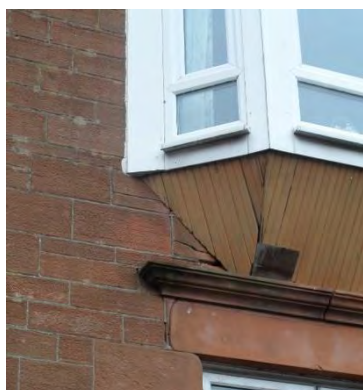
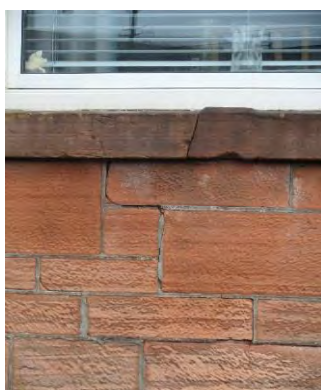
### 5-7 Burnside Road Residential (Thonyburn)

Restrictions	Ground – occupied First – occupied Surveyed from Burnside Road only.
Structural Issues	Cracking/ damaged lintol at oriel window. Cracked cill to r.h.s of ground floor window and below ground floor window.
Storey Height	2 – end terrace.
Roof	Natural slate with zinc ridge and clips. Lead abutment flashing and chimney flashing. Mortar skew.
Chimneys	Red brick chimney to r.h.s. with 2no. ornamental pots.
Walls	Red sandstone. Cement mortar pointing. Timber dentil moulded cornice at wall head. 3no. ornate air grilles.
Windows	1no. 1x1 timber sash & case window with horns at first floor level. Refurbish. All other windows are uPVC.
Doors	Modern timber vertically lined storm doors.
External Pipework	uPVC gutters and downpipes. Gutter blocked.

- Carry out minor slate repairs
- Replace mortar skew
- Carry out structural inspection & any recommended remedial repairs
- Replace cracked cills and lintols
- Repoint
- Refurbish timber sash and case window
- Replace uPVC windows
- Replace door
- Replace uPVC gutters and down pipes with CI

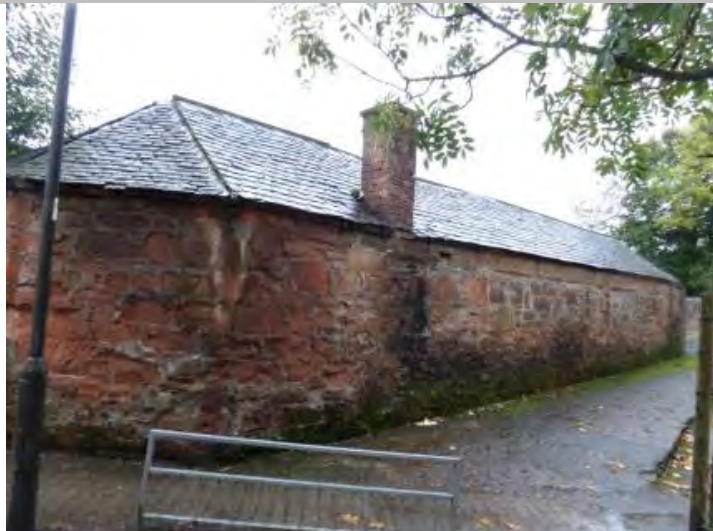
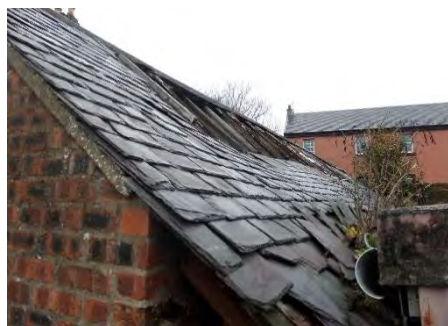
## Burnside Road Outhouse

Restrictions	Vacant – partially derelict
Structural Issues	Surveyed from Burnside Road and courtyard. Crack at corner of brickwork.
Storey Height	1 – detached.
Roof	Natural slate. Ridge missing – partially collapsed to rear. Mortar skews to chimney.
Chimneys	Red brick wall head chimney. No pots. Open joints.
Walls	Red sandstone rubble with red brick wall head. Brick gable end. Heavily eroded with heavy cement over pointing. Very damp at ground floor level.
Windows	Remains of cast iron roof lights, now missing.
Doors	n/a
External Pipework	Missing.

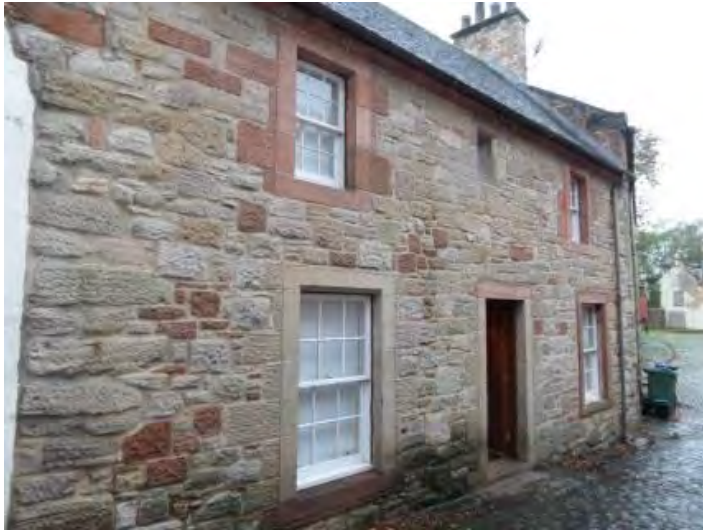
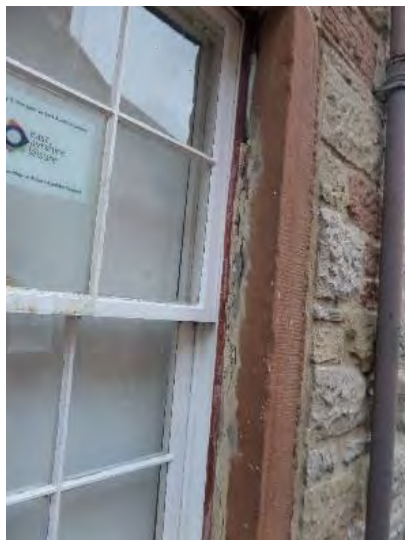
Nance Tinnocks Ale House (Part of Museum)

Category B Listed	Occupied
Restrictions	Surveyed from Castle Street only.
Structural Issues	None apparent.
Storey Height	2 – terraced.
Roof	Natural slate with lead ridge flashing and clips.
Chimneys	Brick chimneys at each party wall with black terracotta pots

- Repair damaged ingo
- Remove gutter connection from No 3 / 5 The Cross by installing additional downpipe.

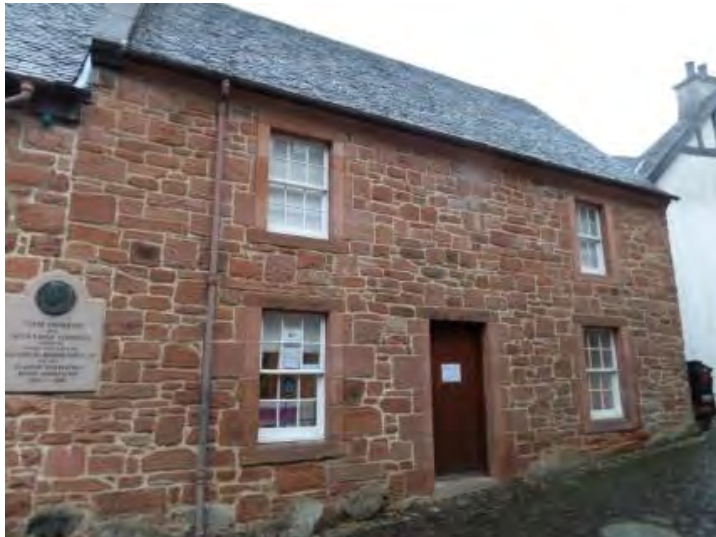
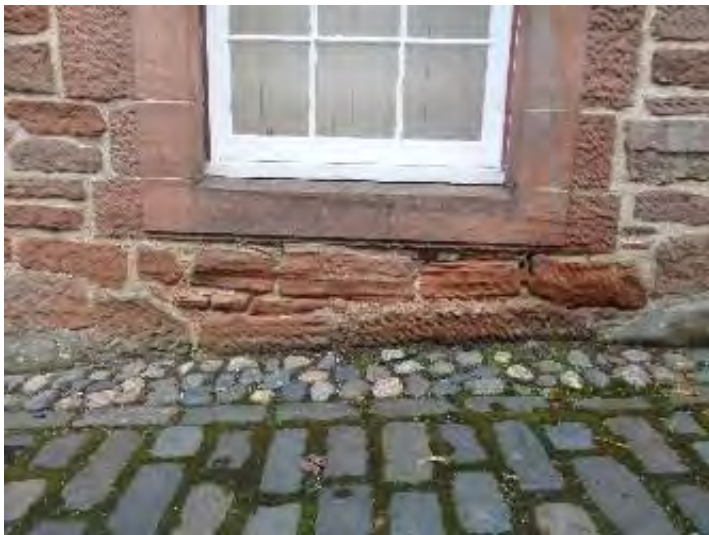
Part of Burns Museum

Category B Listed	Occupied
Restrictions	Surveyed from Castle Street only.
Structural Issues	None apparent.
Storey Height	2 - end terrace.
Roof	Natural slate with lead ridge flashing and clips. Stepped lead soakers / mortar at chimney.
Chimneys	At party wall. Red

- Clear vegetation from chimney and mortar verge and repoint
- Carry out localised stone repairs and repoint below window
- Reseal around windows
- Refurbish cast iron rainwater goods

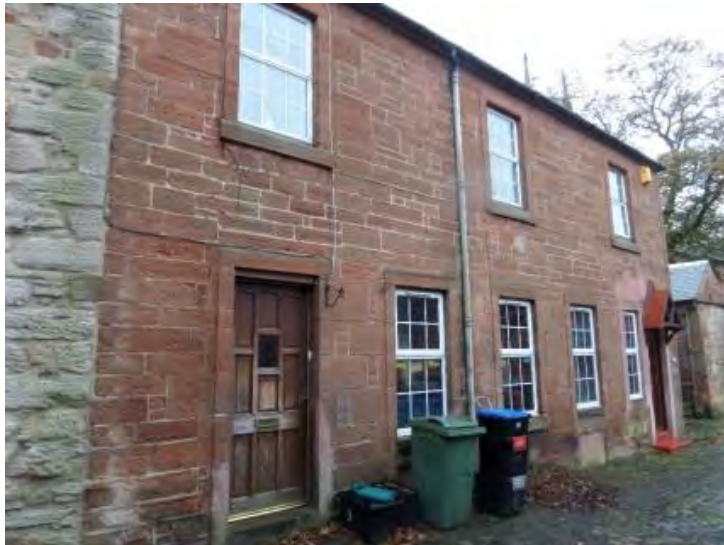
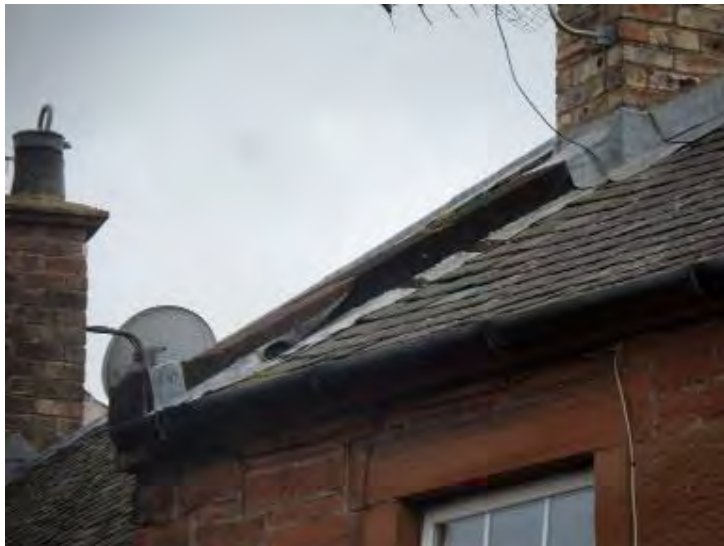
Movement crack between ground and first floor windows – No5.

2 – end terrace.  
Natural slate with zinc ridge and clips.

Lead/felt flashing at straight skew. Felt loose.
Chimneys	Brick chimney on party wall with No. 1 with 4no. cans. Brick chimney at wall head on gable return of No.5.
Walls	Squared red sandstone rubble with ashlar door and window dressings. Cementitious mortar with cementitious repairs around ground floor window to No.5 and up flue line on return.
Windows	7 no. uPVC windows.
Doors	2no. modern timber panelled doors. Modern timber porch to No. 5.
External Pipework	uPVC gutter. 1no. circular cast iron downpipe – requires refurbishment.

**Priority Score** (0+2+1) 3

- Carry out minor slate repairs
- Replace felt flashing at skew with lead
- Replace uPVC gutter with CI
- Refurbish CI downpipe
- Replace windows
- Replace doors
- Remove mortar repairs around window and on gable, carry out stone repairs, and locally repoint

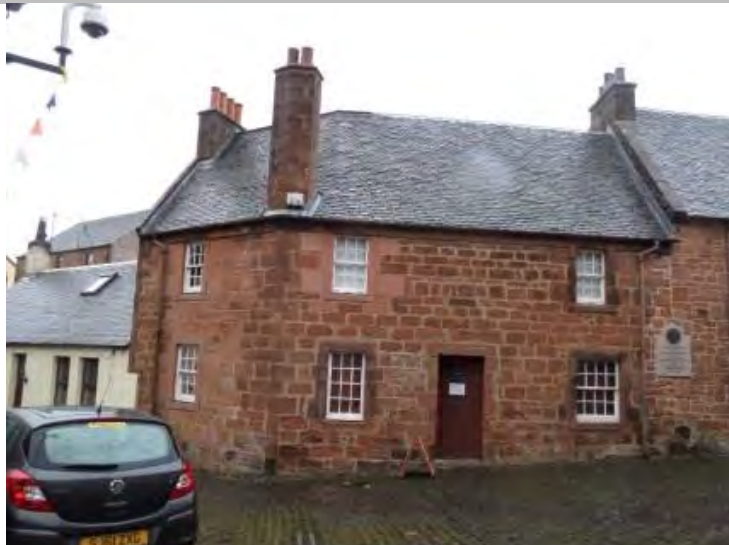
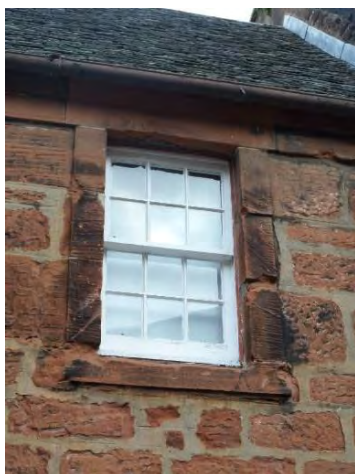
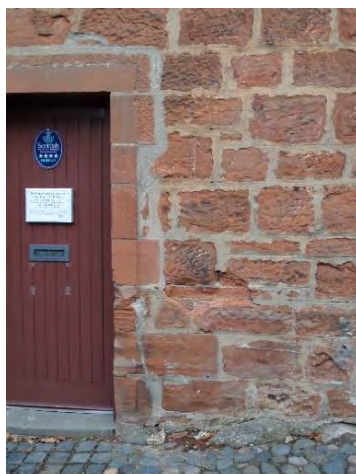
## 4 Castle Street

Category B Listed	Occupied
Restrictions	Surveyed from Castle Street only.
Structural Issues	None apparent.
Storey Height	2 – corner mid terrace, squared
Roof	Natural slate, close mitred hip, lead ridge flashing and clips, flat lead roof with wood core rolls. Lead skew and chimney flashings.
Chimneys	Hexagonal ashlar sandstone chimney on corner return at wall head with 2no. plain terracotta pots. Rectangular stack at party wall with No. 6 with 4no. terracotta pots with terracotta elephants' feet.
Walls	Heavy cementitious over pointing. Some scaling and eroded stones around entrance at ground level and also around window. Evidence of some stone repairs. 1 modern louvred aluminium solum vent.
Windows	4no. 4 x 6 timber sash & case windows, 1 with horns. 1no. 8 x 8 timber

sash & case window. 1no. 12 pane timber
Doors	Modern vertically lined timber door.
External Pipework	Cast iron half round gutters and 2no. cast iron circular downpipes. Require refurbishment.
<b>Priority Score</b>	<b>(2+3+0) 5</b>

- Rake out and repoint
- Carry out stone repairs around doorway and window
- Refurbish CI rainwater goods
- Replace modern vent

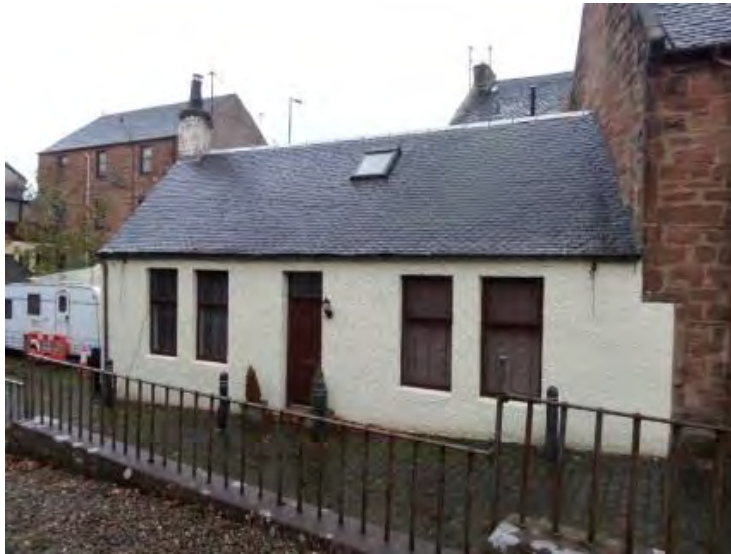
**6 Castle Street**  
Residential

Structural Issues	None apparent
Storey Height	1 – end terrace.
Roof	Natural slate with zinc ridge and clips. Some loose along ridge. Lead chimney flashing. Mortar verge with no.4. Modern roof light.
Chimneys	Rendered chimney with modern metal can.
Walls	Modern cementitious wet dash. 2no. modern brick vents
Windows	4no. uPVC with leaded upper lights
Doors	Modern timber panelled door with fan light.
External Pipework	Cast iron half round gutter with 1no. cast iron down pipe. Requires refurbishment.
<b>Priority Score</b>	<b>(0+2+1) 3</b>

- Carry out minor slate repairs
- Replace mortar skew
- Remove cementitious render, repoint stonework and apply lime based render system
- Replace modern vents
- Replace windows
- Replace door
- Refurbish cast iron rainwater goods

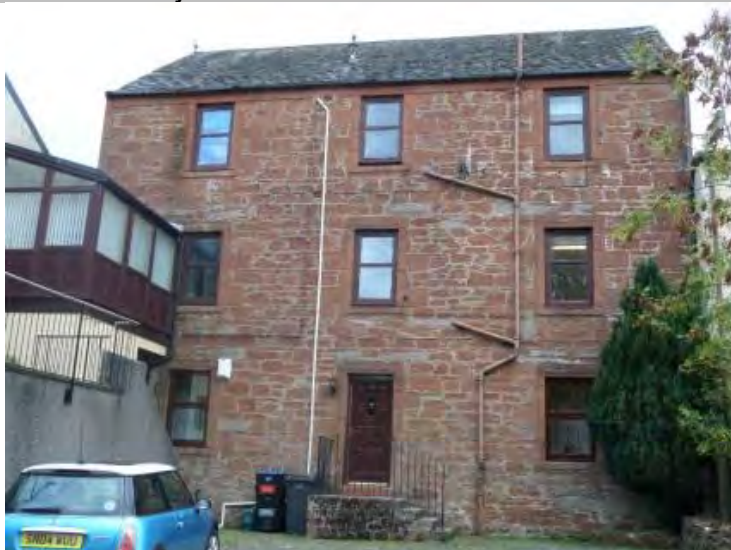
Ground – occupied First – occupied Second - occupied
Restrictions	Surveyed from Castle Street and Kilmarnock Road.
Structural Issues	None apparent.
Storey Height	3 – flatted.
Roof	Natural slate with zinc ridge and clips
Chimneys	n/a
Walls	Red sandstone. 2no. modern terracotta high level air bricks.
Windows	Modern timber casements at ground level. uPVC at 1 <sup>st</sup> and 2 <sup>nd</sup> floors.
Doors	1 modern timber

panelled door with bullseye glass vision panel. Lever handle, letter box.
External Pipework	uPVC gutter, sagging and overflowing at one end. uPVC downpipe. Cast iron stack and branches. Refurbish
<b>Priority Score</b>	(0+2+1) 3

- Carry out minor slate repairs
- Replace windows
- Replace door
- Replace uPVC rainwater goods with CI
- Refurbish CI stack

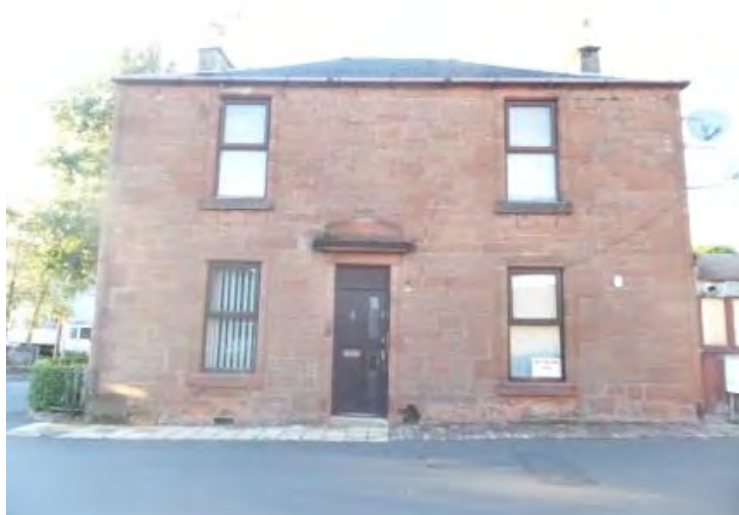
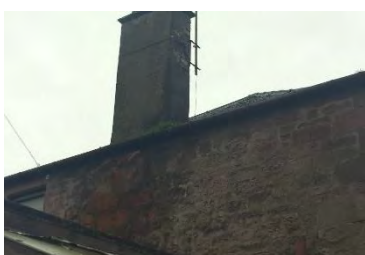
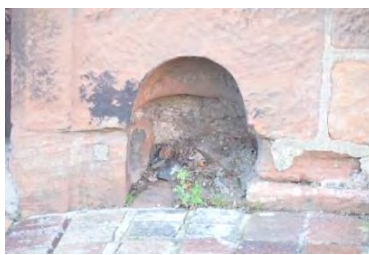
### 5 Cowgate Residential

Occupied
Restrictions	Surveyed from Cowgate and also gable ends.
Structural Issues	None apparent.
Storey Height	2 - detached
Roof	Hipped roof. Natural slate with zinc ridges and clips. No skews. Assume lead chimney flashing
Chimneys	Brick chimneys to l.h.s. and r.h.s. each with 2no. decorative cans.
Walls	Squared red sandstone rubble with ashlar window dressings and door surround. Street frontage requires repointing. Erosion below windows. Dry dash on l.h. gable. Heavy stone erosion along flue line on r.h. gable. 1no. modern grille. Recess for shoe scraper – ironwork missing.
Windows	Modern timber.
Doors	Modern door blank with vision panels.

- Carry out minor slate repairs
- Repoint main elevation and r.h. gable
- Carry out stone repairs below windows and on r.h. gable end
- Remove dry dash from l.h. gable, repoint and re-render with lime-based product
- Replace modern vent

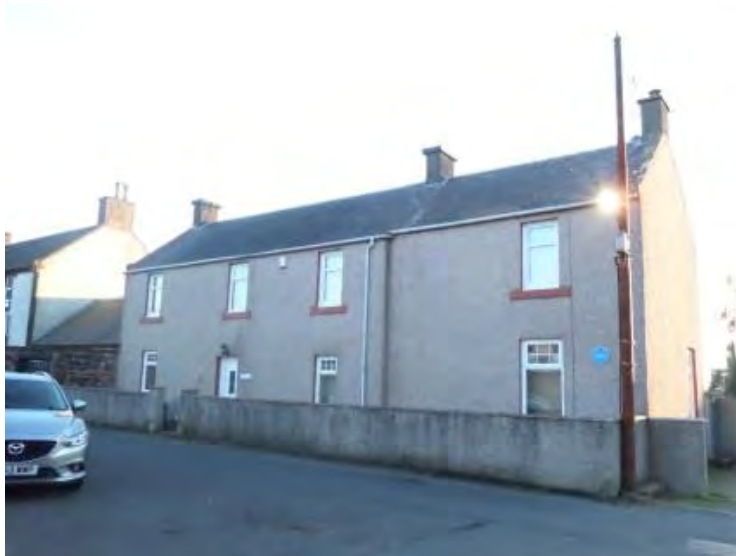
Restrictions	Surveyed from Cowgate only.
Structural Issues	None apparent.
Storey Height	2 – detached if one property.
Roof	Natural slate with zinc ridge and clips. Mortar skews and lead chimney

flashings.
Chimneys	3no. rendered chimneys. 2 capped. With metal flashings.
Walls	Dry dashed.
Windows	7no. uPVC
Doors	1no. uPVC
External Pipework	uPVC gutter. 1no. uPVC downpipe.

**Priority Score** (0+1+1) 2

- Carry out minor slate repairs
- Remove dry dash, repoint and re-render in a lime-based product
- Replace windows
- Replace door
- Replace uPVC rainwater goods with CI
-

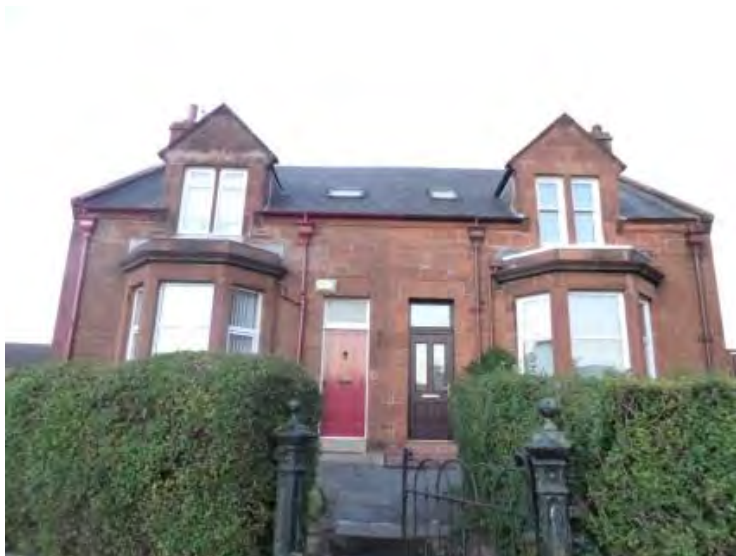
**1-3 Cumnock Road**  
Residential

Restrictions	Restricted survey due to front garden.
Structural Issues	None apparent.
Storey Height	1.5 – 2 x semi-detached.
Roof	Natural slate with zinc ridge and clips. Mortar skews. Lead chimney flashings and on bay window roof. Lead dormer valleys. 2no. modern roof lights.
Chimneys	1no. red sandstone gable stack with 1no. can to l.h.s. 1no. red sandstone gable stack with 3no. cans to r.h.s.

Walls	Red squared sandstone with ashlar window and door surrounds. Single storey bay window. Masonry appears in good condition. No air bricks visible.
Windows	uPVC.
Doors	No.1 - Modern timber with fanlight No.3 – uPVC with fanlight
External Pipework	Cast iron wall head gutters. Rectangular cast iron downpipes with decorative hoppers and ear bands.
<b>Priority Score</b>	<b>(0+2+1) 3</b>

- Carry out minor slate repairs
- Replace mortar skews
- Replace uPVC windows

- Refurbish timber sash and case windows
- Replace 2no. doors
- Refurbish CI rainwater goods

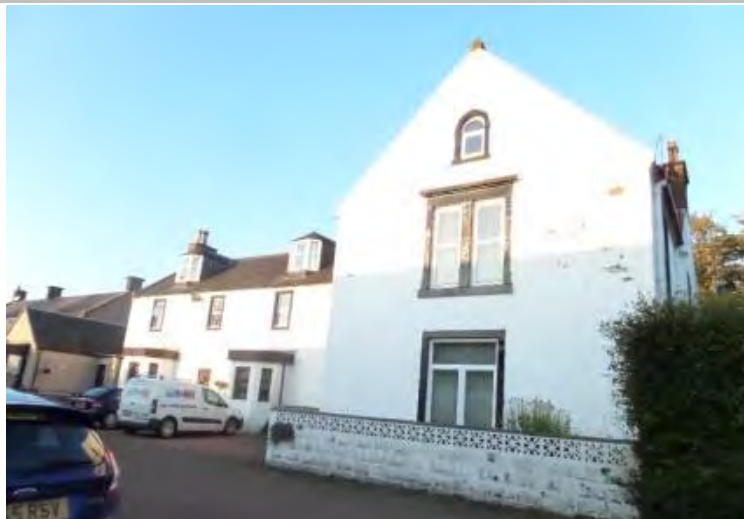
**6A Cumnock Road / 6 Grove Park**  
Residential (may be flatted)

Ground – occupied First – occupied Second - occupied
Restrictions	Surveyed from Grove Park/Cumnock Road only.
Structural Issues	None apparent
Storey Height	2 – 2 x semi detached
Roof	Polygonal dormer windows. and roof lights. Natural slate with zinc ridge and clips. Mortar skews. Lead valleys and chimney flashings.
Chimneys	1no. stone stack with 3no. ornamental pots. 1no. stone ridge stack with no pots. 1no. stone stack with 2no. ornamental cans. 1no. stone stack with 3no. ornamental cans.
Walls	Painted masonry - requires repainting. Modern air bricks.
Windows	uPVC
Doors	uPVC

- Carry out minor slate repairs
- Replace mortar skews
- Repaint masonry (all elevations)
- Replace modern vents
- Replace windows
- Replace doors
- Replace uPVC rainwater goods with CI
- Refurbish CI rainwater goods

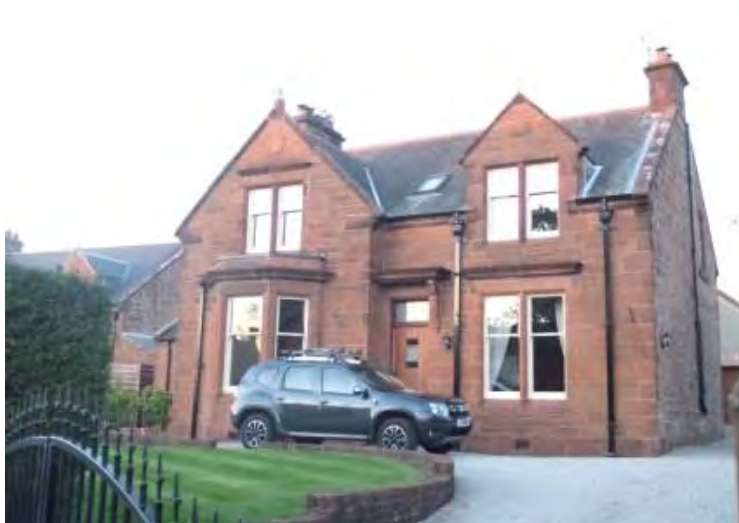
Residential - Willowbank

Squared red  
rubble sandstone  
masonry with  
single storey bay  
window. Masonry  
appears in good  
condition. Cast  
iron air grilles.

- Carry out minor slate repairs
- Refurbish timber sash and case windows
- Replace door and fanlight
- Refurbish CI rainwater goods

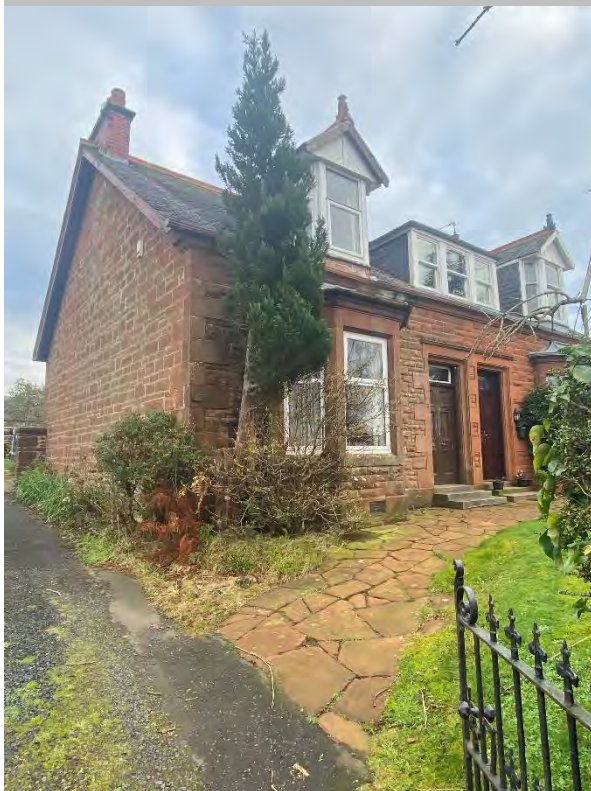
**11 Cumnock Road**  
Residential

Restrictions	Access very restricted for survey
Structural Issues	None apparent
Storey Height	1.5 – semi-detached.
Roof	Dormer windows. Natural slate with crested terracotta ridge. Lead dormer and chimney flashings.
Chimneys	Red brick chimney with 3no. cans
Walls	Rock faced red sandstone with ashlar window dressings to bay window. Masonry appears in good condition. Ornate cast iron air grille below bay window.
Windows	uPVC
Doors	Timber panelled storm doors.
External Pipework	Not visible.

- Carry out minor slate repairs
- Replace uPVC windows
- Refurbish storm door
- Replace 2no. doors
- Make allowance for new CI rainwater goods

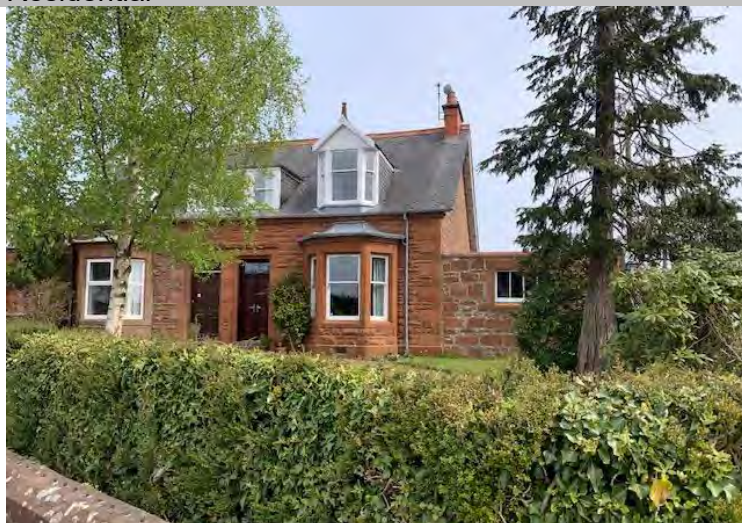
**13 Cumnock Road**  
Residential

Restrictions	Access very restricted for survey.
Structural Issues	None apparent
Storey Height	1.5 – semi-detached.
Roof	Dormer windows. Natural slate with crested terracotta ridge. Lead dormer and chimney flashings.
Chimneys	Red brick chimney with 4no. cans.
Walls	Rock faced red sandstone with ashlar window dressings to bay window. No structural issues apparent. Masonry appears in good condition. Air bricks not visible.
Windows	1x1 timber sash and case.
Doors	uPVC
External Pipework	
<b>Priority Score</b>	(0+2+1) 3

- Carry out minor slate repairs
- Refurbish timber sash and case windows
- Make allowance for replacing 1no. door
- Replace uPVC rainwater goods
