# Mauchline Conservation Area Management and Maintenance Plan

Prepared for East Ayrshire Council  
by  
Wylie Shanks Architects

Adopted 27.03.2023

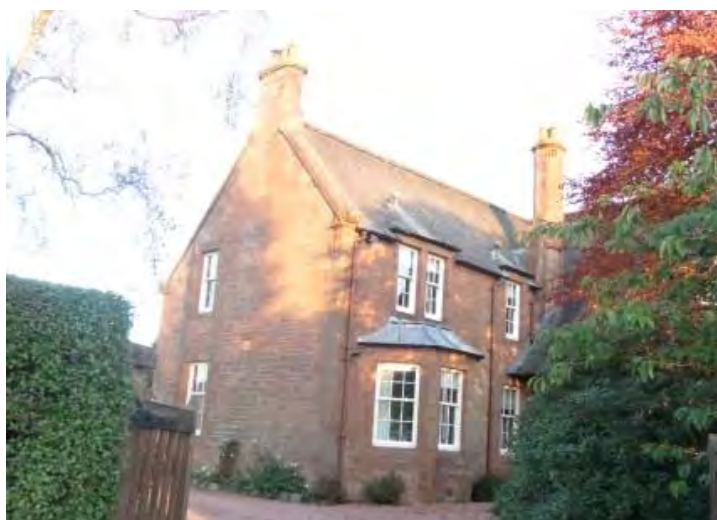
**15 Cumnock Road**  
Residential - Haplan

Restrictions	Survey access very restricted by driveway.
Structural Issues	None apparent
Storey Height	2 - detached
Roof	Natural slate, stone ridge tiles, mitred hips. Lead flashings and valleys. Skews not visible.
Chimneys	Visible. 1no. stone gable stack with 3no. cans. 1no. stone wall head stack with 3no. cans.

Walls	1no. stone stack with 3no. cans. Red sandstone with ashlar window and door surrounds. No structural issues apparent. Masonry in good condition. Cast iron air grille visible.
Windows	6x6 timber sash and case.
Doors	Original Arts and Crafts entrance door.
External Pipework	Cast iron gutters and cast-iron downpipes with ornamental ear bands.
Other	UPVC modern conservatory to Cumnock Road side.

- Carry out minor slate repairs
- Refurbish timber sash and case windows
- Refurbish CI rainwater goods

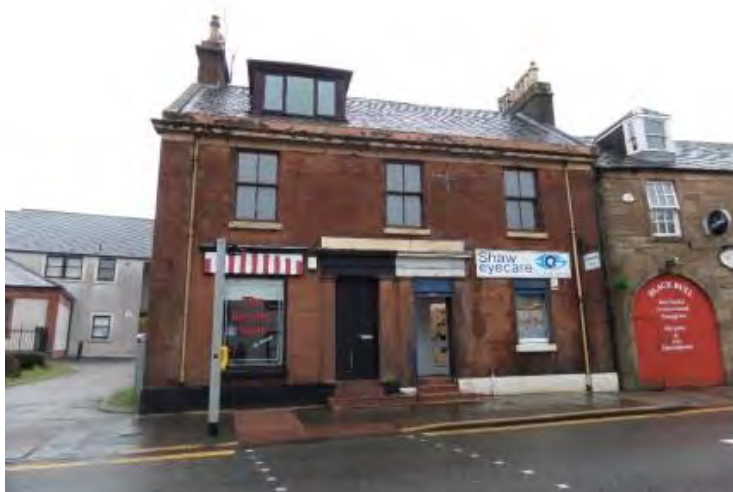
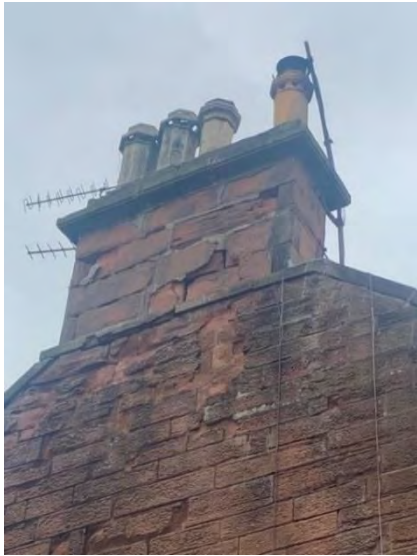
### 1-3 Earl Grey Street

Restrictions	Ground – occupied First – occupied Second - occupied Surveyed from Earl Grey Street only.
Structural Issues	LH chimney leaning / heavily eroded stonework.
Storey Height	2 – end terrace.
Roof	Natural slate pitched roof with straight skewes. Box roof dormer. Ridge needs replaced. Lead skewes / chimney / dormer flashings. Parapet gutter.
Chimneys	Stone stack with 4no. ornate pots to l.h.s. Stone stack with 8no. pots on party

Walls	wall. Red ashlar sandstone. Masonry has heavy staining/erosion to parapet. Some damp below window to r.h.s.
Windows	3no. modern timber sash & case with horns at first floor level. uPVC in dormer.
Doors	Timber storm doors to l.h.s. Door to r.h.s. obscured by roller shutter.
Shopfronts	Timber shopfront to l.h.s with dentil moulded fascia. uPVC to r.h.s with external security shutter. Tiled steps with original iron boot scrape on top step.
External Pipework	2no. cast iron downpipes – both require refurbishment.

**Priority Score** (0+2+2) 4

- Carry out minor slate repair
- Replace ridge with wood core lead roll and clips
- Allow for replacing lead parapet flashings
- Repoint along cornice line
- Refurbish CI rainwater goods
- Remove external roller shutters and replace with internal security grille to window.
- Replace dormer window
- Repaint sash and case windows
- Repaint timber shop front to l.h.s and timber fascia
- Replace window to r.h.s
- Refurbish existing storm doors
- Install new storm doors to r.h.s
- Install new fascia to r.h.s. to match l.h.s
- Paint stone pediment over doors
- New fascia signs and hanging signs (x2)
- Existing steps and original iron boot scrape to be retained and refurbished.

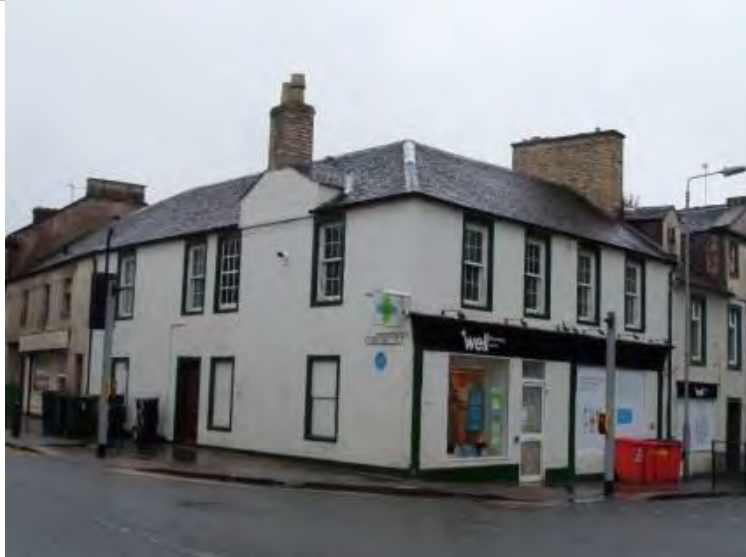
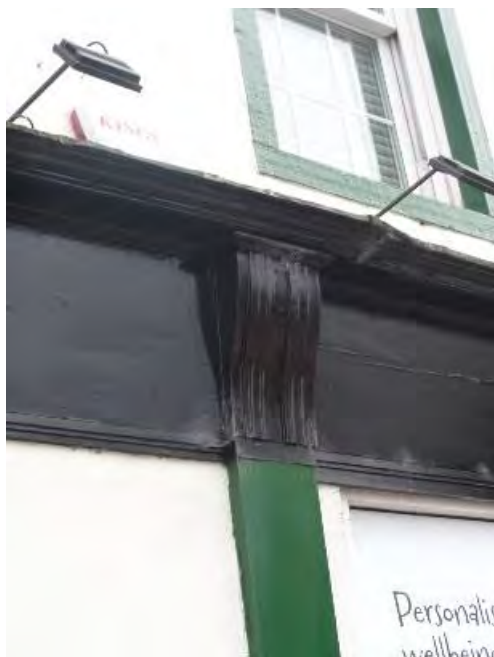
**2 Earl Grey Street / 1-3 Loudoun Street**  
Pharmacy / Residential

Category B Listed	Ground – occupied First – occupied
Restrictions	Surveyed from Earl Grey Street/Loudoun Street only.
Structural Issues	None apparent
Storey Height	2 – corner terrace.
Roof	Pitched roof with hipped return. Natural slate with zinc ridge and clips. Lead chimney flashings.
Chimneys	1no. shouldered brick wall head stack on Earl Grey Street with 2no. terracotta pots. 1no. brick stack, no pots on party wall on Loudoun Street.
Walls	Painted render.
Windows	Earl Grey Street - 3no. blind openings at ground floor level. 3no. uPVC/1no. blind opening at first floor level. Loudoun Street – 2no. blind openings at

ground floor level. 4no. uPVC windows at first floor level.
Doors	Modern timber panelled door to Earl Grey Street.
External Pipework	uPVC gutter (blocked). Cast iron downpipes.
Shopfronts	Aluminium shopfront and door on to Loudoun Street. Timber fascia with console brackets and pilasters.
<b>Priority Score</b>	<b>(2+2+1) 5</b>

- Carry out minor slate repairs
- Repaint render
- Replace uPVC windows
- Glaze blind openings
- Install internal security grilles
- Replace door to Earl Grey Street
- Replace shopfront
- Replace uPVC gutter with CI
- Refurbish CI downpipe
- Repaint timber fascia
- New hanging sign

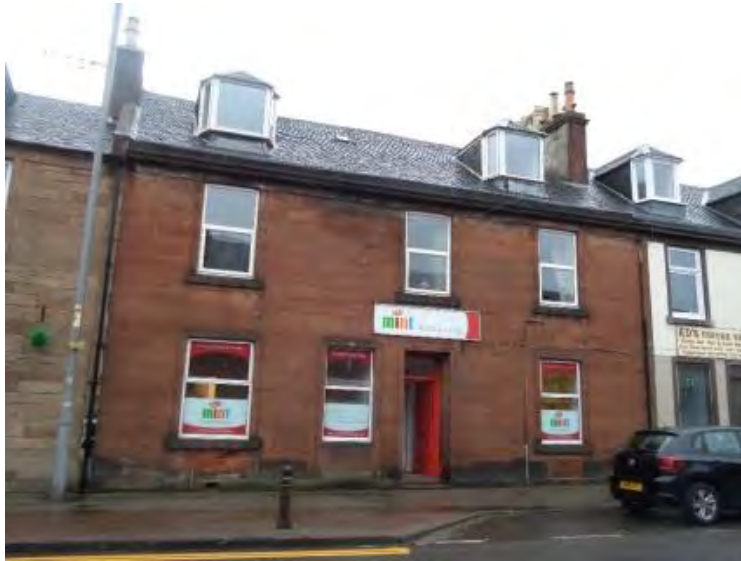
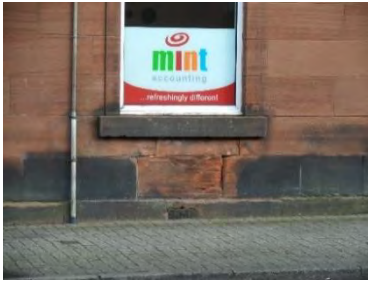
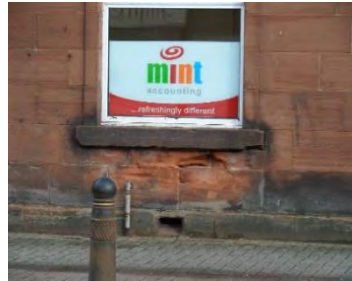
Mint Accounting / Residential

Ground – occupied First – occupied Second – uncertain
Restrictions	Surveyed from Earl Grey Street only.
Structural Issues	None apparent.
Storey Height	2 – mid terrace.

Roof	Pitched roof with straight skew to l.h.s. 2no. hipped dormers. Natural slate with zinc ridge and clips. Lead skews/ chimney flashings/dormer flashings and parapet gutter flashing.
Chimneys	Red sandstone stack on party wall to r.h.s. with 9no. pots (1no. heavily damaged). Blonde sandstone stack on party wall to l.h.s. with 8no. pots.
Walls	Red ashlar sandstone. Heavy erosion of stonework below left-hand window and right-hand window. Heavy staining at parapet level. 1no. cast iron air grille /1no. also missing. Shoe scraper recesses to either side of door – ironwork missing.
Windows	uPVC
Doors	Modern timber panelled door with fanlight
External Pipework	Cast iron downpipe. Damaged bottom section. Full refurbishment required.
<b>Priority Score</b>	<b>(0+2+2) 4</b>

- Carry out minor slate repairs
- Replace damaged terracotta pot
- Allow for replacing lead parapet flashings
- Repoint along cornice line
- Carry out stone repairs and repoint below windows
- Replace missing grille
- Replace ironwork to shoe scrapers (2no.)
- Replace windows
- Replace door and fanlight
- Repair and replace CI rainwater goods
- New fascia signage

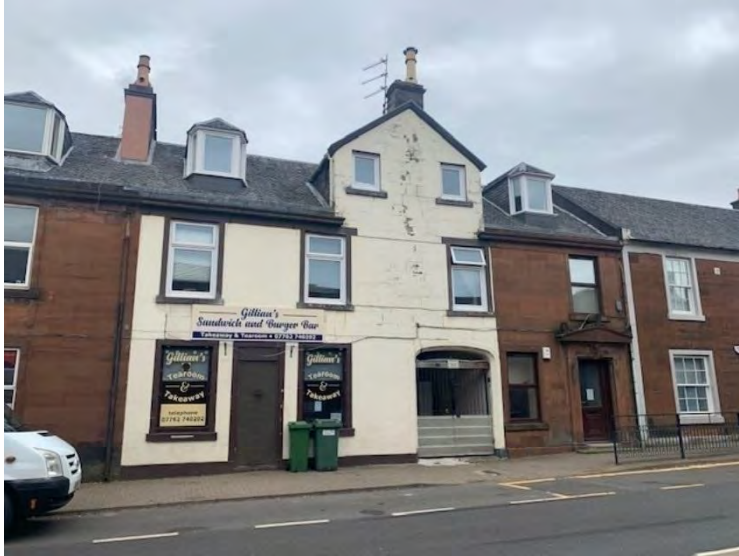
Gillian's Sandwich + Burger Bar / Residential

Restrictions	Surveyed from Earl Grey Street only.
Structural Issues	None apparent
Storey Height	2 – mid terrace.
Roof	Pitched roof. Gable dormer plus 1no. hipped dormer. Natural slate with lead ridge. Lead chimney / dormer / parapet flashings. Parapet gutters blocked. Plastic dormer apron flashings.
Chimneys	Red sandstone stack on party wall to l.h.s. 9no. ornate pots - 1no. heavily damaged/taped up. 1no. stack on wall head dormer with 1no. pot.
Walls	Painted masonry – requires repainting. 2no. ornate air grilles – over painted. Pend access to rear.
Windows	uPVC.
Doors	Modern glazed timber door. No storm doors.
External Pipework	n/a
<b>Priority Score</b>	<b>(0+2+1) 3</b>

- Carry out minor slate repairs
- Replace heavily damaged terracotta chimney pot
- Replace dormer flashings with lead
- Repaint masonry / ideally remove paint
- Replace windows
- Remove roller shutter
- Install storm doors
- New fascia signage

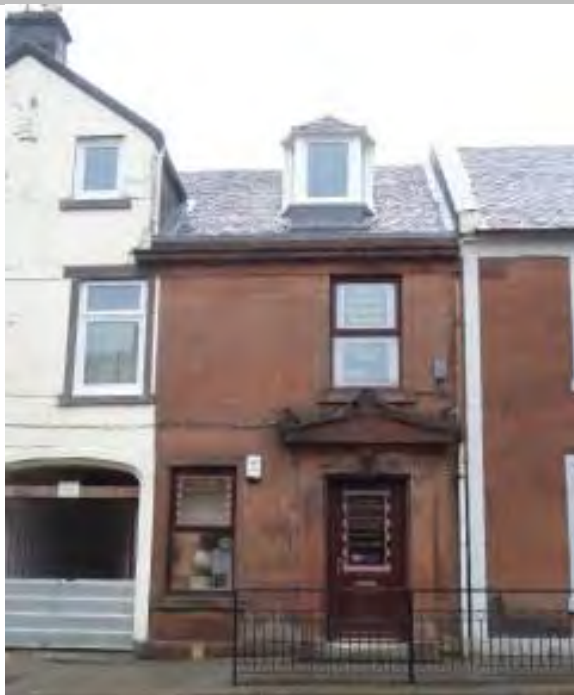
### 15 Earl Grey Street CARS Office / Residential

Ground – occupied First – occupied Second - uncertain
Restrictions	Surveyed from Earl Grey Street only.
Structural Issues	None apparent.
Storey Height	2 – mid terrace.
Roof	Pitched roof with straight skew to r.h.s. Hipped dormer. Natural slate with lead ridge. Lead skew and parapet flashing. Plastic flashing to front of dormer. Parapet gutter.
Chimneys	n/a
Walls	Masonry requires minor repairs where signage has been removed and to r.h. door pilaster. 1no. brass modern air grille.
Windows	uPVC
Doors	uPVC
External Pipework	Part cast iron/part uPVC downpipe.
<b>Priority Score</b>	<b>(0+2+1) 3</b>

- Carry out minor slate repairs
- Replace dormer flashings with lead
- Carry out minor stone repairs
- Replace modern grille
- Replace windows
- Replace door
- Refurbish CI rainwater goods
- Replace uPVC section of downpipe with CI

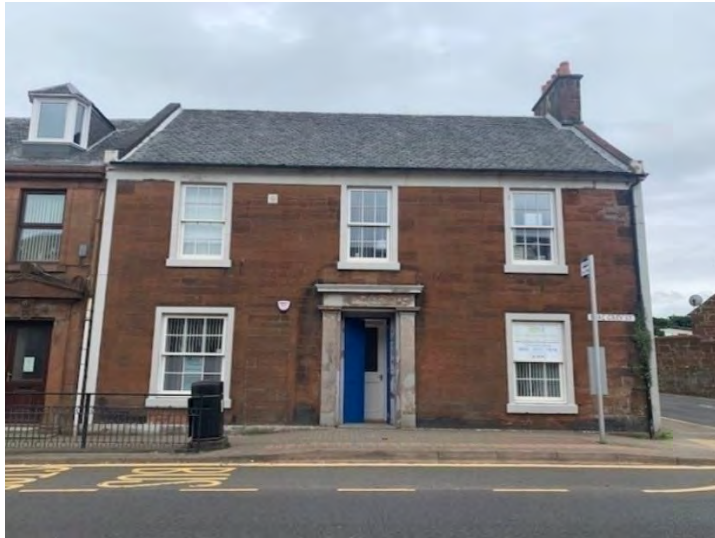
Restrictions	Surveyed from Earl Grey Street / Mansfield Road only.
Structural Issues	None apparent.
Storey Height	2 – end terrace.
Roof	Pitched roof with straight skewes. Natural slate with zinc ridge and clips. Lead skewes and chimney flashing.
Chimneys	Red sandstone chimney to r.h.s. with 5no. terracotta pots.
Walls	Red squared rubble sandstone with painted ashlar window and door surrounds. Some erosion at corner adjacent to downpipe. Minor repairs required. 3no. modern air grilles.
Windows	3no. 6x6 timber sash & case windows at first floor level on Earl Grey Street, no horns. 1no. 6x6 timber sash & case window at first floor level on Mansfield Road, no horns. 2no. modern timber windows at ground floor level on Earl Grey Street. 1no. modern timber window at ground floor level on Mansfield Road.

Doors	Panelled storm doors
External Pipework	Cast iron half round gutter and cast-iron downpipe. Requires refurbishment.
<b>Priority Score</b>	<b>(0+2+2) 4</b>

- Carry out minor slate repairs
- Carry out stone repairs at r.h.s and repoint
- Replace modern grilles
- Refurbish CI rainwater goods

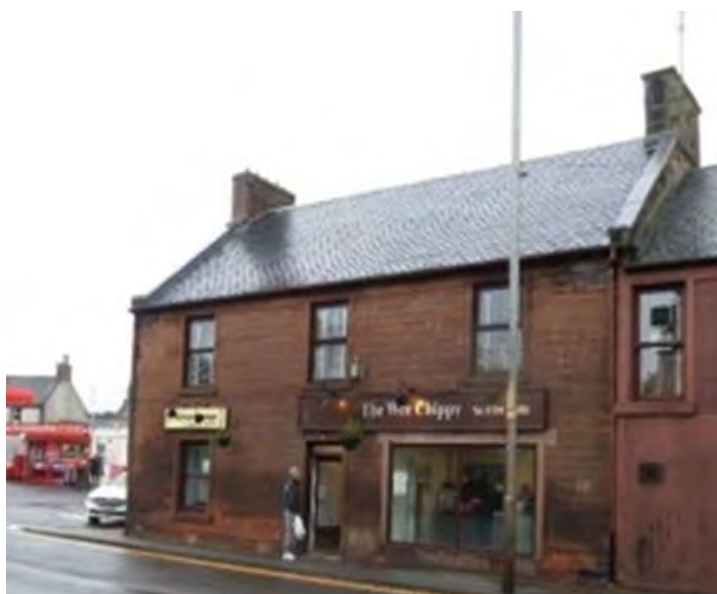
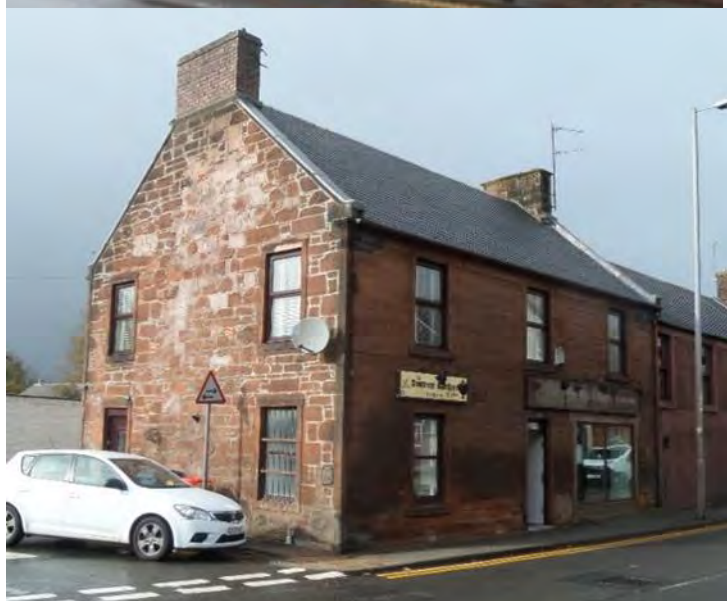
**18 Earl Grey Street**  
Corner Barber / Wee Chippy / Residential

Restrictions	Surveyed from Earl Grey Street / Cowgate only.
Structural Issues	None apparent
Storey Height	2 – end terrace.
Roof	Pitched roof with straight skewes. Natural slate (new) with zinc ridge and clips. Lead skew flashings and caps.
Chimneys	Red brick chimney to l.h.s. No pots. Red sandstone stack to r.h.s. on party wall. No pots.
Walls	Red squared rubble sandstone. Heavy erosion to masonry below windows and around window to l.h.s at ground level. Heavy pointing/plastic repairs to gable. Modern terracotta airbricks.
Windows	uPVC
Doors	uPVC
Shopfronts	uPVC shopfront/ timber fascia to r.h.s.
External Pipework	uPVC gutter (blocked). Cast iron downpipe (last section is uPVC) - Needs refurbishment.

- Carry out minor slate repairs
- Carry out stone repairs to gable and below windows, repoint full gable and below windows
- Replace modern airbricks
- Replace windows
- Replace door
- Replace shopfront
- New fascia signage
- New hanging signs (2no.)

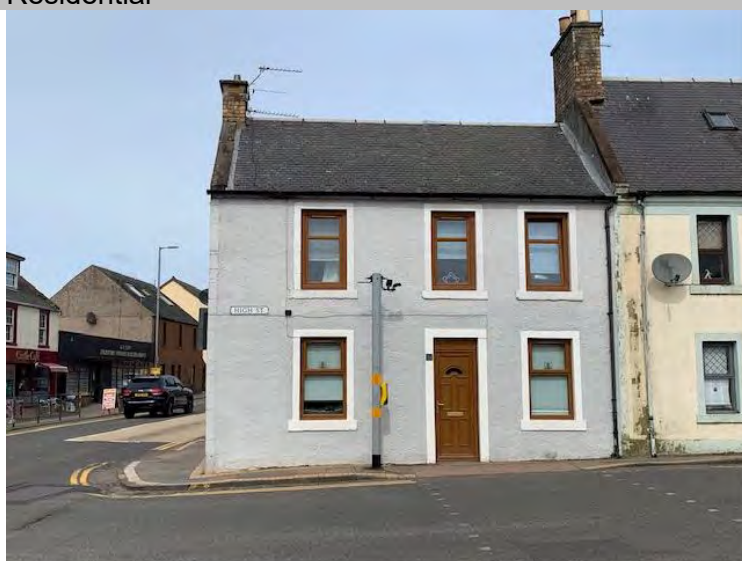
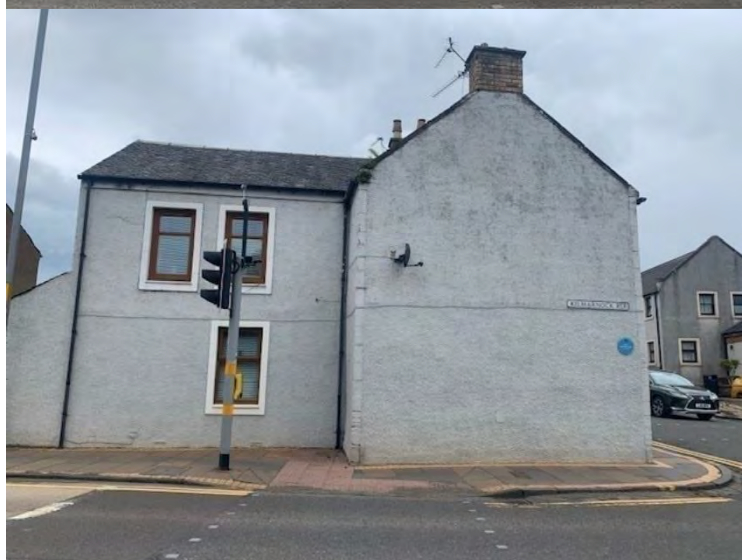
**1 High Street**

Restrictions	First – occupied Surveyed from High Street/Kilmarnock Road only.
Structural Issues	None apparent
Storey Height	2 – end terrace.
Roof	Natural slate with zinc ridge and clips. Some loose slates evident on High Street. Lead skew flashings No flashing visible at chimney. Timber fascia board (modern addition) requires painting.
Chimneys	Brick chimney on corner gable. No pots. Flue vent.
Walls	Rendered with painted ashlar dressings around windows and doors. Some cracking in wet dash render on Kilmarnock Road elevation. Modern painted terracotta brick vents onto Kilmarnock Road.
Windows	uPVC
Doors	uPVC door.
External Pipework	Kilmarnock Road – uPVC gutter and 2no. uPVC downpipes. High Street – Damp at skew putt. uPVC gutter and 1no. uPVC downpipe.
Priority Score	(0+2+1) 3

- Carry out slate repairs
- Allow for installing chimney flashings
- Remove cementitious render, repoint and re-render with a lime based product
- Replace modern vents
- Repaint timber fascias
- Replace windows
- Replace door
- Replace uPVC rainwater goods with CI

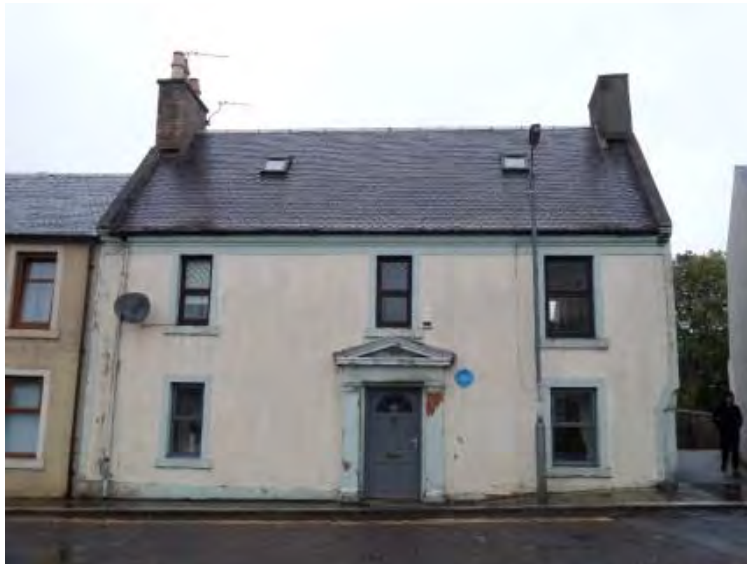
**3 High Street**  
Residential

Category B Listed	Ground – occupied First – occupied
Restrictions	Surveyed from High Street only
Structural Issues	Chimney to l.h.s appears to be leaning.
Storey Height	2 – end terrace
Roof	Slate with zinc ridges and straps. Lead chimney flashings. Mortar skews. Modern in-line roof lights.
Chimneys	Brick chimney to l.h.s with 4no. pots. Rendered chimney to r.h.s. No pots.
Walls	Painted smooth render to High Street. Dry dash render to gable.
Windows	uPVC
Doors	Modern timber panelled door
External Pipework	Cast iron cutter. uPVC downpipe.

- Check chimney stability
- Carry out minor slate repairs
- Replace flashings and skews
- Remove cementitious render, repoint and re-render with a lime based product
- Remove paint from window and door surrounds
- Replace windows
- Replace door
- Replace uPVC rainwater goods with CI

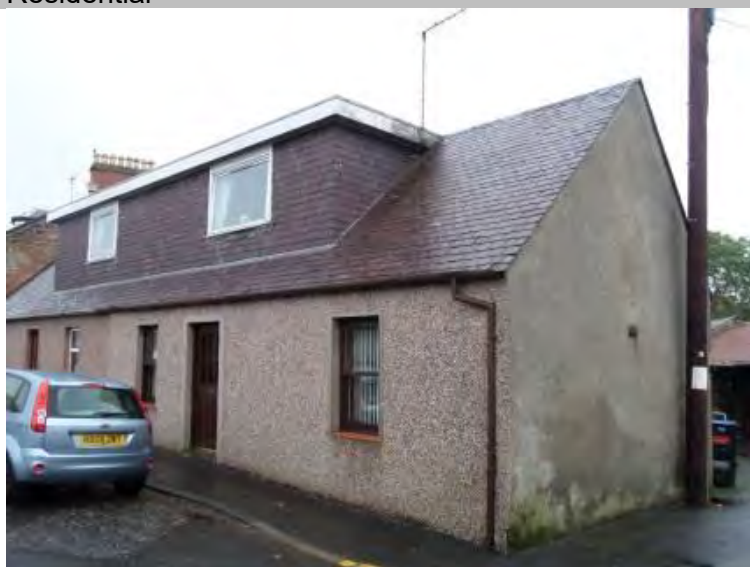
Restrictions	Surveyed from High Street / gable end only.
Structural Issues	None apparent
Storey Height	1 – end terraced.
Roof	Large flat roofed box dormer. Natural slate with zinc ridge and clips. Lead flashings around dormer.
Chimneys	n/a
Walls	Dry dash render.
Windows	Modern timber sash & case with horns at ground level, tiled cills. Modern timber casement in dormer.
Doors	Modern timber door with 6no. glass panels. Ironmongery not of note.
External Pipework	uPVC gutter and 1no. uPVC downpipe.
<b>Priority Score</b>	(0+1+1) 2

- Carry out minor slate repairs
- Remove dry dash render, repoint and re-render with lime based product
- Replace dormer windows
- Replace door
- Replace uPVC rainwater goods with CI

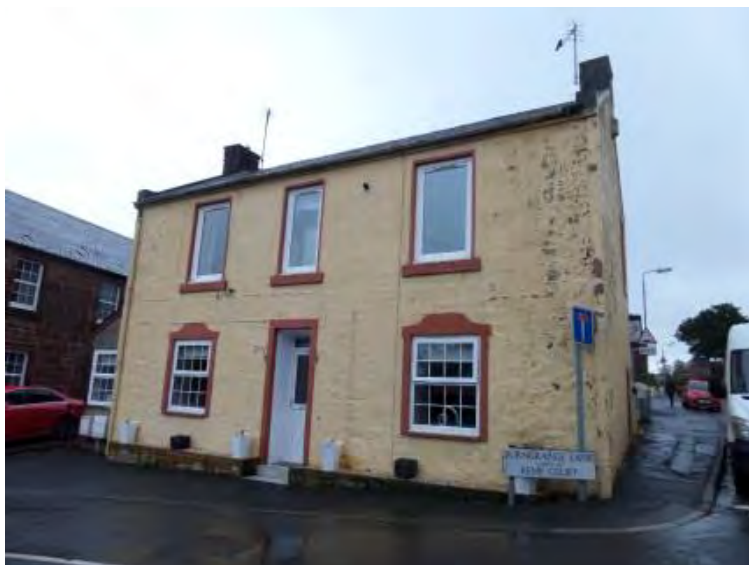
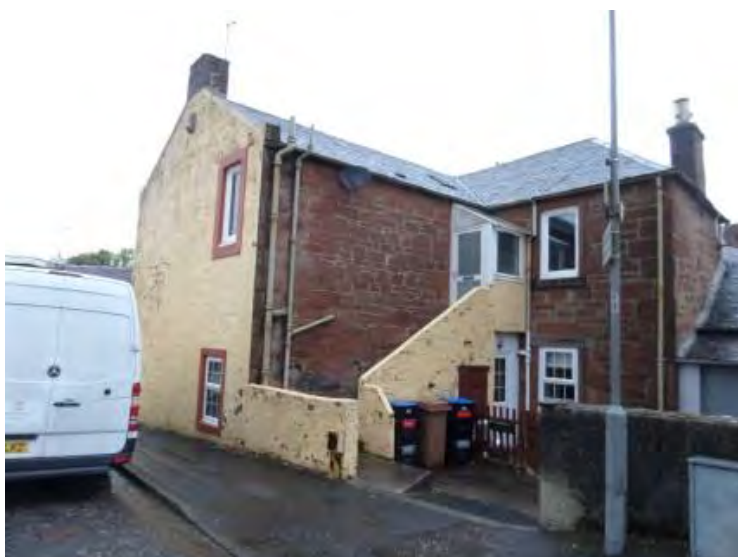
Structural Issues	None apparent
Storey Height	2- semi-detached.
Roof	Natural slate with zinc ridge and clips. Leaded skews and chimney flashing.
Chimneys	2no.masonry gable stacks, no pots to Burngrange Lane. 1no. masonry wall head stack with 1no. pot to High Street.
Walls	Painted masonry to street frontages. Squared red sandstone rubble to visible internal faces. Ashlar door and window surrounds. Heavy cement mortar pointing where masonry visible. Paint flaking.
Windows	10no. uPVC
Doors	2no. uPVC doors, main door with fanlight.
External Pipework	Burngrange Lane - uPVC half round gutter and cast-iron downpipe with uPVC connection – Refurb. High Street - Cast iron half round gutters, 1no. cast iron downpipe and 3no. cast iron vent stacks (1no. with uPVC top section).

- Carry out minor slate repairs
- Repaint masonry
- Repoint stonework
- Replace uPVC windows
- Replace doors and fanlight
- Refurbish CI rainwater goods
- Replace uPVC section with CI

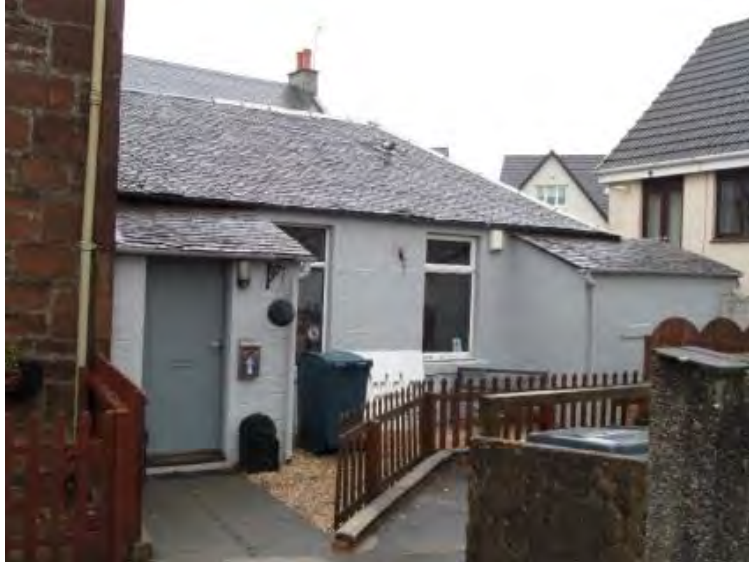
**19 High Street**  
The Workshop

Restrictions	Surveyed from High Street only.
Structural Issues	None apparent.
Storey Height	1 – semi-detached.
Roof	Natural slate with zinc ridge and clips. Lead abutment flashing. Zinc hip flashing.
Chimneys	n/a
Walls	Painted masonry and painted brick porch and extension. Masonry in good condition.
Windows	2no. uPVC
Doors	Modern painted door blank. Ironmongery not of note.
External Pipework	Cast iron half round gutter to main building. uPVC gutters and downpipes to porch extension.

- Carry out minor slate repairs
- Replace windows
- Replace door
- Refurbish CI rainwater goods
- Replace uPVC rainwater goods with CI

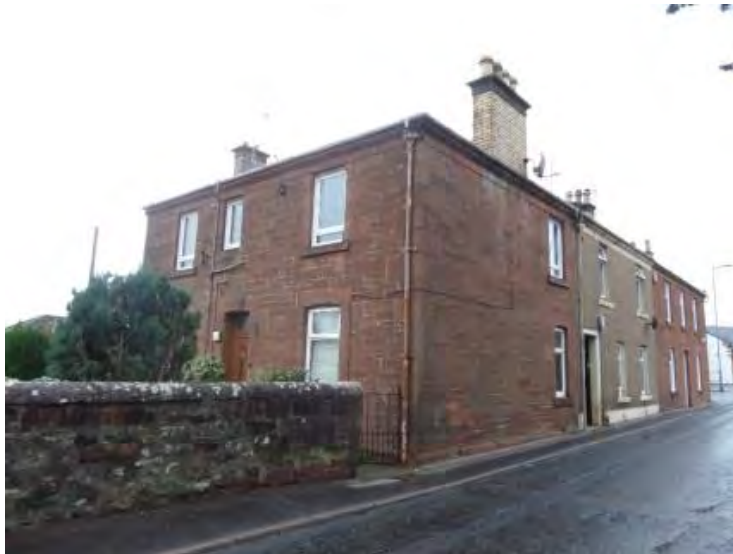
Structural Issues	None apparent.
Storey Height	2 – end terrace.
Roof	Pitched hip roof. Slate with zinc ridge and clips. Lead chimney flashings.
Chimneys	Yellow brick chimney with stone dentil moulded cap to l.h.s. No pots. Yellow brick wall head chimney to r.h.s. with dentil moulded cap. 4no. ornate pots.
Walls	Red squared sandstone rubble. Dentil moulded wall head cornice. Masonry generally in good condition. 1no. ornate cast iron air grille. 1no. also blocked up.
Windows	uPVC
Doors	uPVC (Side elevation)
External Pipework	Cast iron circular downpipe with decorative ear bands and hopper. uPVC gutter.
<b>Priority Score</b>	<b>(0+2+1) 3</b>

- Carry out minor slate repairs
- Reinstate missing vent
- Replace windows
- Replace door
- Replace uPVC gutter with CI
- Refurbish CI rainwater goods

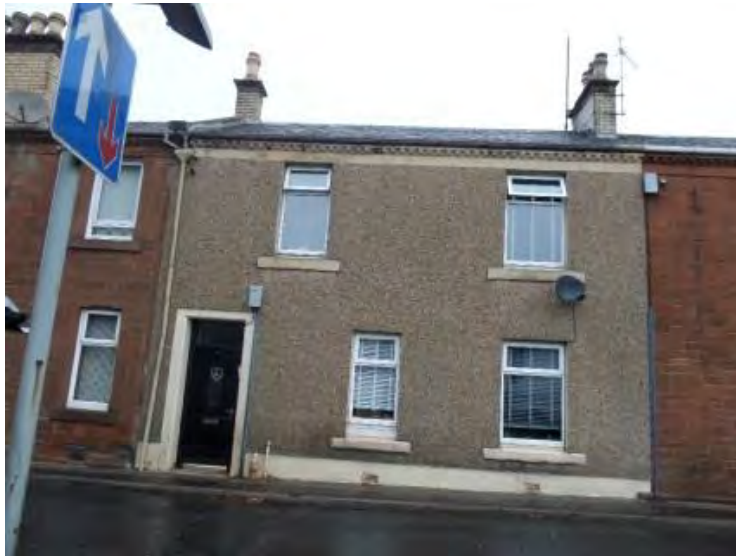
Restrictions	Surveyed from High Street only.
Structural Issues	None apparent
Storey Height	2 – mid terrace.
Roof	Pitched roof with 1no. straight skew to l.h.s. Natural slate with zinc ridge and clips. 1no. mortar skew. Lead chimney flashings.
Chimneys	Yellow brick chimney with dentil moulded stone cap

Walls	and 1no. ornate pot to l.h.s. yellow brick chimney with dentil moulded stone cap and 3no. ornate pots t r.h.s. Dry dash render. Dentil moulded wall head cornice 2no. modern louvred air grilles.
Windows	Composite
Doors	Modern timber door with fanlight
External Pipework	uPVC

- Carry out minor slate repairs
- Replace mortar skewes
- Remove dry dash render, repoint and re-render with lime-based product
- Replace modern grilles
- Replace windows
- Replace door and fanlight
- Replace uPVC rainwater goods with CI

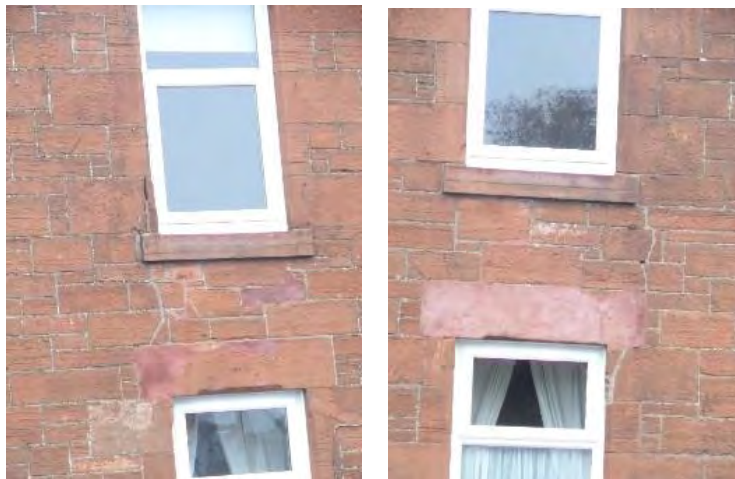
Restrictions	Surveyed from High Street only.
Structural Issues	Cracking between windows. 2no. cracked cills at ground level.
Storey Height	2 – end terrace.
Roof	Pitched roof with 1no. straight skew. Natural slate with zinc ridge and clips. Lead skew and partial capping. Lead chimney flashings.
Chimneys	Yellow brick chimney with dentil moulded stone cap and 3no. ornate pots on party wall to l.h.s. Yellow brick chimney with

concrete cap and 2no. ornate pots to r.h.s.
Walls	Red squared sandstone rubble. Dentil moulded wall head cornice. Plastic repairs to lintols and some stones. 2no. modern louvred air grilles.
Windows	uPVC
Doors	Modern composite door with fanlight.
External Pipework	uPVC

- Carry out minor slate repairs
- Carry out structural inspection & any recommended remedial repairs
- Replace cracked cills and lintols
- Carry out stone repairs where plastic repairs have been made.
- Replace modern grilles
- Replace uPVC windows
- Replace door and fanlight
- Replace uPVC gutters and down pipes with CI

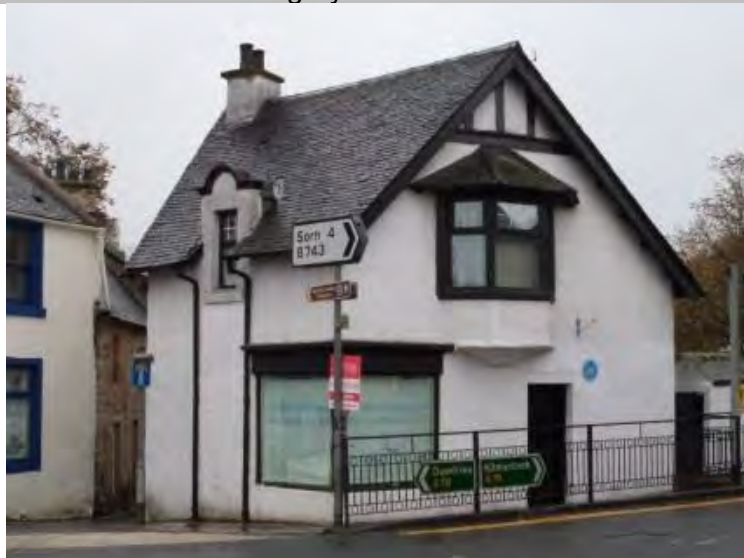
**1 Kilmarnock Road**  
Mauchline Dental Surgery

Ground – occupied First – occupied
Restrictions	Surveyed from Kilmarnock Road / Castle Street only.
Structural issues	None apparent
Storey Height	1.5 – end terraced.
Roof	Natural slate with zinc ridge and clips. Lead parapet flashings.
Chimneys	Rendered chimney with 2no. pots
Walls	Wet dash render.
Windows	Timber casements with uPVC astragals at first floor level.
Doors	Panelled timber storm doors
Shopfronts	Timber shopfront with fascia.
External pipework	Cast iron half round gutter with cast iron circular downpipes. Small section of cast iron to one side. No gutter on first floor projecting bow window. Section of gutter loose alongside Castle Street

- Carry out minor slate repairs
- Repaint render
- Replace windows
- Refurbish storm doors
- Paint shopfront
- New hanging sign
- Resecure gutter adjacent to Castle Street

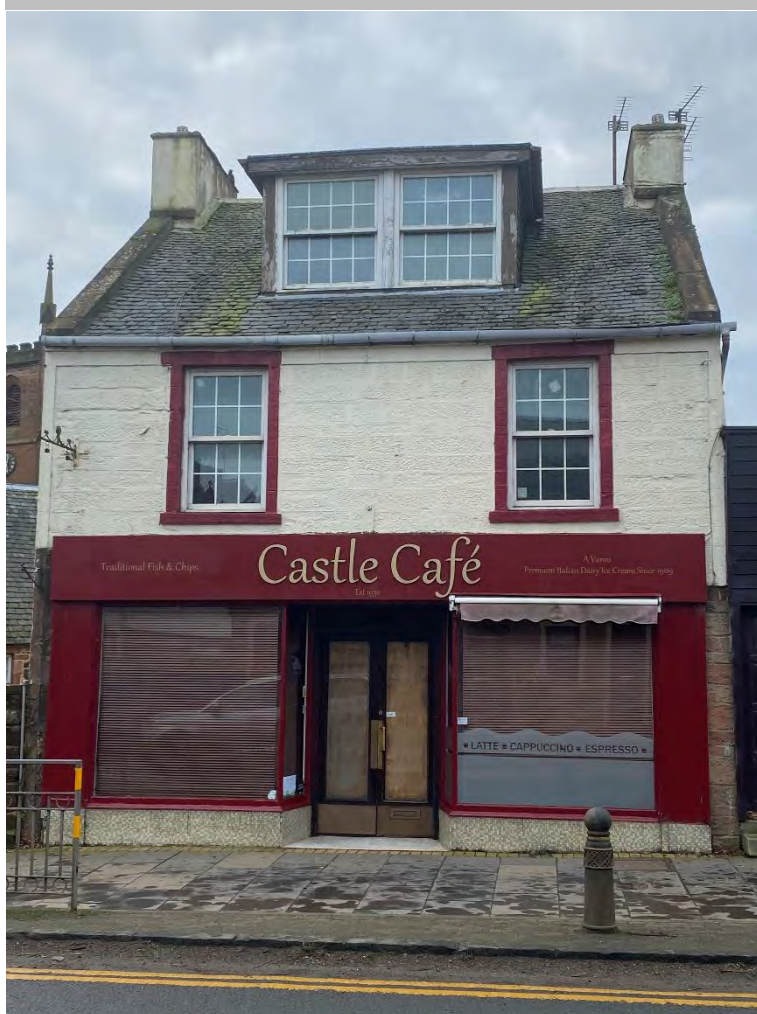
**3 Kilmarnock Road**  
Castle Café / Residential

Second - uncertain
Restrictions	Surveyed from Kilmarnock Road only
Structural issues	Crack on gable end.
Storey Height	2 - end terrace.
Roof	Natural slate with zinc ridge and clips – needs overhauled. Mortar skewes – overgrown. Lead dormer flashings and chimney flashings.
Dormer	Box dormer – timber in poor condition. uPVC windows
Chimneys	Rendered brick chimney to r.h.s. No pots. Needs re-rendered.
Walls	Painted masonry.
Windows	uPVC
Doors	1920's/1930's timber entrance doors.
Shopfronts	Double fronted shopfront with recessed doorway. Modern fascia. Tiled stall riser.
External Pipework	uPVC gutter – overflowing at corner.

- Carry out structural inspection & any recommended remedial repairs
- Reslate roof and dormer
- Replace leadwork
- Replace ridge with wood core lead roll
- Replace mortar skewes
- Replace dormer timbers
- Re-render chimney
- Replace windows, including dormer
- Refurbish door
- Repaint shopfront
- Install new timber fascia and signage
- New hanging sign
- Replace uPVC rainwater goods with CI

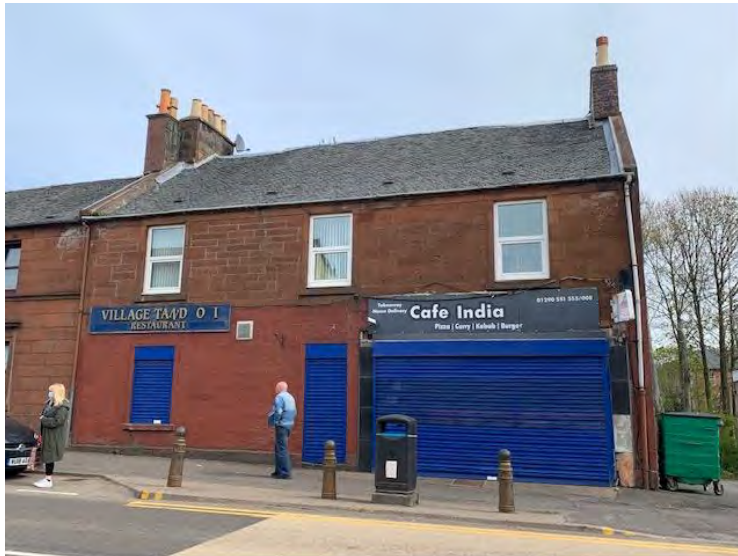
#### 4-6 Kilmarnock Road

Restrictions	Surveyed from Kilmarnock Road only.
Structural Issues	Deviating ridge line.
Storey Height	2 – end terraced.
Roof	Natural slate with zinc ridge and clips. uPVC roof vents. Part lead skews / part mortar.
Chimneys	1no. stone chimney to l.h.s

- Carry out minor slate repairs
- Replace mortar skeews
- Carry out structural inspection & any recommended remedial repairs
- Remove paint from masonry
- Replace uPVC windows (including ground left)
- Remove external security shutters
- Install internal security shutters
- Install new storm door
- Install new shopfront
- Install new full length timber fascia and signage
- New hanging signs (x2)
- Replace uPVC gutter with CI
- Replace uPVC section of downpipe with CI and refurbish remaining CI downpipe

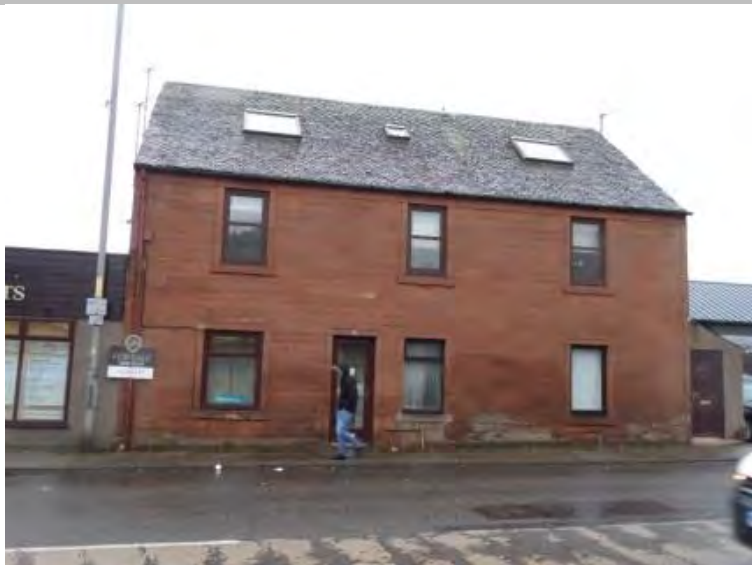
Ground – occupied First – occupied Second – uncertain
Restrictions	Surveyed from Kilmarnock Road and Castle Street.
Structural Issues	None apparent
Storey Height	2 – end terrace.
Roof	Natural slate with zinc ridge and clips. 3no. modern rooflights
Chimneys	n/a
Walls	Red sandstone. Concrete cill where door blocked up needs repointing. Damaged cill to l.h.s. Heavy erosion below window on r.h.s. damaged corner stones. 1no. partially hidden modern vent.
Windows	1no. uPVC and 2no. timber casements at ground floor level. uPVC at first floor level.
Doors	2no. uPVC doors
External Pipework	uPVC gutter with cast iron

- Carry out minor slate repairs
- Replace concrete cill with stone cill
- Replace stone cill to l.h.s
- Carry out stone repairs below cill line and repoint
- Replace modern vent
- Replace windows
- Replace doors (2no.)
- Replace uPVC gutter with CI
- Refurbish CI downpipe

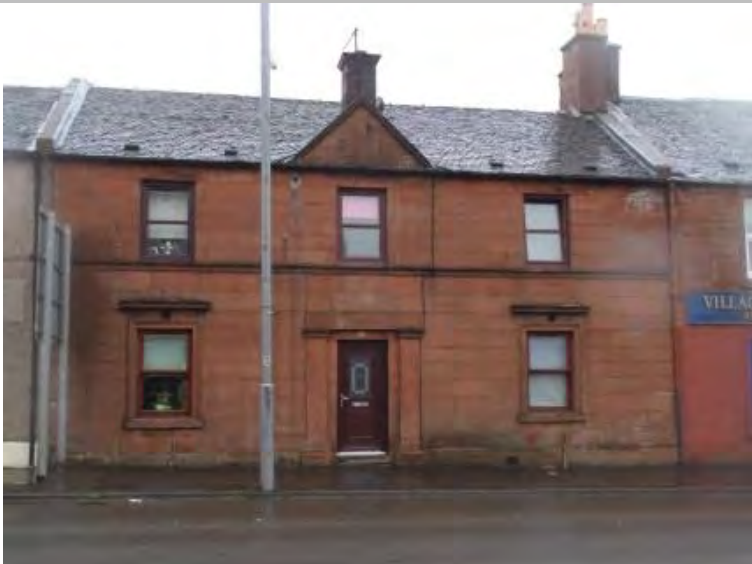
Restrictions		Surveyed from Kilmarnock Road only.
	Structural Issues		None apparent.
	Storey height		2 – mid terrace.
	Roof		Natural slate with zinc ridge and clips. uPVC roof vents. Lead skewes and partial capping and lead valleys to gablet.
	Chimneys		Stone wall head chimney with no pots. Rendered chimney to r.h.s with 2no. pots.
	Walls		Red ashlar sandstone with pilasters either side of doorway. Some masonry erosion around doorway. 2no. modern air grilles.
	Windows		Modern timber casements at ground floor level. uPVC at first floor level.
<b>Recommendations:</b>			
<ul style="list-style-type: none"> <li>• Carry out minor slate repairs</li> <li>• Carry out stone repairs around doorway</li> <li>• Replace modern vents</li> <li>• Replace windows</li> <li>• Replace door</li> <li>• Replace uPVC gutter with CI</li> <li>• Refurbish CI downpipe</li> </ul>

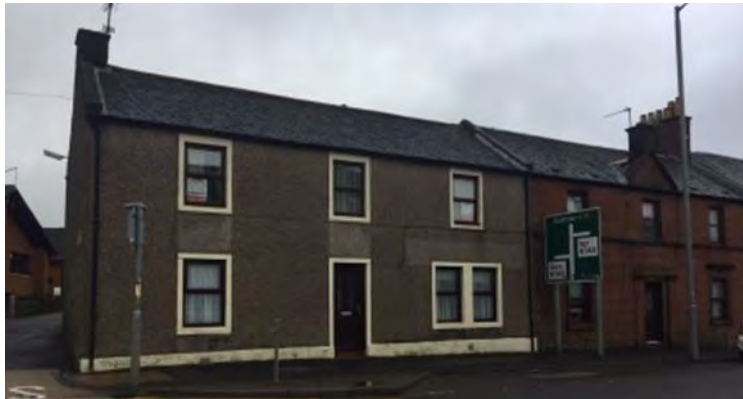
Chimneys	red terracotta ridge tiles. Lead skewers. Small section of mortar skew t r.h.s. Rendered chimney to l.h.s. No pots.
Walls	Dry dash render with smooth rendered base course and window and door surrounds. Patch repairs. 2no. cast iron air grilles.
Windows	uPVC
Doors	uPVC
External Pipework	Cast iron half round gutter and 2no. circular cast iron downpipes – Need refurbishment.

- Carry out minor slate repairs
- Remove dry dash render, repoint and re-render with lime-based product
- Replace windows
- Replace door
- Refurbish CI rainwater goods

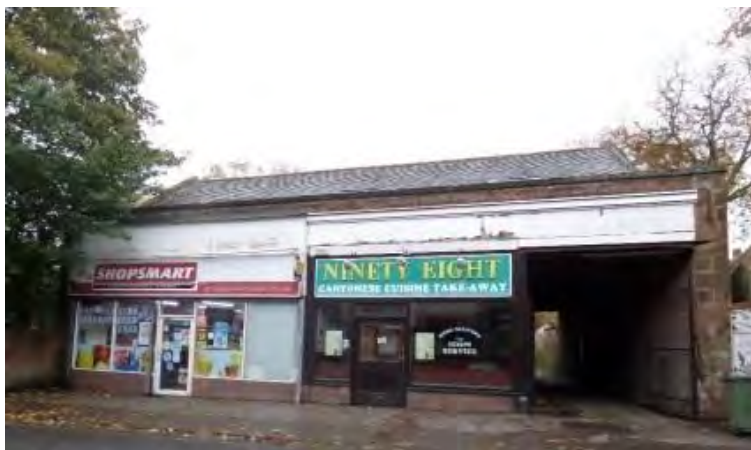
Restrictions	Surveyed from Loudoun Street only.
Structural issues	None apparent
Storey Height	1 - standalone
Roof	Natural slate with red clay ridge tiles. Lead skewers. 3no. former rooflights sheeted over with corrugated iron.
Chimneys	n/a
Walls	Damage to red sandstone to r.h.s of pend.
Shopfronts	Modern timber shopfront to r.h.s. Aluminium shopfront with external shutters to l.h.s. Granite stall risers.
External Pipework	Parapet gutter

- Slate over 3no. former roof lights and carry out minor slate repairs generally
- Replace leadwork to parapet gutter
- Repair sandstone pillar to r.h.s. of pend
- Remove external security shutters
- Install new shopfronts
- Install full length timber fascia and signage

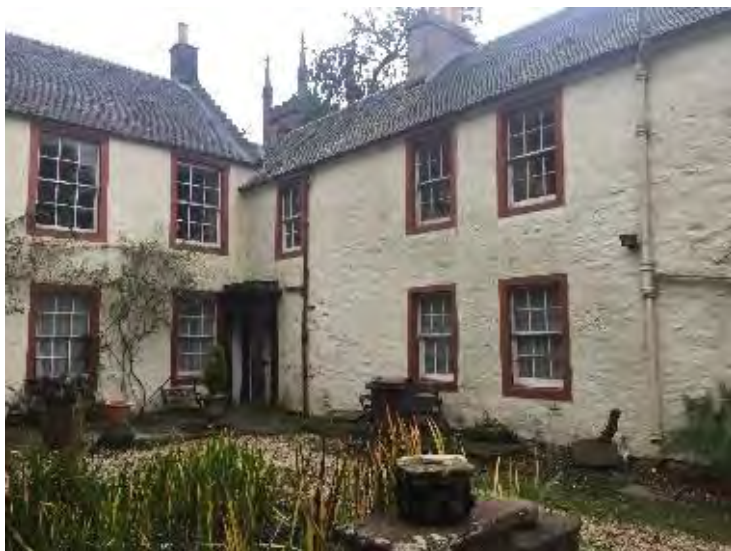
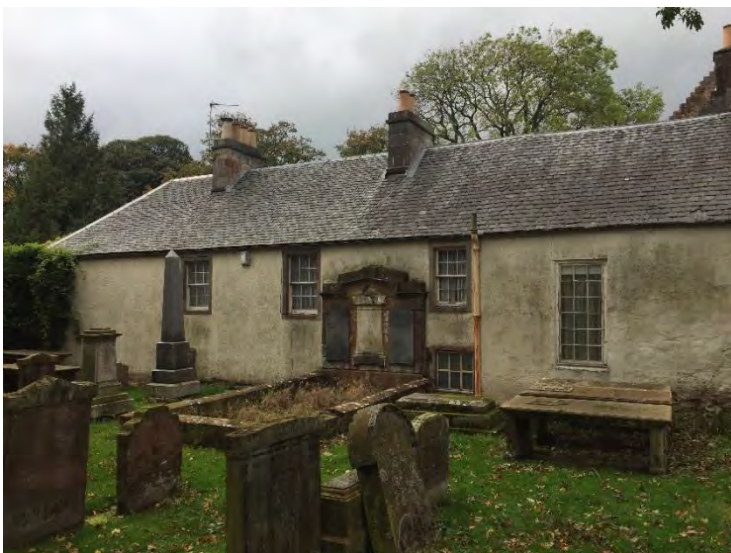
Category A  
 Listed House -  
 unoccupied

Structural Issues	Localised areas of bulging in external walls. Localised distortion on ridge line. Structural survey carried out 2018.
Storey Height Roof	2 – detached Slate, hipped gable to west
Chimneys	5no. stone chimney stacks and 1 brick chimney stack.
Walls	Painted masonry. Wet dash render to south and east elevations
Windows	Original timber sash and case
Doors	Timber panelled
External Pipework	Cast iron downpipes generally, uPVC downpipe on west elevation

**House Priority Score** (3+3+3) 9

- Stabilise stonework in accordance with Structural Engineer's recommendations and repoint.
- Carry out inspection of roof timbers
- Carry out slate repairs
- Replace mortar skewes
- Remove paint from masonry & re-paint with breathable product
- Remove existing render, repoint & re-render with lime-based product
- Repair and refurbish sash and case windows
- Refurbish timber panelled doors
- Replace uPVC downpipe with CI.
- Refurbish CI rainwater goods & replace missing section

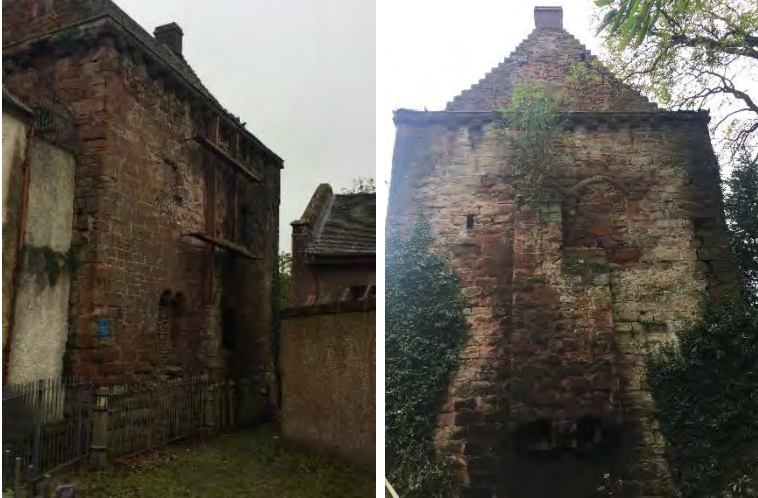
Abbot Hunter's Tower (Castle)		Category A Listed	Unoccupied

Restrictions	Limited access	
	Structural Issues	Structural cracks with ongoing movement. Previous bracing carried out. Loose corbie stones. Defective stone lintols. Structural survey carried out 2018 (restricted access) Tower recommended to BARR.	
<b>Recommendations:</b> <ul style="list-style-type: none"> <li>• Stabilise stonework in accordance with Structural Engineer's recommendations and repoint.</li> <li>• Extensive slate repairs / re-slate</li> <li>• Remove plant growth</li> <li>• Replace internal and external stone lintols</li> <li>• Reinstate floor at first floor level</li> </ul>	Roof	Slate with lead ridge and lead skew flashings. Rooflight. Lead capping at parapet.	
	Chimneys	Stone stack to north gable. No pot.	
	Walls	Red sandstone rubble.	
	Windows	Various blocked up openings, some with dressed surrounds.	
	Doors	Timber

External Pipework	None	
	<b>Castle Priority Score</b>	(3+3+3) 9

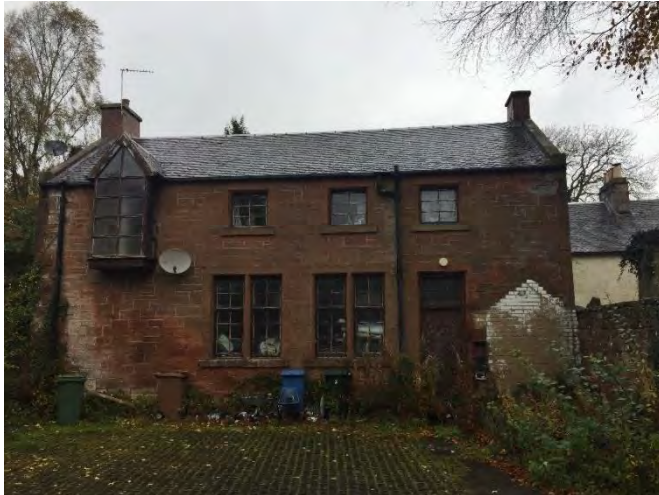
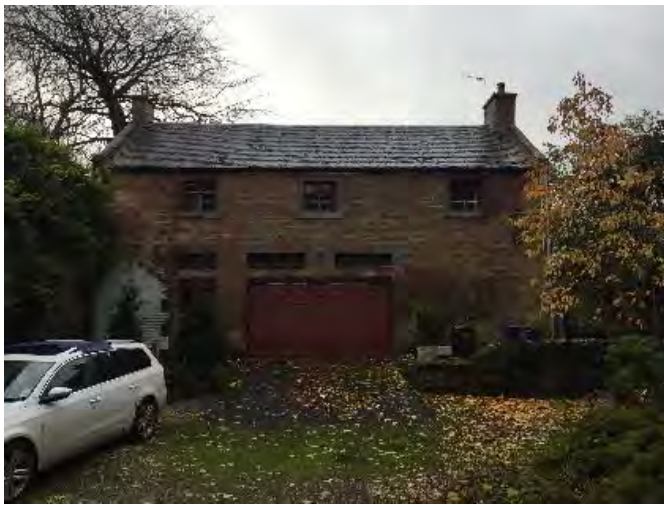
Old Bakehouse		Unlisted	Unoccupied
	Restrictions	None.	
	Structural Issues	None evident – structural survey carried out 2018.	
	Storey Height	2 - detached	
	Roof	Slate with zinc ridge and straps, lead skews and flashings	
	Chimneys	Brick chimney stacks at each

gable end. 1 pot on r.h.s, no pots on l.h.s.

**Walls** Red sandstone squared rubble. Area of white glazed brick on north elevation. Evidence of damp staining on north and east elevations.

**Bakehouse Priority Score** (0+2+3) **5**

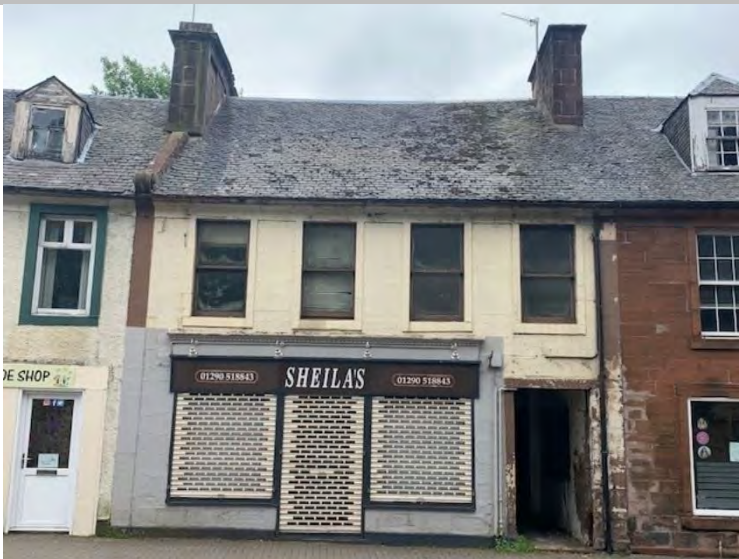
**9-11 Loudoun Street**  
Sheila's / Residential

Category B Listed	Ground – vacant First – vacant (Dangerous buildings notice to first floor flat)
Restrictions	Surveyed from Loudoun Street only.
Structural Issues	None apparent.
Storey Height	2 – mid terraced.
Roof	Natural slate with zinc ridge and clips. Mortar skews.
Chimneys	Stone stack on party wall to l.h.s., no pots. Stone stack on party wall to r.h.s., 1 pot.
Walls	Painted ashlar. Requires repainting. Scrolled skew putts. Pend access to flats above.
Windows	4no. timber sash and case at first floor level.
Doors	Glazed timber. Door to close missing.
Shopfronts	Timber shopfront. External grilles. Dentil moulded cornice to timber fascia.
External Pipework	Cast iron half round gutter - requires repainting – connecting into

shared uPVC down pipe.

Priority Score (2+2+3) 7

- Carry out minor slate repairs
- Replace mortar skews
- Repaint stonework
- Refurbish timber sash and case windows
- Remove external grilles
- Install internal security grilles
- Repaint shopfront and fascia
- New fascia signage
- New hanging sign
- Refurbish CI rainwater goods

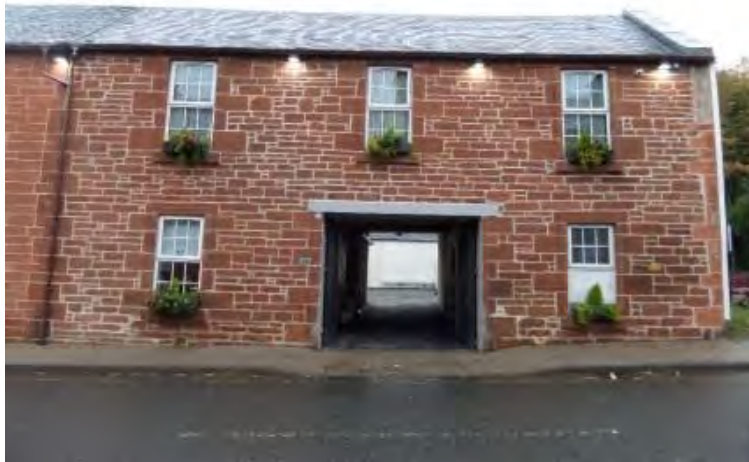
12 Loudoun Street  
Fairburn Hotel

Restrictions	Surveyed from Loudoun Street and car park access road only.
Structural Issues	None apparent.
Storey Height	2 – semi-detached.
Roof	Modern slate with lead ridge and clips. Lead covered straight skew.
Chimneys	n/a
Walls	Squared red sandstone rubble walls. Walls and

pointing appear generally in good condition. Dry dash over cladding to gable end. 1no. decorative iron grille. Central pend to rear court.
Windows	uPVC, 1no. with uPVC blind panel.
Doors	Timber vertically lined doors to pend.
External Pipework	uPVC profiled gutter and shared uPVC downpipe.

- Remove drydash render, repoint and re-render with lime based product.
- Replace windows
- Replace uPVC rainwater goods with CI

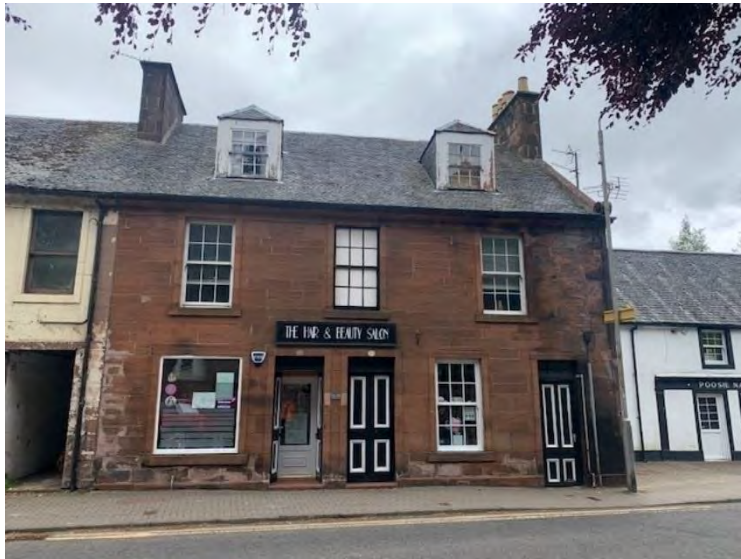
**13-15 Loudoun Street**  
The Hair and Beauty Salon / Residential

Category B Listed	Ground – occupied First – occupied Second - occupied
Restrictions	Surveyed from Loudoun Street only.
Structural Issues	None apparent.
Storey Height	2- mid terraced with
Roof	Natural slate with zinc ridge and clips. Mortar skews. Scrolled skew putt. Lead dormer flashing. 2no. hipped dormers.

Chimneys	Red sandstone chimneys on party wall and gable wall. 1no. pot to l.h.s. 5no. pots to r.h.s.
Walls	Red ashlar sandstone. Masonry erosion at far gutter end and at ground level. Some plastic repairs. Pick pointing required. Damp staining around shopfront. 2no. modern terracotta air bricks. Pend access to flat above.
Dormers	2 gabled dormers with 6 over 6 timber sash & case windows. Windows and timber surrounds in poor condition. Slated cheeks.
Windows	1 blind opening at first floor level. uPVC at first floor. Timber sash & case (6x6) in dormers.
Doors	2no. sets panelled timber storm doors. Panelled timber door to pend – requires refurbishment.
Shopfronts	uPVC shopfront.
External Pipework	uPVC deep flow gutter. Shared uPVC downpipe.
Priority Score	(2+2+2) 6

- Carry out minor slate repairs
- Replace mortar skews
- Carry out localised stone repairs and repointing
- Replace modern air bricks
- Replace dormer timbers
- Replace ground & first floor windows
- Refurbish dormer windows
- Replace shopfront
- Replace uPVC rainwater goods with CI
