# Mauchline Conservation Area Management and Maintenance Plan

Prepared for East Ayrshire Council  
by  
Wylie Shanks Architects

Adopted 27.03.2023

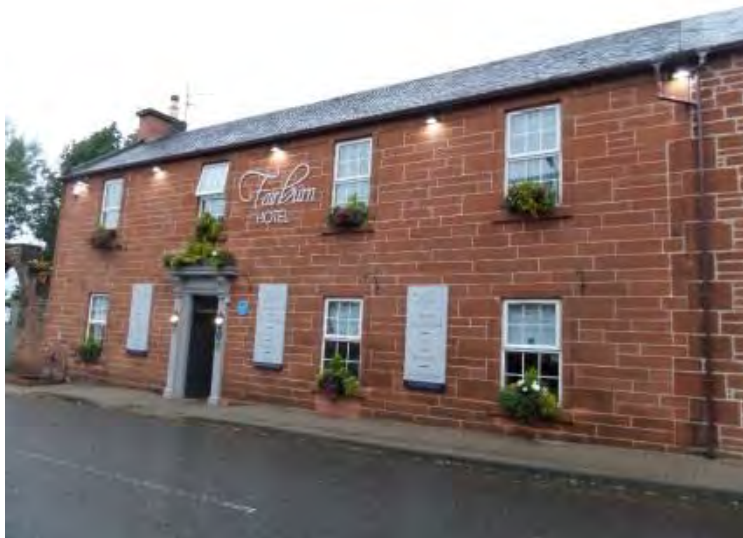
**14 Loudoun Street**  
Fairburn Hotel

Restrictions	Surveyed from Loudoun Street only.
Structural Issues	None apparent
Storey Height	2 – semi detached
Roof	Natural slate with lead ridge and clips.
Chimneys	Red brick chimney to l.h.s. with 1no. can.
Walls	Red sandstone with ashlar window surrounds and classical doorway. Loudoun Spout to l.h.s.
Windows	uPVC
Doors	Modern timber storm doors – painted blanks. Ironmongery not of note.
External Pipework	uPVC profiled gutter and 1no. shared uPVC downpipe.

**Priority Score** (0+2+1) 3

- Replace windows
- Replace door
- Replace uPVC rainwater goods with CI

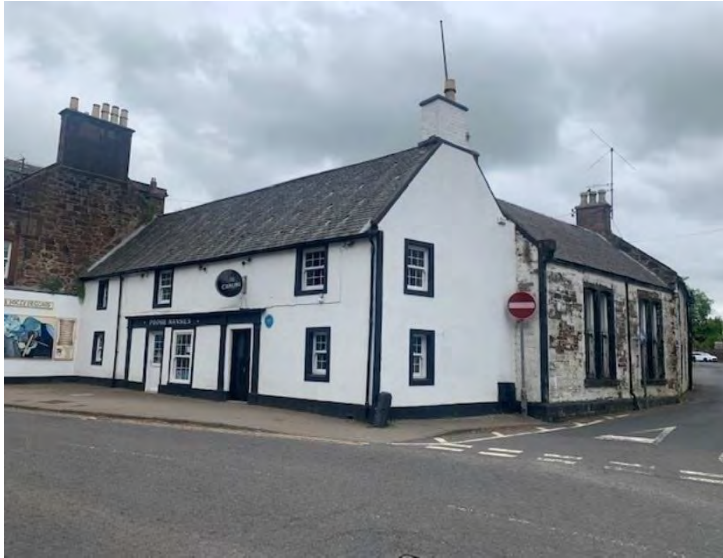
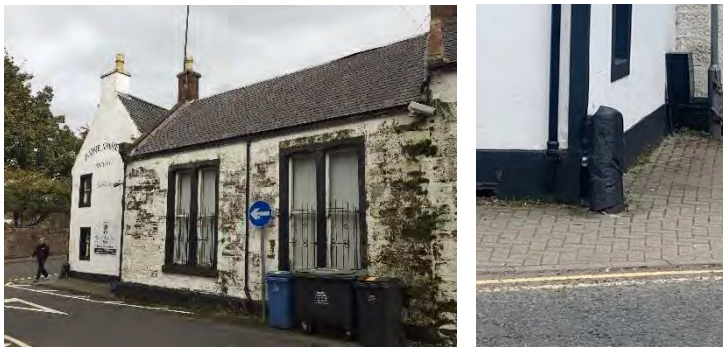
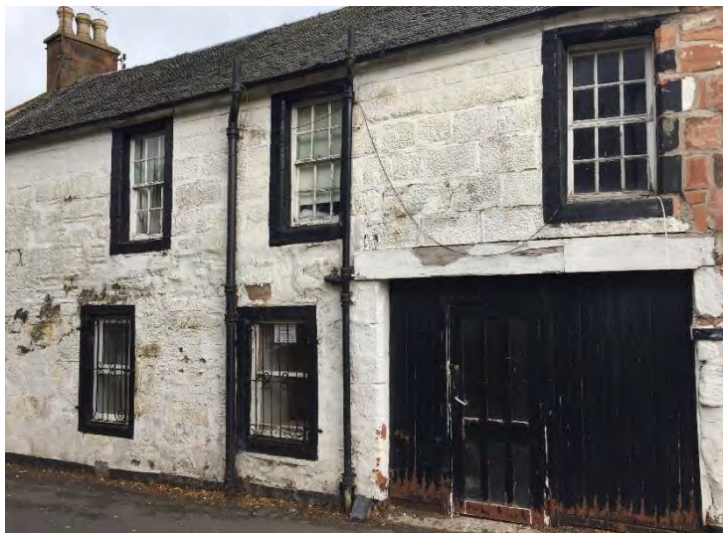
**21 Loudon Street**  
Poosie Nansie's Ale House

Restrictions	Surveyed from Loudoun Street / Cowgate only.
Structural Issues	Deviations in roof line to rear
Storey Height	2 – end terrace returning on to Cowgate single storey, stepping back up to 2-storey on Cowgate.
Roof	Slate with zinc ridge and straps. Lead soakers / vents to Loudoun Street side. Lead skew flashings & mortar skews.
Chimneys	Rendered chimney on corner with 1 pot. Stone chimney to Cowgate l.h.s with 1 pot. Central stone chimney on Cowgate with 3 pots.
Walls	Painted render to Loudoun Street. Painted masonry to Cowgate. Areas of damp from defective rainwater goods.
Windows	uPVC to Loudoun Street Timber sash and case to Cowgate.
Doors	uPVC to Loudoun Street. Modern timber storm doors. Modern timber to Cowgate.
External Pipework	Cast iron gutters and downpipes
Priority Score	(2+3+3) 8

- Remove soakers / roof vents and relocate
- Carry out minor slate repairs
- Replace missing ridge flashing to Cowgate side
- Replace mortar skews

- Remove cement render, repoint, re-render with lime-based material, carrying out stone repairs where necessary.
- Remove paint from masonry.
- Replace windows
- Replace doors
- Refurbish CI rainwater goods, replacing uPVC.
- Add new downpipe to Cowgate elevation
- Replace signage.

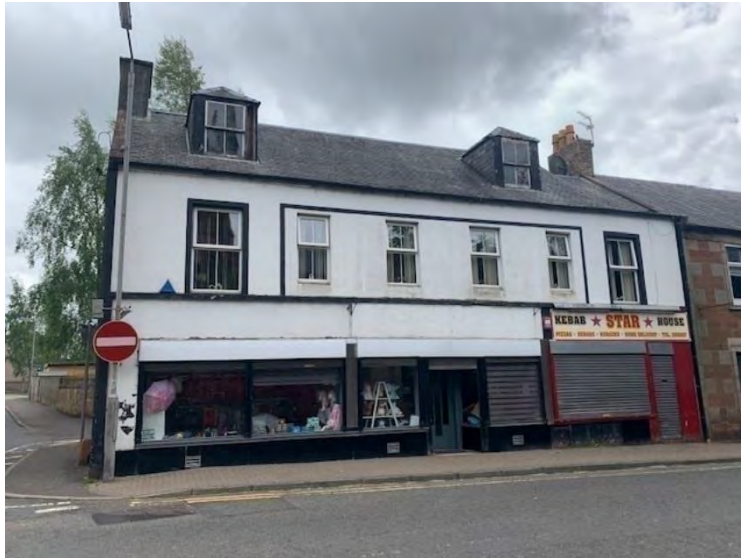
## 23/23a-25 Loudoun Street

Ground – occupied First – occupied Second – uncertain
Restrictions	Surveyed from Loudoun Street only.
Structural Issues	None apparent.
Storey Height	2 – end terrace with 2no. hipped dormers.
Roof	Natural slate with zinc ridge and clips. 1no. mortar skew to l.h.s. 2no. lead skews. Lead flashing to dormers and chimneys.
Chimneys	Rendered chimney to l.h.s. No pots. Brick chimney on party wall to r.h.s with 3no. pots.
Walls	Render is in an acceptable condition. Security shutters down. 1no. large fascia over 3 units. 3no. modern air grilles
Dormers	2no. gabled dormers with 2 x 2 timber sash & case windows and timber surrounds in poor condition. Slated cheeks.
Windows	uPVC to first floor. 2x2 timber sash & Timber 2x2 sash and case in dormers.
Doors	Modern timber to commercial property
Shopfronts	Timber. uPVC sign to r.h.s.
External Pipework	uPVC gutter and downpipe

**(0+2+2) 4**

- Carry out minor slate repairs
- Replace mortar skews
- Repair / repaint dormer timbers
- Paint render
- Replace modern grilles
- Replace uPVC windows
- Refurbish dormer timber sash and case windows
- Remove external roller shutters
- Replace shop fronts
- Install full length timber fascia and signage
- New hanging signs (x2)
- Install internal security grilles
- Replace uPVC rainwater goods with CI

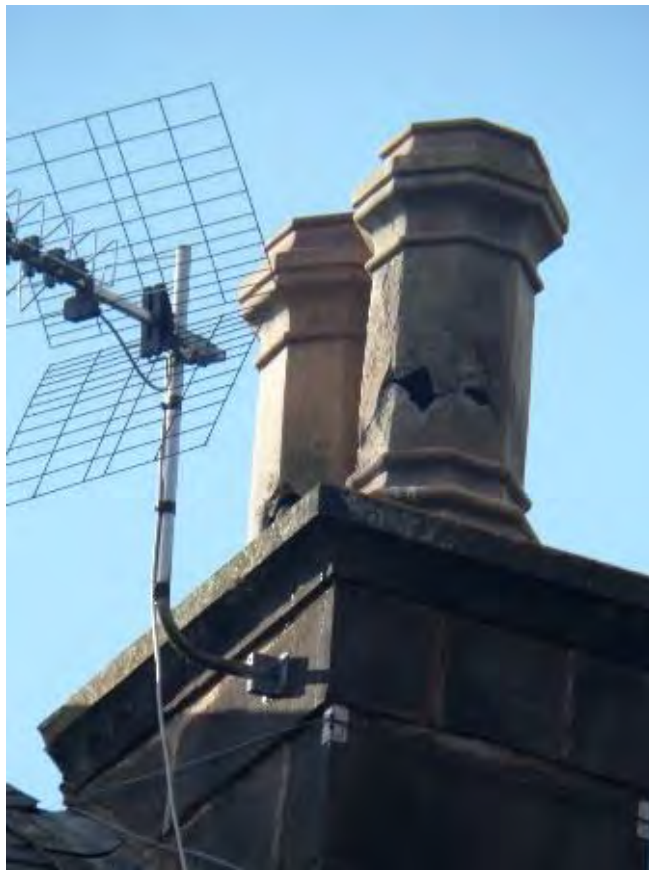
**27-31 Loudoun Street**  
Commercial / Residential

Ground – vacant First – occupied
Restrictions	Surveyed from Loudoun Street only
Structural Issues	None apparent
Storey Height	2 - mid terrace.
Roof	Natural slate with zinc ridge and clips. 1no. mortar skew. Lead chimney flashing. 1no. copper skew putt flashing. Section of mortar skew missing.
Chimneys	Brick chimney with 3no. pots to party wall on l.h.s. Stone chimney with 2no. damaged pots to r.h.s.
Walls	Red ashlar sandstone with blonde sandstone quoins. Partially rendered. 1no. dropped lintol to l.h.s. window at first floor level. Masonry in reasonable condition. Some heavy mortar repairs around downpipe connection. Some low-level staining

(0+2+2) 4

- Carry out minor slate repairs
- Replace mortar skew
- Replace damaged chimney pots
- Carry out localised stone repairs
- Replace modern grilles
- Replace shopfronts and door
- Replace uPVC gutter with CI
- Refurbish CI downpipe

- New fascia signage

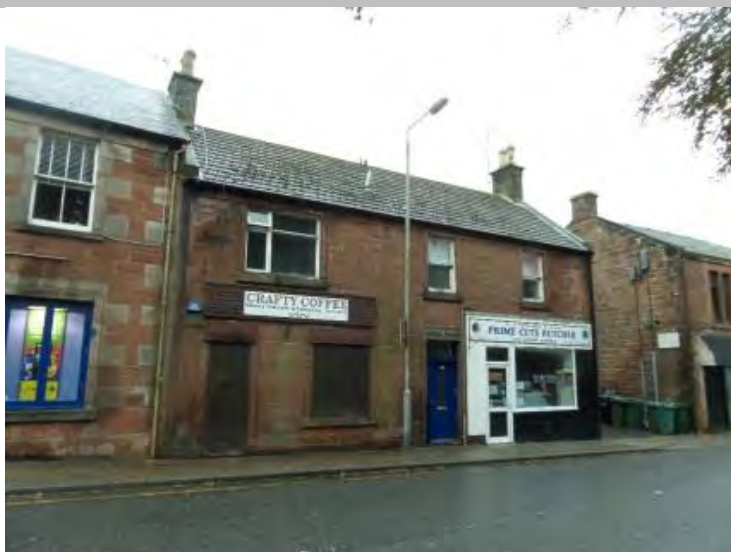
### **33-35 Loudoun Street**

Concrete tiles and ridge. Lead skew and chimney flashings – Poor condition.

Stone chimney on party wall to l.h.s. with 2no. damaged pots. Same to gable on r.h.s.

Red ashlar sandstone. Central door to flats above. Movement in corner at r.h.s. crack in cill at first floor level. Some plastic repairs. Erosion at each end of gutter and at ground level.

Shopfronts	door to flats above Aluminium shopfront to l.h.s. with external shutters. uPVC to r.h.s. with ceramic tiles
External Pipework	uPVC gutter and downpipe.

**Priority Score** (0+2+2) 4

- Reslate roof
- Replace lead skews and flashing
- Install wood core lead ridge
- Replace damaged chimney pots (see 27-31 Loudoun Street)
- Carry out localised stone repairs and repointing
- Replace modern casement
- Refurbish timber sash and case windows
- Replace doors (2no.)

- Remove external shutters
- Replace shop fronts
- Install internal security grilles
- Install new timber fascias and signage
- New hanging signs (2no.)
- Replace uPVC rainwater goods with CI

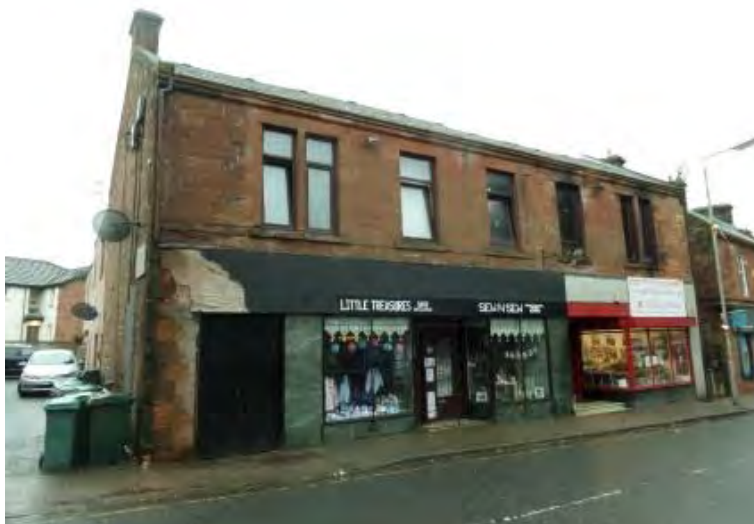
### 37-41 Loudoun Street

Restrictions	Surveyed from Loudoun Street only
Structural Issues	None apparent
Storey Height	2 - detached
Roof	Natural slate with zinc ridge and clips. uPVC ridge. Lead skews and chimney flashings. Ridge vents.
Chimneys	1no. red sandstone stack to l.h.s. No pots.
Walls	Red sandstone. Cracked lintol and cill to l.h.s. window at first floor level. Masonry is heavily water damaged and stained at first floor level, particularly to r.h.s.

- Carry out minor slate repairs
- Replace cracked cill and lintol

- Repoint below gutter line
- Carry out localised stone repairs
- Replace modern grilles
- Replace first floor windows
- Remove external shutters
- Replace shopfronts but retain doors
- Install full length timber fascia and signage
- New hanging signs (3no.)
- Replace uPVC downpipes with CI
- Refurbish CI gutter

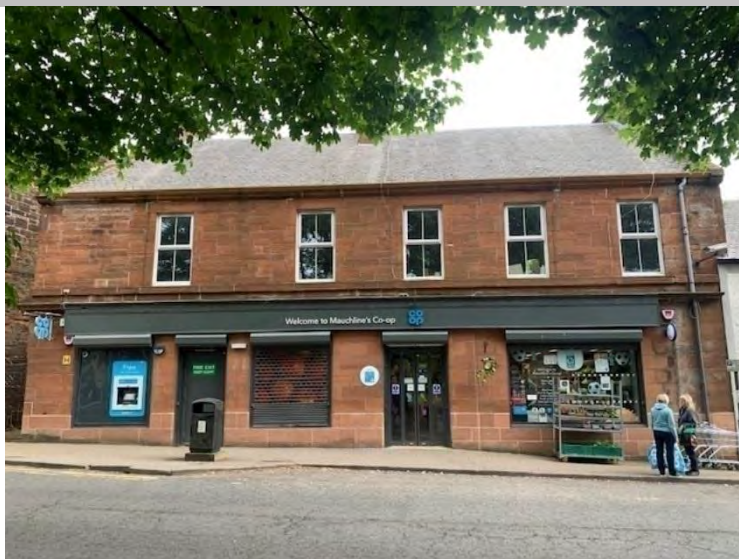
### 43-51 Loudoun Street The Co-op / Residential

Ground – occupied First – about to be split into flats.
Restrictions	Surveyed from Loudoun Street only
Structural Issues	None apparent
Storey Height	2 – end terrace.
Roof	Natural slate roof with zinc ridges and clips. Lead chimney flashings / mortar skews.
Chimneys	3no. red sandstone stacks. No pots
Walls	Red ashlar sandstone. Masonry is heavily eroded at base course. Staining at either end of gutter

and at downpipe. ATM.
Windows	uPVC at first floor
Doors	Bi-fold aluminium entrance door. Painted blank escape door.
Shopfronts	External security shutters. Timber shopfronts and fascia. Bi-folding aluminium doors
External Pipework	Cast iron wall head gutter and downpipe.

- Carry out minor slate repairs
- Replace mortar skews
- Carry out stone indenting below cill line for full length of elevation
- Remove external shutters
- Install internal security shutters
- New hanging sign (1no.)
- Replace escape door
- Refurbish CI rainwater goods

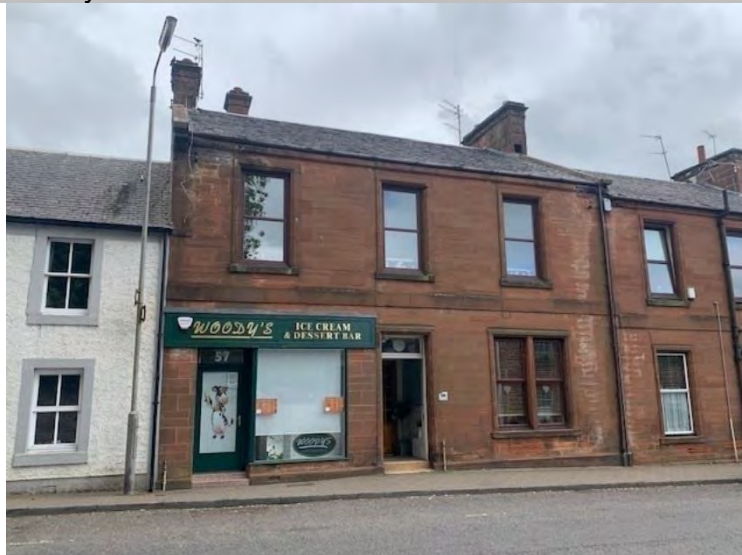
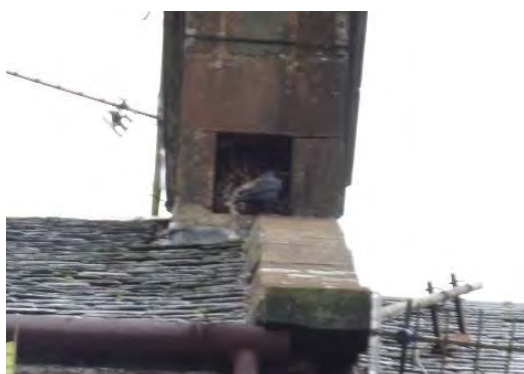
### 57-59 Loudoun Street

Chimneys Red sandstone chimneys at each end. 1no pot to l.h.s. Additional chimney evident at rear. Stone missing from stack on r.h.s.

External Pipework uPVC gutter and down pipe.

- Carry out minor slate repairs
- Replace mortar skews
- Replace missing stone to stack
- Carry out localised stone repairs and repointing
- Replace modern grille
- Replace uPVC windows
- Refurbish storm doors and fanlight
- Replace uPVC rainwater goods with CI

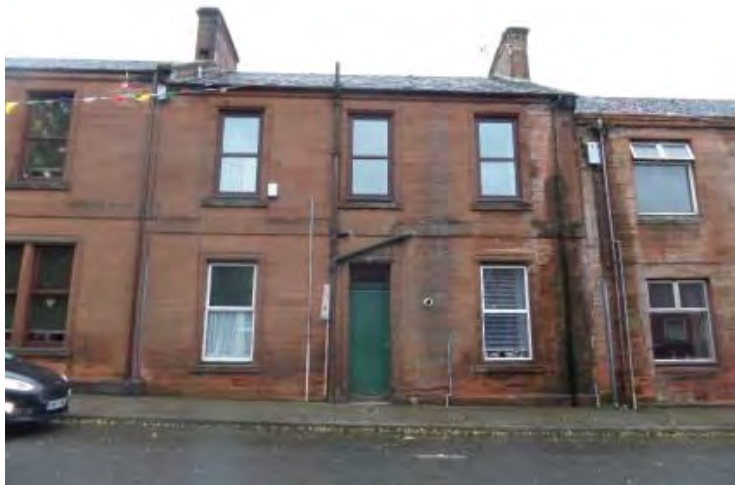
**61 Loudoun Street**  
Residential

Ground - occupied First – vacant
Restrictions	Surveyed from Loudoun Street only
Structural Issues	None apparent
Storey Height	2 – mid terraced.
Roof	Natural slate with zinc ridge and clips. uPVC vents. Lead / mortar skew, lead chimney flashings
Chimneys	Red sandstone chimneys at each party wall. 1no. pot to r.h.s. No. pots to l.h.s. Stone missing from stack on l.h.s.
Walls	Red ashlar sandstone. Masonry erosion at ground level. Heavily stained, water damaged due to defective downpipe at r.h.s. 1no. cast iron grille.
Windows	uPVC
Doors	Modern painted blank with fanlight. No ironmongery of note.
External Pipework	Cast iron half round gutter. Cast iron vent stack and

cast iron rain water pipe to r.h.s. defective.

- Carry out minor slate repairs
- Replace mortar skew
- Replace missing stone to stack (see 57-59 Loudoun Street)
- Carry out localised stone repairs and repointing
- Replace uPVC windows
- Replace door and fanlight
- Refurbish / repair CI rainwater goods

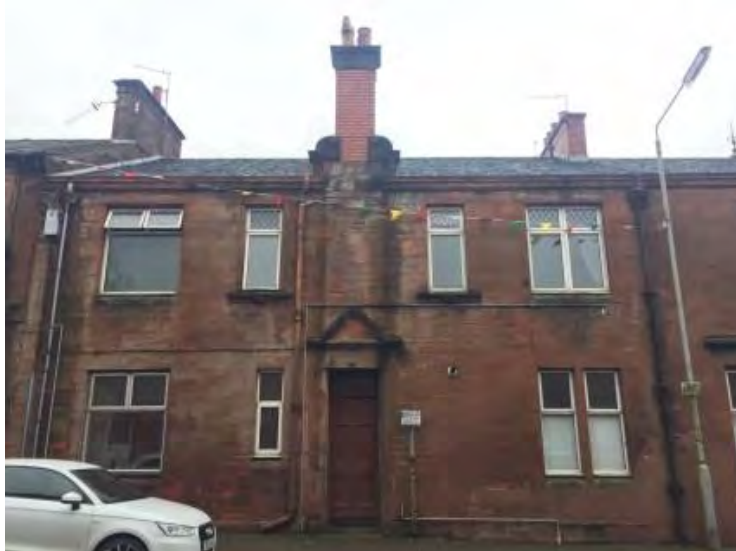
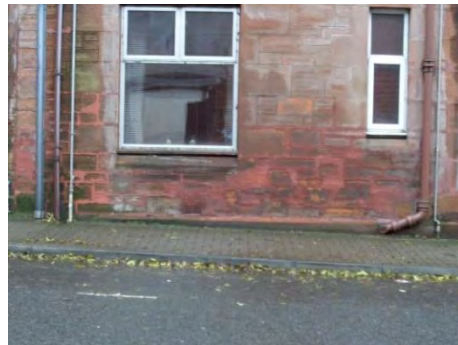
**63 Loudoun Street**  
Residential

Ground – occupied(partially) First – occupied (partialy)
Restrictions	Surveyed from Loudoun Street only.
Structural Issues	None apparent
Storey Height	2 – mid terrace.
Roof	Natural slate with lead ridge and clips. Lead skew and chimney flashings.
Chimneys	Red brick wall head chimney with scrolled stone shoulders and stone cap with 2no. pots. Red brick chimney shared with No. 65 to r.h.s.
Walls	Squared rugged red sandstone. Significant damage from defective rain water goods. Heavy over pointing at ground level particularly at gutter ends and shared downpipe. 1no. modern aluminium grille and 1no. ornate cast iron grille.
Windows	3no. stone mullions may have been removed. 7no. uPVC windows 1no. aluminium window
Doors	Panelled timber door with fanlight.
External	Cast iron wall head

- Carry out minor slate repairs
- Carry out localised stone repairs and repointing
- Reinstall stone mullions
- Replace modern grille
- Replace windows
- Refurbish door and fanlight
- Refurbish CI rainwater goods
- Replace uPVC section with CI

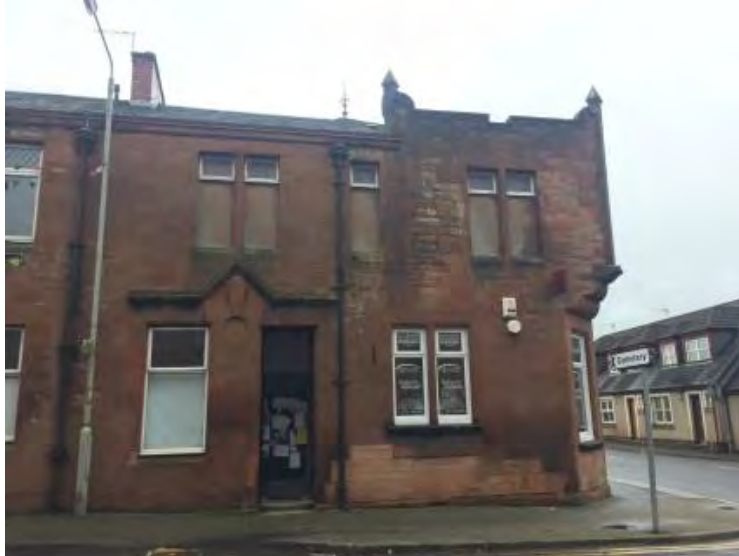
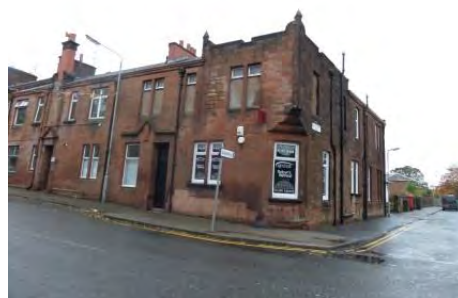
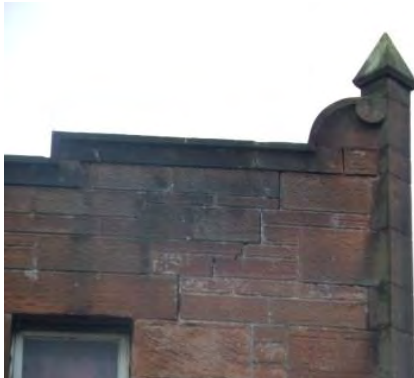
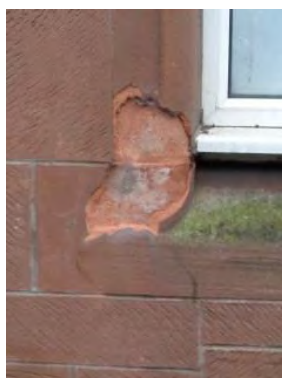
## 65 Loudoun Street

**Structural Issues** Crack in lintol at ground floor window. Some movement evident in parapet at corner.

**Chimneys** Red brick chimney at party wall with 4no. terracotta cans.

**Walls** Red sandstone. Squared ashlar chamfered corner with corbelled corner projection. Castellated parapet detail at corner with stone finials. Decorative iron roof finial. Some damp staining. Extensive indents at ground floor level. Additional indents and repointing required. 1no. partially covered

ornate cast iron grille.
Windows	uPVC. First floor windows have partially been blocked up.
Doors	Panelled timber door with Georgian wire fanlight
External Pipework	<u>Loudoun Street</u> - Cast iron wall head gutter, 1no. and 1 shared cast iron downpipe with decorative hoppers and ears. Shared downpipe showing evidence of damage. Damaged stonework and 2 ears broken. <u>Barskimming Road</u> - 1no. cast iron downpipe with decorative hopper and 1no. cast iron vent stack both with decorative ears.
<b>Priority Score</b>	<b>(0+2+3) 5</b>

- Carry out structural inspection & any recommended remedial repairs
- Carry out minor slate repairs
- Replace lead parapet gutter
- Carry out stone repairs
- Repoint
- Replace uPVC windows
- Open up first floor windows and install new timber sash and case windows
- Refurbish door
- Refurbish CI rainwater goods

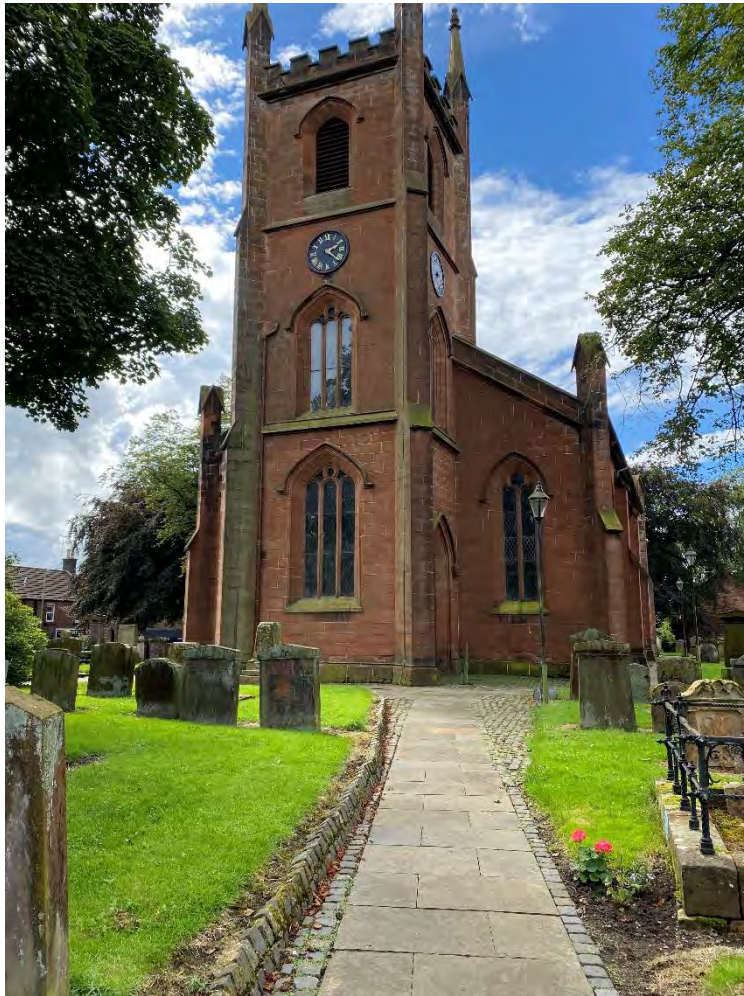
### Loudon Street Mauchline Church and Churchyard

Restrictions	Full access.
Structural Issues	None apparent
Storey Height	1 – stand alone.
Roof	Natural slate with lead ridge and clips. Lead skewes and flashing.
Chimneys	n/a
Walls	Red sandstone. No structural issues apparent. Stonework and pointing generally in good condition. Small localised areas of damage. Modern louvred air grilles.
Windows	Diamond leaded coloured glass with

Doors	secondary glazing externally. Ornate timber storm doors to main entrance. (2no. sets)
External Pipework	Cast iron half round gutters and circular downpipes.
Priority Score	(2+3+0) 5

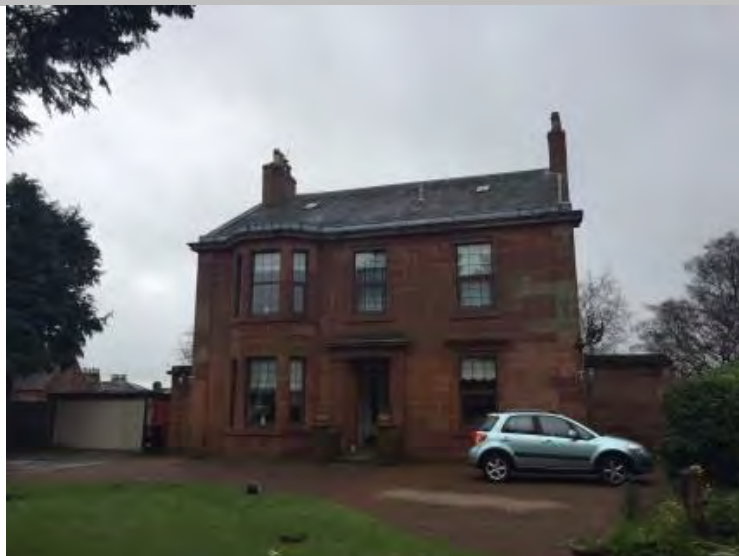
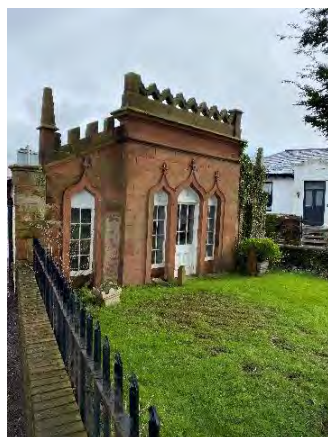
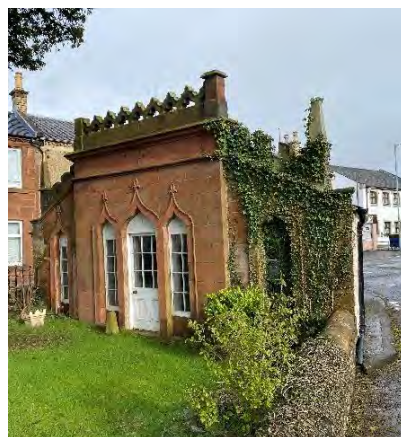
**25 Mansefield Road**  
Residential (Springfield)

Summer House Category B Listed	Occupied
Restrictions	Survey restricted due to driveway
Structural Issues	None apparent
Storey Height	2 – detached.
Roof	Pitched roof with straight skews. Natural slate with zinc ridge and clips. Lead skews, partial cappings, chimney flashings and parapet flashings. 2no. cast iron rooflights – refurbish.
Chimneys	Red brick chimney with 4no. decorative pots to l.h.s and to r.h.s.
Walls	Red ashlar sandstone to principal elevation. Frontage masonry appears in good condition. Gable requires some stone repairs/repointing. 2no. modern louvred air grilles.
Windows	uPVC. Timber casements to summerhouse.
Doors	Timber storm doors with fanlight. Timber half glazed door to Summer House.
External Pipework	Parapet gutter
<b>Priority Score</b> Main House	(0+2+1) 3
<b>Priority Score</b> Summer House	(2+2+2) 6

- Carry out minor slate repairs
- Refurbish roof lights
- Carry out stone repairs / repointing to gable
- Replace modern grilles
- Replace windows
- Refurbish door
- Repoint stonework to Summer House
- Refurbish windows and door to Summer House.

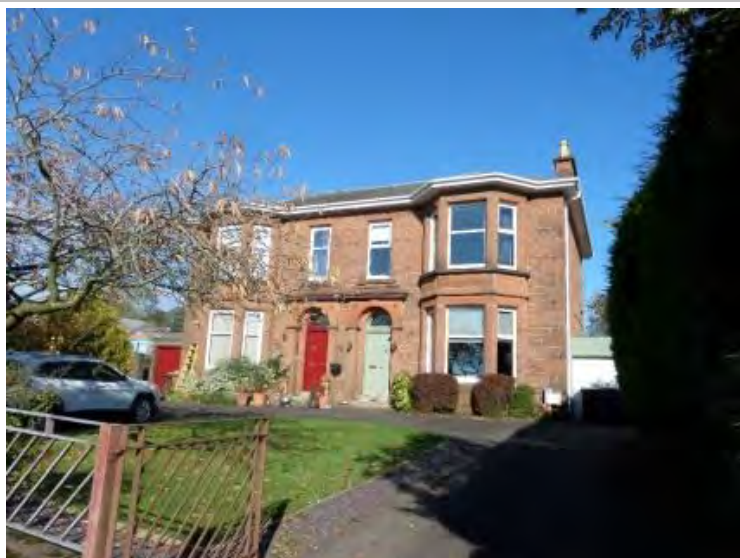
### 1-3 Tanfield Residential

Restrictions	Restricted visibility due to driveways.
Structural Issues	None apparent
Storey Height	2 – 2 semi-detached properties.
Roof	Natural slate with zinc ridges and clips. Lead chimney and valley flashings.
Chimneys	Red sandstone stack to r.h.s. with 4no. ornate pots.
Walls	Red ashlar sandstone. Masonry in good condition. Air bricks not visible.
Windows	2 storey bay windows. uPVC. Modern Velux to r.h.s.
Doors	Vertically lined timber storm doors each with semi-circular fan light.
External Pipework	uPVC gutters and downpipes.
<b>Priority Score</b>	<b>(0+2+1) 3</b>

- Minor slate repairs
- Replace windows
- Refurbish storm doors
- Replace uPVC rainwater goods with CI

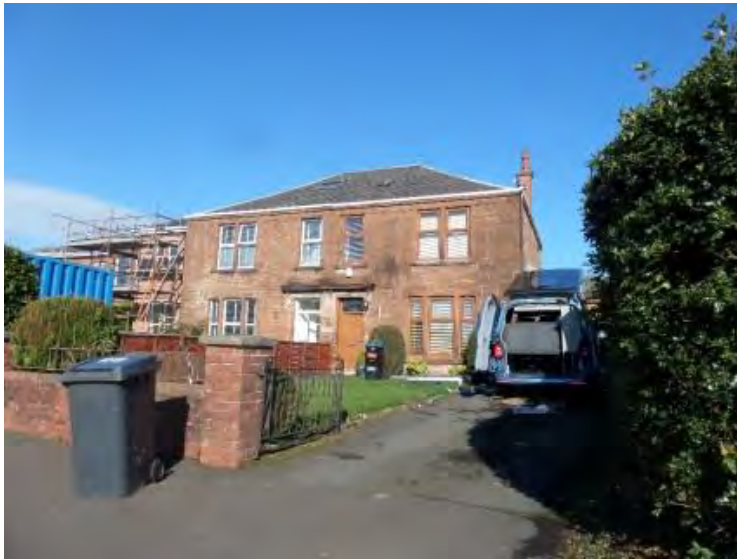
Restrictions	Restricted visibility due to driveways.
Structural Issues	None apparent.
Storey Height	2 – 2 semi-detached.
Roof	Natural slate with zinc ridges and clips. Lead chimney flashings.
Chimneys	Red brick chimney to r.h.s. with 1no. pot.
Walls	Red ashlar sandstone. Masonry appears in good condition. Air bricks not

1 house has very recent side extension.

- Minor slate repairs
- Refurbish CI roof light
- Replace windows
- Replace doors
- Replace uPVC rainwater goods with CI

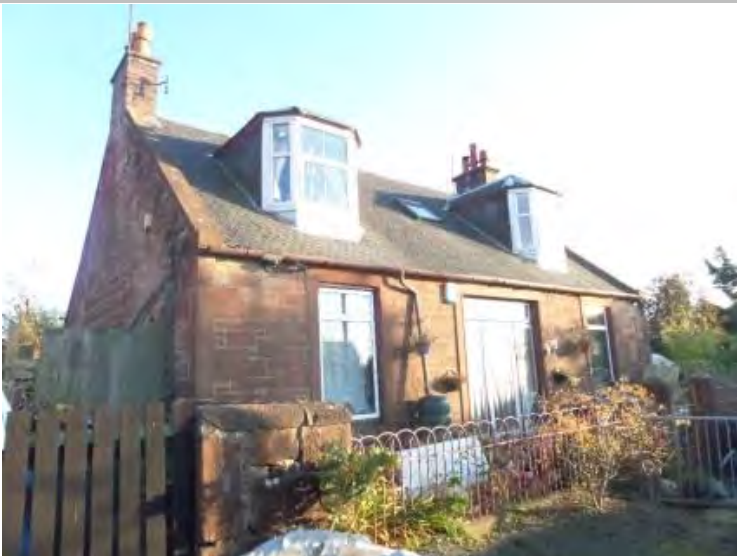
elevation in reasonably good condition. Heavy erosion and over pointing on gable. Air bricks not visible.
Dormers	uPVC windows. Hipped slate roofs and slated cheeks. Timber below windows requires refinishing.
Windows	uPVC windows and dormer window. Modern Velux.
Doors	Aluminium door, side lights and fan light.
External Pipework	uPVC gutters and downpipes (2no.). Water butt

- Minor slate repairs
- Replace mortar skewes

- Make stone repairs and repoint gable
- Repaint / repair dormer timbers
- Replace windows
- Replace door and fanlight
- Replace uPVC rainwater goods with CI

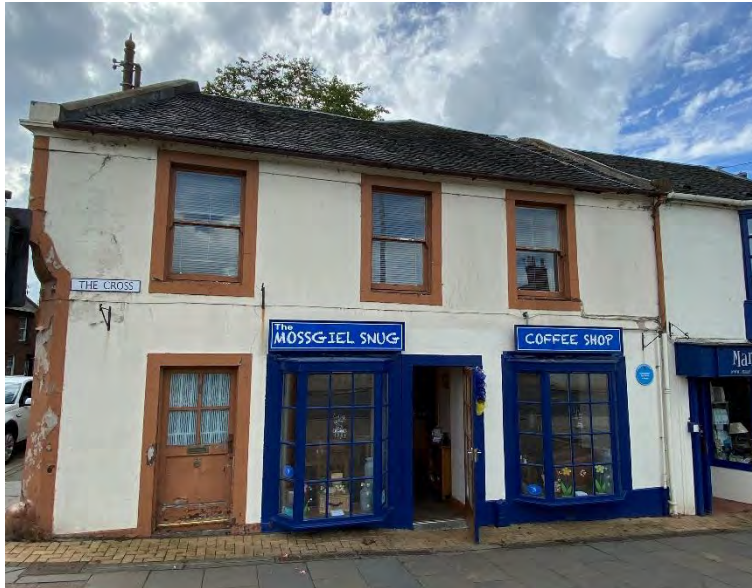
The Mossgeil Snug / Residential

Ground – occupied First - occupies
Restrictions	Surveyed from The Cross only
Structural Issues	None apparent
Storey Height	2 – corner terrace.
Roof	Slate roof with zinc ridge and clips. Mortar skewers.
Chimneys	n/a

- Carry out minor slate repairs
- Replace mortar skew
- Repaint render
- Refurbish timber sash and case windows
- Replace door to flat
- Paint shopfront and fascia's
- Refurbish CI rainwater goods
- New hanging sign

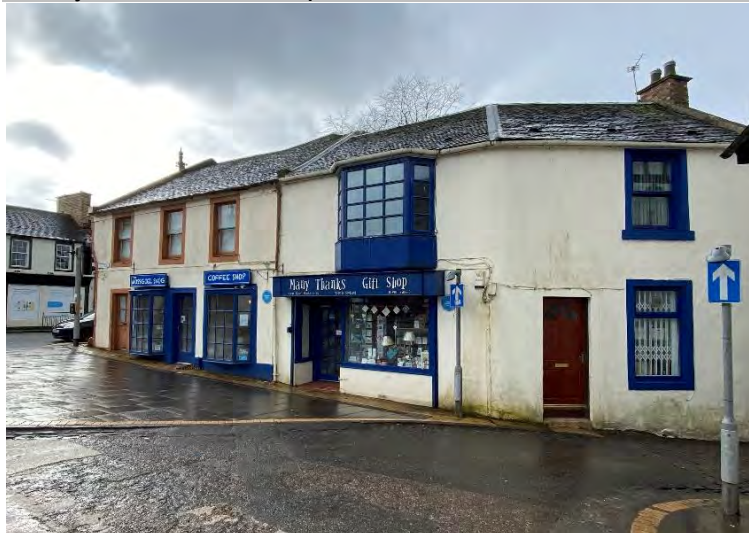
### 3-5 The Cross

Doors	Modern glazed door to gift shop. Panelled timber door to Flat 3a.
Shopfronts	Timber shopfront with fascia. Recessed doorway. External security shutter.
External Pipework	uPVC gutter. uPVC downpipe discharging into gutter of adjoining property.

- Carry out minor slate repairs
- Replace mortar skew

- Repaint render
- Refurbish timber sash and case windows
- Replace timber casement
- Replace door to flat
- Paint shopfront, bow window and timber fascia's
- Refurbish CI rainwater goods
- Install new CI downpipe with new below ground connection
- Install internal security shutter
- New hanging sign
