# **Mauchline Conservation Area Management and Maintenance Plan**

**Gazetteer**

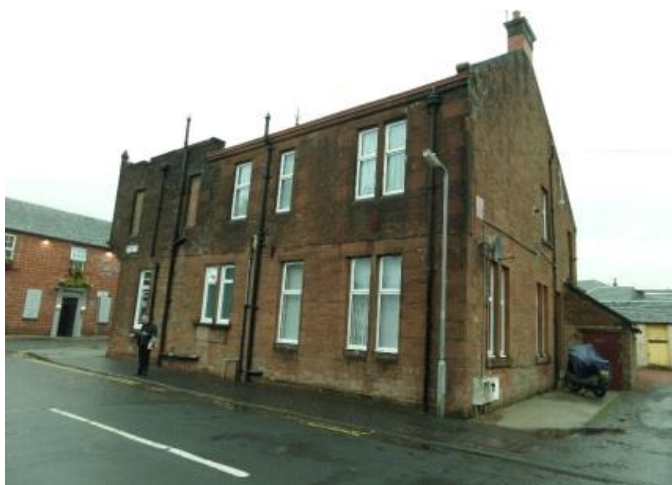
## 1 Barskimming Road

Ground – occupied First – occupied
Restrictions	Surveyed from Barskimming Road only.
Structural Issues	None apparent.
Storey Height	2 – end terrace.
Roof	Pitched natural slate with straight skewes. Small section of lead flat roof at ridge. Cast iron roof light. Lead skew flashings and chimney flashing.
Chimneys	Red brick chimney to r.h.s with stone top section with 3no. terracotta pots.
Walls	Red ashlar sandstone. Masonry requires pointing below cill line. 3no. ornate cast iron air grilles
Windows	uPVC
Doors	n/a
External Pipework	Cast iron wall head gutter. Cast iron downpipe with ornate hopper. Lower section is uPVC. Cast iron vent stack.
<b>Priority Score</b>	<b>(0+2+2) 4</b>

- Minor slate repairs
- Refurbish cast iron roof light
- Refurbish CI rainwater goods
- Replace uPVC lower section of downpipe with CI to match existing
- Repoint stonework below cill line

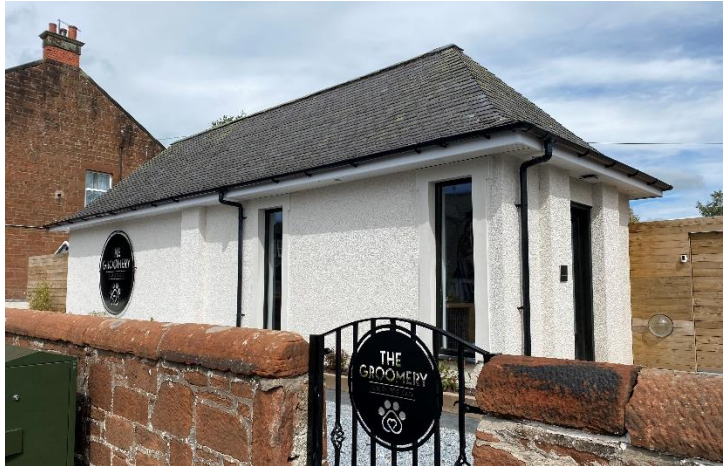
## 1a Barskimming Road

Restrictions	Surveyed on all elevations.
Structural Issues	None apparent.
Storey Height	1 – detached
Roof	Natural slate with close mitred hips. Concrete ridge tiles. Timber fascia's and soffits.
Chimneys	n/a
Walls	Wet dash render in

Windows	good condition uPVC.
Doors	Modern painted blank.
External Pipework	uPVC gutter and downpipes.

- Minor slate repairs
- Refurbish windows
- Replace door
- Replace uPVC gutters and downpipes with CI

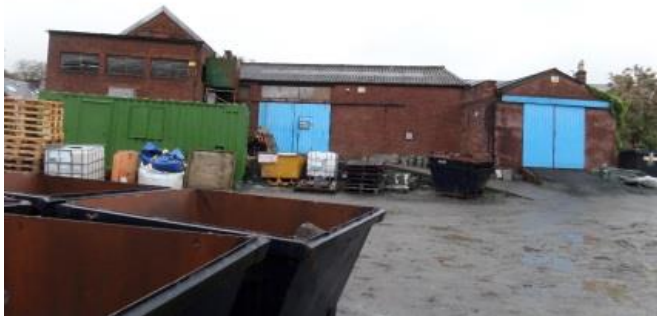
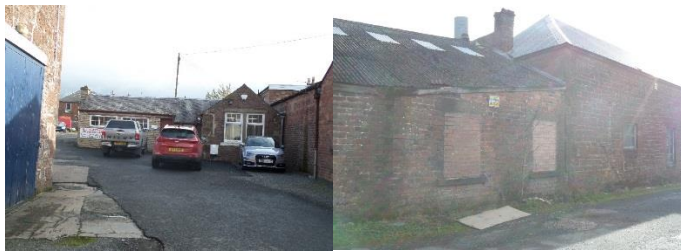
**9-13 Barskimming Road**  
Andrew Kay & Co.

Restrictions	Surveyed from fence line on Barskimming Road only
Structural Issues	None apparent
Storey Height	1
Roof	Predominantly profiled metal sheets. Natural slate with zinc ridge and clips to the rear. Possible asbestos roof?

Chimneys	Red brick. No pots.
Walls	Original building red sandstone rubble. Later extensions in red brick with stone cills and quoins, and buff brick.
Windows	Combination of timber casements and uPVC. A number of blocked up openings.
Doors	Not visible.
External Pipework	Cast iron to the rear. None to the front.

- Make minor slate repairs to rear extension
- Replace windows
- Refurbish existing CI rainwater goods
- Install new CI rainwater goods
-

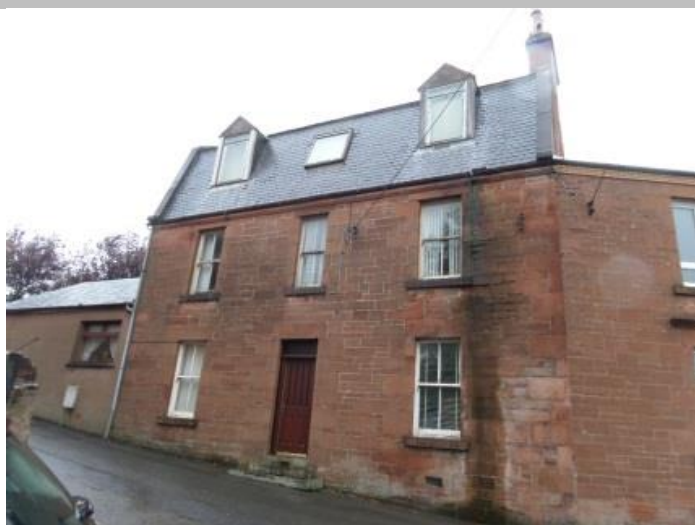
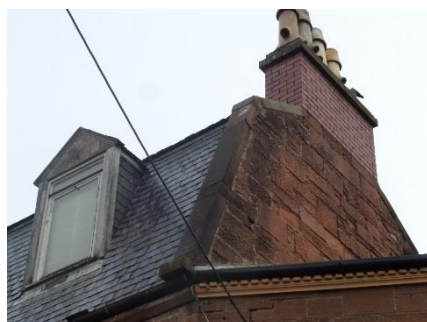
## 1-3 Burnside Road

Restrictions	Surveyed from Burnside Road only.
Structural Issues	Cracked cill to bottom l.h. window.
Storey Height	2 – mid terrace.
Roof	Natural slate mansard roof with 2no. gabled dormers. Natural slate. Ridge not visible. Lead dormer flashings. Mortar skews.
Rooflight / Dormers	2no. gable dormers. Timber and windows to dormer in poor condition. Modern rooflight.
Chimneys	Red brick chimney to r.h.s. with 4no. terracotta pots.
Walls	Red squared sandstone rubble. Masonry has heavy staining, damp, moss and vegetation and open joints below damaged gutter. Stone repairs and pointing required below chimney. 3no. ornate cast iron air grilles.
Windows	2x2 timber sash & case windows with horns to ground and first floor level. Need repaired and refurbished.
Doors	Modern timber door with fanlight.
External Pipework	Cast iron half round gutter. Damaged uPVC downpipe.

- Carry out stone repairs below chimney
- Repoint below chimney
- Carry out minor slate repairs
- Replace mortar skews
- Repair and repaint timber to dormers
- Replace cracked cill
- Repair and refurbish CI gutter
- Replace uPVC downpipe with CI
- Remove vegetation and repoint masonry to r.h.s
- Repair & refurbish timber sash and case windows
- Replace dormer windows
- Replace entrance door and fanlight

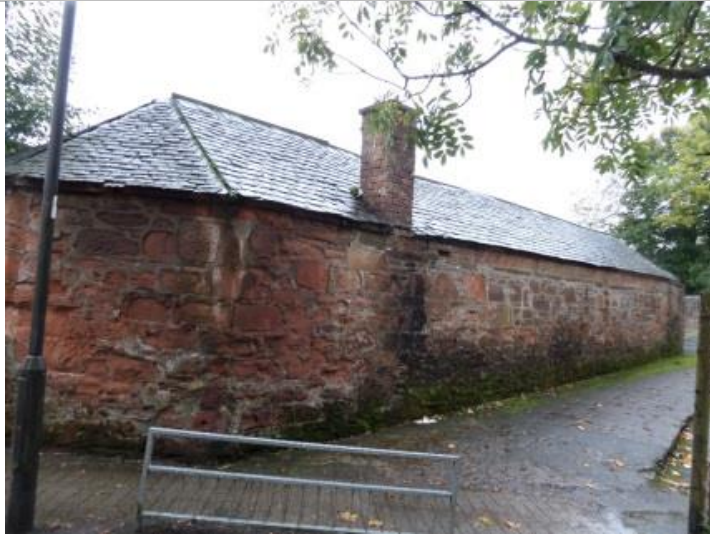
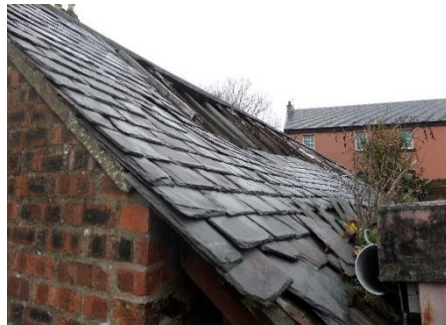
**Burnside Road**  
Outhouse

Vacant – partially derelict
Restrictions	Surveyed from Burnside Road and courtyard.
Structural Issues	Crack at corner of brickwork.
Storey Height	1 – detached.
Roof	Natural slate. Ridge missing – partially collapsed to rear. Mortar skews to chimney.
Chimneys	Red brick wall head chimney. No pots. Open joints.
Walls	Red sandstone rubble with red brick wall head. Brick gable end. Heavily eroded with heavy cement over pointing. Very damp at ground floor level.
Windows	Remains of cast iron roof lights, now missing.
Doors	n/a
External Pipework	Missing.

- Carry out structural appraisal and remedial work, including likely rot repairs to roof timbers
- Reinstall roof glazing
- Carry out extensive slate repairs and install new wood cored lead ridge
- Install CI rainwater goods
- Repoint all masonry
- Install new door (assumed)

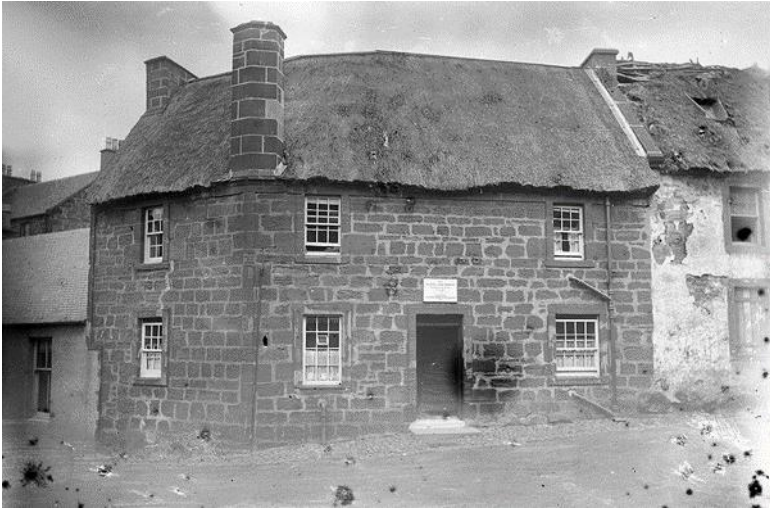
**4 Castle Street**  
Part of Burns Museum

Category B Listed	Occupied
Restrictions	Surveyed from Castle Street only.
Structural Issues	None apparent.
Storey Height	2 – corner mid terrace, squared
Roof	Natural slate, close mitred hip, lead ridge flashing and clips, flat lead roof with wood core rolls. Lead skew and chimney flashings.
Chimneys	Hexagonal ashlar sandstone chimney on corner return at wall head with 2no. plain terracotta pots. Rectangular stack at party wall with No. 6 with 4no. terracotta pots with terracotta elephants' feet.
Walls	Heavy cementitious over pointing. Some scaling and eroded stones around entrance at ground level and also around window. Evidence of some stone repairs. 1 modern louvred aluminium solum vent.
Windows	4no. 4 x 6 timber sash & case windows, 1 with horns. 1no. 8 x 8 timber

sash & case window. 1no. 12 pane timber
Doors	Modern vertically lined timber door.
External Pipework	Cast iron half round gutters and 2no. cast iron circular downpipes. Require refurbishment.
<b>Priority Score</b>	<b>(2+3+0) 5</b>

- Rake out and repoint
- Carry out stone repairs around doorway and window
- Refurbish CI rainwater goods
- Replace modern vent

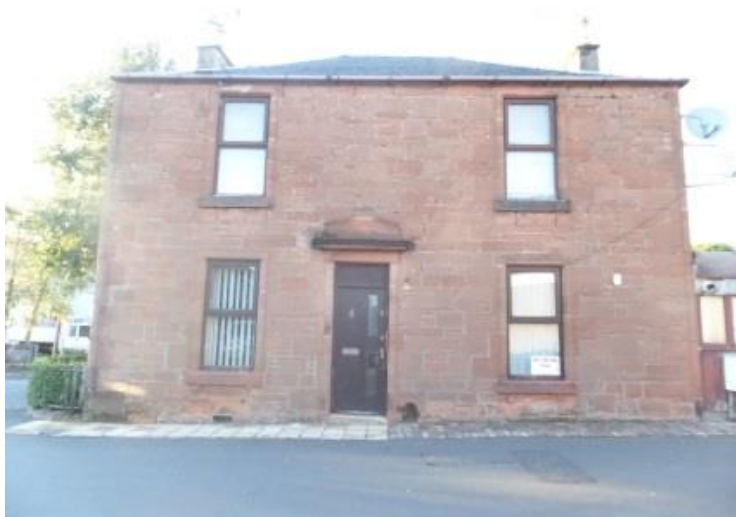
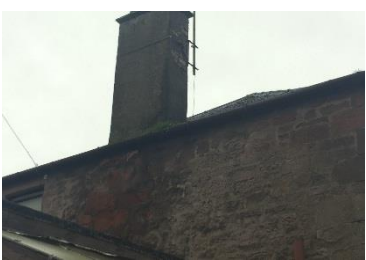
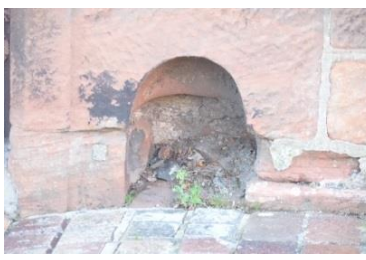
**5 Cowgate Residential** Occupied

Restrictions	Surveyed from Cowgate and also gable ends.
Structural Issues	None apparent.
Storey Height	2 - detached
Roof	Hipped roof. Natural slate with zinc ridges and clips. No skewes. Assume lead chimney flashing
Chimneys	Brick chimneys to l.h.s. and r.h.s. each with 2no. decorative cans.
Walls	Squared red sandstone rubble with ashlar window dressings and door surround. Street frontage requires repointing. Erosion below windows. Dry dash on l.h. gable. Heavy stone erosion along flue line on r.h. gable. 1no. modern grille. Recess for shoe scraper – ironwork missing.
Windows	Modern timber.
Doors	Modern door blank with vision panels.

External Pipework Fanlight boarded over.  
uPVC gutter to main elevation.  
Gutter missing on gable.

- Carry out minor slate repairs
- Repoint main elevation and r.h. gable
- Carry out stone repairs below windows and on r.h. gable end
- Remove dry dash from l.h. gable, repoint and re-render with lime-based product
- Replace modern vent

- Replace windows
- Replace door and fanlight
- Replace uPVC gutters with CI
- Install 2no. new CI downpipes.
- Replace ironwork to shoe scraper

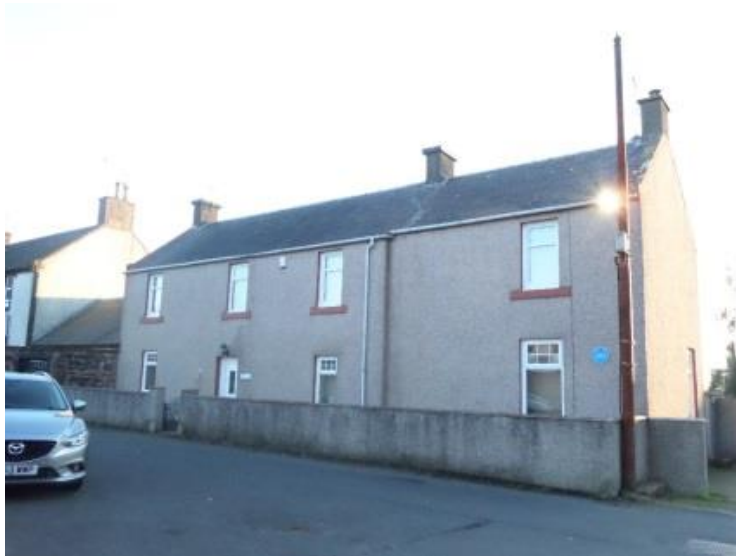
Roof Natural slate with zinc ridge and clips. Mortar skews and lead chimney

Chimneys	flashings. 3no. rendered chimneys. 2 capped. With metal flashings.
Walls	Dry dashed.
Windows	7no. uPVC
Doors	1no. uPVC
External Pipework	uPVC gutter. 1no. uPVC downpipe.

- Carry out minor slate repairs
- Remove dry dash, repoint and re-render in a lime-based product
- Replace windows
- Replace door
- Replace uPVC rainwater goods with CI
-

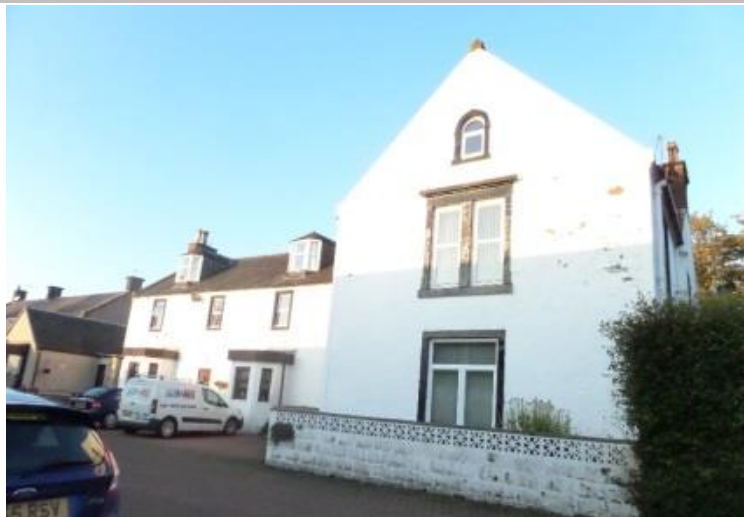
**6A Cumnock Road / 6 Grove Park**  
Residential (may be flatted)

Ground – occupied First – occupied Second - occupied
Restrictions	Surveyed from Grove Park/Cumnock Road only.
Structural Issues	None apparent
Storey Height	2 – 2 x semi detached
Roof	Polygonal dormer windows. and roof lights. Natural slate with zinc ridge and clips. Mortar skews. Lead valleys and chimney flashings.
Chimneys	1no. stone stack with 3no. ornamental pots. 1no. stone ridge stack with no pots. 1no. stone stack with 2no. ornamental cans. 1no. stone stack with 3no. ornamental cans.
Walls	Painted masonry - requires repainting. Modern air bricks.
Windows	uPVC
Doors	uPVC

- Carry out minor slate repairs
- Replace mortar skews
- Repaint masonry (all elevations)
- Replace modern vents
- Replace windows
- Replace doors
- Replace uPVC rainwater goods with CI
- Refurbish CI rainwater goods

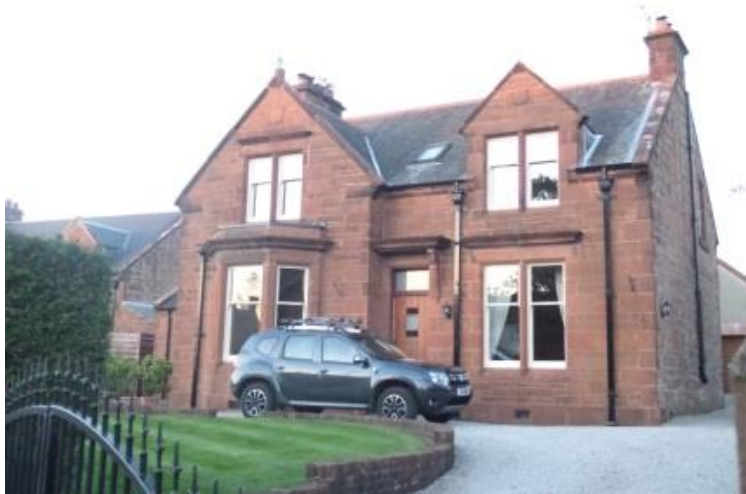
**9 Cumnock Road**  
Residential - Willowbank Occupied

Walls Squared red rubble sandstone masonry with single storey bay window. Masonry appears in good condition. Cast iron air grilles.

- Carry out minor slate repairs
- Refurbish timber sash and case windows
- Replace door and fanlight
- Refurbish CI rainwater goods

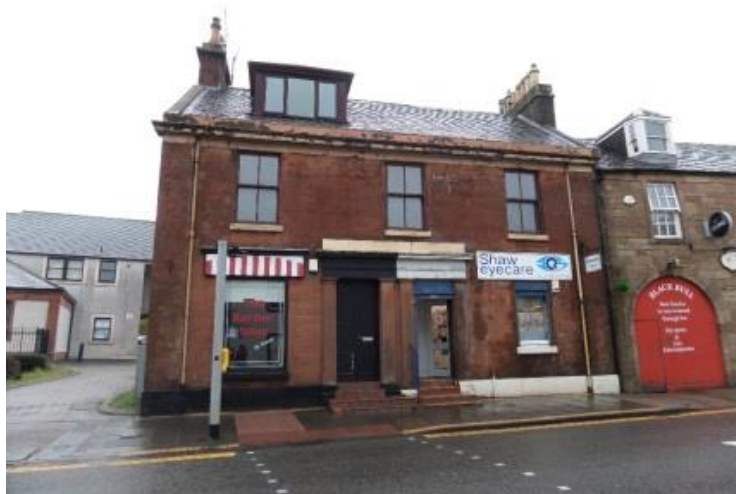
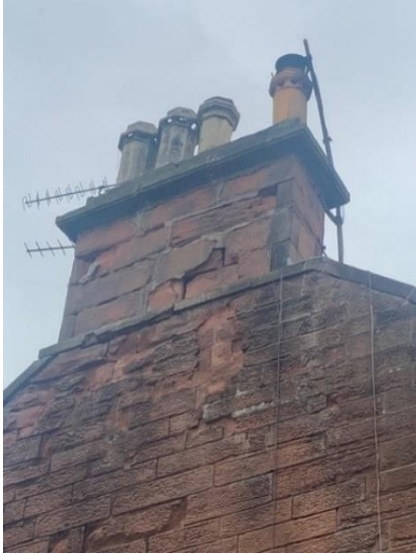
The Barber Shop / Shaw Eyecare / Residential

Restrictions	Surveyed from Earl Grey Street only.
Structural Issues	LH chimney leaning / heavily eroded stonework.
Storey Height	2 – end terrace.
Roof	Natural slate pitched roof with straight skews. Box roof dormer. Ridge needs replaced. Lead skews / chimney / dormer flashings. Parapet gutter.
Chimneys	Stone stack with 4no. ornate pots to l.h.s. Stone stack with 8no. pots on party

Walls	wall. Red ashlar sandstone. Masonry has heavy staining/erosion to parapet. Some damp below window to r.h.s.
Windows	3no. modern timber sash & case with horns at first floor level. uPVC in dormer.
Doors	Timber storm doors to l.h.s. Door to r.h.s. obscured by roller shutter.
Shopfronts	Timber shopfront to l.h.s with dentil moulded fascia. uPVC to r.h.s with external security shutter. Tiled steps with original iron boot scrape on top step.
External Pipework	2no. cast iron downpipes – both require refurbishment.

- Carry out minor slate repair
- Replace ridge with wood core lead roll and clips
- Allow for replacing lead parapet flashings
- Repoint along cornice line
- Refurbish CI rainwater goods
- Remove external roller shutters and replace with internal security grille to window.
- Replace dormer window
- Repaint sash and case windows
- Repaint timber shop front to l.h.s and timber fascia
- Replace window to r.h.s
- Refurbish existing storm doors
- Install new storm doors to r.h.s
- Install new fascia to r.h.s. to match l.h.s
- Paint stone pediment over doors
- New fascia signs and hanging signs (x2)
- Existing steps and original iron boot scrape to be retained and refurbished.

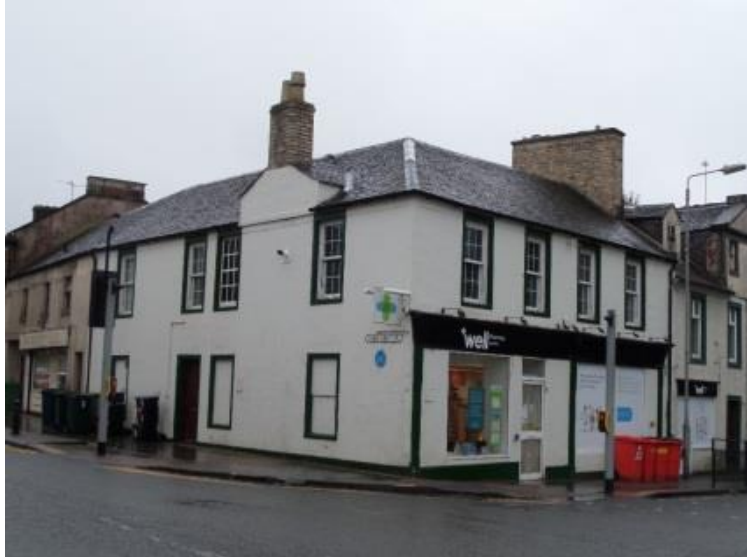
**2 Earl Grey Street / 1-3 Loudoun Street**  
Pharmacy / Residential

Category B Listed	Ground – occupied First – occupied
Restrictions	Surveyed from Earl Grey Street/Loudoun Street only.
Structural Issues	None apparent
Storey Height	2 – corner terrace.
Roof	Pitched roof with hipped return. Natural slate with zinc ridge and clips. Lead chimney flashings.
Chimneys	1no. shouldered brick wall head stack on Earl Grey Street with 2no. terracotta pots. 1no. brick stack, no pots on party wall on Loudoun Street.
Walls	Painted render.
Windows	Earl Grey Street - 3no. blind openings at ground floor level. 3no. uPVC/1no. blind opening at first floor level. Loudoun Street – 2no. blind openings at

- Carry out minor slate repairs
- Repaint render
- Replace uPVC windows
- Glaze blind openings
- Install internal security grilles
- Replace door to Earl Grey Street
- Replace shopfront
- Replace uPVC gutter with CI
- Refurbish CI downpipe
- Repaint timber fascia
- New hanging sign

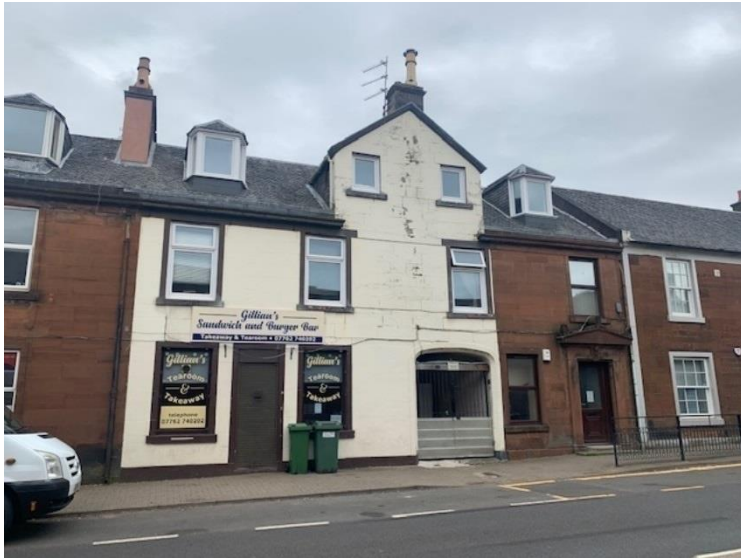
**11 Earl Grey Street**  
 Gillian’s Sandwich + Burger Bar / Residential  
 Ground – occupied  
 First – occupied  
 Second – occupied.

Restrictions	Surveyed from Earl Grey Street only.
Structural Issues	None apparent
Storey Height	2 – mid terrace.
Roof	Pitched roof. Gable dormer plus 1no. hipped dormer. Natural slate with lead ridge. Lead chimney / dormer / parapet flashings. Parapet gutters blocked. Plastic dormer apron flashings.
Chimneys	Red sandstone stack on party wall to l.h.s. 9no. ornate pots -1no. heavily damaged/taped up. 1no. stack on wall head dormer with 1no. pot.
Walls	Painted masonry – requires repainting. 2no. ornate air grilles – over painted. Pend access to rear.
Windows	uPVC.
Doors	Modern glazed timber door. No storm doors.
External Pipework	n/a
<b>Priority Score</b>	<b>(0+2+1) 3</b>

- Carry out minor slate repairs
- Replace heavily damaged terracotta chimney pot
- Replace dormer flashings with lead
- Repaint masonry / ideally remove paint
- Replace windows
- Remove roller shutter
- Install storm doors
- New fascia signage

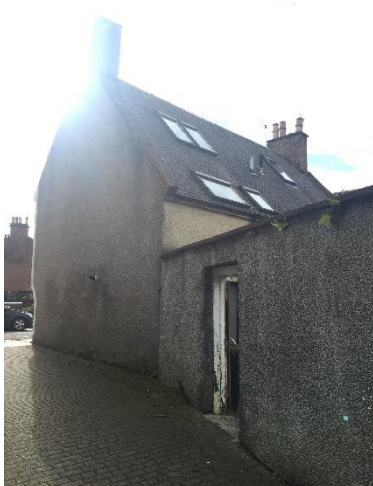
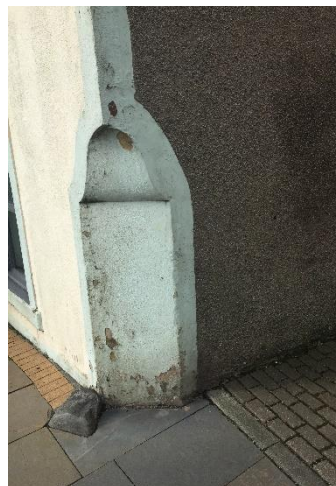
External Pipework Cast iron cutter. uPVC downpipe.

- Check chimney stability
- Carry out minor slate repairs
- Replace flashings and skews
- Remove cementitious render, repoint and re-render with a lime based product
- Remove paint from window and door surrounds
- Replace windows
- Replace door
- Replace uPVC rainwater goods with CI

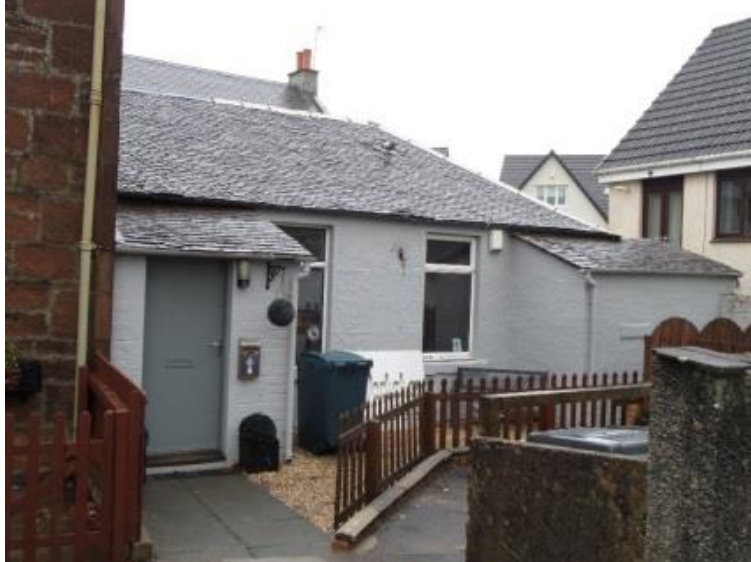
**19 High Street**  
The Workshop

Restrictions	Surveyed from High Street only.
Structural Issues	None apparent.
Storey Height	1 – semi-detached.
Roof	Natural slate with zinc ridge and clips. Lead abutment flashing. Zinc hip flashing.
Chimneys	n/a
Walls	Painted masonry and painted brick porch and extension. Masonry in good condition.
Windows	2no. uPVC
Doors	Modern painted door blank. Ironmongery not of note.
External Pipework	Cast iron half round gutter to main building. uPVC gutters and downpipes to porch extension.

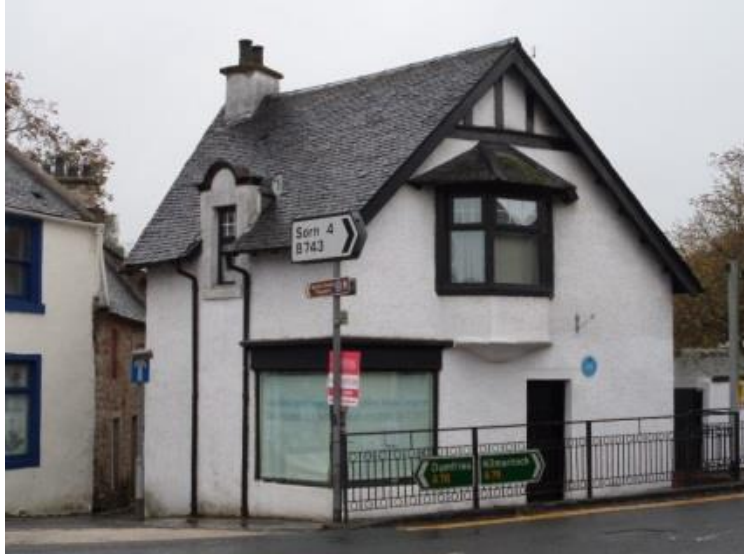
**1 Kilmarnock Road**  
Mauchline Dental Surgery

Ground – occupied First – occupied
Restrictions	Surveyed from Kilmarnock Road / Castle Street only.
Structural issues	None apparent
Storey Height	1.5 – end terraced.
Roof	Natural slate with zinc ridge and clips. Lead parapet flashings.
Chimneys	Rendered chimney with 2no. pots
Walls	Wet dash render.
Windows	Timber casements with uPVC astragals at first floor level.
Doors	Panelled timber storm doors
Shopfronts	Timber shopfront with fascia.
External pipework	Cast iron half round gutter with cast iron circular downpipes. Small section of cast iron to one side. No gutter on first floor projecting bow window. Section of gutter loose alongside Castle Street

- Carry out minor slate repairs
- Repaint render
- Replace windows
- Refurbish storm doors
- Paint shopfront
- New hanging sign
- Resecure gutter adjacent to Castle Street

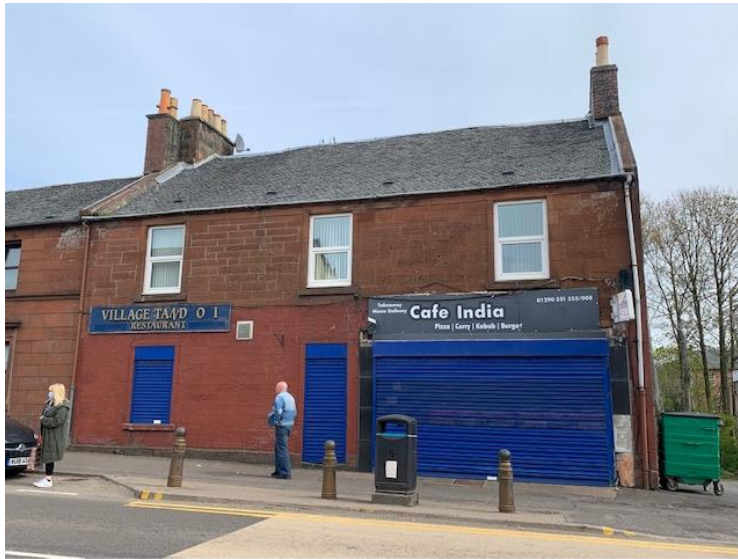
**4-6 Kilmarnock Road**  
Café India / Village Tandoori / Residential

Storey Height  
Roof  
2 – end terraced.  
Natural slate with zinc ridge and clips. uPVC roof vents. Part lead skews / part mortar.

Chimneys  
1no. stone chimney to l.h.s

- Carry out minor slate repairs
- Replace mortar skeews
- Carry out structural inspection & any recommended remedial repairs
- Remove paint from masonry
- Replace uPVC windows (including ground left)
- Remove external security shutters
- Install internal security shutters
- Install new storm door
- Install new shopfront
- Install new full length timber fascia and signage
- New hanging signs (x2)
- Replace uPVC gutter with CI
- Replace uPVC section of downpipe with CI and refurbish remaining CI downpipe

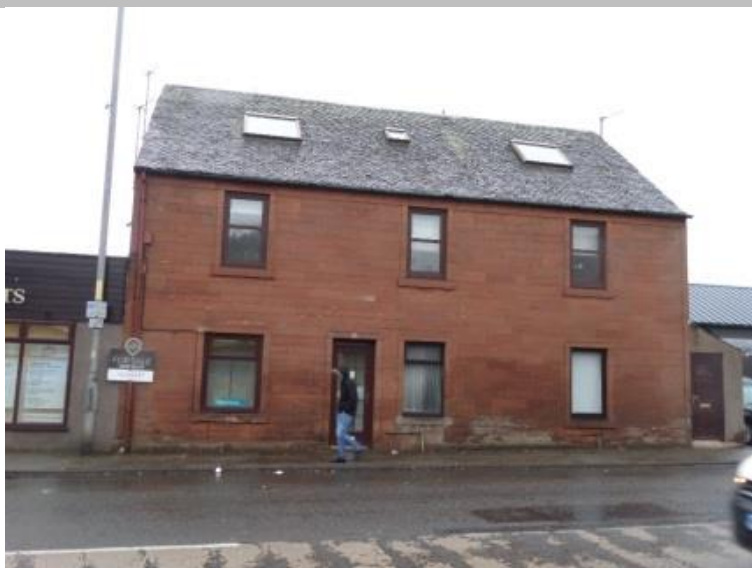
### 7-9 Kilmarnock Road

Ground – occupied First – occupied Second – uncertain
Restrictions	Surveyed from Kilmarnock Road and Castle Street.
Structural Issues	None apparent
Storey Height	2 – end terrace.
Roof	Natural slate with zinc ridge and clips. 3no. modern rooflights
Chimneys	n/a
Walls	Red sandstone. Concrete cill where door blocked up needs repointing. Damaged cill to l.h.s. Heavy erosion below window on r.h.s. damaged corner stones. 1no. partially hidden modern vent.
Windows	1no. uPVC and 2no. timber casements at ground floor level. uPVC at first floor level.
Doors	2no. uPVC doors
External Pipework	uPVC gutter with cast iron

- Carry out minor slate repairs
- Replace concrete cill with stone cill
- Replace stone cill to l.h.s
- Carry out stone repairs below cill line and repoint
- Replace modern vent
- Replace windows
- Replace doors (2no.)
- Replace uPVC gutter with CI
- Refurbish CI downpipe

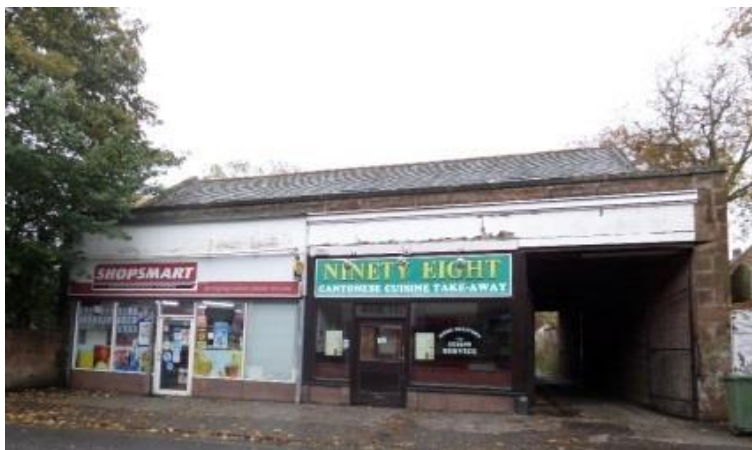
**4-6 Loudoun Street** Occupied  
Shopsmart Convenience Store / Ninety-Eight Cantonese Takeaway

Restrictions	Surveyed from Loudoun Street only.
Structural issues	None apparent
Storey Height	1 - standalone
Roof	Natural slate with red clay ridge tiles. Lead skews. 3no. former rooflights sheeted over with corrugated iron.
Chimneys	n/a
Walls	Damage to red sandstone to r.h.s of pend.
Shopfronts	Modern timber shopfront to r.h.s. Aluminium shopfront with external shutters to l.h.s. Granite stall risers.
External Pipework	Parapet gutter

- Slate over 3no. former roof lights and carry out minor slate repairs generally
- Replace leadwork to parapet gutter
- Repair sandstone pillar to r.h.s. of pend
- Remove external security shutters
- Install new shopfronts
- Install full length timber fascia and signage

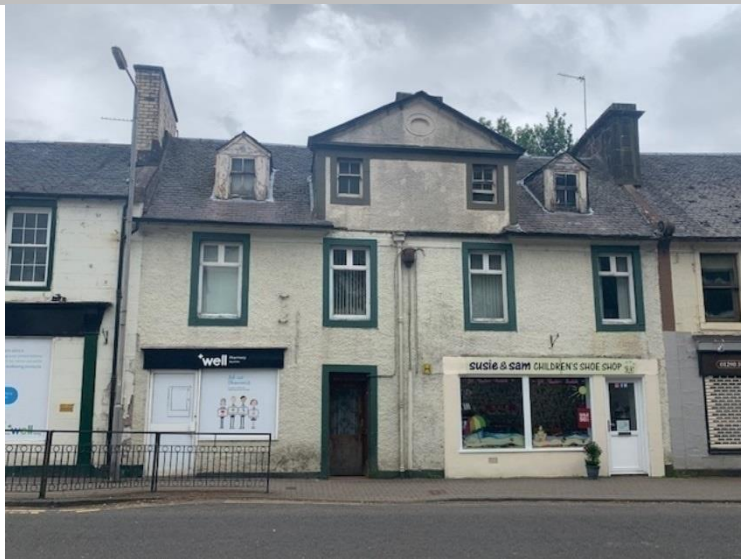
**5-7 Loudoun Street**

Category B Listed	Ground – occupied First – occupied Second – occupied
Restrictions	Surveyed from Loudoun Street only.
Structural Issues	No issues apparent.
Storey Height	2.5 – mid terraced with wall head gable and 2no. gabled dormers.
Roof	Natural slate with zinc ridge and clips. Mortar skews. Lead flashings to dormers. The dormers have timber surrounds and 2 over 2 sash & case windows in poor condition. Slated cheeks.
Chimneys	Stone chimney on party wall to r.h.s. No pots. Brick chimney to party wall on l.h.s. No pots.
Walls	Wet dash. Requires repainting.

Windows	Damage where section of gutter has been removed. 1no. modern grille below florist window. Modern timber casements at first floor. Timber sash & case in dormers.
Doors	Aluminium door to Pharmacy. Modern half glazed blank to flats. uPVC door to Florist.
Shopfronts	Timber shopfront, modern fascia to shoe shop. Aluminium shopfront, traditional fascia to Pharmacy.
External Pipework	Cast iron half round gutter. Cast iron downpipe with hopper. Gutter needs refurbished.

- Carry out minor slate repairs
- Replace mortar skews
- Replace dormer timbers
- Make render repairs and repaint render
- Replace modern grille
- Refurbish timber sash and case windows
- Replace modern timber casements
- New modern fascia to show shops

- New timber fascia above florist with new signage (r.h.s shop unit only)
- New hanging sign
- Reinstall missing section of CI gutter
- Refurbish CI rainwater goods
- Tidy up and consider re-locating electrical boxes, and associated cabling.

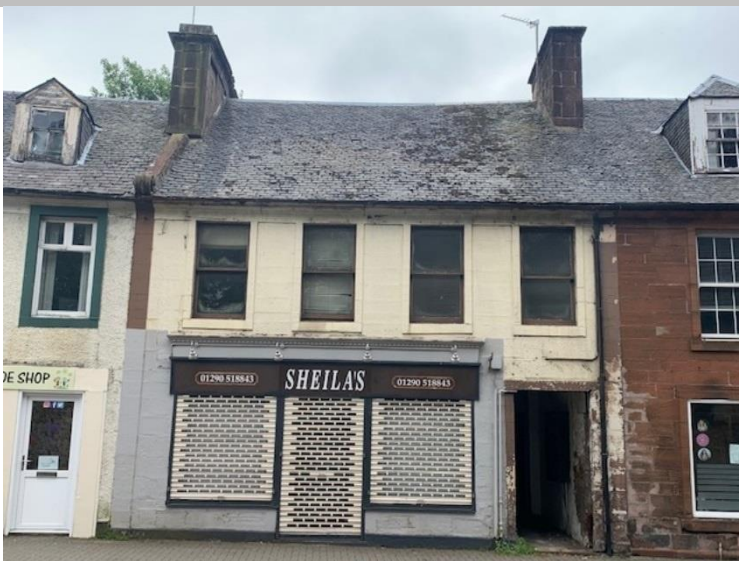
**9-11 Loudoun Street**  
Sheila's / Residential

Category B Listed	Ground – vacant First – vacant (Dangerous buildings notice to first floor flat)
Restrictions	Surveyed from Loudoun Street only.
Structural Issues	None apparent.
Storey Height	2 – mid terraced.
Roof	Natural slate with zinc ridge and clips. Mortar skewes.
Chimneys	Stone stack on party wall to l.h.s., no pots. Stone stack on party wall to r.h.s., 1 pot.
Walls	Painted ashlar. Requires repainting. Scrolled skew putts. Pend access to flats above.
Windows	4no. timber sash and case at first floor level.
Doors	Glazed timber. Door to close missing.
Shopfronts	Timber shopfront. External grilles. Dentil moulded cornice to timber fascia.
External Pipework	Cast iron half round gutter - requires repainting – connecting into

shared uPVC down pipe.

- Carry out minor slate repairs
- Replace mortar skewes
- Repaint stonework
- Refurbish timber sash and case windows
- Remove external grilles
- Install internal security grilles
- Repaint shopfront and fascia
- New fascia signage
- New hanging sign
- Refurbish CI rainwater goods

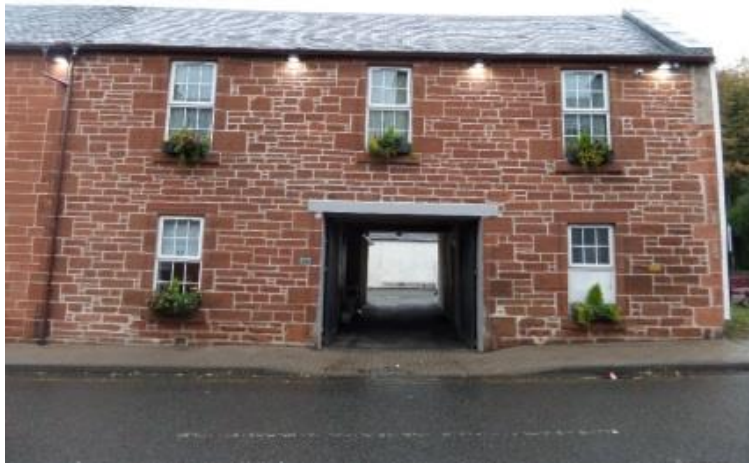
**12 Loudoun Street**  
Fairburn Hotel

Restrictions	Surveyed from Loudoun Street and car park access road only.
Structural Issues	None apparent.
Storey Height	2 – semi-detached.
Roof	Modern slate with lead ridge and clips. Lead covered straight skew.
Chimneys	n/a
Walls	Squared red sandstone rubble walls. Walls and

pointing appear generally in good condition. Dry dash over cladding to gable end. 1no. decorative iron grille. Central pend to rear court.
Windows	uPVC, 1no. with uPVC blind panel.
Doors	Timber vertically lined doors to pend.
External Pipework	uPVC profiled gutter and shared uPVC downpipe.

- Remove drydash render, repoint and re-render with lime based product.
- Replace windows
- Replace uPVC rainwater goods with CI

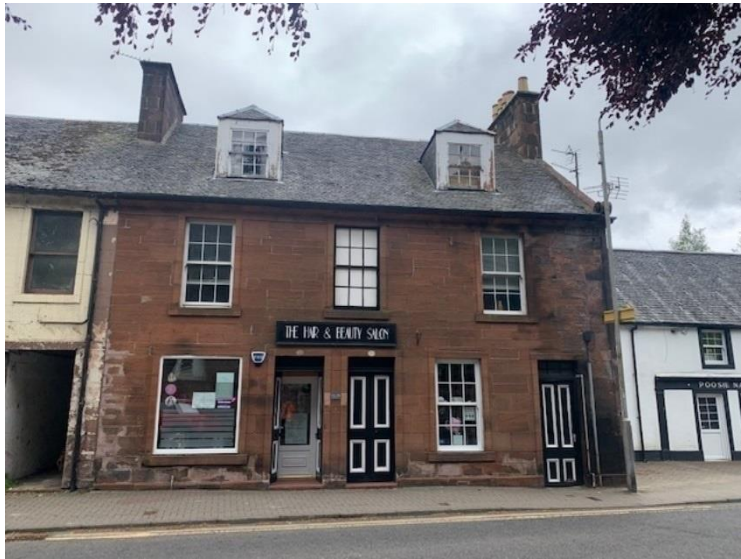
Chimneys	Red sandstone chimneys on party wall and gable wall. 1no. pot to l.h.s. 5no. pots to r.h.s.
Walls	Red ashlar sandstone. Masonry erosion at far gutter end and at ground level. Some plastic repairs. Pick pointing required. Damp staining around shopfront. 2no. modern terracotta air bricks. Pend access to flat above.
Dormers	2 gabled dormers with 6 over 6 timber sash & case windows. Windows and timber surrounds in poor condition. Slated cheeks.
Windows	1 blind opening at first floor level. uPVC at first floor. Timber sash & case (6x6) in dormers.
Doors	2no. sets panelled timber storm doors. Panelled timber door to pend – requires refurbishment.
Shopfronts	uPVC shopfront.
External Pipework	uPVC deep flow gutter. Shared uPVC downpipe.
<b>Priority Score</b>	<b>(2+2+2) 6</b>

- Carry out minor slate repairs
- Replace mortar skewes
- Carry out localised stone repairs and repointing
- Replace modern air bricks
- Replace dormer timbers
- Replace ground & first floor windows
- Refurbish dormer windows
- Replace shopfront
- Replace uPVC rainwater goods with CI

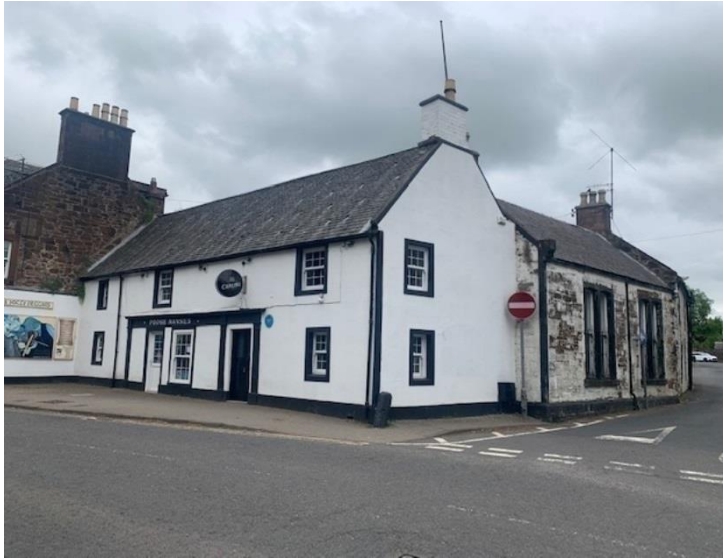
**21 Loudon Street**  
Poosie Nansie's Ale House

Restrictions	Surveyed from Loudoun Street / Cowgate only.
Structural Issues	Deviations in roof line to rear
Storey Height	2 – end terrace returning on to Cowgate single storey, stepping back up to 2-storey on Cowgate.
Roof	Slate with zinc ridge and straps. Lead soakers / vents to Loudoun Street side. Lead skew flashings & mortar skewes.
Chimneys	Rendered chimney on corner with 1 pot. Stone chimney to Cowgate l.h.s with 1 pot. Central stone chimney on Cowgate with 3 pots.
Walls	Painted render to Loudoun Street. Painted masonry to Cowgate. Areas of damp from defective rainwater goods.
Windows	uPVC to Loudoun Street Timber sash and case to Cowgate.
Doors	uPVC to Loudoun Street. Modern timber storm doors. Modern timber to Cowgate.
External Pipework	Cast iron gutters and downpipes
<b>Priority Score</b>	<b>(2+3+3) 8</b>

- Remove soakers / roof vents and relocate
- Carry out minor slate repairs
- Replace missing ridge flashing to Cowgate side
- Replace mortar skewes

- Remove cement render, repoint, re-render with lime-based material, carrying out stone repairs where necessary.
- Remove paint from masonry.
- Replace windows
- Replace doors
- Refurbish CI rainwater goods, replacing uPVC.
- Add new downpipe to Cowgate elevation
- Replace signage.

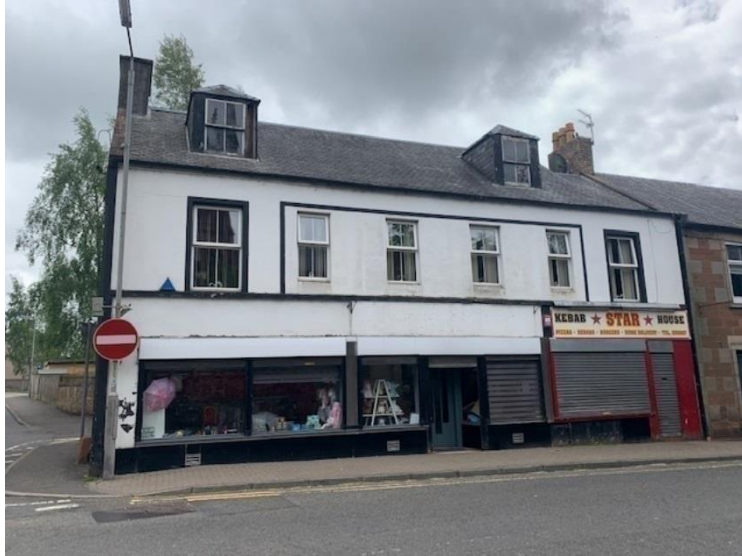
**23/23a-25 Loudoun Street**  
 Blu Design / Residential

Ground – occupied First – occupied Second – uncertain
Restrictions	Surveyed from Loudoun Street only.
Structural Issues	None apparent.
Storey Height	2 – end terrace with 2no. hipped dormers.
Roof	Natural slate with zinc ridge and clips. 1no. mortar skew to l.h.s. 2no. lead skewes. Lead flashing to dormers and chimneys.
Chimneys	Rendered chimney to l.h.s. No pots. Brick chimney on party wall to r.h.s with 3no. pots.
Walls	Render is in an acceptable condition. Security shutters down. 1no. large fascia over 3 units. 3no. modern air grilles
Dormers	2no. gabled dormers with 2 x 2 timber sash & case windows and timber surrounds in poor condition. Slated cheeks.
Windows	uPVC to first floor. 2x2 timber sash & Timber 2x2 sash and case in dormers.
Doors	Modern timber to commercial property
Shopfronts	Timber. uPVC sign to r.h.s.
External Pipework	uPVC gutter and downpipe

- Carry out minor slate repairs
- Replace mortar skewes
- Repair / repaint dormer timbers
- Paint render
- Replace modern grilles
- Replace uPVC windows
- Refurbish dormer timber sash and case windows
- Remove external roller shutters
- Replace shop fronts
- Install full length timber fascia and signage
- New hanging signs (x2)
- Install internal security grilles
- Replace uPVC rainwater goods with CI

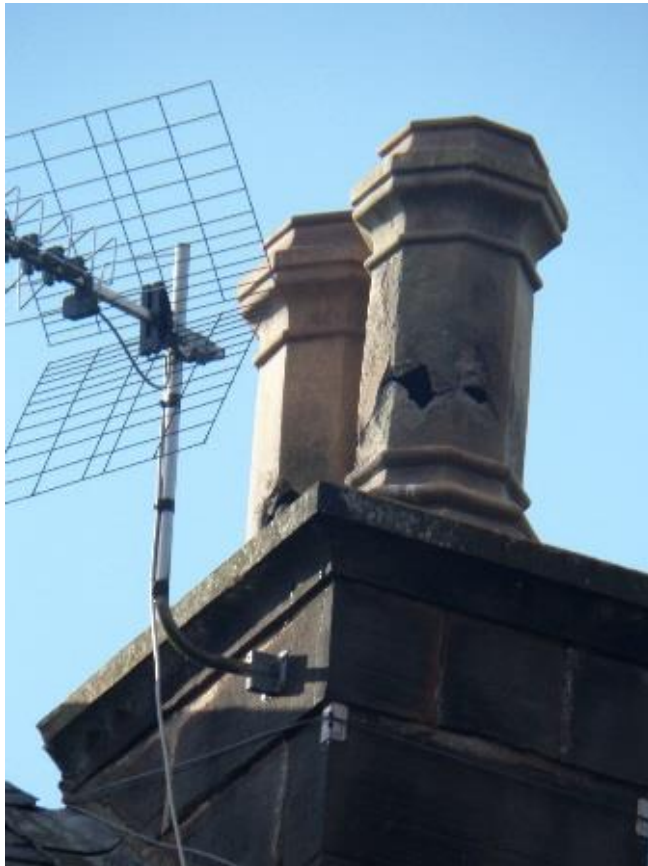
**27-31 Loudoun Street**  
Commercial / Residential

Ground – vacant First – occupied
Restrictions	Surveyed from Loudoun Street only
Structural Issues	None apparent
Storey Height	2 - mid terrace.
Roof	Natural slate with zinc ridge and clips. 1no. mortar skews. Lead chimney flashing. 1no. copper skew putt flashing. Section of mortar skew missing.
Chimneys	Brick chimney with 3no. pots to party wall on l.h.s. Stone chimney with 2no. damaged pots to r.h.s.
Walls	Red ashlar sandstone with blonde sandstone quoins. Partially rendered. 1no. dropped lintol to l.h.s. window at first floor level. Masonry in reasonable condition. Some heavy mortar repairs around downpipe connection. Some low-level staining

and erosion of render. 2no modern louvered air grilles.
Windows	uPVC
Doors	Modern timber glazed door
Shopfronts	Modern timber shopfronts. Doorway appears to have been reduced in size. Modern fascia's.
External Pipework	uPVC gutter. Cast iron downpipe requires refurbishment.

- Carry out minor slate repairs
- Replace mortar skew
- Replace damaged chimney pots
- Carry out localised stone repairs
- Replace modern grilles
- Replace shopfronts and door
- Replace uPVC gutter with CI
- Refurbish CI downpipe

- New fascia signage

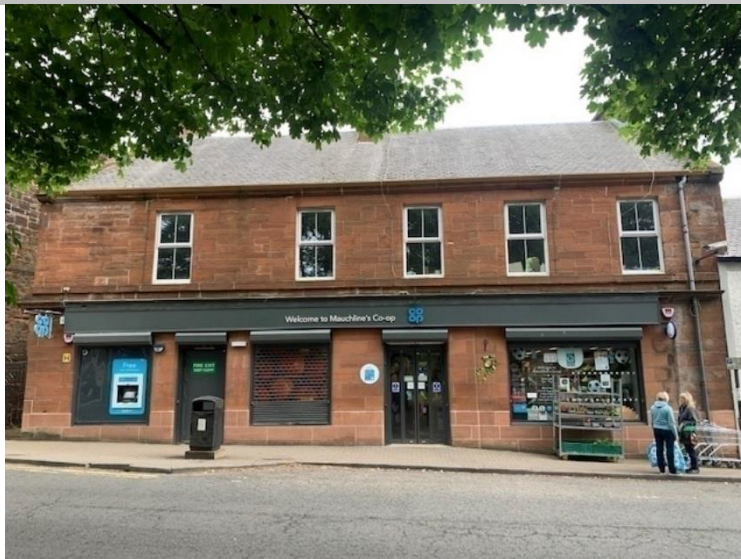
### 43-51 Loudoun Street The Co-op / Residential

Ground – occupied First – about to be split into flats.
Restrictions	Surveyed from Loudoun Street only
Structural Issues	None apparent
Storey Height	2 – end terrace.
Roof	Natural slate roof with zinc ridges and clips. Lead chimney flashings / mortar skewes.
Chimneys	3no. red sandstone stacks. No pots
Walls	Red ashlar sandstone. Masonry is heavily eroded at base course. Staining at either end of gutter

and at downpipe. ATM.
Windows	uPVC at first floor
Doors	Bi-fold aluminium entrance door. Painted blank escape door.
Shopfronts	External security shutters. Timber shopfronts and fascia. Bi-folding aluminium doors
External Pipework	Cast iron wall head gutter and downpipe.

- Carry out minor slate repairs
- Replace mortar skewes
- Carry out stone indenting below cill line for full length of elevation
- Remove external shutters
- Install internal security shutters
- New hanging sign (1no.)
- Replace escape door
- Refurbish CI rainwater goods

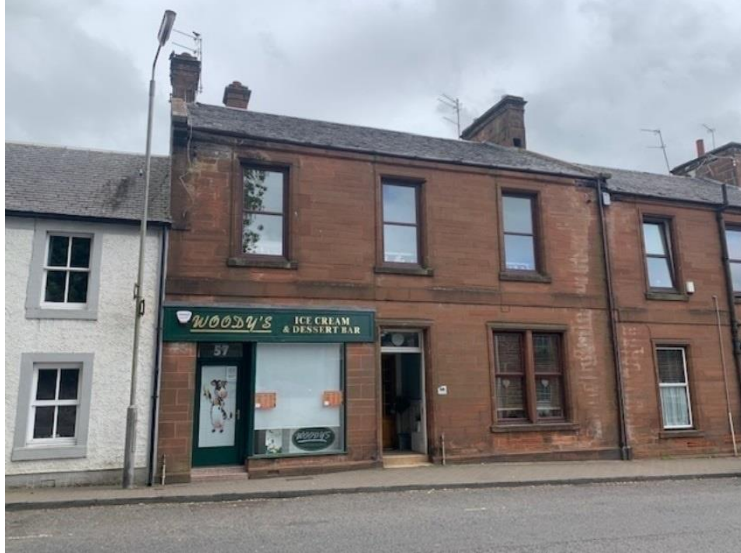
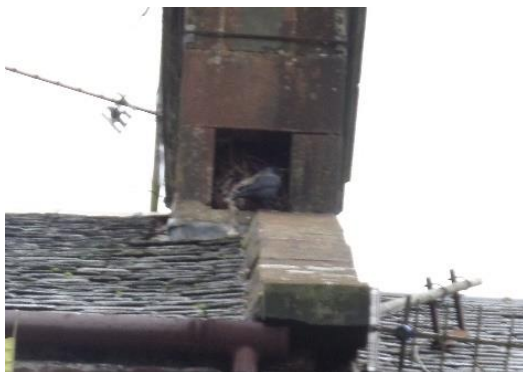
### 57-59 Loudoun Street

Ground – occupied  
First – occupied

Restrictions Surveyed from Loudoun Street only

Chimneys Red sandstone chimneys at each end. 1 no pot to l.h.s. Additional chimney evident at rear. Stone missing from stack on r.h.s.

#### Recommendations:

- Carry out minor slate repairs
- Replace mortar skews
- Replace missing stone to stack
- Carry out localised stone repairs and repointing
- Replace modern grille
- Replace uPVC windows
- Refurbish storm doors and fanlight
- Replace uPVC rainwater goods with CI

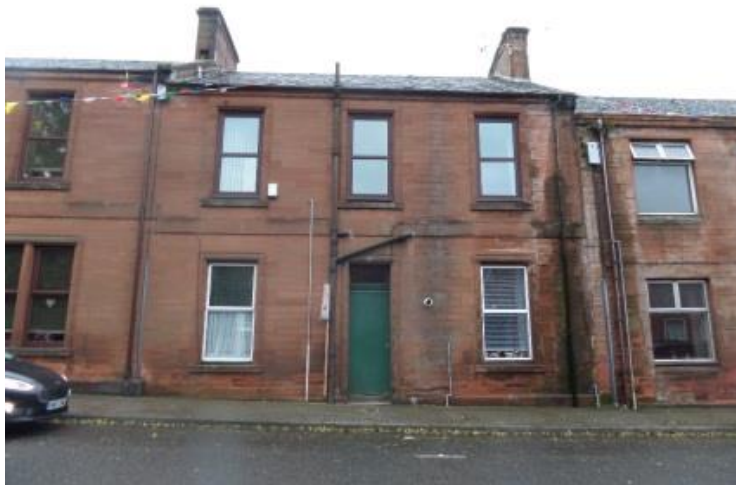
**61 Loudoun Street**  
Residential

Restrictions	Surveyed from Loudoun Street only
Structural Issues	None apparent
Storey Height	2 – mid terraced.
Roof	Natural slate with zinc ridge and clips. uPVC vents. Lead / mortar skew, lead chimney flashings
Chimneys	Red sandstone chimneys at each party wall. 1no. pot to r.h.s. No. pots to l.h.s. Stone missing from stack on l.h.s.
Walls	Red ashlar sandstone. Masonry erosion at ground level. Heavily stained, water damaged due to defective downpipe at r.h.s. 1no. cast iron grille.
Windows	uPVC
Doors	Modern painted blank with fanlight. No ironmongery of note.
External Pipework	Cast iron half round gutter. Cast iron vent stack and

cast iron rain water pipe to r.h.s. defective.

**Recommendations:**

- Carry out minor slate repairs
- Replace mortar skew
- Replace missing stone to stack (see 57-59 Loudoun Street)
- Carry out localised stone repairs and repointing
- Replace uPVC windows
- Replace door and fanlight
- Refurbish / repair CI rainwater goods

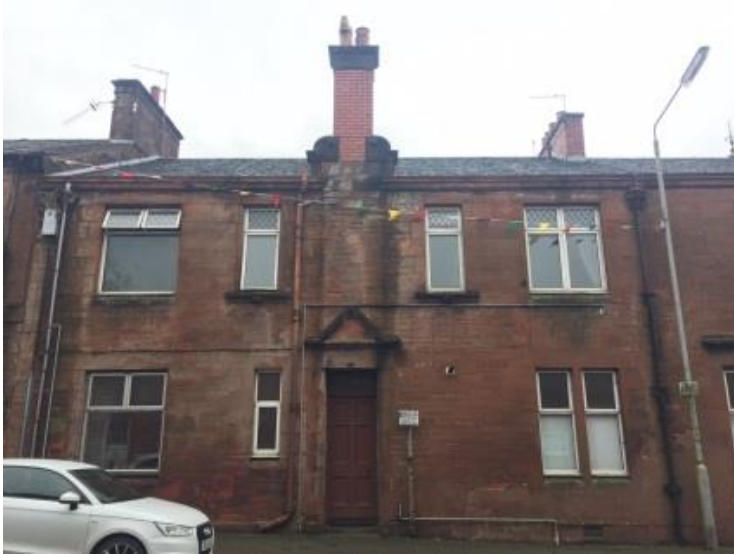
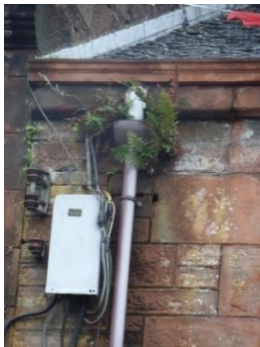
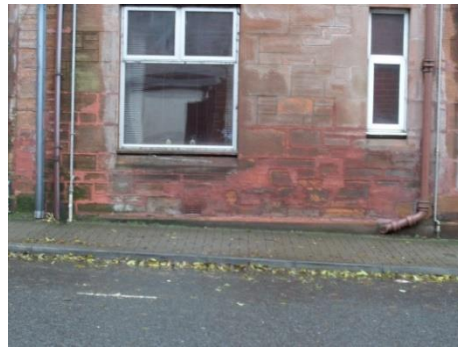
**63 Loudoun Street**  
Residential

**Walls** Squared rugged red sandstone. Significant damage from defective rain water goods. Heavy over pointing at ground level particularly at gutter ends and shared downpipe. 1no. modern aluminium grille and 1no. ornate cast iron grille.

**Recommendations:**

- Carry out minor slate repairs
- Carry out localised stone repairs and repointing
- Reinstall stone mullions
- Replace modern grille
- Replace windows
- Refurbish door and fanlight
- Refurbish CI rainwater goods
- Replace uPVC section with CI

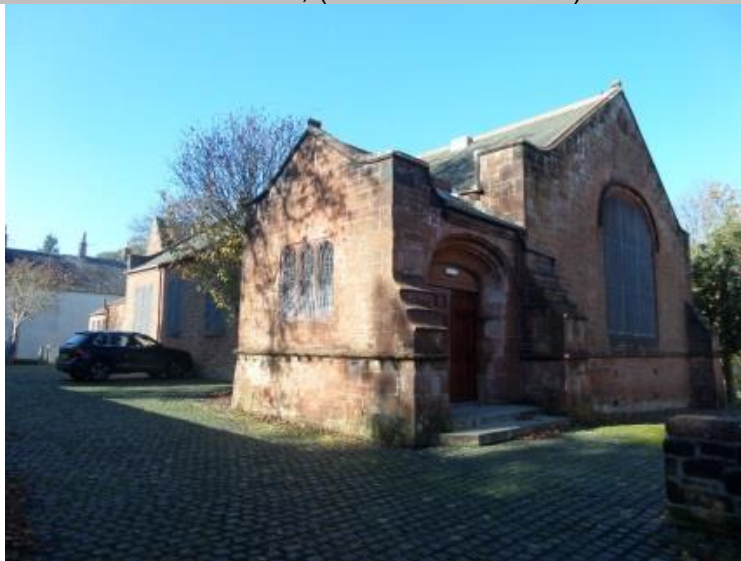
Mauchline Church Hall, (Site of Mortons Inn)

Restrictions	Full access
Structural Issues	None apparent
Storey Height	1 – standalone.
Roof	Natural slate roof with crested red terracotta ridge tiles with some missing. Mitred hip to rear. 2no. roof vents (Over sheeted?) Mortar skew to main hall. Lead valleys, copper flashings to rear vent.
Chimneys	Stone chimney to rear of main hall. 1no. pot
Walls	Squared red sandstone

<p>predominantly. Ashlar to rear. Masonry heavily overpainted in places / missing pointing. Erosion on entrance gablet. Repointing required around entrance. Some damage due to hard pointing. Modern air grilles/ eroded cast iron air grilles.</p>
Windows	<p>Modern timber to Fellowship / Dunlop Halls. Georgian wire glass in stone surrounds to main hall. Window grilles with ferrous fixings into stone.</p>
Doors	<p>Soffits and fascia on rear extension require painting. Panelled main doors – good condition</p>
External Pipework	<p>Cast iron downpipes/ uPVC gutters to main hall. Cast iron/uPVC at entrance. uPVC downpipe to side of main hall. Overgrown cast iron gutters &amp; downpipes on 1990's extension. Need refurbishment. Damage to cast iron downpipe at rear door. uPVC gutter/cast iron gutter to rear entrance/kitchen.</p>
<b>Priority Score</b>	<b>(0+3+1) 4</b>

**Recommendations:**

- Carry out minor slate repairs
- Replace missing ridge tiles
- Replace mortar skews
- Repoint
- Carry out localised stone repairs
- Replace modern / damaged grilles
- Replace ferrous fixings to window grilles
- Repaint timber fascia's / soffits to rear extension
- Refurbish main doors
- Refurbish CI rainwater goods
- Replace uPVC rainwater goods with CI

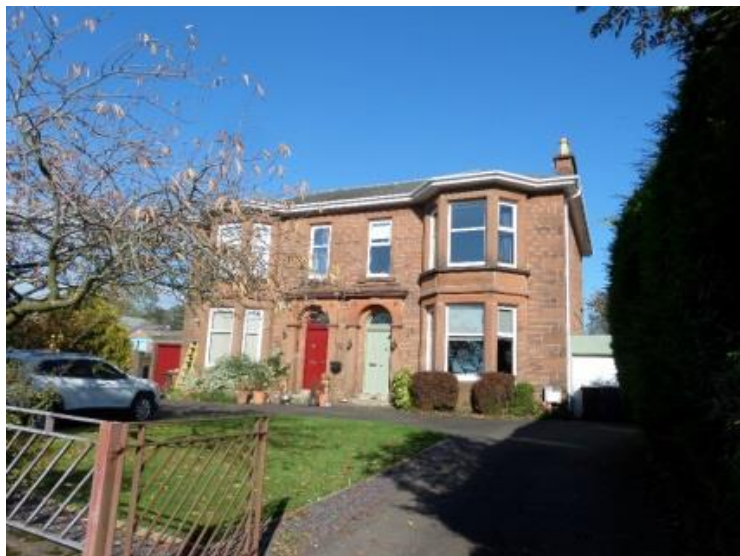
**1-3 Tanfield**  
Residential

Restrictions	Restricted visibility due to driveways.
Structural Issues	None apparent
Storey Height	2 – 2 semi-detached properties.
Roof	Natural slate with zinc ridges and clips. Lead chimney and valley flashings.
Chimneys	Red sandstone stack to r.h.s. with 4no. ornate pots.
Walls	Red ashlar sandstone. Masonry in good condition. Air bricks not visible.
Windows	2 storey bay windows. uPVC. Modern Velux to r.h.s.
Doors	Vertically lined timber storm doors each with semi-circular fan light.
External Pipework	uPVC gutters and downpipes.
<b>Priority Score</b>	<b>(0+2+1) 3</b>

**Recommendations:**

- Minor slate repairs
- Replace windows
- Refurbish storm doors
- Replace uPVC rainwater goods with CI
