# **Mauchline Conservation Area Management and Maintenance Plan**

**Gazetteer**

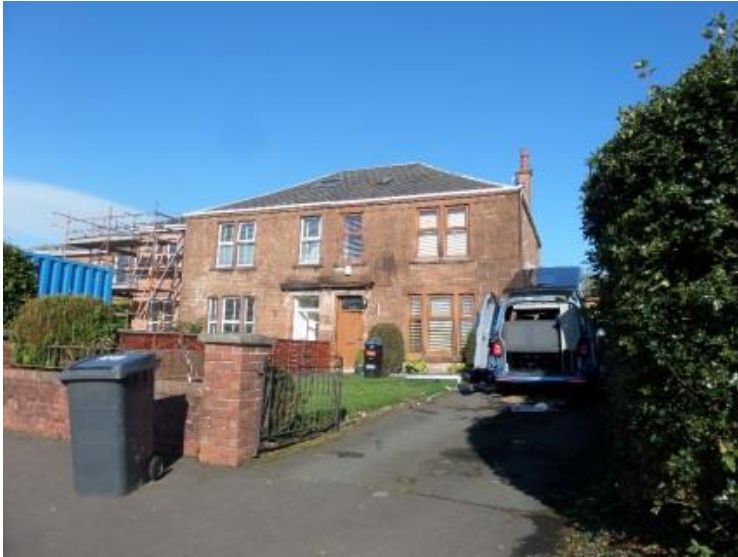
Restrictions	Restricted visibility due to driveways.
Structural Issues	None apparent.
Storey Height	2 – 2 semi-detached.
Roof	Natural slate with zinc ridges and clips. Lead chimney flashings.
Chimneys	Red brick chimney to r.h.s. with 1no. pot.
Walls	Red ashlar sandstone. Masonry appears in good condition. Air bricks not

Windows	visible. uPVC. 1no. modern Velux and 1no. cast iron roof light
Doors	uPVC
External Pipework	uPVC
<b>Priority Score</b>	<b>(0+2+1) 3</b>

**Recommendations:**

- Minor slate repairs
- Refurbish CI roof light
- Replace windows
- Replace doors
- Replace uPVC rainwater goods with CI

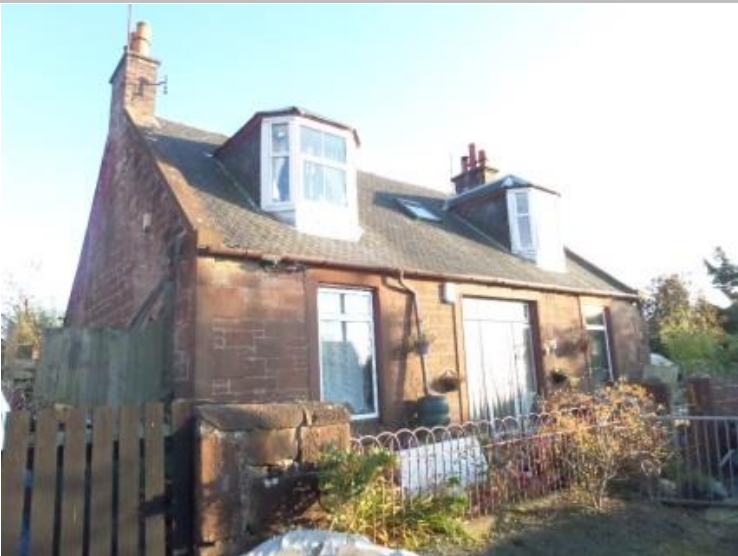
**6-8-10 Tanfield** Occupied  
Residential

elevation in reasonably good condition. Heavy erosion and over pointing on gable. Air bricks not visible.
Dormers	uPVC windows. Hipped slate roofs and slated cheeks. Timber below windows requires refinishing.
Windows	uPVC windows and dormer window. Modern Velux.
Doors	Aluminium door, side lights and fan light.
External Pipework	uPVC gutters and downpipes (2no.). Water butt
<b>Priority Score</b>	<b>(0+2+2) 4</b>

**Recommendations:**

- Minor slate repairs
- Replace mortar skewes

- Make stone repairs and repoint gable
- Repaint / repair dormer timbers
- Replace windows
- Replace door and fanlight
- Replace uPVC rainwater goods with CI

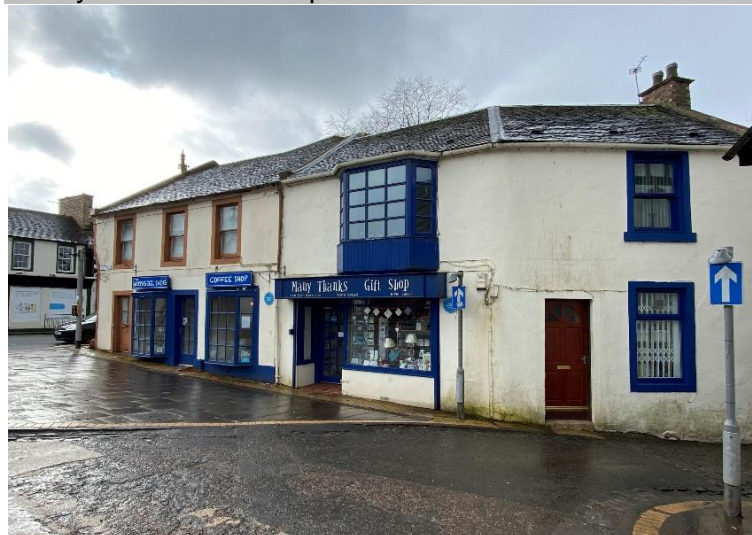
Many Thanks Gift Shop / Residential

Doors	Modern glazed door to gift shop. Panelled timber door to Flat 3a.
Shopfronts	Timber shopfront with fascia. Recessed doorway. External security shutter.
External Pipework	uPVC gutter. uPVC downpipe discharging into gutter of adjoining property.

**Recommendations:**

- Carry out minor slate repairs
- Replace mortar skew
