Mauchline Conservation Area Management and Maintenance Plan

Gazetteer

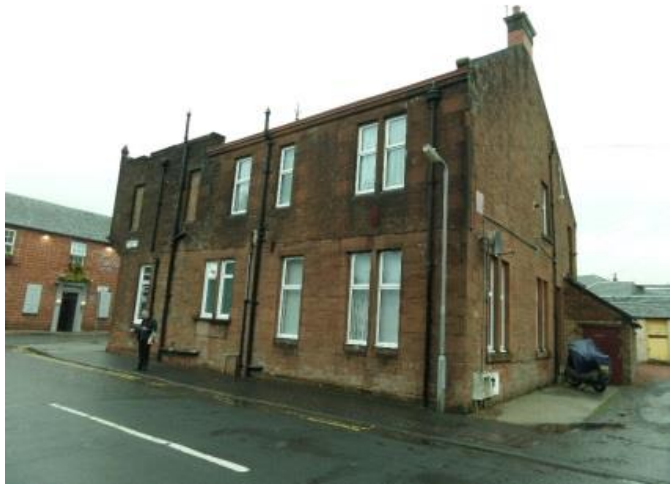
1 Barskimming Road

Ground – occupied First – occupied
Restrictions	Surveyed from Barskimming Road only.
Structural Issues	None apparent.
Storey Height	2 – end terrace.
Roof	Pitched natural slate with straight skewes. Small section of lead flat roof at ridge. Cast iron roof light. Lead skew flashings and chimney flashing.
Chimneys	Red brick chimney to r.h.s with stone top section with 3no. terracotta pots.
Walls	Red ashlar sandstone. Masonry requires pointing below cill line. 3no. ornate cast iron air grilles
Windows	uPVC
Doors	n/a
External Pipework	Cast iron wall head gutter. Cast iron downpipe with ornate hopper. Lower section is uPVC. Cast iron vent stack.
Priority Score	(0+2+2) 4

Recommendations:

- Minor slate repairs
- Refurbish cast iron roof light
- Refurbish CI rainwater goods
- Replace uPVC lower section of downpipe with CI to match existing
- Repoint stonework below cill line

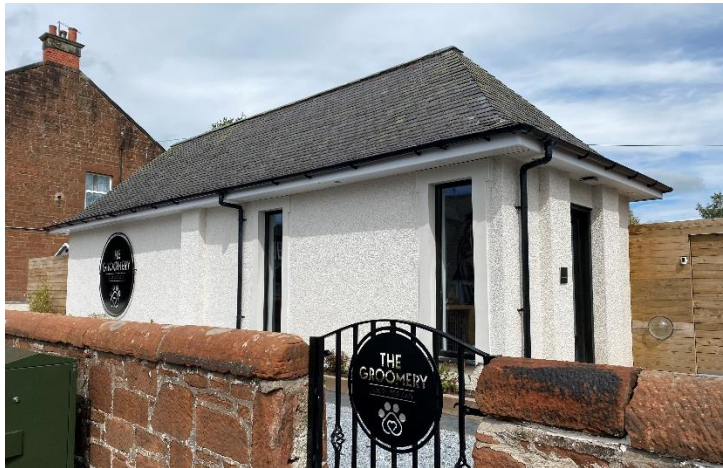
1a Barskimming Road

Restrictions	Surveyed on all elevations.
Structural Issues	None apparent.
Storey Height	1 – detached
Roof	Natural slate with close mitred hips. Concrete ridge tiles. Timber fascia's and soffits.
Chimneys	n/a
Walls	Wet dash render in

Windows	good condition
Doors	uPVC.
External Pipework	Modern painted blank.
	uPVC gutter and downpipes.

Recommendations:

- Minor slate repairs
- Refurbish windows
- Replace door
- Replace uPVC gutters and downpipes with CI

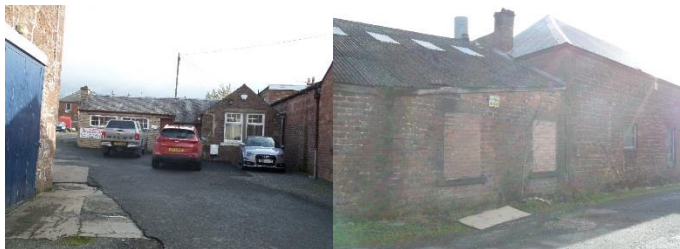
Restrictions	Surveyed from fence line on Barskimming Road only
Structural Issues	None apparent
Storey Height	1
Roof	Predominantly profiled metal sheets. Natural slate with zinc ridge and clips to the rear. Possible asbestos roof?

Recommendations:

- Make minor slate repairs to rear extension
- Replace windows
- Refurbish existing CI rainwater goods
- Install new CI rainwater goods
-

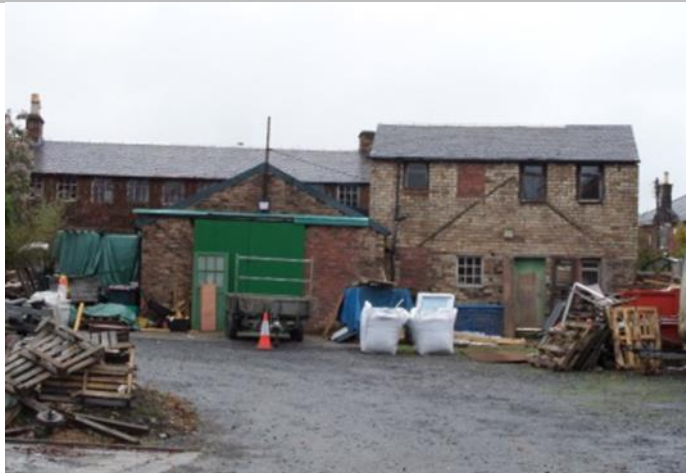
17 Barskimming Road

Chimneys	Red brick. No pots.
Walls	Original building red sandstone rubble. Later extensions in red brick with stone cills and quoins, and buff brick.
Windows	Combination of timber casements and uPVC. A number of blocked up openings.
Doors	Not visible.
External Pipework	Cast iron to the rear. None to the front.

Restrictions	Surveyed from fence line on Barskimming Road only.
Structural Issues	Movement cracks to top right hand corner.
Storey Height	2
Roof	Natural slate with zinc ridge and clips.
Chimneys	None visible
Walls	Buff brick / red brick
Windows	Predominantly modern casement. 1no. 9 paned casement
Doors	Ply door blank
External Pipework	uPVC
Priority Score	(0+1+2) 3

Recommendations:

- Carry out structural inspection & any recommended remedial repairs
- Carry out minor slate repairs
- Repoint brickwork
- Replace windows
- Replace door
- Replace uPVC rainwater goods with CI

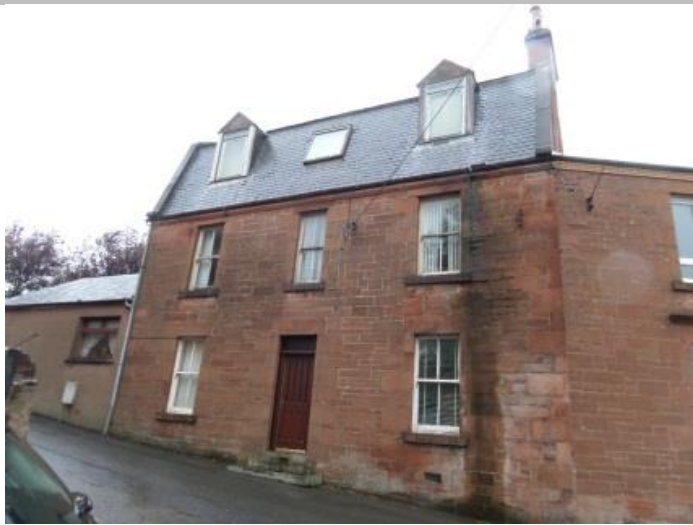
1-3 Burnside Road

Ground – occupied First – occupied Second - unclear
Restrictions	Surveyed from Burnside Road only.
Structural Issues	Cracked cill to bottom l.h. window.
Storey Height	2 – mid terrace.
Roof	Natural slate mansard roof with 2no. gabled dormers. Natural slate. Ridge not visible. Lead dormer flashings. Mortar skews.
Rooflight / Dormers	2no. gable dormers. Timber and windows to dormer in poor condition. Modern rooflight.
Chimneys	Red brick chimney to r.h.s. with 4no. terracotta pots.
Walls	Red squared sandstone rubble. Masonry has heavy staining, damp, moss and vegetation and open joints below damaged gutter. Stone repairs and pointing required below chimney. 3no. ornate cast iron air grilles.
Windows	2x2 timber sash & case windows with horns to ground and first floor level. Need repaired and refurbished.
Doors	Modern timber door with fanlight.
External Pipework	Cast iron half round gutter. Damaged uPVC downpipe.

Priority Score (0+2+2) 4

Recommendations:

- Carry out stone repairs below chimney
- Repoint below chimney
- Carry out minor slate repairs
- Replace mortar skews
- Repair and repaint timber to dormers
- Replace cracked cill
- Repair and refurbish CI gutter
- Replace uPVC downpipe with CI
- Remove vegetation and repoint masonry to r.h.s
- Repair & refurbish timber sash and case windows
- Replace dormer windows
- Replace entrance door and fanlight

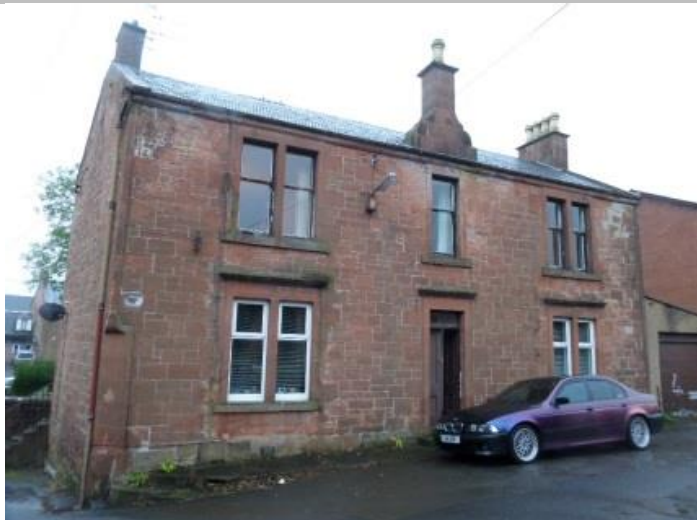
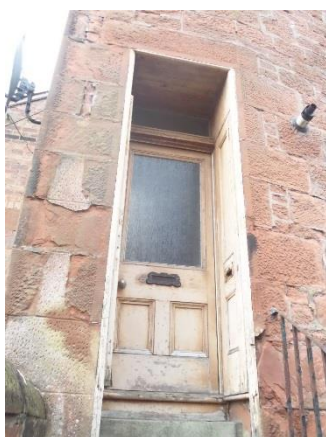
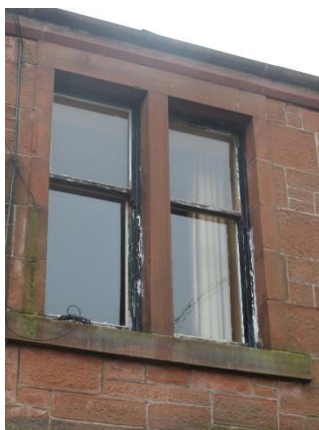
4-6 Burnside Road
Residential

Ground – occupied First – occupied
Restrictions	Surveyed from Burnside Road only.
Structural Issues	None apparent.
Storey Height	2 – detached.
Roof	Pitched roof with straight skewes. Natural slate with zinc ridge and clips. Mortar skewes and lead chimney flashings.
Chimneys	Red ashlar sandstone stack to r.h.s. with 4no. ornamental pots. Stone wall head stack with 1no. ornamental pot. Red brick stack to l.h.s – no pots.
Walls	Red squared sandstone rubble with ashlar window and door surround. Chamfered, corbelled corner Masonry has some signs of erosion, particularly at ground l.h.s. Some pick pointing required. The render has some cement mortar pointing/patch repairs. Significant stone repairs and repointing required on gable. 3no. cast iron air grilles.
Windows	uPVC at ground level. 1x1 timber sash and case windows with horns at first floor level. Refurbishment required.
Doors	No. 4 -Timber storm doors with leaded fanlight. No.6 – Timber storm doors evident but unused.

Priority Score (0+2+2) 4

Recommendations:

- Carry out minor slate repairs
- Replace mortar skews
- Refurbish CI rainwater goods
- Carry out stone repairs and repoint below windows and full gable elevation
- Replace ground floor uPVC windows
- Refurbish 2no. sets storm doors

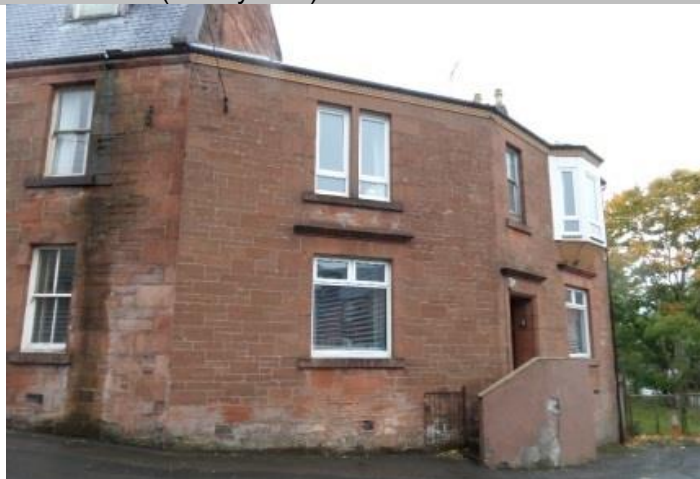
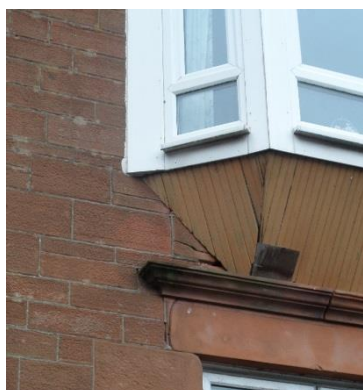
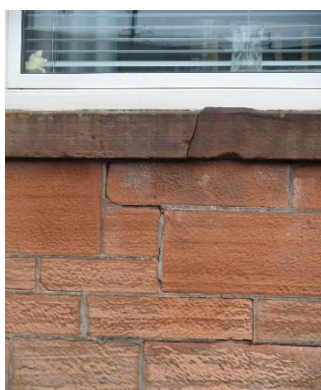
5-7 Burnside Road Residential (Thonyburn)

Restrictions	Ground – occupied First – occupied
Structural Issues	Surveyed from Burnside Road only. Cracking/ damaged lintol at oriel window. Cracked cill to r.h.s of ground floor window and below ground floor window.
Storey Height	2 – end terrace.
Roof	Natural slate with zinc ridge and clips. Lead abutment flashing and chimney flashing. Mortar skew.
Chimneys	Red brick chimney to r.h.s. with 2no. ornamental pots.
Walls	Red sandstone. Cement mortar pointing. Timber dentil moulded cornice at wall head. 3no. ornate air grilles.
Windows	1no. 1x1 timber sash & case window with horns at first floor level. Refurbish. All other windows are uPVC.
Doors	Modern timber vertically lined storm doors.
External Pipework	uPVC gutters and downpipes. Gutter blocked.

Priority Score (0+1+1) 2

Recommendations:

- Carry out minor slate repairs
- Replace mortar skew
- Carry out structural inspection & any recommended remedial repairs
- Replace cracked cills and lintols
- Repoint
- Refurbish timber sash and case window
- Replace uPVC windows
- Replace door
- Replace uPVC gutters and down pipes with CI

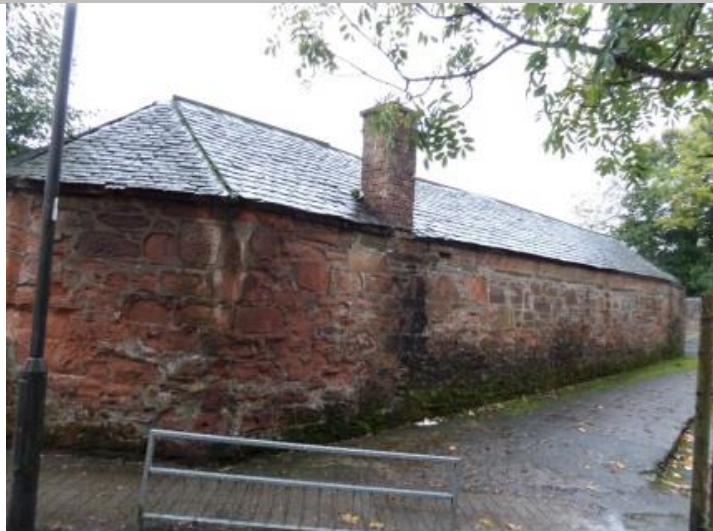
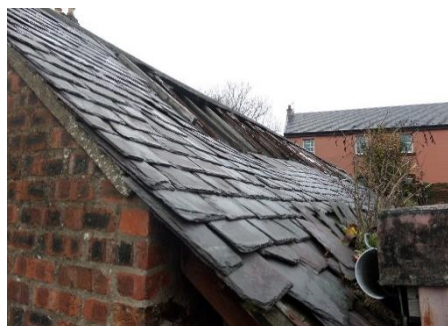
Burnside Road Outhouse

Restrictions	Vacant – partially derelict
Structural Issues	Surveyed from Burnside Road and courtyard. Crack at corner of brickwork.
Storey Height	1 – detached.
Roof	Natural slate. Ridge missing – partially collapsed to rear. Mortar skews to chimney.
Chimneys	Red brick wall head chimney. No pots. Open joints.
Walls	Red sandstone rubble with red brick wall head. Brick gable end. Heavily eroded with heavy cement over pointing. Very damp at ground floor level.
Windows	Remains of cast iron roof lights, now missing.
Doors	n/a
External Pipework	Missing.

Priority Score (0+1+3) 4

Recommendations:

- Carry out structural appraisal and remedial work, including likely rot repairs to roof timbers
- Reinstall roof glazing
- Carry out extensive slate repairs and install new wood cored lead ridge
- Install CI rainwater goods
- Repoint all masonry
- Install new door (assumed)

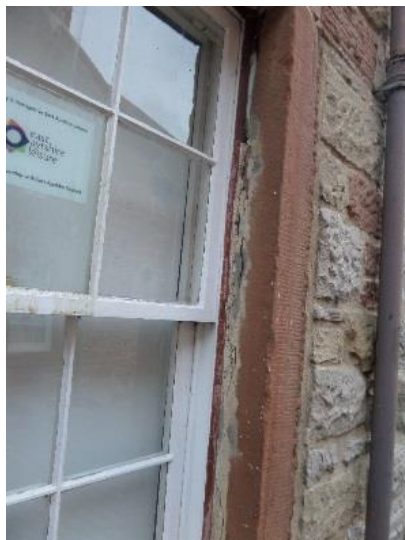
Nance Tinnocks Ale House (Part of Museum)

Category B Listed	Occupied
Restrictions	Surveyed from Castle Street only.
Structural Issues	None apparent.
Storey Height	2 – terraced.
Roof	Natural slate with lead ridge flashing and clips.
Chimneys	Brick chimneys at each party wall with black terracotta pots

Walls	and zinc cans. Generally, masonry and pointing in good condition though some evidence of dampness at low level.
Windows	4no. 6 x 6 sash & case windows. Some masonry damage on right hand ingo, bottom r/h window. 1no. blind opening above door.
Doors	Modern timber vertically lined storm doors.
External Pipework	Cast iron half round gutter and circular cast iron downpipe. Overgrown at outlet. High level uPVC connection into gutter from adjoining No3/5 The Cross.

Recommendations:

- Repair damaged ingo
- Remove gutter connection from No 3 / 5 The Cross by installing additional downpipe.

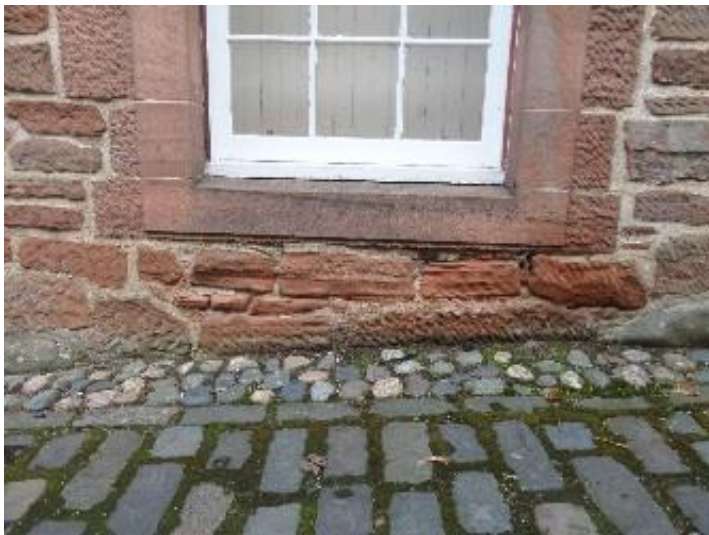
Part of Burns Museum

Category B Listed	Occupied
Restrictions	Surveyed from Castle Street only.
Structural Issues	None apparent.
Storey Height	2 - end terrace.
Roof	Natural slate with lead ridge flashing and clips. Stepped lead soakers / mortar at chimney.
Chimneys	At party wall. Red

Timber 6 x 6 single glazed sash & case. Cracks around burnt sand mastic seals.

Recommendations:

- Clear vegetation from chimney and mortar verge and repoint
- Carry out localised stone repairs and repoint below window
- Reseal around windows
- Refurbish cast iron rainwater goods

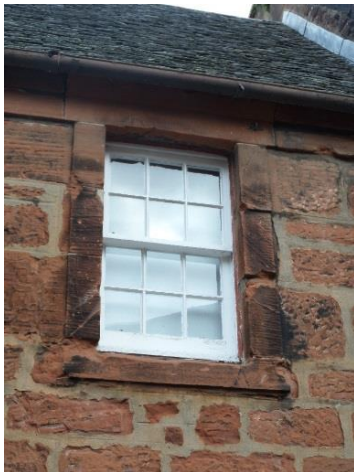
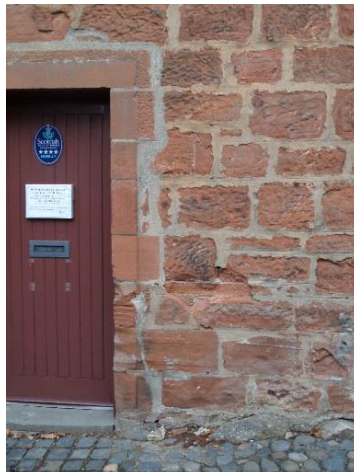
4 Castle Street

Category B Listed	Occupied
Restrictions	Surveyed from Castle Street only.
Structural Issues	None apparent.
Storey Height	2 – corner mid terrace, squared
Roof	Natural slate, close mitred hip, lead ridge flashing and clips, flat lead roof with wood core rolls. Lead skew and chimney flashings.
Chimneys	Hexagonal ashlar sandstone chimney on corner return at wall head with 2no. plain terracotta pots. Rectangular stack at party wall with No. 6 with 4no. terracotta pots with terracotta elephants' feet.
Walls	Heavy cementitious over pointing. Some scaling and eroded stones around entrance at ground level and also around window. Evidence of some stone repairs. 1 modern louvred aluminium solum vent.
Windows	4no. 4 x 6 timber sash & case windows, 1 with horns. 1no. 8 x 8 timber

sash & case window. 1no. 12 pane timber
Doors	Modern vertically lined timber door.
External Pipework	Cast iron half round gutters and 2no. cast iron circular downpipes. Require refurbishment.
Priority Score	(2+3+0) 5

Recommendations:

- Rake out and repoint
- Carry out stone repairs around doorway and window
- Refurbish CI rainwater goods
- Replace modern vent

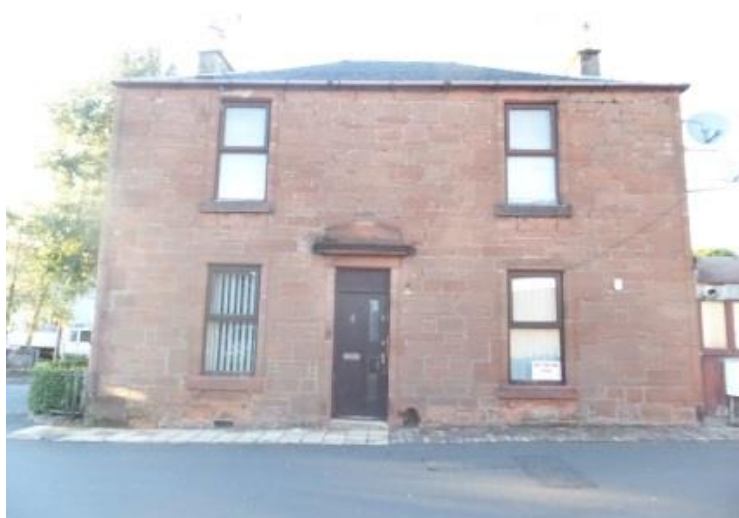
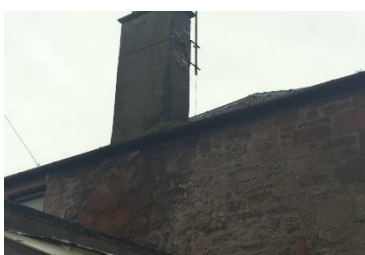
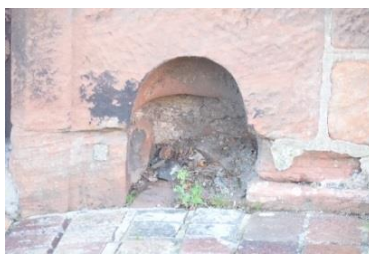
5 Cowgate Residential

Restrictions	Surveyed from Cowgate and also gable ends.
Structural Issues	None apparent.
Storey Height	2 - detached
Roof	Hipped roof. Natural slate with zinc ridges and clips. No skews. Assume lead chimney flashing
Chimneys	Brick chimneys to l.h.s. and r.h.s. each with 2no. decorative cans.
Walls	Squared red sandstone rubble with ashlar window dressings and door surround. Street frontage requires repointing. Erosion below windows. Dry dash on l.h. gable. Heavy stone erosion along flue line on r.h. gable. 1no. modern grille. Recess for shoe scraper – ironwork missing.
Windows	Modern timber.
Doors	Modern door blank with vision panels.

External Pipework	Fanlight boarded over.
	uPVC gutter to main elevation. Gutter missing on gable.

Recommendations:

- Carry out minor slate repairs
- Repoint main elevation and r.h. gable
- Carry out stone repairs below windows and on r.h. gable end
- Remove dry dash from l.h. gable, repoint and re-render with lime-based product
- Replace modern vent

- Replace windows
- Replace door and fanlight
- Replace uPVC gutters with CI
- Install 2no. new CI downpipes.
- Replace ironwork to shoe scraper

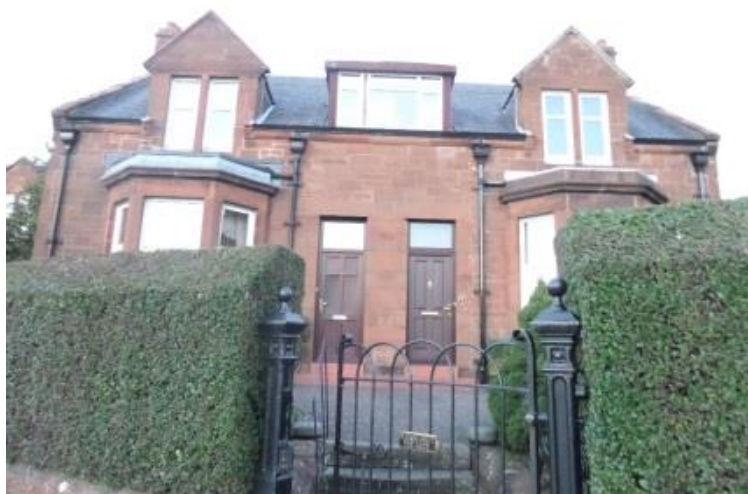
Residential (Benatto No. 5)

Restrictions	Restricted survey due to front garden.
Structural Issues	None apparent
Storey Height	1.5 – 2 x semi-detached.
Roof	Natural slate with zinc ridge and clips. Box dormer. Mortar skewers. Lead chimney flashings and on bay window roof.
Chimneys	1no. red sandstone gable stack with 4no. cans to l.h.s. 1no. red sandstone gable stack with 4no. cans to r.h.s.
Walls	Red squared sandstone with ashlar window and door surrounds. Single storey bay window. No

structural issues apparent. Masonry appears in good condition. No air bricks visible.
Windows	uPVC
Doors	uPVC with fanlights
External Pipework	Cast iron wall head gutters. Rectangular cast iron downpipes with decorative hoppers and ear bands.
Priority Score	(0+2+1) 3

Recommendations:

- Carry out minor slate repairs
- Replace mortar skewers
- Replace uPVC windows
- Refurbish timber sash and case windows
- Replace 2no. doors
- Refurbish CI rainwater goods

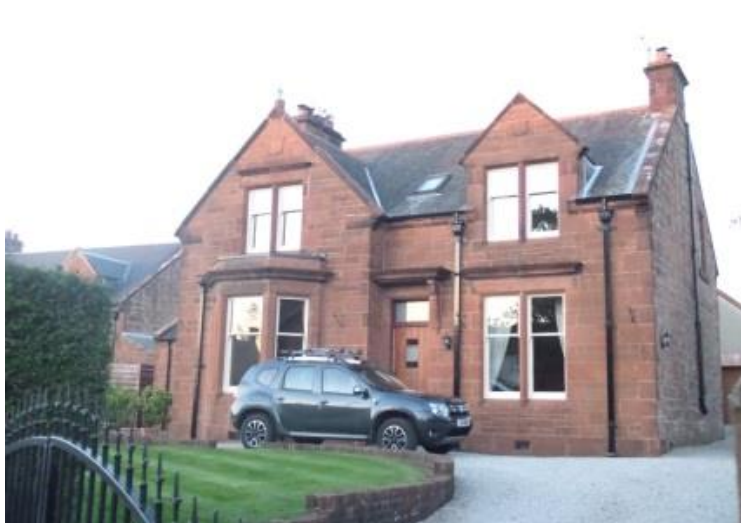
Residential - Willowbank

Restricted survey
due to driveway.

Squared red
rubble sandstone
masonry with
single storey bay
window. Masonry
appears in good
condition. Cast
iron air grilles.

Priority Score (0+2+1) 3

Recommendations:

- Carry out minor slate repairs
- Refurbish timber sash and case windows
- Replace door and fanlight
- Refurbish CI rainwater goods

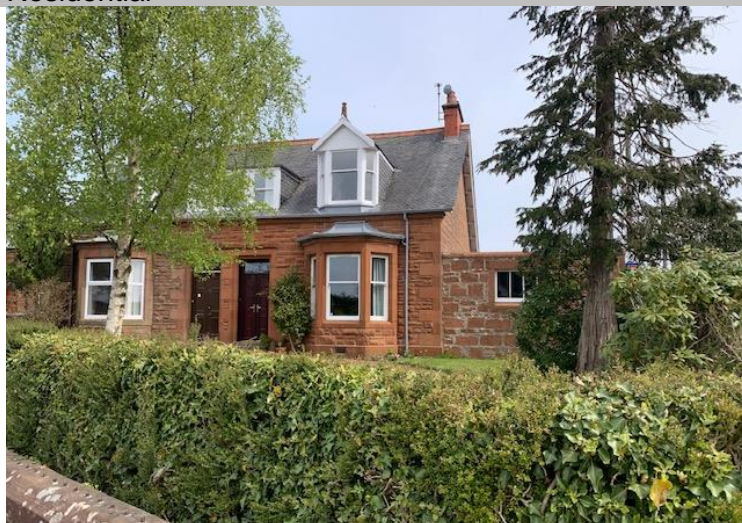
13 Cumnock Road

Occupied	
Restrictions	Access very restricted for survey.
Structural Issues	None apparent
Storey Height	1.5 – semi-detached.
Roof	Dormer windows. Natural slate with crested terracotta ridge. Lead dormer and chimney flashings.
Chimneys	Red brick chimney with 4no. cans.
Walls	Rock faced red sandstone with ashlar window dressings to bay window. No structural issues apparent. Masonry appears in good condition. Air bricks not visible.
Windows	1x1 timber sash and case.
Doors	uPVC
External Pipework	
Priority Score	(0+2+1) 3

Recommendations:

- Carry out minor slate repairs
- Refurbish timber sash and case windows
- Make allowance for replacing 1no. door
- Replace uPVC rainwater goods

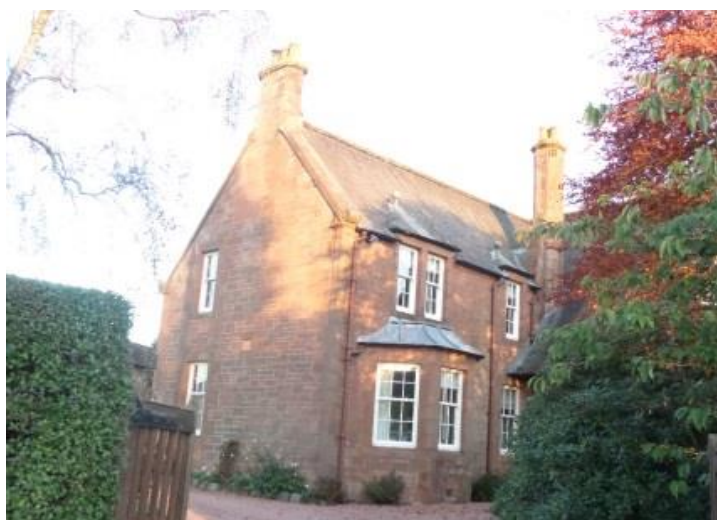
15 Cumnock Road

Occupied	
Restrictions	Survey access very restricted by driveway.
Structural Issues	None apparent
Storey Height	2 - detached
Roof	Natural slate, stone ridge tiles, mitred hips. Lead flashings and valleys. Skews not visible.
Chimneys	Visible. 1no. stone gable stack with 3no. cans. 1no. stone wall head stack with 3no. cans.

Walls	1no. stone stack with 3no. cans. Red sandstone with ashlar window and door surrounds. No structural issues apparent. Masonry in good condition. Cast iron air grille visible.
Windows	6x6 timber sash and case.
Doors	Original Arts and Crafts entrance door.
External Pipework	Cast iron gutters and cast-iron downpipes with ornamental ear bands.
Other	UPVC modern conservatory to Cumnock Road side.

Recommendations:

- Carry out minor slate repairs
- Refurbish timber sash and case windows
- Refurbish CI rainwater goods

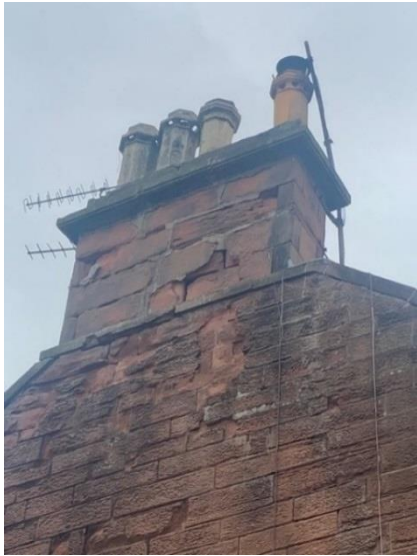
Restrictions	Ground – occupied First – occupied Second - occupied Surveyed from Earl Grey Street only.
Structural Issues	LH chimney leaning / heavily eroded stonework.
Storey Height	2 – end terrace.
Roof	Natural slate pitched roof with straight skews. Box roof dormer. Ridge needs replaced. Lead skews / chimney / dormer flashings. Parapet gutter.
Chimneys	Stone stack with 4no. ornate pots to l.h.s. Stone stack with 8no. pots on party

Walls	wall. Red ashlar sandstone. Masonry has heavy staining/erosion to parapet. Some damp below window to r.h.s.
Windows	3no. modern timber sash & case with horns at first floor level. uPVC in dormer.
Doors	Timber storm doors to l.h.s. Door to r.h.s. obscured by roller shutter.
Shopfronts	Timber shopfront to l.h.s with dentil moulded fascia. uPVC to r.h.s with external security shutter. Tiled steps with original iron boot scrape on top step.
External Pipework	2no. cast iron downpipes – both require refurbishment.

Priority Score (0+2+2) 4

Recommendations:

- Carry out minor slate repair
- Replace ridge with wood core lead roll and clips
- Allow for replacing lead parapet flashings
- Repoint along cornice line
- Refurbish CI rainwater goods
- Remove external roller shutters and replace with internal security grille to window.
- Replace dormer window
- Repaint sash and case windows
- Repaint timber shop front to l.h.s and timber fascia
- Replace window to r.h.s
- Refurbish existing storm doors
- Install new storm doors to r.h.s
- Install new fascia to r.h.s. to match l.h.s
- Paint stone pediment over doors
- New fascia signs and hanging signs (x2)
- Existing steps and original iron boot scrape to be retained and refurbished.

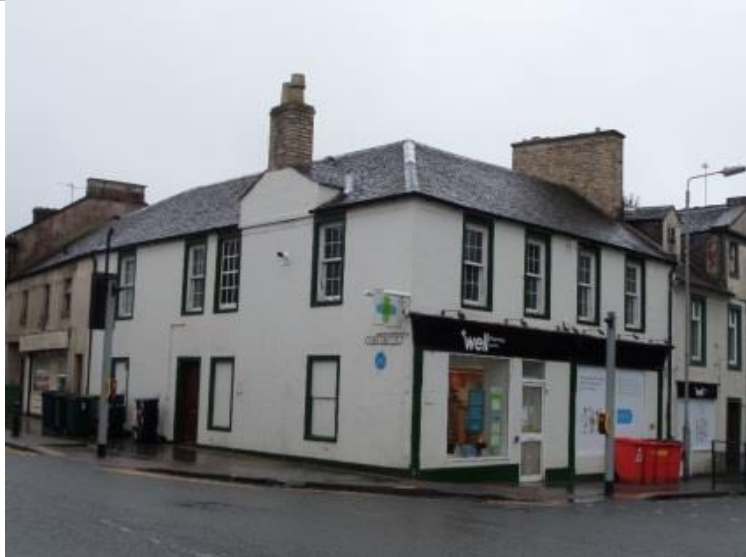
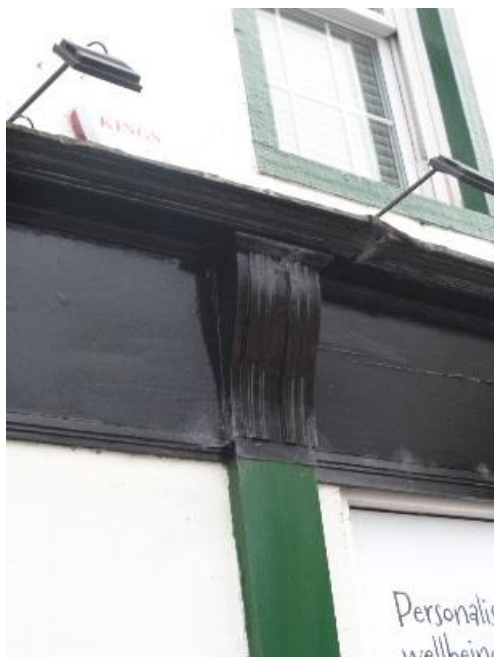
2 Earl Grey Street / 1-3 Loudoun Street
Pharmacy / Residential

Category B Listed	Ground – occupied First – occupied
Restrictions	Surveyed from Earl Grey Street/Loudoun Street only.
Structural Issues	None apparent
Storey Height	2 – corner terrace.
Roof	Pitched roof with hipped return. Natural slate with zinc ridge and clips. Lead chimney flashings.
Chimneys	1no. shouldered brick wall head stack on Earl Grey Street with 2no. terracotta pots. 1no. brick stack, no pots on party wall on Loudoun Street.
Walls	Painted render.
Windows	Earl Grey Street - 3no. blind openings at ground floor level. 3no. uPVC/1no. blind opening at first floor level. Loudoun Street – 2no. blind openings at

ground floor level. 4no. uPVC windows at first floor level.
Doors	Modern timber panelled door to Earl Grey Street.
External Pipework	uPVC gutter (blocked). Cast iron downpipes.
Shopfronts	Aluminium shopfront and door on to Loudoun Street. Timber fascia with console brackets and pilasters.
Priority Score	(2+2+1) 5

Recommendations:

- Carry out minor slate repairs
- Repaint render
- Replace uPVC windows
- Glaze blind openings
- Install internal security grilles
- Replace door to Earl Grey Street
- Replace shopfront
- Replace uPVC gutter with CI
- Refurbish CI downpipe
- Repaint timber fascia
- New hanging sign

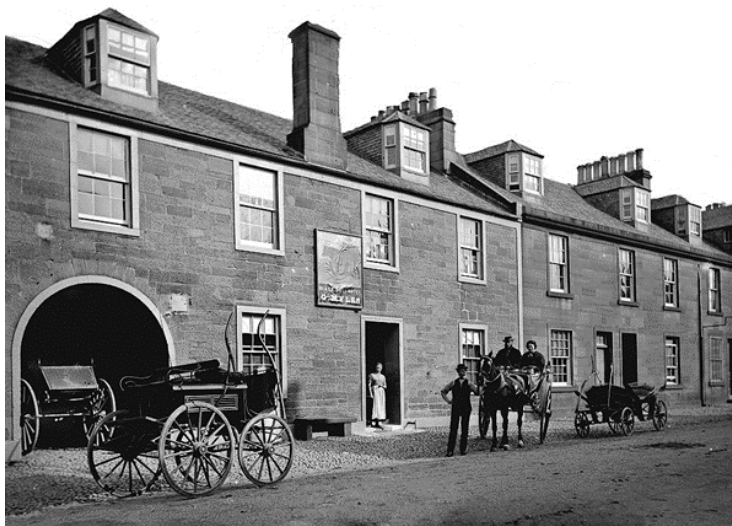
8-16 Earl Grey Street
Kilmarnock Supporters Club

and also to r.h.s. Squared blonde sandstone rubble. Masonry appears in reasonable condition. Some damp staining around downpipe at l.h.s. Arched pend access to rear.

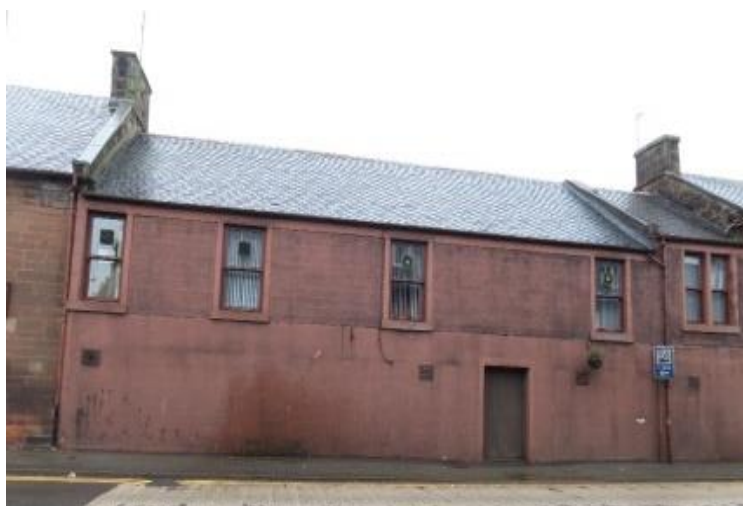
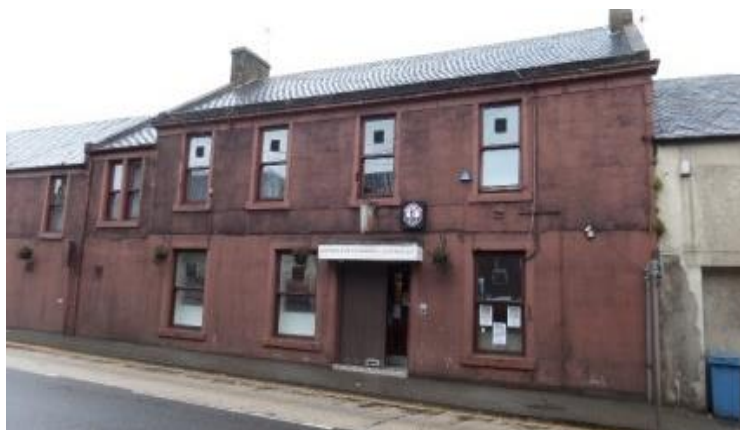
Surveyed from Earl Grey Street only.

- Carry out minor slate repairs
- Replace mortar skews
- Replace leadwork.
- Remove cementitious render, repoint and re-render with a lime based product
- Remove masonry paintwork.
- Replace windows and redirect extracts.
- Replace doors
- Replace uPVC downpipes and gutters with CI.
- New signage

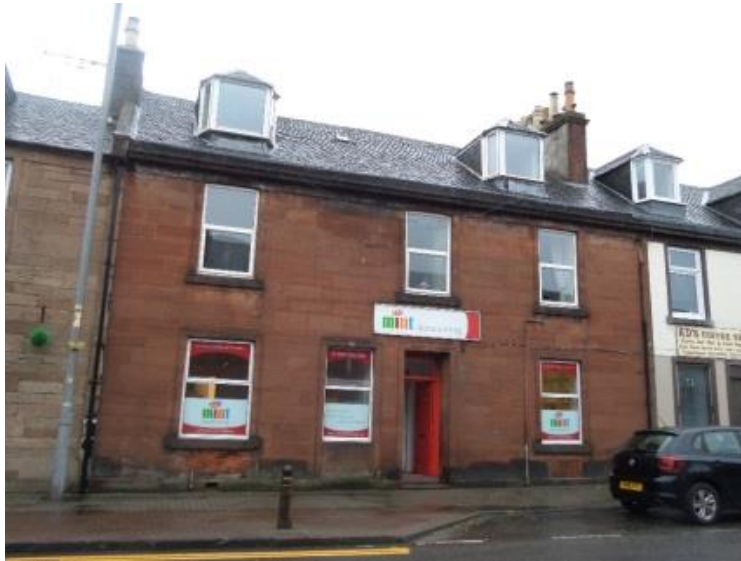
Mint Accounting / Residential

Ground – occupied First – occupied Second – uncertain
Restrictions	Surveyed from Earl Grey Street only.
Structural Issues	None apparent.
Storey Height	2 – mid terrace.

Roof	Pitched roof with straight skew to l.h.s. 2no. hipped dormers. Natural slate with zinc ridge and clips. Lead skews/ chimney flashings/dormer flashings and parapet gutter flashing.
Chimneys	Red sandstone stack on party wall to r.h.s. with 9no. pots (1no. heavily damaged). Blonde sandstone stack on party wall to l.h.s. with 8no. pots.
Walls	Red ashlar sandstone. Heavy erosion of stonework below left-hand window and right-hand window. Heavy staining at parapet level. 1no. cast iron air grille /1no. also missing. Shoe scraper recesses to either side of door – ironwork missing.
Windows	uPVC
Doors	Modern timber panelled door with fanlight
External Pipework	Cast iron downpipe. Damaged bottom section. Full refurbishment required.
Priority Score	(0+2+2) 4
11 Earl Grey Street Gillian's Sandwich + Burger Bar / Residential	
Ground – occupied First – occupied Second – occupied.

- Carry out minor slate repairs
- Replace damaged terracotta pot
- Allow for replacing lead parapet flashings
- Repoint along cornice line
- Carry out stone repairs and repoint below windows
- Replace missing grille
- Replace ironwork to shoe scrapers (2no.)
- Replace windows
- Replace door and fanlight
- Repair and replace CI rainwater goods
- New fascia signage

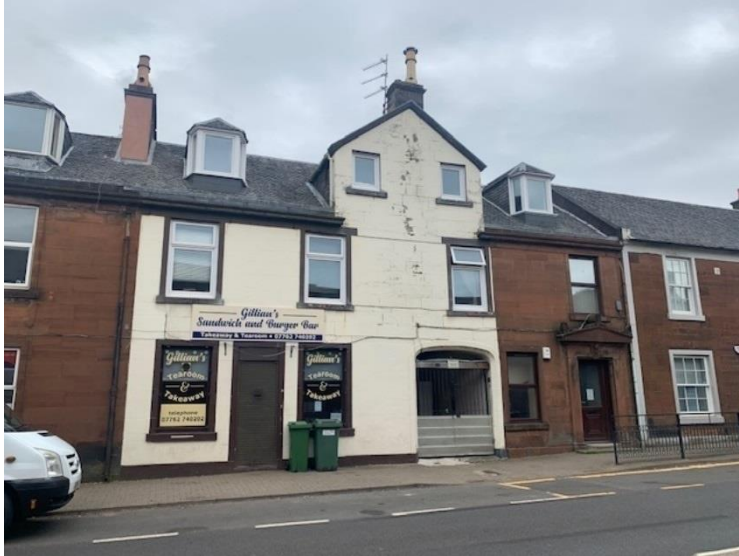
Restrictions	Surveyed from Earl Grey Street only.
Structural Issues	None apparent
Storey Height	2 – mid terrace.
Roof	Pitched roof. Gable dormer plus 1no. hipped dormer. Natural slate with lead ridge. Lead chimney / dormer / parapet flashings. Parapet gutters blocked. Plastic dormer apron flashings.
Chimneys	Red sandstone stack on party wall to l.h.s. 9no. ornate pots -1no. heavily damaged/taped up. 1no. stack on wall head dormer with 1no. pot.
Walls	Painted masonry – requires repainting. 2no. ornate air grilles – over painted. Pend access to rear.
Windows	uPVC.
Doors	Modern glazed timber door. No storm doors.
External Pipework	n/a
Priority Score	(0+2+1) 3

- Carry out minor slate repairs
- Replace heavily damaged terracotta chimney pot
- Replace dormer flashings with lead
- Repaint masonry / ideally remove paint
- Replace windows
- Remove roller shutter
- Install storm doors
- New fascia signage

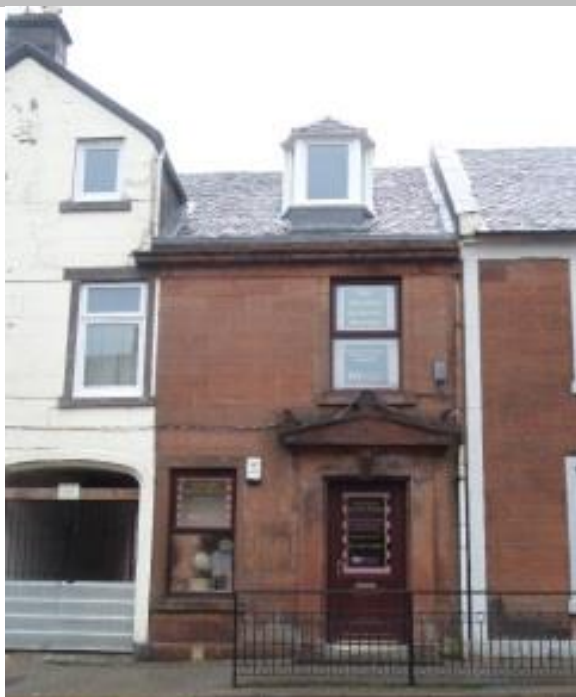
15 Earl Grey Street CARS Office / Residential

Ground – occupied First – occupied Second - uncertain
Restrictions	Surveyed from Earl Grey Street only.
Structural Issues	None apparent.
Storey Height	2 – mid terrace.
Roof	Pitched roof with straight skew to r.h.s. Hipped dormer. Natural slate with lead ridge. Lead skew and parapet flashing. Plastic flashing to front of dormer. Parapet gutter.
Chimneys	n/a
Walls	Masonry requires minor repairs where signage has been removed and to r.h. door pilaster. 1no. brass modern air grille.
Windows	uPVC
Doors	uPVC
External Pipework	Part cast iron/part uPVC downpipe.
Priority Score	(0+2+1) 3

- Carry out minor slate repairs
- Replace dormer flashings with lead
- Carry out minor stone repairs
- Replace modern grille
- Replace windows
- Replace door
- Refurbish CI rainwater goods
- Replace uPVC section of downpipe with CI

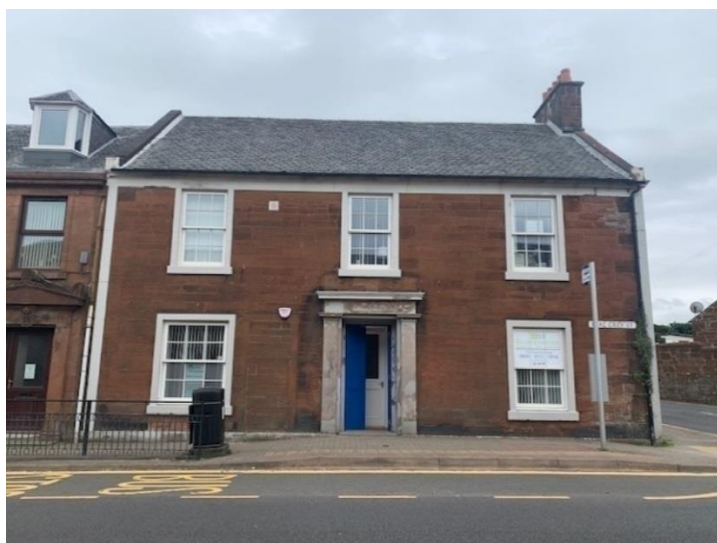
Former bank - Sophie Wasamer Health & Wellbeing / S3
Environmental / Accessory Boutique

Restrictions	Surveyed from Earl Grey Street / Mansfield Road only.
Structural Issues	None apparent.
Storey Height	2 – end terrace.
Roof	Pitched roof with straight skews. Natural slate with zinc ridge and clips. Lead skews and chimney flashing.
Chimneys	Red sandstone chimney to r.h.s. with 5no. terracotta pots.
Walls	Red squared rubble sandstone with painted ashlar window and door surrounds. Some erosion at corner adjacent to downpipe. Minor repairs required. 3no. modern air grilles.
Windows	3no. 6x6 timber sash & case windows at first floor level on Earl Grey Street, no horns. 1no. 6x6 timber sash & case window at first floor level on Mansfield Road, no horns. 2no. modern timber windows at ground floor level on Earl Grey Street. 1no. modern timber window at ground floor level on Mansfield Road.

Doors	Panelled storm doors
External Pipework	Cast iron half round gutter and cast-iron downpipe. Requires refurbishment.
Priority Score	(0+2+2) 4

- Carry out minor slate repairs
- Carry out stone repairs at r.h.s and repoint
- Replace modern grilles
- Refurbish CI rainwater goods

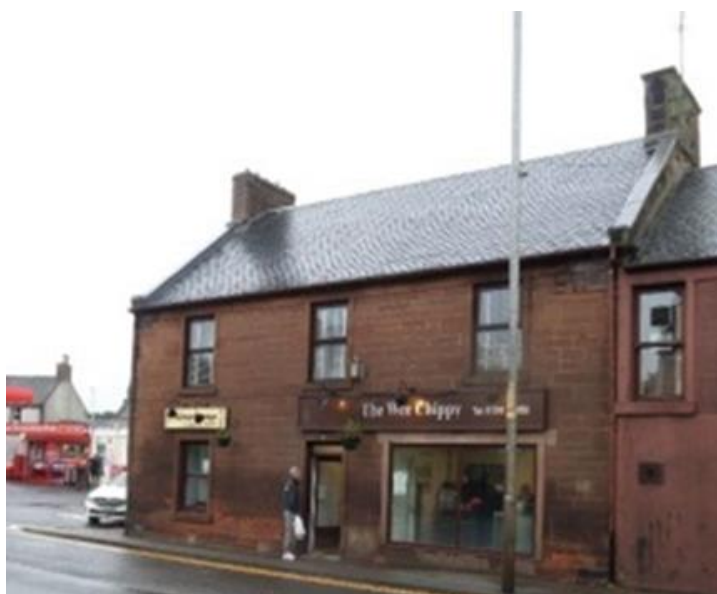
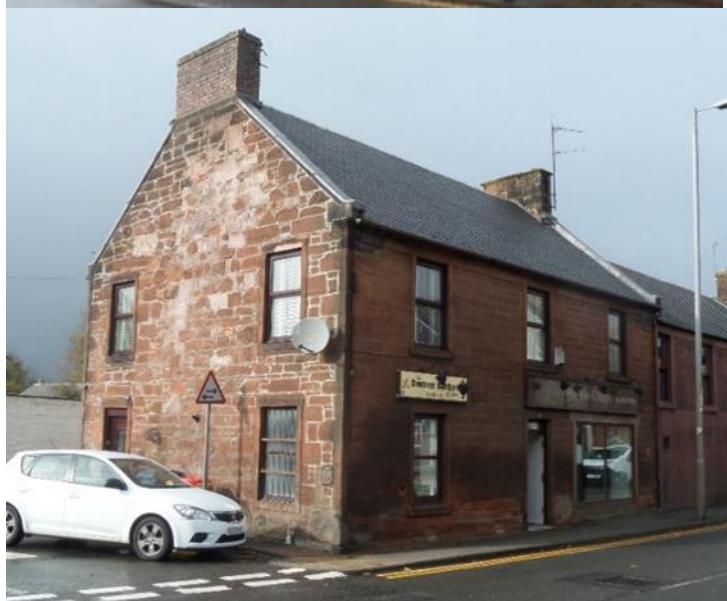
18 Earl Grey Street
Corner Barber / Wee Chippy / Residential

Restrictions	Surveyed from Earl Grey Street / Cowgate only.
Structural Issues	None apparent
Storey Height	2 – end terrace.
Roof	Pitched roof with straight skews. Natural slate (new) with zinc ridge and clips. Lead skew flashings and caps.
Chimneys	Red brick chimney to l.h.s. No pots. Red sandstone stack to r.h.s. on party wall. No pots.
Walls	Red squared rubble sandstone. Heavy erosion to masonry below windows and around window to l.h.s at ground level. Heavy pointing/plastic repairs to gable. Modern terracotta airbricks.
Windows	uPVC
Doors	uPVC
Shopfronts	uPVC shopfront/ timber fascia to r.h.s.
External Pipework	uPVC gutter (blocked). Cast iron downpipe (last section is uPVC) - Needs refurbishment.

- Carry out minor slate repairs
- Carry out stone repairs to gable and below windows, repoint full gable and below windows
- Replace modern airbricks
- Replace windows
- Replace door
- Replace shopfront
- New fascia signage
- New hanging signs (2no.)

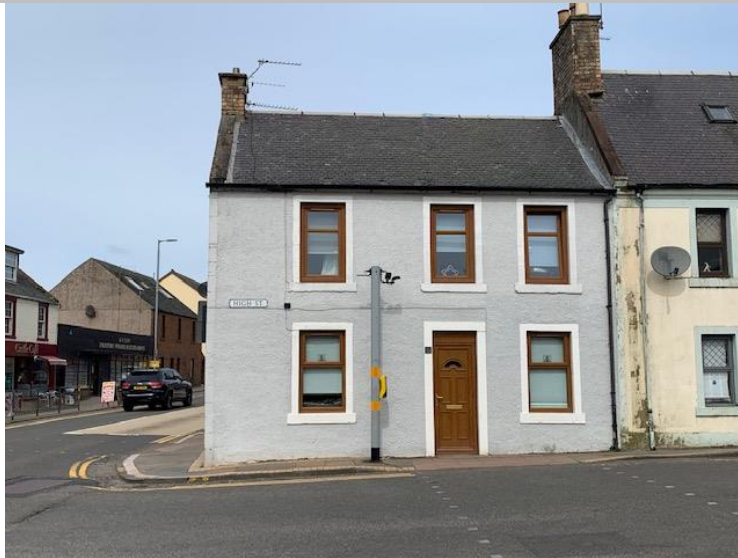
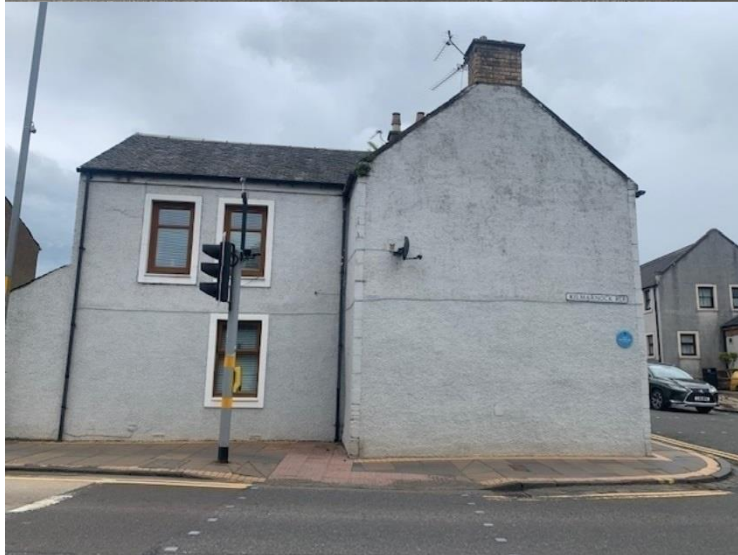
1 High Street

Restrictions	First – occupied Surveyed from High Street/Kilmarnock Road only.
Structural Issues	None apparent
Storey Height	2 – end terrace.
Roof	Natural slate with zinc ridge and clips. Some loose slates evident on High Street. Lead skew flashings No flashing visible at chimney. Timber fascia board (modern addition) requires painting.
Chimneys	Brick chimney on corner gable. No pots. Flue vent.
Walls	Rendered with painted ashlar dressings around windows and doors. Some cracking in wet dash render on Kilmarnock Road elevation. Modern painted terracotta brick vents onto Kilmarnock Road.
Windows	uPVC
Doors	uPVC door.
External Pipework	Kilmarnock Road – uPVC gutter and 2no. uPVC downpipes. High Street – Damp at skew putt. uPVC gutter and 1no. uPVC downpipe.
Priority Score	(0+2+1) 3

- Carry out slate repairs
- Allow for installing chimney flashings
- Remove cementitious render, repoint and re-render with a lime based product
- Replace modern vents
- Repaint timber fascias
- Replace windows
- Replace door
- Replace uPVC rainwater goods with CI

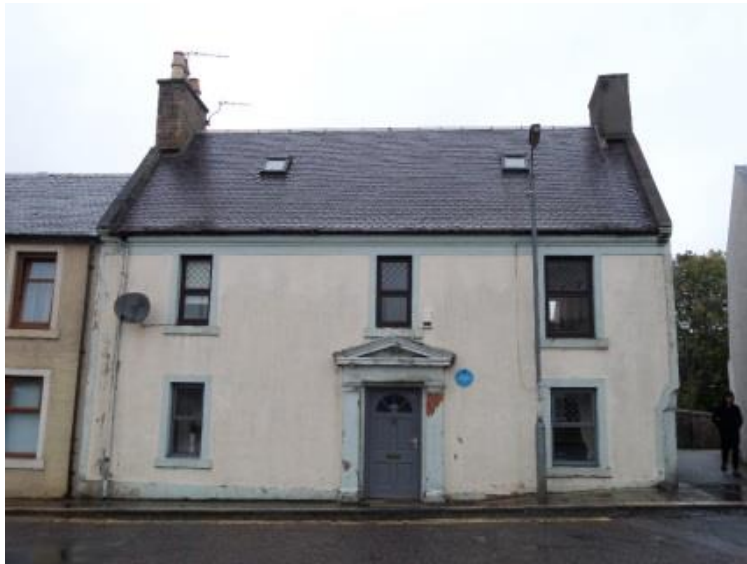
3 High Street
Residential

Category B Listed	Ground – occupied First – occupied
Restrictions	Surveyed from High Street only
Structural Issues	Chimney to l.h.s appears to be leaning.
Storey Height	2 – end terrace
Roof	Slate with zinc ridges and straps. Lead chimney flashings. Mortar skews. Modern in-line roof lights.
Chimneys	Brick chimney to l.h.s with 4no. pots. Rendered chimney to r.h.s. No pots.
Walls	Painted smooth render to High Street. Dry dash render to gable.
Windows	uPVC
Doors	Modern timber panelled door
External Pipework	Cast iron cutter. uPVC downpipe.

- Check chimney stability
- Carry out minor slate repairs
- Replace flashings and skews
- Remove cementitious render, repoint and re-render with a lime based product
- Remove paint from window and door surrounds
- Replace windows
- Replace door
- Replace uPVC rainwater goods with CI

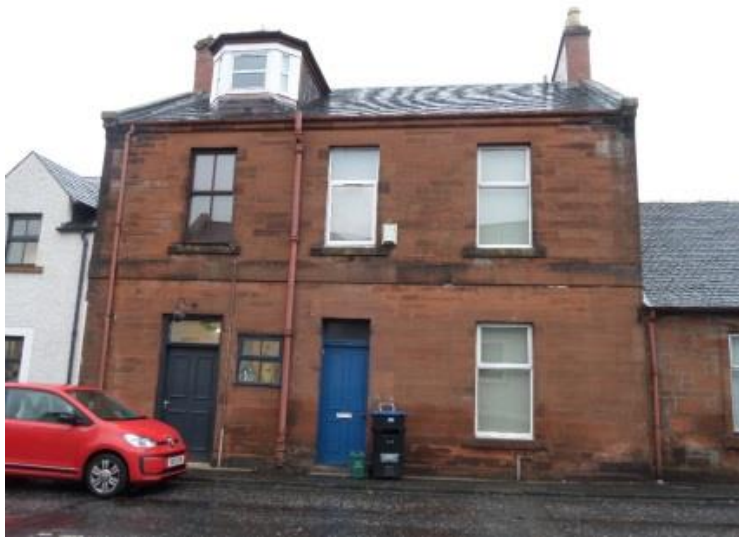
Farm Services / Residential

Ground – occupied First – occupied Second – uncertain
Restrictions	Surveyed from High Street only.
Structural Issues	None apparent
Storey Height	2 – mid terrace.
Roof	Modern slate with zinc ridge and clips. Lead skew and chimney flashings. Polygonal dormer.
Chimneys	Brick chimneys to each end. No pots to l.h.s. 8no original pots to r.h.s.
Walls	No structural

- Carry out minor slate repairs
- Replace uPVC windws
- Replace modern timber casement windows
- Replace doors (2no.)
- Refurbish CI rainwater goods

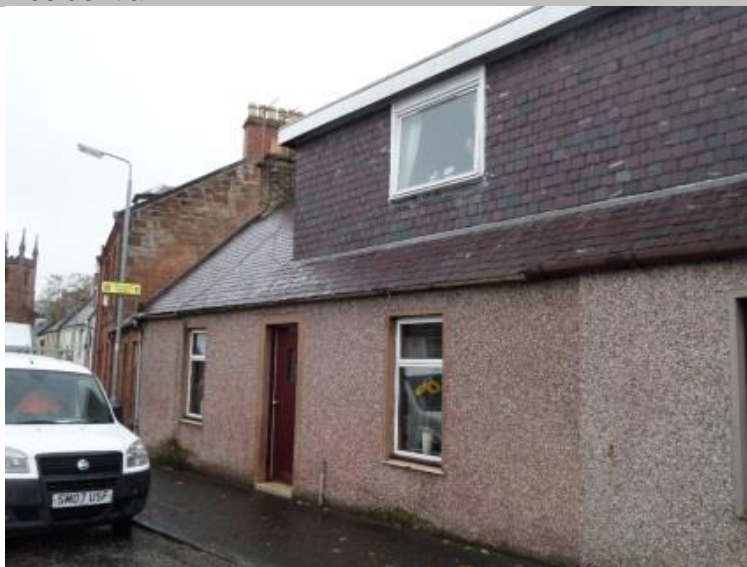
Restrictions	Surveyed from High Street only
Structural issues	None apparent
Storey Height	1- mid terrace.
Roof	Large flat roofed box dormer. Natural slate with zinc ridge and clips. Mortar skew. Lead flashing to dormer.
Chimneys	Brick chimney to l.h.s. 2no. pots Some movement evident in brick.
Walls	Dry dash render. Area of damp at low level. 1no. modern steel grille.
Windows	2no. uPVC windows with slate cills. Modern

- Instruct Structural Engineer to assess chimney
- Carry out minor slate repairs
- Replace mortar skew

- Remove dry dash render, repoint and re-render with lime based product
- Replace modern grille
- Replace windows (including dormer)
- Replace door
- Refurbish CI rainwater goods

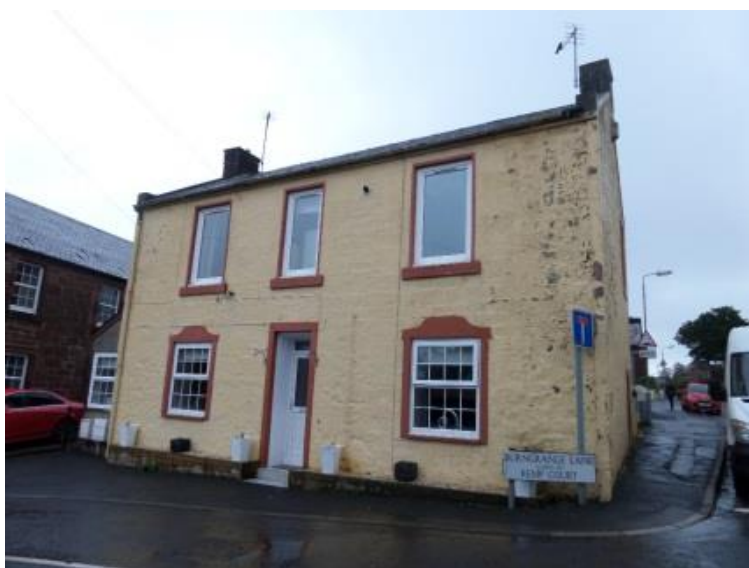
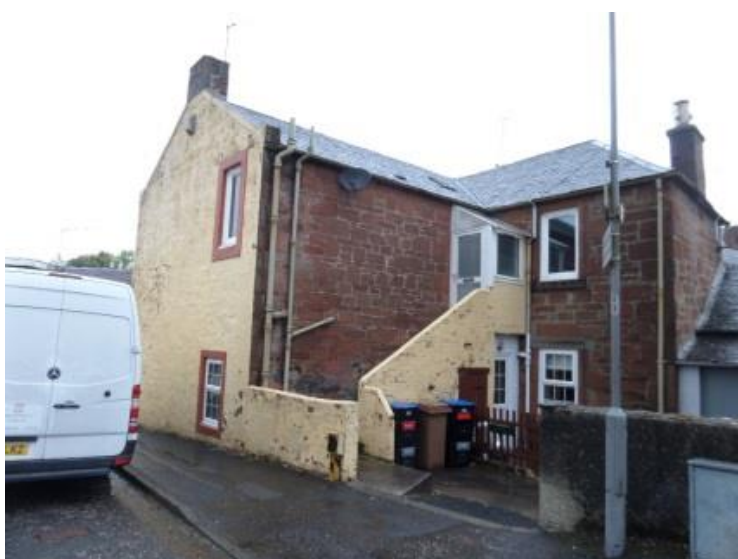
Structural Issues	None apparent
Storey Height	2- semi-detached.
Roof	Natural slate with zinc ridge and clips. Leaded skews and chimney flashing.
Chimneys	2no.masonry gable stacks, no pots to Burngrange Lane. 1no. masonry wall head stack with 1no. pot to High Street.
Walls	Painted masonry to street frontages. Squared red sandstone rubble to visible internal faces. Ashlar door and window surrounds. Heavy cement mortar pointing where masonry visible. Paint flaking.
Windows	10no. uPVC
Doors	2no. uPVC doors, main door with fanlight.
External Pipework	Burngrange Lane - uPVC half round gutter and cast-iron downpipe with uPVC connection – Refurb. High Street - Cast iron half round gutters, 1no. cast iron downpipe and 3no. cast iron vent stacks (1no. with uPVC top section).

- Carry out minor slate repairs
- Repaint masonry
- Repoint stonework
- Replace uPVC windows
- Replace doors and fanlight
- Refurbish CI rainwater goods
- Replace uPVC section with CI

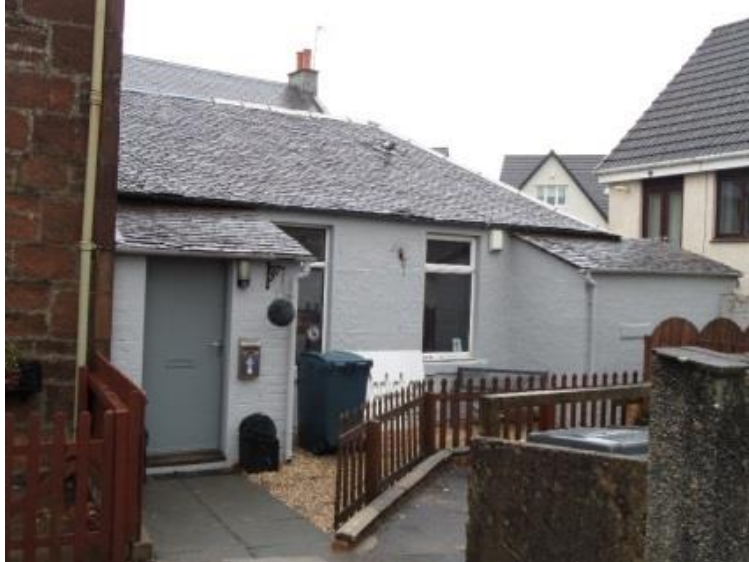
19 High Street
The Workshop

Restrictions	Surveyed from High Street only.
Structural Issues	None apparent.
Storey Height	1 – semi-detached.
Roof	Natural slate with zinc ridge and clips. Lead abutment flashing. Zinc hip flashing.
Chimneys	n/a
Walls	Painted masonry and painted brick porch and extension. Masonry in good condition.
Windows	2no. uPVC
Doors	Modern painted door blank. Ironmongery not of note.
External Pipework	Cast iron half round gutter to main building. uPVC gutters and downpipes to porch extension.

- Carry out minor slate repairs
- Replace windows
- Replace door
- Refurbish CI rainwater goods
- Replace uPVC rainwater goods with CI
