Mauchline Conservation Area Management and Maintenance Plan

Gazetteer

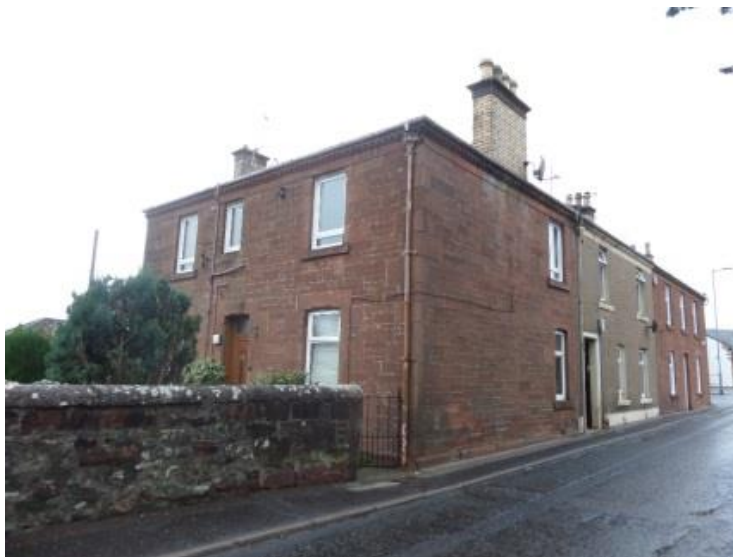
Structural Issues	None apparent.
Storey Height	2 – end terrace.
Roof	Pitched hip roof. Slate with zinc ridge and clips. Lead chimney flashings.
Chimneys	Yellow brick chimney with stone dentil moulded cap to l.h.s. No pots. Yellow brick wall head chimney to r.h.s. with dentil moulded cap. 4no. ornate pots.
Walls	Red squared sandstone rubble. Dentil moulded wall head cornice. Masonry generally in good condition. 1no. ornate cast iron air grille. 1no. also blocked up.
Windows	uPVC
Doors	uPVC (Side elevation)
External Pipework	Cast iron circular downpipe with decorative ear bands and hopper. uPVC gutter.
Priority Score	(0+2+1) 3

- Carry out minor slate repairs
- Reinstate missing vent
- Replace windows
- Replace door
- Replace uPVC gutter with CI
- Refurbish CI rainwater goods

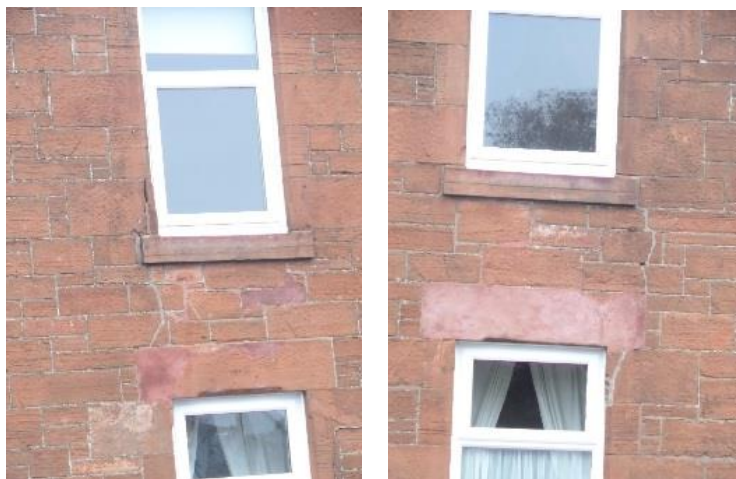
Restrictions	Surveyed from High Street only.
Structural Issues	Cracking between windows. 2no. cracked cills at ground level.
Storey Height	2 – end terrace.
Roof	Pitched roof with 1no. straight skew. Natural slate with zinc ridge and clips. Lead skew and partial capping. Lead chimney flashings.
Chimneys	Yellow brick chimney with dentil moulded stone cap and 3no. ornate pots on party wall to l.h.s. Yellow brick chimney with

concrete cap and 2no. ornate pots to r.h.s.
Walls	Red squared sandstone rubble. Dentil moulded wall head cornice. Plastic repairs to lintols and some stones. 2no. modern louvred air grilles.
Windows	uPVC
Doors	Modern composite door with fanlight.
External Pipework	uPVC

- Carry out minor slate repairs
- Carry out structural inspection & any recommended remedial repairs
- Replace cracked cills and lintols
- Carry out stone repairs where plastic repairs have been made.
- Replace modern grilles
- Replace uPVC windows
- Replace door and fanlight
- Replace uPVC gutters and down pipes with CI

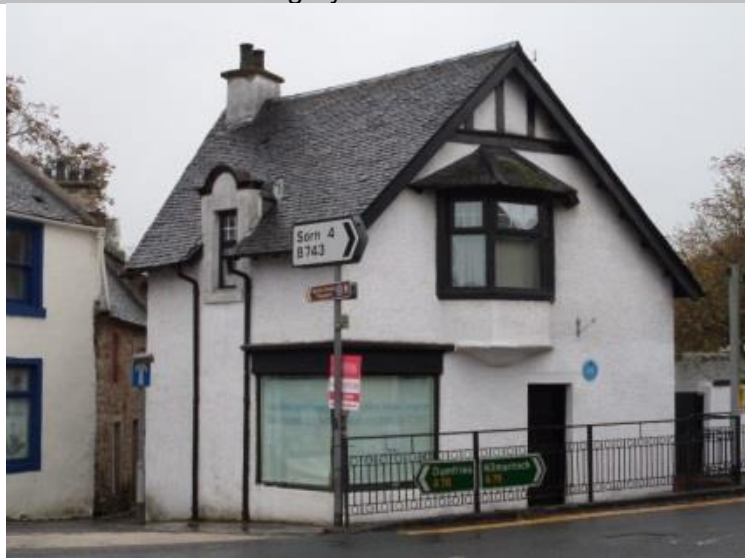
1 Kilmarnock Road
Mauchline Dental Surgery

Ground – occupied First – occupied
Restrictions	Surveyed from Kilmarnock Road / Castle Street only.
Structural issues	None apparent
Storey Height	1.5 – end terraced.
Roof	Natural slate with zinc ridge and clips. Lead parapet flashings.
Chimneys	Rendered chimney with 2no. pots
Walls	Wet dash render.
Windows	Timber casements with uPVC astragals at first floor level.
Doors	Panelled timber storm doors
Shopfronts	Timber shopfront with fascia.
External pipework	Cast iron half round gutter with cast iron circular downpipes. Small section of cast iron to one side. No gutter on first floor projecting bow window. Section of gutter loose alongside Castle Street

- Carry out minor slate repairs
- Repaint render
- Replace windows
- Refurbish storm doors
- Paint shopfront
- New hanging sign
- Resecure gutter adjacent to Castle Street

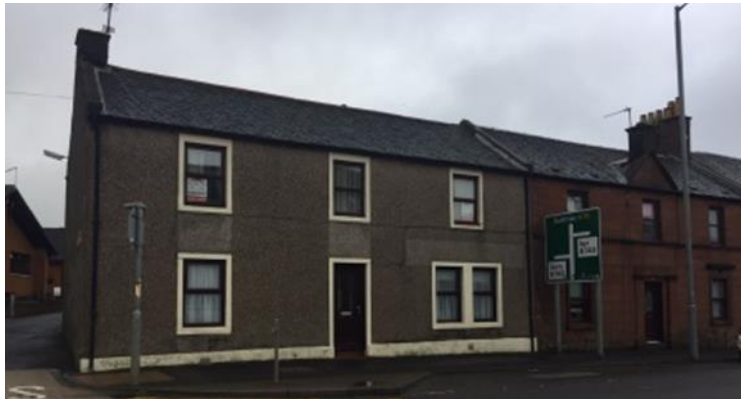
10 Kilmarnock Road			Ground – occupied First – occupied
Residential			
	Restrictions		Surveyed from Kilmarnock Road only.
	Structural Issues		None apparent.
	Storey Height		2 – end terrace.
	Roof		Natural slate with

Chimneys	red terracotta ridge tiles. Lead skews. Small section of mortar skew t r.h.s. Rendered chimney to l.h.s. No pots.
Walls	Dry dash render with smooth rendered base course and window and door surrounds. Patch repairs. 2no. cast iron air grilles.
Windows	uPVC
Doors	uPVC
External Pipework	Cast iron half round gutter and 2no. circular cast iron downpipes – Need refurbishment.

- Carry out minor slate repairs
- Remove dry dash render, repoint and re-render with lime-based product
- Replace windows
- Replace door
- Refurbish CI rainwater goods

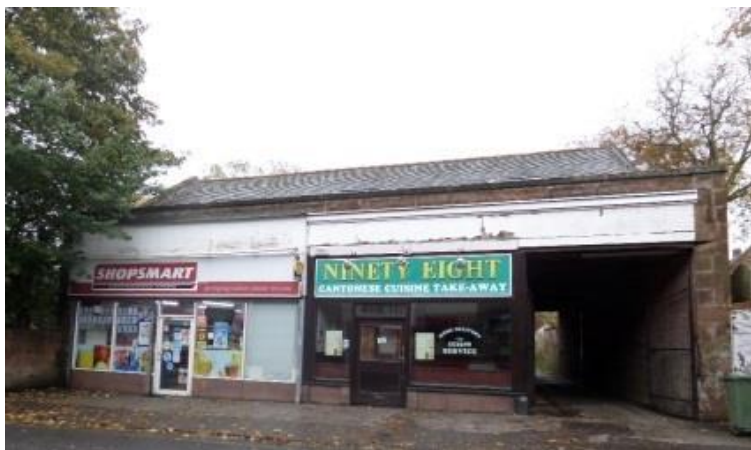
Shopsmart Convenience Store / Ninety-Eight Cantonese Takeaway

Restrictions	Surveyed from Loudoun Street only.
Structural issues	None apparent
Storey Height	1 - standalone
Roof	Natural slate with red clay ridge tiles. Lead skews. 3no. former rooflights sheeted over with corrugated iron.
Chimneys	n/a
Walls	Damage to red sandstone to r.h.s of pend.
Shopfronts	Modern timber shopfront to r.h.s. Aluminium shopfront with external shutters to l.h.s. Granite stall risers.
External Pipework	Parapet gutter

- Slate over 3no. former roof lights and carry out minor slate repairs generally
- Replace leadwork to parapet gutter
- Repair sandstone pillar to r.h.s. of pend
- Remove external security shutters
- Install new shopfronts
- Install full length timber fascia and signage

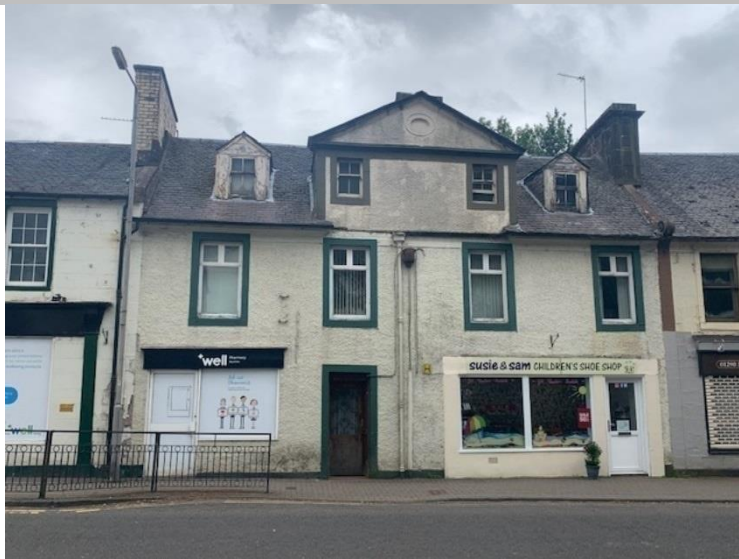
5-7 Loudoun Street

2.5 – mid terraced with wall head gable and 2no. gabled dormers. Natural slate with zinc ridge and clips. Mortar skewes. Lead flashings to dormers. The dormers have timber surrounds and 2 over 2 sash & case windows in poor condition. Slated cheeks.

Damage where section of gutter has been removed. 1no. modern grille below florist window.
Windows	Modern timber casements at first floor. Timber sash & case in dormers.
Doors	Aluminium door to Pharmacy. Modern half glazed blank to flats. uPVC door to Florist.
Shopfronts	Timber shopfront, modern fascia to shoe shop. Aluminium shopfront, traditional fascia to Pharmacy.
External Pipework	Cast iron half round gutter. Cast iron downpipe with hopper. Gutter needs refurbishing.

- Carry out minor slate repairs
- Replace mortar skewes
- Replace dormer timbers
- Make render repairs and repaint render
- Replace modern grille
- Refurbish timber sash and case windows
- Replace modern timber casements
- New modern fascia to show shops

- New timber fascia above florist with new signage (r.h.s shop unit only)
- New hanging sign
- Reinstall missing section of CI gutter
- Refurbish CI rainwater goods
- Tidy up and consider re-locating electrical boxes, and associated cabling.

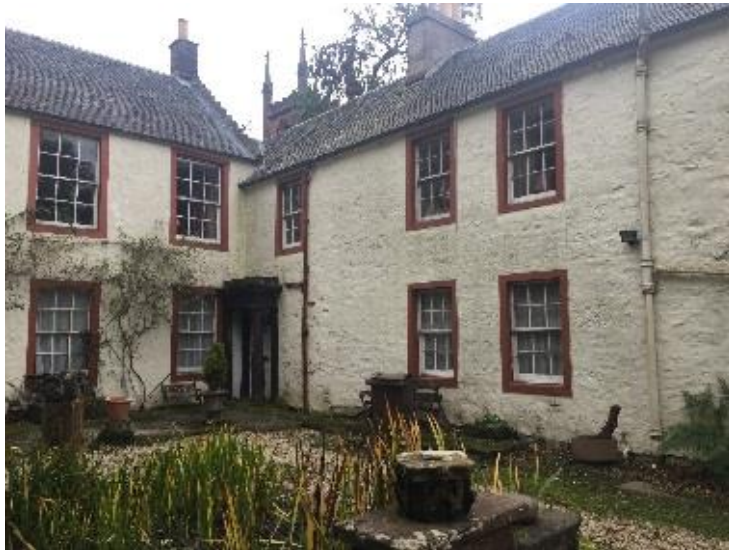
8 Loudoun Street
Gavin Hamilton's House
 Residential

Structural Issues	Localised areas of bulging in external walls. Localised distortion on ridge line. Structural survey carried out 2018.
Storey Height Roof	2 – detached Slate, hipped gable to west
Chimneys	5no. stone chimney stacks and 1 brick chimney stack.
Walls	Painted masonry. Wet dash render to south and east elevations
Windows	Original timber sash and case
Doors	Timber panelled
External Pipework	Cast iron downpipes generally, uPVC downpipe on west elevation

- Stabilise stonework in accordance with Structural Engineer's recommendations and repoint.
- Carry out inspection of roof timbers
- Carry out slate repairs
- Replace mortar skews
- Remove paint from masonry & re-paint with breathable product
- Remove existing render, repoint & re-render with lime-based product
- Repair and refurbish sash and case windows
- Refurbish timber panelled doors
- Replace uPVC downpipe with CI.
- Refurbish CI rainwater goods & replace missing section

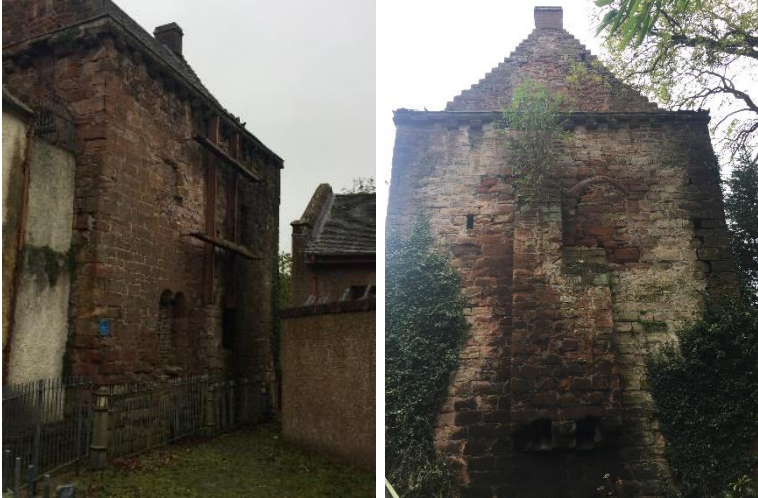
Abbot Hunter's Tower (Castle)		Category A Listed	Unoccupied

Restrictions		Limited access
	Structural Issues		Structural cracks with ongoing movement. Previous bracing carried out. Loose corbie stones. Defective stone lintols. Structural survey carried out 2018 (restricted access) Tower recommended to BARR.
Recommendations: <ul style="list-style-type: none"> • Stabilise stonework in accordance with Structural Engineer's recommendations and repoint. • Extensive slate repairs / re-slate • Remove plant growth • Replace internal and external stone lintols • Reinstate floor at first floor level 	Roof		Slate with lead ridge and lead skew flashings. Rooflight. Lead capping at parapet.
	Chimneys		Stone stack to north gable. No pot.
	Walls		Red sandstone rubble.
	Windows		Various blocked up openings, some with dressed surrounds.
	Doors		Timber
	External Pipework		None
Castle Priority Score			(3+3+3) 9

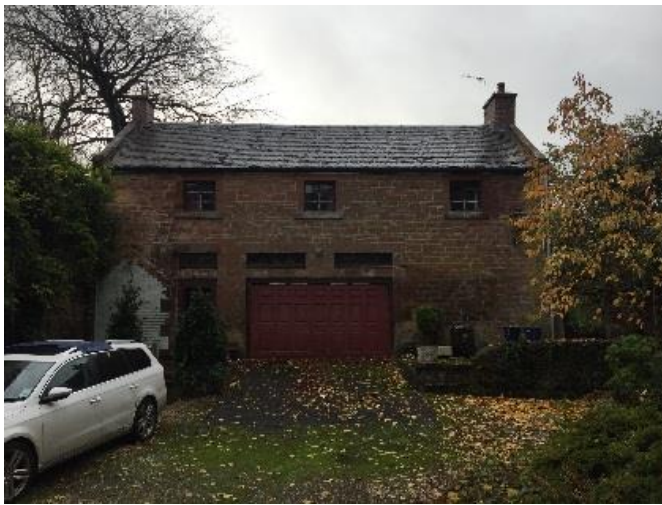
Old Bakehouse		Unlisted	Unoccupied
	Restrictions		None.
	Structural Issues		None evident – structural survey carried out 2018.
	Storey Height		2 - detached
	Roof		Slate with zinc ridge and straps, lead skews and flashings
	Chimneys		Brick chimney stacks at each

Walls Red sandstone squared rubble. Area of white glazed brick on north elevation. Evidence of damp staining on north and east elevations.

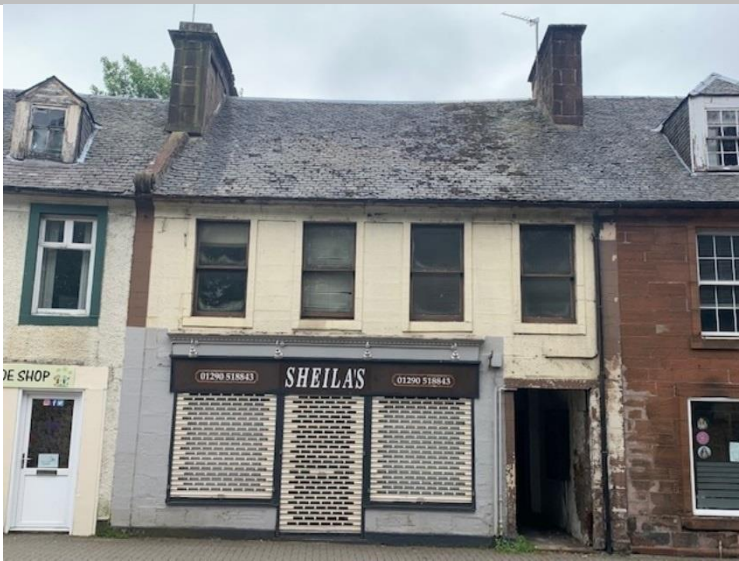
9-11 Loudoun Street
Sheila's / Residential

Category B Listed	Ground – vacant First – vacant (Dangerous buildings notice to first floor flat)
Restrictions	Surveyed from Loudoun Street only.
Structural Issues	None apparent.
Storey Height	2 – mid terraced.
Roof	Natural slate with zinc ridge and clips. Mortar skewes.
Chimneys	Stone stack on party wall to l.h.s., no pots. Stone stack on party wall to r.h.s., 1 pot.
Walls	Painted ashlar. Requires repainting. Scrolled skew putts. Pend access to flats above.
Windows	4no. timber sash and case at first floor level.
Doors	Glazed timber. Door to close missing.
Shopfronts	Timber shopfront. External grilles. Dentil moulded cornice to timber fascia.
External Pipework	Cast iron half round gutter - requires repainting – connecting into

shared uPVC down pipe.

Priority Score (2+2+3) 7

Recommendations:

- Carry out minor slate repairs
- Replace mortar skewes
- Repaint stonework
- Refurbish timber sash and case windows
- Remove external grilles
- Install internal security grilles
- Repaint shopfront and fascia
- New fascia signage
- New hanging sign
- Refurbish CI rainwater goods

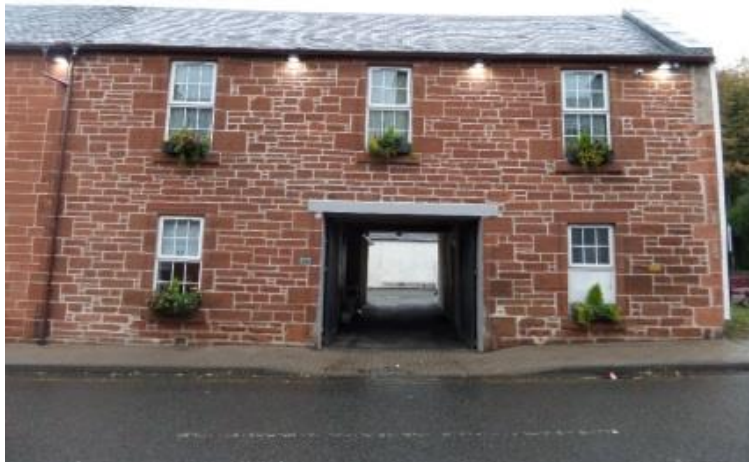
12 Loudoun Street
Fairburn Hotel

Restrictions	Surveyed from Loudoun Street and car park access road only.
Structural Issues	None apparent.
Storey Height	2 – semi-detached.
Roof	Modern slate with lead ridge and clips. Lead covered straight skew.
Chimneys	n/a
Walls	Squared red sandstone rubble walls. Walls and

pointing appear generally in good condition. Dry dash over cladding to gable end. 1no. decorative iron grille. Central pend to rear court.
Windows	uPVC, 1no. with uPVC blind panel.
Doors	Timber vertically lined doors to pend.
External Pipework	uPVC profiled gutter and shared uPVC downpipe.

Recommendations:

- Remove drydash render, repoint and re-render with lime based product.
- Replace windows
- Replace uPVC rainwater goods with CI

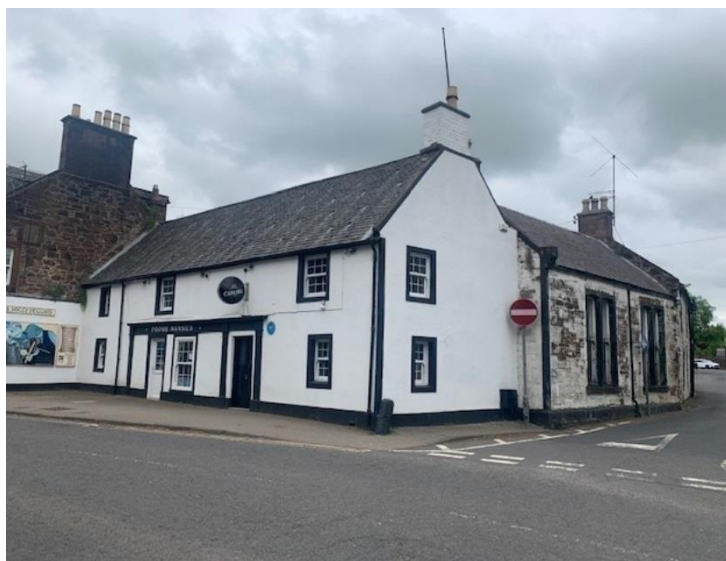
21 Loudon Street
Poosie Nansie's Ale House

Restrictions	Surveyed from Loudoun Street / Cowgate only.
Structural Issues	Deviations in roof line to rear
Storey Height	2 – end terrace returning on to Cowgate single storey, stepping back up to 2-storey on Cowgate.
Roof	Slate with zinc ridge and straps. Lead soakers / vents to Loudoun Street side. Lead skew flashings & mortar skewes.
Chimneys	Rendered chimney on corner with 1 pot. Stone chimney to Cowgate l.h.s with 1 pot. Central stone chimney on Cowgate with 3 pots.
Walls	Painted render to Loudoun Street. Painted masonry to Cowgate. Areas of damp from defective rainwater goods.
Windows	uPVC to Loudoun Street Timber sash and case to Cowgate.
Doors	uPVC to Loudoun Street. Modern timber storm doors. Modern timber to Cowgate.
External Pipework	Cast iron gutters and downpipes
Priority Score	(2+3+3) 8

Recommendations:

- Remove soakers / roof vents and relocate
- Carry out minor slate repairs
- Replace missing ridge flashing to Cowgate side
- Replace mortar skewes

- Remove cement render, repoint, re-render with lime-based material, carrying out stone repairs where necessary.
- Remove paint from masonry.
- Replace windows
- Replace doors
- Refurbish CI rainwater goods, replacing uPVC.
- Add new downpipe to Cowgate elevation
- Replace signage.

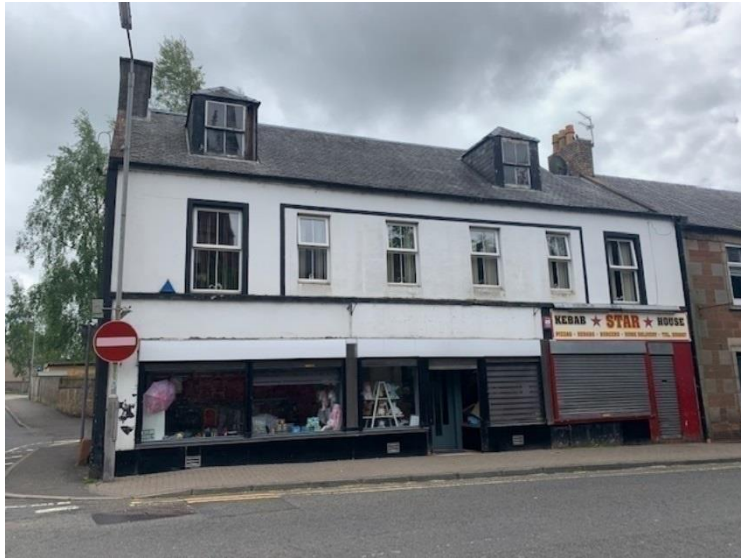
23/23a-25 Loudoun Street

Ground – occupied First – occupied Second – uncertain
Restrictions	Surveyed from Loudoun Street only.
Structural Issues	None apparent.
Storey Height	2 – end terrace with 2no. hipped dormers.
Roof	Natural slate with zinc ridge and clips. 1no. mortar skew to l.h.s. 2no. lead skews. Lead flashing to dormers and chimneys.
Chimneys	Rendered chimney to l.h.s. No pots. Brick chimney on party wall to r.h.s with 3no. pots.
Walls	Render is in an acceptable condition. Security shutters down. 1no. large fascia over 3 units. 3no. modern air grilles
Dormers	2no. gabled dormers with 2 x 2 timber sash & case windows and timber surrounds in poor condition. Slated cheeks.
Windows	uPVC to first floor. 2x2 timber sash & Timber 2x2 sash and case in dormers.
Doors	Modern timber to commercial property
Shopfronts	Timber. uPVC sign to r.h.s.
External Pipework	uPVC gutter and downpipe

(0+2+2) 4

Recommendations:

- Carry out minor slate repairs
- Replace mortar skews
- Repair / repaint dormer timbers
- Paint render
- Replace modern grilles
- Replace uPVC windows
- Refurbish dormer timber sash and case windows
- Remove external roller shutters
- Replace shop fronts
- Install full length timber fascia and signage
- New hanging signs (x2)
- Install internal security grilles
- Replace uPVC rainwater goods with CI

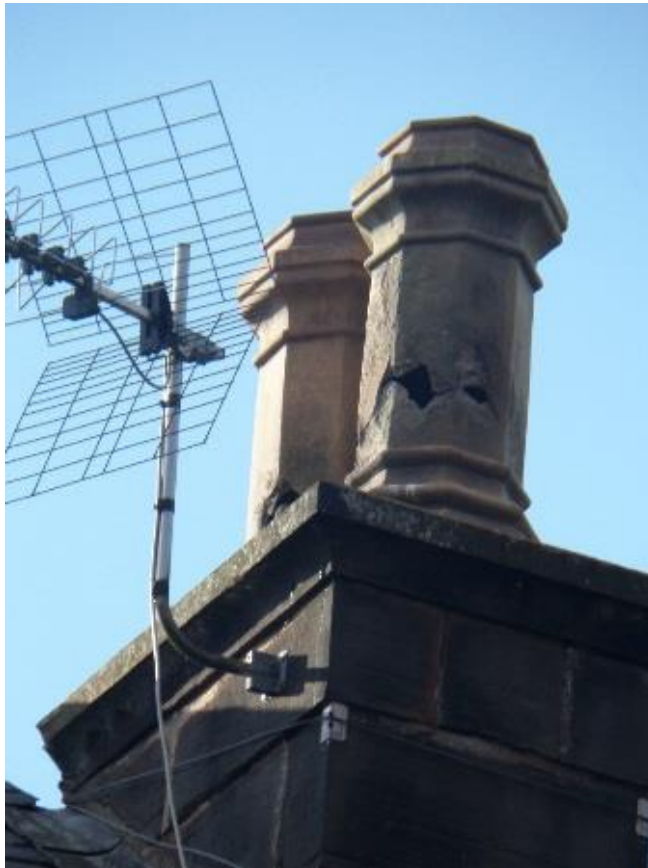
27-31 Loudoun Street
Commercial / Residential

Ground – vacant First – occupied
Restrictions	Surveyed from Loudoun Street only
Structural Issues	None apparent
Storey Height	2 - mid terrace.
Roof	Natural slate with zinc ridge and clips. 1no. mortar skew. Lead chimney flashing. 1no. copper skew putt flashing. Section of mortar skew missing.
Chimneys	Brick chimney with 3no. pots to party wall on l.h.s. Stone chimney with 2no. damaged pots to r.h.s.
Walls	Red ashlar sandstone with blonde sandstone quoins. Partially rendered. 1no. dropped lintol to l.h.s. window at first floor level. Masonry in reasonable condition. Some heavy mortar repairs around downpipe connection. Some low-level staining

(0+2+2) 4

Recommendations:

- Carry out minor slate repairs
- Replace mortar skew
- Replace damaged chimney pots
- Carry out localised stone repairs
- Replace modern grilles
- Replace shopfronts and door
- Replace uPVC gutter with CI
- Refurbish CI downpipe

- New fascia signage

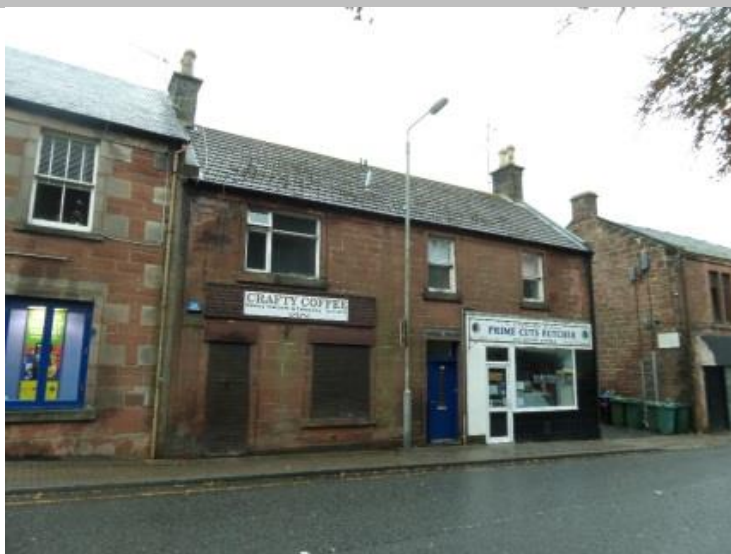
33-35 Loudoun Street

Restrictions	Surveyed from Loudoun Street only
Structural Issues	None apparent
Storey Height	2 – end terraced.
Roof	Concrete tiles and ridge. Lead skew and chimney flashings – Poor condition.
Chimneys	Stone chimney on party wall to l.h.s. with 2no. damaged pots. Same to gable on r.h.s.
Walls	Red ashlar sandstone. Central door to flats above. Movement in corner at r.h.s. crack in cill at first floor level. Some plastic repairs. Erosion at each end of gutter and at ground level.
Windows	uPVC
Doors	Modern timber partially glazed

Shopfronts	door to flats above Aluminium shopfront to l.h.s. with external shutters. uPVC to r.h.s. with ceramic tiles
External Pipework	uPVC gutter and downpipe.

Priority Score (0+2+2) 4

Recommendations:

- Reslate roof
- Replace lead skews and flashing
- Install wood core lead ridge
- Replace damaged chimney pots (see 27-31 Loudoun Street)
- Carry out localised stone repairs and repointing
- Replace modern casement
- Refurbish timber sash and case windows
- Replace doors (2no.)

- Remove external shutters
- Replace shop fronts
- Install internal security grilles
- Install new timber fascias and signage
- New hanging signs (2no.)
- Replace uPVC rainwater goods with CI

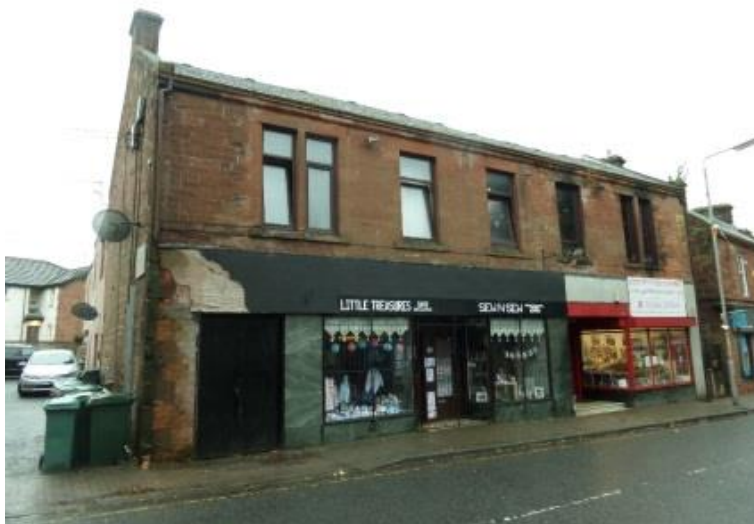
37-41 Loudoun Street

Restrictions	Surveyed from Loudoun Street only
Structural Issues	None apparent
Storey Height	2 - detached
Roof	Natural slate with zinc ridge and clips. uPVC ridge. Lead skewes and chimney flashings. Ridge vents.
Chimneys	1no. red sandstone stack to l.h.s. No pots.
Walls	Red sandstone. Cracked lintol and cill to l.h.s. window at first floor level. Masonry is heavily water damaged and stained at first floor level, particularly to r.h.s.

Open joints below gutter. Vegetation. Corner partially rebuilt in brick. 2no. iron air grilles.
Windows	uPVC
Doors	Timber vertical lined access doors to l.h.s. Unusual handles to both units, possibly Art Deco.
Shopfronts	Modern timber shopfronts. External shutters to r.h.s. Oversized fascia / poor signage. Iron security grilles.
External Pipework	Cast iron wall head gutter – requires refurbishment. 2no. uPVC downpipes.

Priority Score (0+2+2) 4

Recommendations:

- Carry out minor slate repairs
- Replace cracked cill and lintol

- Repoint below gutter line
- Carry out localised stone repairs
- Replace modern grilles
- Replace first floor windows
- Remove external shutters
- Replace shopfronts but retain doors
- Install full length timber fascia and signage
- New hanging signs (3no.)
- Replace uPVC downpipes with CI
- Refurbish CI gutter

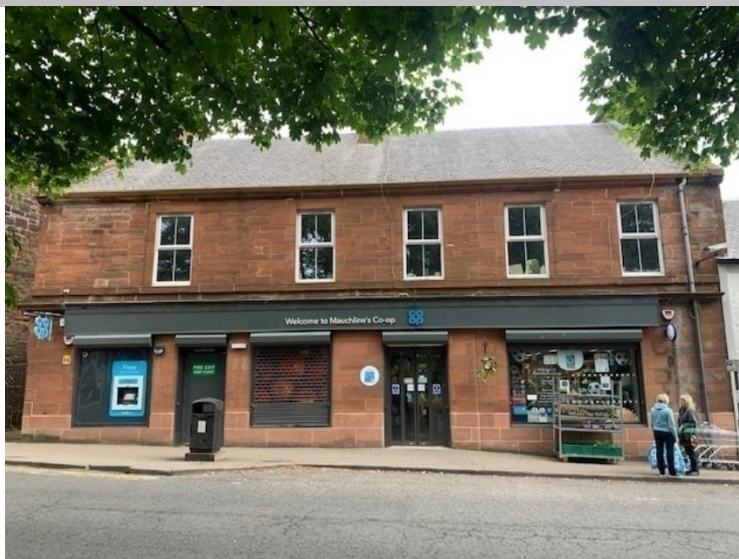
43-51 Loudoun Street The Co-op / Residential

Ground – occupied First – about to be split into flats.
Restrictions	Surveyed from Loudoun Street only
Structural Issues	None apparent
Storey Height	2 – end terrace.
Roof	Natural slate roof with zinc ridges and clips. Lead chimney flashings / mortar skews.
Chimneys	3no. red sandstone stacks. No pots
Walls	Red ashlar sandstone. Masonry is heavily eroded at base course. Staining at either end of gutter

and at downpipe. ATM.
Windows	uPVC at first floor
Doors	Bi-fold aluminium entrance door. Painted blank escape door.
Shopfronts	External security shutters. Timber shopfronts and fascia. Bi-folding aluminium doors
External Pipework	Cast iron wall head gutter and downpipe.

Priority Score (0+2+1) 3

- Carry out minor slate repairs
- Replace mortar skews
- Carry out stone indenting below cill line for full length of elevation
- Remove external shutters
- Install internal security shutters
- New hanging sign (1no.)
- Replace escape door
- Refurbish CI rainwater goods

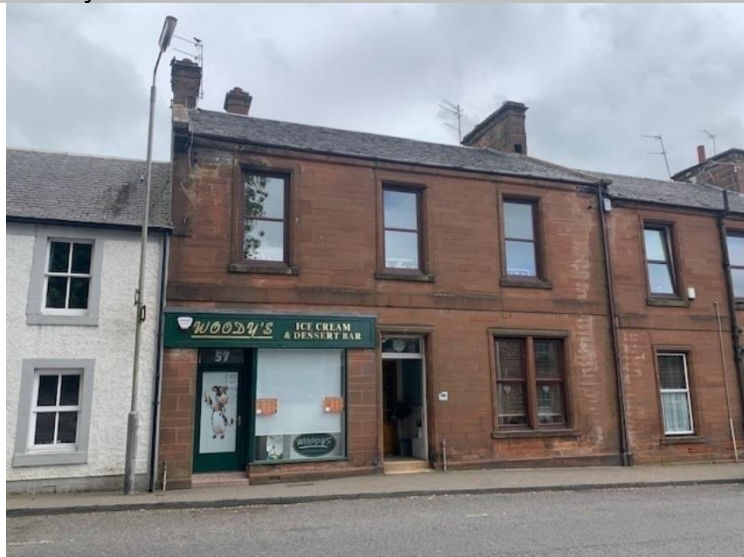
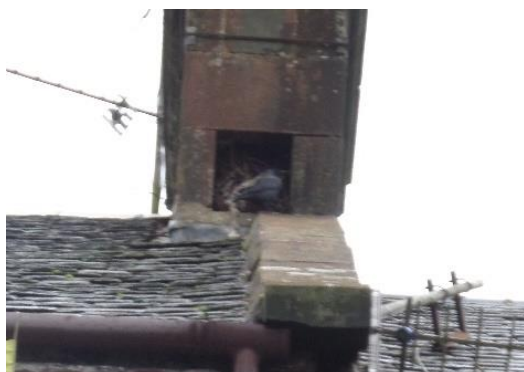
57-59 Loudoun Street

Restrictions Surveyed from Loudoun Street only

Structural Issues None apparent

Chimneys Red sandstone chimneys at each end. 1 no pot to l.h.s. Additional chimney evident at rear. Stone missing from stack on r.h.s.

- Carry out minor slate repairs
- Replace mortar skews
- Replace missing stone to stack
- Carry out localised stone repairs and repointing
- Replace modern grille
- Replace uPVC windows
- Refurbish storm doors and fanlight
- Replace uPVC rainwater goods with CI

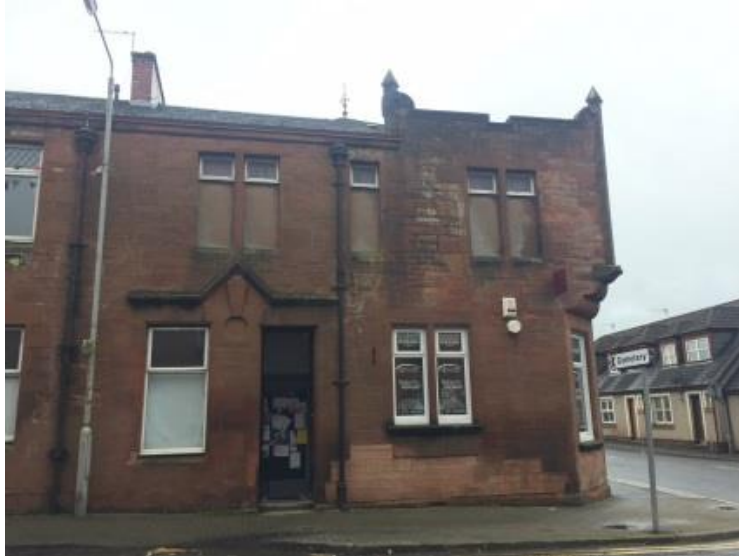
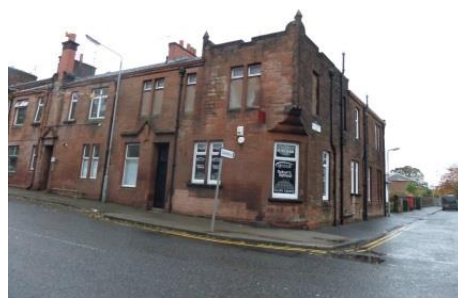
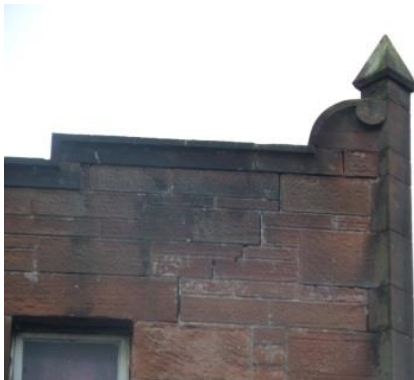
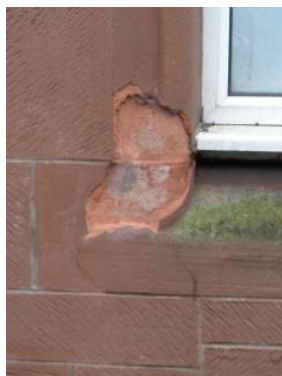
65 Loudoun Street

Restrictions Surveyed from Loudoun Street and Barskimming Road only.

Structural Issues Crack in lintol at ground floor window. Some movement evident in parapet at corner.

Chimneys Red brick chimney at party wall with 4no. terracotta cans.

Walls Red sandstone. Squared ashlar chamfered corner with corbelled corner projection. Castellated parapet detail at corner with stone finials. Decorative iron roof finial. Some damp staining. Extensive indents at ground floor level. Additional indents and repointing required. 1no. partially covered

ornate cast iron grille.
Windows	uPVC. First floor windows have partially been blocked up.
Doors	Panelled timber door with Georgian wire fanlight
External Pipework	<u>Loudoun Street</u> - Cast iron wall head gutter, 1no. and 1 shared cast iron downpipe with decorative hoppers and ears. Shared downpipe showing evidence of damage. Damaged stonework and 2 ears broken. <u>Barskimming Road</u> - 1no. cast iron downpipe with decorative hopper and 1no. cast iron vent stack both with decorative ears.
Priority Score	(0+2+3) 5

- Carry out structural inspection & any recommended remedial repairs
- Carry out minor slate repairs
- Replace lead parapet gutter
- Carry out stone repairs
- Repoint
- Replace uPVC windows
- Open up first floor windows and install new timber sash and case windows
- Refurbish door
- Refurbish CI rainwater goods

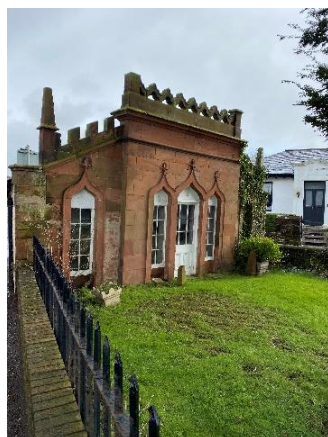
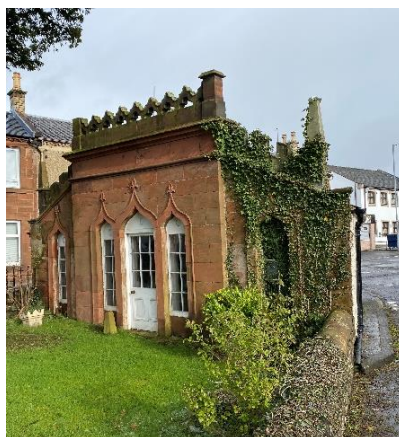
25 Mansefield Road
Residential (Springfield)

Summer House Category B Listed	Occupied
Restrictions	Survey restricted due to driveway
Structural Issues	None apparent
Storey Height	2 – detached.
Roof	Pitched roof with straight skews. Natural slate with zinc ridge and clips. Lead skews, partial cappings, chimney flashings and parapet flashings. 2no. cast iron rooflights – refurbish.
Chimneys	Red brick chimney with 4no. decorative pots to l.h.s and to r.h.s.
Walls	Red ashlar sandstone to principal elevation. Frontage masonry appears in good condition. Gable requires some stone repairs/repointing. 2no. modern louvred air grilles.
Windows	uPVC. Timber casements to summerhouse.
Doors	Timber storm doors with fanlight. Timber half glazed door to Summer House.
External Pipework	Parapet gutter
Priority Score Main House	(0+2+1) 3
Priority Score Summer House	(2+2+2) 6

- Carry out minor slate repairs
- Refurbish roof lights
- Carry out stone repairs / repointing to gable
- Replace modern grilles
- Replace windows
- Refurbish door
- Repoint stonework to Summer House
- Refurbish windows and door to Summer House.

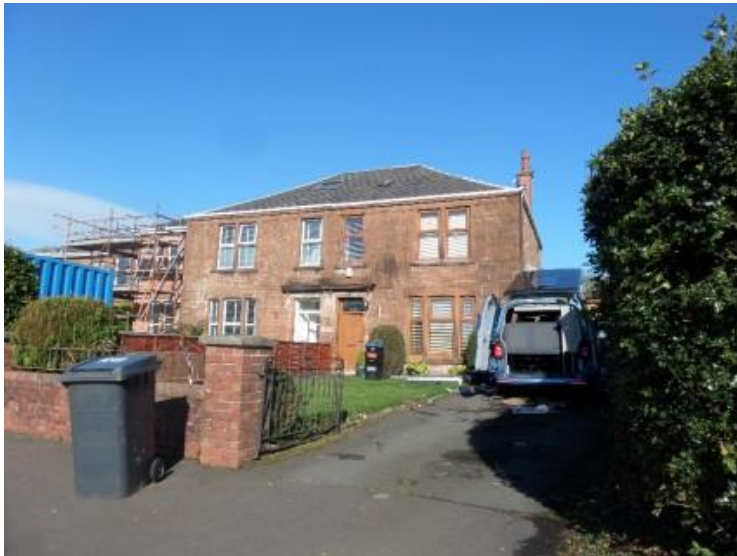
2-4 Tanfield Residential

Occupied	
Restrictions	Restricted visibility due to driveways.
Structural Issues	None apparent.
Storey Height	2 – 2 semi-detached.
Roof	Natural slate with zinc ridges and clips. Lead chimney flashings.
Chimneys	Red brick chimney to r.h.s. with 1no. pot.
Walls	Red ashlar sandstone. Masonry appears in good condition. Air bricks not

1 house has very recent side extension.

- Minor slate repairs
- Refurbish CI roof light
- Replace windows
- Replace doors
- Replace uPVC rainwater goods with CI

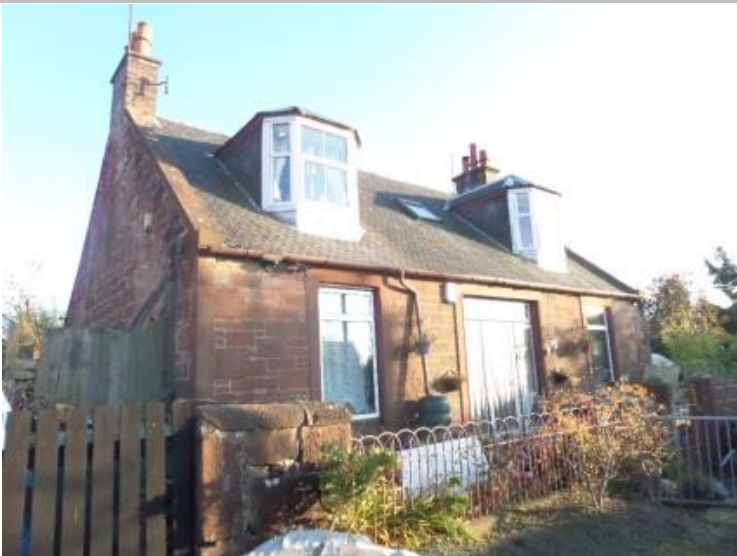
elevation in reasonably good condition. Heavy erosion and over pointing on gable. Air bricks not visible.
Dormers	uPVC windows. Hipped slate roofs and slated cheeks. Timber below windows requires refinishing.
Windows	uPVC windows and dormer window. Modern Velux.
Doors	Aluminium door, side lights and fan light.
External Pipework	uPVC gutters and downpipes (2no.). Water butt

- Minor slate repairs
- Replace mortar skews

- Make stone repairs and repoint gable
- Repaint / repair dormer timbers
- Replace windows
- Replace door and fanlight
- Replace uPVC rainwater goods with CI

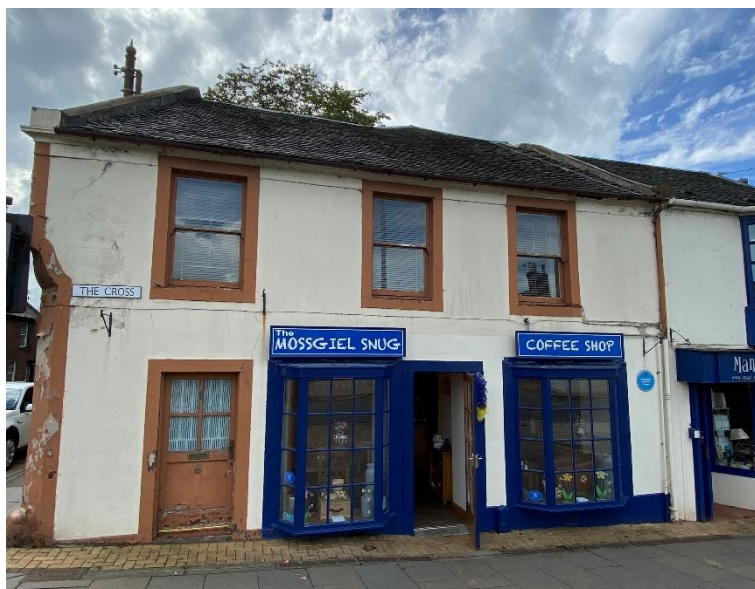
The Mossgeil Snug / Residential

Ground – occupied First - occupies
Restrictions	Surveyed from The Cross only
Structural Issues	None apparent
Storey Height	2 – corner terrace.
Roof	Slate roof with zinc ridge and clips. Mortar skewers.
Chimneys	n/a

- Carry out minor slate repairs
- Replace mortar skews
- Repaint render
- Refurbish timber sash and case windows
- Replace door to flat
- Paint shopfront and fascia's
- Refurbish CI rainwater goods
- New hanging sign

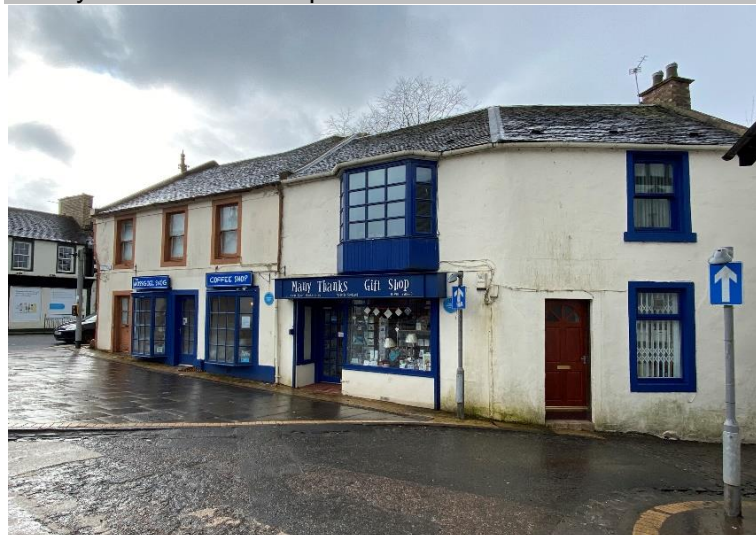
3-5 The Cross

Doors	Modern glazed door to gift shop. Panelled timber door to Flat 3a.
Shopfronts	Timber shopfront with fascia. Recessed doorway. External security shutter.
External Pipework	uPVC gutter. uPVC downpipe discharging into gutter of adjoining property.

Priority Score (0+2+1) 3

- Carry out minor slate repairs
- Replace mortar skew

- Repaint render
- Refurbish timber sash and case windows
- Replace timber casement
- Replace door to flat
- Paint shopfront, bow window and timber fascia's
- Refurbish CI rainwater goods
- Install new CI downpipe with new below ground connection
- Install internal security shutter
- New hanging sign
