Mauchline Conservation Area Management and Maintenance Plan

Prepared for East Ayrshire Council
by
Wylie Shanks Architects

Adopted 27.03.2023

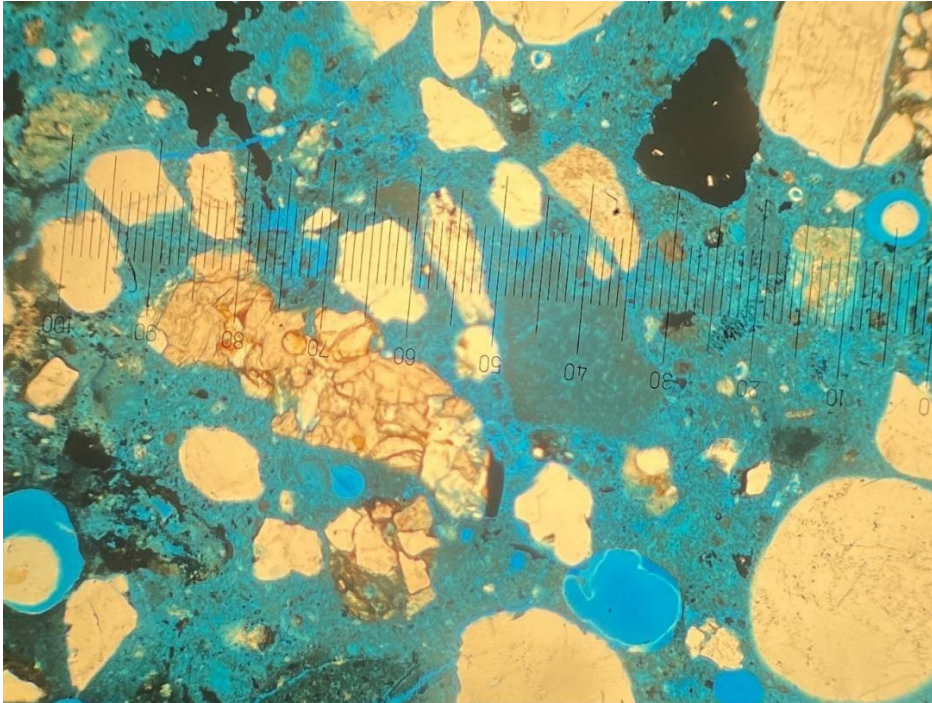
Figure 2. Thin section of the sample under plane polarised light. Pore spaces are highlighted in bright blue, while areas of dark/dull blue indicate the lime binder that has absorbed some of the blue dye. The binder is predominately heterogeneous throughout the sample. Image showing a typical view of large rounded aggregate grains and carbonated binder.

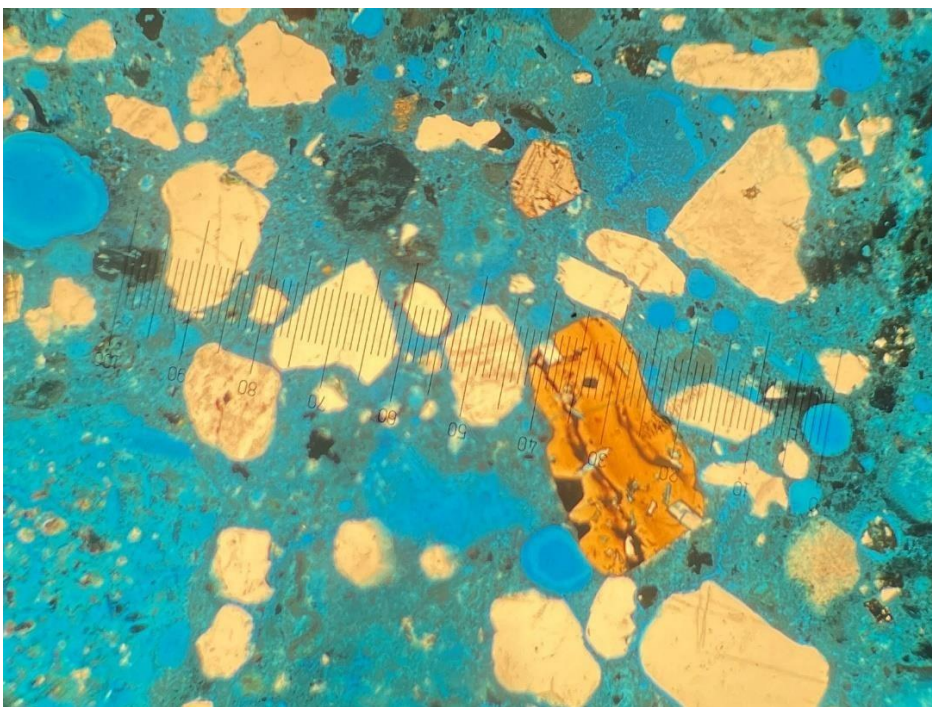
Figure 3. Thin section of the sample under plane polarised light. Pore spaces are highlighted in bright blue, while areas of dark/dull blue indicate the lime binder that has absorbed some of the blue dye. This image shows an area of the binder with a high proportion of opaque, amorphous material.

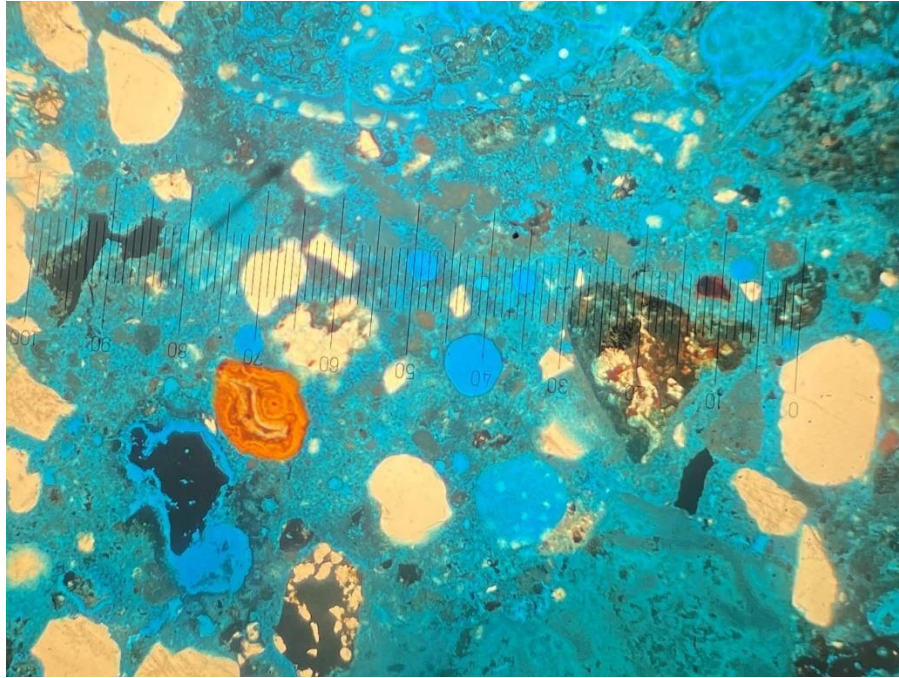
Figure 4. Thin section of the sample under plane polarised light. Pore spaces are highlighted in bright blue, while areas of dark/dull blue indicate the lime binder that has absorbed some of the blue dye. Most lime inclusions show a diffuse contact with the surrounding paste (highlighted by red arrow).

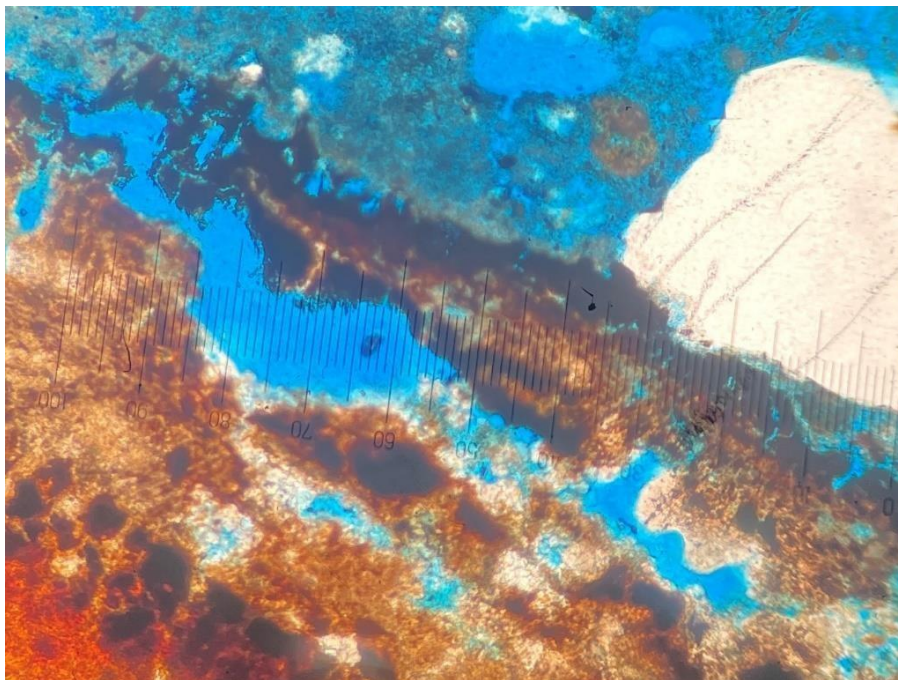
Figure 5. Thin section of the sample under plane polarised light. Pore spaces are highlighted in bright blue, while areas of dark/dull blue indicate the lime binder that has absorbed some of the blue dye). Microcracks in some areas are lined by secondary binder products - evidence of abundant binder leaching and dissolution, highlighted by red arrows.

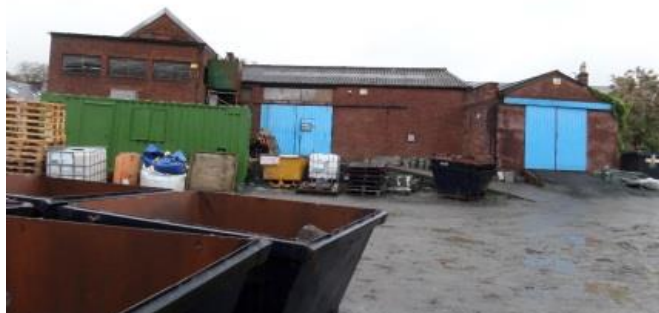
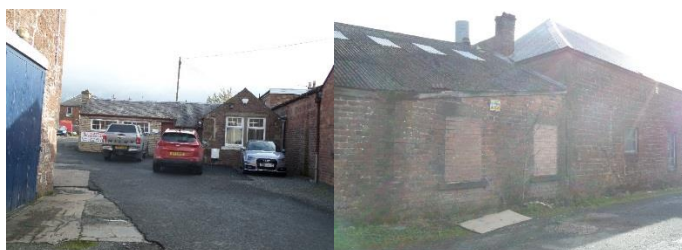
Restrictions	Surveyed from fence line on Barskimming Road only
Structural Issues	None apparent
Storey Height	1
Roof	Predominantly profiled metal sheets. Natural slate with zinc ridge and clips to the rear. Possible asbestos roof?

- Make minor slate repairs to rear extension
- Replace windows
- Refurbish existing CI rainwater goods
- Install new CI rainwater goods
-

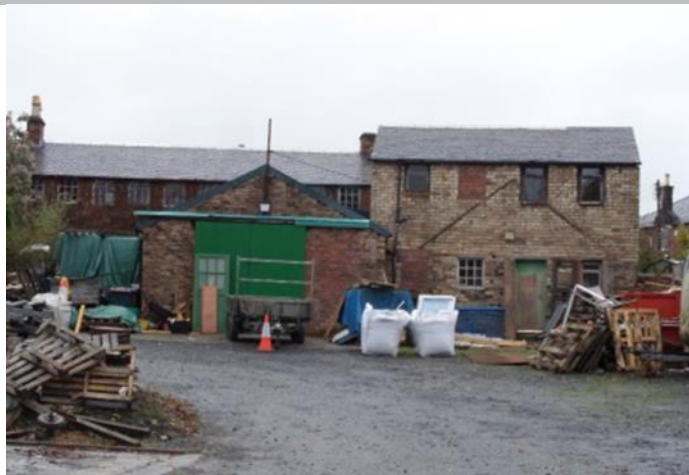
17 Barskimming Road

Chimneys	Red brick. No pots.
Walls	Original building red sandstone rubble. Later extensions in red brick with stone cills and quoins, and buff brick.
Windows	Combination of timber casements and uPVC. A number of blocked up openings.
Doors	Not visible.
External Pipework	Cast iron to the rear. None to the front.

- Carry out structural inspection & any recommended remedial repairs
- Carry out minor slate repairs
- Repoint brickwork
- Replace windows
- Replace door
- Replace uPVC rainwater goods with CI

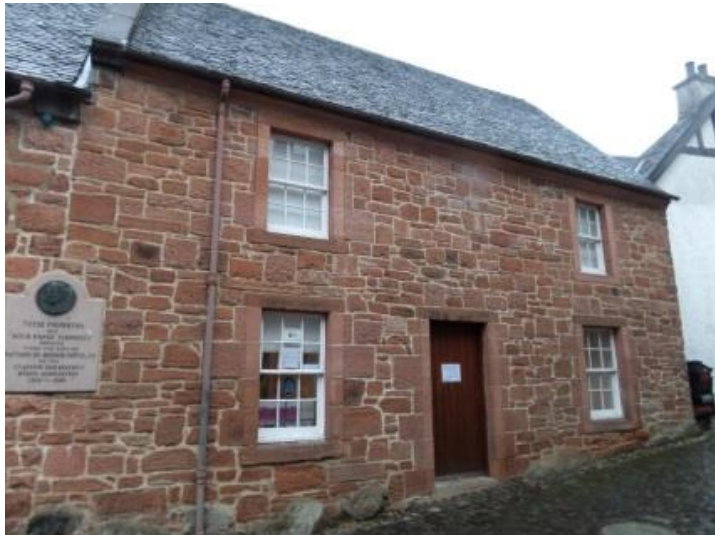
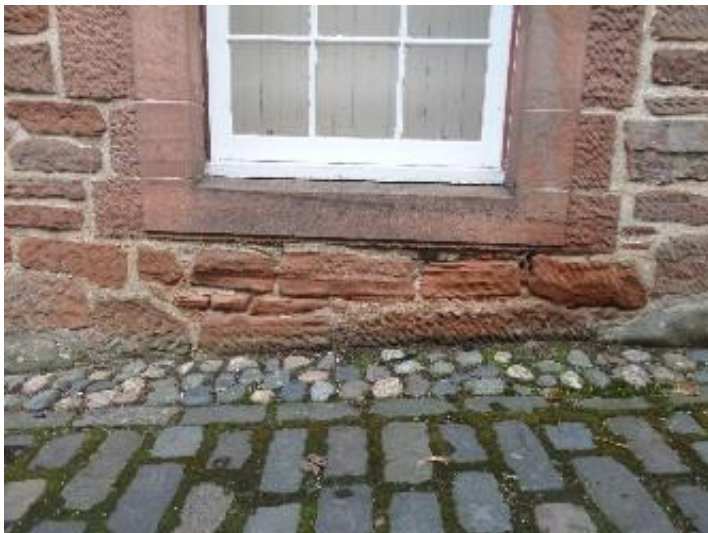
Part of Burns Museum

Category B Listed	Occupied
Restrictions	Surveyed from Castle Street only.
Structural Issues	None apparent.
Storey Height	2 - end terrace.
Roof	Natural slate with lead ridge flashing and clips. Stepped lead soakers / mortar at chimney.
Chimneys	At party wall. Red

- Clear vegetation from chimney and mortar verge and repoint
- Carry out localised stone repairs and repoint below window
- Reseal around windows
- Refurbish cast iron rainwater goods

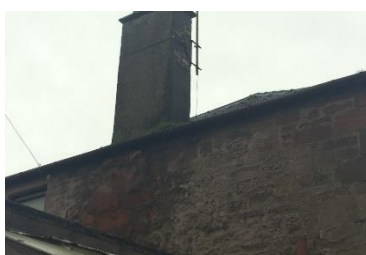
5 Cowgate Residential

Restrictions	Surveyed from Cowgate and also gable ends.
Structural Issues	None apparent.
Storey Height	2 - detached
Roof	Hipped roof. Natural slate with zinc ridges and clips. No skews. Assume lead chimney flashing
Chimneys	Brick chimneys to l.h.s. and r.h.s. each with 2no. decorative cans.
Walls	Squared red sandstone rubble with ashlar window dressings and door surround. Street frontage requires repointing. Erosion below windows. Dry dash on l.h. gable. Heavy stone erosion along flue line on r.h. gable. 1no. modern grille. Recess for shoe scraper – ironwork missing.
Windows	Modern timber.
Doors	Modern door blank with vision panels.

External Pipework	Fanlight boarded over.
	uPVC gutter to main elevation. Gutter missing on gable.

- Carry out minor slate repairs
- Repoint main elevation and r.h. gable
- Carry out stone repairs below windows and on r.h. gable end
- Remove dry dash from l.h. gable, repoint and re-render with lime-based product
- Replace modern vent

- Replace windows
- Replace door and fanlight
- Replace uPVC gutters with CI
- Install 2no. new CI downpipes.
- Replace ironwork to shoe scraper

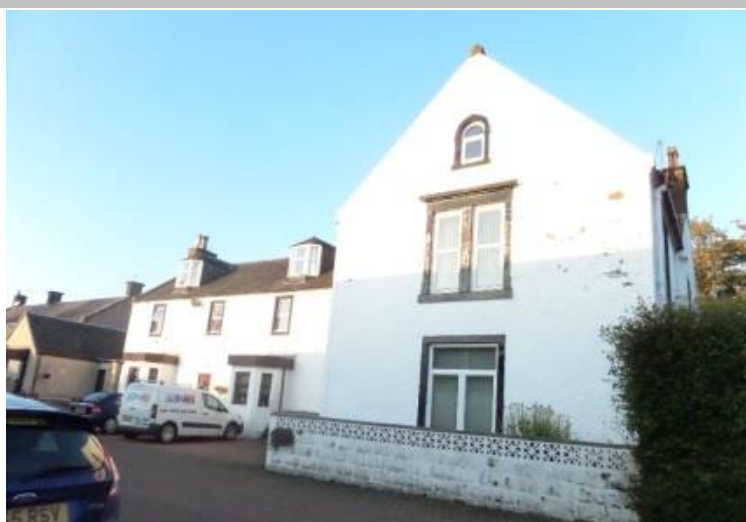
6A Cumnock Road / 6 Grove Park

Ground – occupied First – occupied Second - occupied
Restrictions	Surveyed from Grove Park/Cumnock Road only.
Structural Issues	None apparent
Storey Height	2 – 2 x semi detached
Roof	Polygonal dormer windows. and roof lights. Natural slate with zinc ridge and clips. Mortar skews. Lead valleys and chimney flashings.
Chimneys	1no. stone stack with 3no. ornamental pots. 1no. stone ridge stack with no pots. 1no. stone stack with 2no. ornamental cans. 1no. stone stack with 3no. ornamental cans.
Walls	Painted masonry - requires repainting. Modern air bricks.
Windows	uPVC
Doors	uPVC

- Carry out minor slate repairs
- Replace mortar skews
- Repaint masonry (all elevations)
- Replace modern vents
- Replace windows
- Replace doors
- Replace uPVC rainwater goods with CI
- Refurbish CI rainwater goods

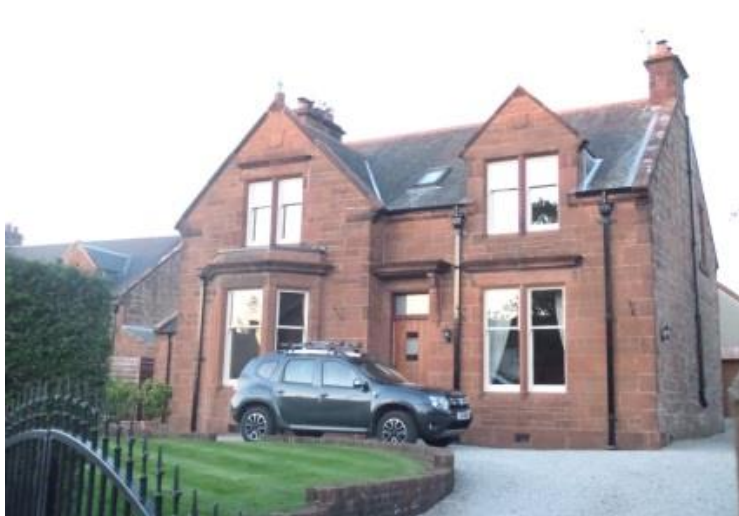
Residential - Willowbank

Restricted survey
due to driveway.

- Carry out minor slate repairs
- Refurbish timber sash and case windows
- Replace door and fanlight
- Refurbish CI rainwater goods

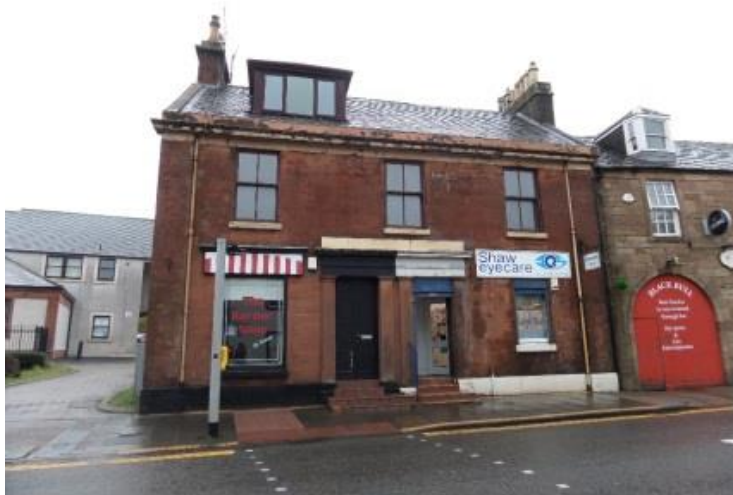
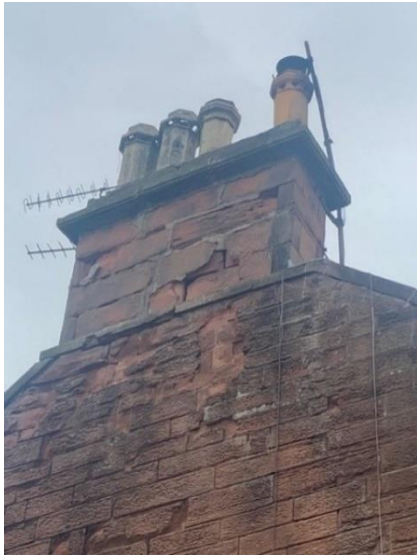
1-3 Earl Grey Street

Restrictions	Ground – occupied First – occupied Second - occupied Surveyed from Earl Grey Street only.
Structural Issues	LH chimney leaning / heavily eroded stonework.
Storey Height	2 – end terrace.
Roof	Natural slate pitched roof with straight skewes. Box roof dormer. Ridge needs replaced. Lead skewes / chimney / dormer flashings. Parapet gutter.
Chimneys	Stone stack with 4no. ornate pots to l.h.s. Stone stack with 8no. pots on party

Walls	wall. Red ashlar sandstone. Masonry has heavy staining/erosion to parapet. Some damp below window to r.h.s.
Windows	3no. modern timber sash & case with horns at first floor level. uPVC in dormer.
Doors	Timber storm doors to l.h.s. Door to r.h.s. obscured by roller shutter.
Shopfronts	Timber shopfront to l.h.s with dentil moulded fascia. uPVC to r.h.s with external security shutter. Tiled steps with original iron boot scrape on top step.
External Pipework	2no. cast iron downpipes – both require refurbishment.

Priority Score (0+2+2) 4

- Carry out minor slate repair
- Replace ridge with wood core lead roll and clips
- Allow for replacing lead parapet flashings
- Repoint along cornice line
- Refurbish CI rainwater goods
- Remove external roller shutters and replace with internal security grille to window.
- Replace dormer window
- Repaint sash and case windows
- Repaint timber shop front to l.h.s and timber fascia
- Replace window to r.h.s
- Refurbish existing storm doors
- Install new storm doors to r.h.s
- Install new fascia to r.h.s. to match l.h.s
- Paint stone pediment over doors
- New fascia signs and hanging signs (x2)
- Existing steps and original iron boot scrape to be retained and refurbished.

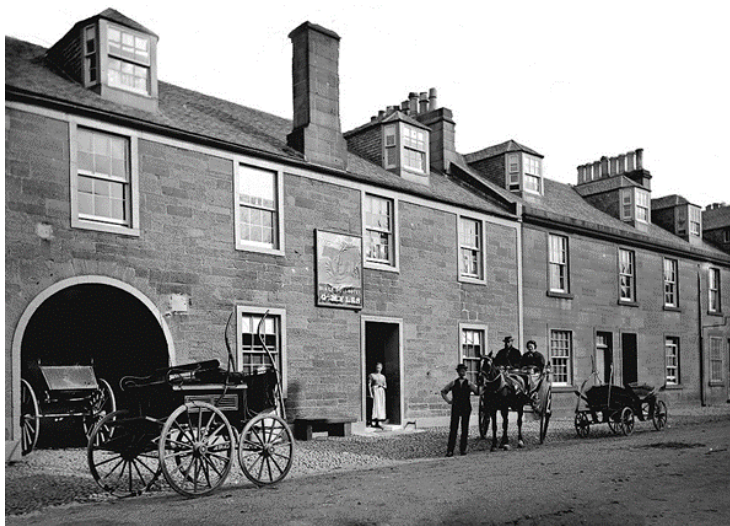
8-16 Earl Grey Street
Kilmarnock Supporters Club

and also to r.h.s. Squared blonde sandstone rubble. Masonry appears in reasonable condition. Some damp staining around downpipe at l.h.s. Arched pend access to rear.

- Carry out minor slate repairs
- Replace mortar skews
- Replace first floor and dormer windows
- Refurbish timber sash and case windows
- Refurbish storm doors
- Refurbish CI rainwater goods
- New hanging sign

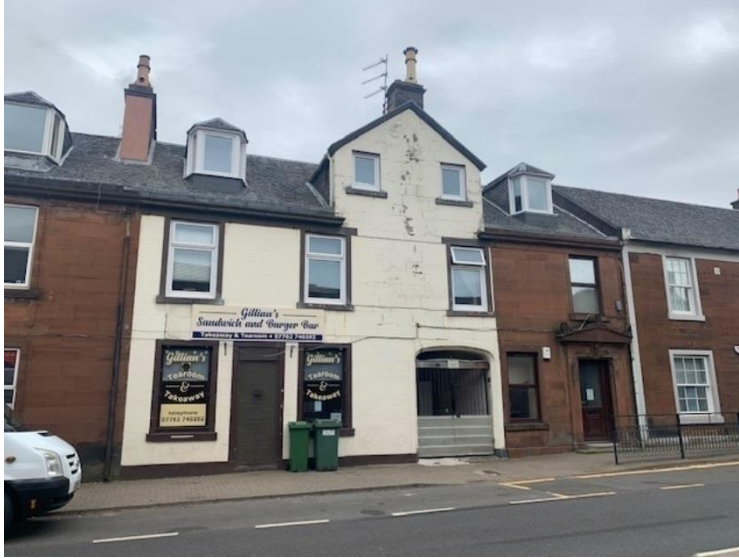
Restrictions	Surveyed from Earl Grey Street only.
Structural Issues	None apparent
Storey Height	2 – mid terrace.
Roof	Pitched roof. Gable dormer plus 1no. hipped dormer. Natural slate with lead ridge. Lead chimney / dormer / parapet flashings. Parapet gutters blocked. Plastic dormer apron flashings.
Chimneys	Red sandstone stack on party wall to l.h.s. 9no. ornate pots -1no. heavily damaged/taped up. 1no. stack on wall head dormer with 1no. pot.
Walls	Painted masonry – requires repainting. 2no. ornate air grilles – over painted. Pend access to rear.
Windows	uPVC.
Doors	Modern glazed timber door. No storm doors.
External Pipework	n/a
Priority Score	(0+2+1) 3

- Carry out minor slate repairs
- Replace heavily damaged terracotta chimney pot
- Replace dormer flashings with lead
- Repaint masonry / ideally remove paint
- Replace windows
- Remove roller shutter
- Install storm doors
- New fascia signage

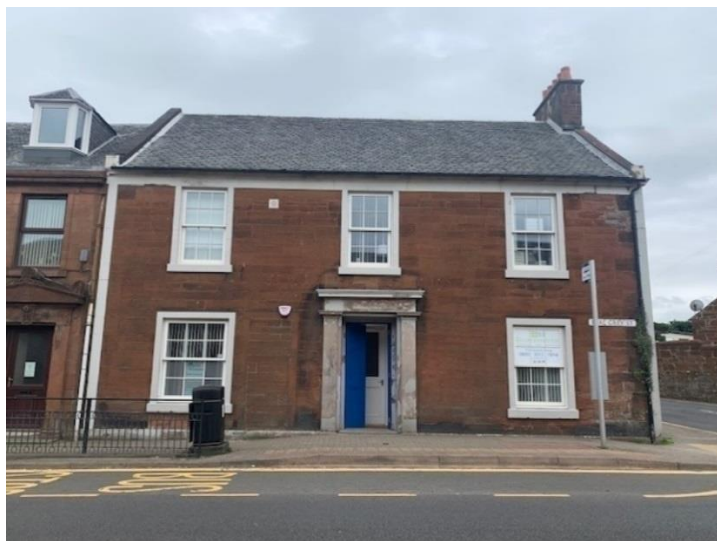
Former bank - Sophie Wasamer Health & Wellbeing / S3
Environmental / Accessory Boutique

Restrictions	Surveyed from Earl Grey Street / Mansfield Road only.
Structural Issues	None apparent.
Storey Height	2 – end terrace.
Roof	Pitched roof with straight skews. Natural slate with zinc ridge and clips. Lead skews and chimney flashing.
Chimneys	Red sandstone chimney to r.h.s. with 5no. terracotta pots.
Walls	Red squared rubble sandstone with painted ashlar window and door surrounds. Some erosion at corner adjacent to downpipe. Minor repairs required. 3no. modern air grilles.
Windows	3no. 6x6 timber sash & case windows at first floor level on Earl Grey Street, no horns. 1no. 6x6 timber sash & case window at first floor level on Mansfield Road, no horns. 2no. modern timber windows at ground floor level on Earl Grey Street. 1no. modern timber window at ground floor level on Mansfield Road.

Doors	Panelled storm doors
External Pipework	Cast iron half round gutter and cast-iron downpipe. Requires refurbishment.
Priority Score	(0+2+2) 4

- Carry out minor slate repairs
- Carry out stone repairs at r.h.s and repoint
- Replace modern grilles
- Refurbish CI rainwater goods

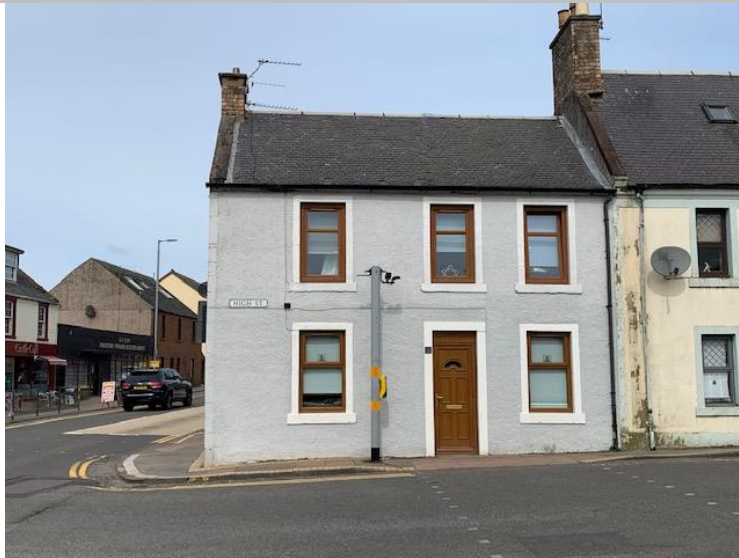
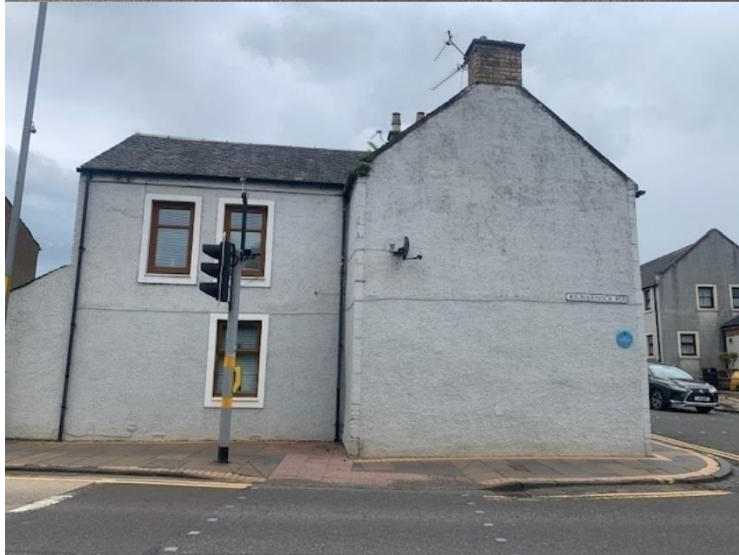
1 High Street

Restrictions	First – occupied Surveyed from High Street/Kilmarnock Road only.
Structural Issues	None apparent
Storey Height	2 – end terrace.
Roof	Natural slate with zinc ridge and clips. Some loose slates evident on High Street. Lead skew flashings No flashing visible at chimney. Timber fascia board (modern addition) requires painting.
Chimneys	Brick chimney on corner gable. No pots. Flue vent.
Walls	Rendered with painted ashlar dressings around windows and doors. Some cracking in wet dash render on Kilmarnock Road elevation. Modern painted terracotta brick vents onto Kilmarnock Road.
Windows	uPVC
Doors	uPVC door.
External Pipework	Kilmarnock Road – uPVC gutter and 2no. uPVC downpipes. High Street – Damp at skew putt. uPVC gutter and 1no. uPVC downpipe.
Priority Score	(0+2+1) 3

- Carry out slate repairs
- Allow for installing chimney flashings
- Remove cementitious render, repoint and re-render with a lime based product
- Replace modern vents
- Repaint timber fascias
- Replace windows
- Replace door
- Replace uPVC rainwater goods with CI

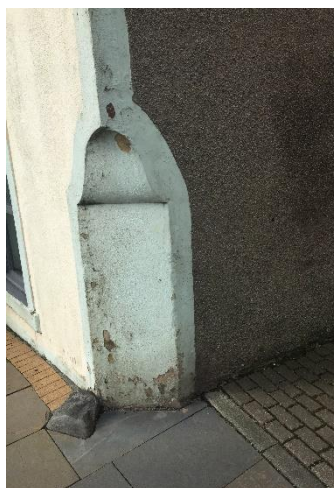
3 High Street
Residential

Category B Listed	Ground – occupied First – occupied
Restrictions	Surveyed from High Street only
Structural Issues	Chimney to l.h.s appears to be leaning.
Storey Height	2 – end terrace
Roof	Slate with zinc ridges and straps. Lead chimney flashings. Mortar skews. Modern in-line roof lights.
Chimneys	Brick chimney to l.h.s with 4no. pots. Rendered chimney to r.h.s. No pots.
Walls	Painted smooth render to High Street. Dry dash render to gable.
Windows	uPVC
Doors	Modern timber panelled door
External Pipework	Cast iron cutter. uPVC downpipe.

Priority Score (2+3+2) 7

- Check chimney stability
- Carry out minor slate repairs
- Replace flashings and skews
- Remove cementitious render, repoint and re-render with a lime based product
- Remove paint from window and door surrounds
- Replace windows
- Replace door
- Replace uPVC rainwater goods with CI

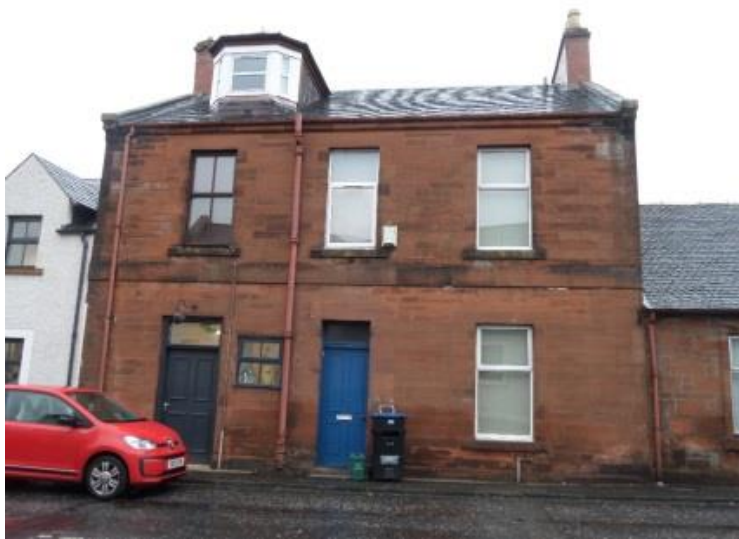
Farm Services / Residential

Ground – occupied First – occupied Second – uncertain
Restrictions	Surveyed from High Street only.
Structural Issues	None apparent
Storey Height	2 – mid terrace.
Roof	Modern slate with zinc ridge and clips. Lead skew and chimney flashings. Polygonal dormer.
Chimneys	Brick chimneys to each end. No pots to l.h.s. 8no original pots to r.h.s.
Walls	No structural

- Carry out minor slate repairs
- Replace uPVC windws
- Replace modern timber casement windows
- Replace doors (2no.)
- Refurbish CI rainwater goods

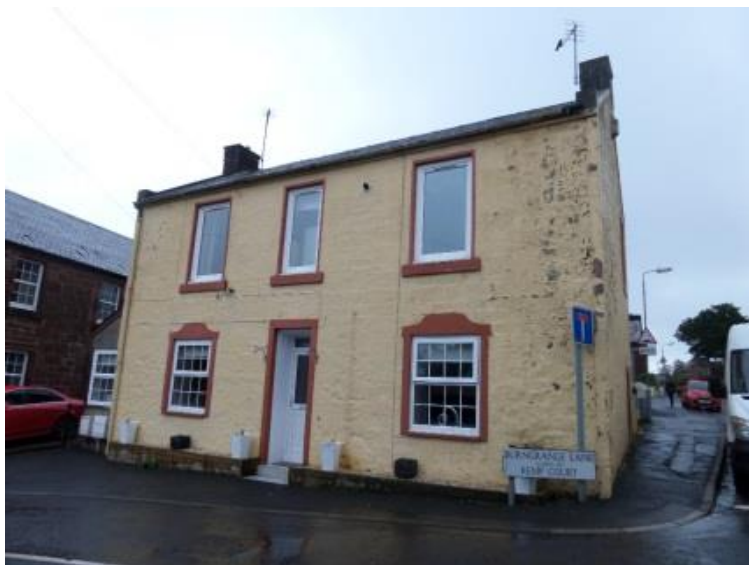
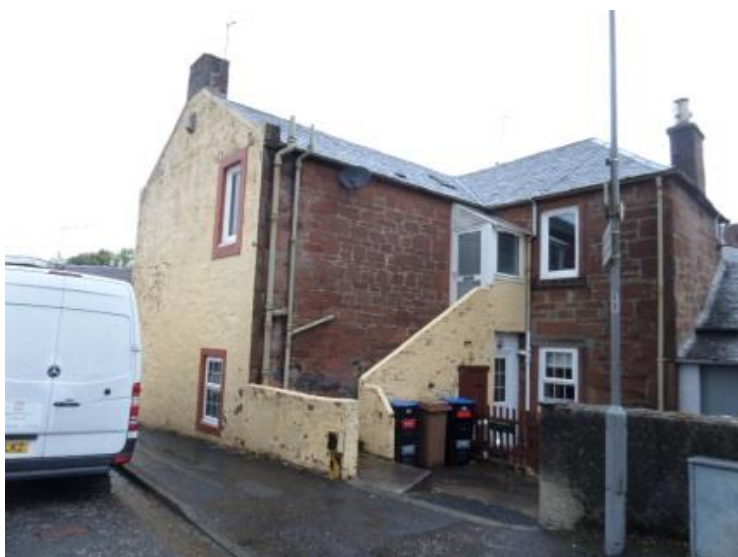
Restrictions	Surveyed from Burngrange Lane & High Street only.
--------------	---

Structural Issues	None apparent
Storey Height	2- semi-detached.
Roof	Natural slate with zinc ridge and clips. Leaded skews and chimney flashing.
Chimneys	2no.masonry gable stacks, no pots to Burngrange Lane. 1no. masonry wall head stack with 1no. pot to High Street.
Walls	Painted masonry to street frontages. Squared red sandstone rubble to visible internal faces. Ashlar door and window surrounds. Heavy cement mortar pointing where masonry visible. Paint flaking.
Windows	10no. uPVC
Doors	2no. uPVC doors, main door with fanlight.
External Pipework	Burngrange Lane - uPVC half round gutter and cast-iron downpipe with uPVC connection – Refurb. High Street - Cast iron half round gutters, 1no. cast iron downpipe and 3no. cast iron vent stacks (1no. with uPVC top section).

- Carry out minor slate repairs
- Repaint masonry
- Repoint stonework
- Replace uPVC windows
- Replace doors and fanlight
- Refurbish CI rainwater goods
- Replace uPVC section with CI

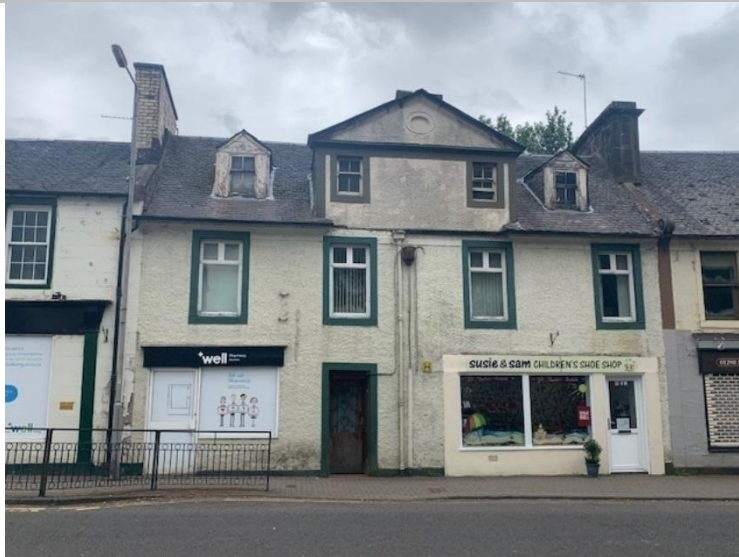
5-7 Loudoun Street

Category B Listed	Ground – occupied First – occupied Second – occupied
Restrictions	Surveyed from Loudoun Street only.
Structural Issues	No issues apparent.
Storey Height	2.5 – mid terraced with wall head gable and 2no. gabled dormers.
Roof	Natural slate with zinc ridge and clips. Mortar skewes. Lead flashings to dormers. The dormers have timber surrounds and 2 over 2 sash & case windows in poor condition. Slated cheeks.
Chimneys	Stone chimney on party wall to r.h.s. No pots. Brick chimney to party wall on l.h.s. No pots.
Walls	Wet dash. Requires repainting.

Damage where section of gutter has been removed. 1no. modern grille below florist window.
Windows	Modern timber casements at first floor. Timber sash & case in dormers.
Doors	Aluminium door to Pharmacy. Modern half glazed blank to flats. uPVC door to Florist.
Shopfronts	Timber shopfront, modern fascia to shoe shop. Aluminium shopfront, traditional fascia to Pharmacy.
External Pipework	Cast iron half round gutter. Cast iron downpipe with hopper. Gutter needs refurbishing.

- Carry out minor slate repairs
- Replace mortar skewes
- Replace dormer timbers
- Make render repairs and repaint render
- Replace modern grille
- Refurbish timber sash and case windows
- Replace modern timber casements
- New modern fascia to show shops

- New timber fascia above florist with new signage (r.h.s shop unit only)
- New hanging sign
- Reinstall missing section of CI gutter
- Refurbish CI rainwater goods
- Tidy up and consider re-locating electrical boxes, and associated cabling.

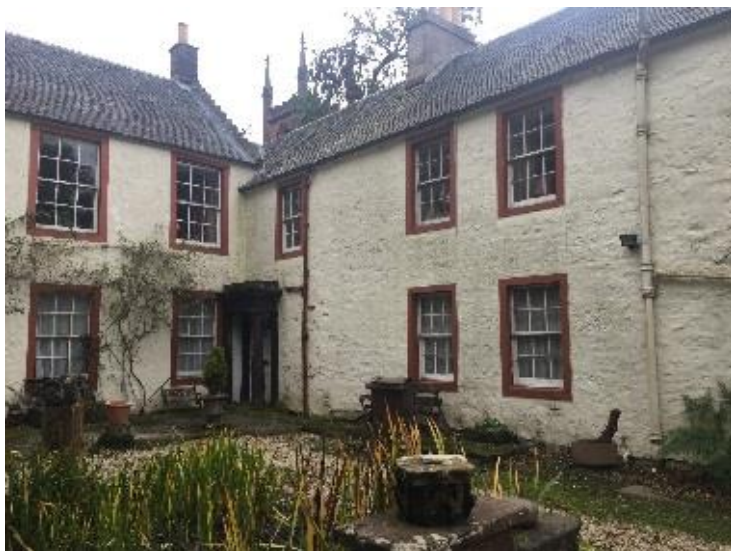
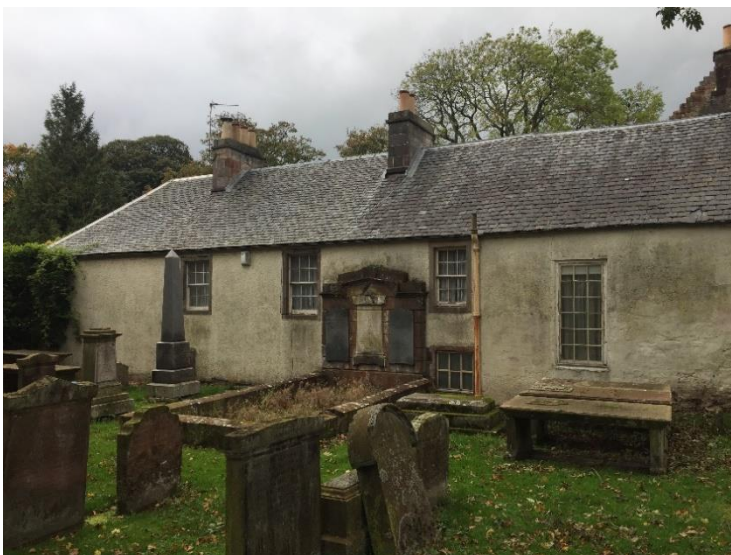
8 Loudoun Street
Gavin Hamilton's House
 Residential

Structural Issues	Localised areas of bulging in external walls. Localised distortion on ridge line. Structural survey carried out 2018.
Storey Height Roof	2 – detached Slate, hipped gable to west
Chimneys	5no. stone chimney stacks and 1 brick chimney stack.
Walls	Painted masonry. Wet dash render to south and east elevations
Windows	Original timber sash and case
Doors	Timber panelled
External Pipework	Cast iron downpipes generally, uPVC downpipe on west elevation

- Stabilise stonework in accordance with Structural Engineer's recommendations and repoint.
- Carry out inspection of roof timbers
- Carry out slate repairs
- Replace mortar skews
- Remove paint from masonry & re-paint with breathable product
- Remove existing render, repoint & re-render with lime-based product
- Repair and refurbish sash and case windows
- Refurbish timber panelled doors
- Replace uPVC downpipe with CI.
- Refurbish CI rainwater goods & replace missing section

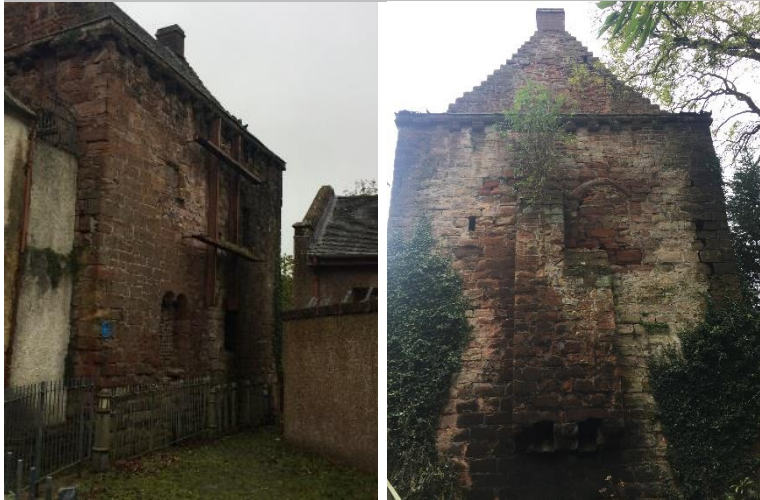
Abbot Hunter's Tower (Castle)		Category A Listed	Unoccupied

Restrictions		Limited access
	Structural Issues		Structural cracks with ongoing movement. Previous bracing carried out. Loose corbie stones. Defective stone lintols. Structural survey carried out 2018 (restricted access) Tower recommended to BARR.
Recommendations: <ul style="list-style-type: none"> • Stabilise stonework in accordance with Structural Engineer's recommendations and repoint. • Extensive slate repairs / re-slate • Remove plant growth • Replace internal and external stone lintols • Reinstate floor at first floor level 	Roof		Slate with lead ridge and lead skew flashings. Rooflight. Lead capping at parapet.
	Chimneys		Stone stack to north gable. No pot.
	Walls		Red sandstone rubble.
	Windows		Various blocked up openings, some with dressed surrounds.
	Doors		Timber
	External Pipework		None
Castle Priority Score			(3+3+3) 9

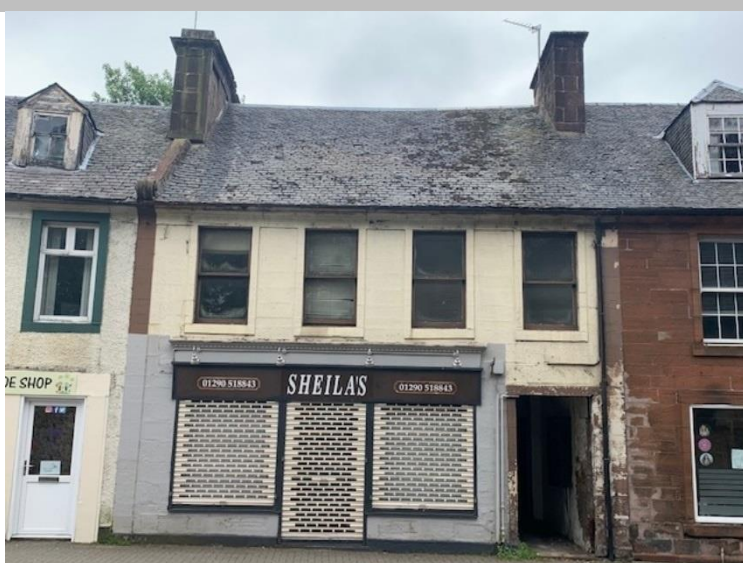
9-11 Loudoun Street
Sheila's / Residential

Category B Listed	Ground – vacant First – vacant (Dangerous buildings notice to first floor flat)
Restrictions	Surveyed from Loudoun Street only.
Structural Issues	None apparent.
Storey Height	2 – mid terraced.
Roof	Natural slate with zinc ridge and clips. Mortar skews.
Chimneys	Stone stack on party wall to l.h.s., no pots. Stone stack on party wall to r.h.s., 1 pot.
Walls	Painted ashlar. Requires repainting. Scrolled skew putts. Pend access to flats above.
Windows	4no. timber sash and case at first floor level.
Doors	Glazed timber. Door to close missing.
Shopfronts	Timber shopfront. External grilles. Dentil moulded cornice to timber fascia.
External Pipework	Cast iron half round gutter - requires repainting – connecting into

shared uPVC down pipe.

- Carry out minor slate repairs
- Replace mortar skews
- Repaint stonework
- Refurbish timber sash and case windows
- Remove external grilles
- Install internal security grilles
- Repaint shopfront and fascia
- New fascia signage
- New hanging sign
- Refurbish CI rainwater goods

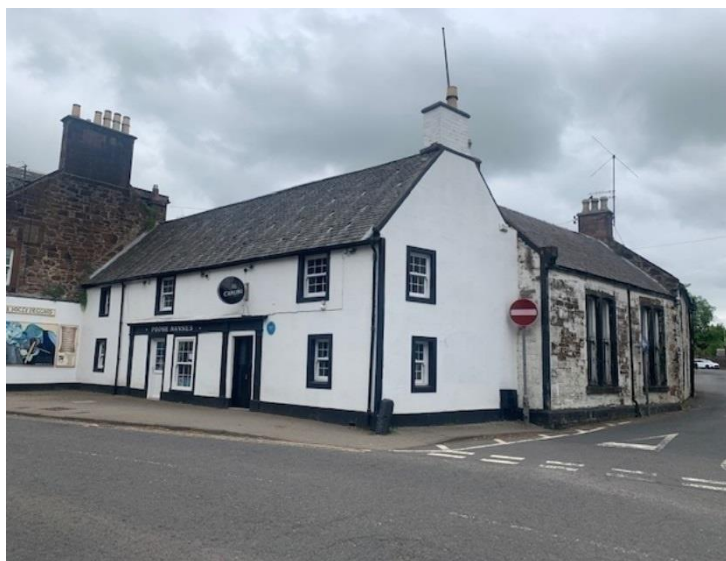
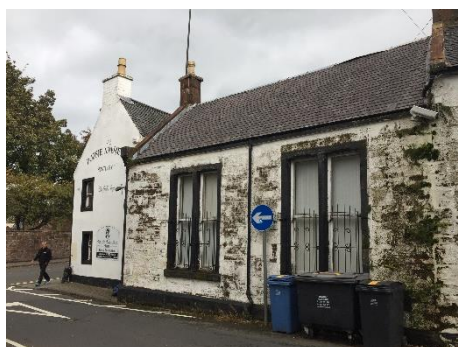
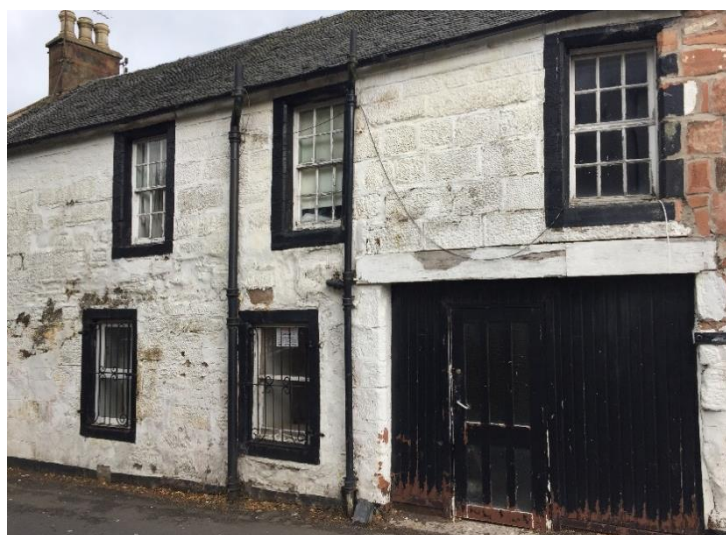
21 Loudon Street
Poosie Nansie's Ale House

Restrictions	Surveyed from Loudoun Street / Cowgate only.
Structural Issues	Deviations in roof line to rear
Storey Height	2 – end terrace returning on to Cowgate single storey, stepping back up to 2-storey on Cowgate.
Roof	Slate with zinc ridge and straps. Lead soakers / vents to Loudoun Street side. Lead skew flashings & mortar skewes.
Chimneys	Rendered chimney on corner with 1 pot. Stone chimney to Cowgate l.h.s with 1 pot. Central stone chimney on Cowgate with 3 pots.
Walls	Painted render to Loudoun Street. Painted masonry to Cowgate. Areas of damp from defective rainwater goods.
Windows	uPVC to Loudoun Street Timber sash and case to Cowgate.
Doors	uPVC to Loudoun Street. Modern timber storm doors. Modern timber to Cowgate.
External Pipework	Cast iron gutters and downpipes
Priority Score	(2+3+3) 8

- Remove soakers / roof vents and relocate
- Carry out minor slate repairs
- Replace missing ridge flashing to Cowgate side
- Replace mortar skewes

- Remove cement render, repoint, re-render with lime-based material, carrying out stone repairs where necessary.
- Remove paint from masonry.
- Replace windows
- Replace doors
- Refurbish CI rainwater goods, replacing uPVC.
- Add new downpipe to Cowgate elevation
- Replace signage.

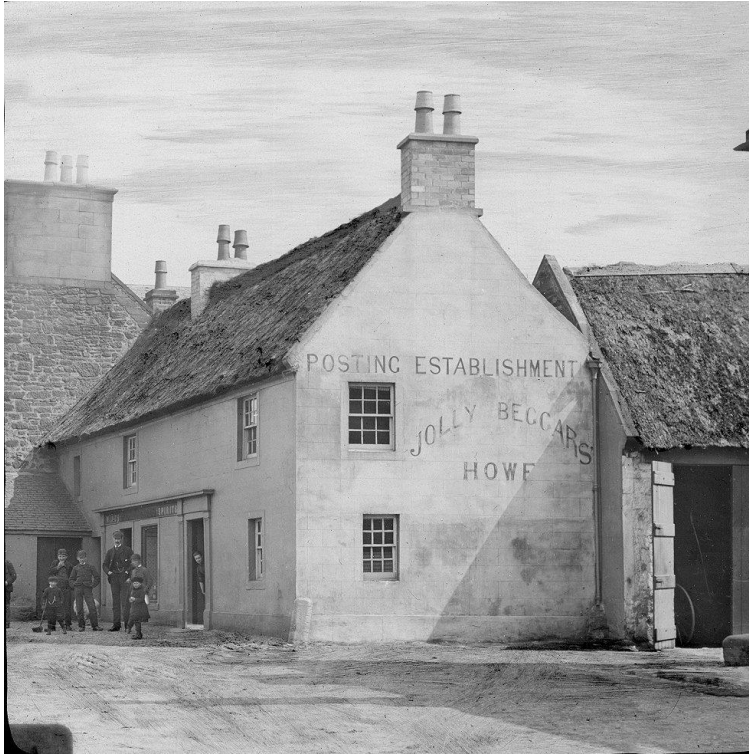
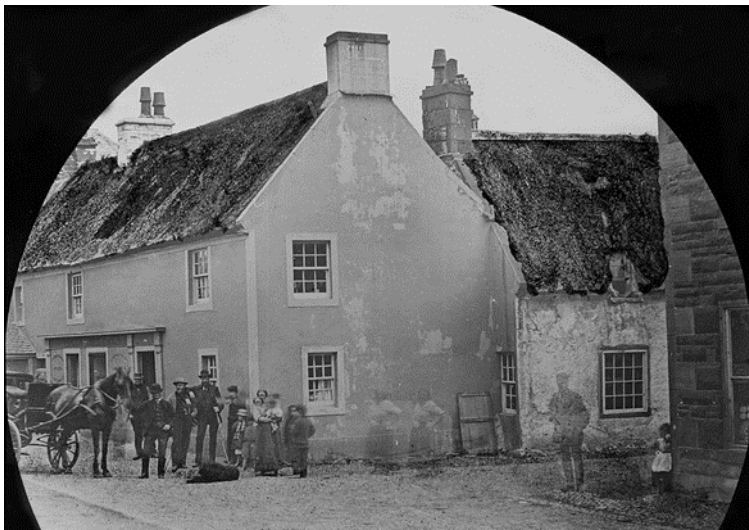
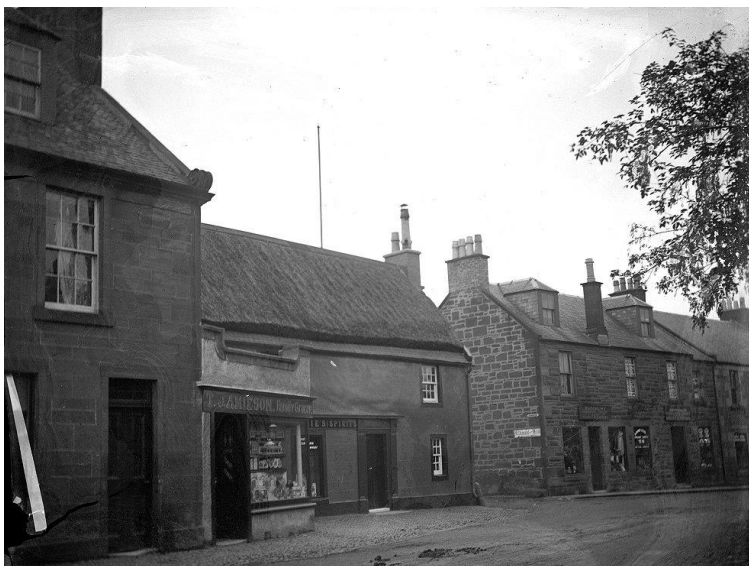
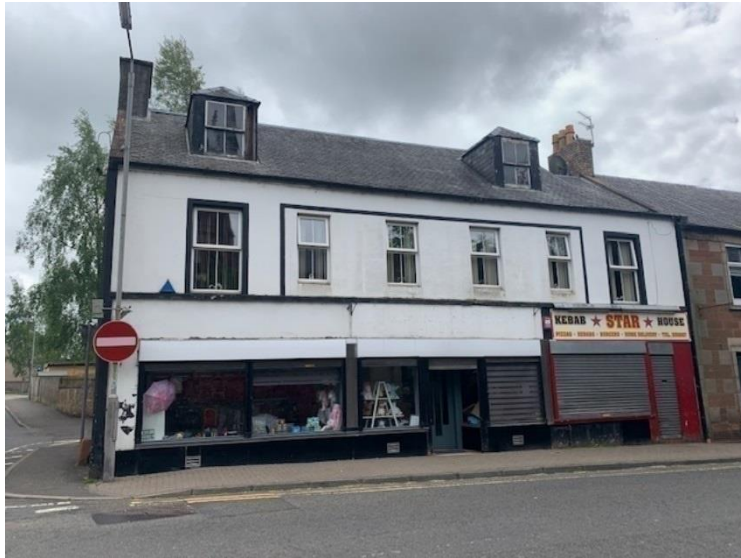
23/23a-25 Loudoun Street

Ground – occupied First – occupied Second – uncertain
Restrictions	Surveyed from Loudoun Street only.
Structural Issues	None apparent.
Storey Height	2 – end terrace with 2no. hipped dormers.
Roof	Natural slate with zinc ridge and clips. 1no. mortar skew to l.h.s. 2no. lead skews. Lead flashing to dormers and chimneys.
Chimneys	Rendered chimney to l.h.s. No pots. Brick chimney on party wall to r.h.s with 3no. pots.
Walls	Render is in an acceptable condition. Security shutters down. 1no. large fascia over 3 units. 3no. modern air grilles
Dormers	2no. gabled dormers with 2 x 2 timber sash & case windows and timber surrounds in poor condition. Slated cheeks.
Windows	uPVC to first floor. 2x2 timber sash & Timber 2x2 sash and case in dormers.
Doors	Modern timber to commercial property
Shopfronts	Timber. uPVC sign to r.h.s.
External Pipework	uPVC gutter and downpipe

(0+2+2) 4

- Carry out minor slate repairs
- Replace mortar skews
- Repair / repaint dormer timbers
- Paint render
- Replace modern grilles
- Replace uPVC windows
- Refurbish dormer timber sash and case windows
- Remove external roller shutters
- Replace shop fronts
- Install full length timber fascia and signage
- New hanging signs (x2)
- Install internal security grilles
- Replace uPVC rainwater goods with CI

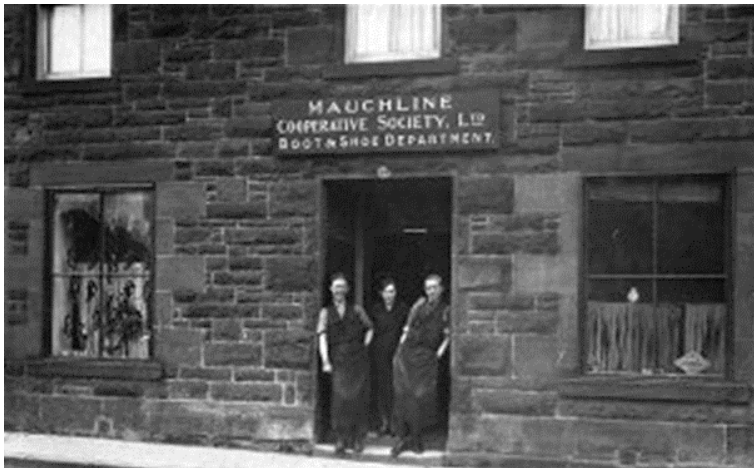
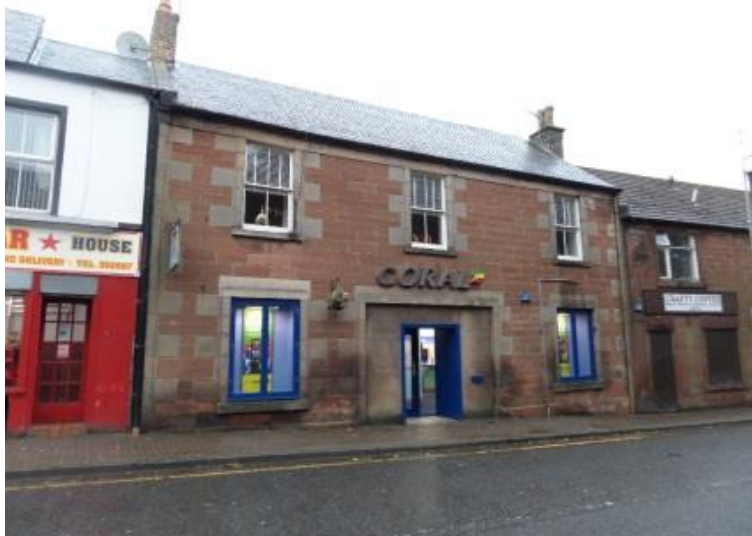
27-31 Loudoun Street
Commercial / Residential

Ground – vacant First – occupied
Restrictions	Surveyed from Loudoun Street only
Structural Issues	None apparent
Storey Height	2 - mid terrace.
Roof	Natural slate with zinc ridge and clips. 1no. mortar skews. Lead chimney flashing. 1no. copper skew putt flashing. Section of mortar skew missing.
Chimneys	Brick chimney with 3no. pots to party wall on l.h.s. Stone chimney with 2no. damaged pots to r.h.s.
Walls	Red ashlar sandstone with blonde sandstone quoins. Partially rendered. 1no. dropped lintol to l.h.s. window at first floor level. Masonry in reasonable condition. Some heavy mortar repairs around downpipe connection. Some low-level staining

and erosion of render. 2no modern louvered air grilles.
Windows	uPVC
Doors	Modern timber glazed door
Shopfronts	Modern timber shopfronts. Doorway appears to have been reduced in size. Modern fascia's.
External Pipework	uPVC gutter. Cast iron downpipe requires refurbishment.

(0+2+2) 4

- Carry out minor slate repairs
- Replace mortar skew
- Replace damaged chimney pots
- Carry out localised stone repairs
- Replace modern grilles
- Replace shopfronts and door
- Replace uPVC gutter with CI
- Refurbish CI downpipe

- New fascia signage

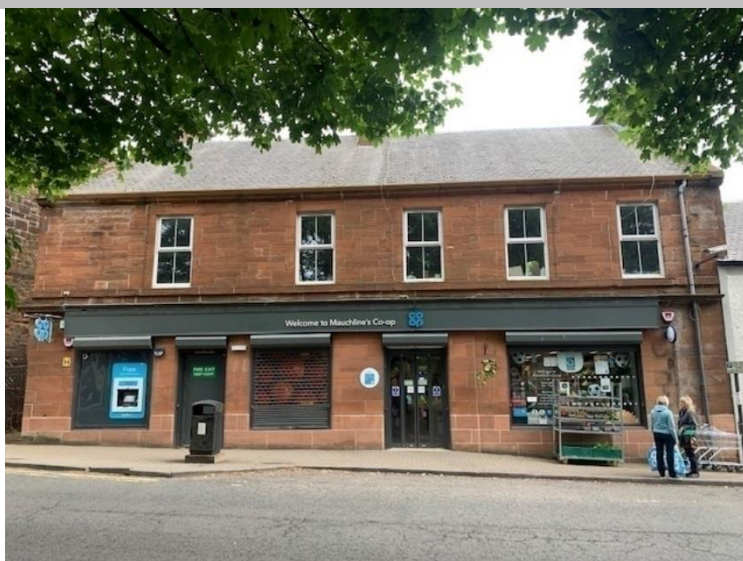
43-51 Loudoun Street The Co-op / Residential

Ground – occupied First – about to be split into flats.
Restrictions	Surveyed from Loudoun Street only
Structural Issues	None apparent
Storey Height	2 – end terrace.
Roof	Natural slate roof with zinc ridges and clips. Lead chimney flashings / mortar skews.
Chimneys	3no. red sandstone stacks. No pots
Walls	Red ashlar sandstone. Masonry is heavily eroded at base course. Staining at either end of gutter

and at downpipe. ATM.
Windows	uPVC at first floor
Doors	Bi-fold aluminium entrance door. Painted blank escape door.
Shopfronts	External security shutters. Timber shopfronts and fascia. Bi-folding aluminium doors
External Pipework	Cast iron wall head gutter and downpipe.

Priority Score (0+2+1) 3

- Carry out minor slate repairs
- Replace mortar skews
- Carry out stone indenting below cill line for full length of elevation
- Remove external shutters
- Install internal security shutters
- New hanging sign (1no.)
- Replace escape door
- Refurbish CI rainwater goods

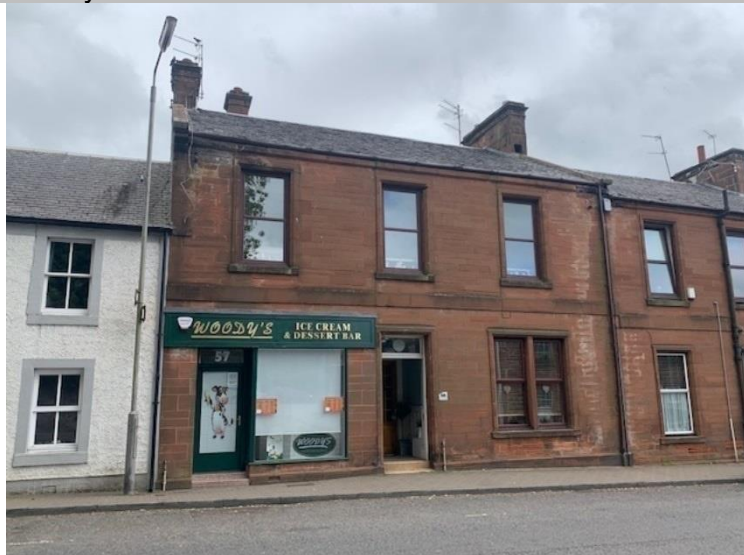
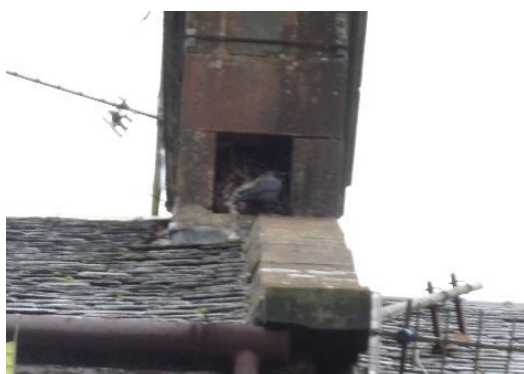
57-59 Loudoun Street

Chimneys Red sandstone chimneys at each end. 1 no pot to l.h.s. Additional chimney evident at rear. Stone missing from stack on r.h.s.

External Pipework uPVC gutter and down pipe.

Priority Score (0+2+1) 3

- Carry out minor slate repairs
- Replace mortar skews
- Replace missing stone to stack
- Carry out localised stone repairs and repointing
- Replace modern grille
- Replace uPVC windows
- Refurbish storm doors and fanlight
- Replace uPVC rainwater goods with CI

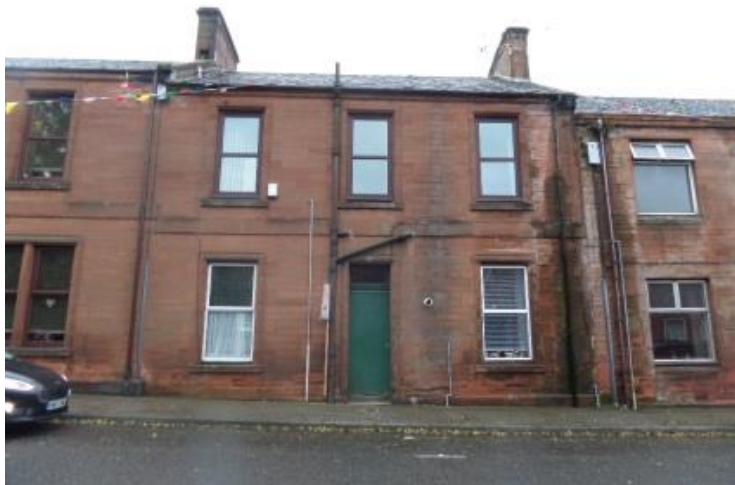
61 Loudoun Street
Residential

Ground - occupied First – vacant
Restrictions	Surveyed from Loudoun Street only
Structural Issues	None apparent
Storey Height	2 – mid terraced.
Roof	Natural slate with zinc ridge and clips. uPVC vents. Lead / mortar skew, lead chimney flashings
Chimneys	Red sandstone chimneys at each party wall. 1no. pot to r.h.s. No. pots to l.h.s. Stone missing from stack on l.h.s.
Walls	Red ashlar sandstone. Masonry erosion at ground level. Heavily stained, water damaged due to defective downpipe at r.h.s. 1no. cast iron grille.
Windows	uPVC
Doors	Modern painted blank with fanlight. No ironmongery of note.
External Pipework	Cast iron half round gutter. Cast iron vent stack and

cast iron rain water pipe to r.h.s. defective.

Priority Score (0+2+2) 4

- Carry out minor slate repairs
- Replace mortar skew
- Replace missing stone to stack (see 57-59 Loudoun Street)
- Carry out localised stone repairs and repointing
- Replace uPVC windows
- Replace door and fanlight
- Refurbish / repair CI rainwater goods
