Mauchline Conservation Area Management and Maintenance Plan

Prepared for East Ayrshire Council
by
Wylie Shanks Architects

Adopted 27.03.2023

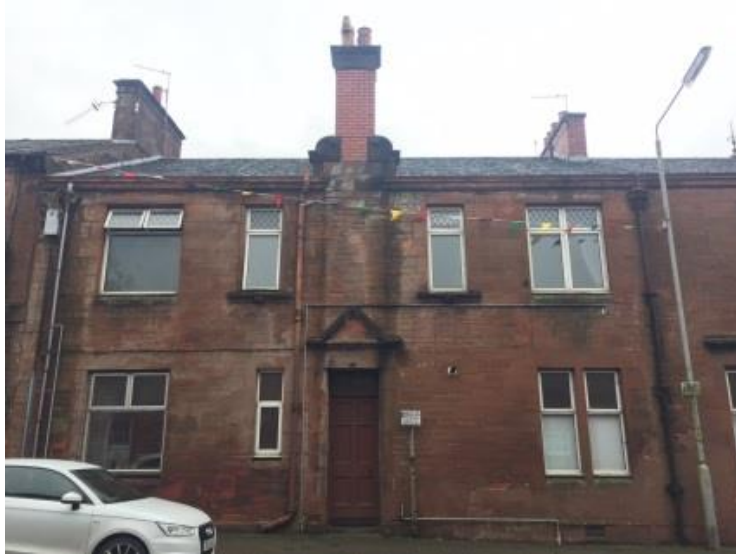
63 Loudoun Street
Residential

Restrictions	Surveyed from Loudoun Street only.
Structural Issues	None apparent
Storey Height	2 – mid terrace.
Roof	Natural slate with lead ridge and clips. Lead skew and chimney flashings.
Chimneys	Red brick wall head chimney with scrolled stone shoulders and stone cap with 2no. pots. Red brick chimney shared with No. 65 to r.h.s.
Walls	Squared rugged red sandstone. Significant damage from defective rain water goods. Heavy over pointing at ground level particularly at gutter ends and shared downpipe. 1no. modern aluminium grille and 1no. ornate cast iron grille.
Windows	3no. stone mullions may have been removed. 7no. uPVC windows 1no. aluminium window
Doors	Panelled timber door with fanlight.
External	Cast iron wall head

- Carry out minor slate repairs
- Carry out localised stone repairs and repointing
- Reinstall stone mullions
- Replace modern grille
- Replace windows
- Refurbish door and fanlight
- Refurbish CI rainwater goods
- Replace uPVC section with CI

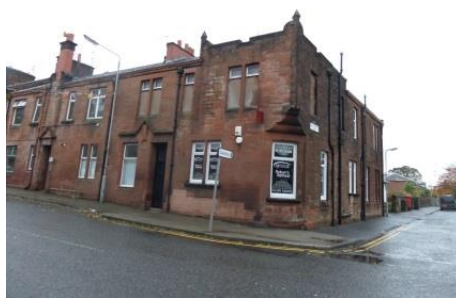
65 Loudoun Street

Structural Issues Crack in lintol at ground floor window. Some movement evident in parapet at corner.

Chimneys Red brick chimney at party wall with 4no. terracotta cans.

Walls Red sandstone. Squared ashlar chamfered corner with corbelled corner projection. Castellated parapet detail at corner with stone finials. Decorative iron roof finial. Some damp staining. Extensive indents at ground floor level. Additional indents and repointing required. 1no. partially covered

ornate cast iron grille.
Windows	uPVC. First floor windows have partially been blocked up.
Doors	Panelled timber door with Georgian wire fanlight
External Pipework	<u>Loudoun Street</u> - Cast iron wall head gutter, 1no. and 1 shared cast iron downpipe with decorative hoppers and ears. Shared downpipe showing evidence of damage. Damaged stonework and 2 ears broken. <u>Barskimming Road</u> - 1no. cast iron downpipe with decorative hopper and 1no. cast iron vent stack both with decorative ears.
Priority Score	(0+2+3) 5

- Carry out structural inspection & any recommended remedial repairs
- Carry out minor slate repairs
- Replace lead parapet gutter
- Carry out stone repairs
- Repoint
- Replace uPVC windows
- Open up first floor windows and install new timber sash and case windows
- Refurbish door
- Refurbish CI rainwater goods

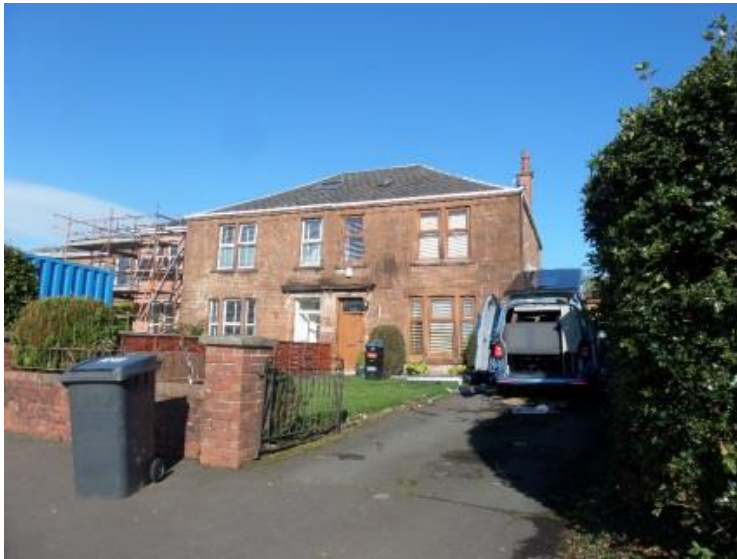
2-4 Tanfield Residential

Occupied	
Restrictions	Restricted visibility due to driveways.
Structural Issues	None apparent.
Storey Height	2 – 2 semi-detached.
Roof	Natural slate with zinc ridges and clips. Lead chimney flashings.
Chimneys	Red brick chimney to r.h.s. with 1no. pot.
Walls	Red ashlar sandstone. Masonry appears in good condition. Air bricks not

1 house has very recent side extension.

- Minor slate repairs
- Refurbish CI roof light
- Replace windows
- Replace doors
- Replace uPVC rainwater goods with CI

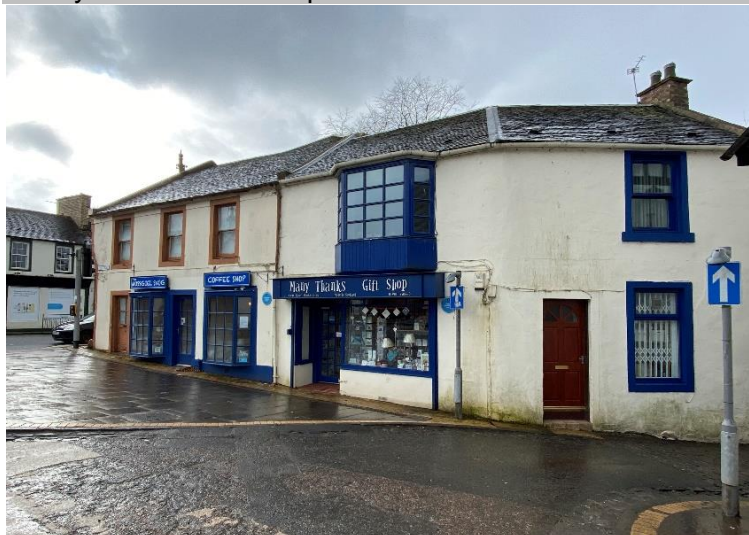
3-5 The Cross

Doors	Modern glazed door to gift shop. Panelled timber door to Flat 3a.
Shopfronts	Timber shopfront with fascia. Recessed doorway. External security shutter.
External Pipework	uPVC gutter. uPVC downpipe discharging into gutter of adjoining property.

Priority Score (0+2+1) 3

Recommendations:

- Carry out minor slate repairs
- Replace mortar skew

- Repaint render
- Refurbish timber sash and case windows
- Replace timber casement
- Replace door to flat
- Paint shopfront, bow window and timber fascia's
- Refurbish CI rainwater goods
- Install new CI downpipe with new below ground connection
- Install internal security shutter
- New hanging sign
