Conservation Area Maintenance Guide

John Finnie Street and Bank Street,
Kilmarnock

Published: East Ayrshire Council, April 2007

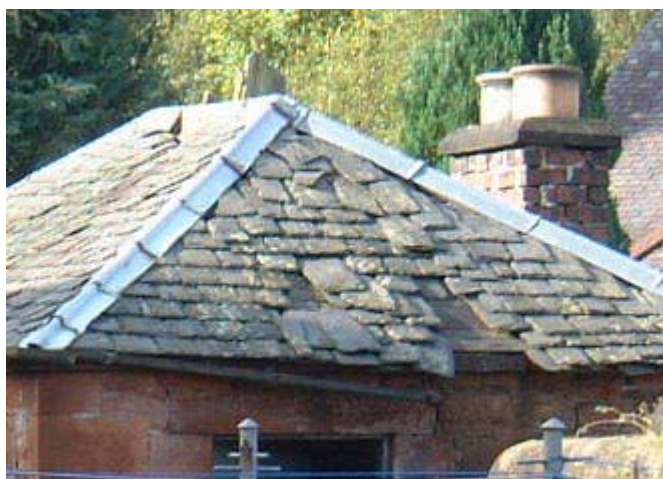
Decay can also occur through the natural ageing process or failure within individual components. As slates on average have a lifespan in excess of 100 years it is often the fixings and supporting timbers that usually deteriorate before the slates. This can result in 'nail sickness' (corrosion of the nails and subsequent slipping of slate work). On noticing several slipped slates along a roof line it is recommended that further inspection into the condition of the nail fixings is carried out.

Slate slippage can also be associated with the natural deterioration of the slate around the nail hole (delamination) or timber decay to the sarking beneath. It is important therefore to fully investigate the cause of slate damage as it may be an indication of a greater defect.

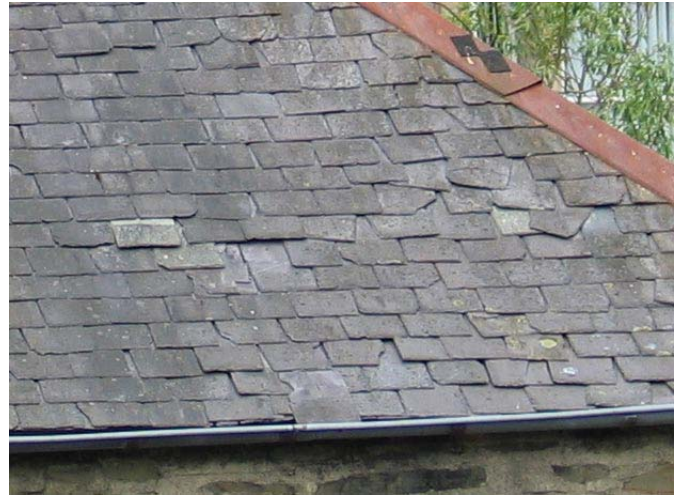
“Slate, though long lasting if properly cared for; is a natural brittle material which can be damaged by weather, impact damage and natural decay.”

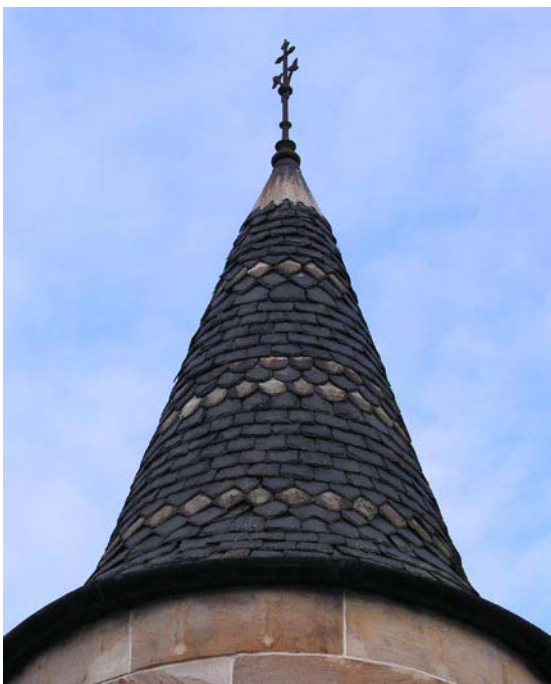
“For repairs, it is advisable to use natural slate rather than modern roofing alternatives ... newer slates should match the original building material as closely as possible in type, colour, texture, size and thickness”

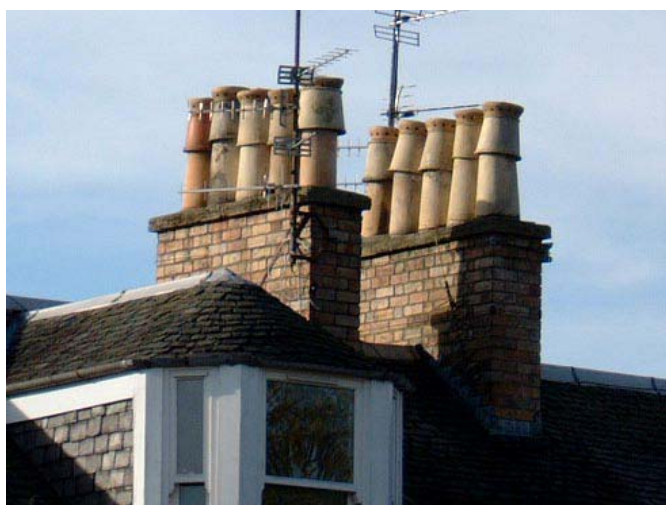
Chimneys come in a variety of shapes, sizes and decorative styles. Their prominent location contributes greatly to the overall appearance and general streetscape within the Outstanding Conservation Area. It is therefore essential that a regular programme of inspection is undertaken. Many chimneys have now become redundant, with general maintenance often being overlooked.

Without regular inspection and ongoing maintenance, chimney stacks will weaken and water penetration can go undetected.

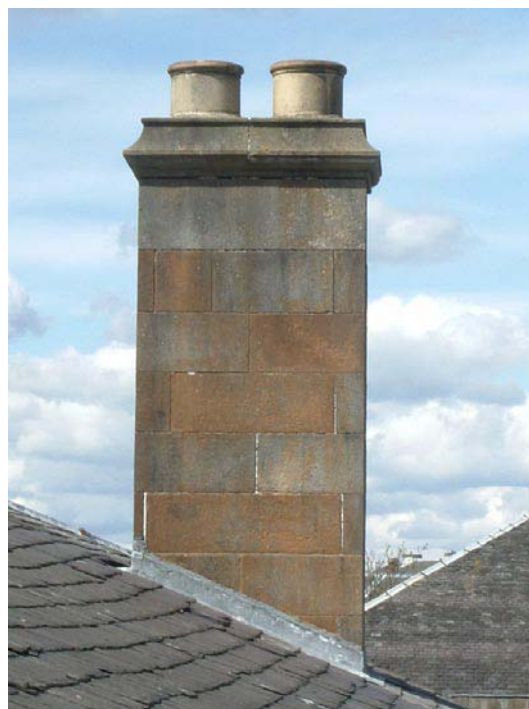
“Although chimneys may no longer be in use, it is still important that such aspects as the flues remain in good working order as they provide essential ventilation to rooms and the internal elements of the building.”

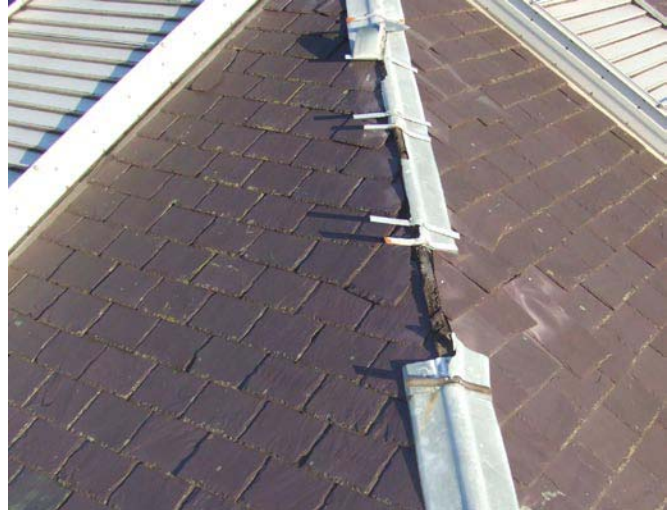
Where lead work has failed and suitable repairs are impractical, decayed sections should be carefully removed by a skilled roofer in order to avoid further damage to surrounding materials. Although newly introduced material may appear bright in contrast to original sections, atmospheric exposure will soon dull the sections to a matt grey colour. Work should follow Lead Sheet Association recommendations; a slightly thicker code of lead should be used in exposed locations.

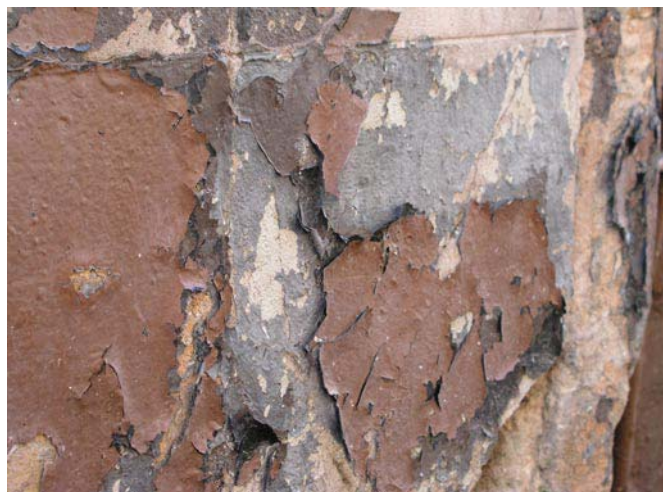
Key areas of stonework which often show evidence of decay are ledges and parapets. Because water

sits on the ledges, the mortar joints weather allowing damp to penetrate. This can usually be addressed by careful repointing and, in extreme cases, a new lead drip or flashing. Particular attention should be made to stonework at ground level as the continual splashing and saturation of stonework with water can result in decay.

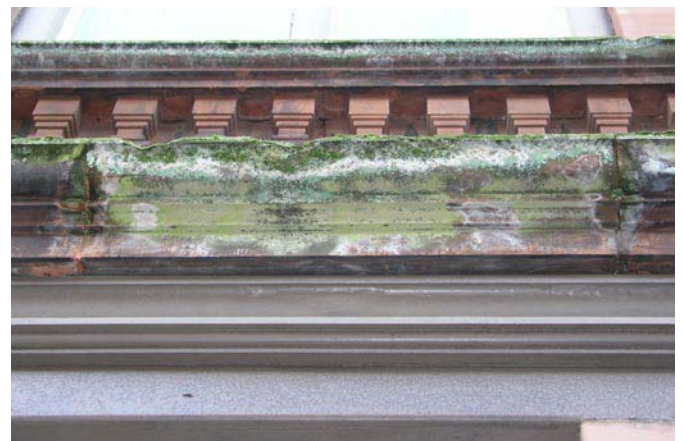
Growth should be cut back carefully, by hand. Under no circumstances should woody stemmed growth or ivy be pulled away, as this can dislodge masonry. Suitable non-staining systemic weedkillers should be applied to the main stems in order to kill the root systems, which must then be cut out carefully from the walls to prevent any possible regrowth.

Ivy should never be allowed to grow on walls as it can cause significant damage, however other species such as Virginia Creeper may be suitable and advice should be sought from East Ayrshire Council before carrying out any work.

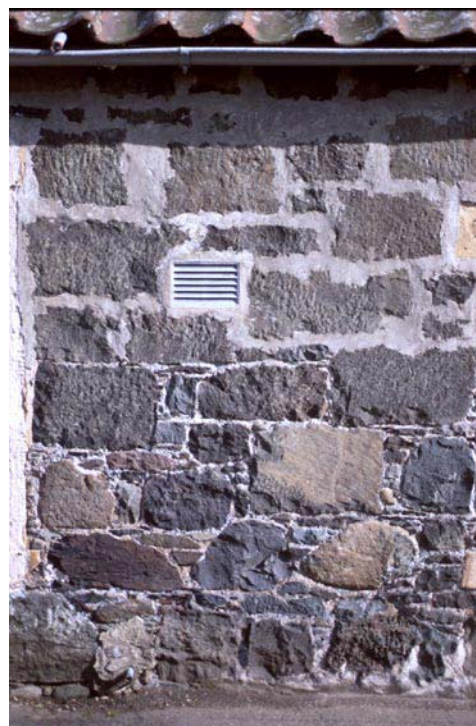
If possible, new fittings should be minimised and preferably fixed to joints rather than stone. Mild and even galvanised steel corrodes damaging stone forever. It is therefore essential that any new fixings be stainless steel which is readily available from all good builders merchants.

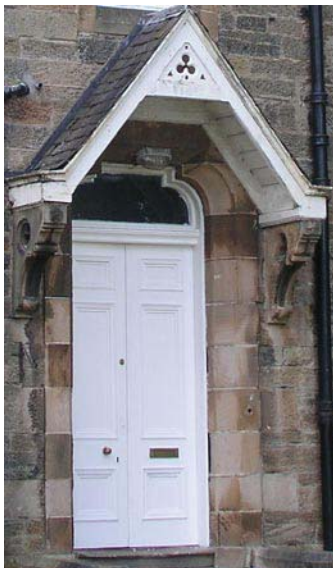
Image courtesy of A-S:L

Hinges can often become loose due to the enlargement of screw holes. To cure this, larger screws should be used or the realignment of hinges should be considered.

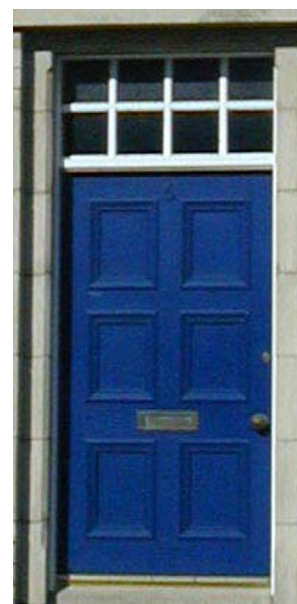
Where the level of decay has passed the point of simple filling and repair, a skilled joiner or carpenter can remove the effected area of timber and splice-in a piece of well seasoned timber. Care should be taken to ensure that replacement timber matches the original. Further advice can be sought from the Council.

Image courtesy of A-S:L

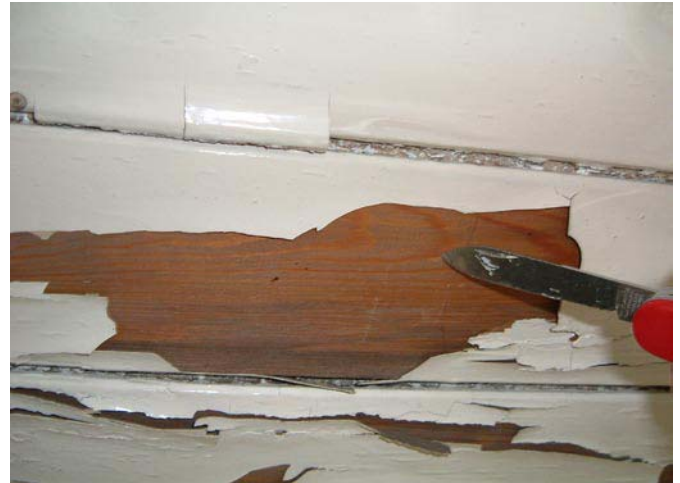
Image courtesy of A-S:L

Older paint finishes must therefore always be removed by heat guns and scraping, rather than sanding. Some finishes can be flammable and special care should be taken. Wherever possible paints should be replaced with breathable traditional finishes or modern microporous paints.

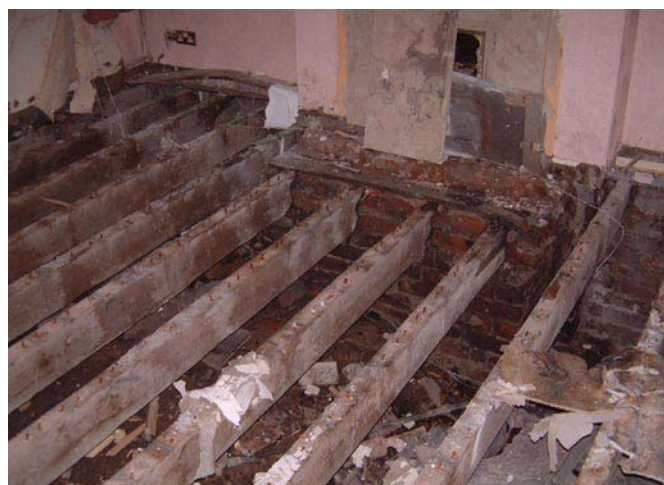
Dampness can also occur in floors; air bricks ventilating the space between the ground floor and the ground may have become blocked, leading to condensation, whilst older stone or concrete floors may not have incorporated a suitable damp proof membrane. If reopening vents does not work, then replacing older floors with concrete may be acceptable but this is likely to be expensive.

Image courtesy of A-S:L
