Mauchline Roof Scape:

Traditional Scottish Slating Practice & Terminology:

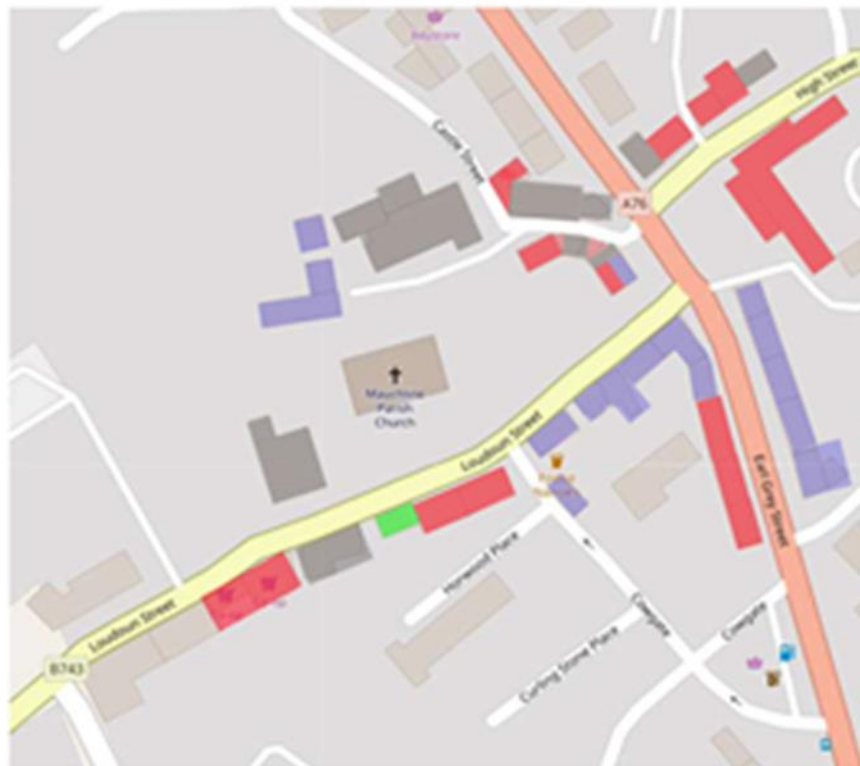
The results of this are shown below:

Roofing Materials:

- Blue – West Highland Slate 38%
- Red – Welsh or Spanish Slate 36%
- Gray – Highland Boundary Slate 23%
- Green – Concrete Tile 3%

Auxiliary Materials:

- Cast-iron Gutters 44%
- PVCu Gutters 40%
- Lead Gutters 16%

Overall, 61% of the roofs are Scottish Slates laid in diminishing courses, and 36% are modern Spanish or Welsh slates laid in a consignment of the same length and width known as 'Tally'. Only 3% of the roofs looked at were new concrete tile.

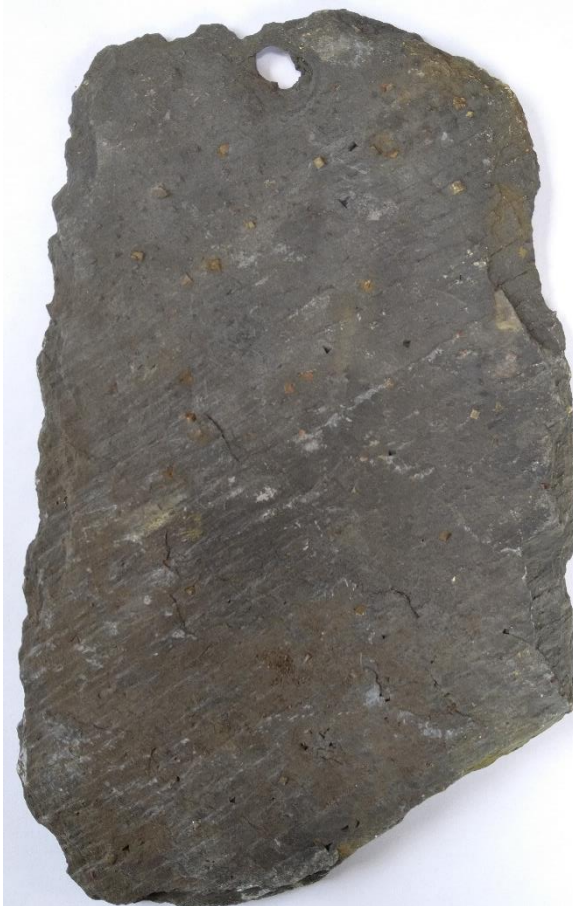
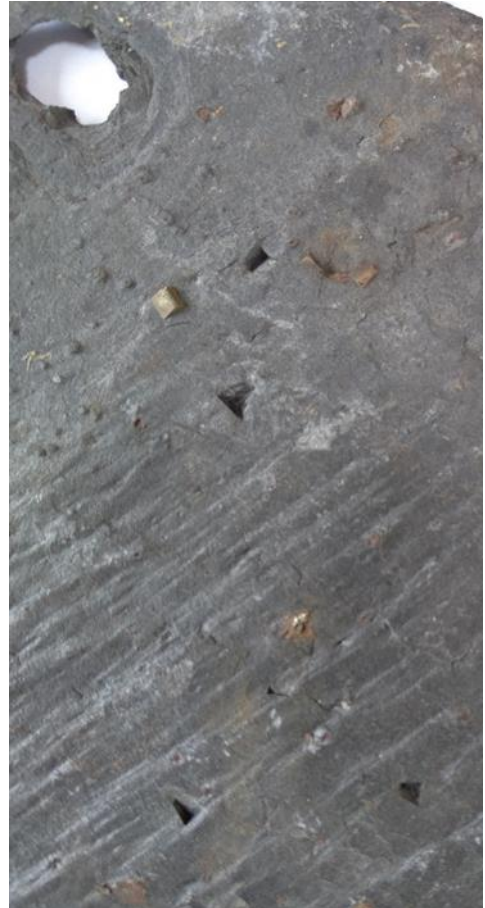
West Highland Slate:

These slates are rugged and durable and have a distinctive ridged surface texture and tiny crystals of fool's gold (pyrite). The reflective sheen on the Slate is also a notable characteristic and Single Nailed.

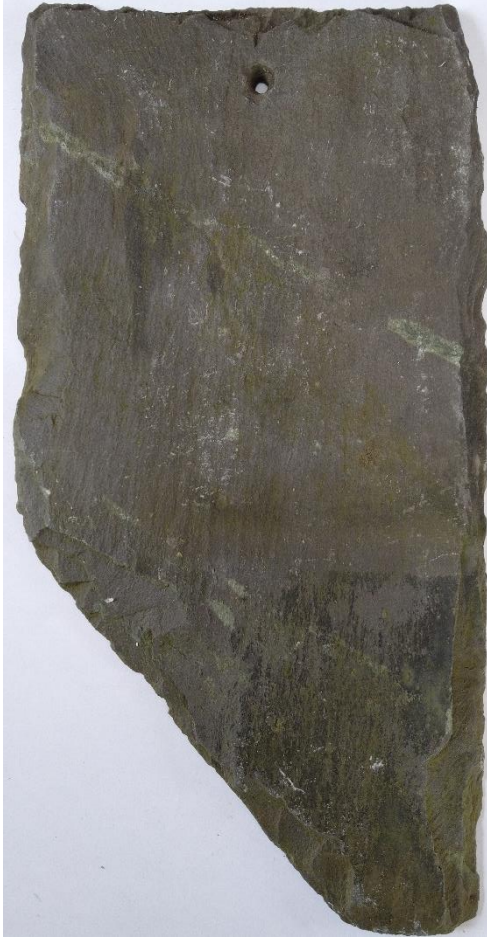
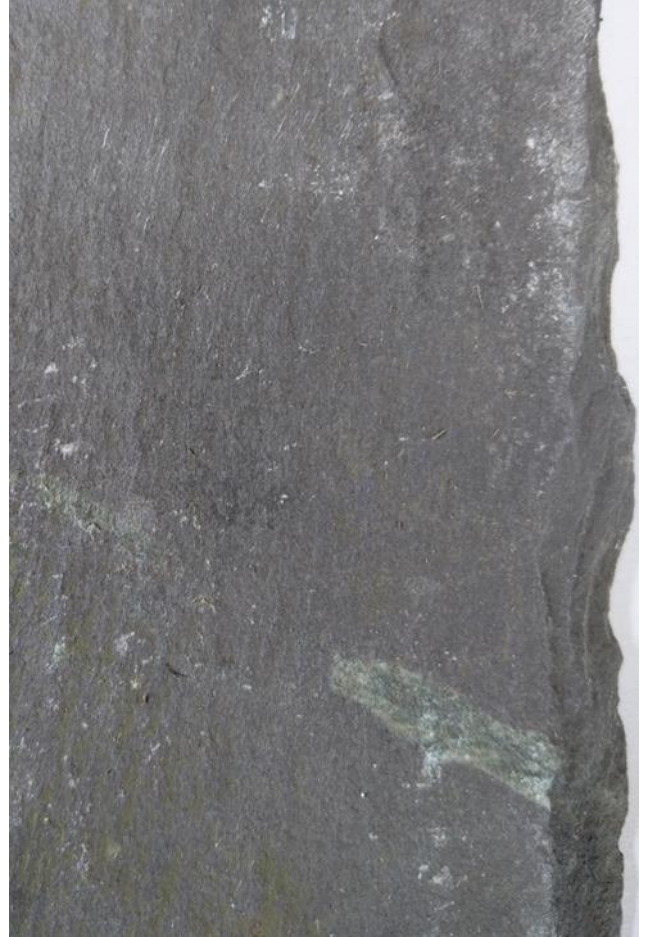
Highland Boundary Slate:

These slates are smoother and lighter in colour than the West Highland Slate. The colour can vary from grey to green and purple, and it often has distinctive ribbon stripes on the surface and Single Nailed.

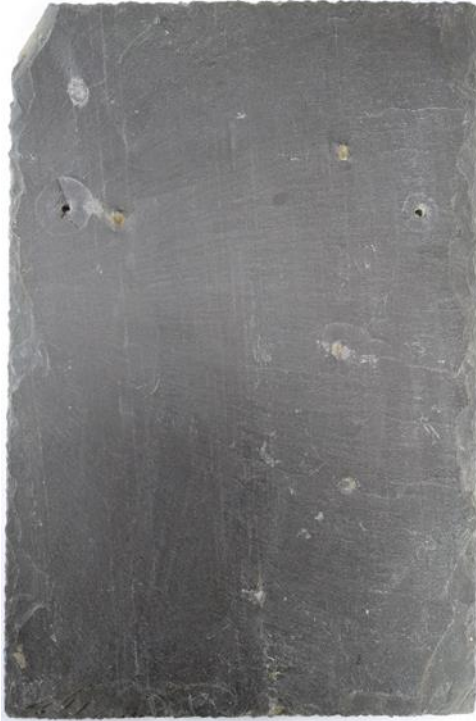
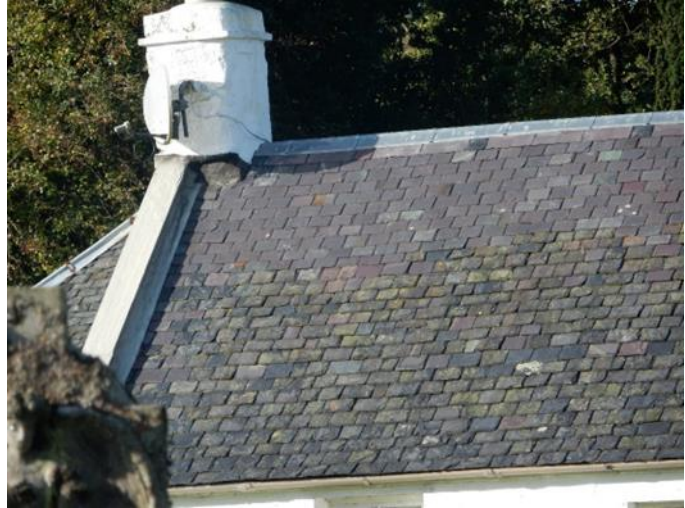
Welsh and Spanish Slate:

These slates are usually regular with two nail holes (Scots slates are typically less regular in shape and are single-nailed). They are grey to purple and thinner than the Scots slates.
